Movement Within Large Fills- Ridge Route Project

Interim Report

HIGHWAY RESEARCH REPORT

NO. M & R 632509-3

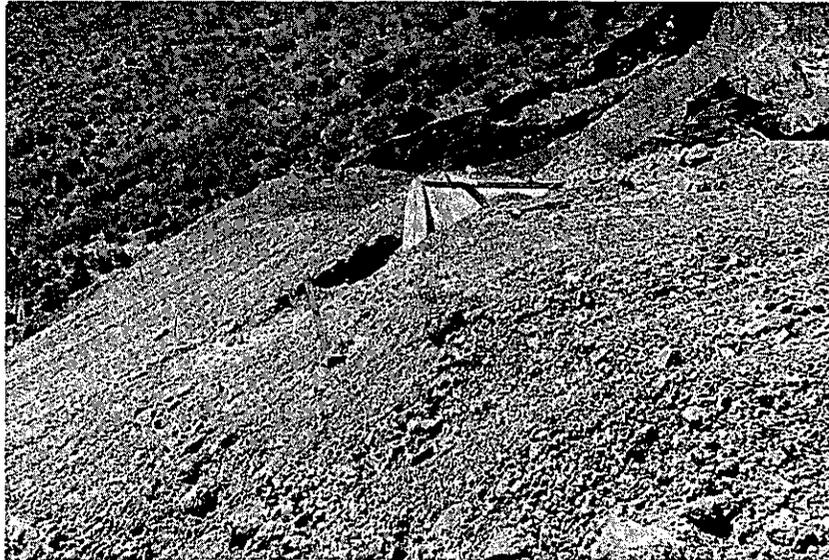
Figure 2. Instrument shelter
in place at Osito Canyon Fill.

The 5-foot diameter by 6-foot long cylindrical metal instrument shelters, which are surplus U. S. Navy missile containers, were used on these installations to prevent the extensive damage to the indicating devices which occurred on the San Luis Reservoir Project. Figures 2, 3 and 4 illustrate the use of those shelters. Backfill material in the instrumentation line trenches consisted of a selected material devoid of sharp, angular rock which might damage the protective plastic pipe and instrument tubing.

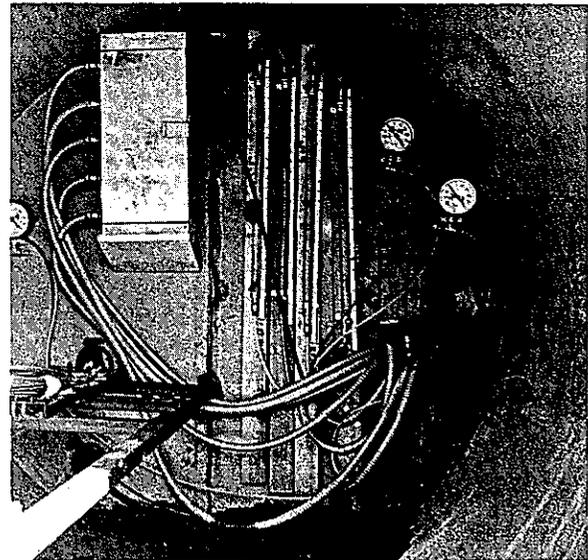
Figure 4. Interior of shelter.
Metal frame at lower left
supports horizontal movement
cables tensioning device and
foot-rule for reading purposes.

Because of space limitations in the instrument shelters, it was necessary to provide springs in lieu of dead weights to hold the horizontal movement cables in tension. The plastic coated 3/16" wire ropes, after being pretensioned with a torque wrench to approximately 200 pounds as shown in Figure 5, were attached to springs anchored in the shelter. These spring lengths were adjusted to apply a nearly constant 50-pound tension on the cables. This tension is checked by stretching the spring to a predetermined length before each subsequent reading is observed and recorded.

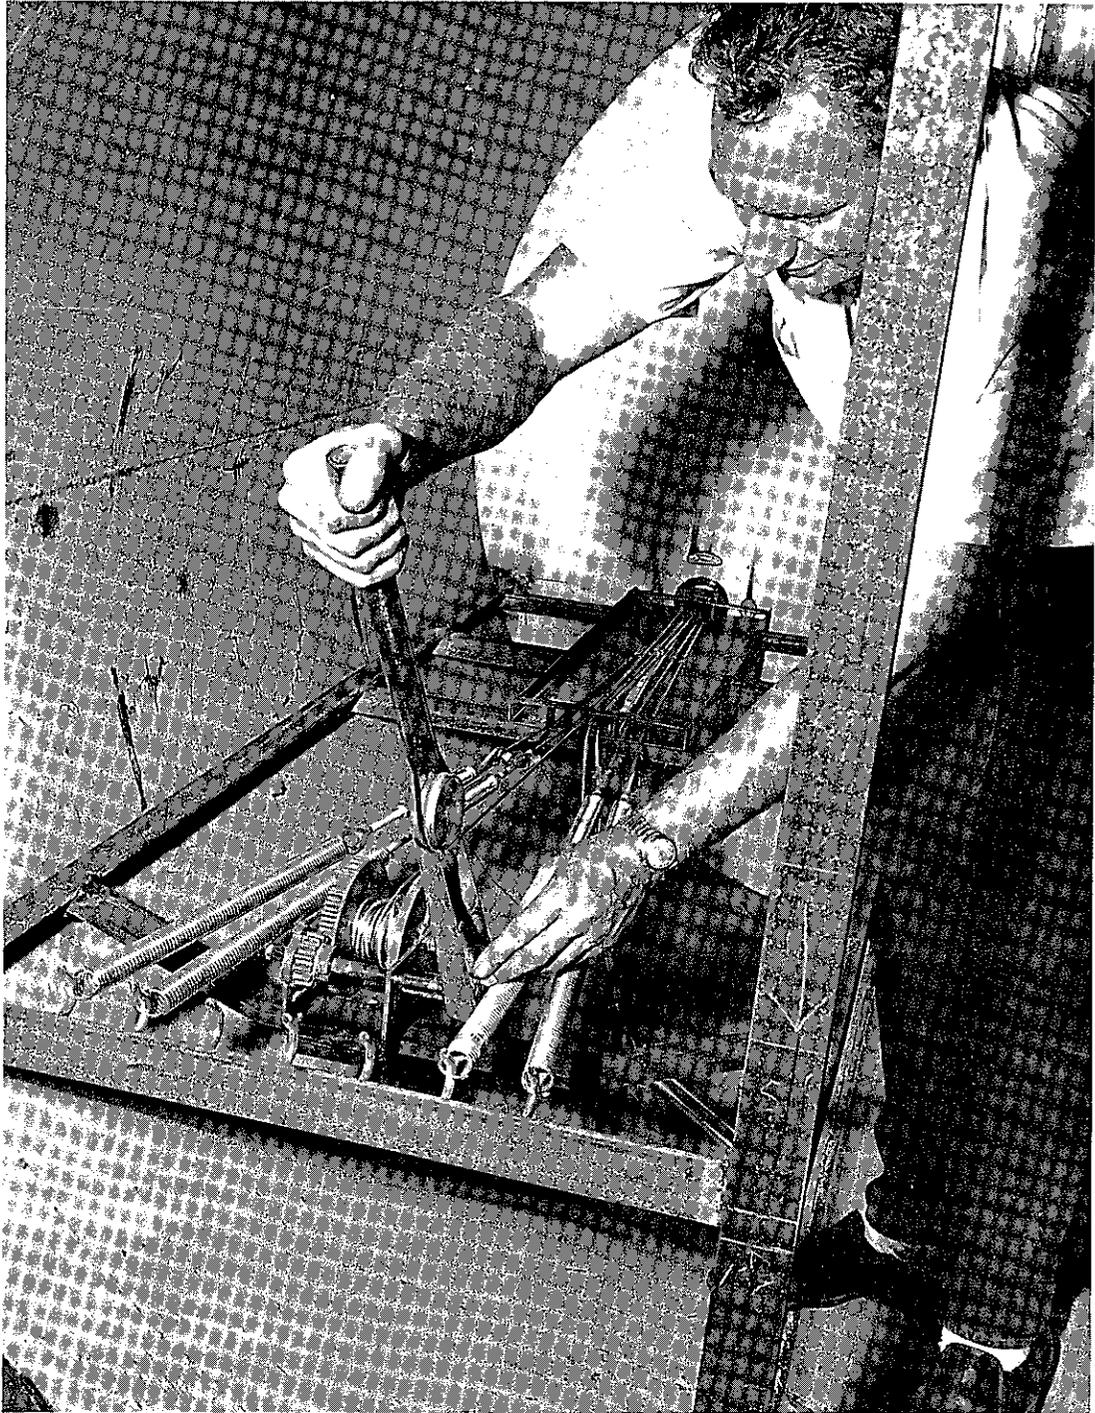
Figure 5

Tension being applied to
horizontal movement cables.

A permanent index is crimped onto each cable where it passes over a reading table in the instrument shelter. Readings are then taken by observing the location of the cable index relative to a scale permanently attached to the reading table. The reading table, scale, and cables with index attached can be seen in Figure 5.

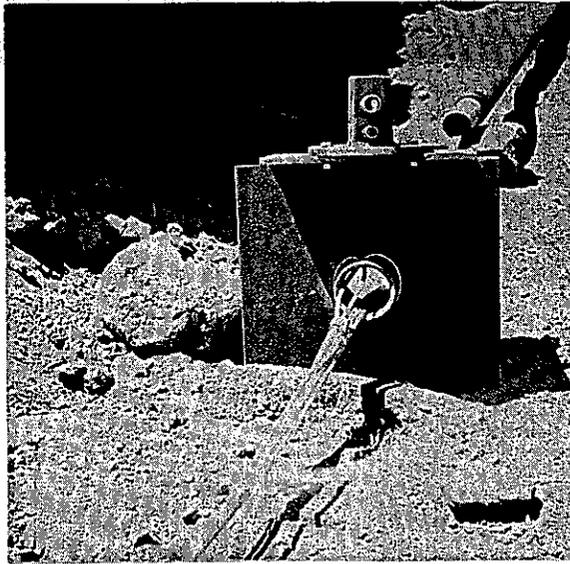
Figure 6. Horizontal movement platform with base of fluid-level type settlement platform riser attached.

The horizontal movement platforms consist of 12-inch square steel plates placed on edge at intervals of approximately 100 feet. The plates have a 2-inch hole in the center to facilitate passage of horizontal movement cables connected to other platforms in the same line of instrumentation (See Figures 6 and 7). Each horizontal movement platform has a cable attached which extends through a 1-1/2-inch polyvinyl chloride (PVC) plastic pipe to the outer edge of the embankment where it is secured to the tensioning spring inside the instrument shelter. The plastic pipe conduit provides a protective covering for the cables and reduces friction. An expansion joint is placed at intervals of 40 feet in the plastic pipe throughout the length of the horizontal movement installations.

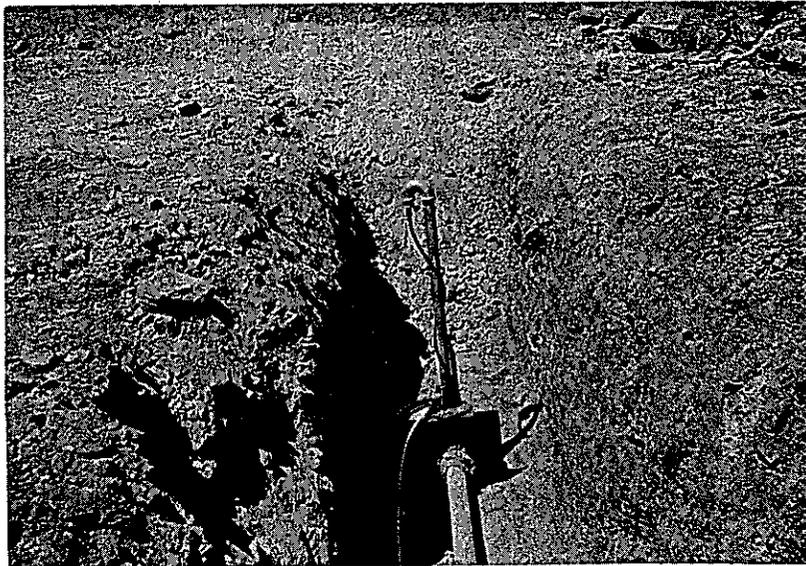
Figure 7. Completed unit of horizontal movement platform and settlement platform ready to be backfilled with select rock-free material.

The measurement of vertical movement within fills is accomplished by the use of water level type settlement platforms which are attached to the top of the horizontal movement platforms as shown in Figure 7. These settlement devices are the same closed system type utilizing air vent and drain lines which were used at Station 80+00 on the San Luis Reservoir Relocation project.

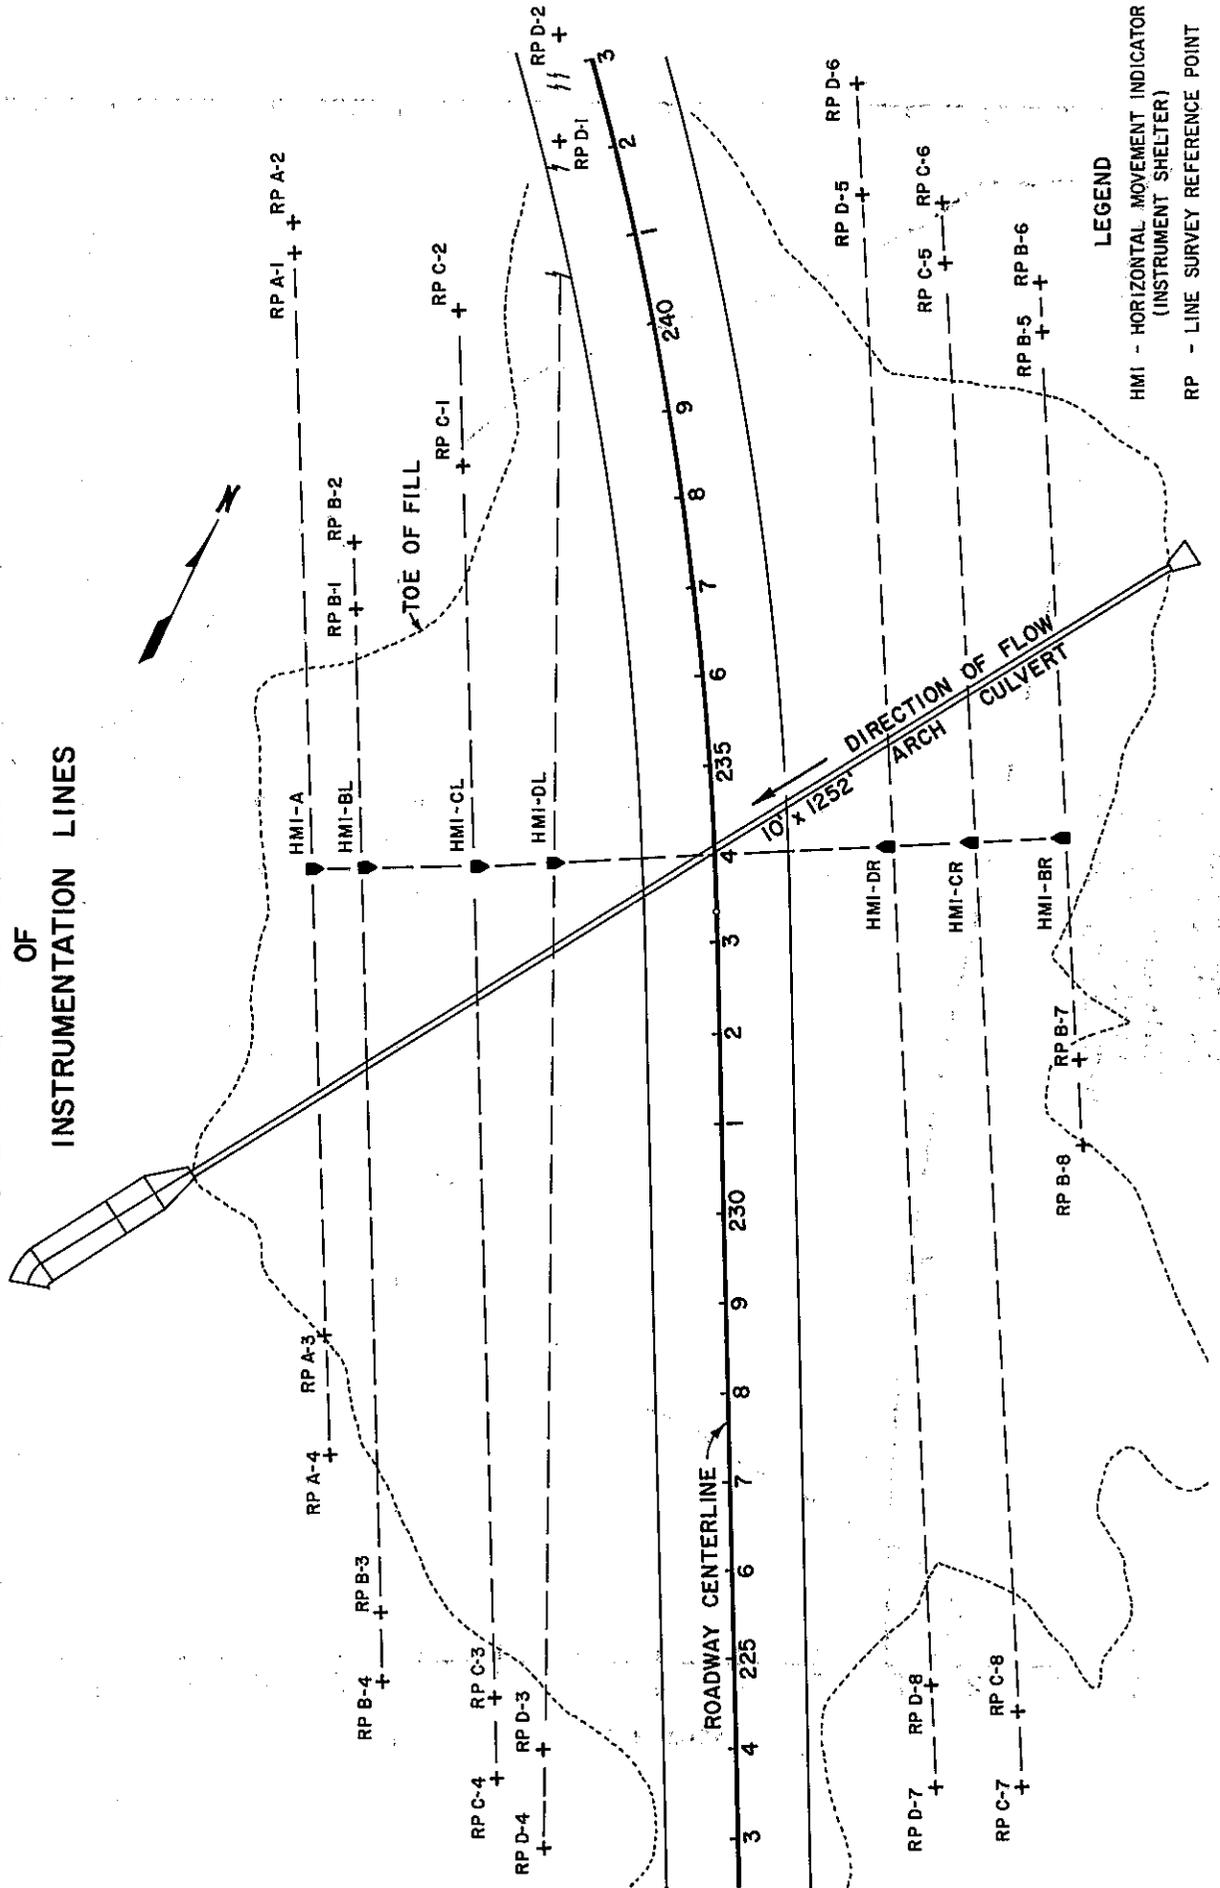
OSITO CANYON

PLAN VIEW SHOWING LOCATION OF INSTRUMENTATION LINES

Survey bench marks were set outside the fill slope in original ground at each instrumentation level to monitor the instrument shelters for movement. These lines are shown in Figures 8 and 15.

Figures 8 and 15 show the lines of instrumentation set normal to roadway centerline rather than parallel to the canyon floor. This difference in alignment is clearly shown in Figure 8 where the Osito Canyon Culvert follows the Canyon alignment. It is very possible that the data obtained at the lower levels of instrumentation were influenced by the effect of soil movement along the sides of these steep, V-shaped canyons.

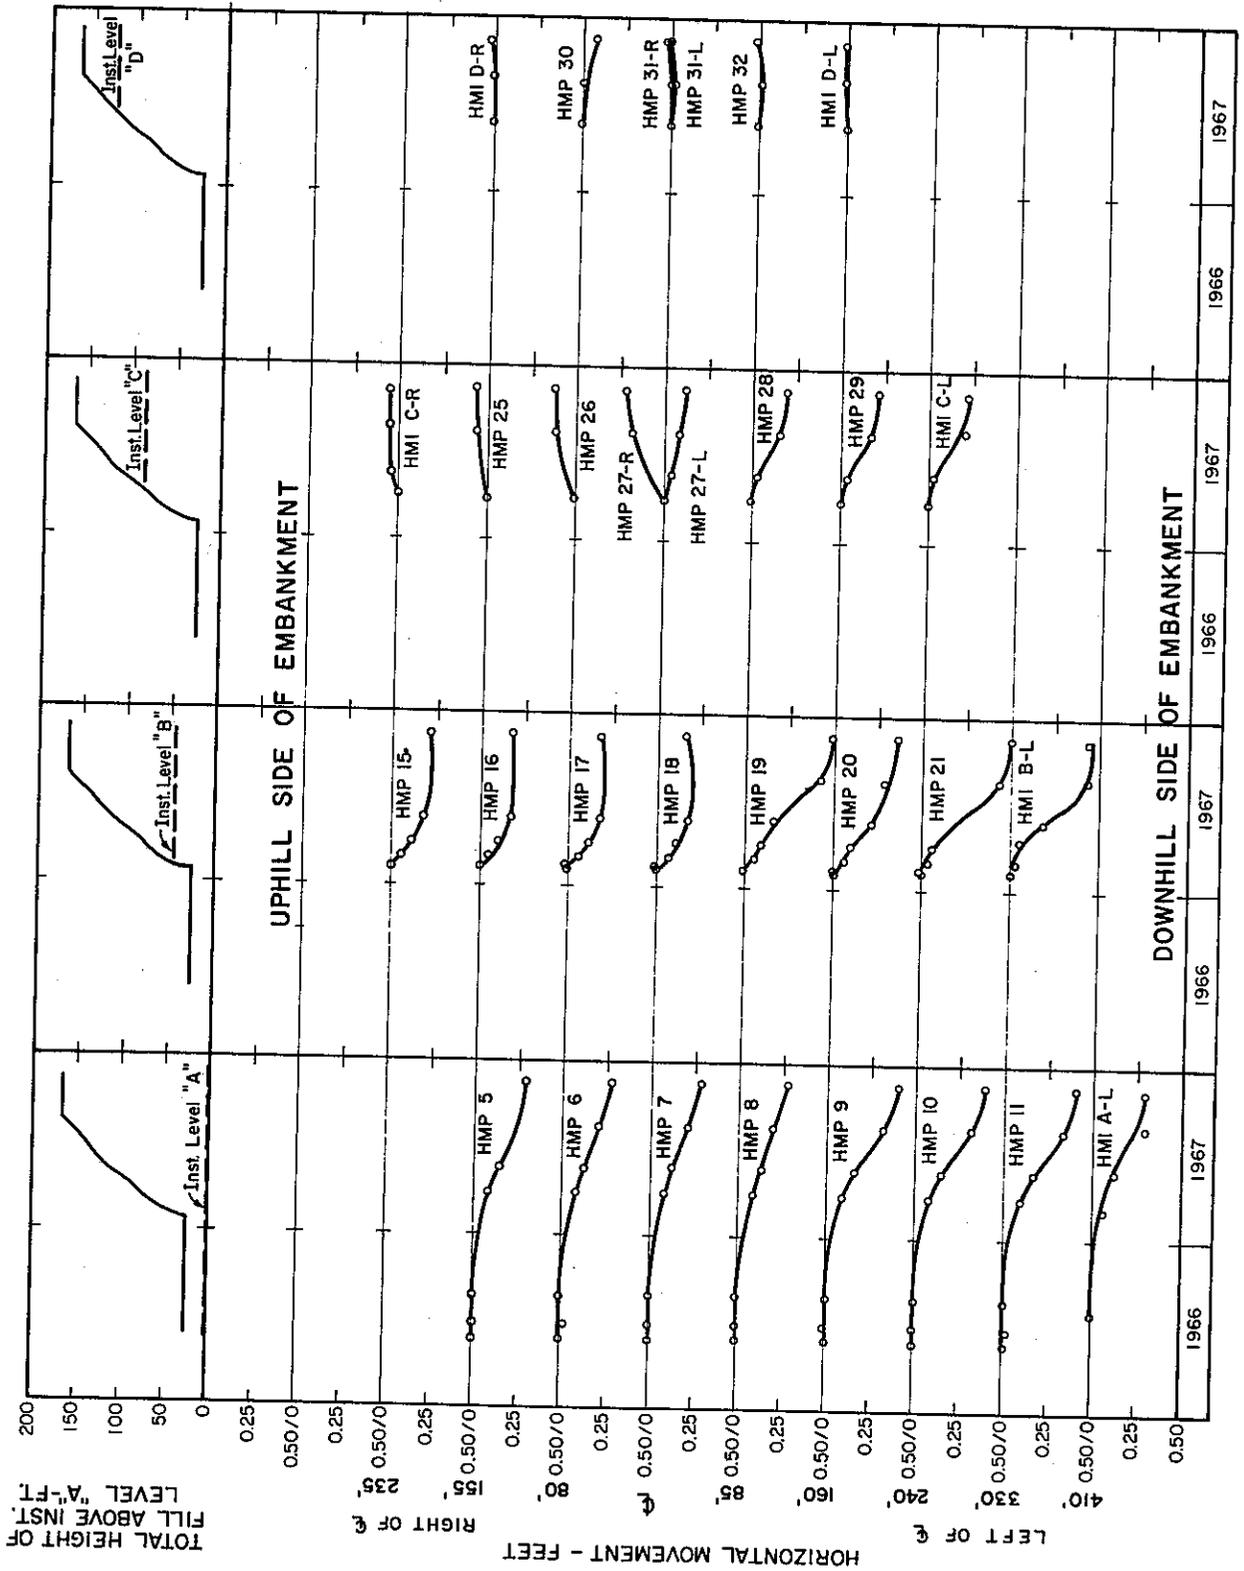
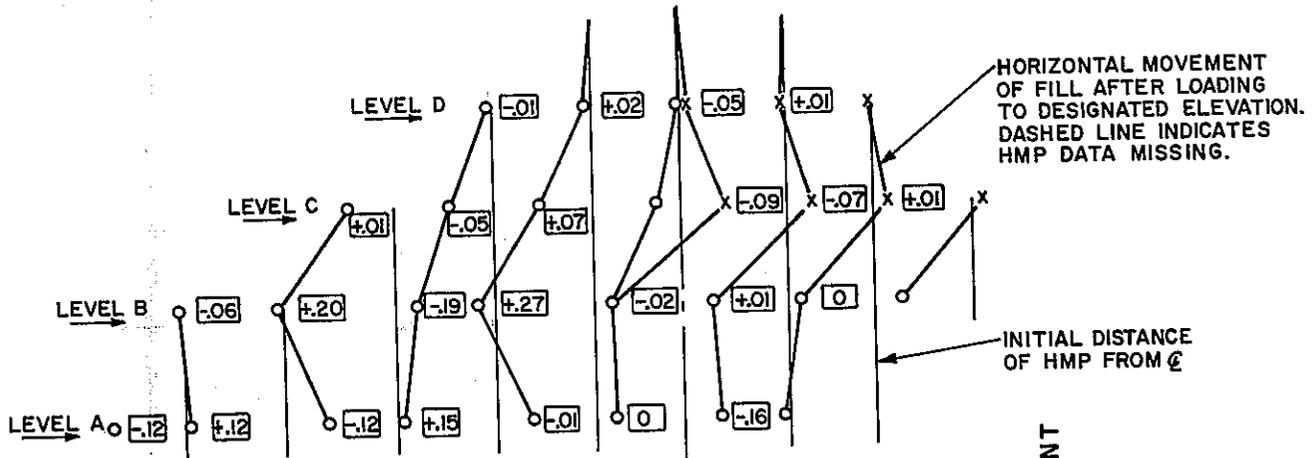
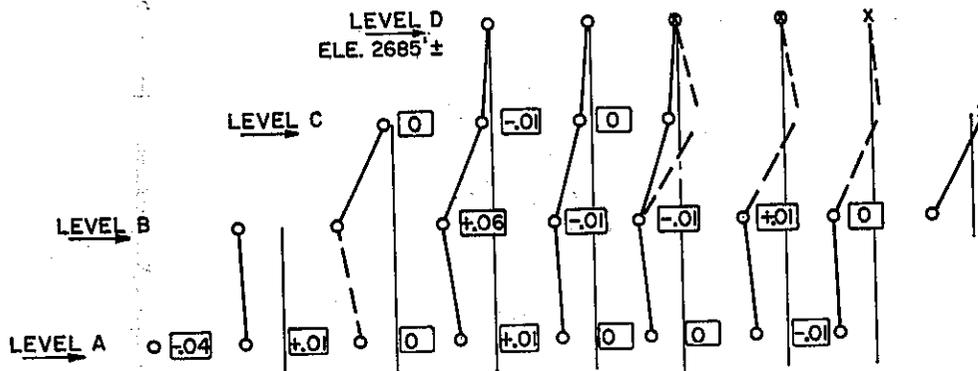
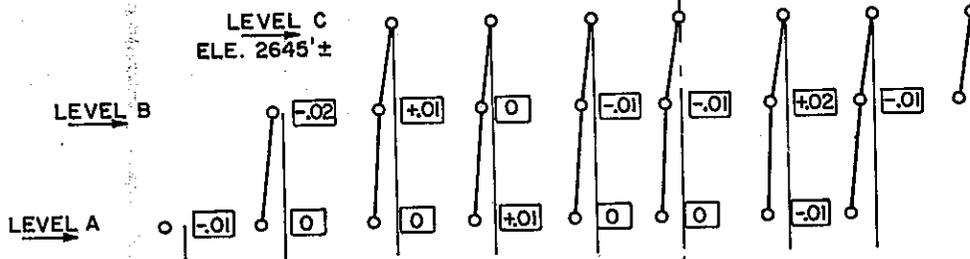
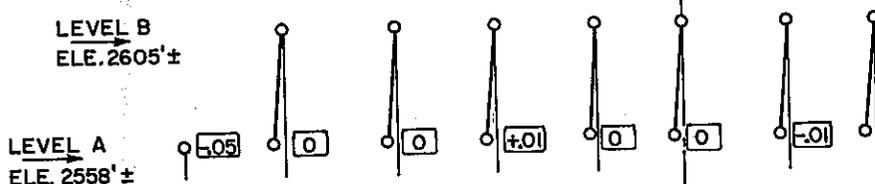
Figure 19

NO-NAME CANYON

HORIZONTAL MOVEMENT BETWEEN LINES OF INSTRUMENTATION
FOR VARIOUS HEIGHTS OF FILL
FILL ELEVATION 2730' (GRADE)

HORIZONTAL MOVEMENT OF FILL AFTER LOADING TO DESIGNATED ELEVATION. DASHED LINE INDICATES HMP DATA MISSING.

VALUES IN INDICATE PERCENT STRAIN BETWEEN PLATFORMS.

Horizontal movement and strain data for No Name Canyon are shown in Figures 18 and 19. In general, the same general horizontal strain trends as discussed above can be seen in this figure. In No Name Canyon, however, it appears that if a "keying" effect exists, it has a tendency to restrain horizontal movement but allows greater strains to be developed in the bottom level of instrumentation. Again, significantly greater strains were developed within the embankment when compared with those near the surface. Although greater slope dilation was observed at No Name Canyon, this dilation may or may not be reflected in the magnitude of the localized internal strains.

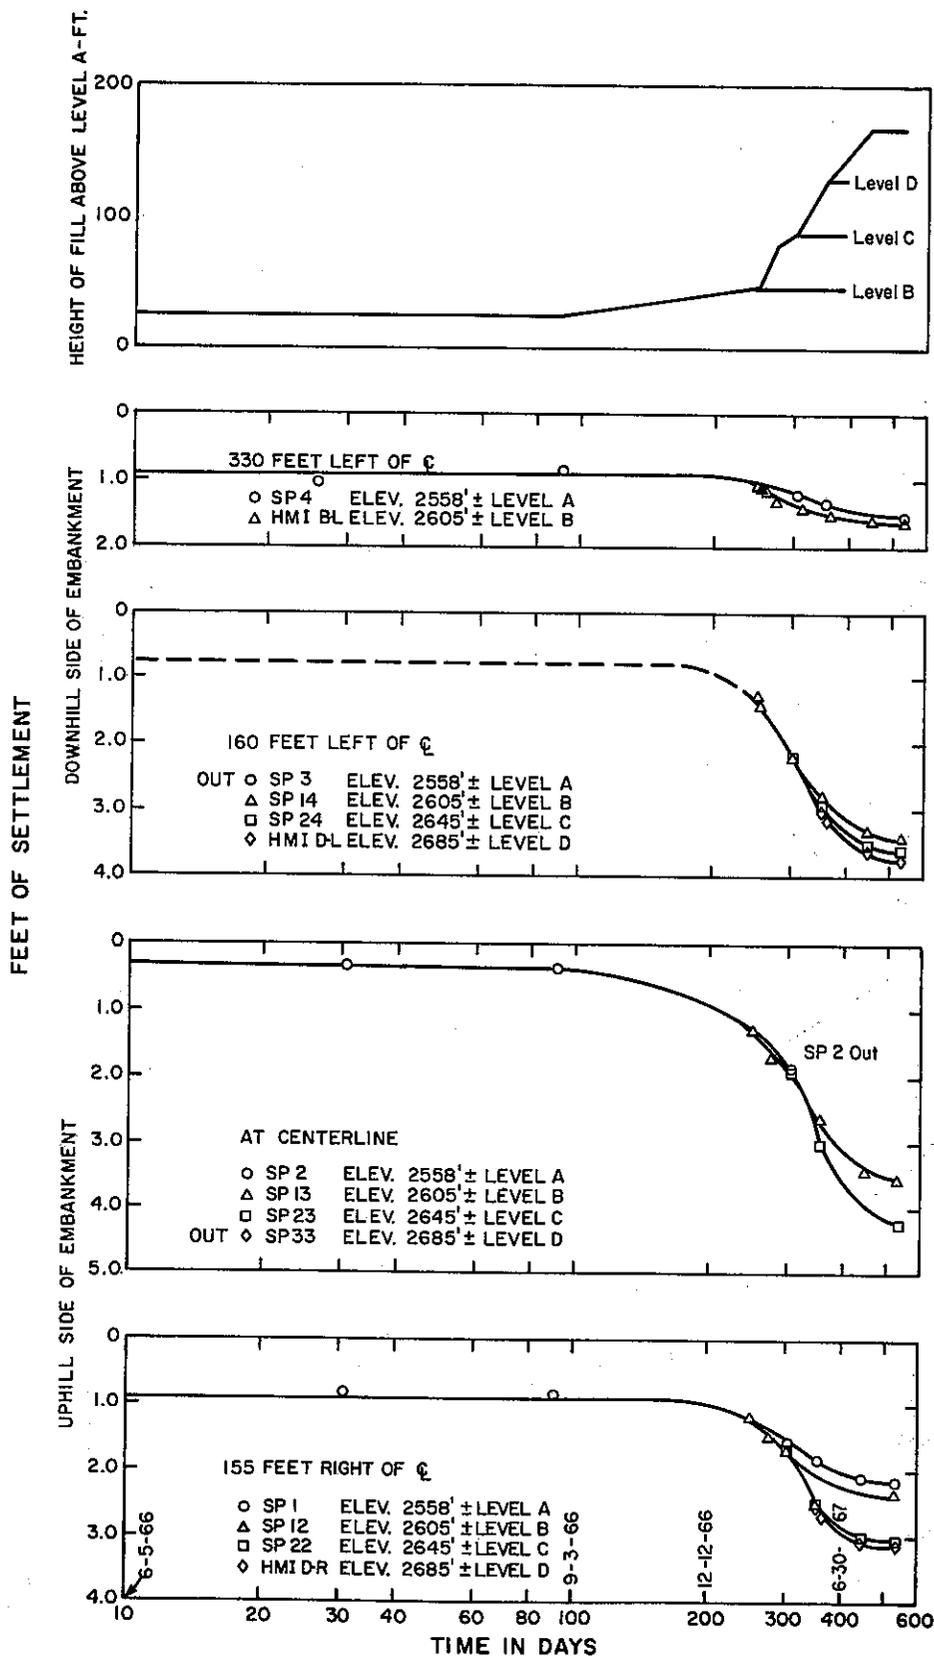
NO NAME CANYON

RATE OF SETTLEMENT COMPARED WITH FILL LOADING

Rate of settlement charts, Figures 13 and 20, indicate a cumulative settlement of about 3.9 feet on centerline upon completion of fill construction at both Osito and No Name Canyons. Subsequent readings at Osito Canyon indicate that the settlement-time curves are approaching a straight line as would be expected. Because of the lighter loads, due to decreasing fill height, settlement readings become less as the distance from centerline increases.

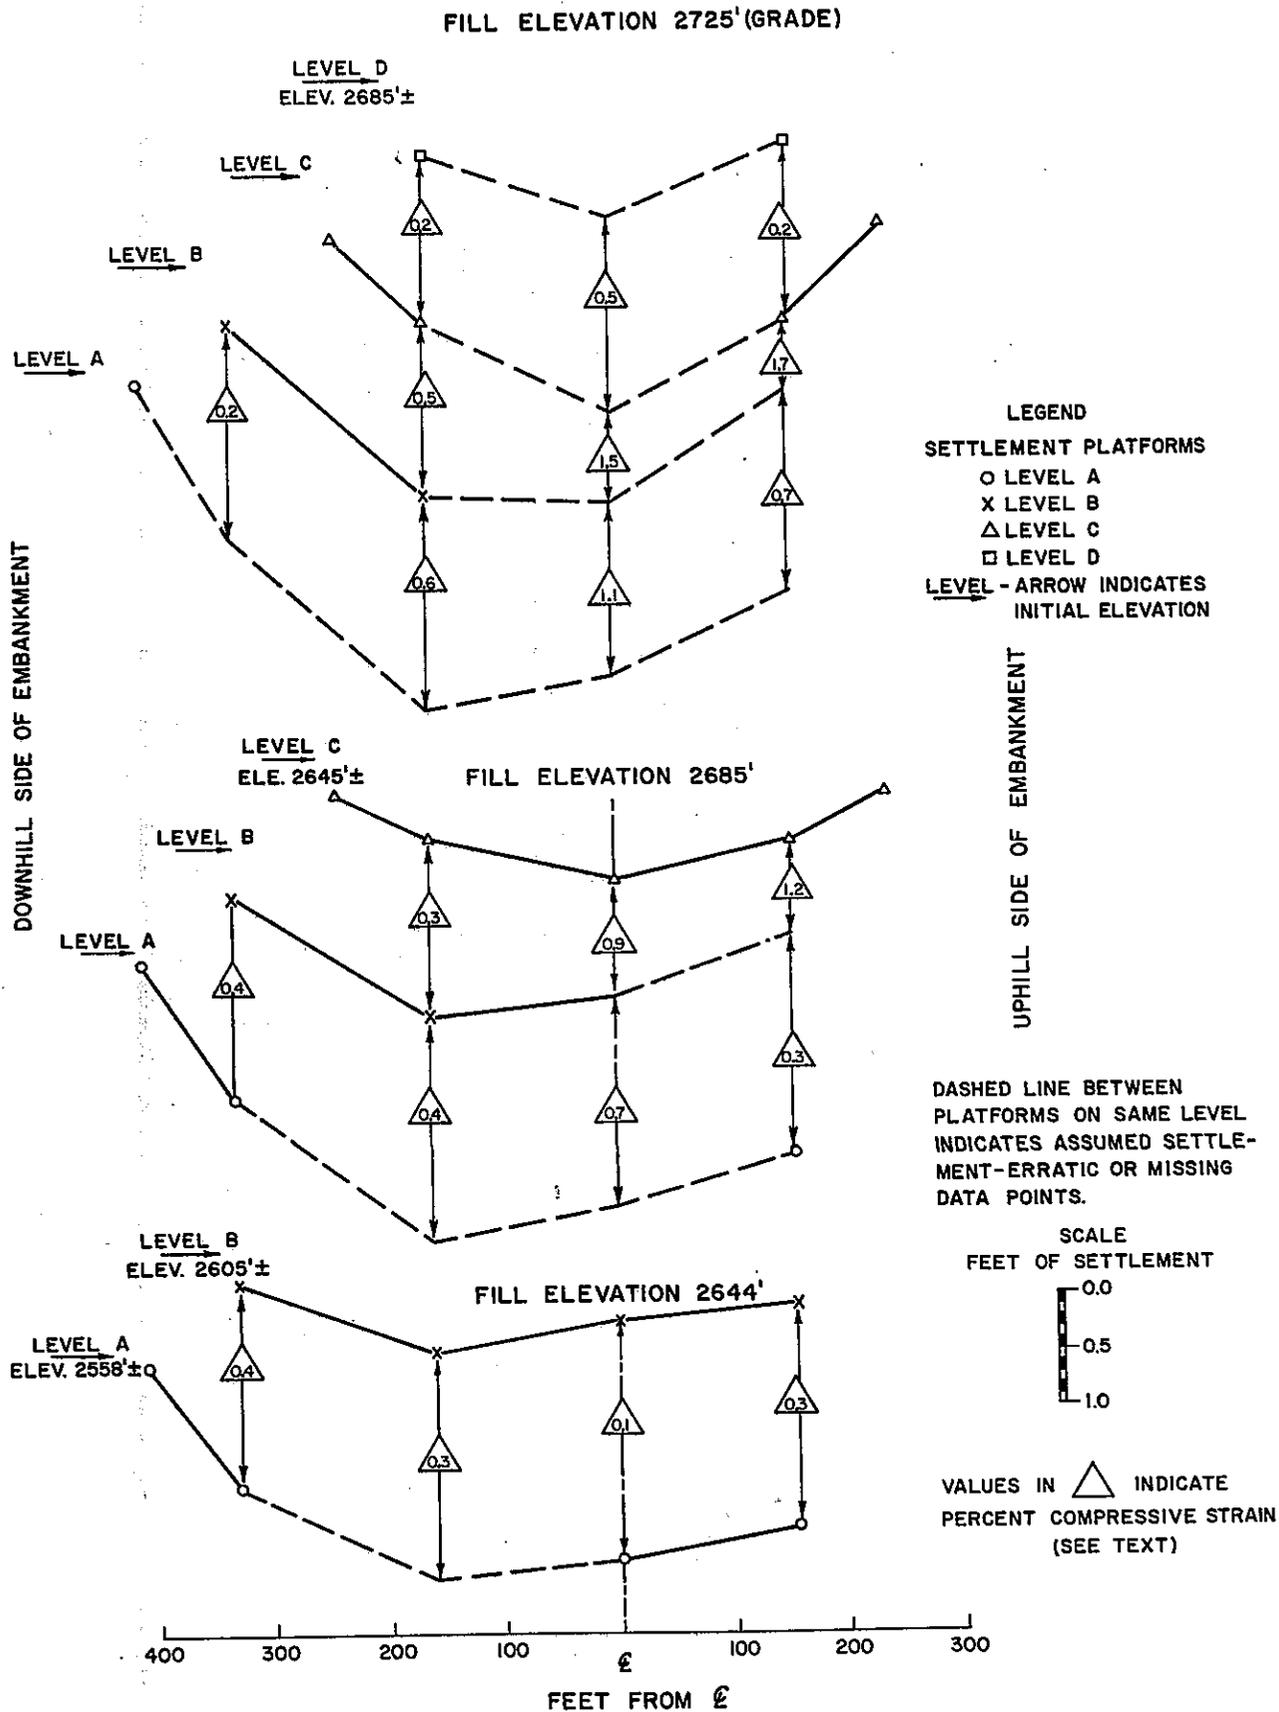
NO NAME CANYON
SETTLEMENT ALONG LINES OF INSTRUMENTATION
FOR VARIOUS HEIGHTS OF FILL

Settlement along lines of instrumentation as well as magnitude of vertical strains for various heights of fill are shown in Figure 14 for Osito Canyon and Figure 21 for No Name Canyon.

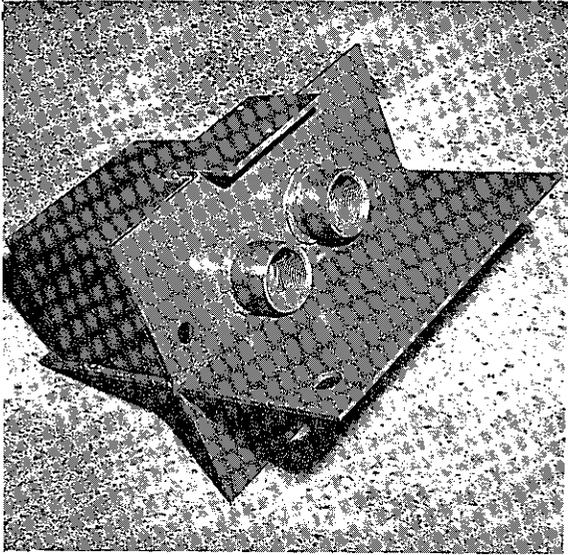
Fig. 22 - New type horizontal movement platform with box for housing potentiometer to measure horizontal strain by electrical resistivity.

A new type of horizontal movement platform, shown in Figures 22 and 23, has recently been developed and incorporated in the instrumentation of the Squaw Creek embankment, to be reported in the next interim report for this project. This new platform consists of two 8 x 12-inch steel plates welded to a 12-inch square plate to form an "X" shaped cross-section. The metal box attached to the platform shown in Figure 22 contains a potentiometer (Figure 24) to allow measurement of horizontal strain by analog resistance.

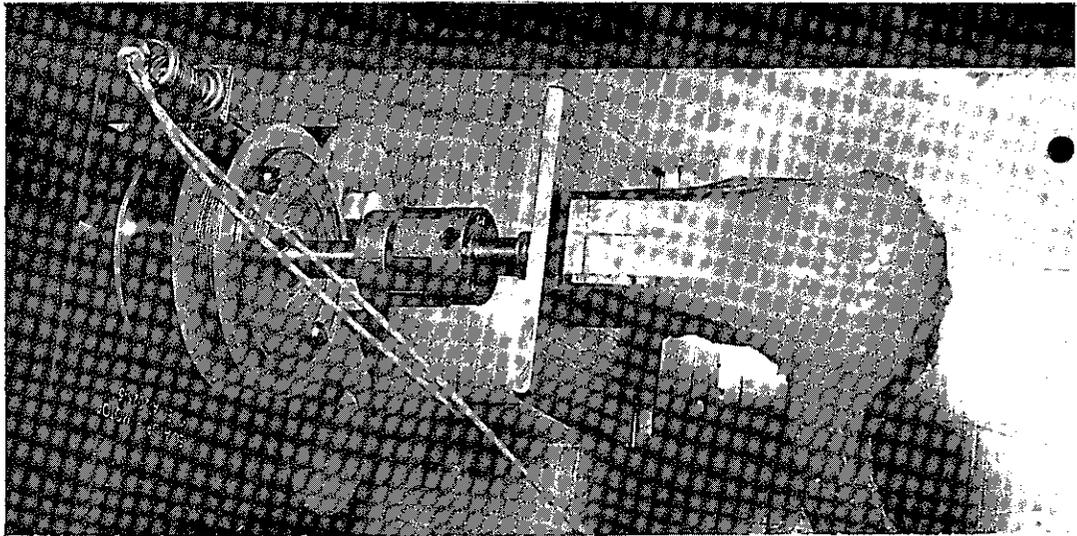
Fig. 24 - Potentiometer and associated equipment removed from horizontal movement platform.

The potentiometer measuring device shown in Figure 24 has been used at four locations in the Squaw Creek embankment and results thus far look encouraging. The potentiometer is coupled to a spring motor providing a constant 5-pound tension on a cable which is, in turn, attached to a rod housed in PVC pipe and pinned to the soil at the other end. In this manner, horizontal strains of + 2.5 feet over the distance between the platform and the point where the rod is pinned to the embankment can be measured electrically at a remote instrument shelter.
