Experimental Tied Back Crib Wall With Salvaged Guardrail Facing

August 1984

Office of Transportation Laboratory  
California Department of Transportation  
Sacramento, California 95819

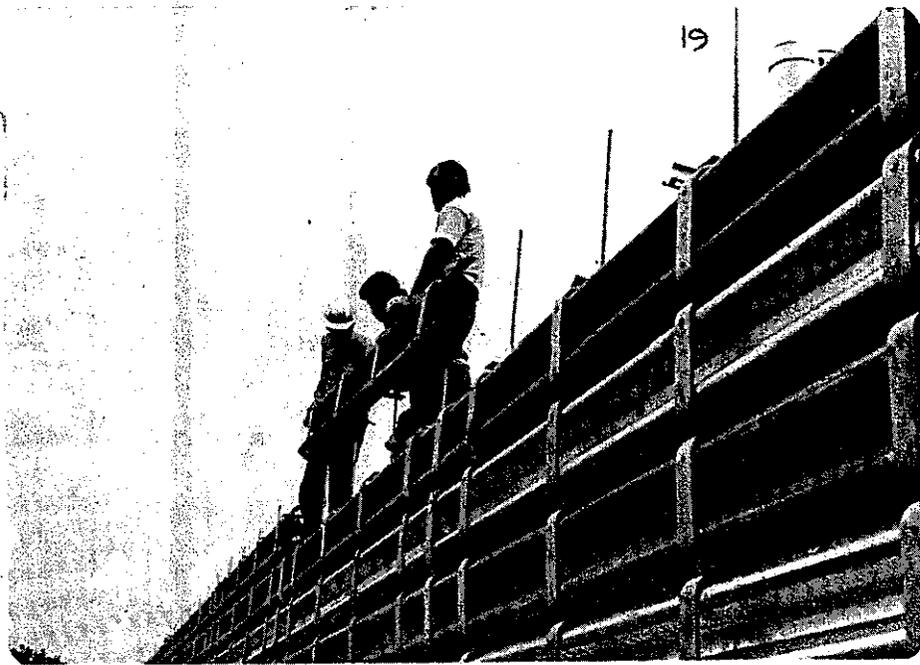
Photo 4. Laborers Placing Guardrail Rail and Mounting Bracket Assembly in Position on Vertical Rods

guardrail and mounting bracket unit and slipped the mounting brackets onto the vertical rods (Photo 4). The tieback, sign post, and anchor beam assembly was then dragged to the guardrail wall facing and bolted to the connection plate (Photo 5). The tieback portion was roughly leveled leaving it ready for burial with backfill material. The above process generated 12.5 feet by 1 foot area of wall facing and required approximately 15 minutes time.
