FHWA/CA/TL-88/09

Revegetating Desert Cut Slopes With Containerized Native Shrubs

October 1988

Transportation Laboratory  
California Department of Transportation  
Sacramento, CA 95819

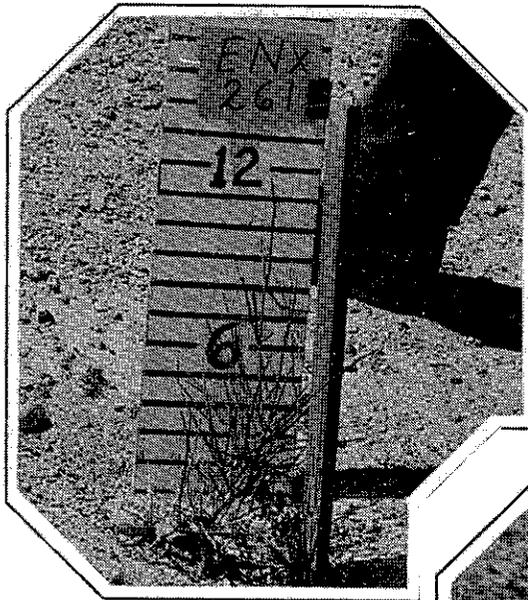
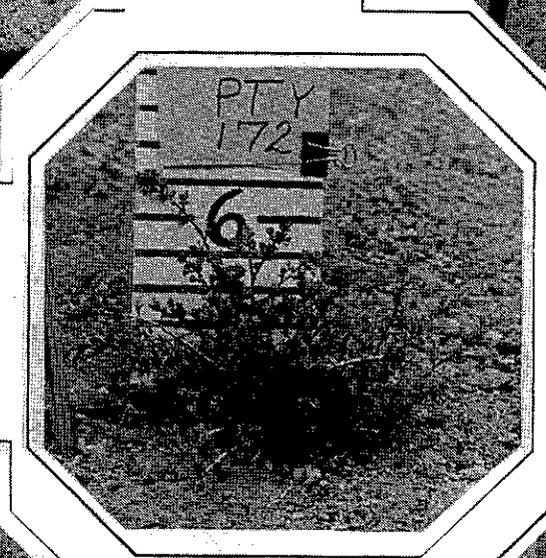
FIGURE 2. EXAMPLES of FIVE SPECIES

EPHEDRA-EN

RABBITBRUSH-CN

BITTERBRUSH-PT

SAGEBRUSH-AT

SALTBRUSH-AC

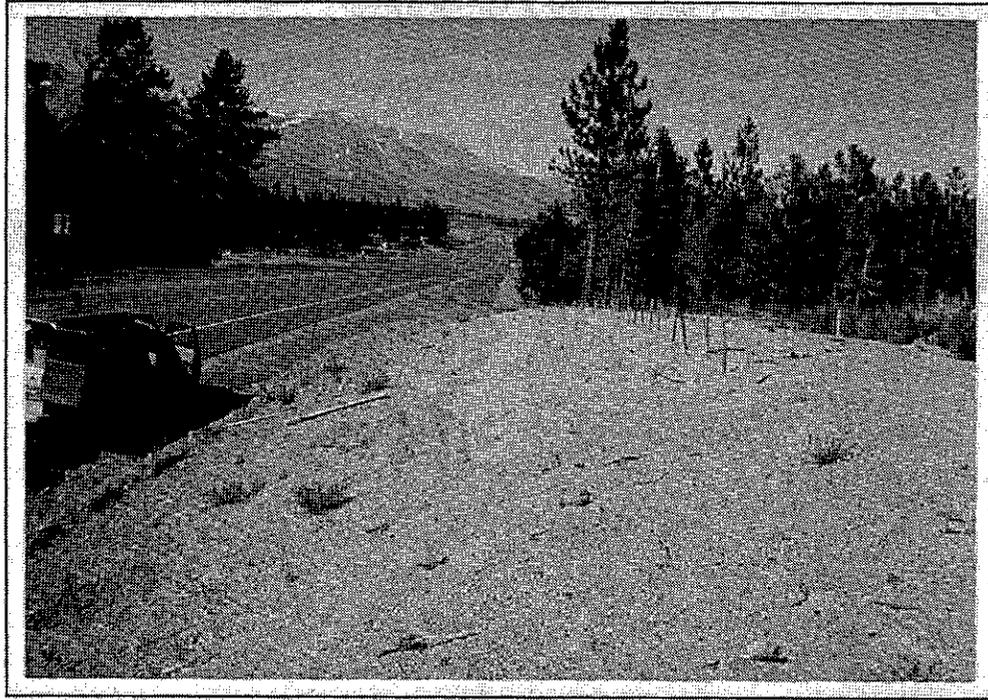
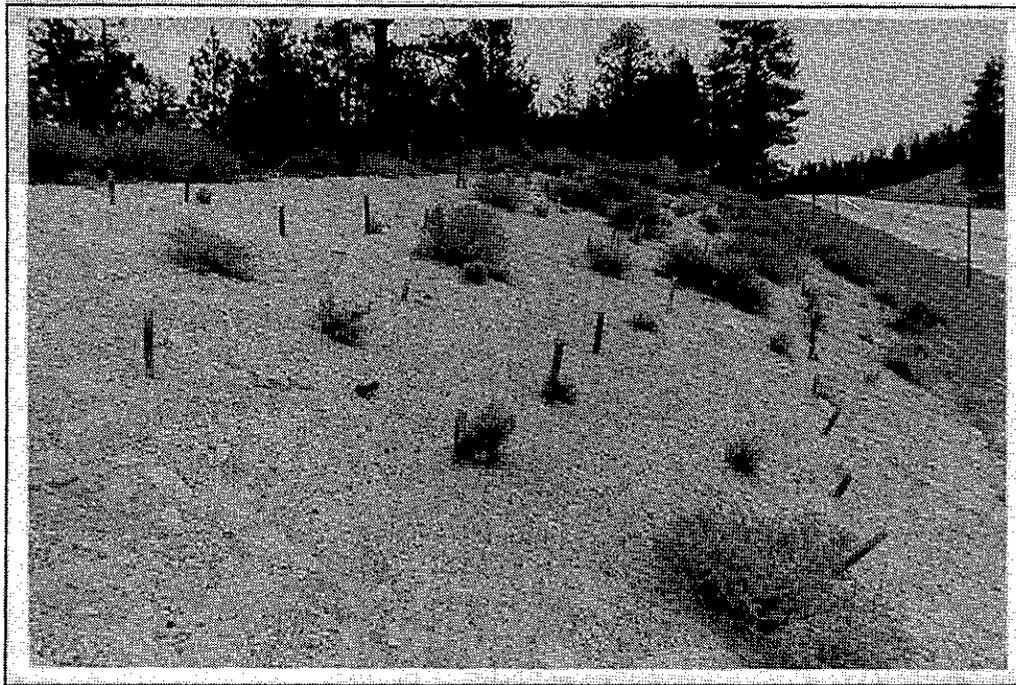
FIGURE 5. JUNE L. S25W: RELATIVE INCREASE in COVER and ROUGHNESS

JUNE LAKE S25W SITE: BEFORE, in 1983

JUNE LAKE S25W SITE: AFTER, in 1988

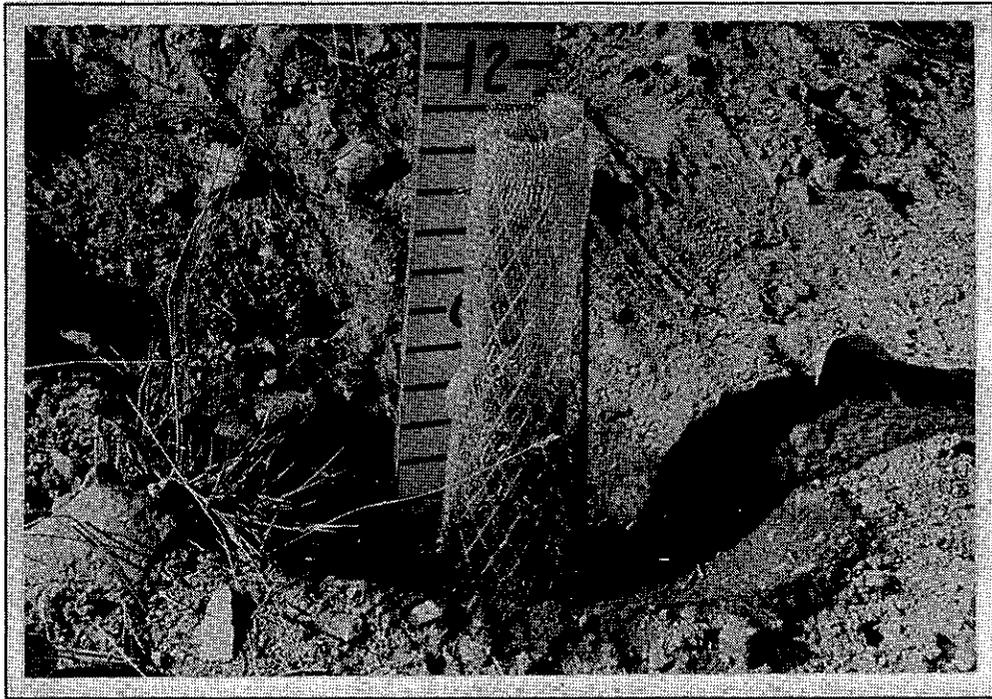
FIGURE 7. TWO KINDS OF CAGES

PLASTIC CAGE

METAL CAGE

Metal cages deterred depredation and significant damage from browsing animals. They were not effective for deterring gophers. Cages also held soil in place which had sloughed from uphill. Cages were salvaged for use on other revegetation projects. Yellow, plastic cages (3-inch diameter by 1-foot tall) were tried on the fall, 1983 plots. They were unsightly and restricted the growth of the shrubs.

Yellow plastic cages were very noticeable on our research slopes. Because they were difficult to install without injuring seedlings, and because they did not do well at the CalTrans/SCS site, plastic cages were removed from the fall plots. We looked for larger, commercially available cages and found none. Using two plastic meshes meant additional material handling and cost. Therefore, instead of plastic, TransLab designed, built, and installed metal cages around all 1080 research seedlings.

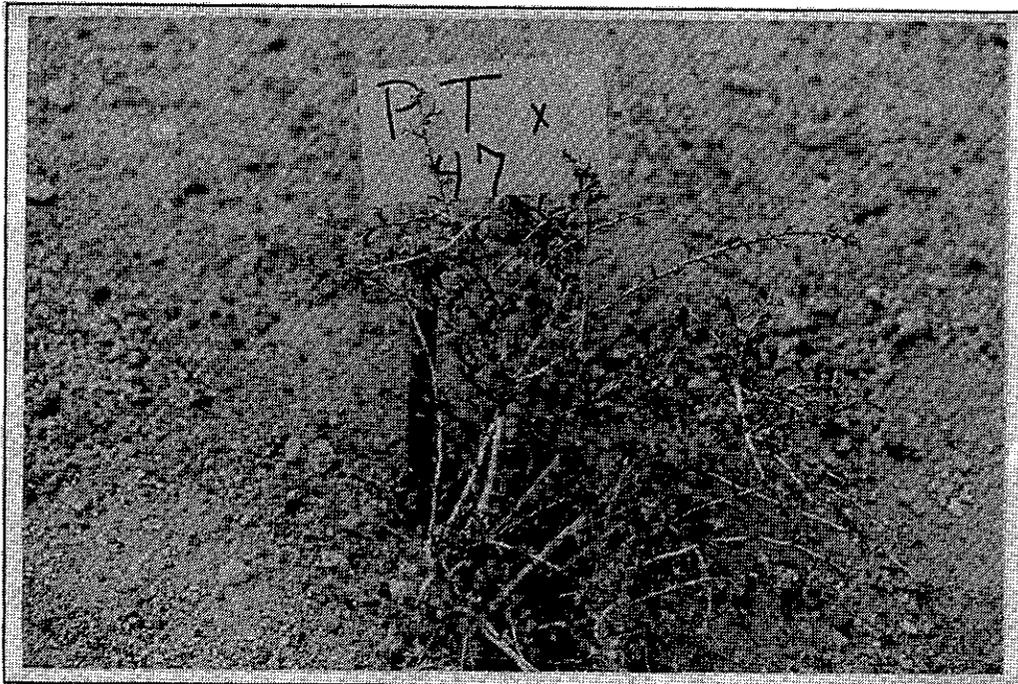
FIGURE 8. EXAMPLE of FLOWERING PLANTS

FLOWERING SAGEBRUSH

FLOWERING BITTERBRUSH

In contrast to ephedra, saltbush, and bitterbrush there were higher percentages of mature sagebrush and rabbitbrush. Flowers and seed were produced by 44 percent (159 of 364) of the sagebrush and 25 percent (68 of 272) of the rabbitbrush. Apparently weather and other conditions were more suitable for the ripening of sagebrush than for rabbitbrush.
