Vehicle Crash Tests of A Thrie Beam Barrier Terminal

September 1993

Final Report # FHWA/CA/ TL-93/19  
Caltrans Study #F82TL16

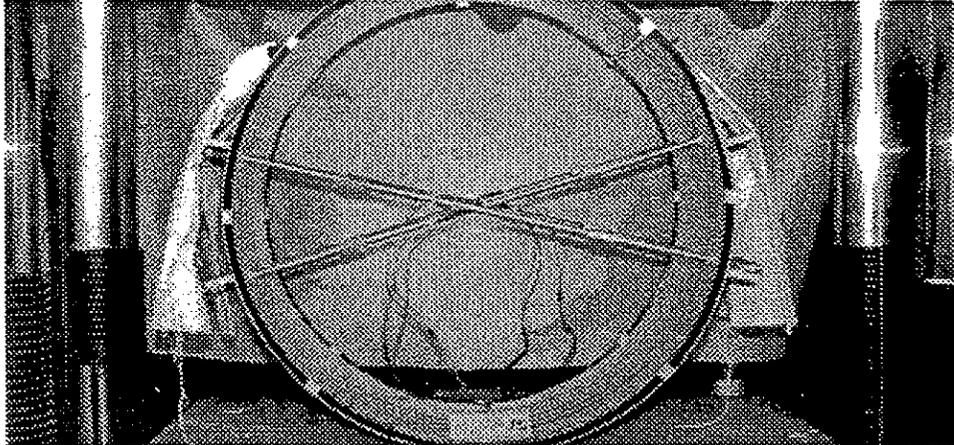
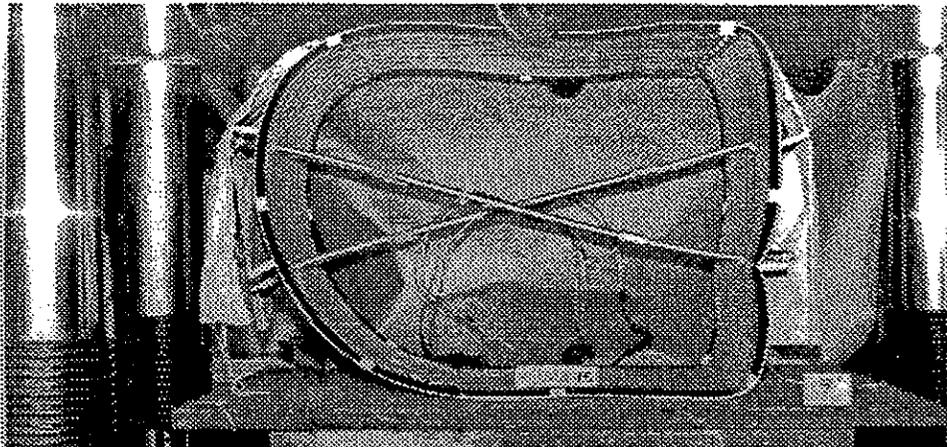
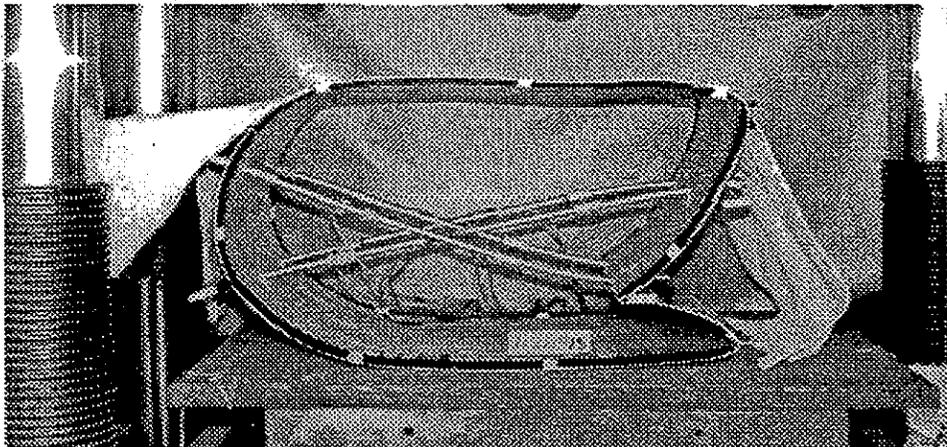
Figure 1: Static Load Tests

Test Number	Test Description
1-14ANR45	14 ga. CSP, unbraced with the seam at a 45° angle from zenith.
2-14ANR00	14 ga. CSP, unbraced with the seam at zenith.
3-14ANR90	14 ga. CSP, unbraced with the seam at 90° from zenith.
4-14ANR00	14 ga. CSP, unbraced with the seam at zenith.
5-14A30	14 ga. CSP, double bracing at 30° from horizontal. Retested as 13-14A30.
6-14A00	14 ga. CSP, braced with 4 bars at 0° from horizontal. Pipe did not fail in proper mode. Bracing redesigned and tested as 12-14A00.
7-12ANR45	12 ga. CSP, unbraced with seam at 45° from zenith. Used to compare shape of curve with 14 ga. CSP (test 4-14ANR00).
8-16ANR45	16 ga. CSP, unbraced with seam at 45° from zenith. Used to compare shape of curve with 14 ga. CSP (test 4-14ANR00).
9-14A10	14 ga. CSP, double braced at 10° from horizontal.
10-14A25	14 ga. CSP, double bracing at 25° from horizontal.
11-14A20	14 ga. CSP, double bracing at 20° from horizontal.

12-14A00	14 ga. CSP, horizontal bracing with 2 bars.
13-14A30	14 ga. CSP, double bracing at 30° from horizontal.
14-14H10	14 ga. helical pipe, double bracing at 10° from horizontal.
15-12A15	12 ga. CSP, double bracing at 15° from horizontal.
16-12A20	12 ga. CSP, double bracing at 20° from horizontal.
<p><i>The first 3 test were conducted at a crush rate of 0.01 m/min (1/2" per minute).</i></p> <p><i>The rest of the tests were conducted at a crush rate of 0.05 m/min (2" per minute)</i></p>

The primary purpose of the static tests was to gather data for use in designing a terminal. The data were used to model the energy absorbing ability of various hypothetical terminals. To facilitate the modeling process, a computer program was written which used the data from the static tests. The model calculates velocity, acceleration, time and distance every 0.01 m (1/2 inch) of crush. It also calculates the average acceleration from  $t=0$  to present every 0.30 m (1 ft), the occupant impact velocity, the time and distance at which occupant impact occurs, the ride down acceleration, and the 50 ms average acceleration. The time period for the ride down and 50 ms acceleration are also given.

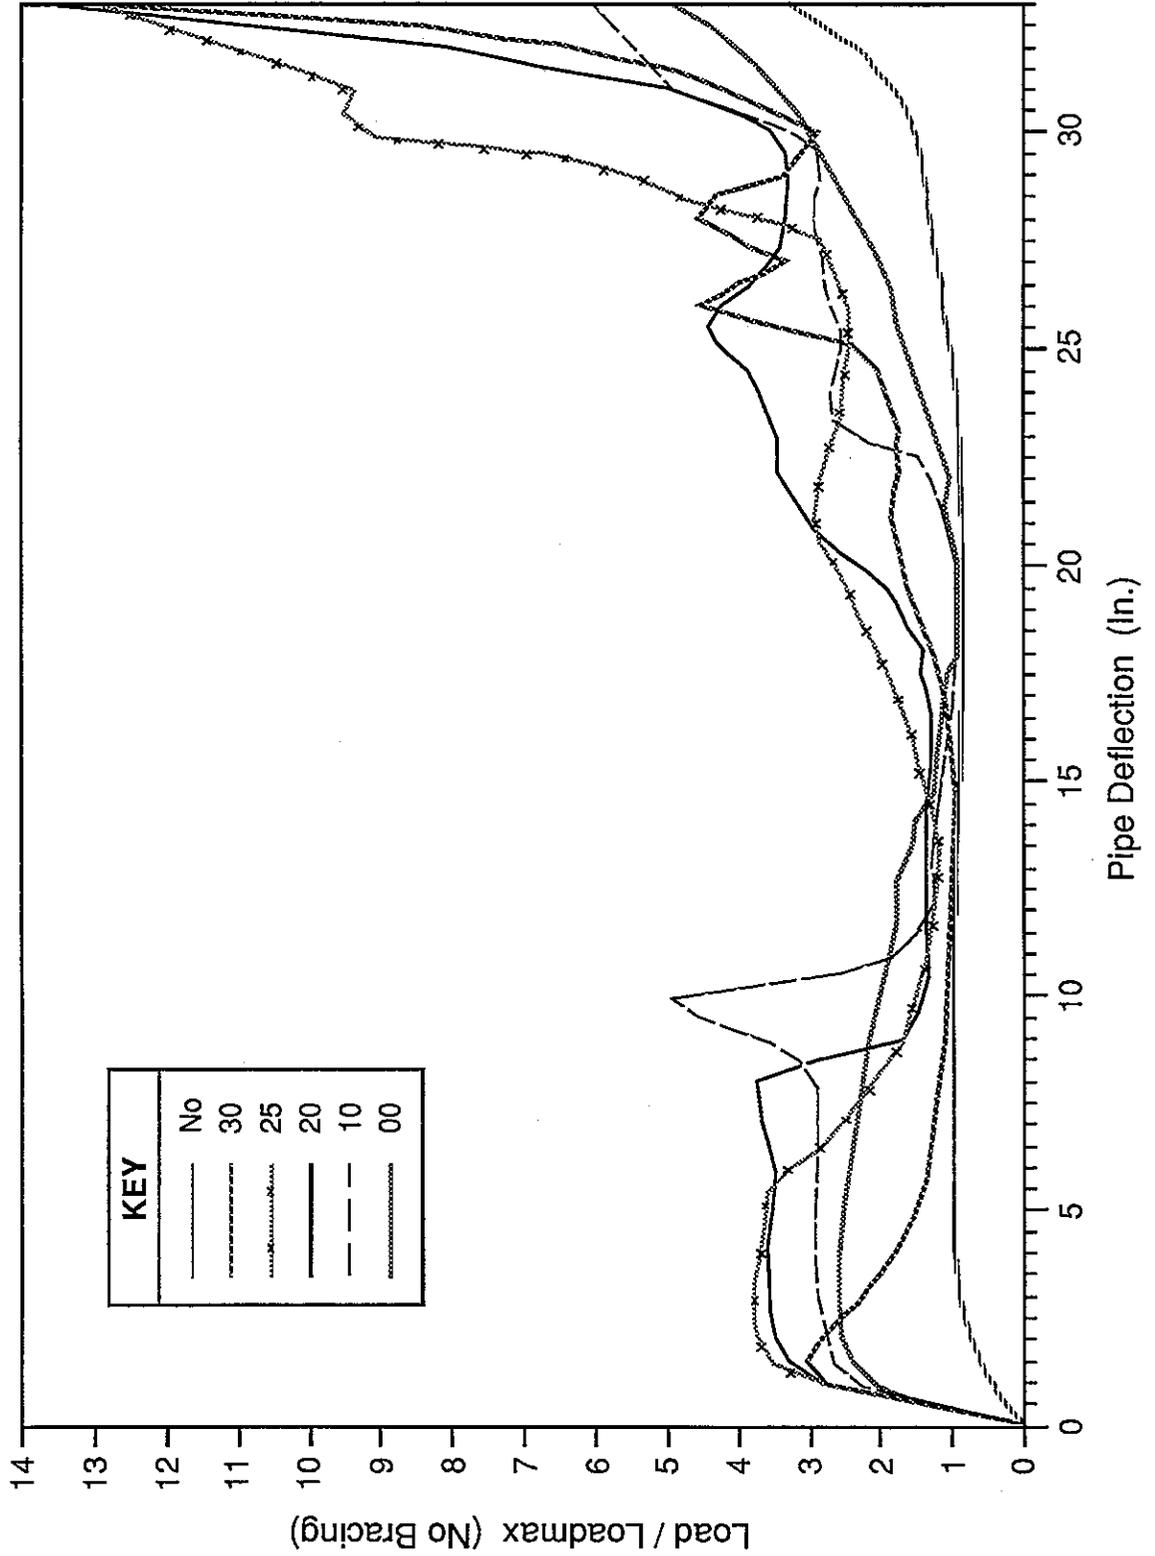
Figure 1a - Static Load Test Results

### Braced Pipe Strength Relative Strength of Double Braced CMP

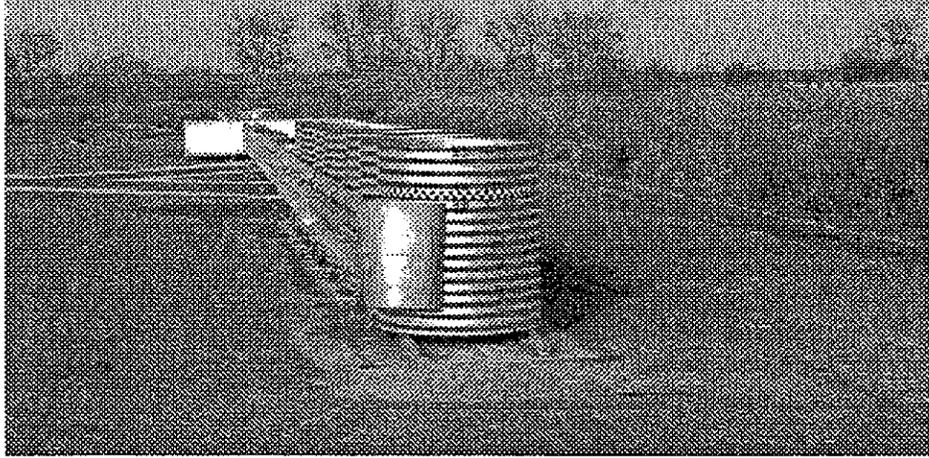
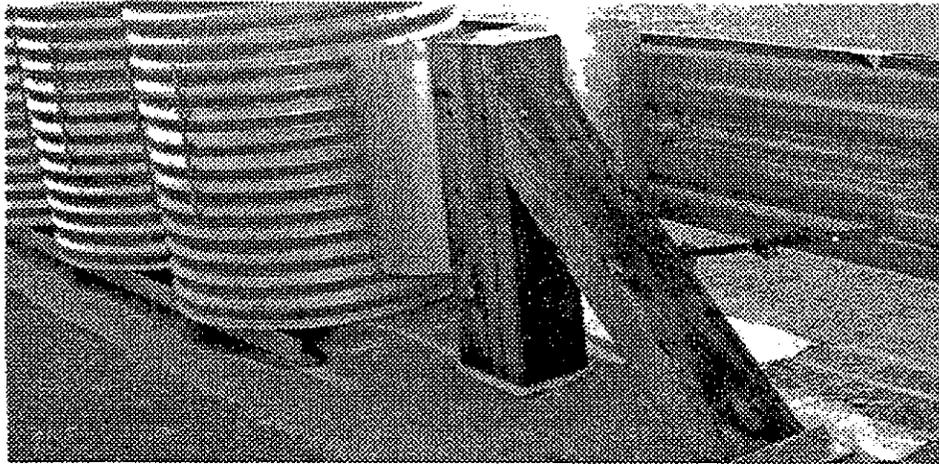
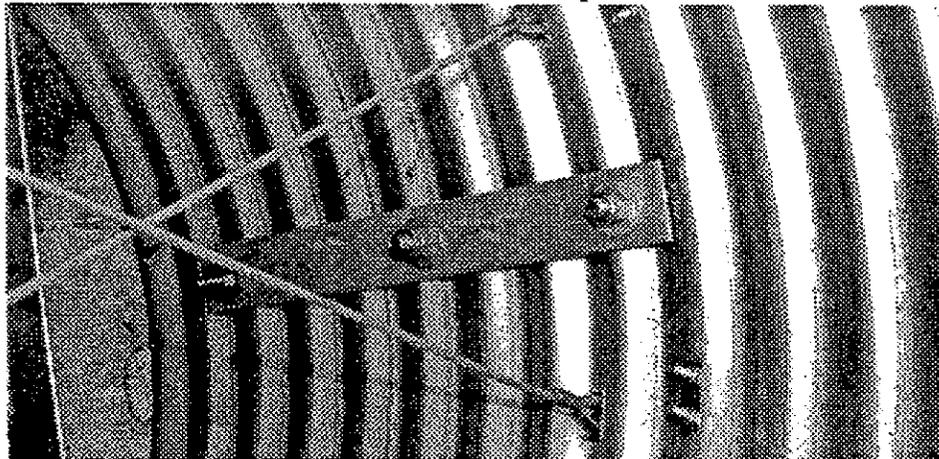
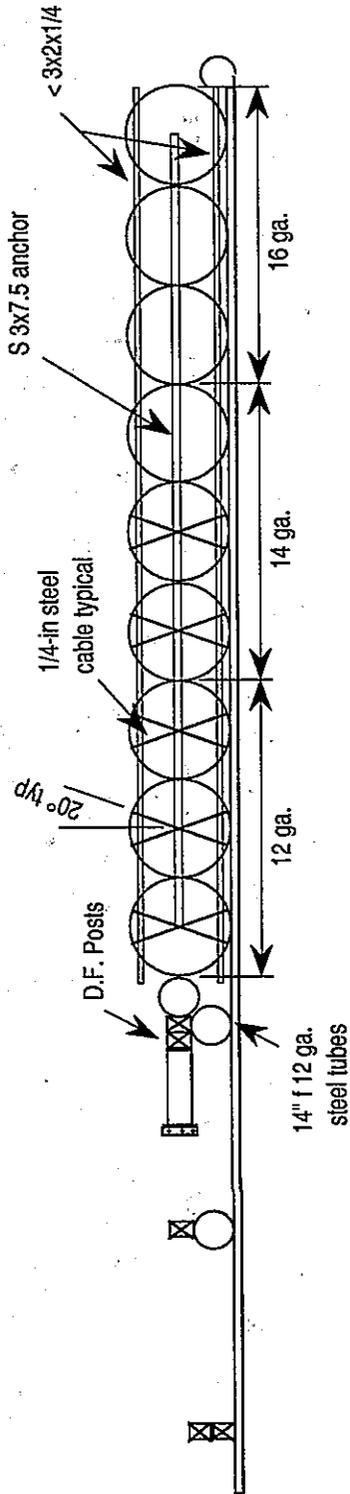
**Figure 2: Barrier Used In Test 491**

Terminal With Chain/Rail Anchors

Wood Posts Used as Backup Structure

Steel Cable Braces & CSP Connection

### Thrie Beam Barrier Terminal - B

The test barrier used for test 491 had an overall length of 24.7 m (81.2 feet). It was installed by a private contractor. The minimum length for test barriers is 22.9 m (75 feet) per NCHRP Report 230 (5). The terminal section had a length of 10.5 m (34.5 feet). The finished barrier is shown in Figure 2. The barrier was constructed in accordance with the Caltrans Standard Specifications (6). The barrier used for test 492 had a length of 24.5 m (80.4 feet), with the terminal section having a length of 11.2 m (36.7 feet). Figure 3 shows the barrier used for test 492.

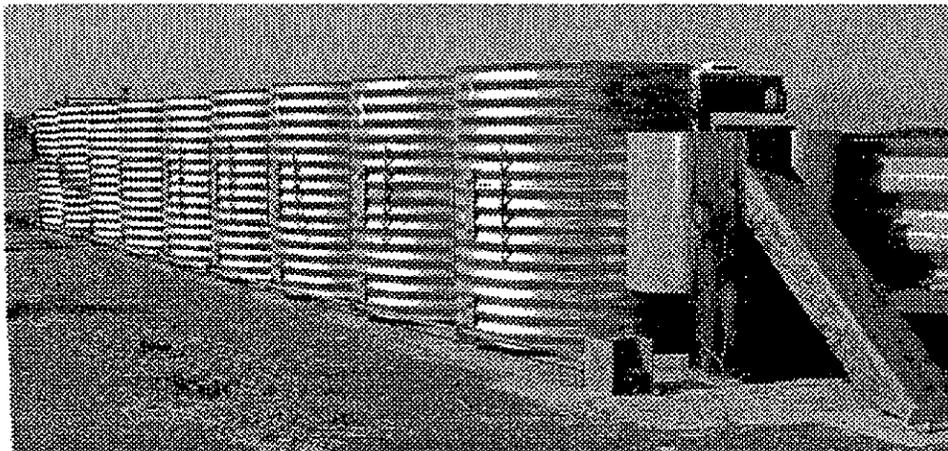
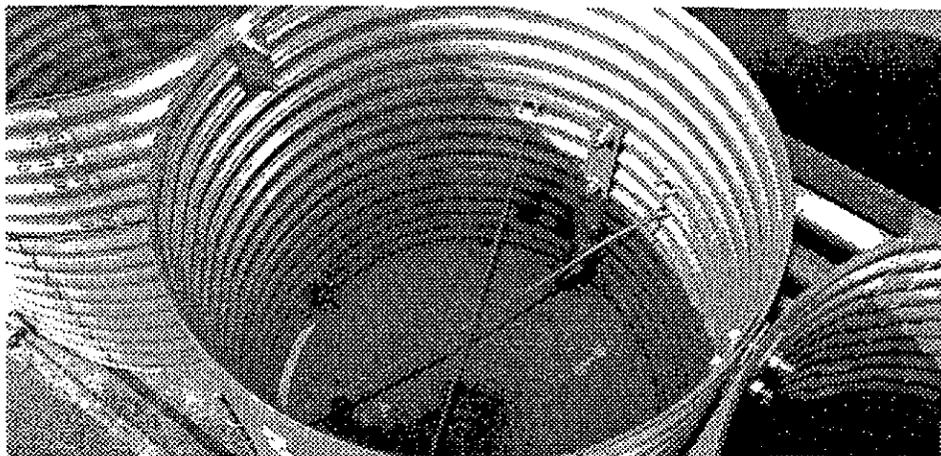
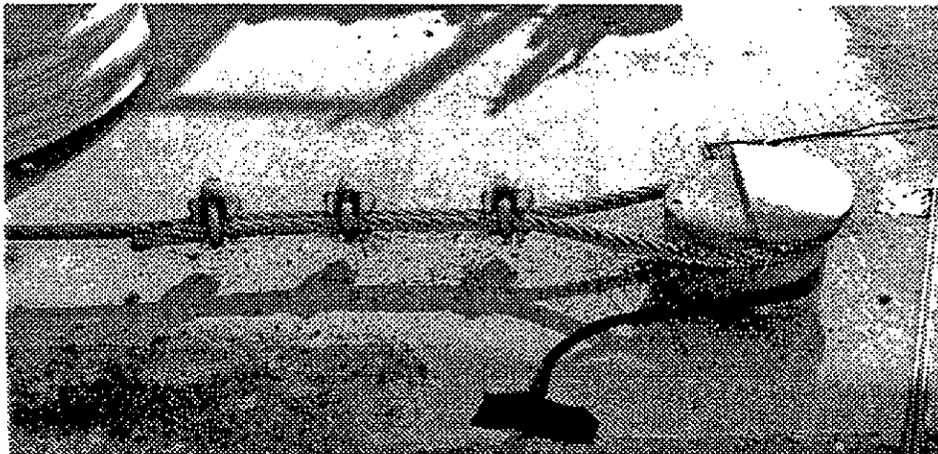
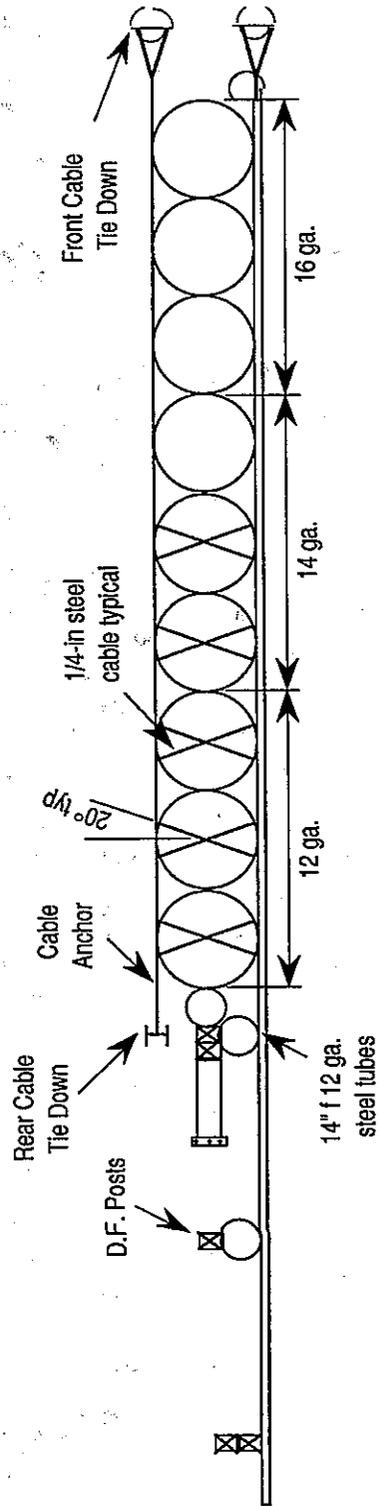
**Figure 3: Barrier Used In Test 492**

Terminal With Cable Anchors

Steel Cable Braces & CSP Connection

Cable Anchor

### Thrie Beam Barrier Terminal - A

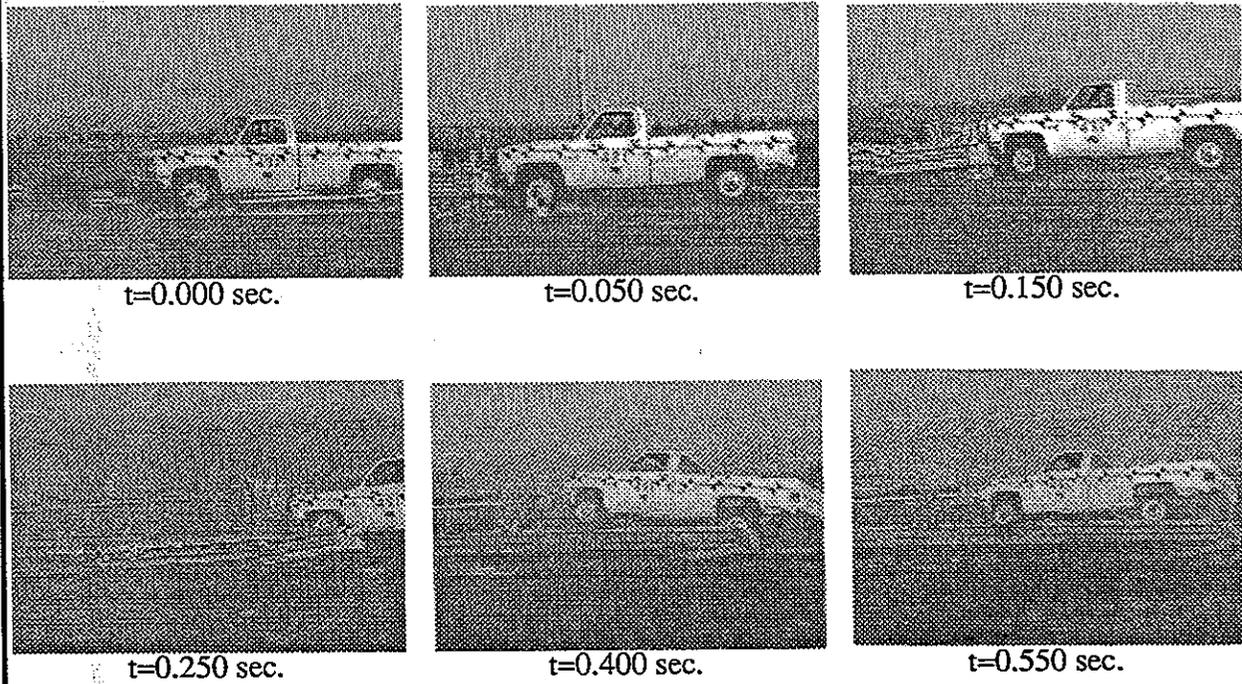
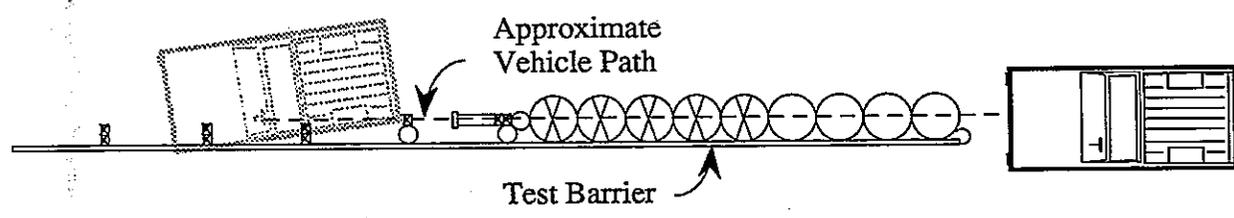
Figure 4: Test 491 Data Summary Sheet

**Test Barrier:**  
 Type: Thrie Beam Terminal - B  
 Overall Length: 24.7 m (81.2 feet)  
 Terminal Length: 10.5 m (34.5 feet)

**Test Data:**  
 Occupant Impact Velocity: 5.7 m/s long. / -1.3 m/s lat.  
 Ridedown Acceleration: -7.2 g's long. / 2.6 g's lat.  
 Max. 50 ms Avg. Accel.: -4.3 g's long. / 1.3 g's lat.  
 TAD/VDI: FD2 / 12FDEW1  
 Max. Roll, Pitch & Yaw: +5.3° / +13.4° / +8.2°

The planned conditions were 2040 kg (4500 lb) at 97 km/h (60 mph) and 0° on the nose of the device. The actual conditions were 2077 kg (4580 lb) at 90 km/h (55.9 mph) and 0°. The data summary sheet and the photos taken before and after impact are shown in Figures 4-6.

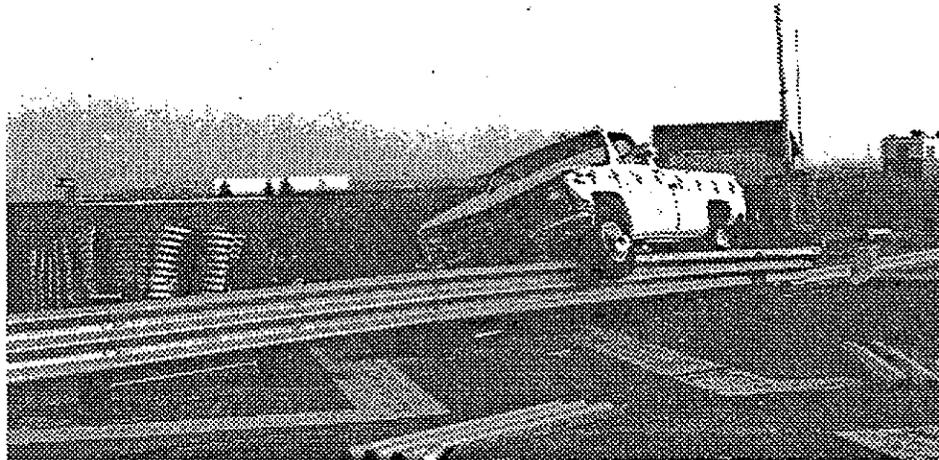
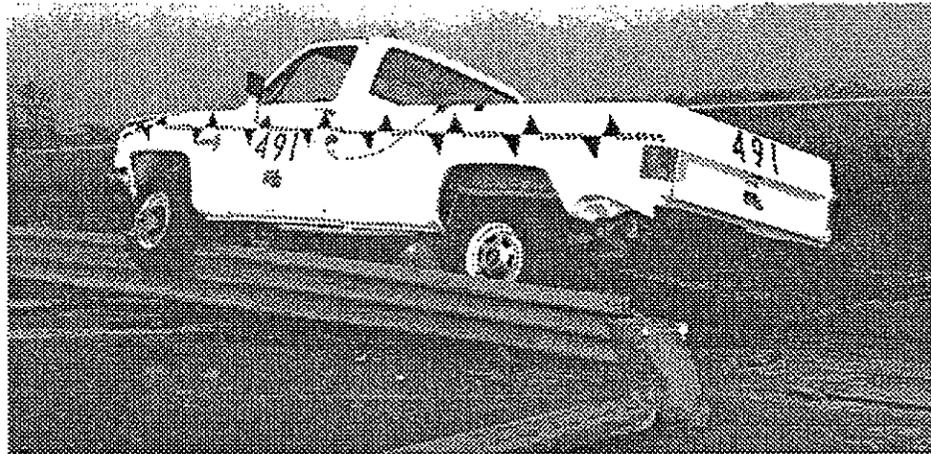
**Figure 6: Test 491 Post-Impact Views of Terminal and Test Vehicle**

The barrier was severely damaged during impact. Tubes 1 through 9 were all almost completely crushed. Posts 1 and 2 were sheared off at the base. The three beam panels flew off as far as 3.44 m (11.3 feet) downstream from the downstream end of the barrier. The crushed barrels remained connected together, and they landed 22.75 feet from the downstream end of the barrier. Figure 6 shows the post-impact photographs.

The test vehicle was moderately damaged after the impact. The contact pattern was initiated at the center of the bumper which was bent during the impact. The radiator was intact and the engine unmoved, however, coolant was leaking out of the radiator. The hood remained closed and could be opened in spite of some crinkling of the sheet metal. The left front fender was crushed. The left front door was scraped, jammed and could not be opened. The tires and wheels were undamaged, the steering system was working and the vehicle could have been driven away if it not for the leaking coolant. There was no intrusion of vehicle or barrier parts

Test 491 did not meet either of the above criteria. The barrier did not bring the vehicle to a complete stop. As a result, the vehicle crushed all nine CSP's and climbed over the three beam guardrail, hence criterion C was not met. Debris from the barrier, including three beam panels and wood posts were scattered over an area extending as far as 4.02 m (13.2 feet) from the face of the barrier. Even with a ten foot shoulder, this means that the debris would have landed into adjacent traffic lanes presenting an unnecessary hazard, hence test 491 did not meet criterion D.

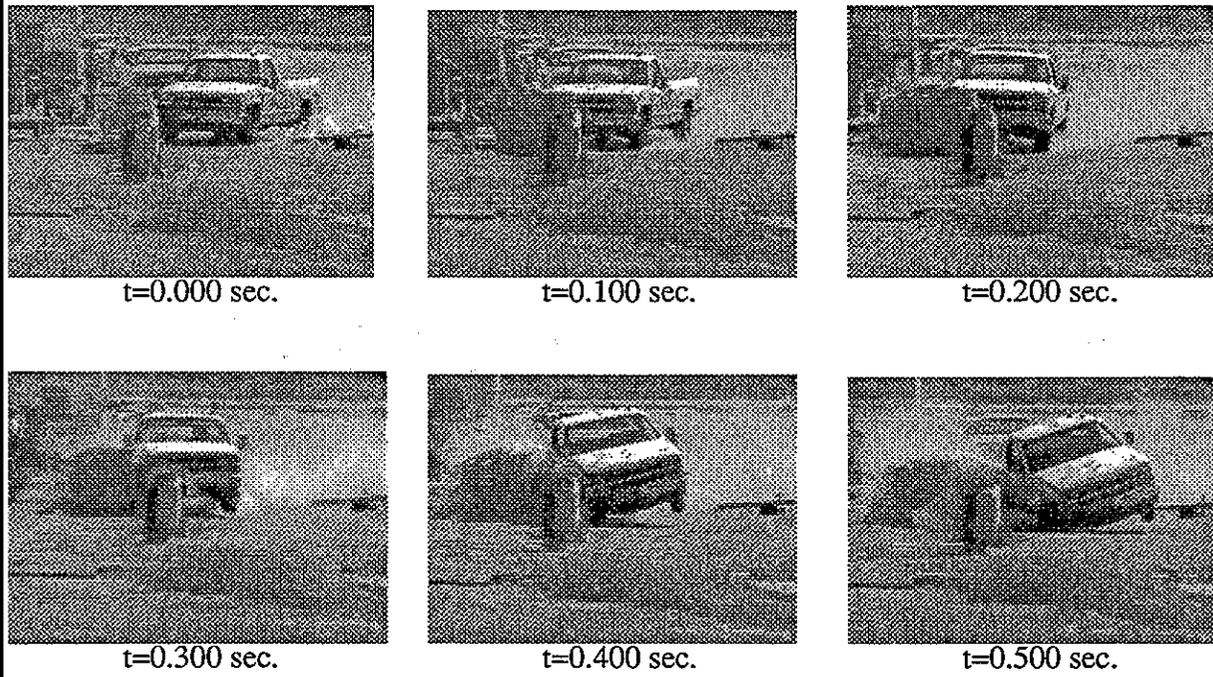
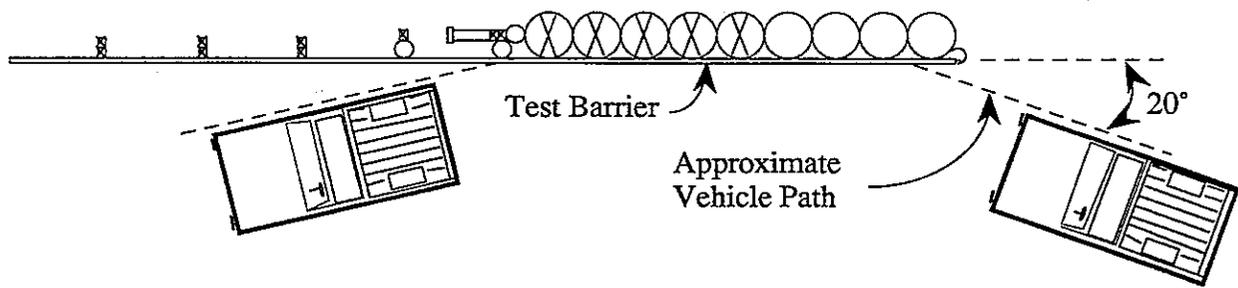
Figure 7: Test 492 Data Summary Sheet

**Test Barrier:**  
 Type: Thrie Beam Terminal - A  
 Overall Length: 24.5 m (80.4 feet)  
 Terminal Length: 11.2 m (36.7 feet)  
 Test Date: 9/16/92

**Test Vehicle:**  
 Model: 1987 Chevy Pickup Truck  
 Inertial Mass: 1928 kg (4250 lb)  
 Impact Velocity: 95 km/h (59.1 mph)  
 Exit Velocity: 52.6 km/h (32.7 mph)  
 Impact/Exit Angle: 20° / n/a

**Test Data:**  
 Occupant Impact Velocity: 5.8 m/s long. / -7.3 m/s lat.  
 Ridedown Acceleration: -2.9 g's long. / 13.4 g's lat.  
 Max. 50 ms Avg. Accel.: -5.5 g's long. / 10.5 g's lat.  
 TAD/VDI: FR4 / 02RSEY7  
 Max. Roll, Pitch & Yaw: +17.3° / -14.7° / +21.1°

The planned test conditions were 2040 kg (4500 lb) at 97 km/h (60 mph) and 20° into the side of the device. The actual conditions were 1928 kg (4250 lb) at 95 km/h (59.1 mph) and 20°. The data summary sheet and the photos taken before and after impact are shown in Figures 7-9.

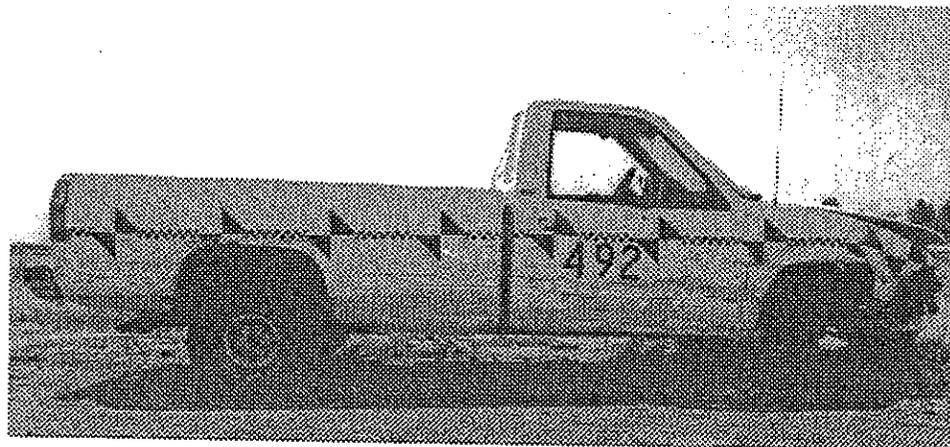
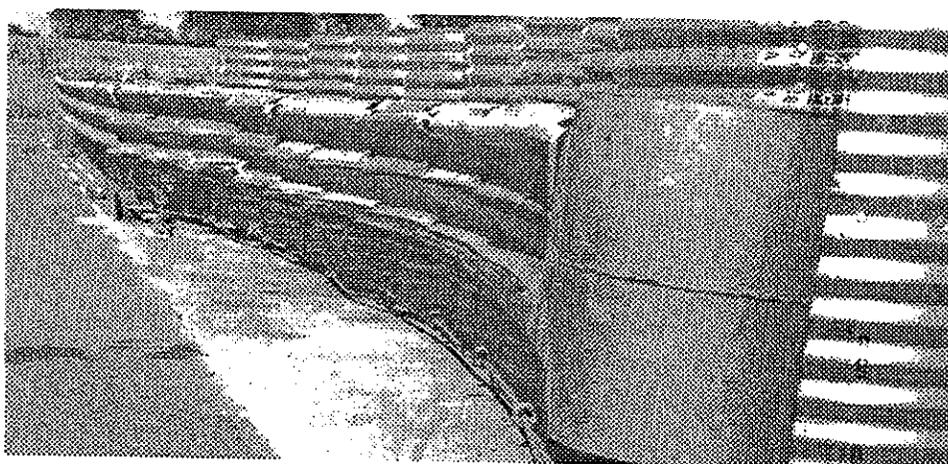
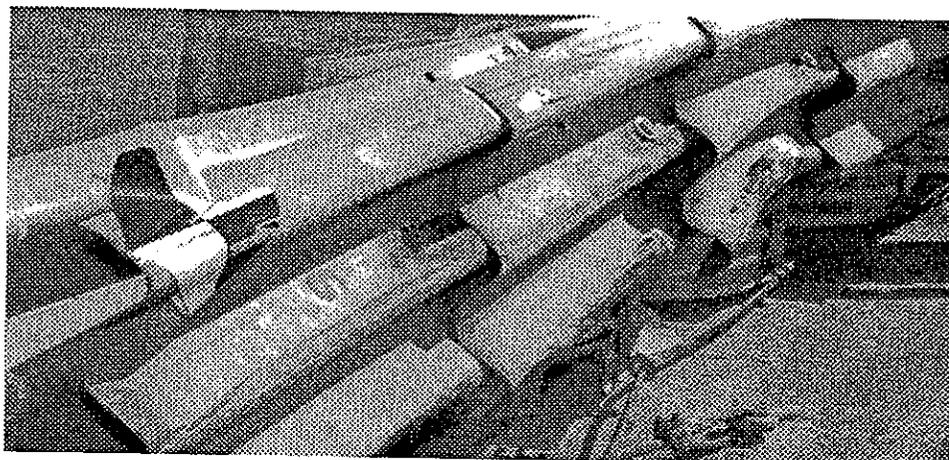
**Figure 9: Test 492 Post-Impact Views of Barrier and Test Vehicle**

The barrier system redirected the vehicle with some damage. All nine tubes were bent; most of the damage to the tubes was at the bottom where the restraining cable anchored the tubes through eye-bolts. The cross braces and the three beam panels on the side prevented substantial crushing of the tubes. The two small tubes in the back which connected the CSP's to the wood posts were crushed, and the anchor cable slipped through one of the cable clips at the upstream end of the barrier. Figure 9 shows the post-impact photographs for this test.

Upon impact, the right front of the vehicle pushed all nine tubes laterally as some redirection of the vehicle occurred. As the tubes displaced sideways, the steel cable maintained good anchorage of the cylinders and prevented excessive displacement. The tubes generally maintained their shapes, and the vehicle exited the barrier system with an approximate speed of 52.6 km/hr (32.7 mph). The exit angle could not be determined because of lack of camera footage. The right front wheel of the vehicle snagged on the I-beam used to anchor the barrels and was severely damaged. Remote brakes were applied after the vehicle was completely redirected and lost contact with the barrier. The vehicle came to rest downstream from the end of the barrier and in front of it.

The test vehicle was severely damaged after the impact. The contact pattern initiated on the right side of the vehicle resulted in the sheet metal on the right side of the body being crushed. The right side of the bumper was crushed and bent back under the vehicle. The grill and headlight on the right side were broken. The hood remained closed and undamaged, but it was pushed sideways about 0.01 m (1/2 inch). The radiator was intact and the engine did not move after the impact. All of the right side of the vehicle was crinkled and crushed due to impact. The right door was jammed shut and could not be opened. The left front tire and wheel were intact, while the right front tire was flat and the wheel was badly bent under the vehicle, restricting movement. The left rear wheel's movement was also restricted because it was bent backwards and pushed up under the vehicle while the right rear tire was flat, but the wheel was intact. The steering system was impaired due to the impact and the vehicle was not in a drivable condition. There was no intrusion of vehicle or barrier parts into the passenger compartment during impact.

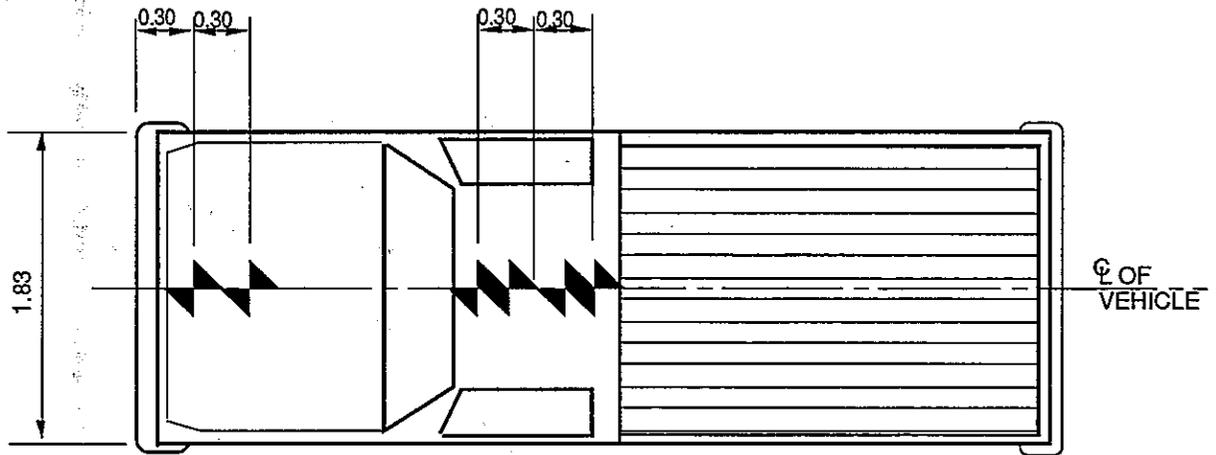
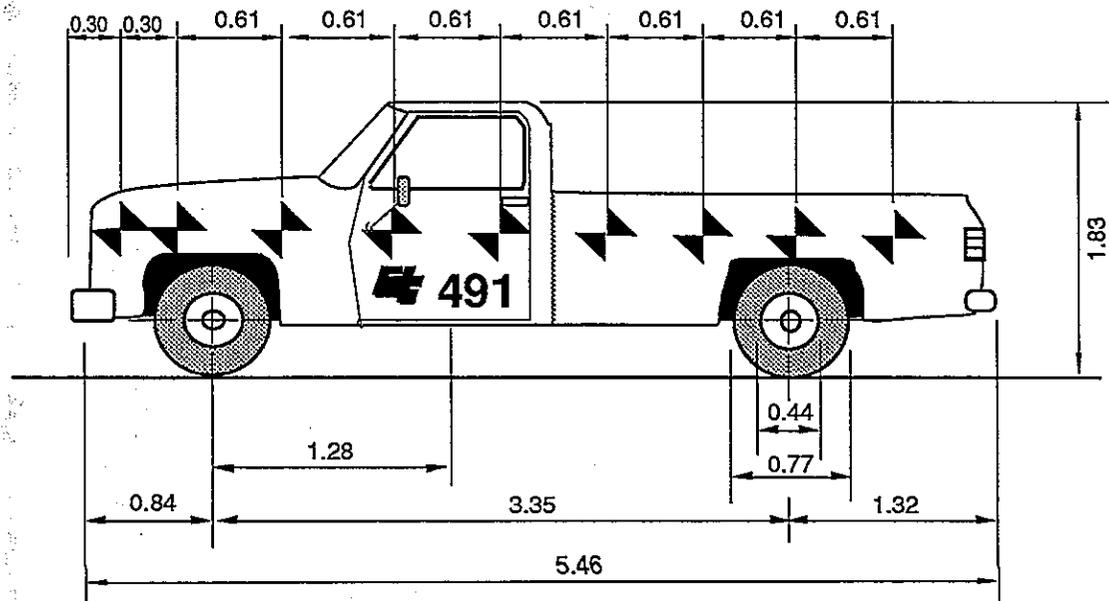
Figure A1: Vehicle Dimensions, Test 491

Figures A1 and A2 on the following pages show the vehicle dimensions. Dimensions were measured.

(All dimensions are in meters)

- Butterfly targets were attached to the top and sides of the test vehicles. The target locations are shown in Figures A1 and A2. The targets established scale factors and horizontal and vertical alignment. The test barrier was targeted with black and white tape also.
- Flashbulbs, mounted on the test vehicle, were electronically flashed to establish (a) initial vehicle to barrier contact, and (b) the application of the vehicle brakes. The impact flashbulbs have a delay of several milliseconds before lighting up.
- Five tape switches, placed at 3.05-m (10-foot) intervals, were attached to the

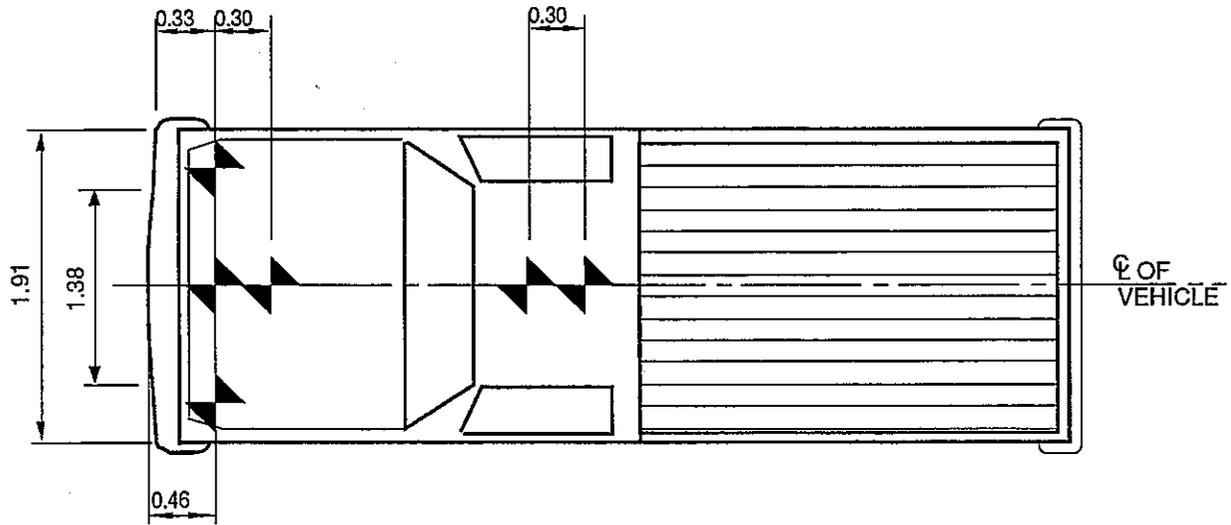
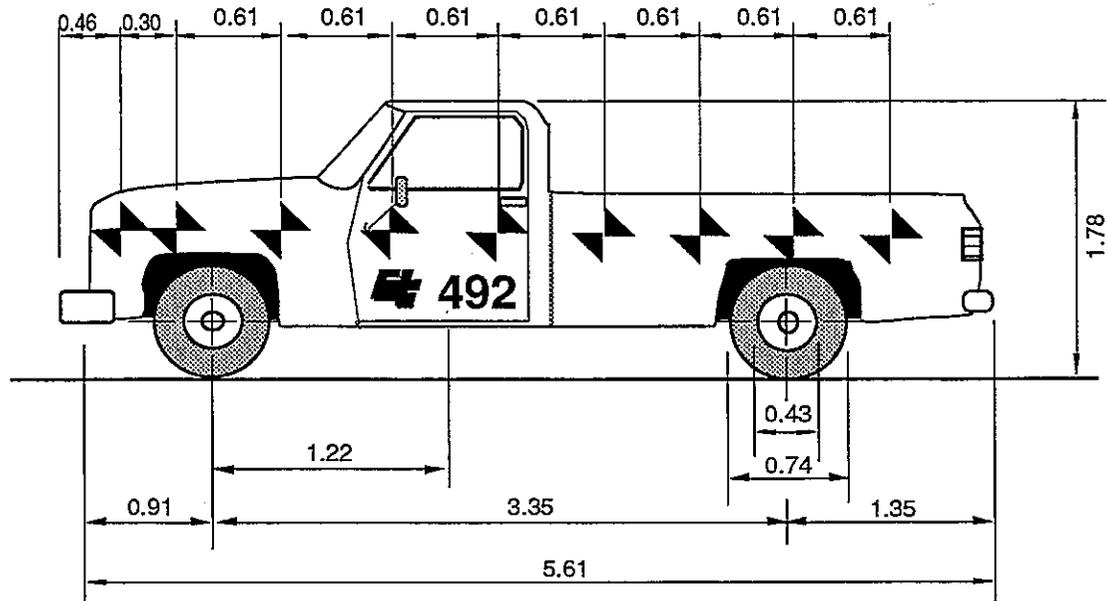
Figure A2: Vehicle Dimensions, Test 492

(All dimensions are in meters)

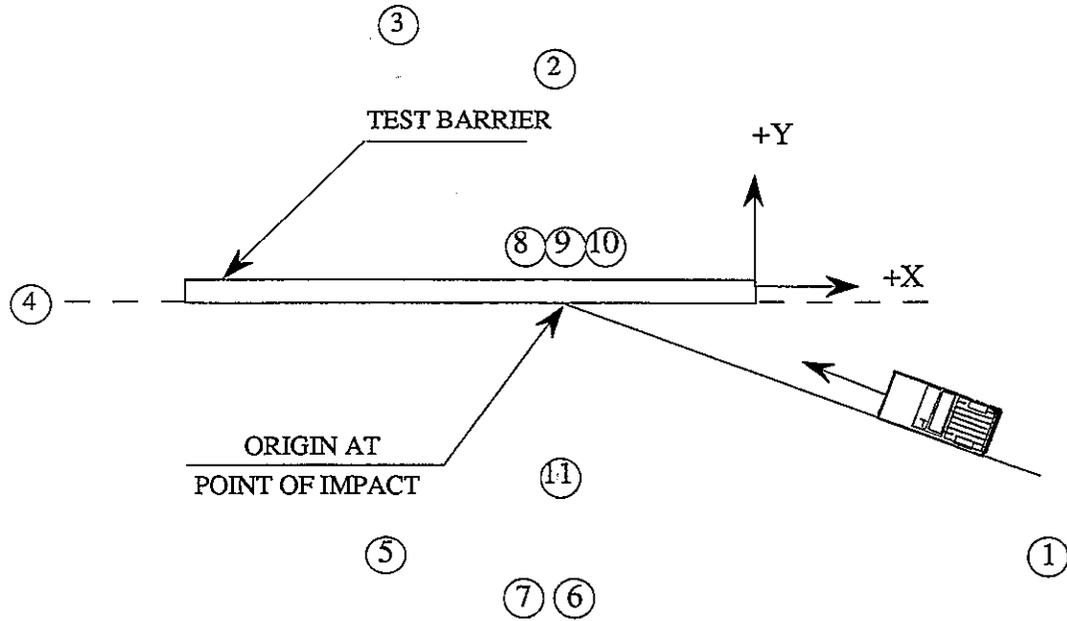
Figure B1: Camera Layout

Cam. No.	Film mm	Camera		Coordinates (m)			
		Type	Film Rate (frames/sec)	Test 491		Test 492	
				X	Y	X	Y
1	16	Redlake - Locam	400	na	na	60.96	na
2	16	Redlake - Locam	400	-4.42	19.93	-15.85	32.31
3	16	Redlake - Locam	400	-23.87	9.66	-41.45	30.48
4	16	Redlake - Locam	400	26.03	0.00	-87.48	0.00
5	16	Redlake - Locam	400	0.00	-14.66	-6.10	-24.69
6	35	Hulcher 35	20	3.57	-19.23	na	na
7	VHS	VHS Video Camera		5.36	-19.23	na	na
8	16	Photosonics	400	-0.30	1.37	-0.30	0.00
9	16	Redlake - Locam	400	0.00	1.37	0.00	0.00
10	16	Photosonics	400	0.30	1.37	0.30	0.00
11	16	Redlake - Locam	400	1.37	-14.90	na	na

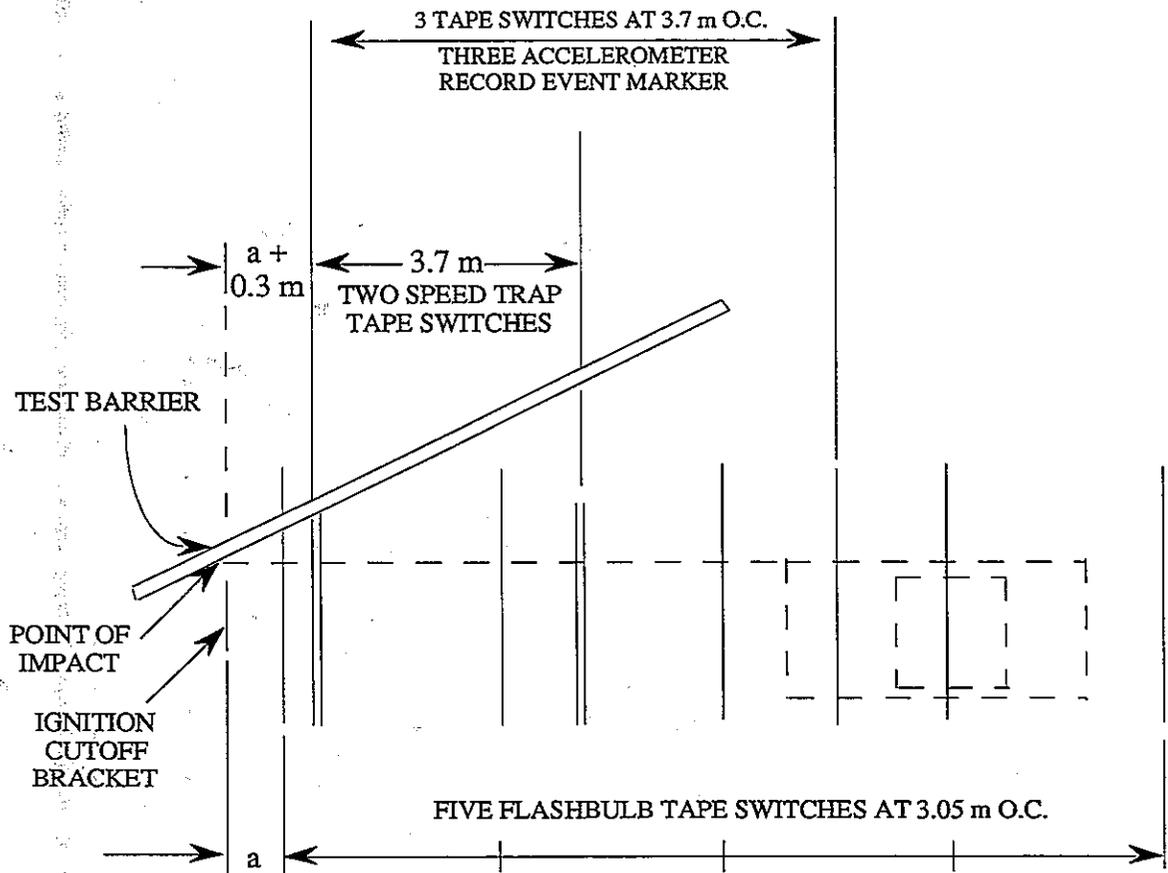
Figure B2: Tape Switch Layout

ground perpendicular to the path of the impacting vehicle near the barrier. Flash bulbs were activated sequentially when the tires of the test vehicle rolled over the tape switches. The flashbulb stand was placed in view of most of the data cameras. The flashing bulbs were used to correlate the cameras with the impact events; and to calculate the impact speed independent of the electronic speed trap. The tape switch layout is shown in Figure B2. All high-speed cameras had timing light generators which exposed red timing pips on the film at a rate of 1000 per second. The pips were used to determine camera frame rates and to establish time-sequence relationships.
