Vehicle Crash Tests of A Thrie Beam Barrier Terminal

September 1993

Final Report # FHWA/CA/ TL-93/19  
Caltrans Study #F82TL16

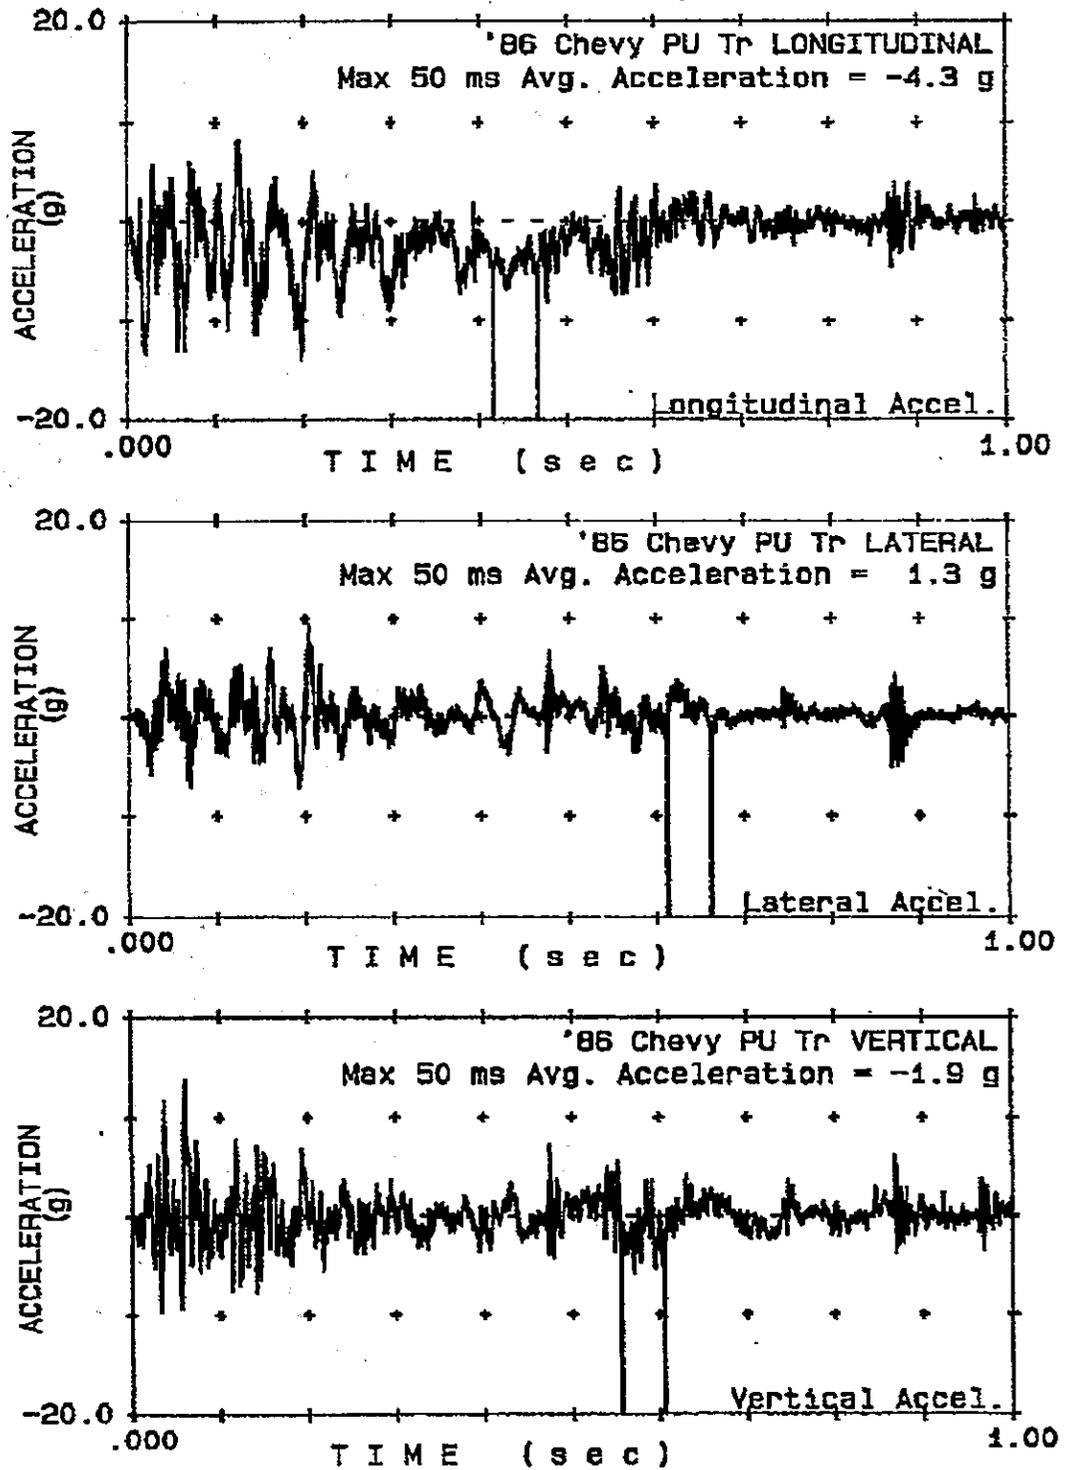
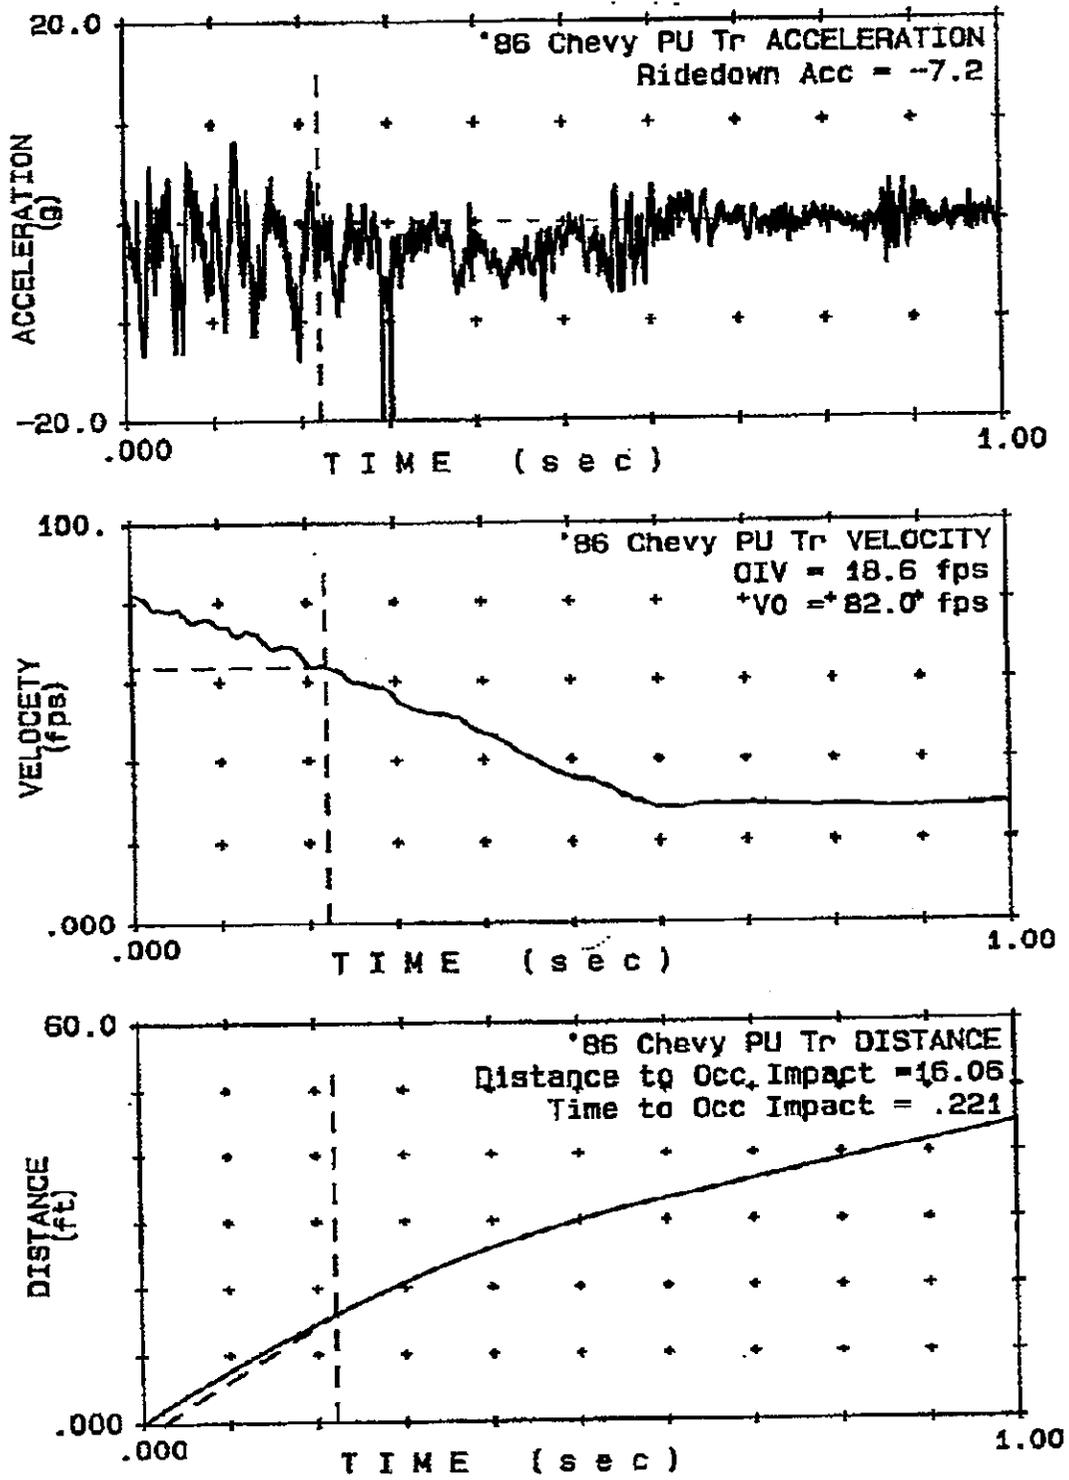
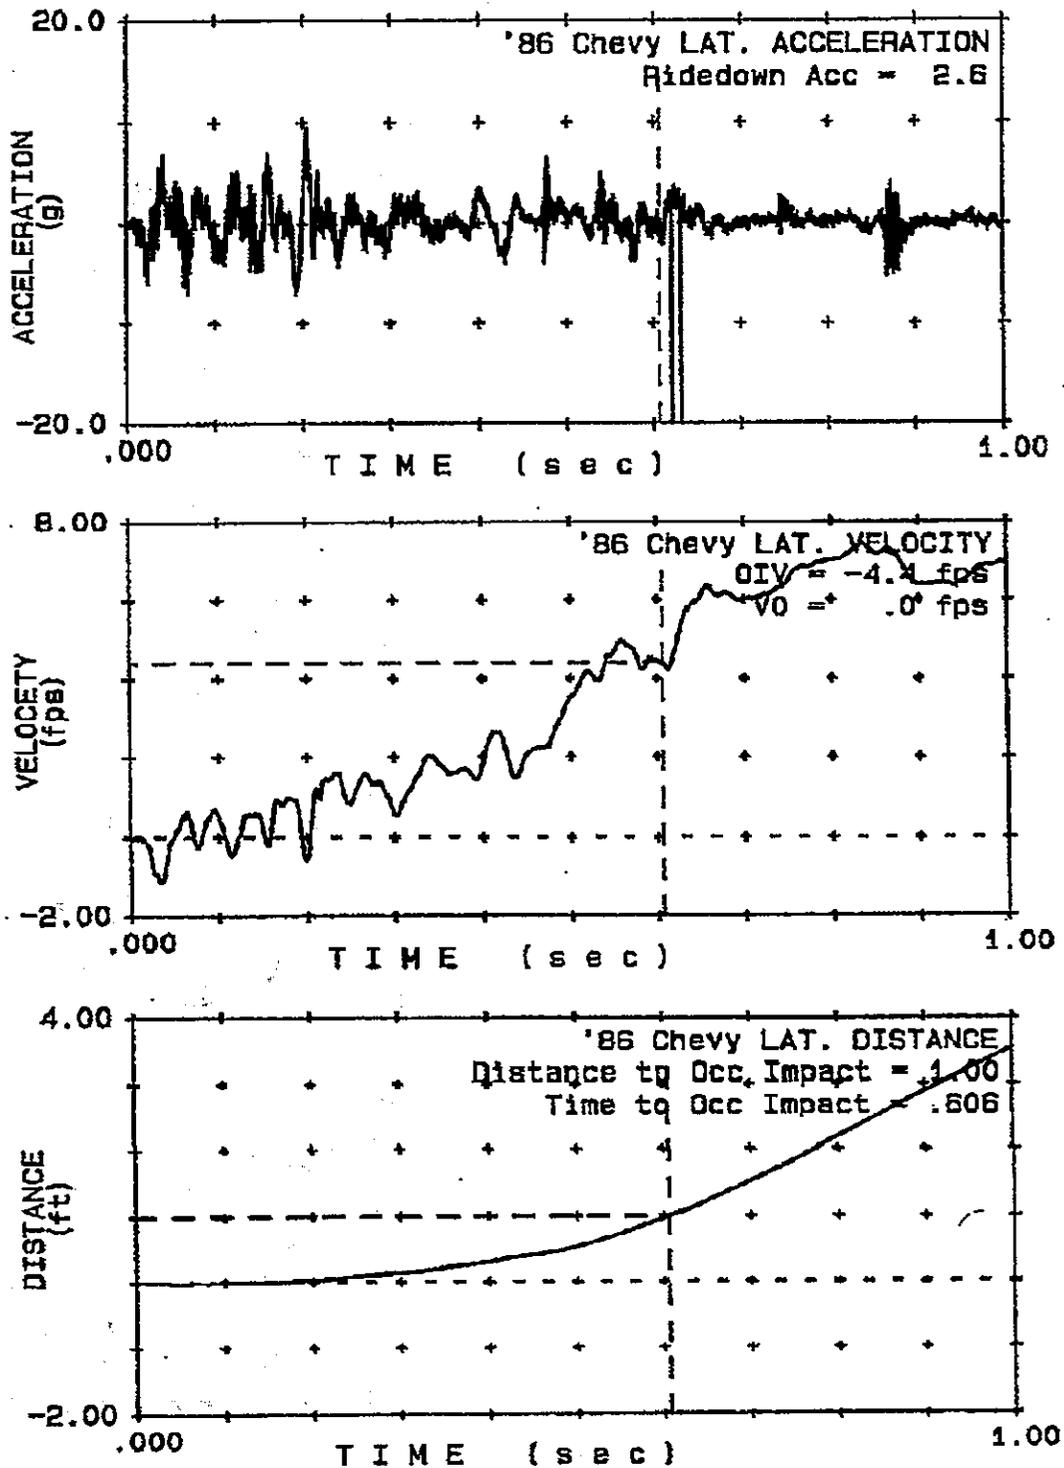
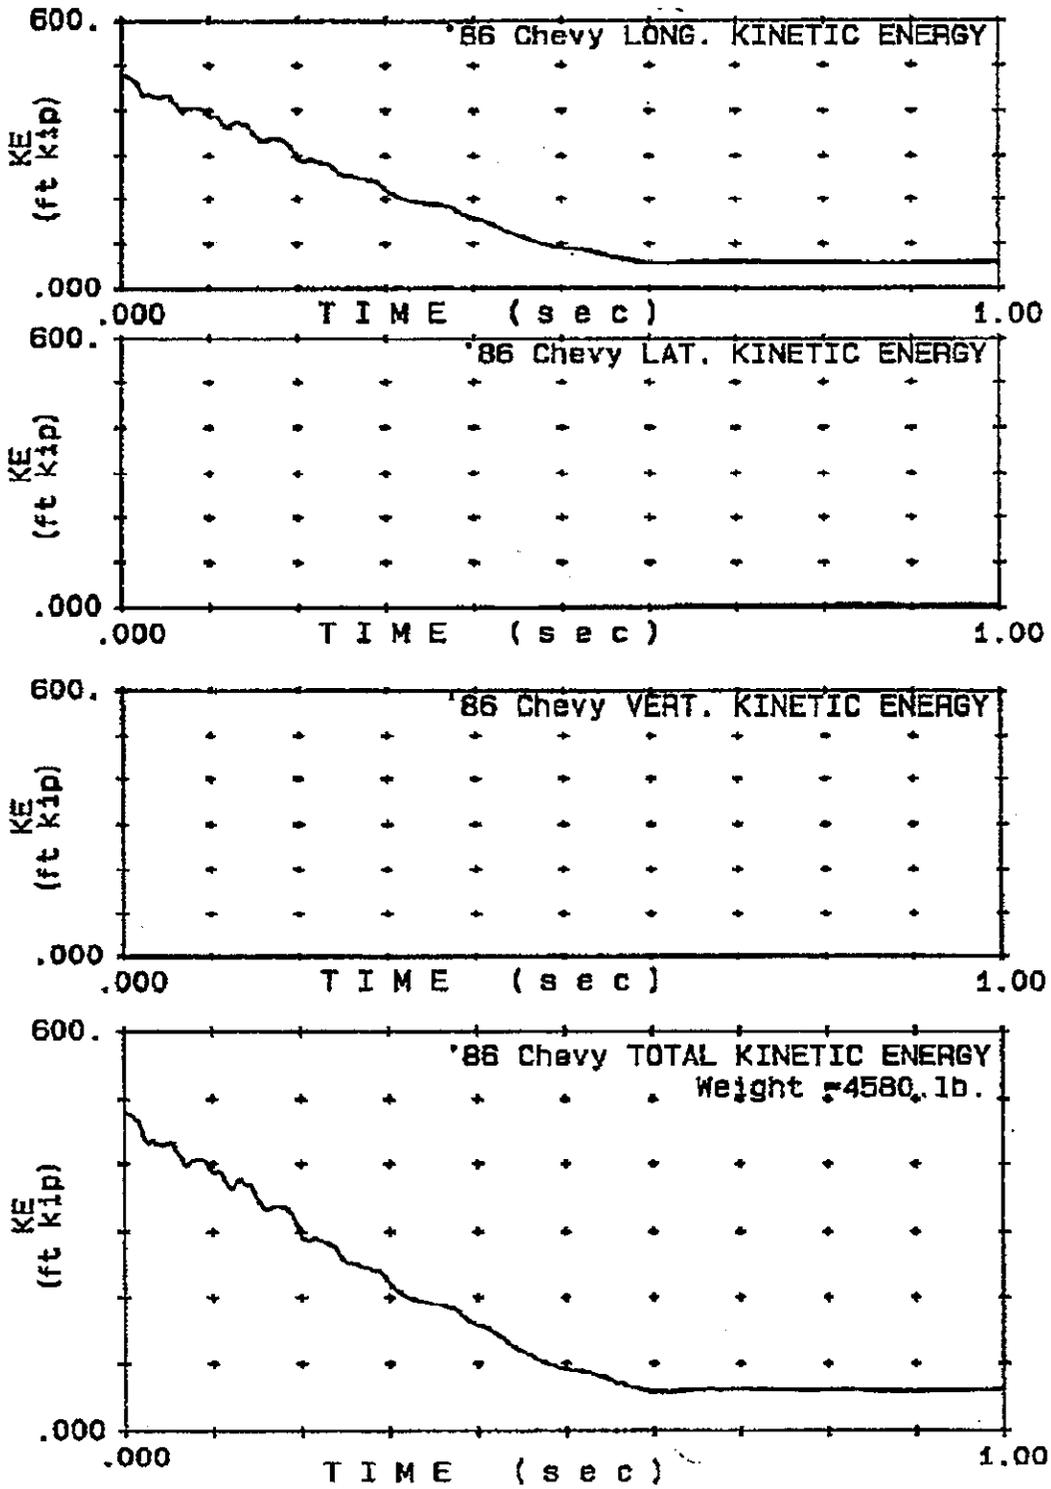
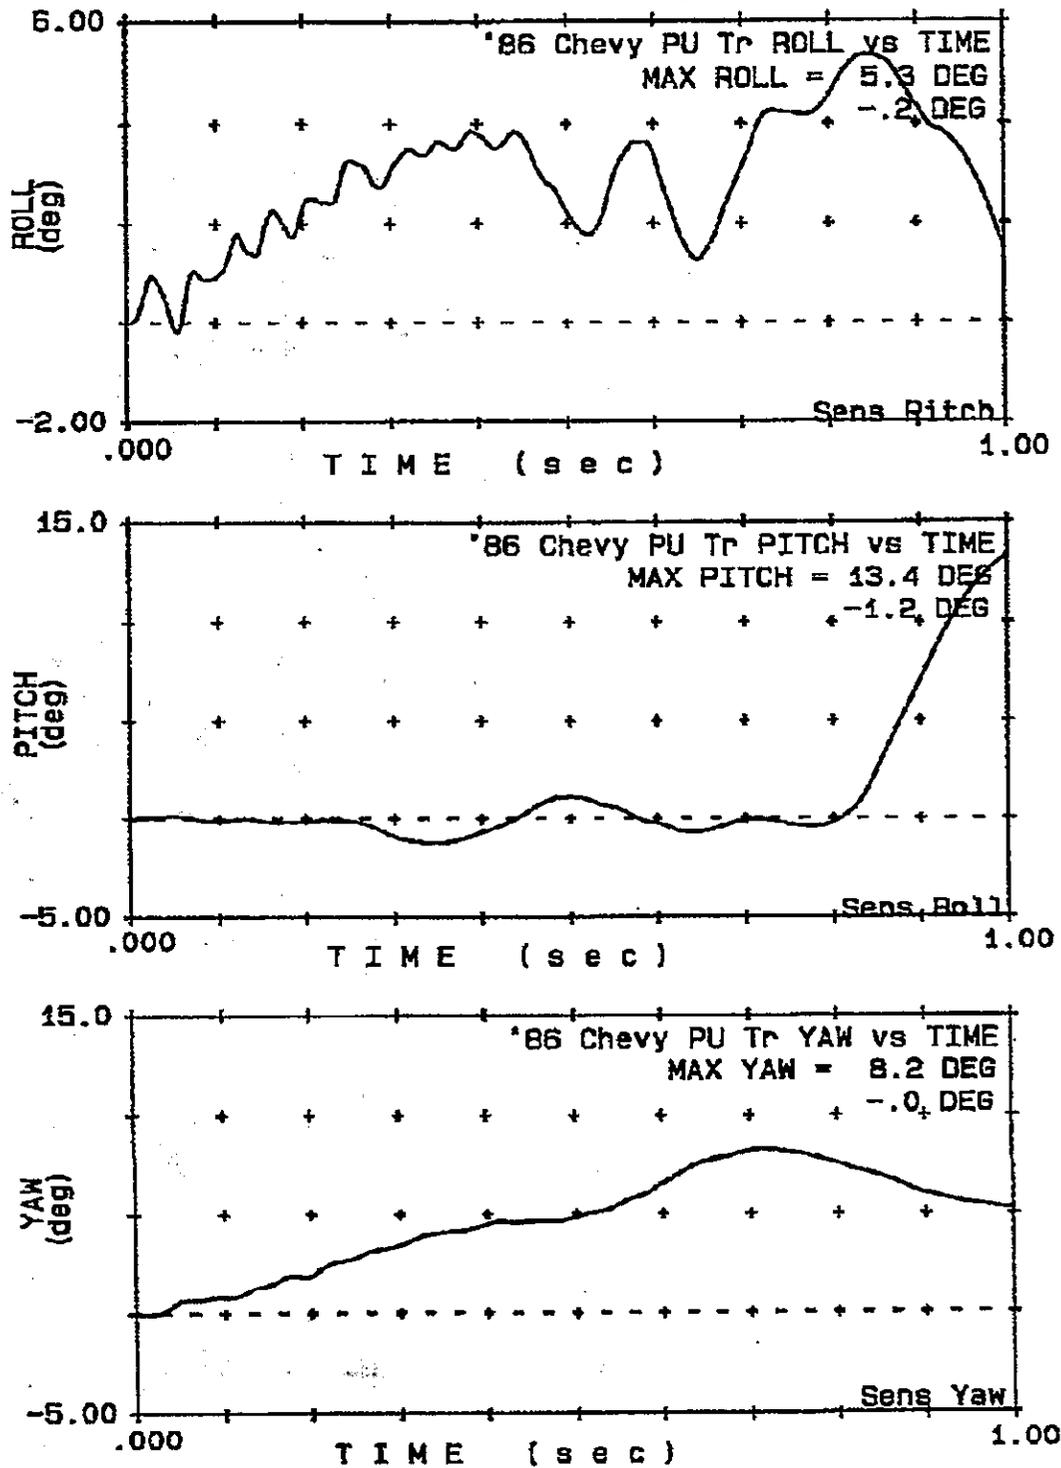
The data curves are shown in Figures C2 through C11 and include the accelerometer and rate gyro records from the vehicle for Tests 491 and 492. They also show the longitudinal velocity and displacement vs. time. These plots were needed to calculate the occupant impact velocity defined in (4). All curves were calculated using the PACDAS.
