1. Report No. CA13-1723	2. Government Access No.	3. Recipient's Catalog No.	
4. Title and Subtitle Investigation of Methacrylate Rehabilitation Strategy to Extend the Service Life of Concrete Bridge Decks		5. Report Date September 2013

# INVESTIGATION OF METHACRYLATE REHABILITATION STRATEGY TO EXTEND THE SERVICE LIFE OF CONCRETE BRIDGE DECKS

*Final Project Report*

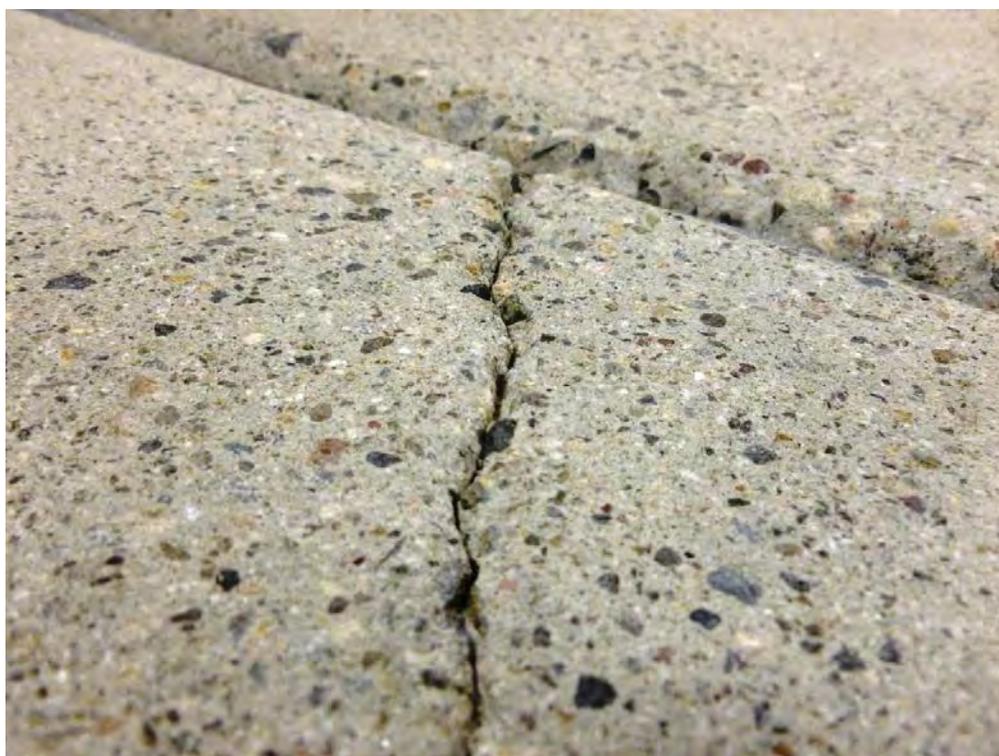
**Figure 32: Crack in deck surface after shot blasting.**

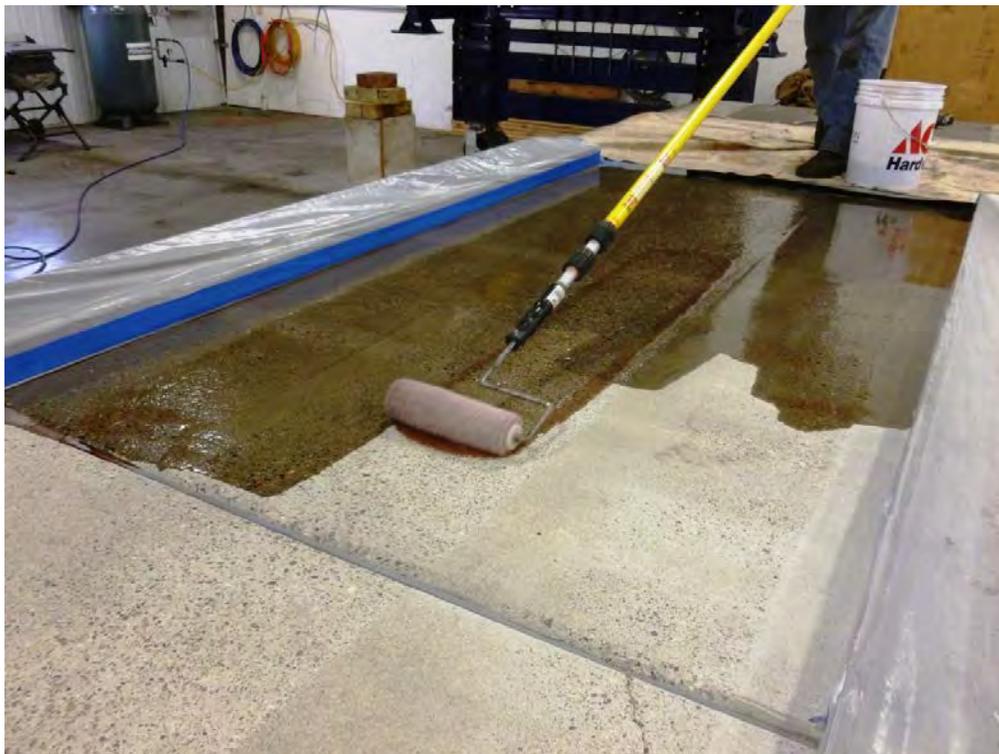
**Figure 33: Application of HMWM surface treatment.**

Subsequent to surface preparation, the KBP 204 (HMWM) was mixed in accordance with Kwik Bond product specifications and applied with a ½-inch nap paint roller (Figure 33). Excess material was rolled to the end of the slab and soaked up or deposited in a trough formed between adjacent test panels. Because cracked areas tended to soak up more methacrylate, special attention was paid to these areas to ensure adequate HMWM was present to fill the cracks prior to curing. The sealer cured for several days before trafficking was resumed. Friction enhancing sand was not added to the surface prior to curing as additional traction was deemed unnecessary in this application, and it was thought that this sand would obscure detection of surface distresses in the deck. A close-up photo of a crack filled with methacrylate is shown in Figure 34.

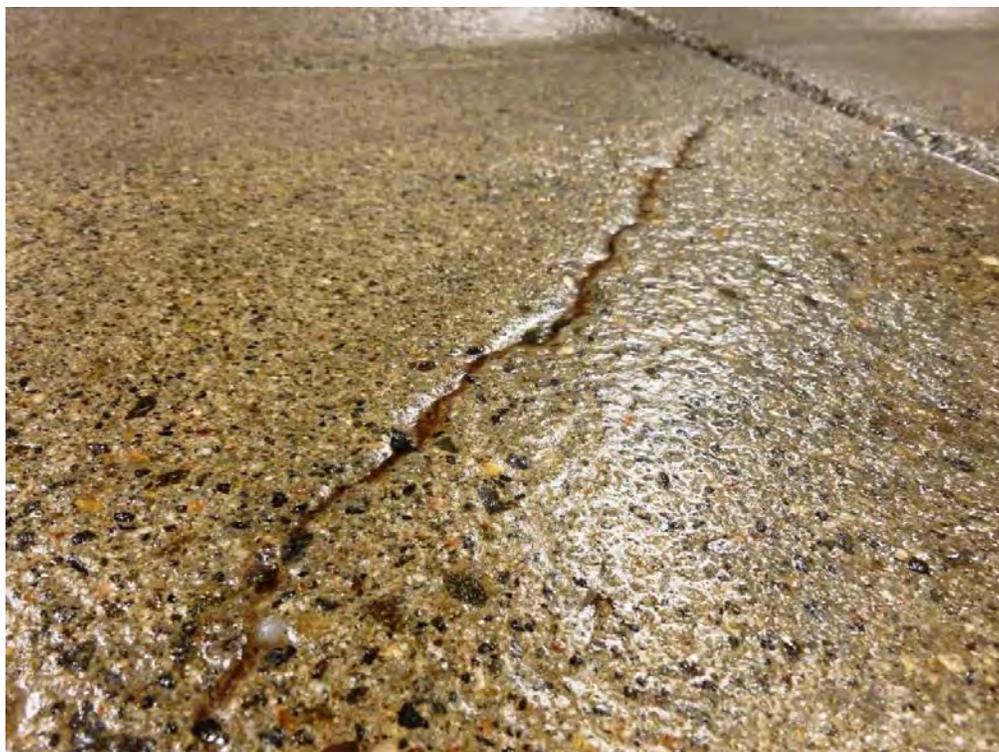
**Figure 34: Close-up of methacrylate-filled crack.**
