## Development and Crash Testing of an Aesthetic, See-through Bridge Rail, Type 90

**RESULTS: A new, aesthetic, see-through bridge rail design was developed and crash tested in an effort to meet National Highway Safety Research Program (NCHRP) Report 350 test level 4. The Type 90 bridge rail design was successfully crash tested and is recommended for operational use as a Test Level 4 bridge rail.**

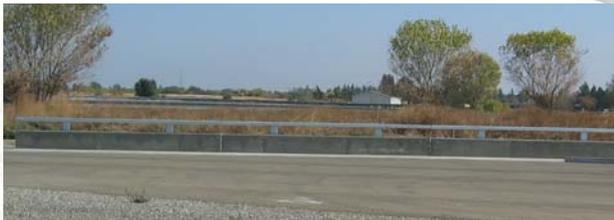
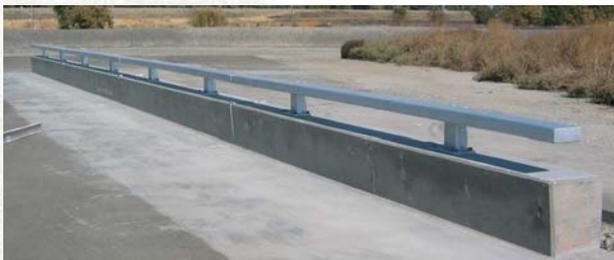
Figure 1 – Type 90 Bridge Rail

The bridge rail design was developed by Caltrans Structures Design in conjunction with Applied Research Associates, who performed the finite element model crash test simulations. The design utilizes a steel rail with posts spaced 3 meters apart atop a "reverse-slope" concrete curb. This means that the top of the curb is closer to the roadway than the bottom, which is the opposite of the other concrete bridge rails such as the

Type 736 and Type 80. The purpose of the reverse-slope curb is to raise the reaction point between the vehicle and barrier, thereby minimizing vehicle roll.

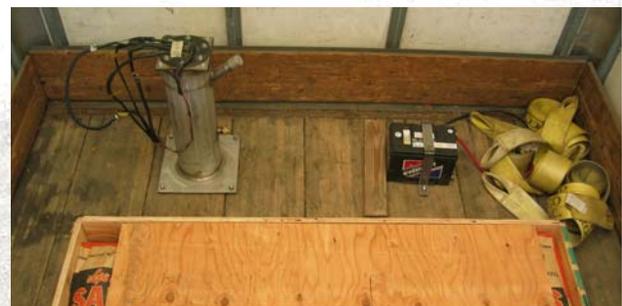
Figure 2 – Safety Fuel Tank & Battery in Truck Cargo Area

In order to improve control and safety of test vehicles, additional modifications were implemented. The first modification was substituting a safety fuel tank for the stock fuel tank. Also, gaseous carbon dioxide was added to the stock fuel tank in order to purge the gas vapors and eliminate oxygen. For the large truck, another modification was to relocate the vehicle battery to the cargo area.

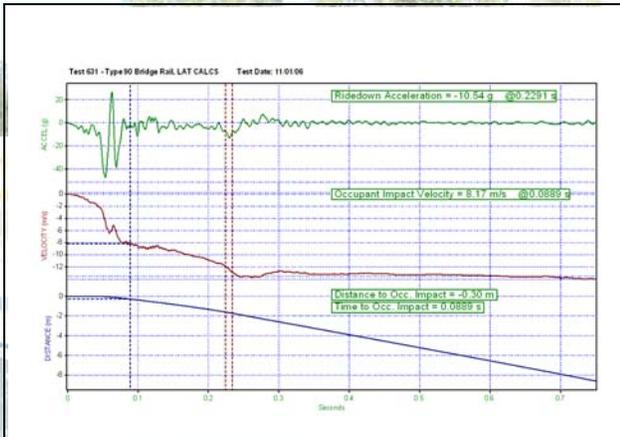
Figure 3 – Longitudinal Acceleration, Velocity, and Distance vs. Time for Test 631

After integrating the accelerometer data, the acceleration, velocity, and distance vs. time of the test vehicles could be determined.

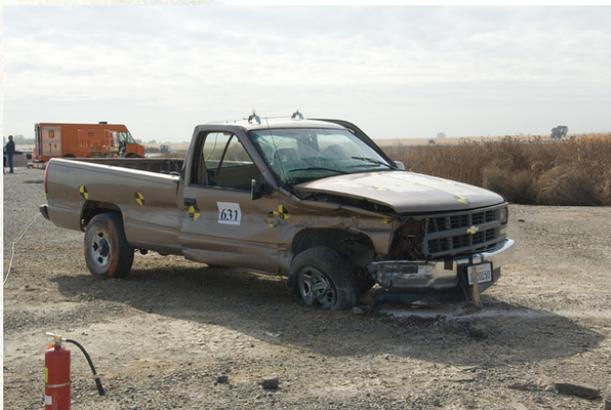
Figure 4 – Test 631 Vehicle Post-Impact

The design performed as expected. None of the vehicles demonstrated a large tendency to roll or launch. The impacts were generally slightly more severe (higher Occupant Impact Velocities and Ridedown Accelerations) than with other sloped profile barriers. However, both of values were within the acceptable range of Report 350 for all vehicles. Additionally, vehicle damage for all vehicles was in the acceptable range for NCHRP Report 350 and within the maximum allowed by FHWA.

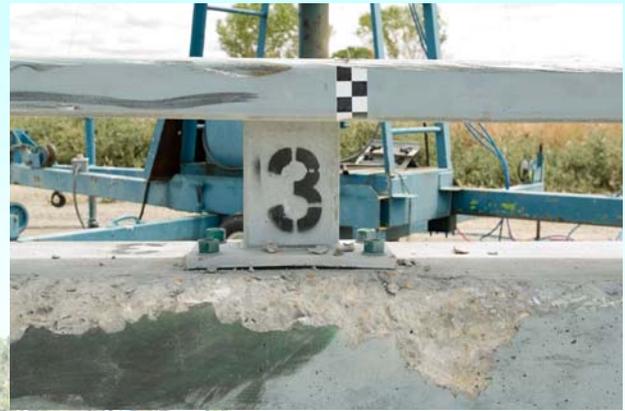
Figure 5 – Test Article Post after Test 634 Impact

NCHRP Report 350 stipulates that crash test performance is assessed according to three evaluation criteria: 1) Structural Adequacy, 2) Occupant Risk, and 3) Vehicle Trajectory. The Type 90 bridge rail design rated acceptable in all these categories. For Structural Adequacy, the only damage more significant than minor concrete spalling occurred during the 8000-kg test. The post mounting plate was bent and there was minor weld cracking at the plate-post seam. For Occupant Risk, there were no signs of snagging of the rail, as well as no sign of spalling concrete penetrating the occupant compartment of the vehicles. Finally for Vehicle Trajectory, the test vehicles remained relatively straight after impact. Therefore, the Type 90 bridge rail is recommended as an NCHRP Report 350 Test Level 4 bridge rail.
