1. REPORT NUMBER CA11-1562 A	2. GOVERNMENT ASSOCIATION NUMBER	3. RECIPIENT'S CATALOG NUMBER
4. TITLE AND SUBTITLE Warm-Mix Asphalt Study: First-Level Analysis of Phase 2 HVS and Laboratory Testing, and Phase 1 and Phase 2 Forensic Assessments		5. REPORT DATE 07/30/2009
		6. PERFORMING ORGANIZATION CODE
7. AUTHOR David Jones, Rongzong Wu, Bor-Wen Tsai, and John T. Harvey		8. PERFORMING ORGANIZATION REPORT NO. UCPRC-RR-2009-02
9. PERFORMING ORGANIZATION NAME AND ADDRESS University of California, Davis & Berkeley Partnered Pavement Research Center 1353 S. 46th Street, Bldg. 452 Richmond, CA 94804		10. WORK UNIT NUMBER
		11. CONTRACT OR GRANT NUMBER 65A0272 Task ID 1562
12. SPONSORING AGENCY AND ADDRESS California Department of Transportation Division of Research and Innovation, MS-83 1227 O Street Sacramento CA 95814		13. TYPE OF REPORT AND PERIOD COVERED Final
		14. SPONSORING AGENCY CODE

TECHNICAL REPORT DOCUMENTATION PAGE

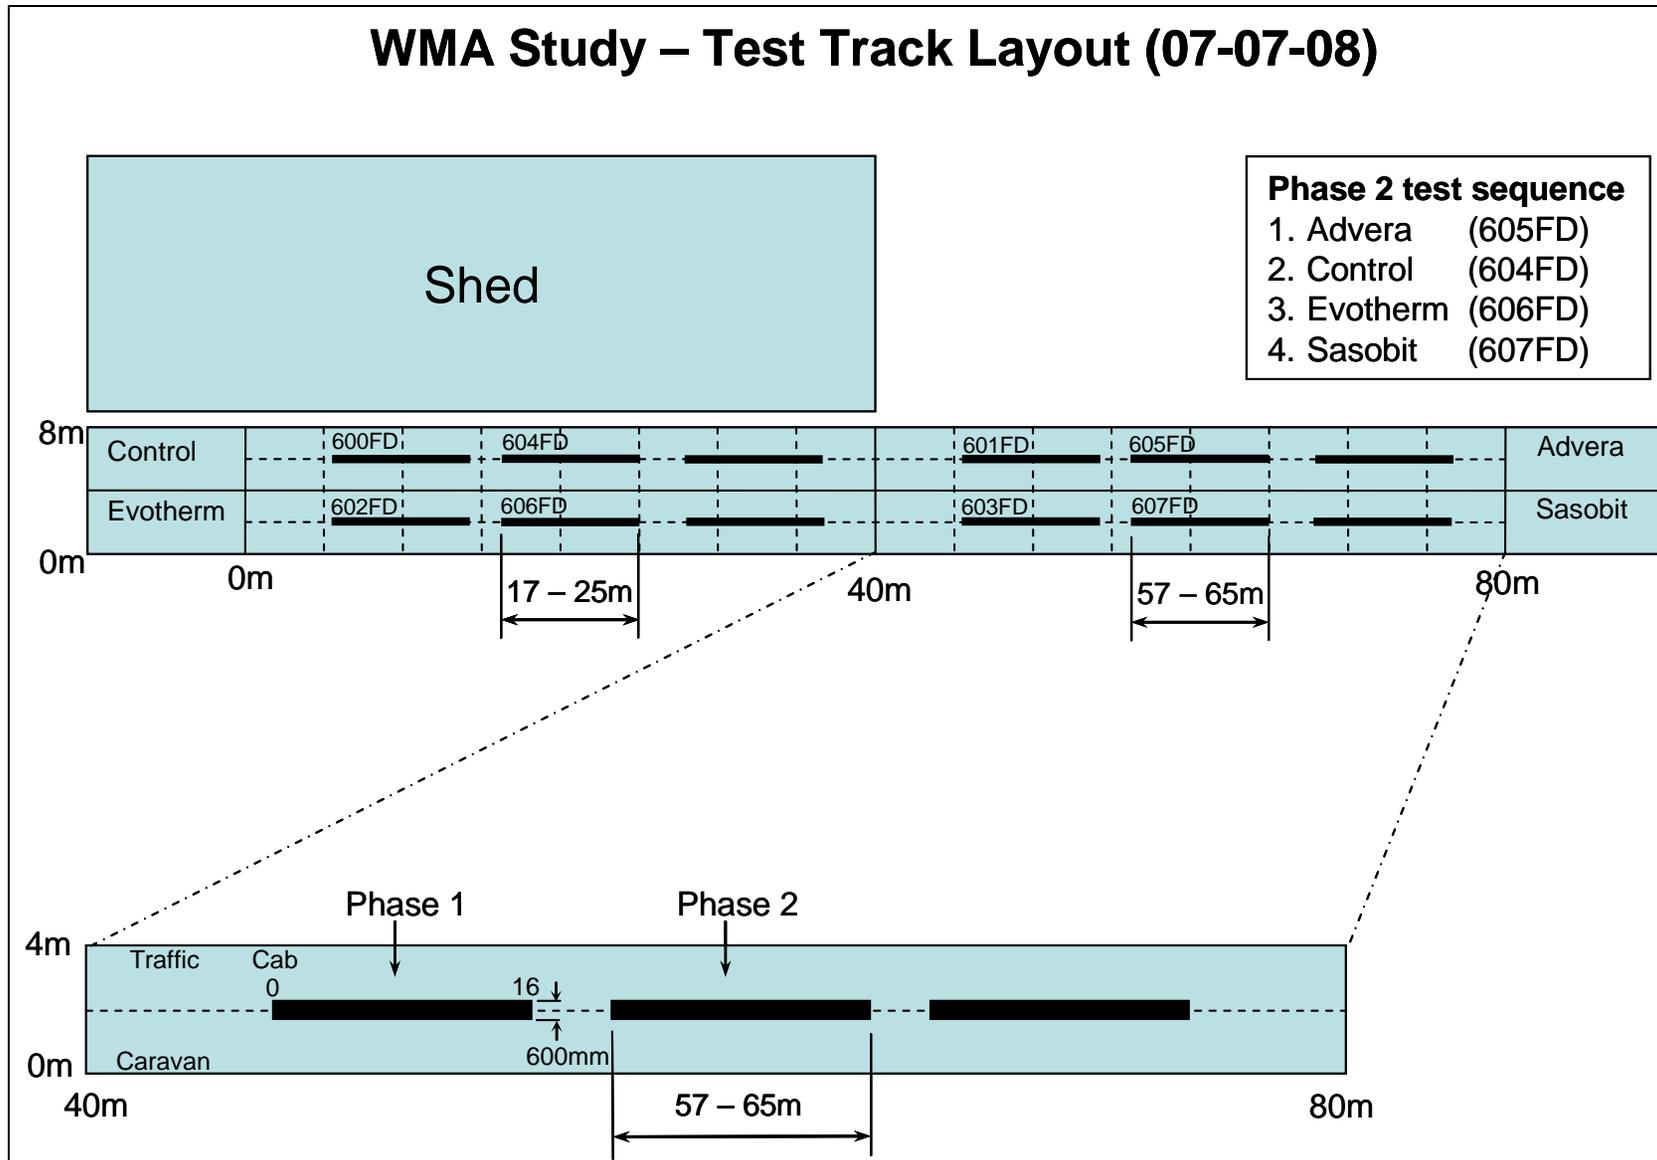
Figure 3.1: Layout of test track and HVS test sections.

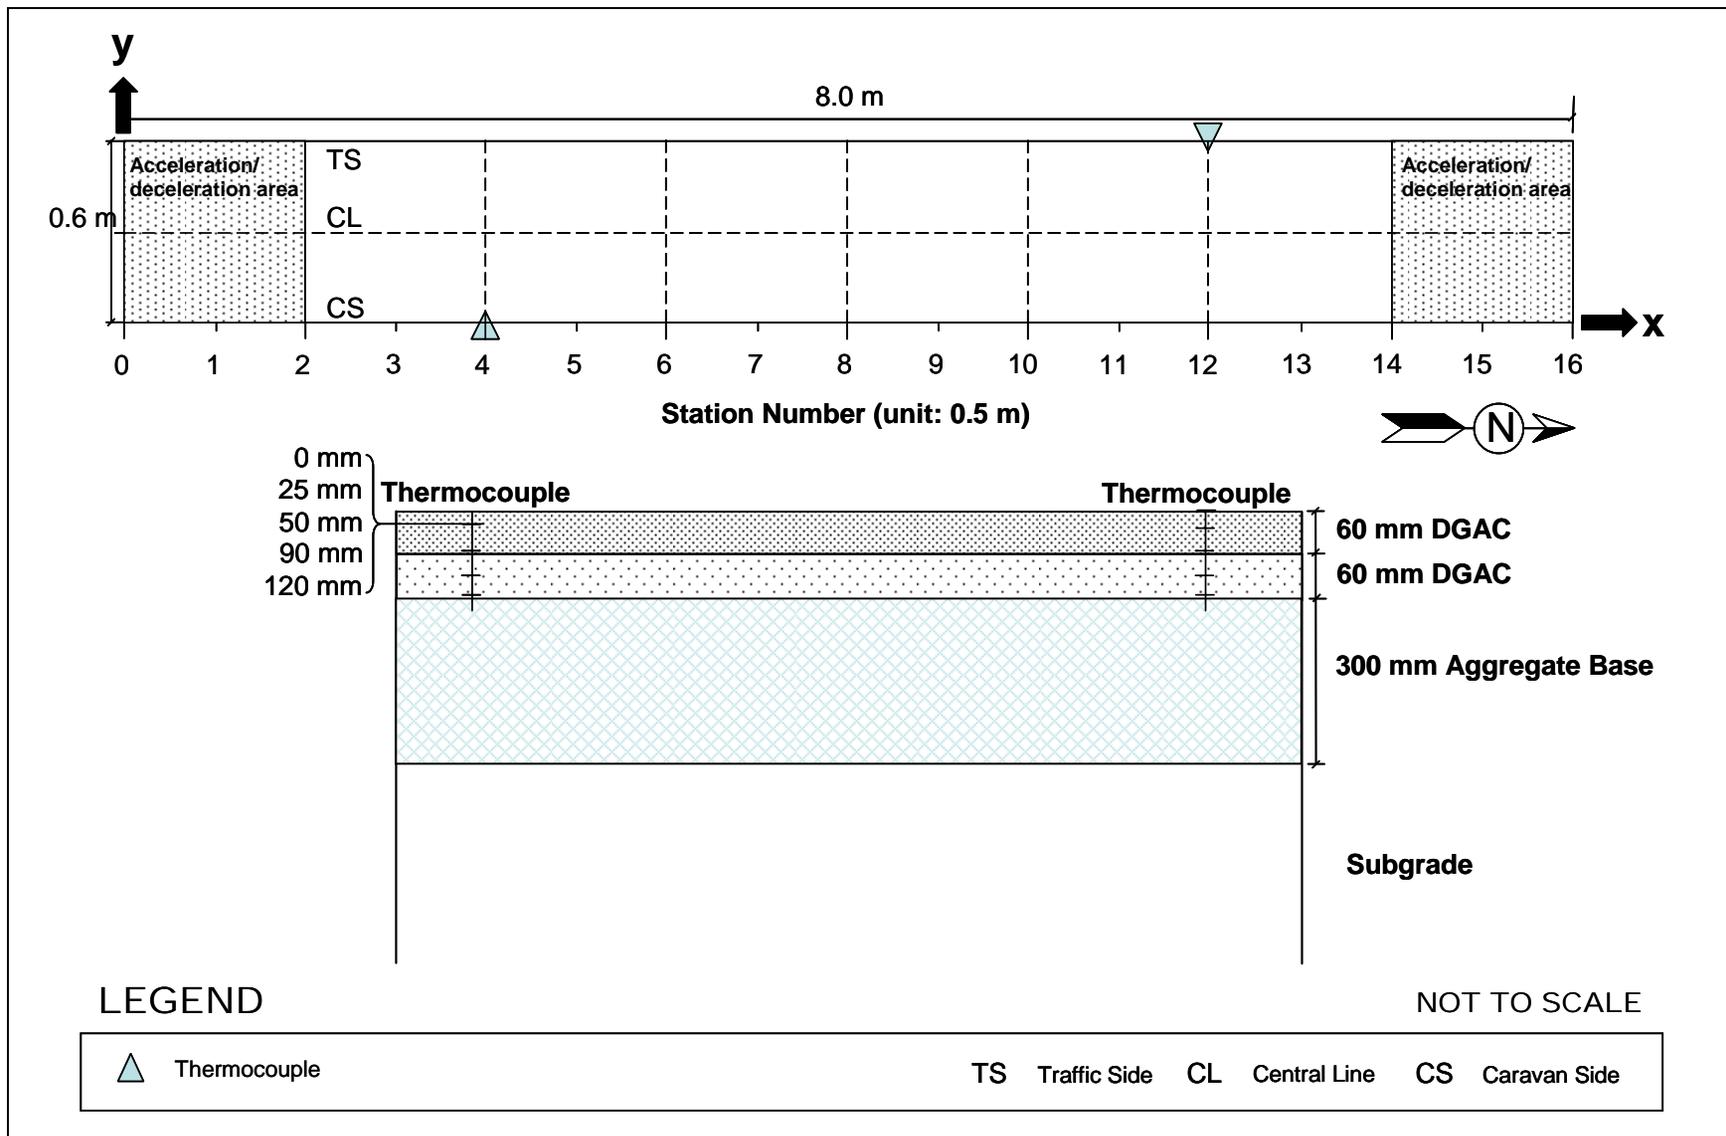
Figure 3.2: Phase 2 test section layout and thermocouple locations.

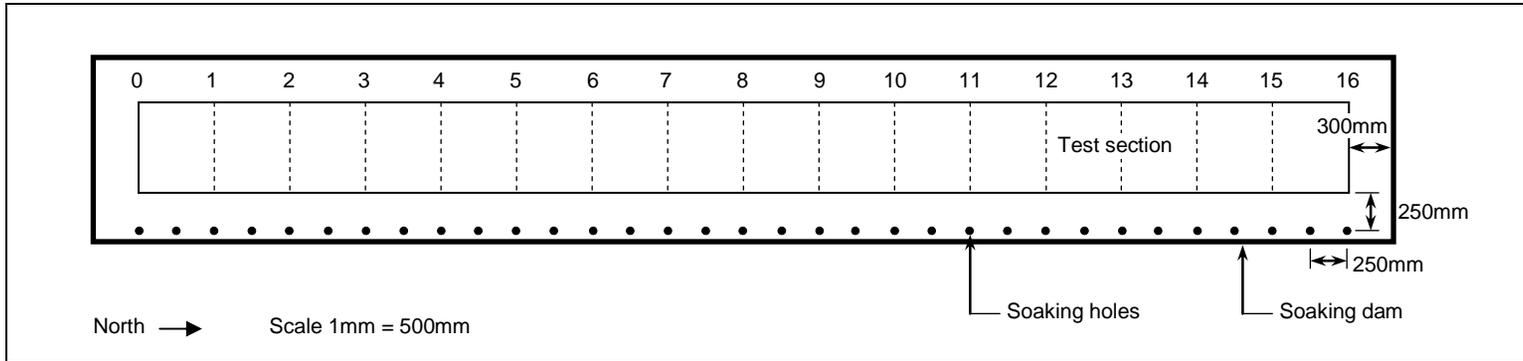
Figure 3.3: Location of presoaking dam and soak holes.

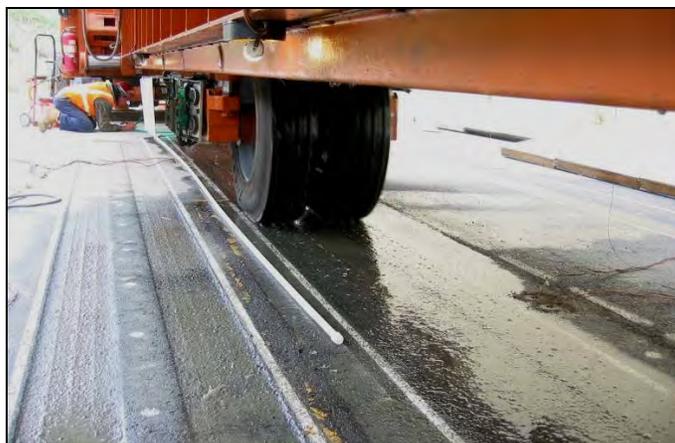
Figure 3.6: Water flow across test section during trafficking.

A flow of surface water across the test sections during HVS trafficking was necessary to identify whether the warm-mix asphalt sections were more sensitive to moisture-related damage (stripping, raveling, and/or rutting) than the Control section. The study focused on rut damage related to moisture retained in the aggregate as a result of lower production temperatures, which would typically materialize as load-related stripping throughout the layer, as opposed to stripping and raveling of the surface aggregate caused by scour from tires on the wet surface. Soaking regimes and surface water flows for this study were determined from a short HVS experiment on a section demarcated between Section 600FD and Section 602FD from the Phase 1 study. Based on observations from this experiment, all Phase 2 HVS testing was carried out with a constant flow of approximately 1.5 liters (0.4 gallons) of water per hour across the section. The water was preheated to $50^{\circ}\text{C}\pm 4^{\circ}\text{C}$ ($122^{\circ}\text{F}\pm 7^{\circ}\text{F}$) to prevent cooling of the pavement surface. The test conditions are shown in Figure 3.6.

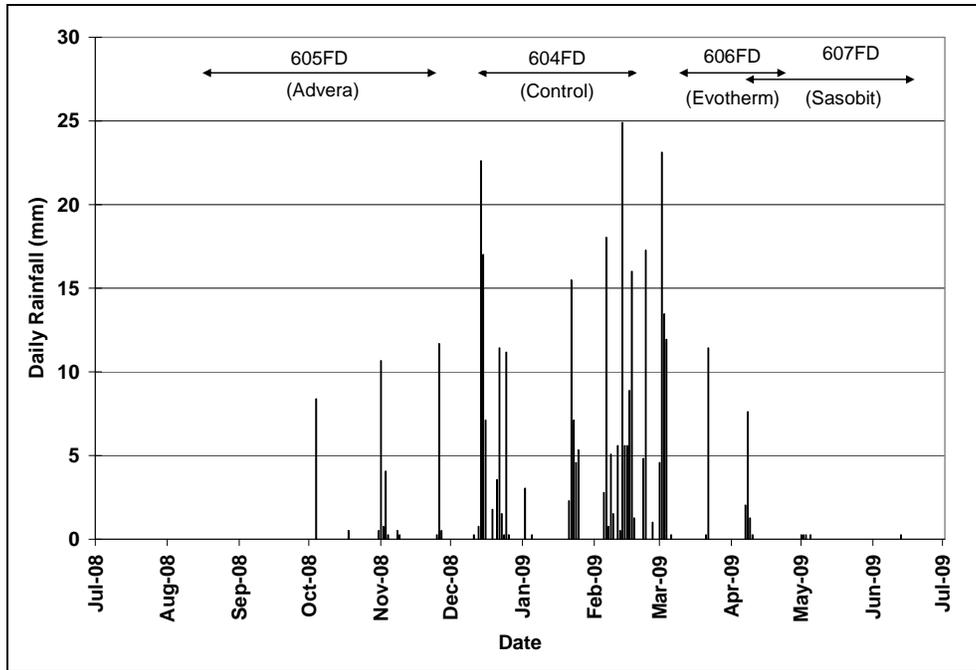
Figure 4.2: Measured rainfall during Phase 2 HVS testing.

Section	Overlay	Rain days	Total (mm [in.])	Highest 24 Hour (mm [in.])
604FD	Control	32	212.4 (8.36)	24.9 (0.98)
605FD	Advera	9	25.9 (1.02)	10.7 (0.42)
606FD	Evotherm	6	22.9 (0.90)	11.5 (0.45)
607FD	Sasobit	9	12.4 (0.49)	7.6 (0.30)

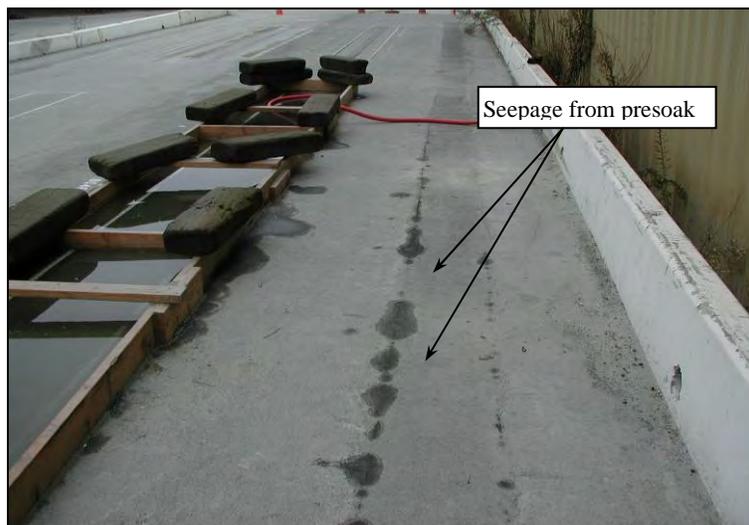
Figure 4.3: Seepage during presoaking.

During presoaking of the section some seepage through the pavement (patched area from earlier sampling after construction of the test track) was observed adjacent to the test section (Figure 4.3) implying that water was possibly seeping between the top and bottom lifts of asphalt.

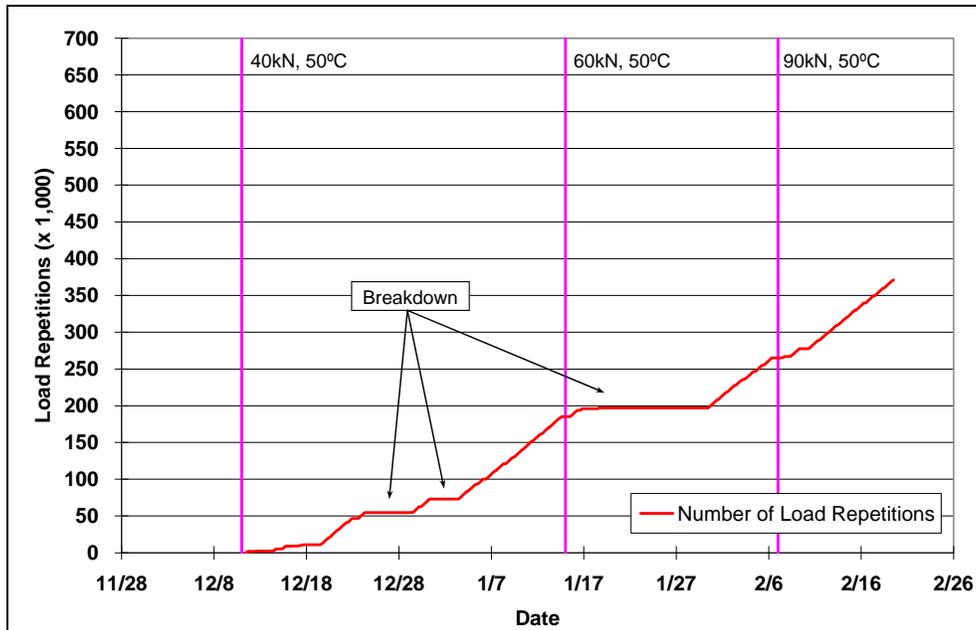
Figure 4.4: 604FD: Load history.

Loading commenced on December 11, 2008, and ended on February 19, 2009. A total of 371,000 load repetitions were applied and 64 datasets were collected. Testing was interrupted on three occasions during equipment breakdowns. The HVS loading history for Section 604FD is shown in Figure 4.4.

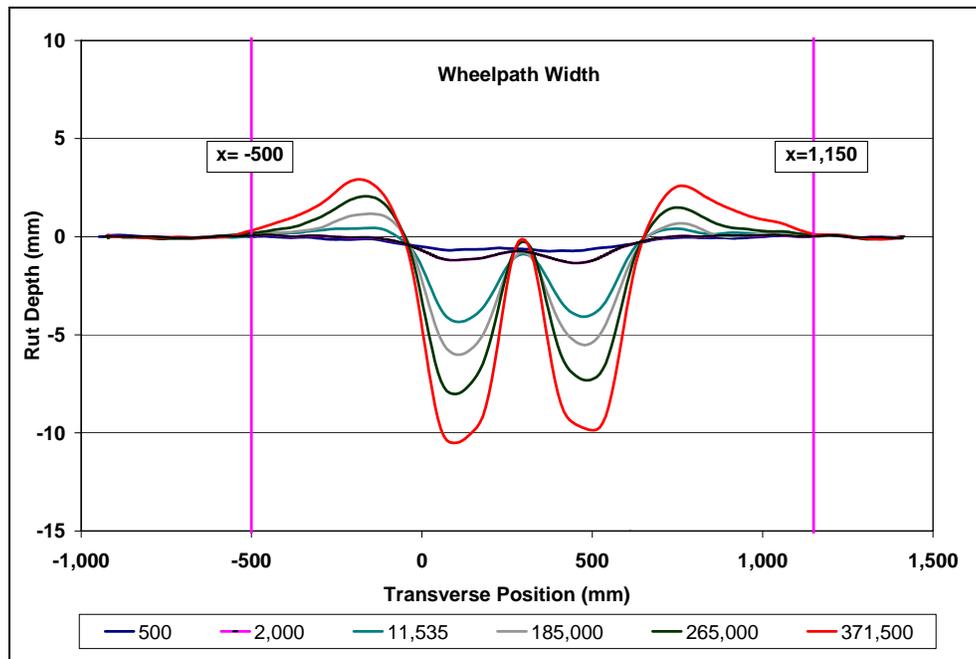
Figure 4.8: 604FD: Profilometer cross section at various load repetitions.

Figure 4.8 shows the average transverse cross section measured with the Laser Profilometer at various stages of the test. This plot clearly shows the increase in rutting and deformation over the duration of the test. The average height of displaced material (i.e., above the pavement surface) was less than 5.0 mm (0.2 in.), while the depth of deformation (i.e., below the pavement surface) was about 10 mm (0.4 in.).

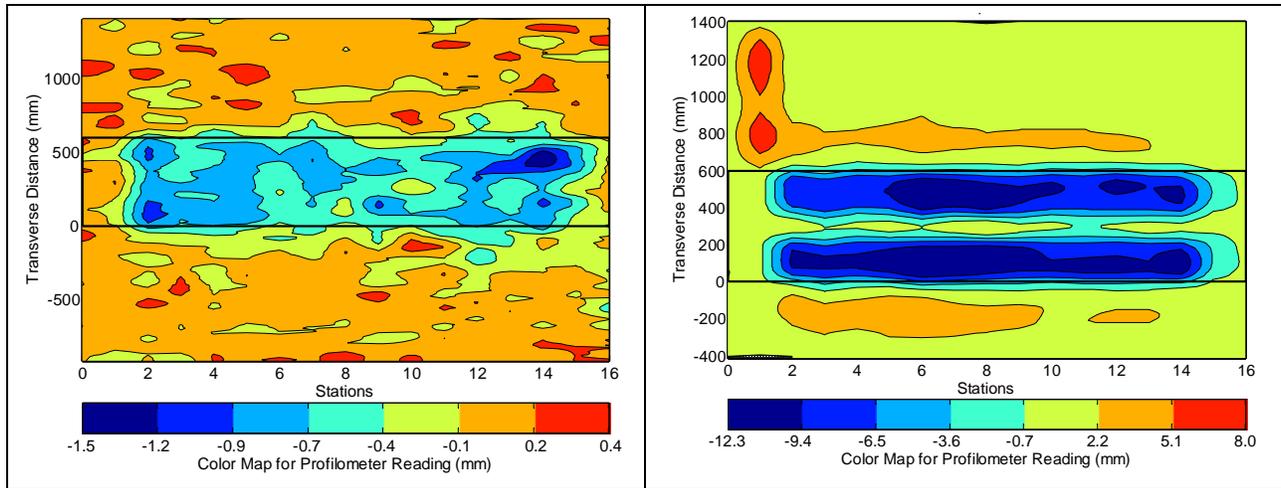
Figure 4.11: 604FD: Contour plot of permanent surface deformation at start and end of test.
(Note that scales are different.)

Figure 4.11 shows a contour plot of the pavement surface at the beginning (after 500 repetitions) and at the end of the test (371,000 repetitions), also indicating minimal variation along the section. After completion of trafficking, the average maximum rut depth and the average deformation were 13.5 mm (0.5 in.) and 8.6 mm (0.33 in.), respectively. The maximum rut depth measured on the section was 16.2 mm (0.64 in.), recorded at Station 6.

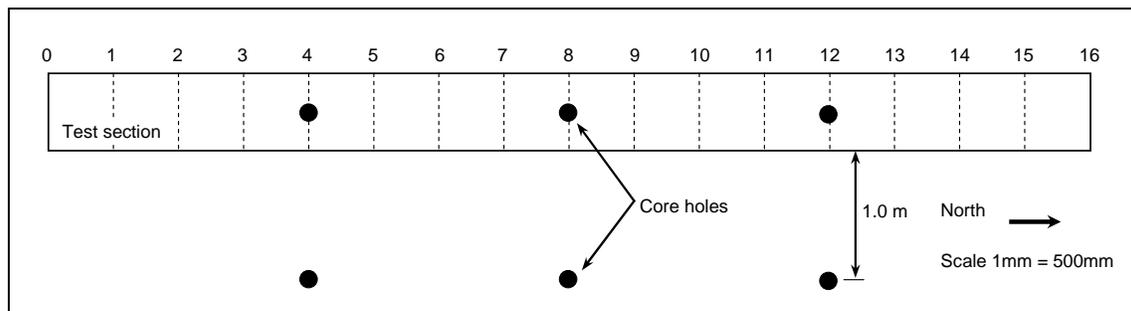
Figure 4.12: Location of cores for moisture content determination.

Moisture contents in the asphalt concrete were determined from 152 mm (6.0 in.) diameter cores removed immediately after testing from the centerline of the test section and from a line 1.0 m (3.3 ft) from the outside edge of the test section at Stations 4, 8 and 12 (Figure 4.12). The cores removed from within the test section were all separated at the bond between the two lifts. No debonding was noted on the cores removed from outside the test section. Photographs of the cores are shown in Figure 4.13.

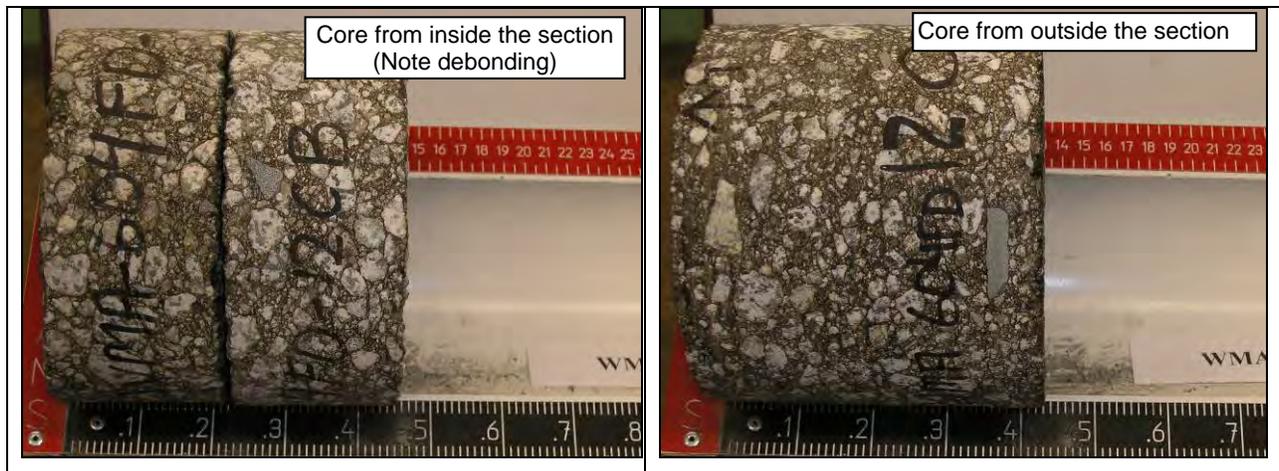
Figure 4.13: 604FD: Cores for moisture content determination.

Station	Moisture Content (%)		
	Inside Test Section	Outside Test Section	Difference
4	0.82	0.35	0.47
8	1.21	0.35	0.86
12	1.40	0.35	1.05

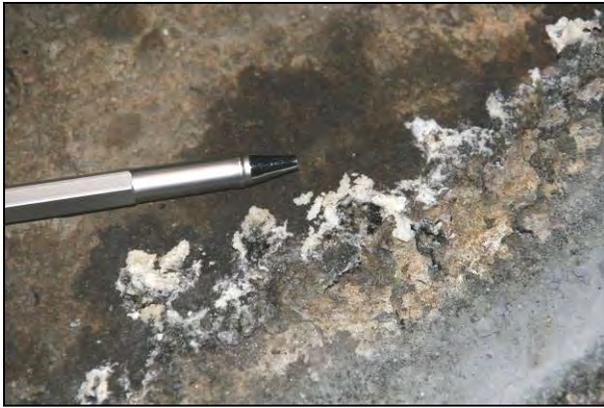
Figure 4.14: 604FD: Crystallized salt on edges of wheelpaths during testing.

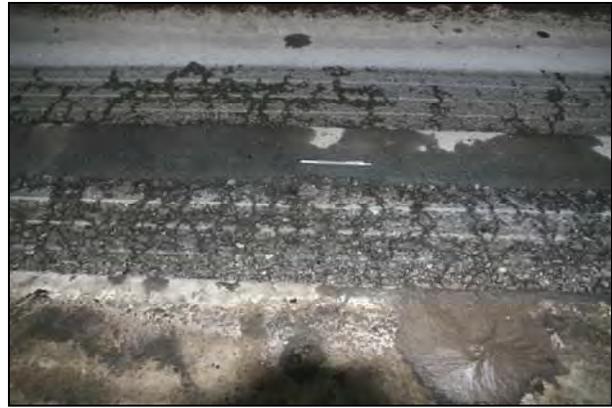
Figure 4.15: 604FD: Cracks in wheelpaths during testing.

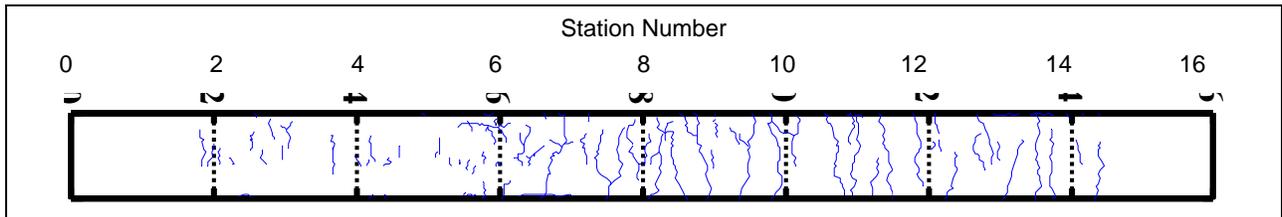
Figure 4.16: 604FD: Final crack pattern.

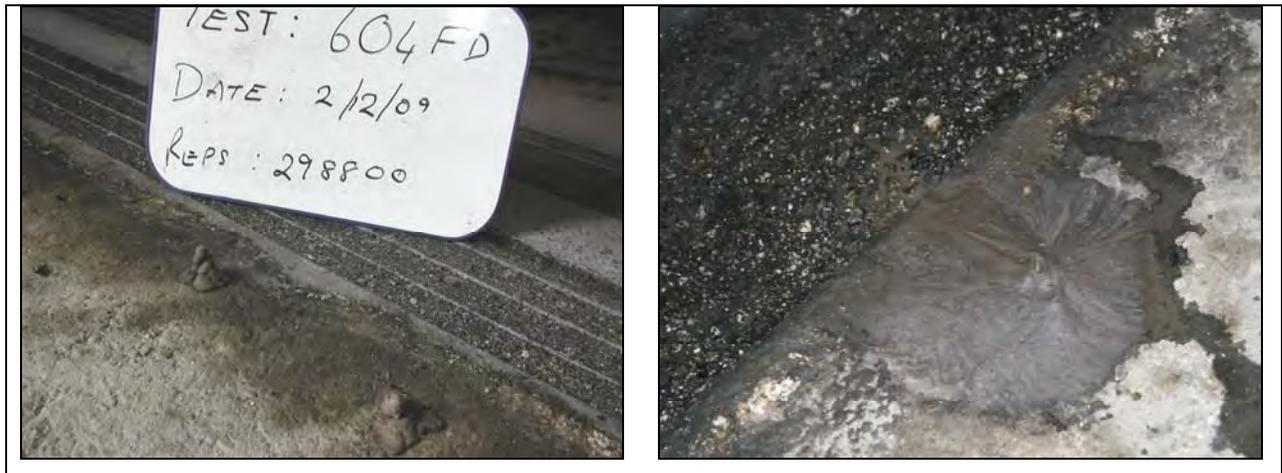
Figure 4.17: 604FD: Fines pumped from holes drilled for presoaking.

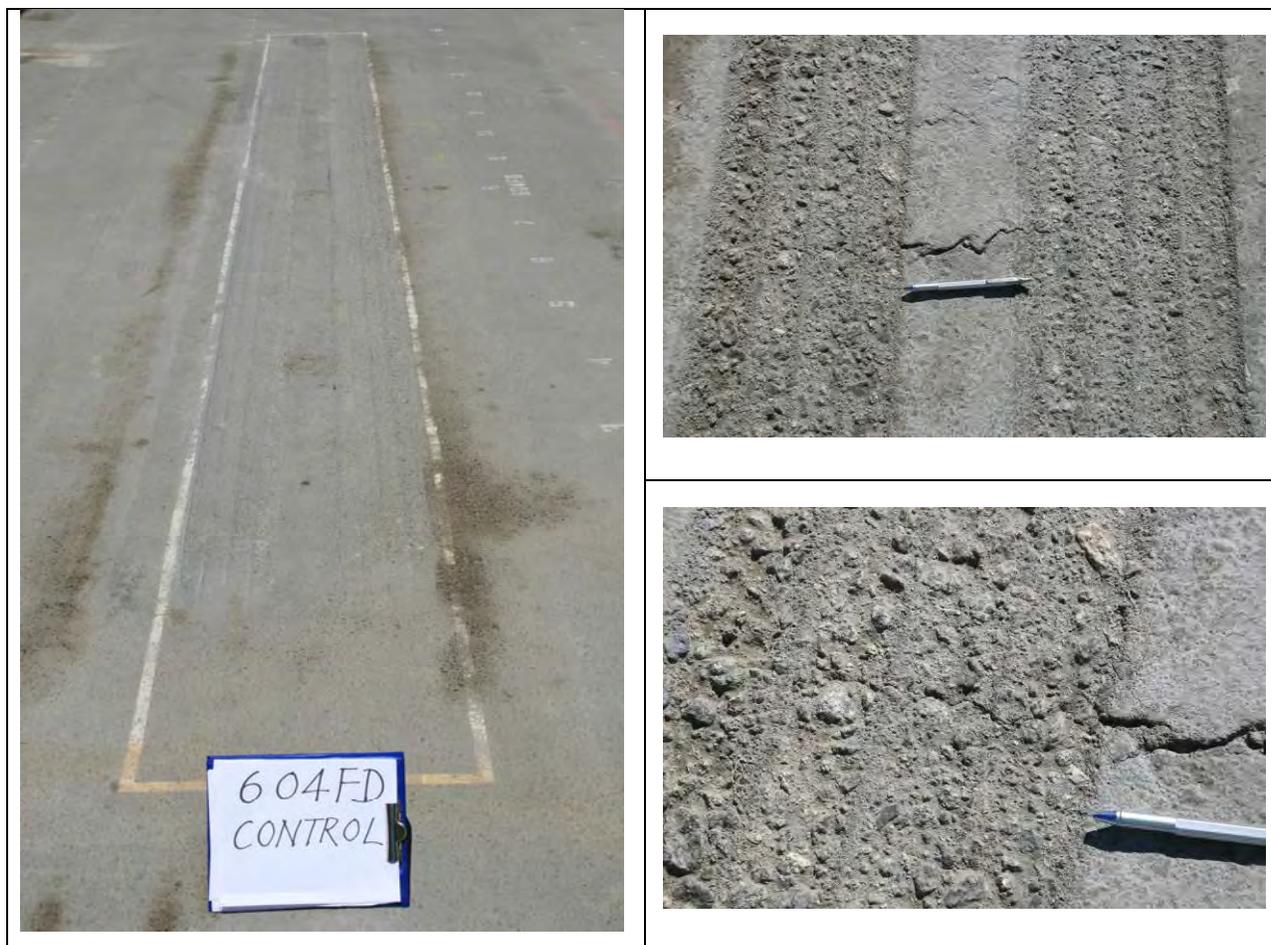
Figure 4.18: 604FD: Section photographs at test completion.

- Although some “wear” (attributed to the channelized traffic and constant water flow) was noted on the surface (Figure 4.18), no aggregate stripping, ravelling or other evidence of moisture damage was noted during or after the test.

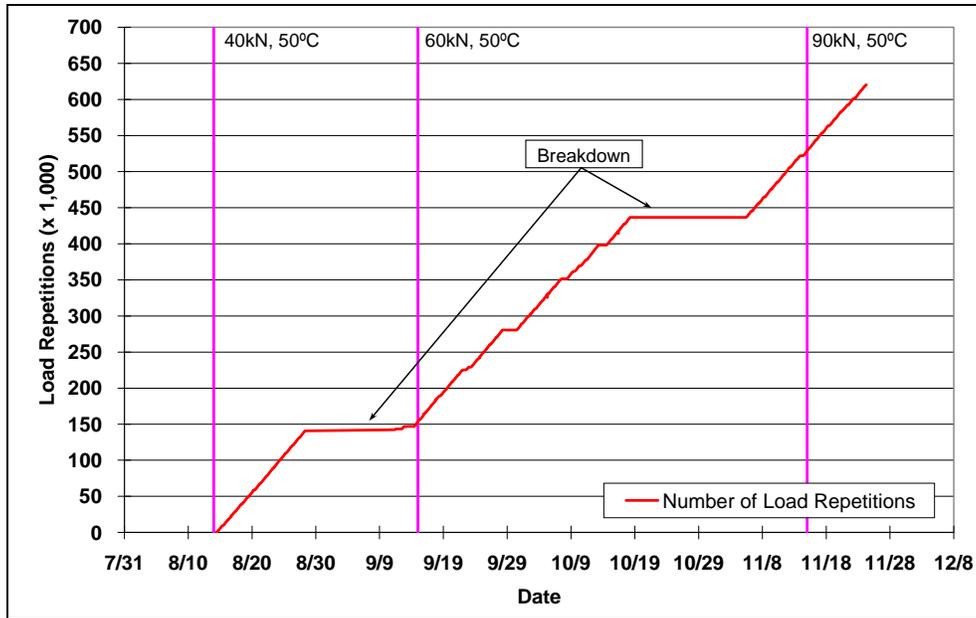
Figure 4.19: 605FD: Load history.

Loading commenced on August 14, 2008, and ended on November 19, 2008. A total of 620,500 load repetitions were applied and 73 datasets were collected. Almost 250,000 more load repetitions were applied compared to the Control. In the interests of completing the project, testing was terminated prior to obtaining an average maximum rut depth of 12.5 mm (0.5 in.). The HVS loading history for Section 605FD is shown in Figure 4.19. Two breakdowns occurred during this test.

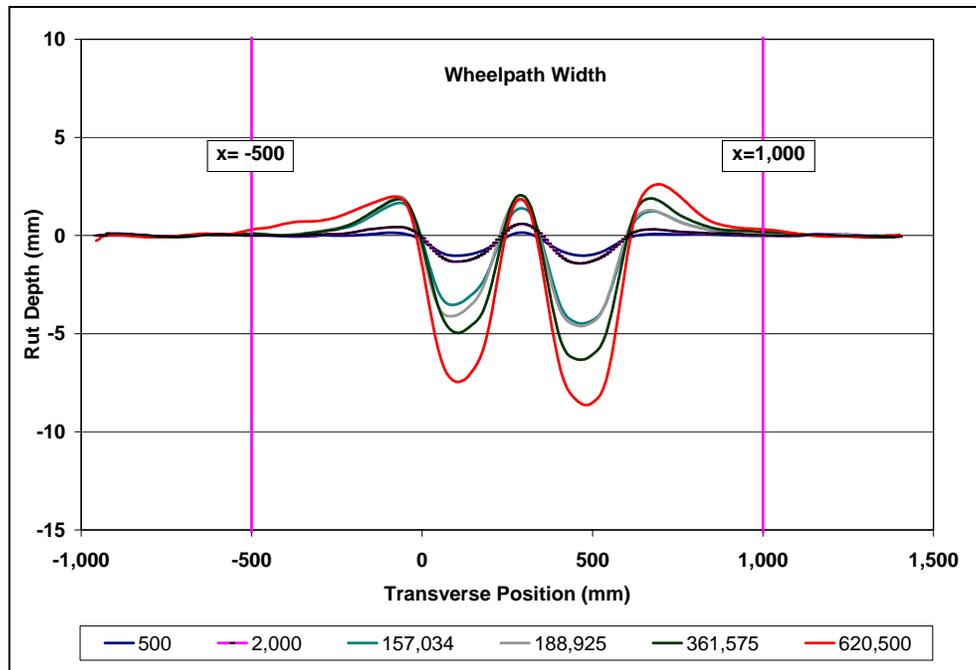
Figure 4.23: 605FD: Profilometer cross section at various load repetitions.

Figure 4.23 shows the average transverse cross section measured with the Laser Profilometer at various stages of the test. This plot clearly shows the increase in rutting and deformation over the duration of the test. Note that HVS trafficking was halted after 620,500 repetitions, before the failure criterion of 12.5 mm (0.5 in.) was reached.

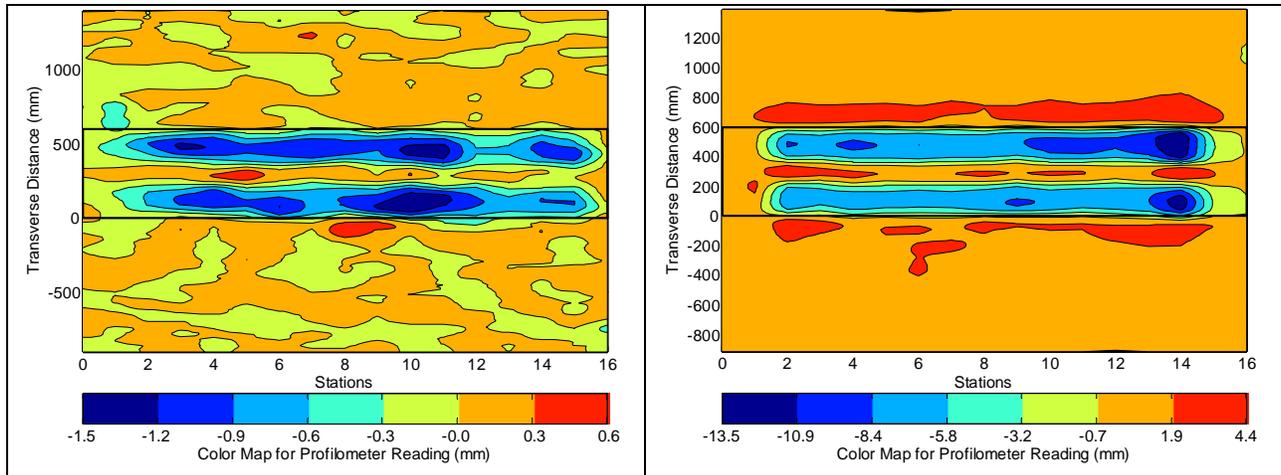
Figure 4.26: 605FD: Contour plot of permanent surface deformation at start and end of test.
 (Note that scales are different.)

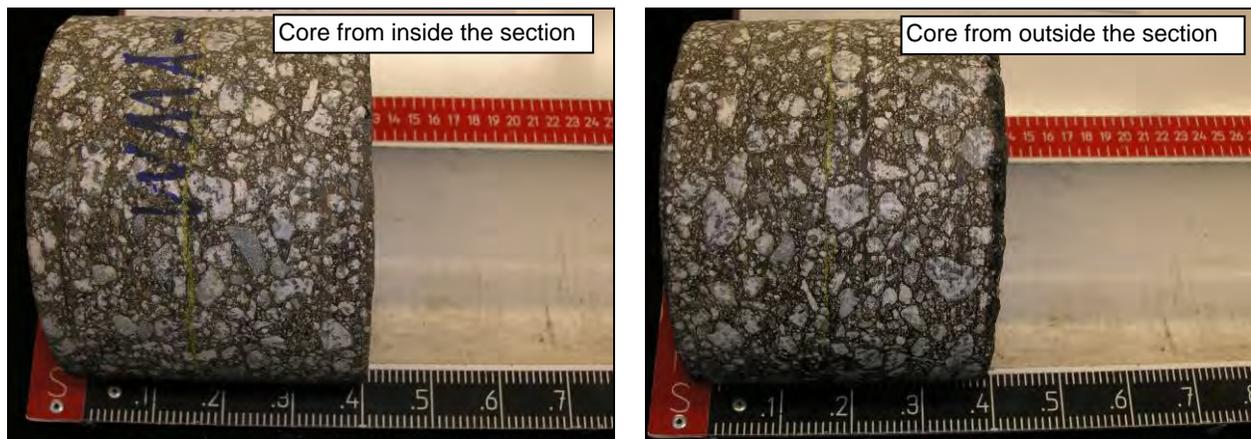
Figure 4.27: 605FD: Cores for moisture content determination.

Moisture contents in the asphalt concrete were determined from 152 mm (6.0 in.) diameter cores removed immediately after testing from the same positions described in Section 4.3.6. No debonding was noted on any of the cores. Photographs of the cores are shown in Figure 4.27. The results are summarized in Table 4.5 and indicate that some moisture (between about 0.5 and 1.0 percent) infiltrated the surface of the test section during the course of the test.

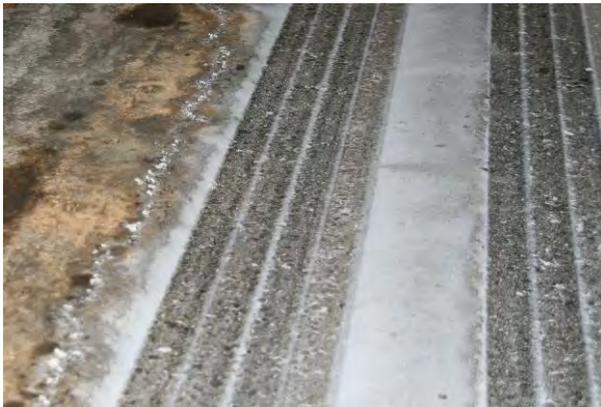
Figure 4.28: 605FD: Crystallized salt on edges of wheelpaths during early testing.

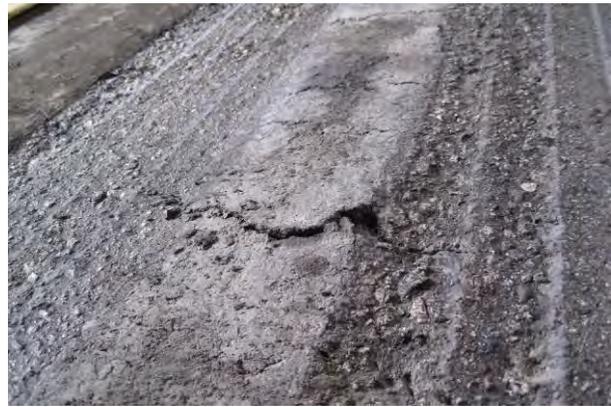
Figure 4.29: 605FD: Cracks in wheelpaths during testing.

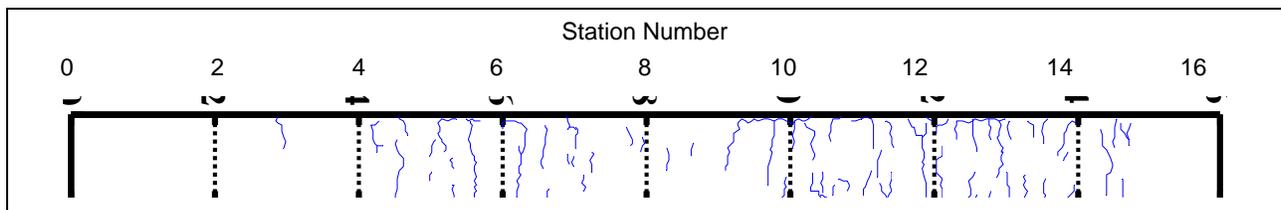
Figure 4.30: 605FD: Final crack pattern.

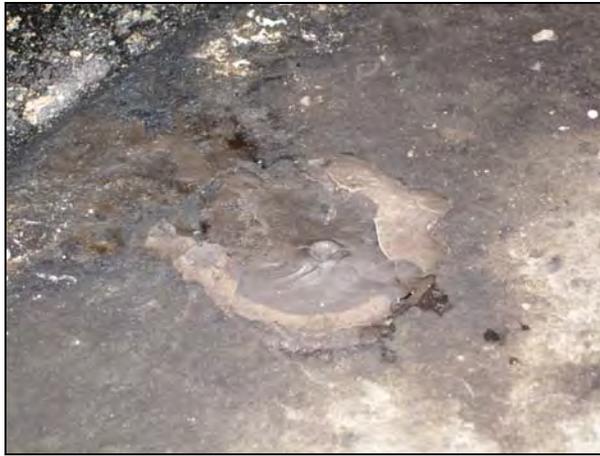
Figure 4.31: 605FD: Fines pumped from holes drilled for presoaking.

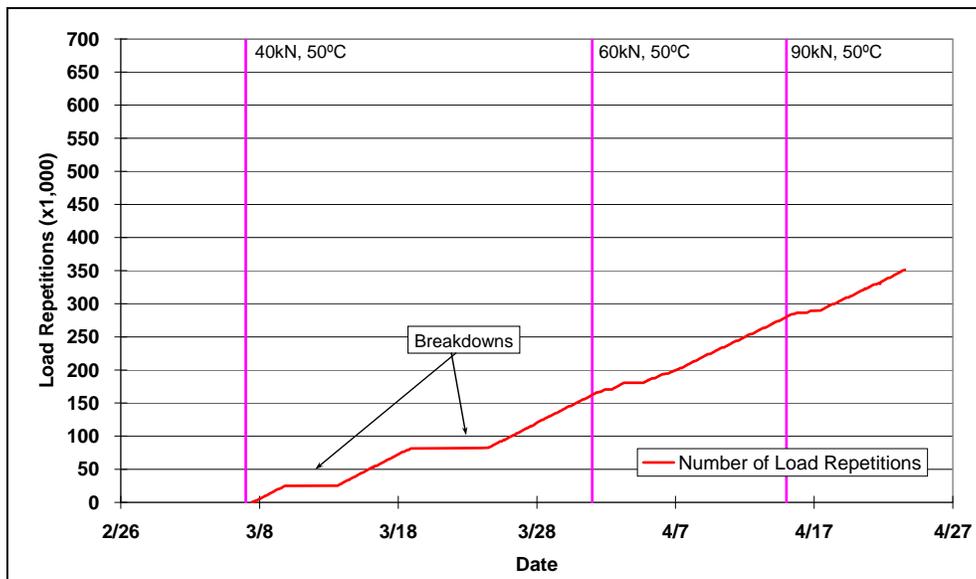
Figure 4.33: 606FD: Load history.

Loading commenced on March 07, 2009 and ended on April 24, 2009. A total of 352,020 load repetitions were applied and 58 datasets were collected. The number of load repetitions applied was very similar to the Control section. The HVS loading history for Section 606FD is shown in Figure 4.33. Two breakdowns occurred during this test.

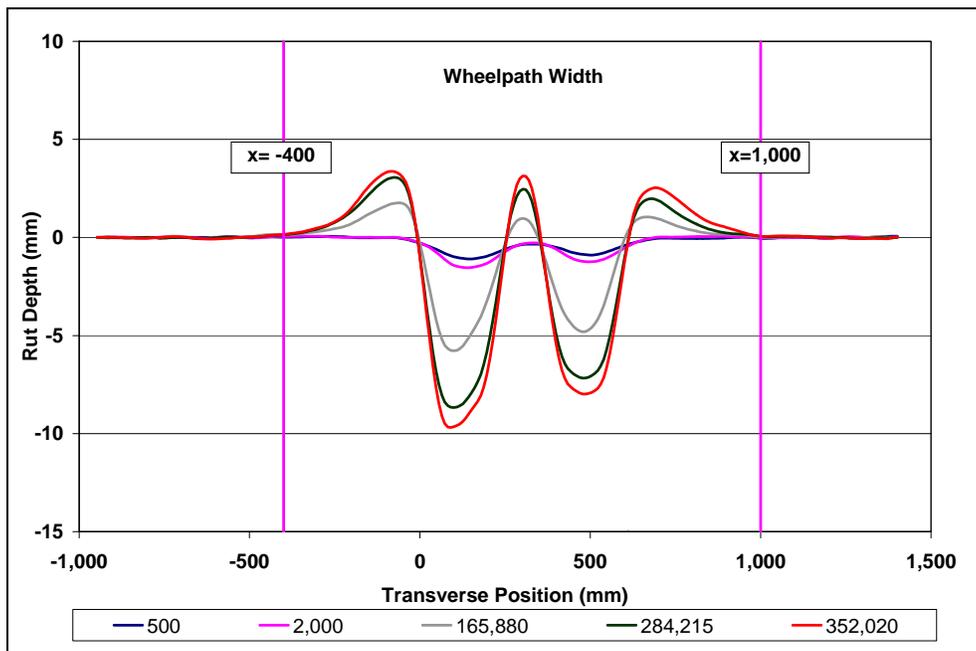
Figure 4.37: 606FD: Profilometer cross section at various load repetitions.

Figure 4.37 shows the average transverse cross section measured with the Laser Profilometer at various stages of the test. This plot clearly shows the increase in rutting and deformation over the duration of the test.

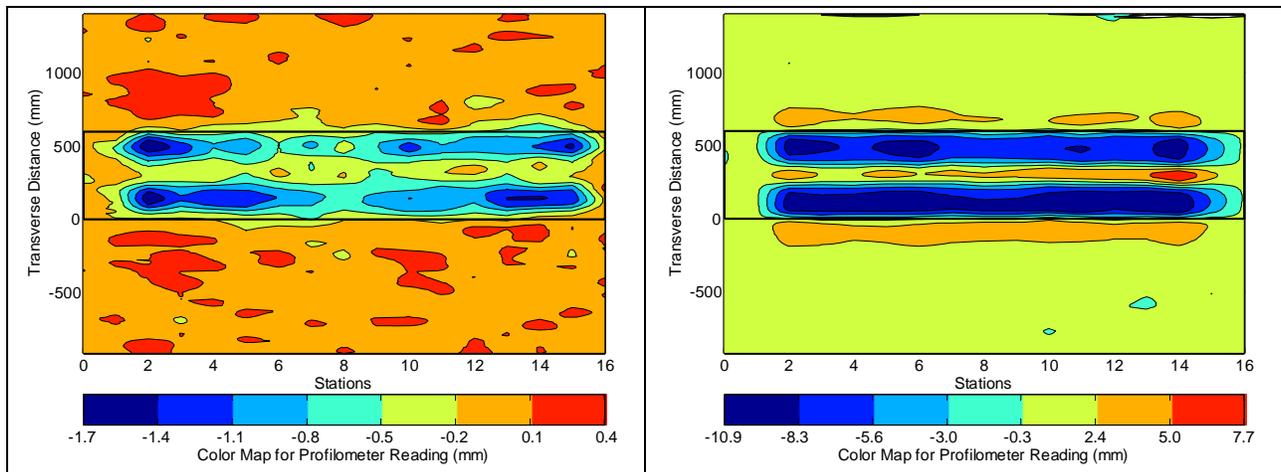
Figure 4.40: 606FD: Contour plot of permanent surface deformation at start and end of test.

Error bars on the average reading indicate that there was very little variation along the length of the section. Figure 4.40 shows contour plots of the pavement surface at the beginning (after 500 repetitions) and at the end of the test (352,000 repetitions), also indicating minimal variation along the section.

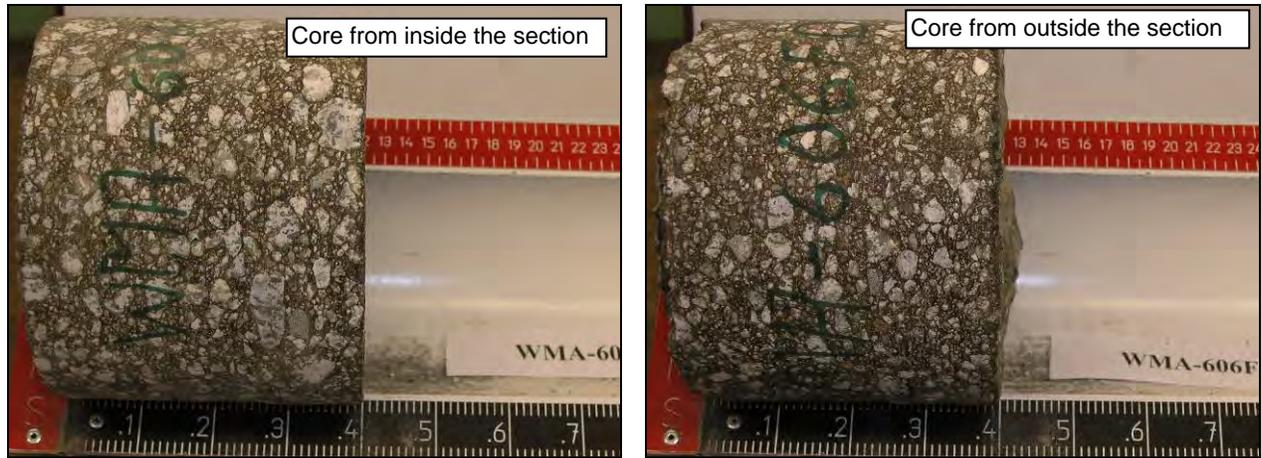
Figure 4.41: 606FD: Cores for moisture content determination.

Moisture contents in the asphalt concrete were determined from 152 mm (6.0 in.) diameter cores removed immediately after testing from the same positions described in Section 4.3.6. No debonding was noted on any of the cores. Photographs of the cores are shown in Figure 4.41.

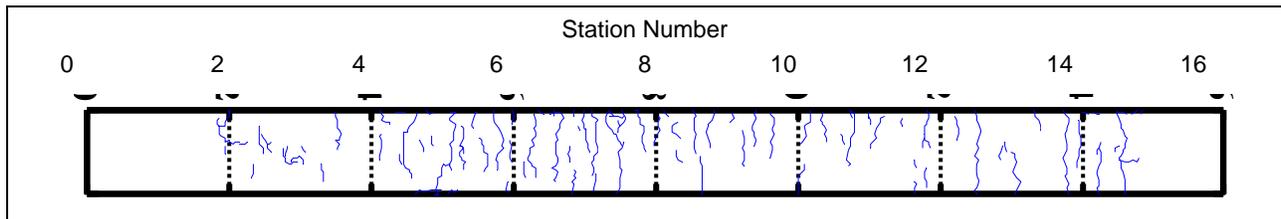
Figure 4.42: 606FD: Final crack pattern.

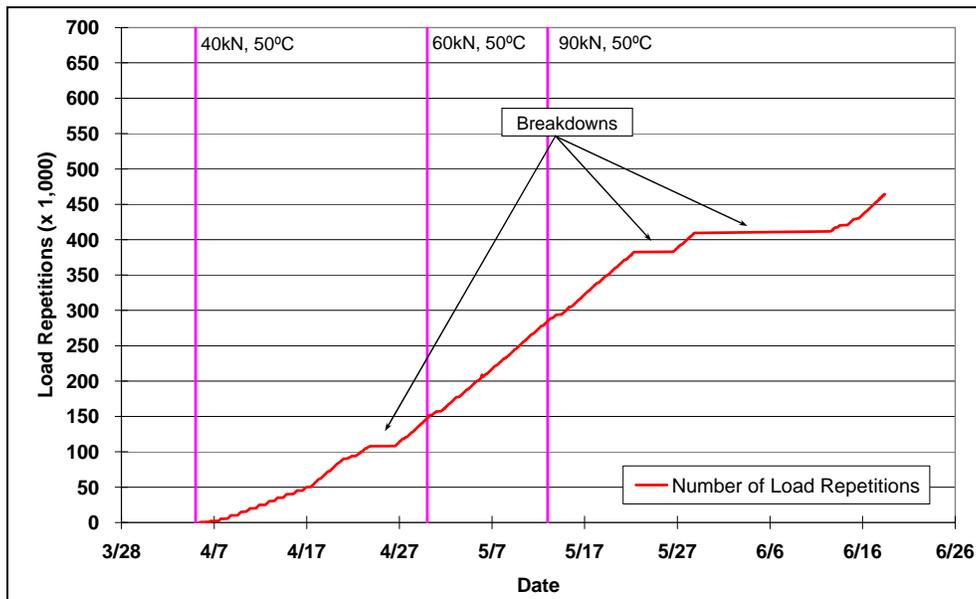
Figure 4.44: 607FD: Load history.

Loading commenced on April 05, 2009, and ended on June 18, 2009. A total of 464,275 load repetitions were applied and 68 datasets were collected. Considerably more load repetitions (90,000) were applied to Section 607FD compared to the Control; however, the failure criterion of 12.5 mm (0.5 in.) was not reached and testing was halted in the interest of completing the project. The high rut resistance was probably attributable in part to the lower binder content of the mix used in this test section, discussed in the Phase 1 report (2) and therefore direct performance comparisons between the Control and this test section are not possible. The HVS loading history for Section 607FD is shown in Figure 4.44. Three breakdowns occurred during testing.

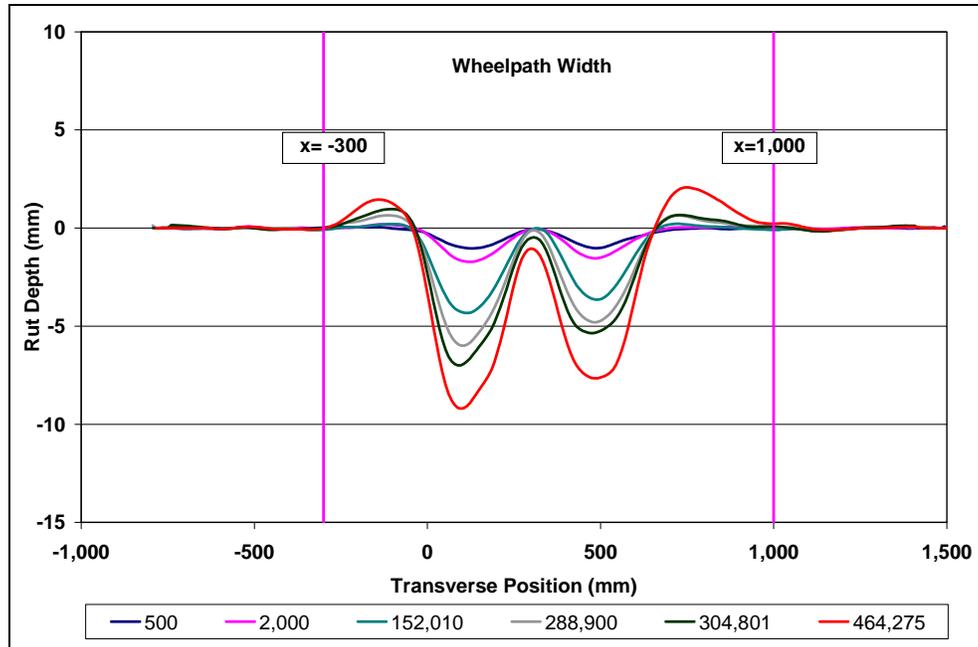
Figure 4.48: 607FD: Profilometer cross section at various load repetitions.

Figure 4.48 shows the average transverse cross section measured with the Laser Profilometer at various stages of the test. This plot clearly shows the increase in rutting and deformation over the duration of the test.

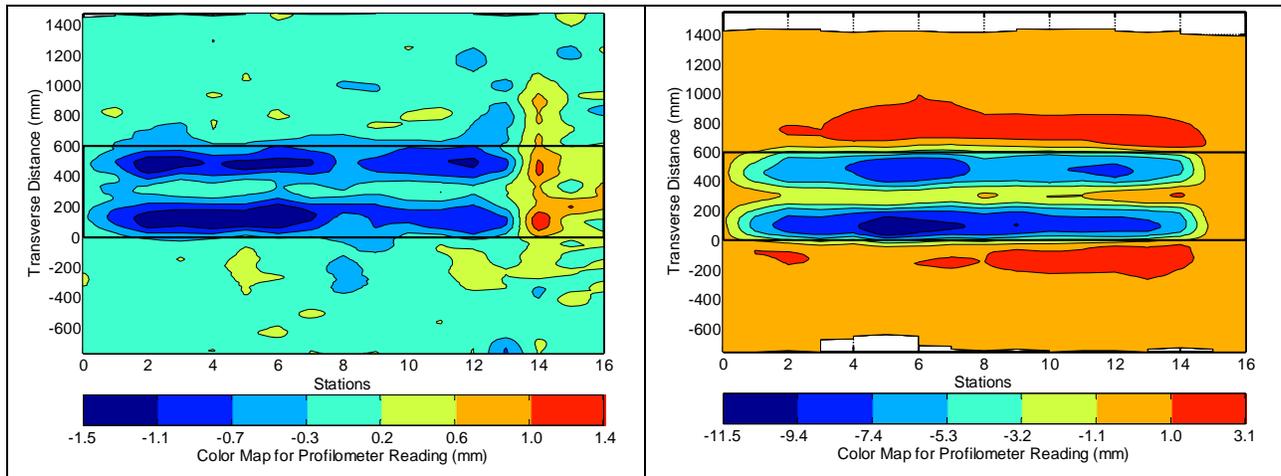
Figure 4.51: 607FD: Contour plot of permanent surface deformation at start and end of test.
 (Note that scales are different)

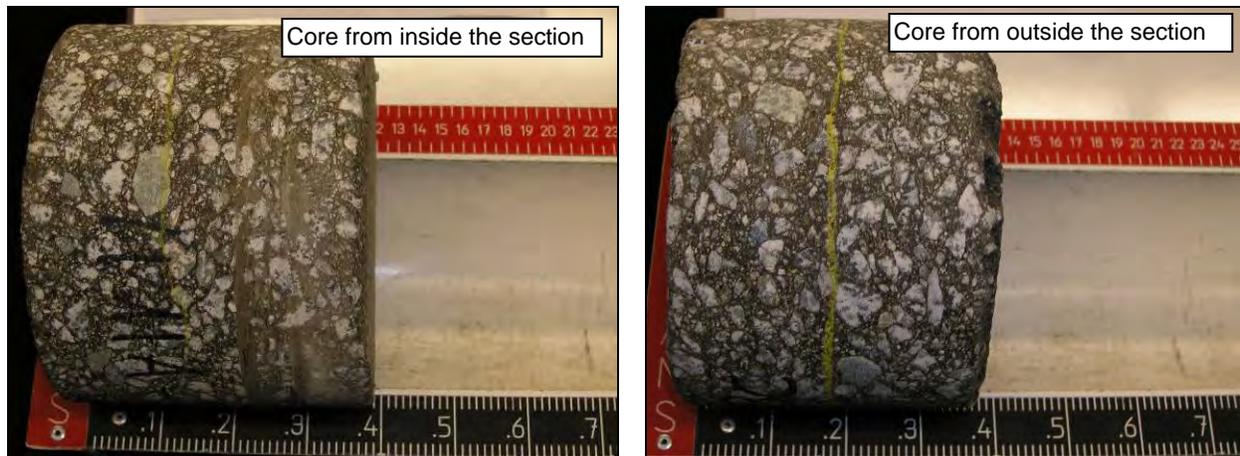
Figure 4.52: 607FD: Cores for moisture content determination.

The results are summarized in Table 4.9 and indicate that some moisture (between about 0.3 and 0.9 percent) infiltrated the surface of the test section during the course of the test.

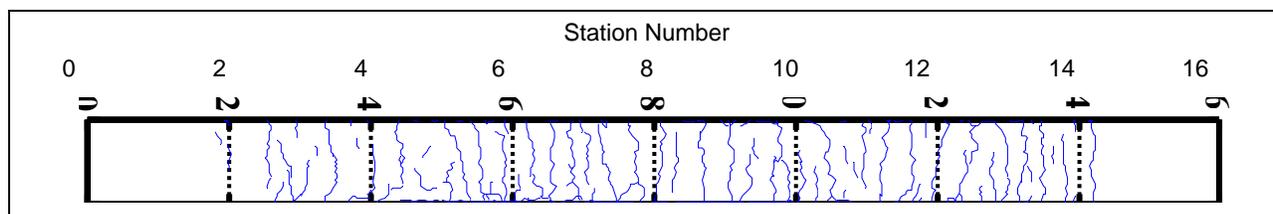
Figure 4.53: 607FD: Final crack pattern.
