1. REPORT NUMBER CA11-1562 A	2. GOVERNMENT ASSOCIATION NUMBER	3. RECIPIENT'S CATALOG NUMBER
4. TITLE AND SUBTITLE Warm-Mix Asphalt Study: First-Level Analysis of Phase 2 HVS and Laboratory Testing, and Phase 1 and Phase 2 Forensic Assessments		5. REPORT DATE 07/30/2009
		6. PERFORMING ORGANIZATION CODE
7. AUTHOR David Jones, Rongzong Wu, Bor-Wen Tsai, and John T. Harvey		8. PERFORMING ORGANIZATION REPORT NO. UCPRC-RR-2009-02
9. PERFORMING ORGANIZATION NAME AND ADDRESS University of California, Davis & Berkeley Partnered Pavement Research Center 1353 S. 46th Street, Bldg. 452 Richmond, CA 94804		10. WORK UNIT NUMBER
		11. CONTRACT OR GRANT NUMBER 65A0272 Task ID 1562
12. SPONSORING AGENCY AND ADDRESS California Department of Transportation Division of Research and Innovation, MS-83 1227 O Street Sacramento CA 95814		13. TYPE OF REPORT AND PERIOD COVERED Final
		14. SPONSORING AGENCY CODE

TECHNICAL REPORT DOCUMENTATION PAGE

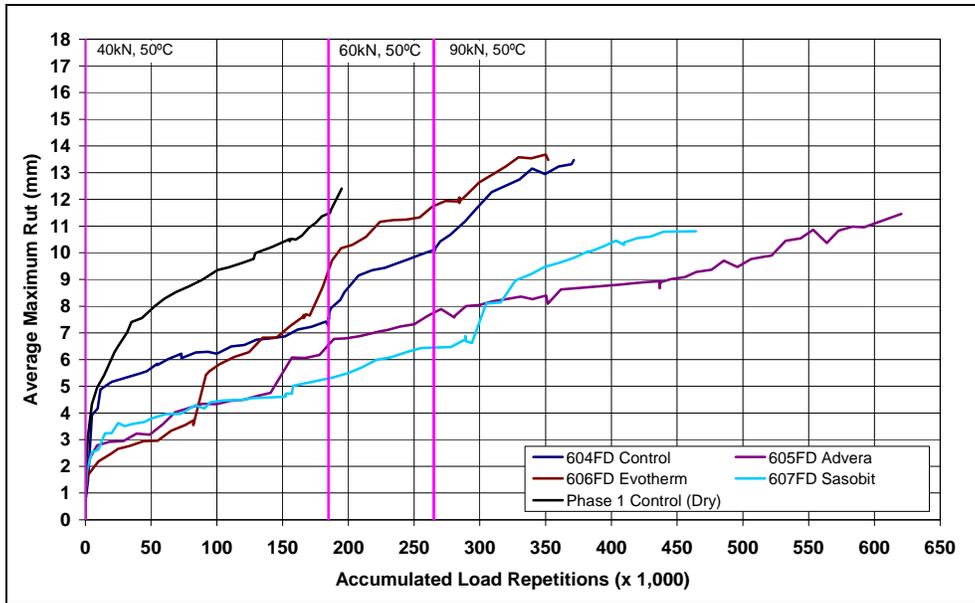
Figure 4.55: Comparison of average maximum rut.

Rutting behavior for the four sections is compared in Figure 4.55 (average maximum rut) and Figure 4.56 (average deformation). HVS trafficking on each of the four sections revealed that the duration and rut depths of the embedment phases (high early-rutting phase of typical two-phase rutting processes) on the warm-mix sections were approximately half that of the Control, a trend opposite that observed in Phase 1 (discussed in Section 4.8). This indicates that the effects of oxidation of the binder at lower production temperatures may only influence rutting performance in the first few months after construction.

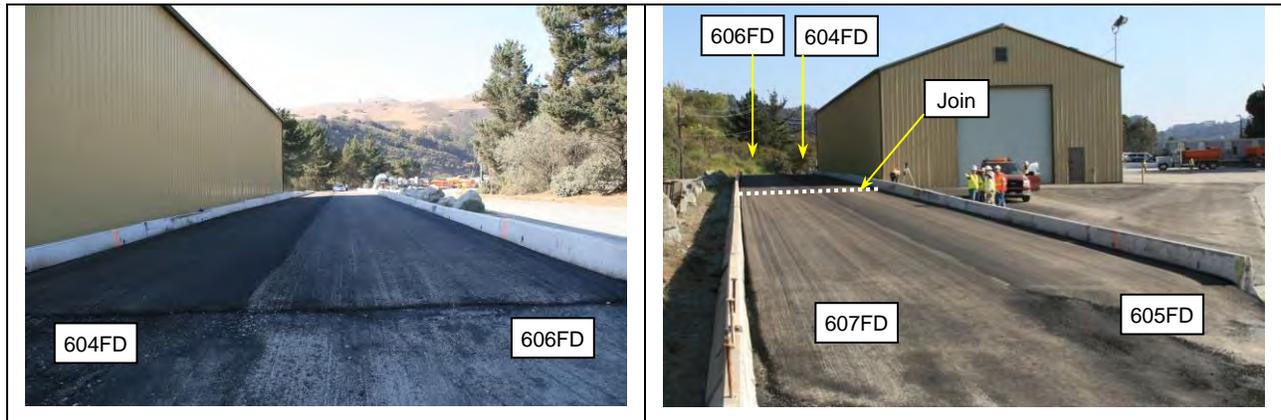
Figure 4.57: Afternoon shade from the shed on Sections 604FD and 606FD.

Sasobit sections in the year since construction, leading to potentially a higher stiffness and consequent better rutting performance. This is being investigated in a separate study, and those results will be presented with the Phase 3 laboratory and HVS test results (on rubberized asphalt) when that testing is complete.

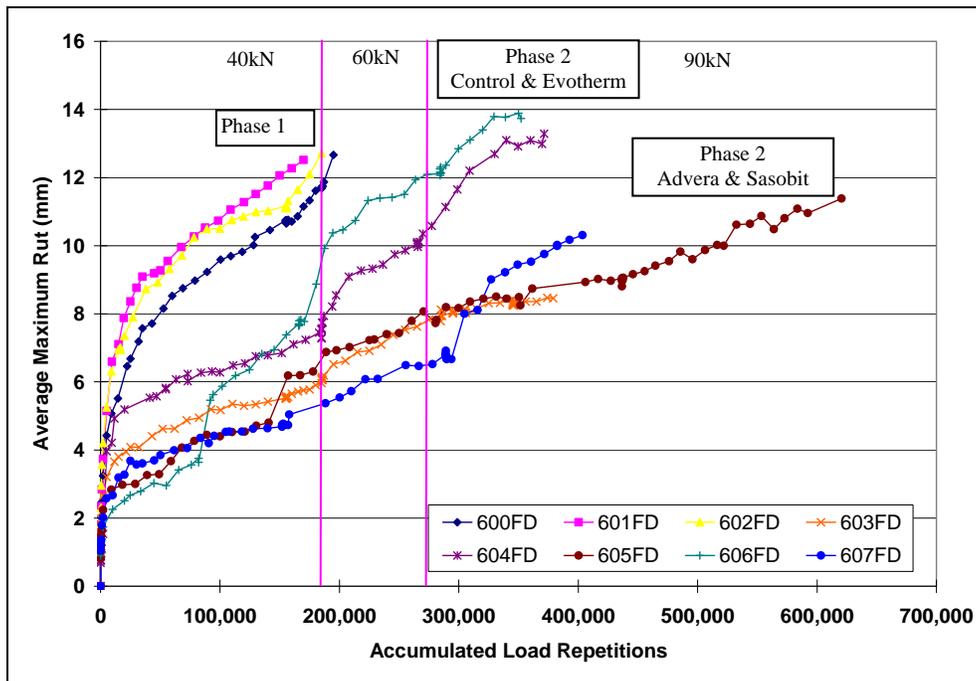
Figure 4.58: Comparison of Phase 1 and Phase 2 rutting performance.

The average maximum rut progression for both phases is shown in Figure 4.58. The plot clearly shows the difference in the embedment phases in terms of duration (number of repetitions) and rut depth and in terms of the difference between the Control and warm-mix sections. In Phase 1, the embedment phases of the warm-mix sections were similar to the Control, but the rut depths were deeper. In Phase 2, the duration of the embedment phase on all sections was again similar; however the rut depth was notably less on the warm-mix sections compared to the Control. The plot also clearly shows the difference in the number of repetitions required to reach an average maximum rut depth of 12.5 mm (0.5 in.), with the Phase 2 sections requiring significantly more repetitions. A significant proportion of the later trafficking on each section in Phase 2 was undertaken at higher wheel loads (60 kN and 90 kN [13,500 lb and 20,250 lb]) than those used in Phase 1.

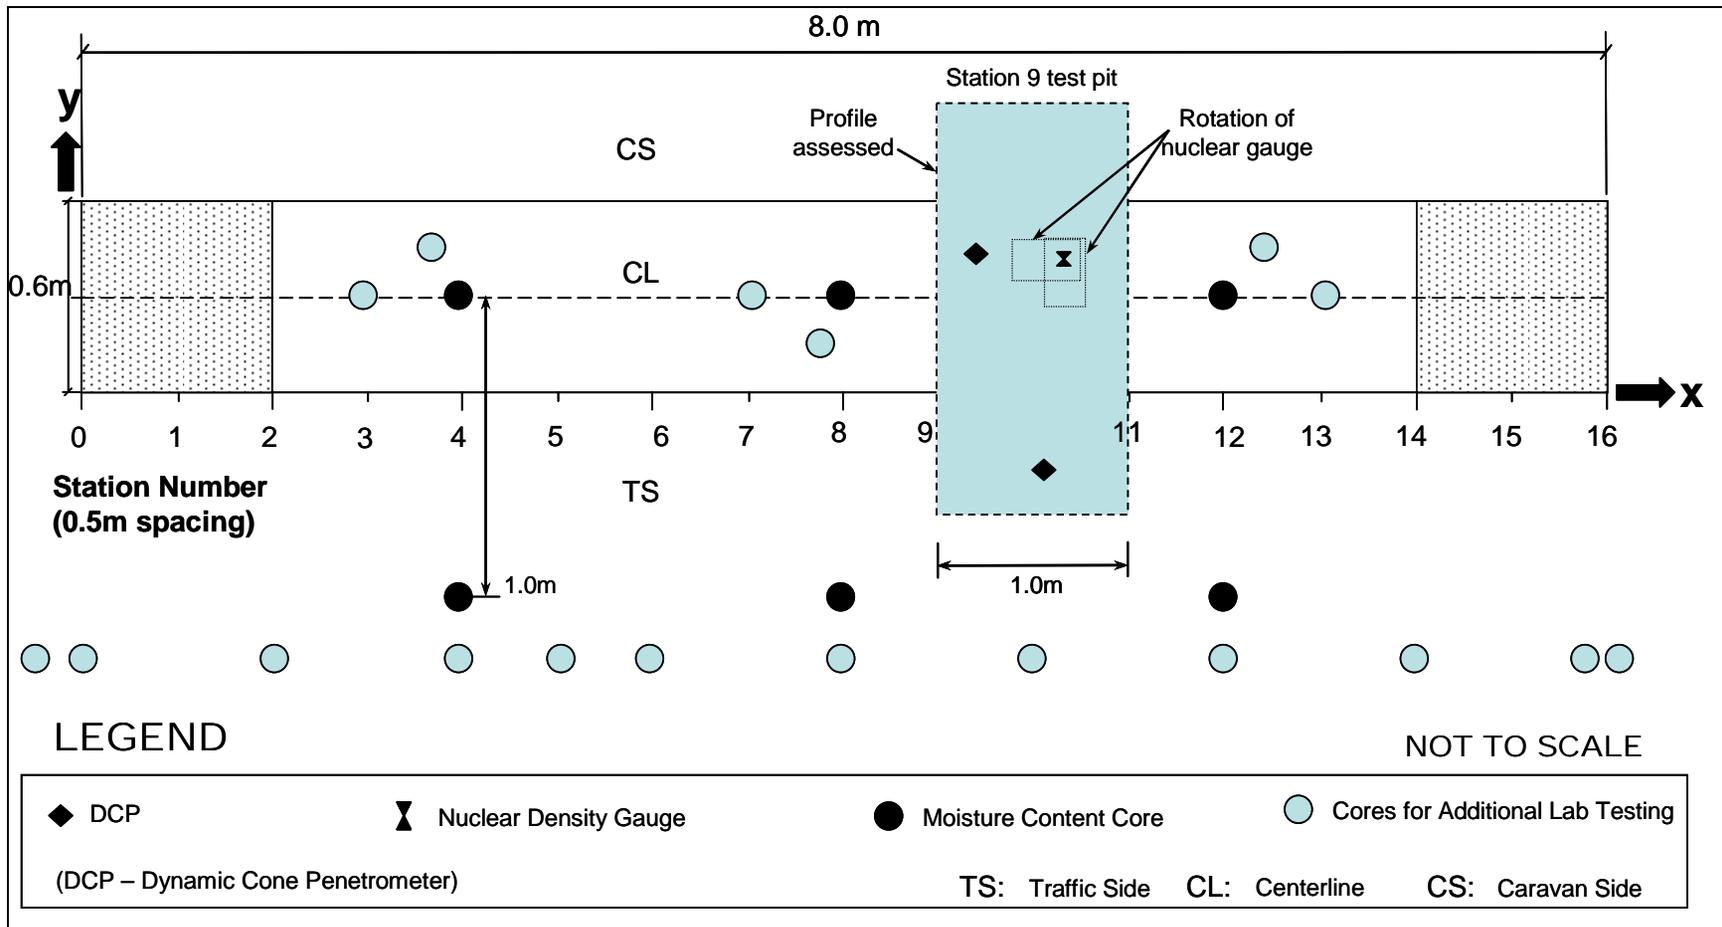
Figure 5.1: Test pit layout.

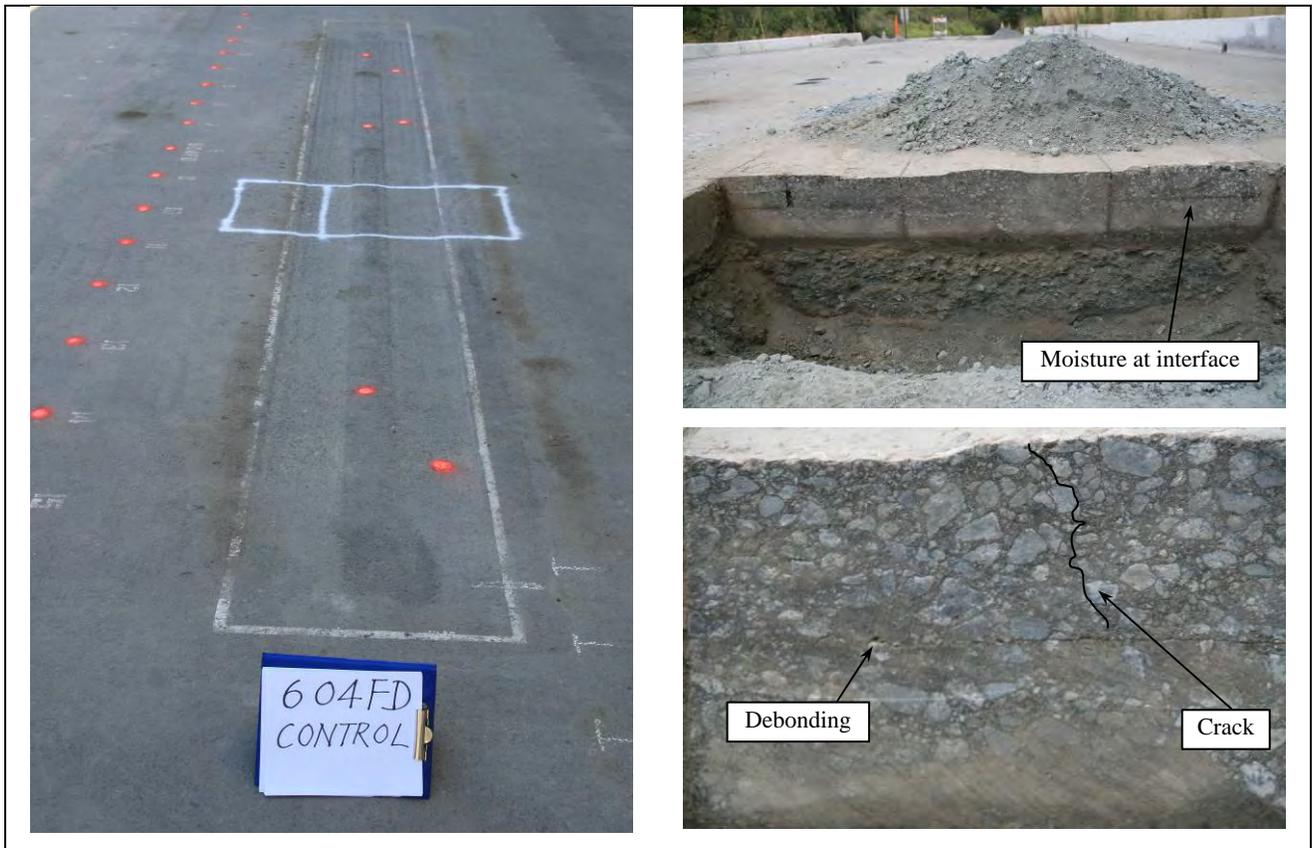
Figure 5.14: 604FD: Test pit photographs.

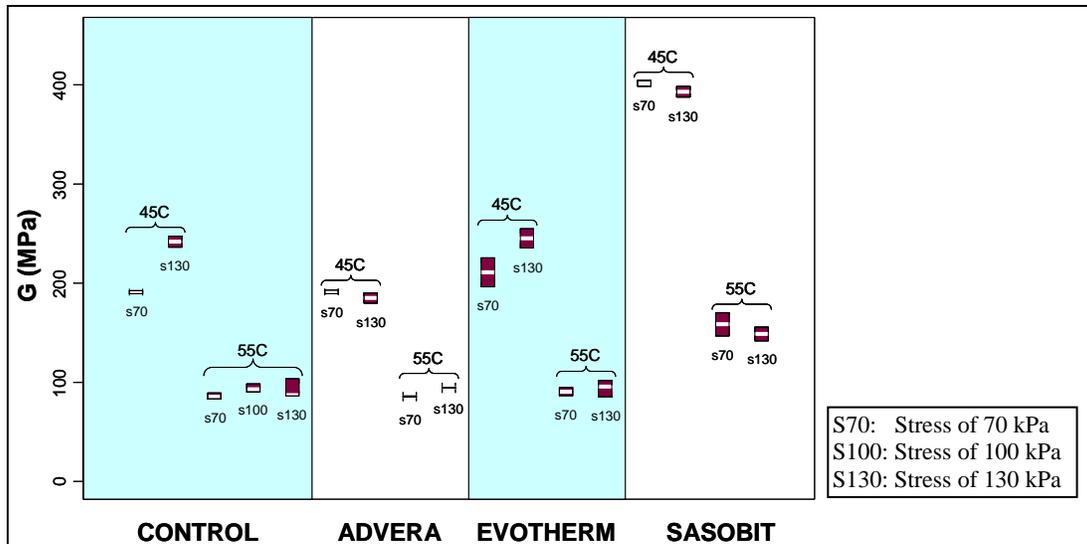
Figure 6.2: Summary boxplots of resilient shear modulus.

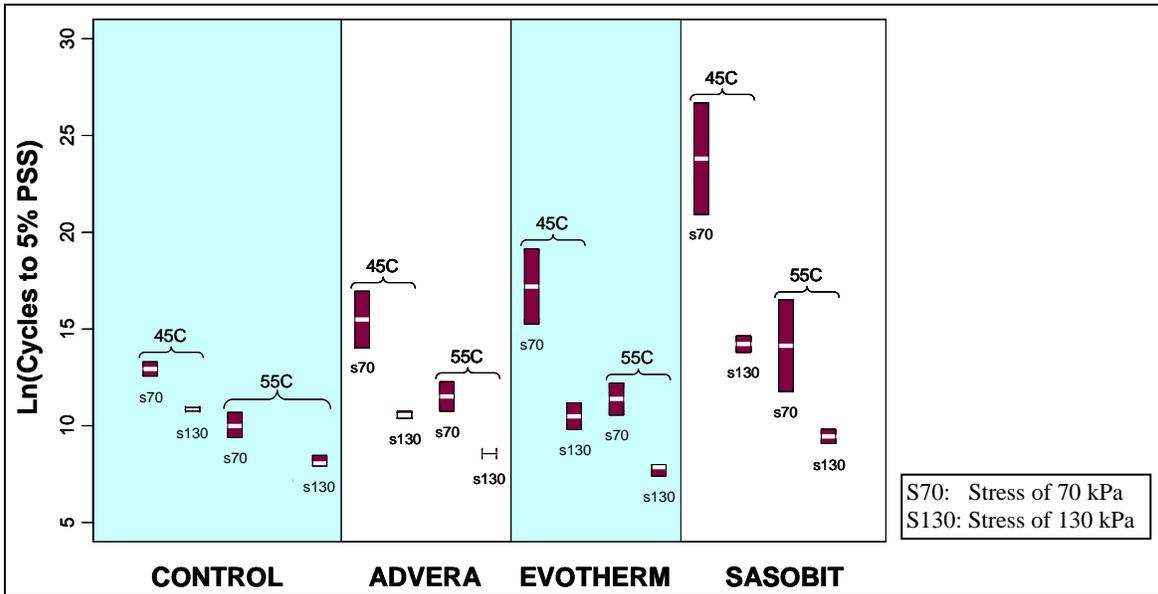
Figure 6.3: Summary boxplots of cycles to 5% permanent shear strain.

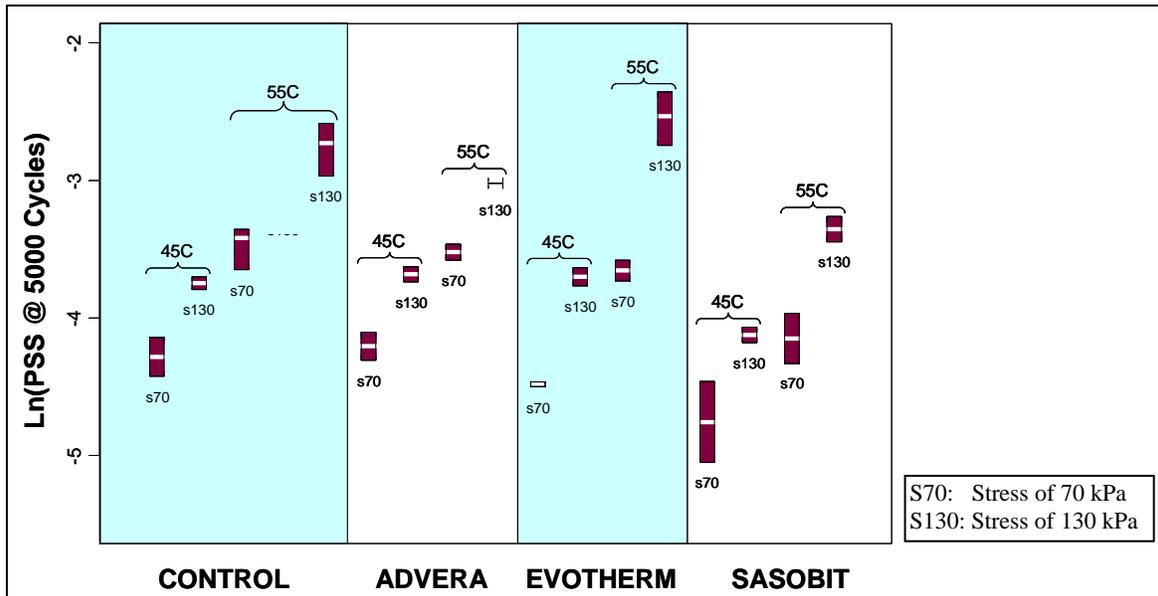
Figure 6.4: Summary boxplots of cumulative permanent shear strain at 5,000 cycles.

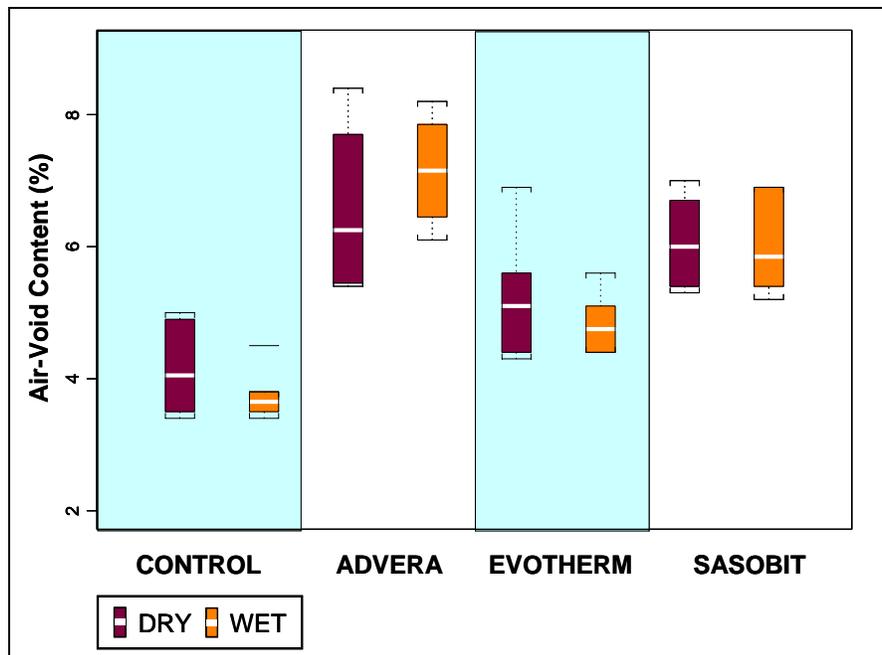
Figure 6.6: Air-void contents of fatigue beam specimens (dry and wet).

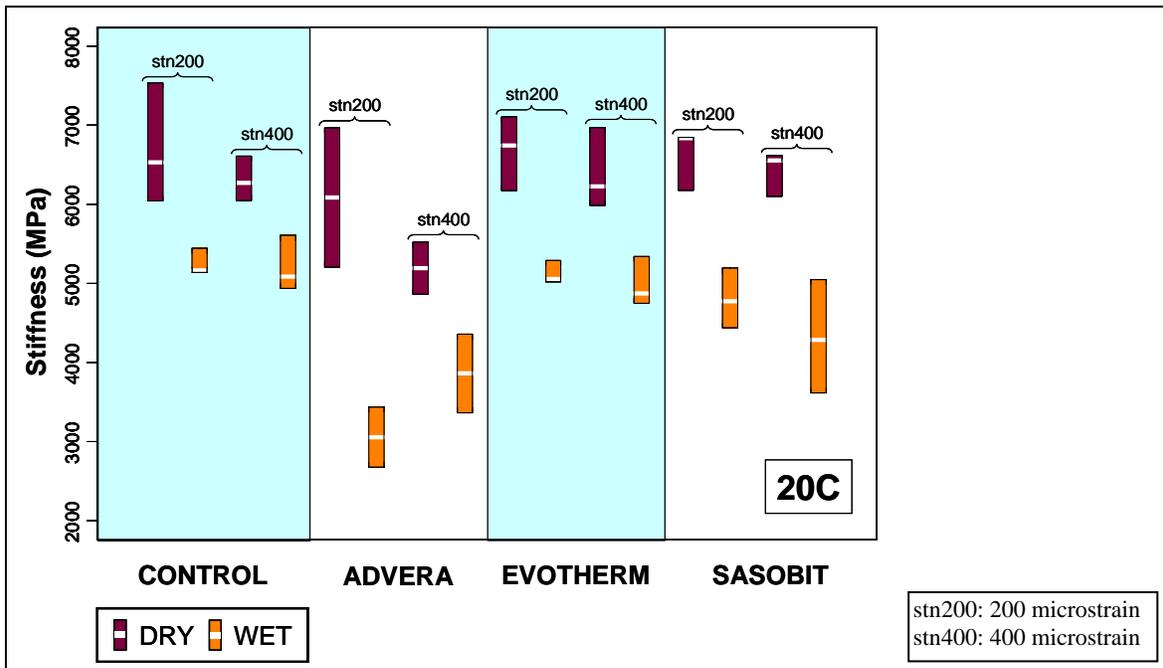
Figure 6.8: Summary boxplots of initial stiffness.

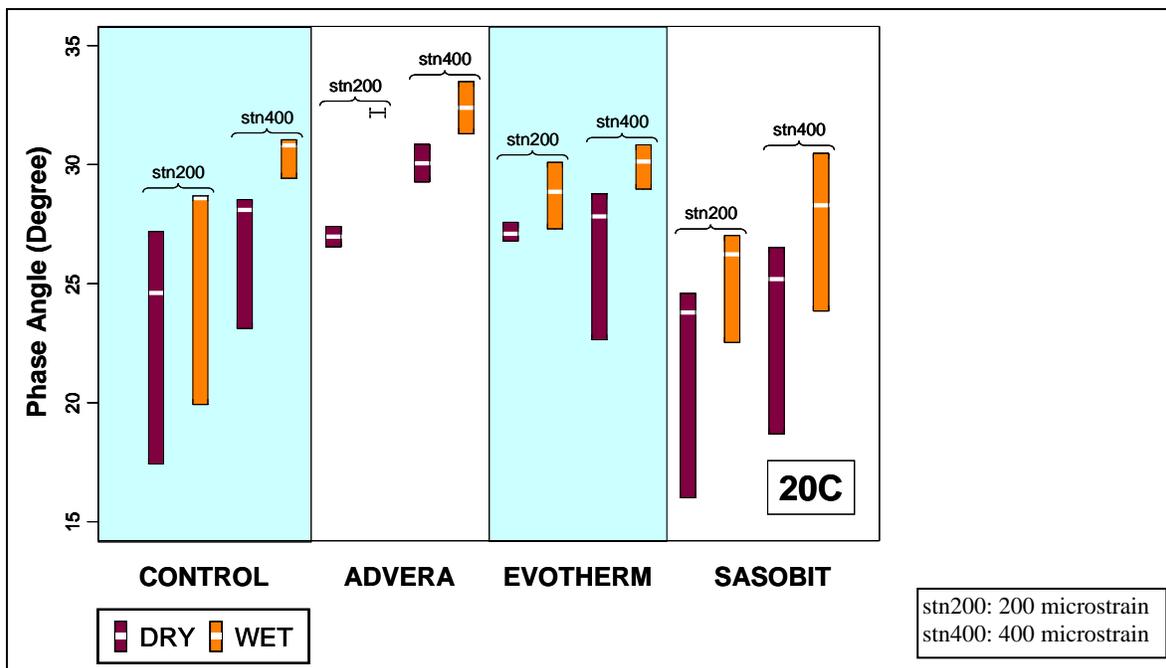
Figure 6.9: Summary boxplots of initial phase angle.

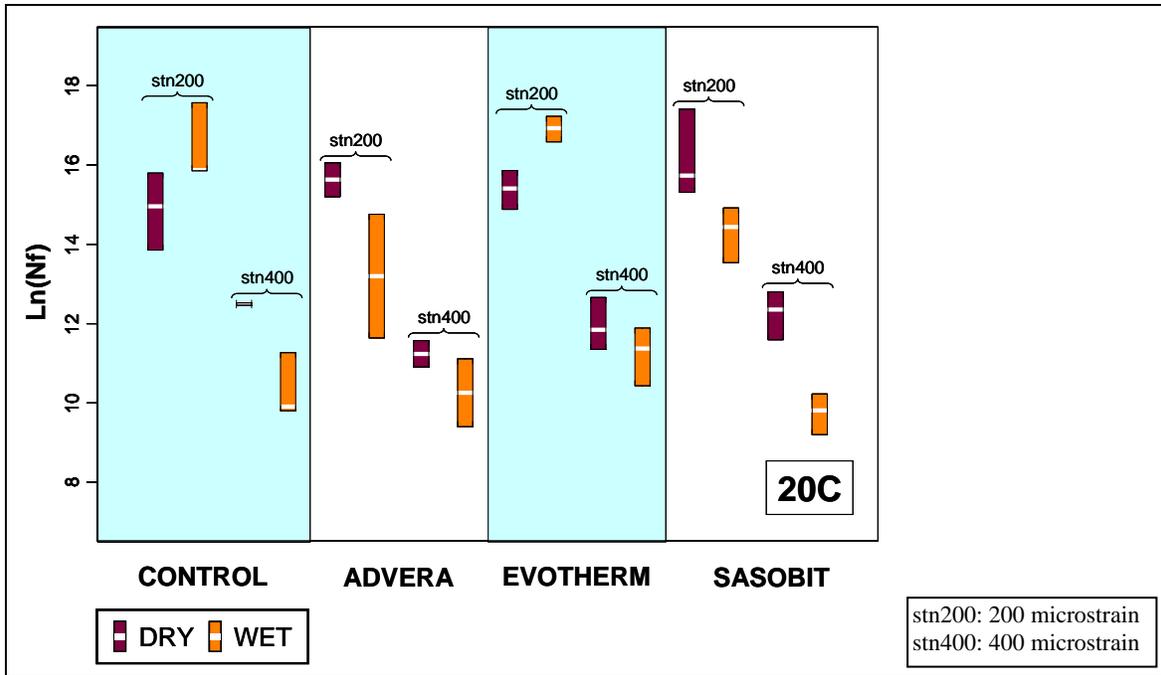
Figure 6.11: Summary boxplots of fatigue life.

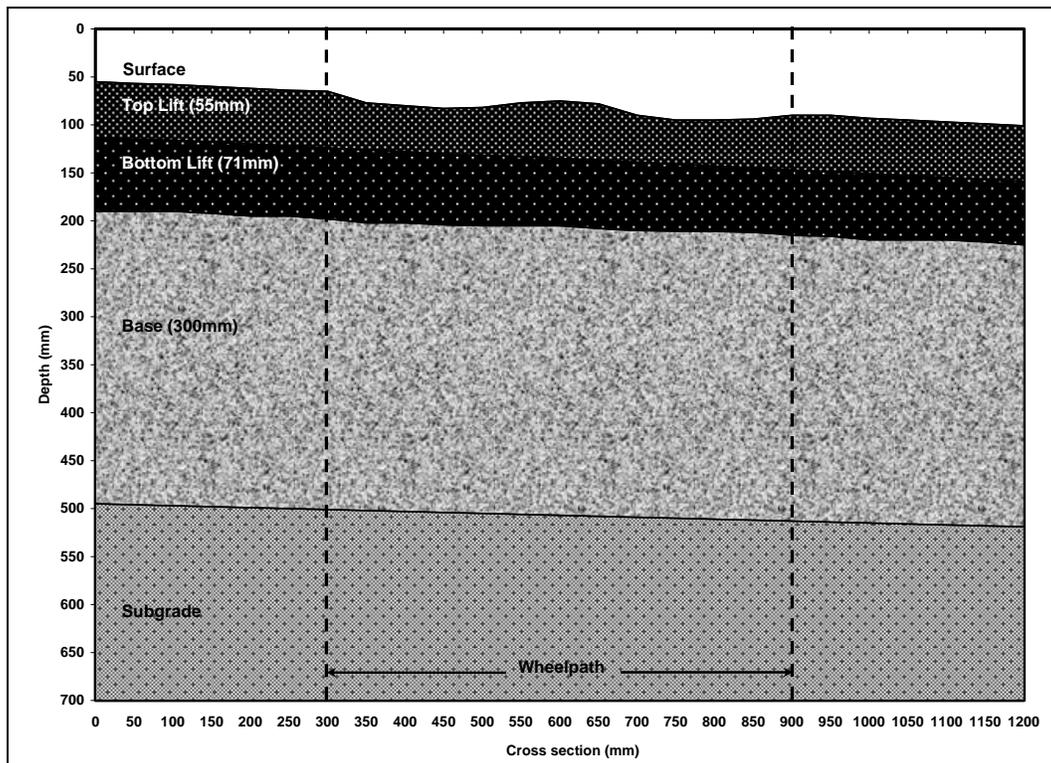
Figure A.1: 600FD: Test pit profile.

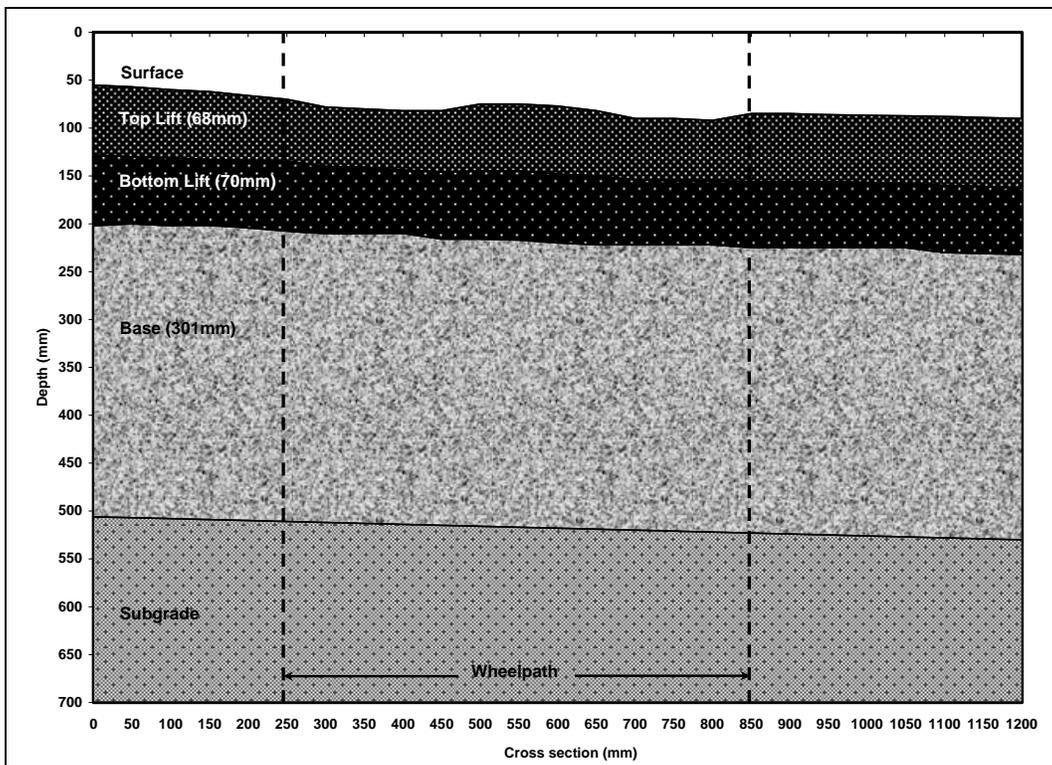
Figure A.5: 604FD: Test pit profile.
