AN EVALUATION OF BANDS USED TO COUPLE CORRUGATED METAL PIPE

JANUARY 1967

State of California
Department of Public Works
Division of Highways
Materials and Research Department

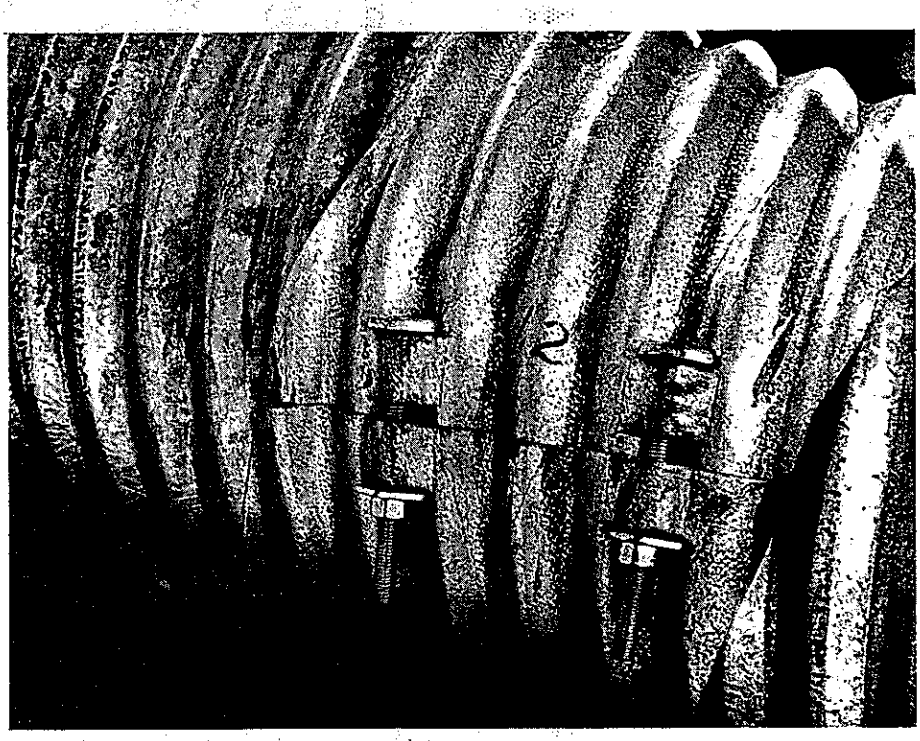
Figure 3

Test No. 5 consisted of a test of helically corrugated pipe connected by a two piece 12-inch wide coupling band connected at the ends of the pieces by bolts through formed lugs (see Figure 3). The coupling band was able to develop the strength of the pipe in bending. An ultimate load of 8400 pounds was recorded when failure occurred at a pipe corrugation adjacent to one of the upper loading blocks. The coupler and the lengths of pipe remained intact (see Table 2 for complete test results).

Twelve Inch Wide Two Piece Coupling
Band with Integral Formed Lug
Connections Used for Helical Pipe.

2. A one or two piece helically corrugated band 12-inches in width and connected by 2- 1/2-inch bolts per connection through integral formed lugs is an acceptable coupling band for joining helically corrugated lockseam pipe in sizes of from 12-inches to 30-inches inclusive. The connecting lugs shall be separated by one full corrugation. The bolt heads and cut washers required under the nuts shall be shaped to fit the corrugation (see Figure 3).

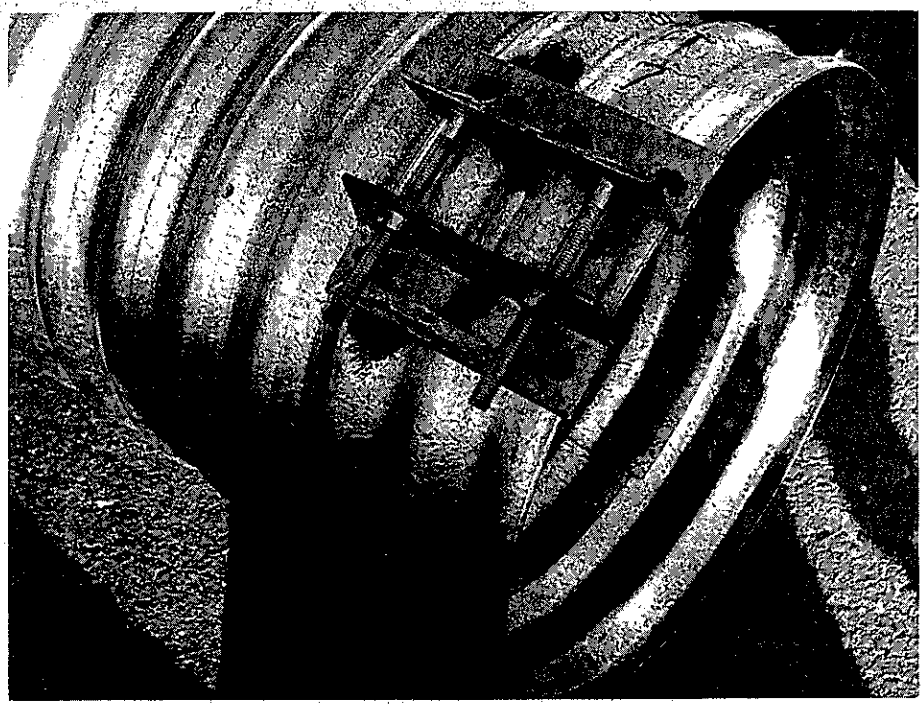
Figure 5

Seven Inch Wide Standard AASHO Coupling Band.

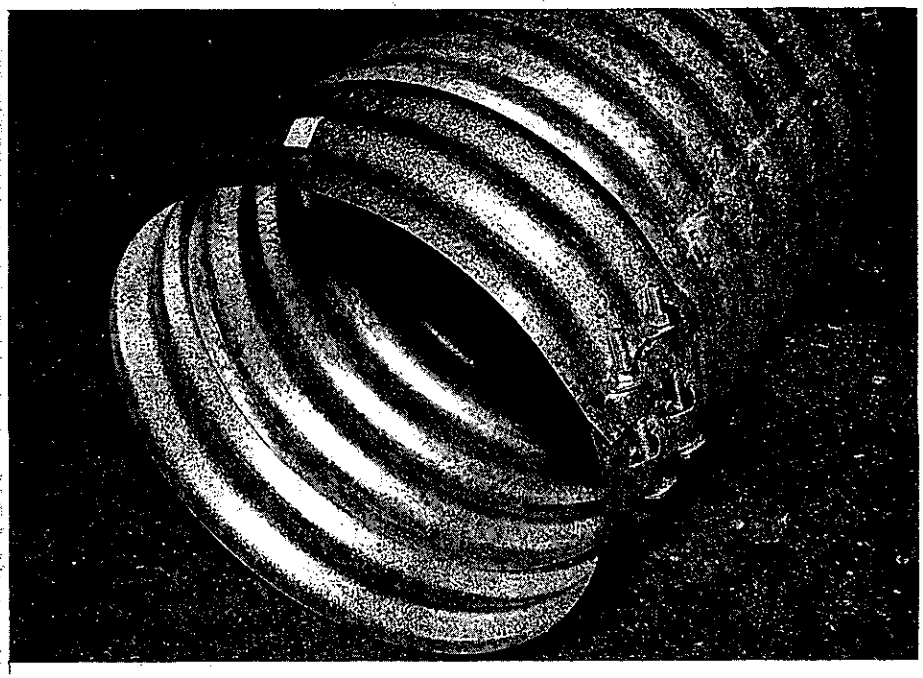
Figure 8

3. The annularly corrugated coupling band, having a nominal width of 7-inches and connected by bolts through formed lugs in the ends of the band, produces a stronger joint than the "standard" AASHO band utilizing angles. However, due to the required slitting of the band material to form the fastening lugs, there is concern that the remaining material between the two lugs on this narrow band may fail during installation or as a result of corrosion and service loads imposed on the coupler. Such a failure can drastically reduce the joint efficiency.

Test No. 16 consisted of a test of annularly corrugated metal pipe joined by a 7-inch wide coupling band connected by bolts through integral formed lugs. Previous tests on this coupling band indicate a superior joint strength as compared to the 7-inch wide band connected by angles. However due to the forming of the lugs for this band, which requires cutting of the band normal to the corrugations, very little sheet material remains between the lugs. There is concern that this weakened portion of the band may fail by overtightening of the connection bolts. To verify such a failure would reduce the joint strength, a test was performed with the material between lugs intentionally ruptured (see Figure 8). The ultimate strength of this coupled pipe was 5300 pounds which is 70% of the strength of the coupled pipe using the original undamaged coupler and 80% of the strength of the pipe coupled with the band connected by angles (see Table 6 for complete test results).

Seven Inch Wide Coupling Band with
Integral Formed Lug Connections.
Material Between Lugs Intentionally
Ruptured. Photo Taken After Flexure Test.

4. The 7-inch wide annularly corrugated coupling band utilizing integral formed connection lugs is considered a questionable coupler due to the possibility of a material failure occurring parallel to and between the lugs. Acceptance of this coupling band is not recommended.

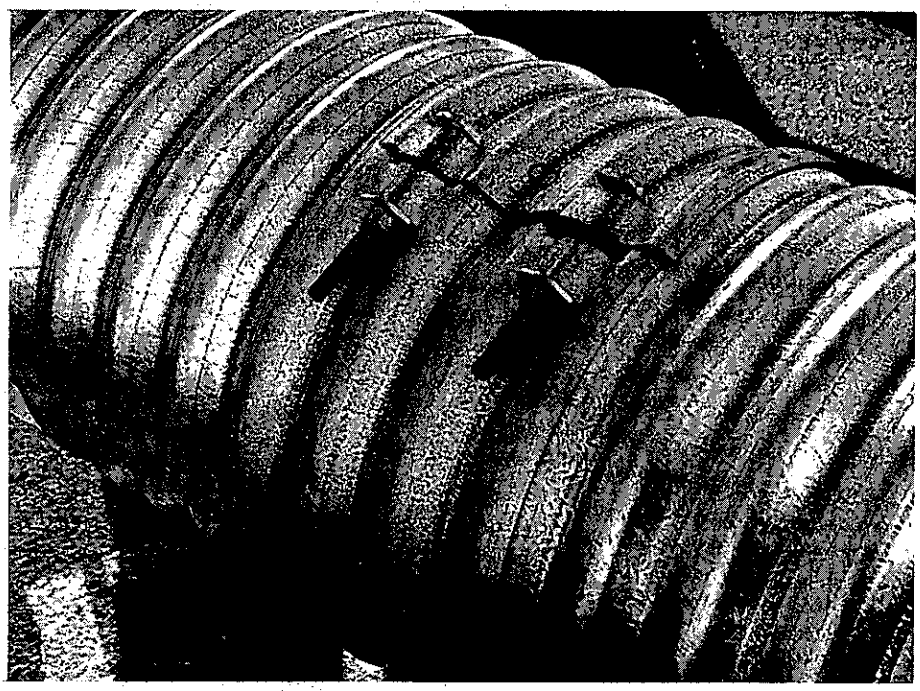
Figure 9

4. The annularly corrugated coupling band, having a nominal width of 9-2/3 inches and connected by bolts through formed lugs in the ends of the band, is equivalent in joint strength to the standard AASHO coupling band. Due to the extra width of the band, there is little likelihood of a tearing failure occurring at the ends of the band due to the required slitting of the sheet to form the connecting lugs. The possibility of this type of failure exists with the 7-inch band discussed in Item #3 above.

Test No. 3 consisted of a test of a 9-1/2 inch wide annularly corrugated coupling band connected at the ends by bolts through formed lugs (see Figure 9). The bolted connection was located at the bottom of the pipe. The ultimate load sustained was 6800 pounds. Test No. 6 was a repeat test with the bolts located on the side of the pipe. The ultimate load for this test was slightly higher at 7040 pounds. It was noted in Test No. 3 that one spot weld failed in one section of the pipe. Several welds failed in subsequent Test No. 6 (see Table 3 for complete test results).

Nine and Two Thirds Inch Wide Coupling
Band with Integral Formed Lug Connections.

sizes up to 30-inches inclusive. The bolt heads and cut washers required under the nuts shall be shaped to fit the corrugation. The connecting lugs shall be separated by one full corrugation. The coupling band shall be not less than 9-2/3 inches wide (see Figure 9).

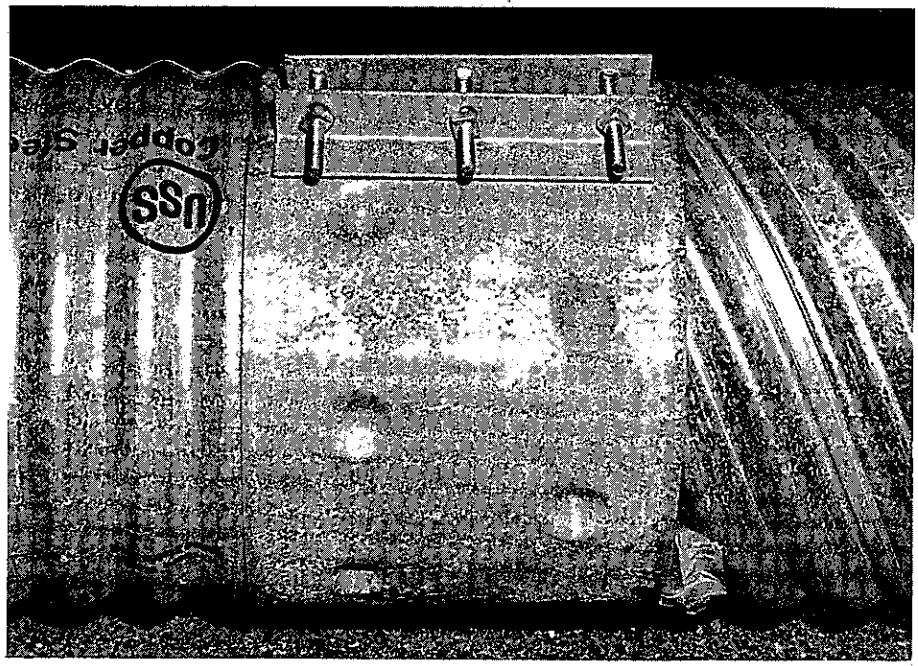
Figure 10

Test No. 1 consisted of a test of lengths of helical and annular corrugated pipe joined by a dimpled coupler (see Figure 10). The coupling band fitted the helical pipe rather poorly. The ultimate load of this system was 5400 pounds. After the completion of the test, it was noted that the helical pipe had a 2-inch by 1/2-inch corrugated profile whereas the band was fabricated to fit the 2-2/3 inch by 1/2-inch corrugation, thus explaining the poor fit and low ultimate load as compared to future tests of this type coupling band (see Table 4 for complete test results).

Universal or Dimpled Coupling Band
Fourteen Inches in Width.

Dimpled coupling bands shall be fabricated from flat galvanized steel sheets and shall have dimples impressed in circumferential rows to register with and engage the corrugations of the pipe to be joined. Each row shall contain at least seven (7) dimples so spaced to effectively engage all corrugations of the pipe ends. The dimples shall conform substantially to the shape of the corrugations of the pipe. There shall be two rows of dimples spaced 7-inches apart (see Figure 10).

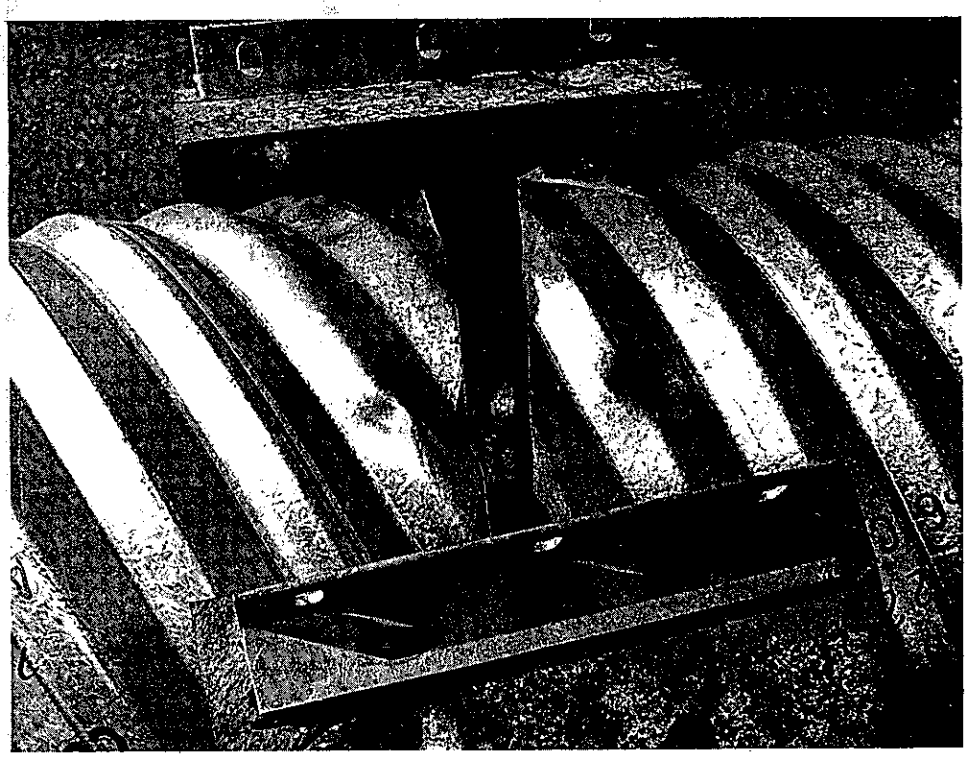
Figure 11

(see Figure 10). The band was connected at the ends by 2-inch by 2-inch by 3/16-inch angles joined by 3- 1/2-inch bolts. The pipe thus connected sustained an ultimate load of 8000 pounds. The pipe failed at the joint by the lower dimples slipping across the corrugations (see Figure 11--note impression of dimples on the pipe corrugations). Actual separation of the pipe did not occur in any of the tests on this type coupling band (see Table 5 for complete test results).

Universal Coupling Band After Test.
Note Impression of Dimples on the
Pipe Corrugations.
