A COMPARISON OF TRANSVERSE WEAKENED PLANE JOINTS FORMED BY SAWING AND BY PLASTIC INSERT

INTERIM REPORT

CA-DOT-TL-5254-1-73-26

September 1973

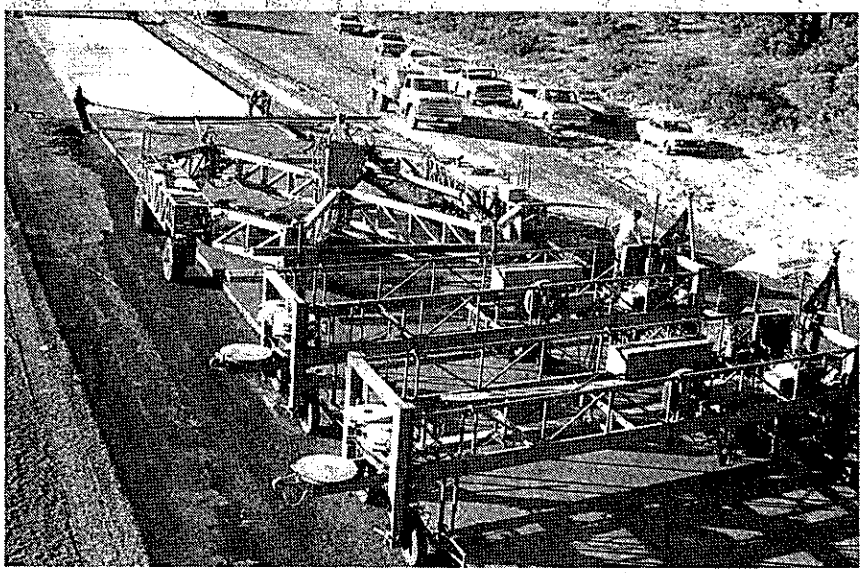
Figure 1. Two plastic joint machines followed by pipe float.

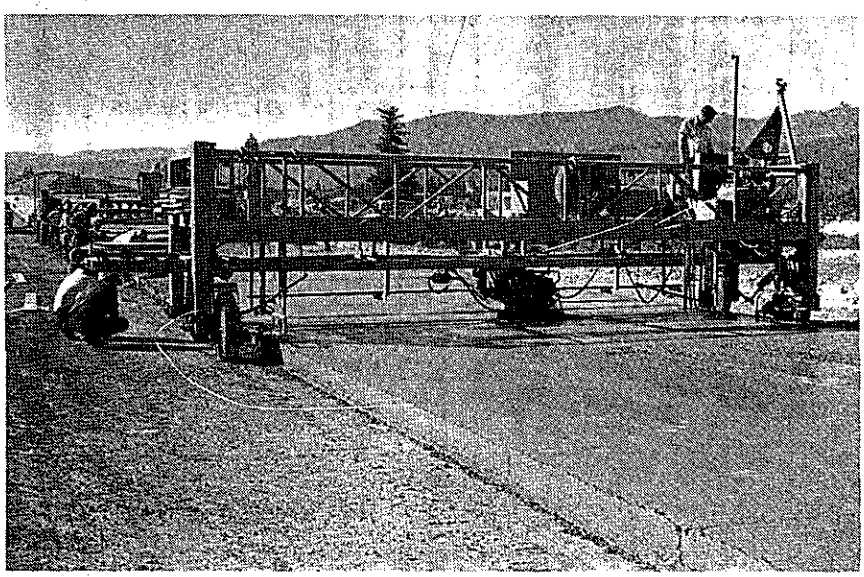
Figure 2. Plastic joint machine in operation.

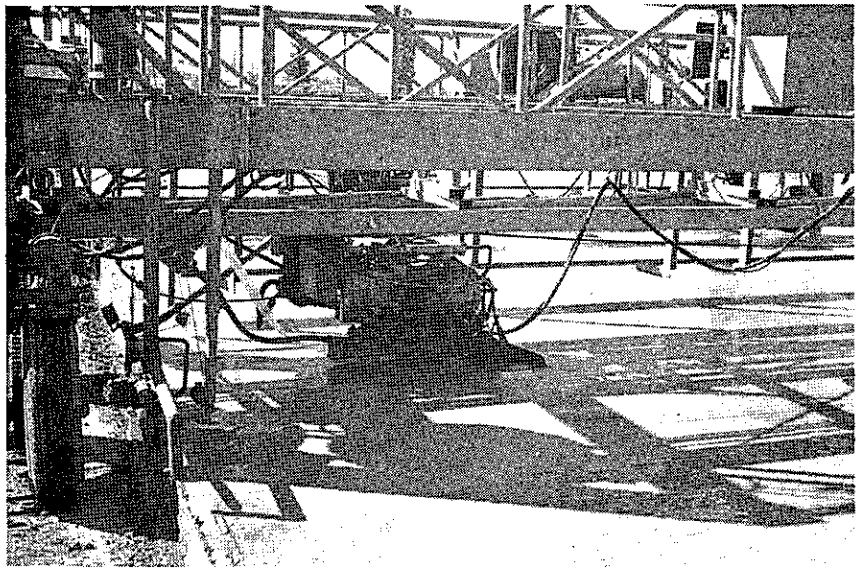
Figure 3. Inserting head on joint machine.

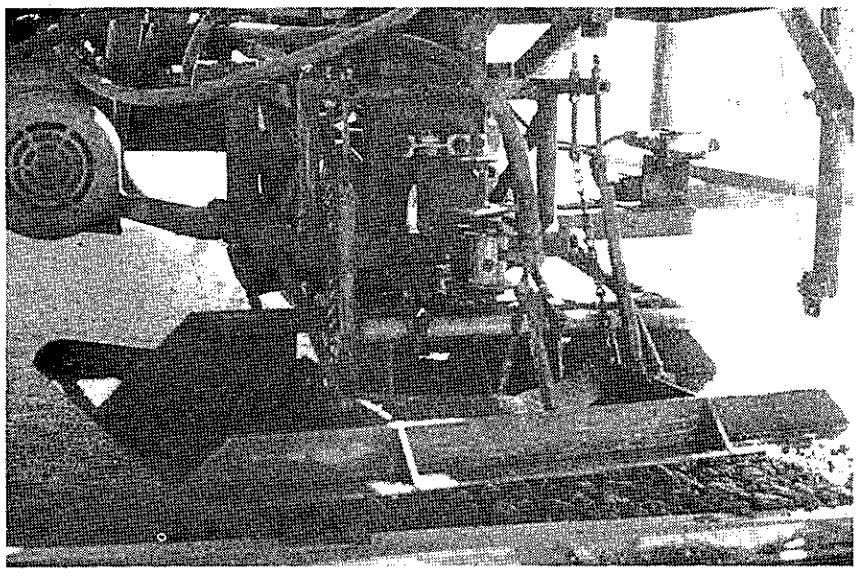
Figure 4. Vibrator and pan float on inserting head.

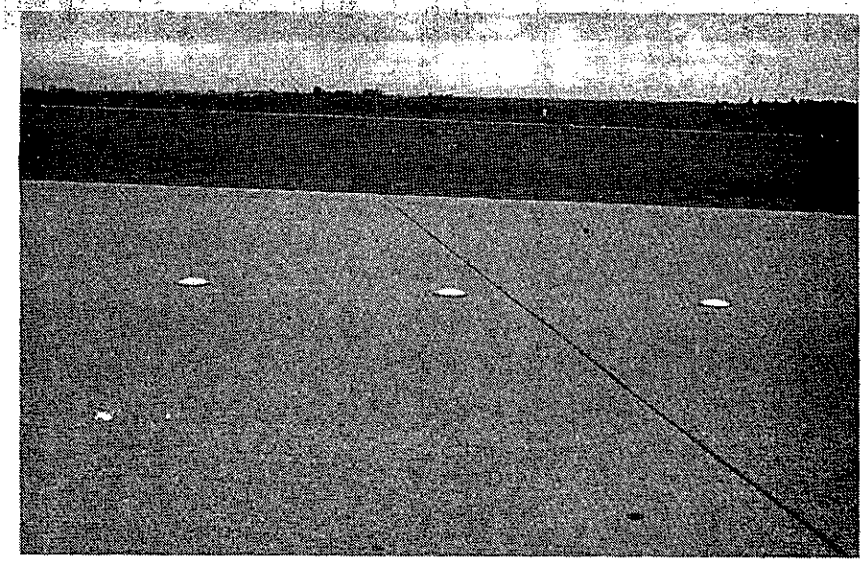
Figure 5. Rating "0". No spalling.

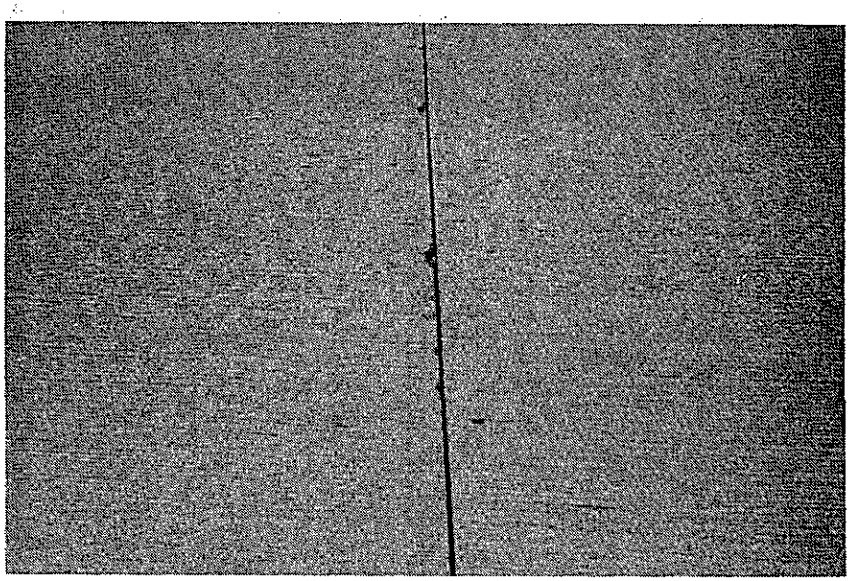
Figure 6. Rating "1". Minor spalling.

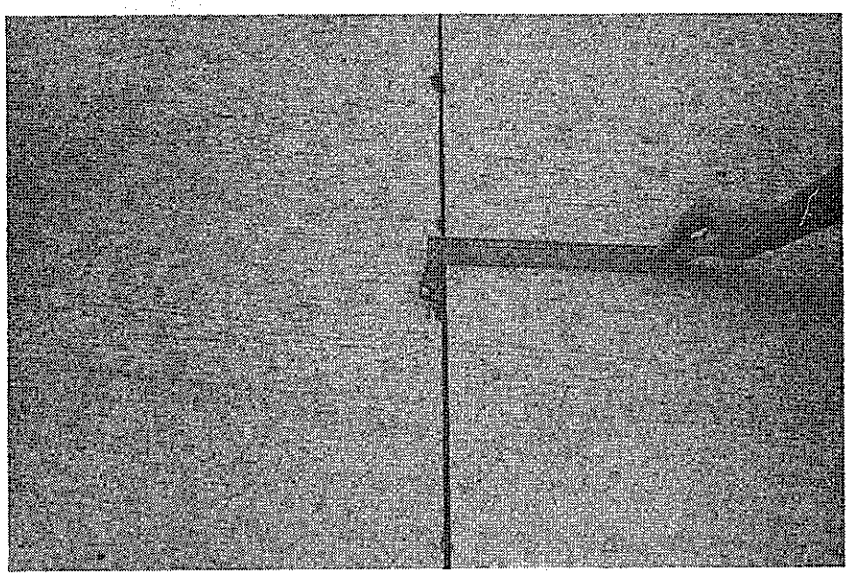
Figure 7. Rating "2". Moderate spalling.

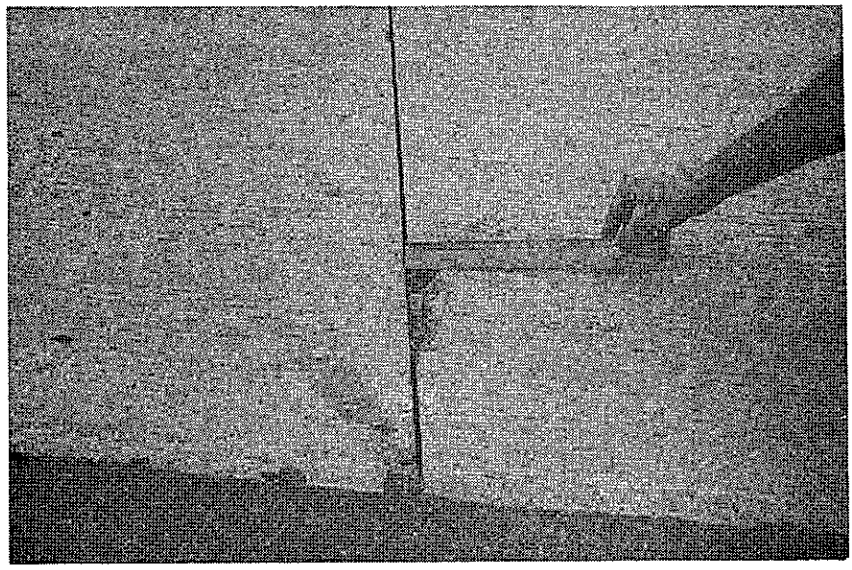
Figure 8. Rating "3". Major spalling.

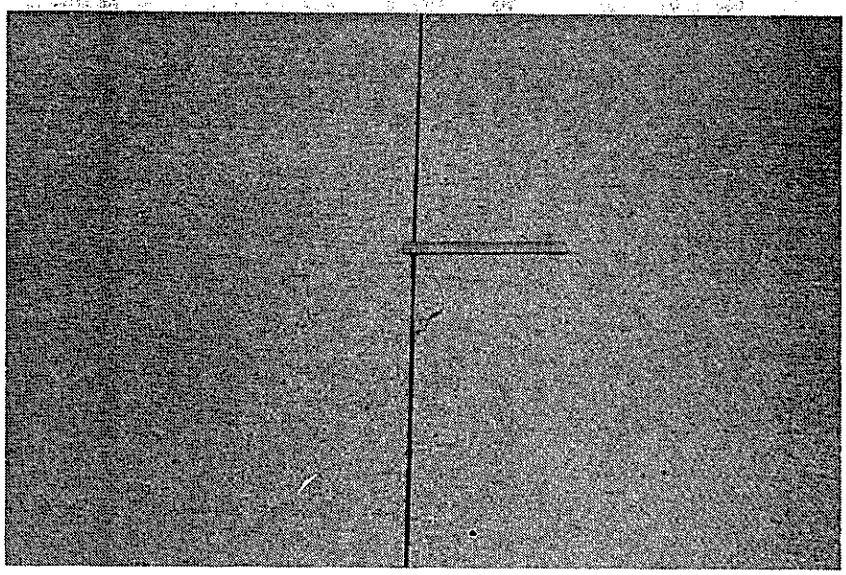
Figure 9. Rating "X". Incipient spalling.

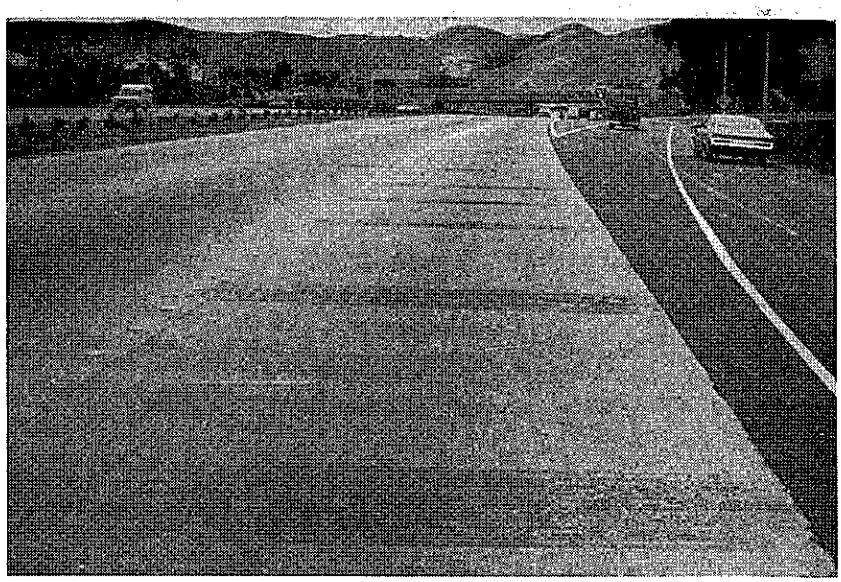
Roughness put in by the joint inserter caused the Contractor to grind transversely on the low side of almost every joint on grades. (See Figure 10.) This still did not improve the ride to any great extent.

Figure 10. Grinding at transverse plastic insert joints.

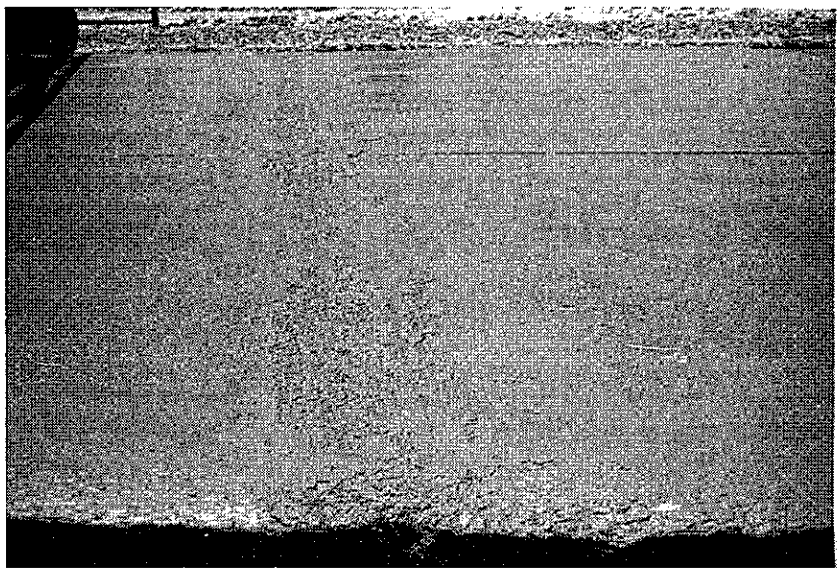
Joint inserter caused bowing of longitudinal tape and edge slump that could not be corrected. Very harsh mix contributed to troubles. (See Figure 11.) Use of inserter was discontinued.

Figure 11. Edge slump at transverse plastic insert joint.

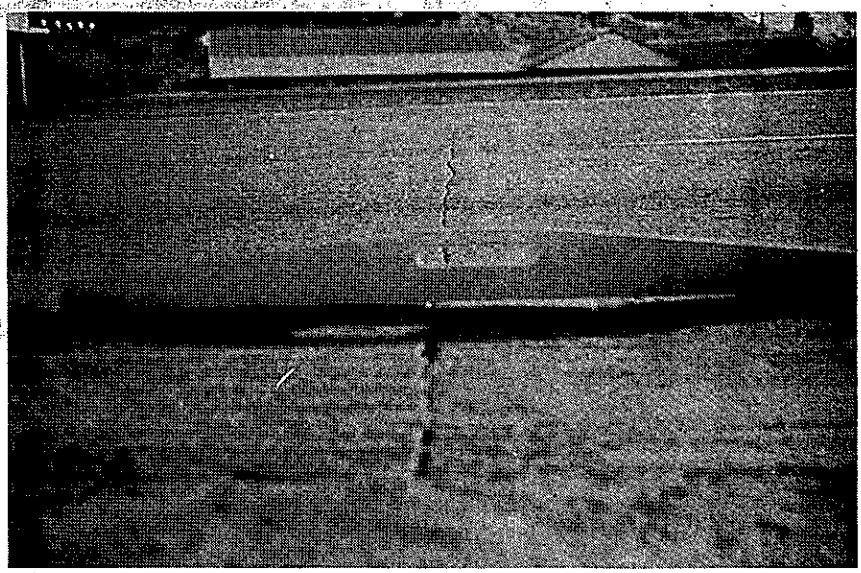
On the debit side, the plastic insert method does occasionally cause an increase in surface roughness. (See Figure 12.) This occurs primarily on grades in excess of 3% and seems to be due to either vibration causing a flow of concrete to the low side, or an inability to keep the inserting head in the same plane as the pavement. While most of these inequalities are not large enough to require remedial action, many can be felt when driven over at highway speeds. Practically all of these joints meet straightedge specifications which allow 0.02 ft. deviation in 12 ft. Also, most are either not apparent on profiles obtained with the California Profilograph, or are not counted in obtaining a profile index since a blanking band eliminates bumps of plus and minus 0.1 inch from consideration. Edge slump caused by removal of the temporary side forms of the inserting machine has been a problem on some projects. When the paving concrete has been of good workability and proper consistency, and the removal of the side forms synchronized with the forward movement of the inserting machine, no edge slump of any consequence has occurred. With some of the harsher mixes, especially those containing all crushed aggregate, the edge slump following the insertion has been severe.

Figure 12. Bump at plastic insert joint.

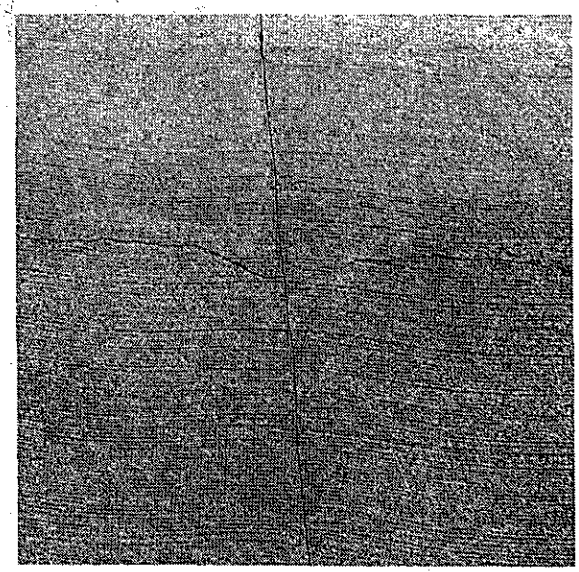
Excessive displacement of the longitudinal joint insert at the intersection with the transverse insert has occurred in about half of the joints surveyed. (See Figure 13.) While this can cause a small triangle of weakness prone to spalling, only a small percentage of those surveyed had spalled to any degree.

Figure 13. Displacement of longitudinal insert.

On several projects where displacement of the longitudinal plastic insert was a problem, changing to a less elastic type plastic for the longitudinal joint and keeping it at the proper elevation has been of considerable help in alleviating the problem. On other projects, edge slump has been reduced by careful adjustment of the movable side forms. No real effort has gone into trying to reduce the inequalities in the pavement surface caused by the inserter as most of these bumps or depressions are within the present specification limit.

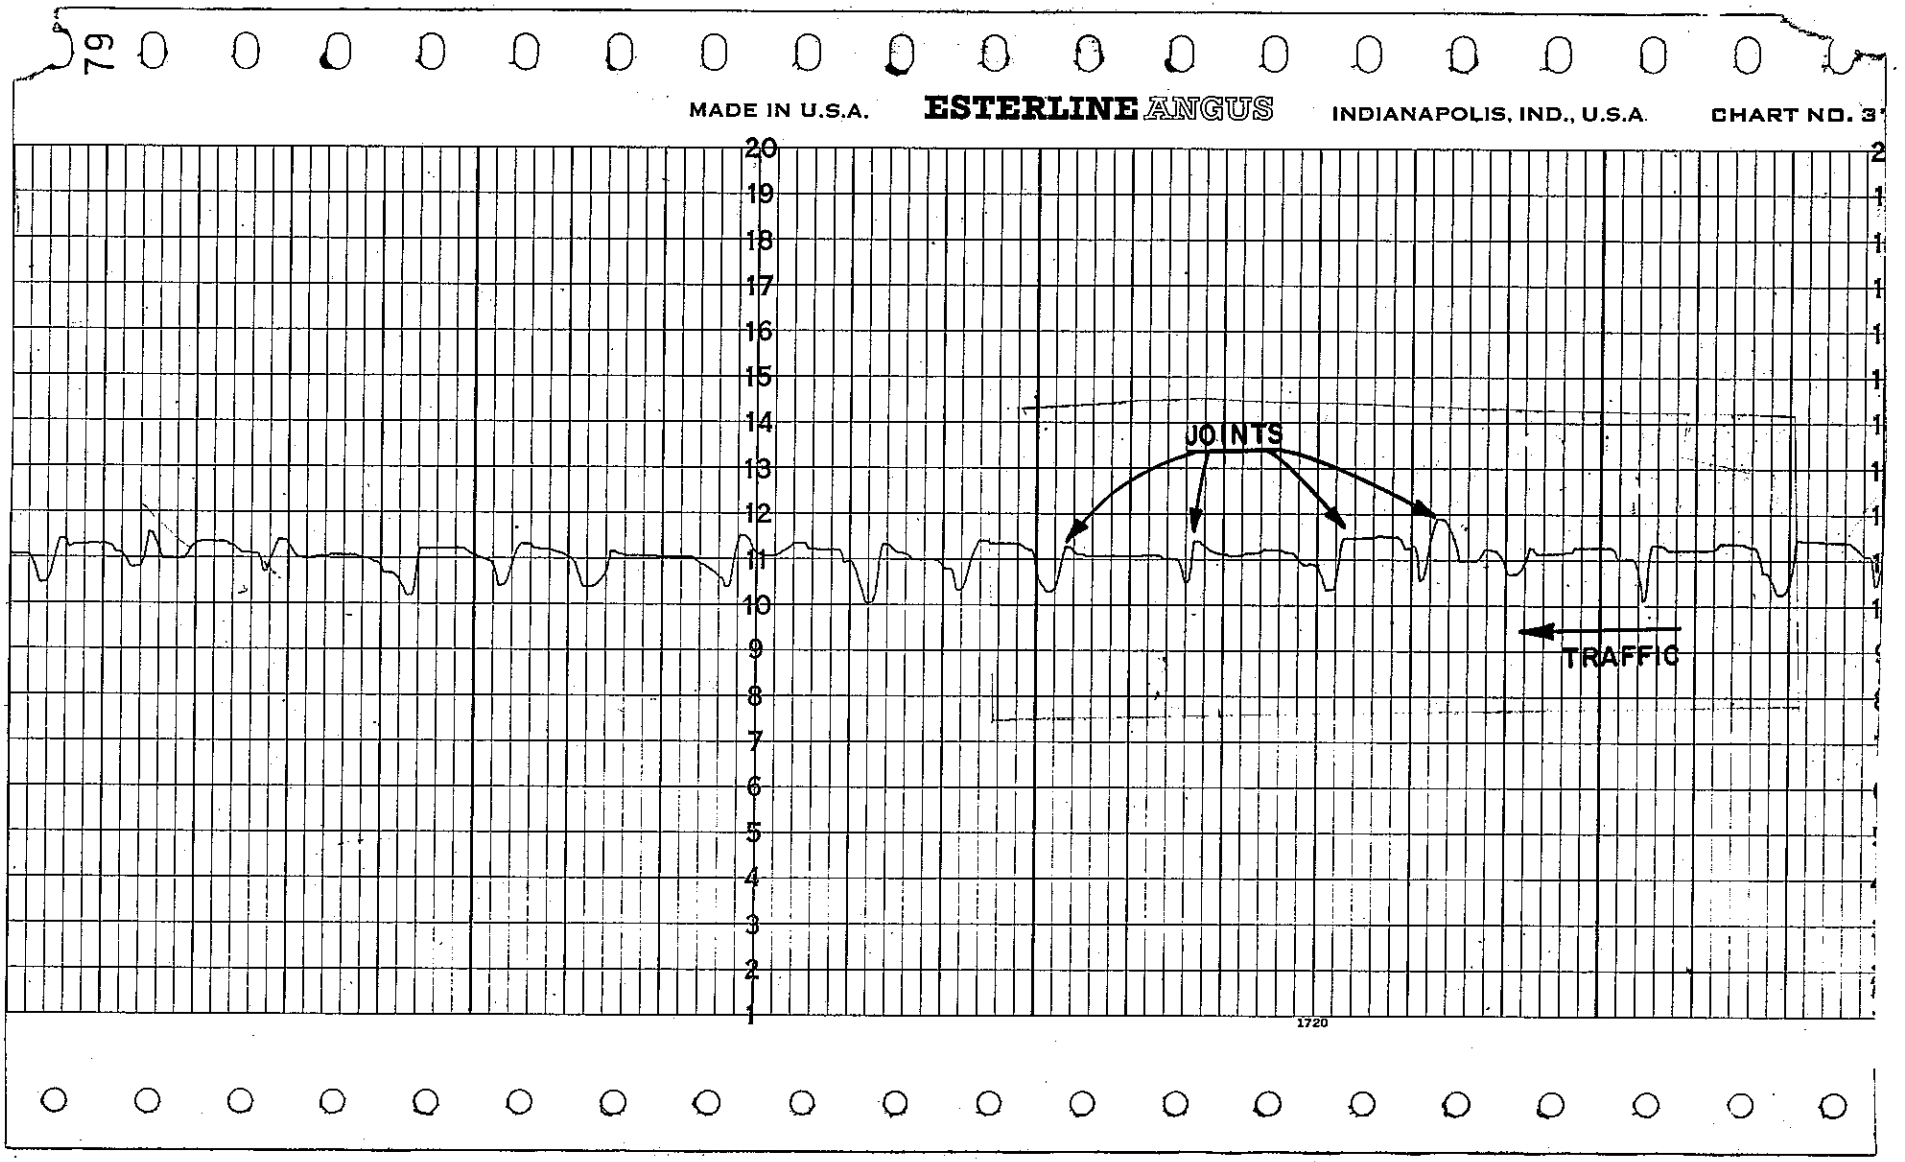
Figure 14. Graph of pavement showing roughness caused by joint inserter

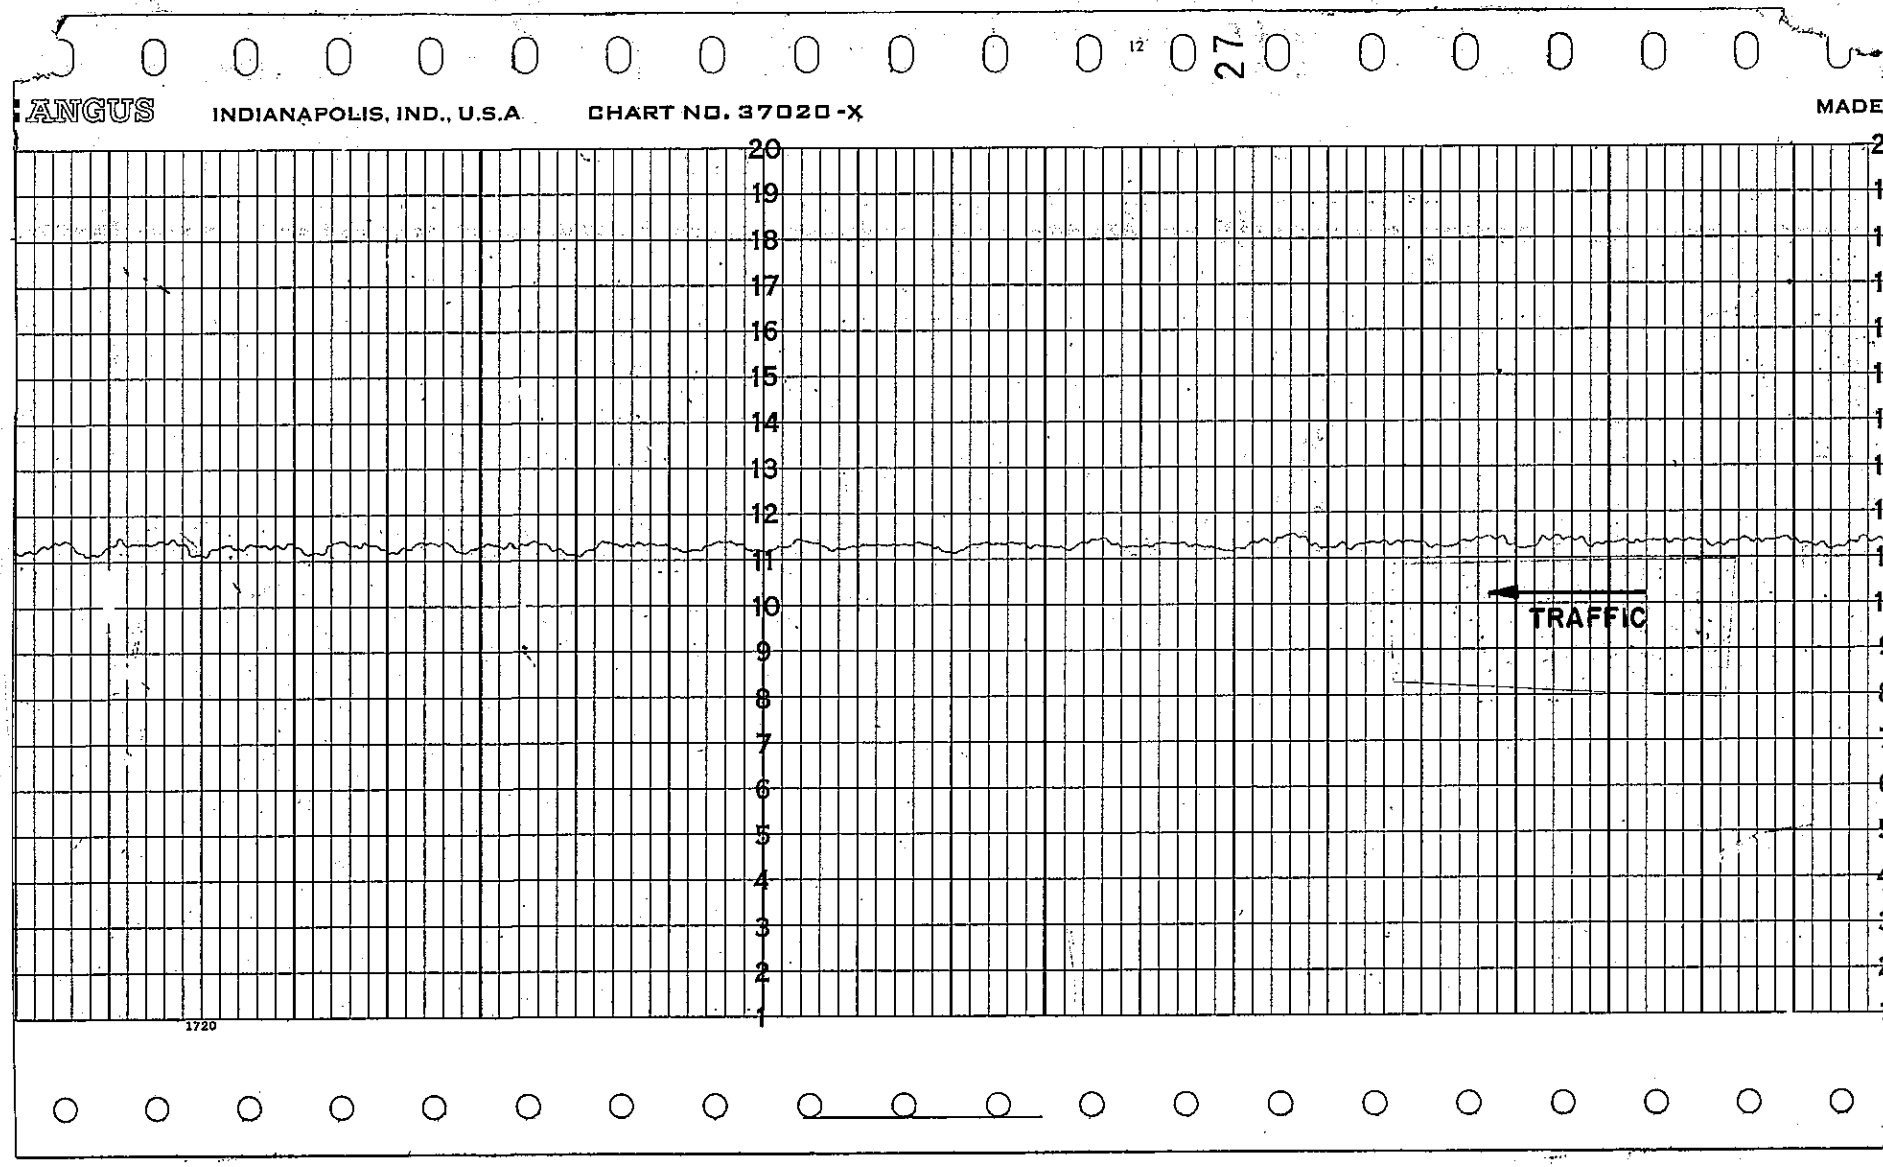
Figure 15. Graph of smooth pavement.

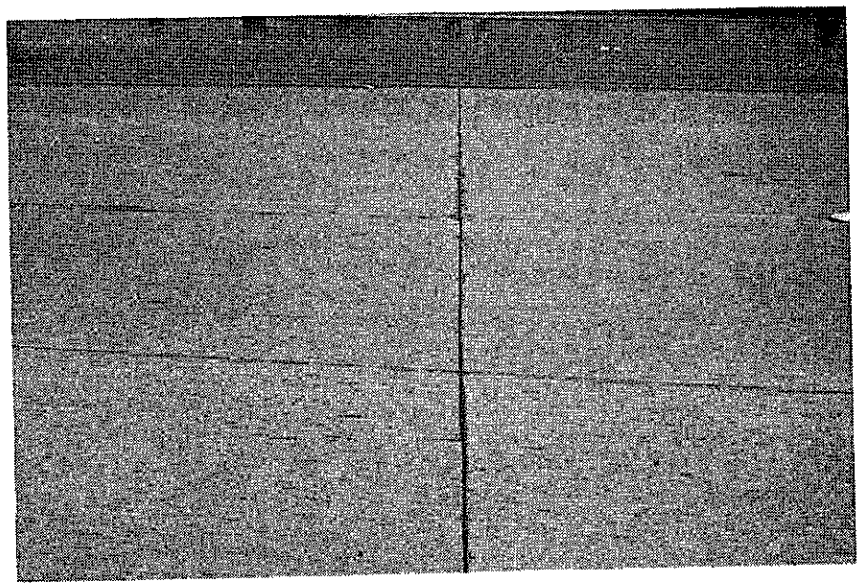
The proper time for sawing is the most critical aspect of the operation. Concrete that is too green when sawed will have unsightly ravelling (see Figure 16) or lead to later ravelling and spalling due to disturbance of the partially hardened concrete. Concrete that is left too long before sawing may develop random cracking. (See Figure 17.) Under certain climatic conditions, large areas of the pavement will crack before sawing can be completed. Mismatch of multiblade saws where they overlap occasionally occur. This results in extra wide openings at that point. These joints cannot be satisfactorily sealed with

Figure 16. Ravelling of sawed joint.

Excessive ravelling or tearing of the concrete adjacent to the saw cut, caused by sawing when the concrete is too green, will be repaired as specified in Section 40-1.08B (3). Excessive ravelling shall be defined as more than one foot of ravelling which exceeds 0.04-foot in width in a 12-foot lane, or more than three feet of ravelling which exceeds 0.01-foot in width in a 12-foot lane.

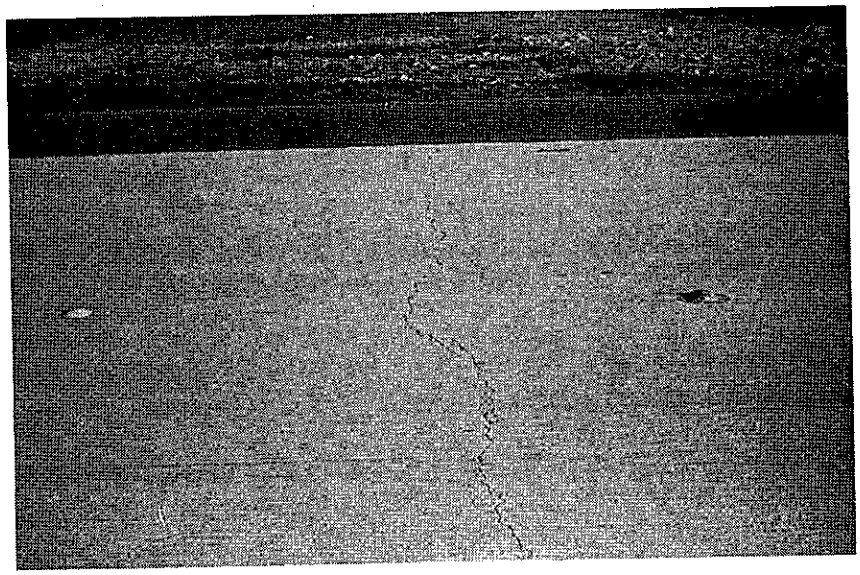
Random cracking in pavements using plastic insert joints is practically nonexistent. A pavement constructed with sawed joints and having no random cracking is the exception rather than the rule. This can and does lead to costly repairs, sometimes even before the project is open to public traffic.

Figure 17. Random crack on sawed joint project.
