4. TITLE AND SUBTITLE
Performance Evaluation of Coastal Gabion Installations
(Interim Report)

State of California
Department of Transportation
Division of New Technology & Research
Office of Transportation Laboratory

Principal Investigator.....Thomas P. Hoover, P.E.

89-02

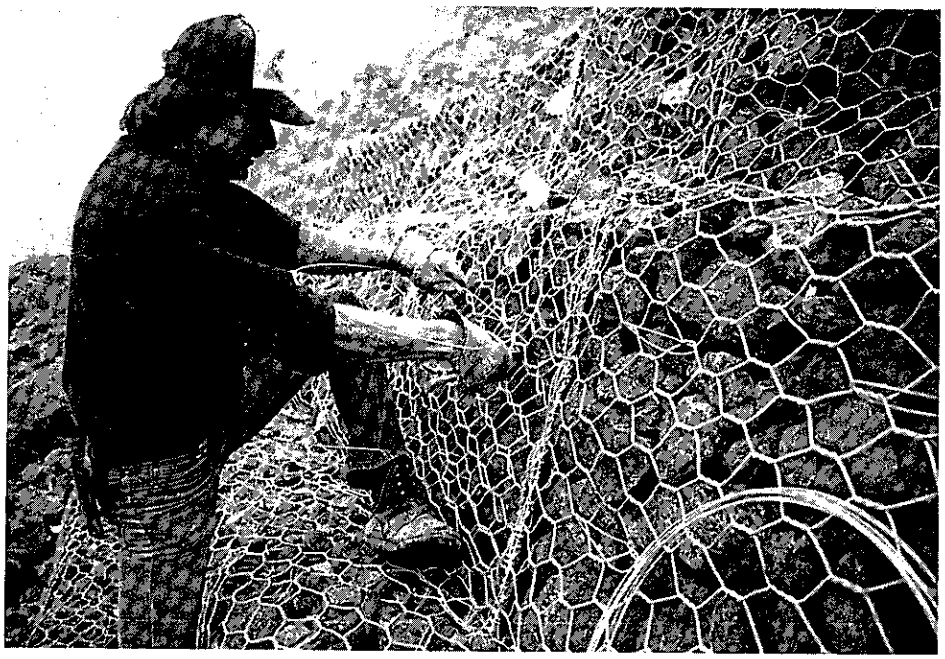
Figure 2 Lacing Panels in Place

Twisted mesh gabion wall with panel being laced against wall face.

Pulling lacing tight to secure test panel to wall face.

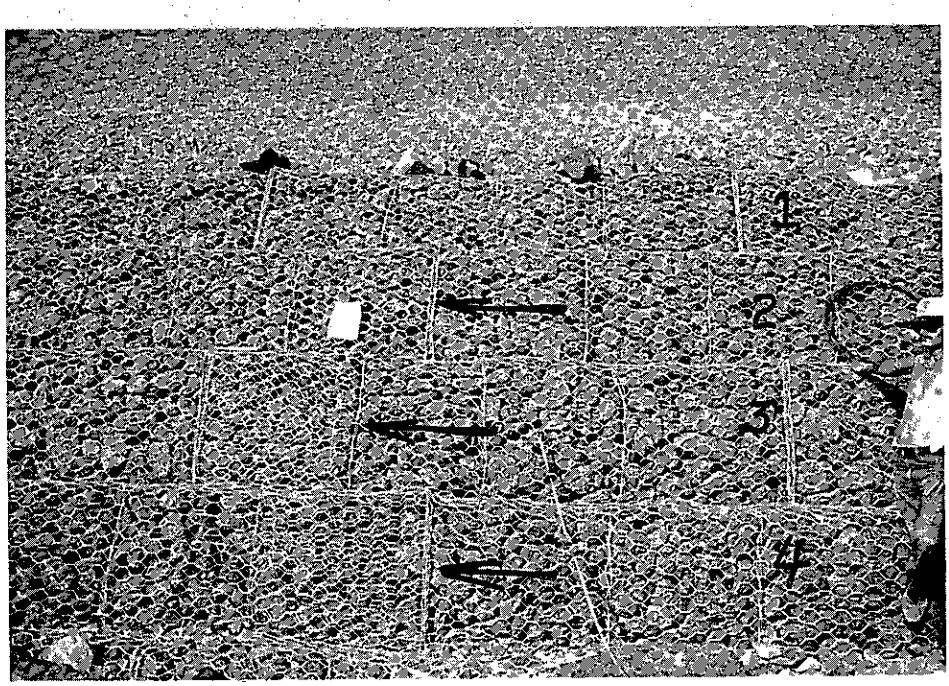
Figure 3 Panel Types and Locations

Southerly Wall showing 3 installed panels: Row 2, PVC; Row 3, galvanized; Row 4, PVC.

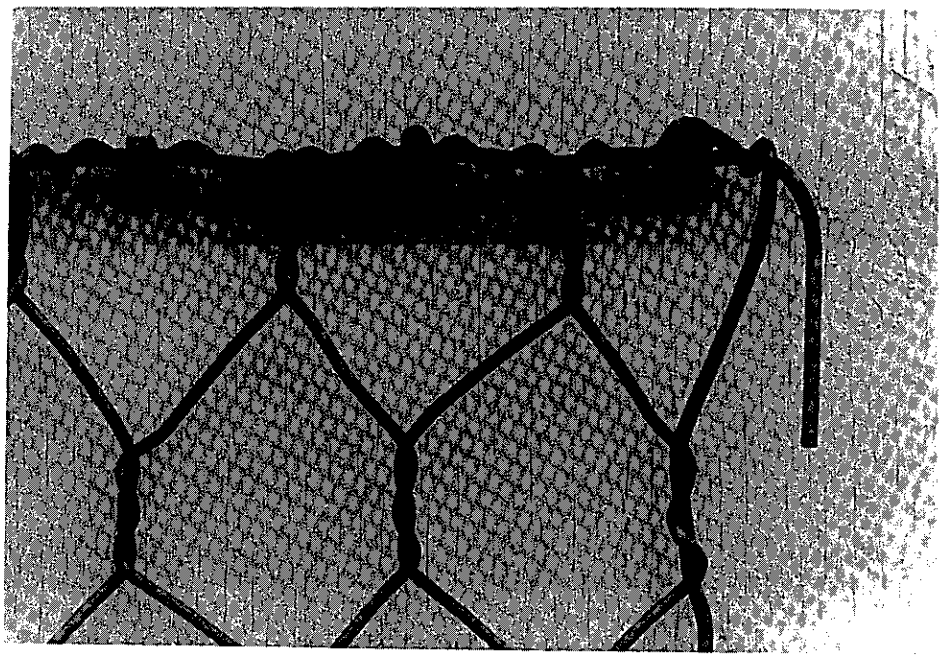
Figure 4 Panel Types

Galvanized Panel

PVC clad panel

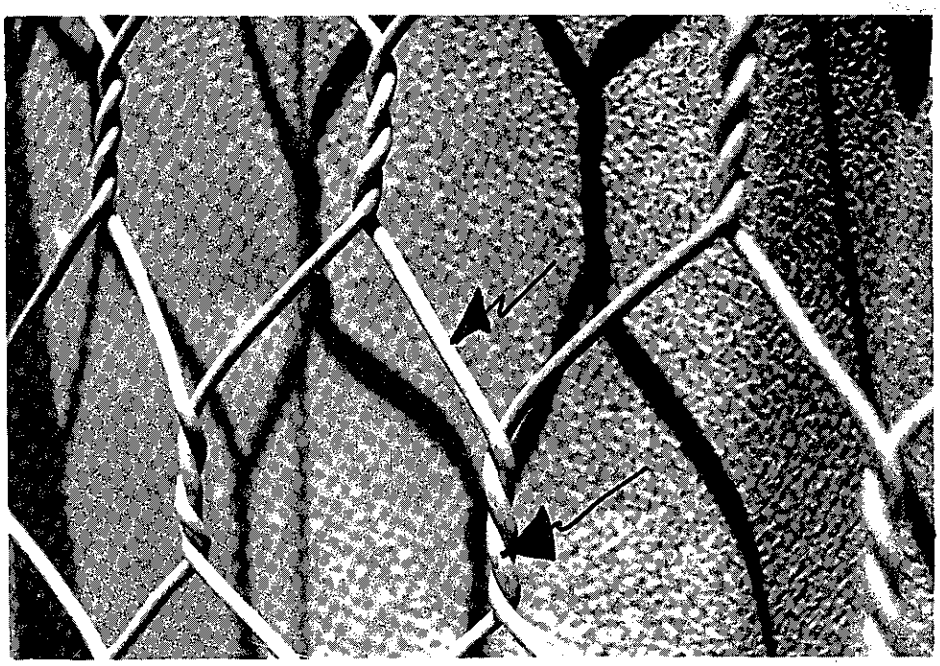
Figure 5 Damage Locations

The galvanized panels were installed as received. The wires of the pvc coated panels were damaged in a random/systematic manner. That is, pvc coated wire pairs were randomly selected for strength testing with three systematic coating damage conditions. On each panel one row of wires was and will be evaluated as received, one row of wires has longitudinal cuts in the pvc to represent cracking of the coating, and one row of wires has blazes to represent rock abrasion of the pvc coating. Rows of ordered pairs of wires have to be used for all sampling because of the normal scatter associated with the strength of wires used to fabricate gabions. This is readily observed in Appendix B by looking at the scatter of wire strengths for the initial unweathered ordered pair tests. While all wires meet the minimum specifications, some substantially exceed the required minimums.

Two types
of cut

Two types
of blaze

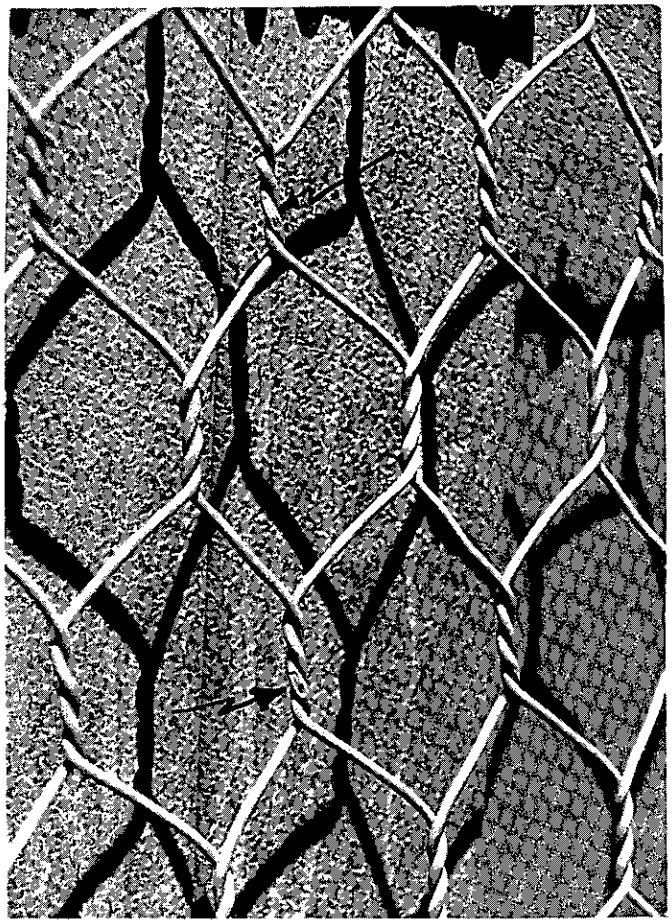
Figure 6 Ordered Pair

Because there appears to be a 23 percent scatter in the wire strengths from strand to strand, all tests are of ordered pairs of wires. (See Figure 6) The PVC coated wire stength ranges from 595 to 732 lb, and the galvanized varies from 694 to 857 lb.

Two subsequent blazes on a
single ordered wire pair.

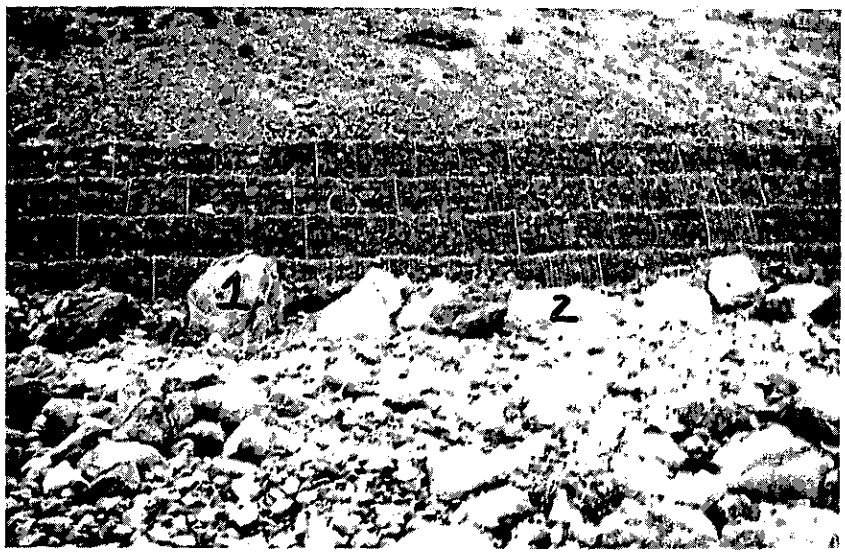
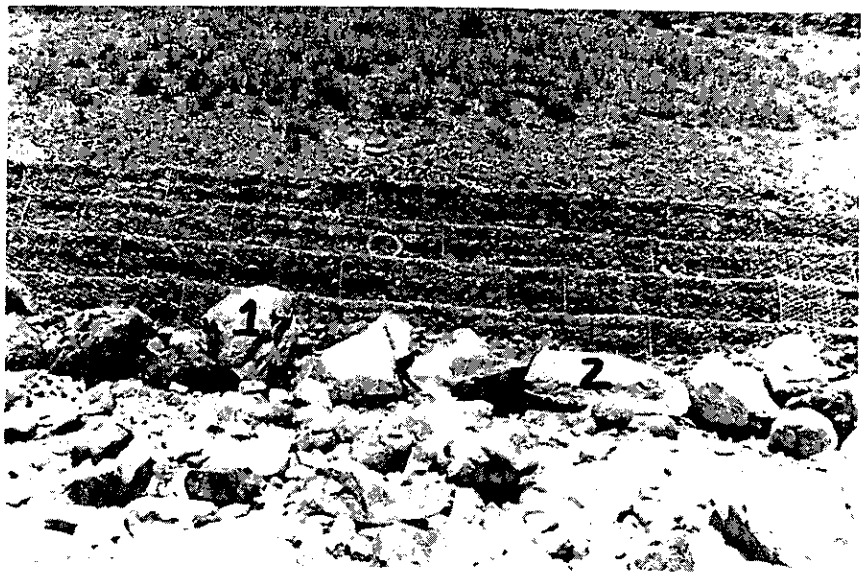
Figure C3

Overview Site
May 3, 19878

Same View,
May 1988
Note increased
scour exposing
more of rocks 1 & 2

Wave Action Effects

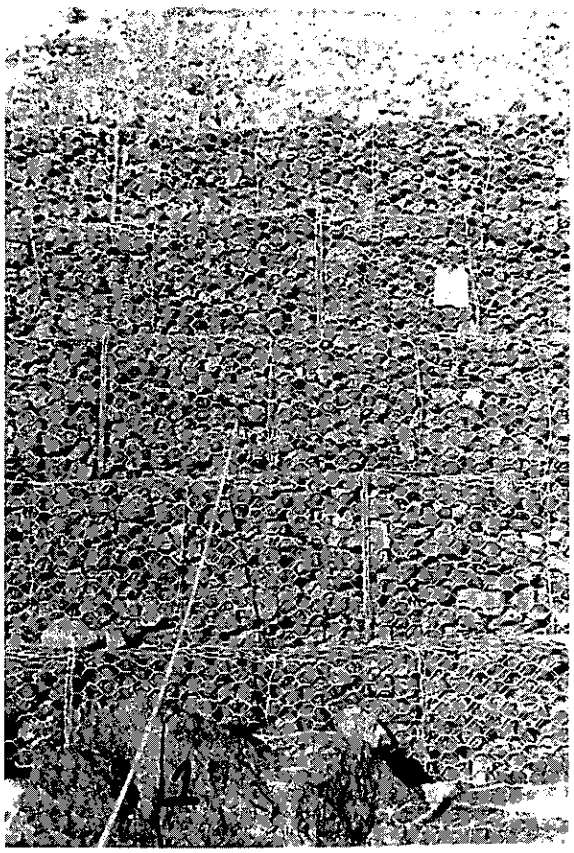
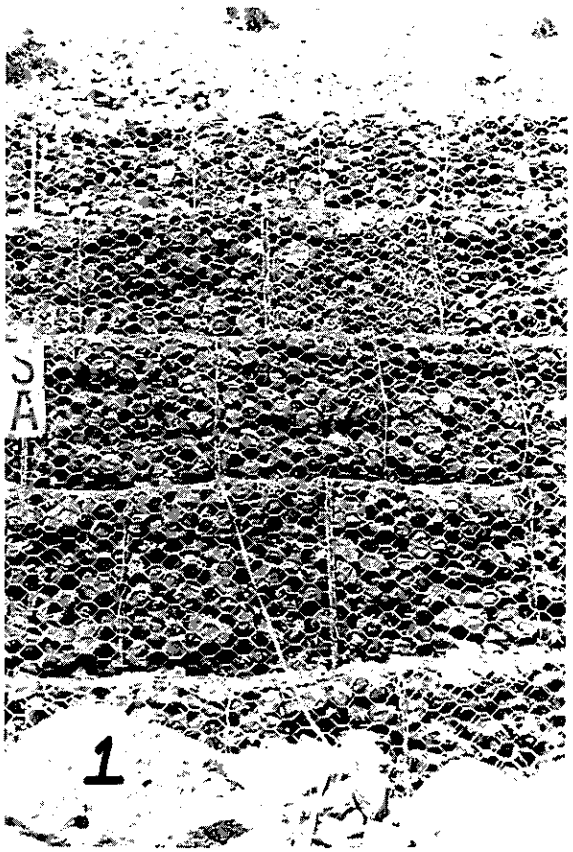
Example of Long Perspective Photo Points

Site 3
Photo Point SA
October 1986- Long
perspective.
Tape attached to
permanent wire marker.

Site 3
Photo Point SA
May 1988 - Long
perspective.
Tape at same wire
marker, new "ID"
letters.

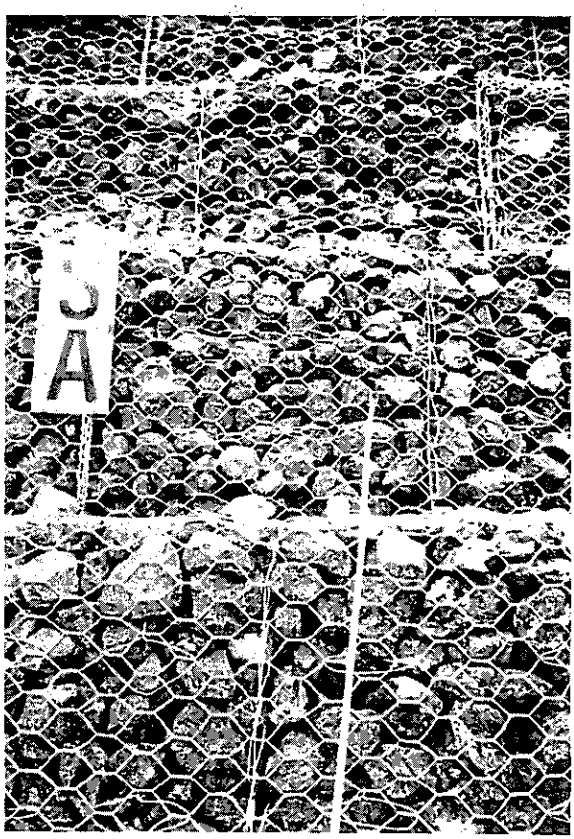
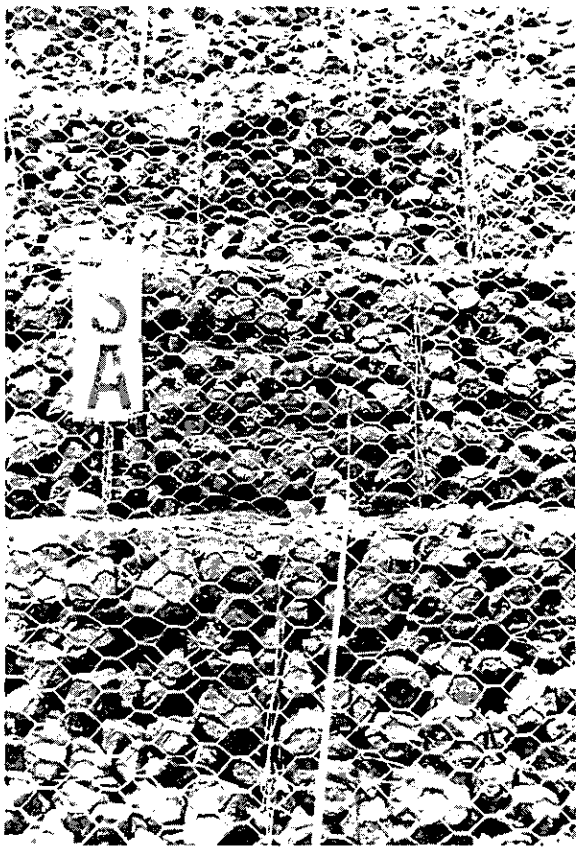
Figure C5

Site 3 Photo Point
SA- Close perspective
May 1987

Site 3 Photo Point
SA- Close perspective
May 1988

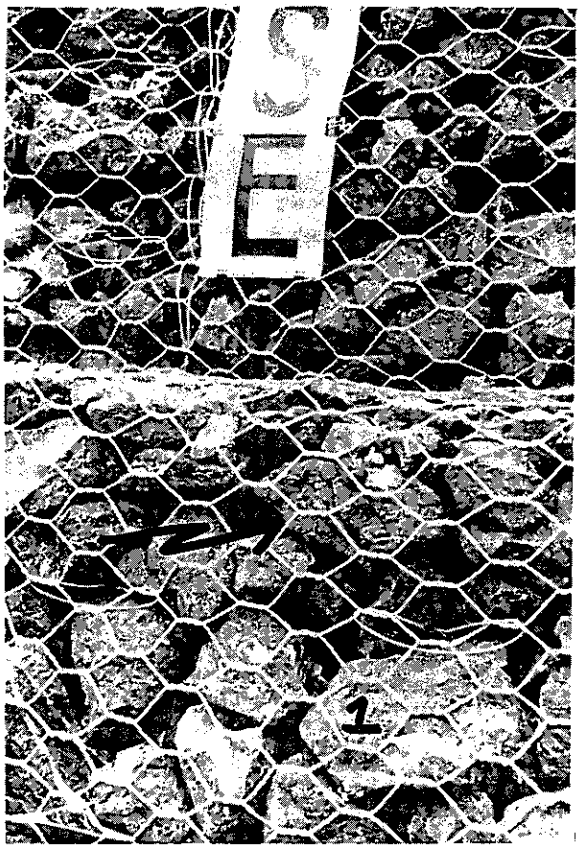
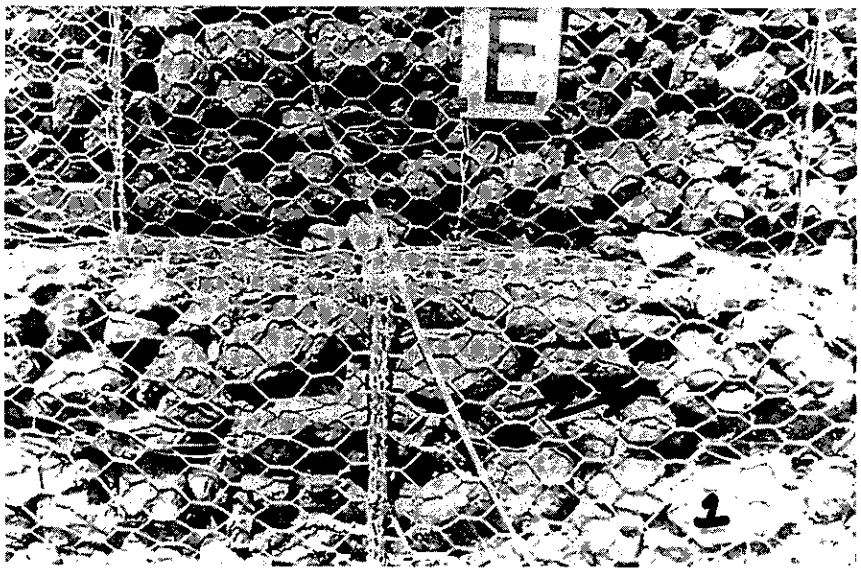
Figure C6

Photo Point SE
Rock condition
May 1987

Photo Point SE
Rock condition
May 1988. Note
rock deterioration,
arrows in both
pictures are in
same wire cell.

Rock Survivability Monitoring, Also See Figure C7

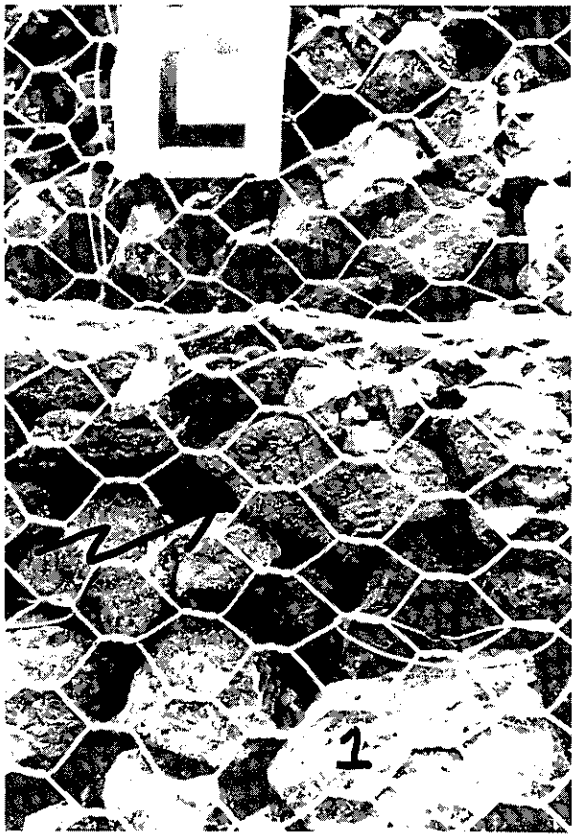
Photo Point SE
close up of Rock
condition - May 1987

Photo Point SE
Close up of
Rock condition
May 1988

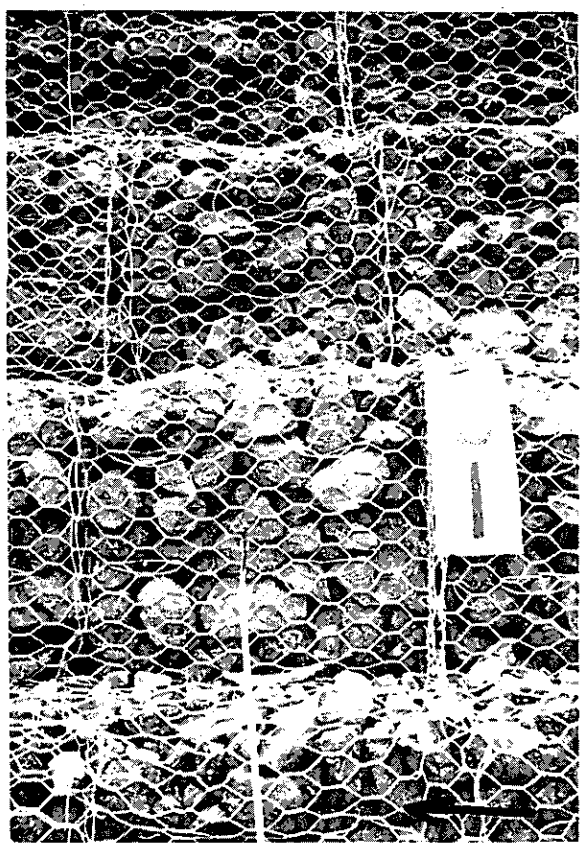
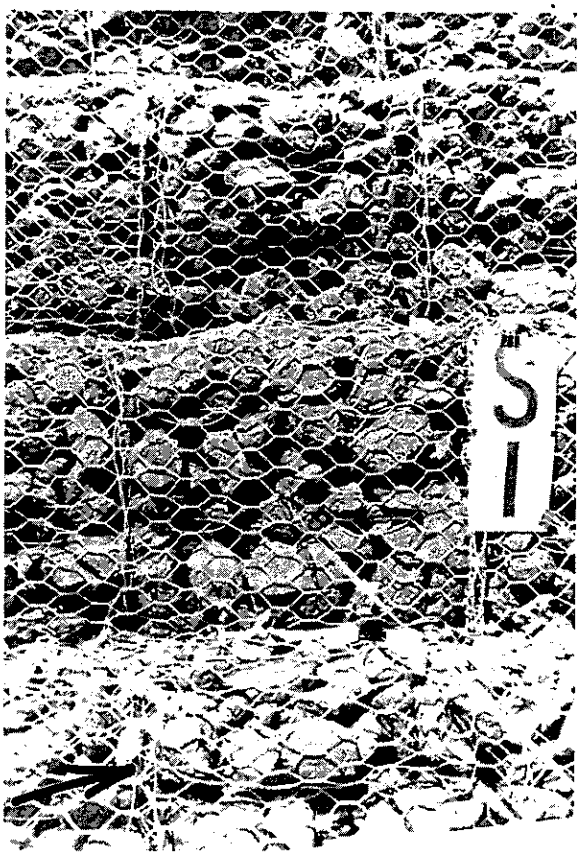
Photo Point SI wire configuration, durability monitoring May 1987. Note bulge from impact.

Photo Point SI wire configuration, durability monitoring May 1988. Note bulge from impact.

Wire Bulging from Impact

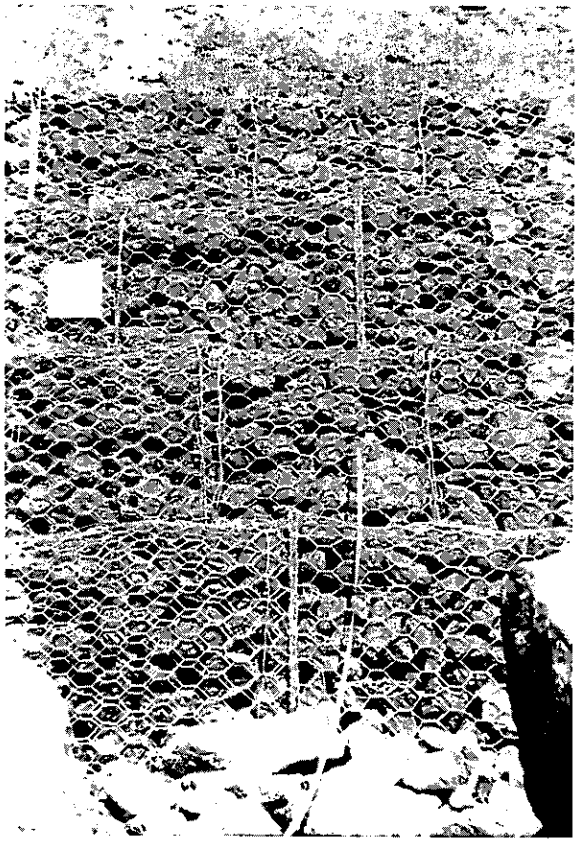
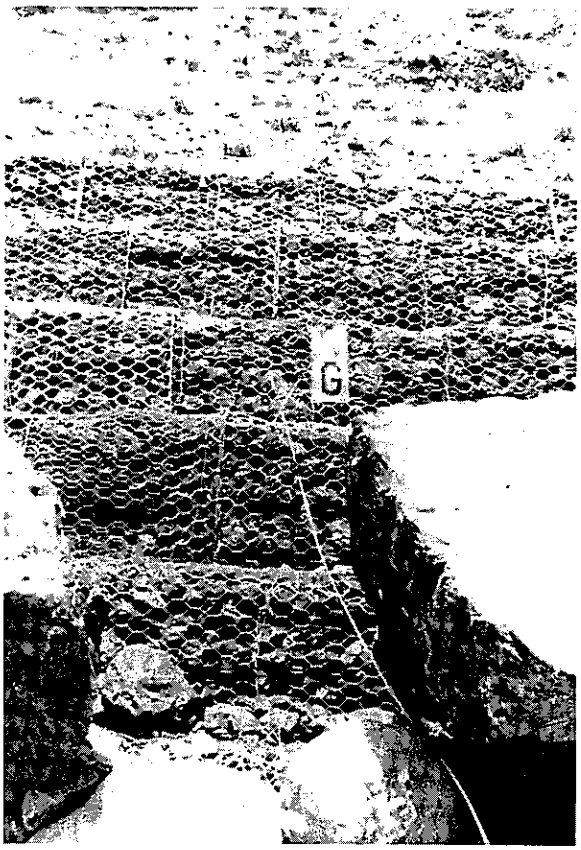
Figure C9

Photo Point NG
Long perspective
October 1986, note
debris at toe.

Photo Point NG
Long perspective
October 1988.
Notescour of debris
shown in 86 photo
above.

Debris movement at Wall Toe

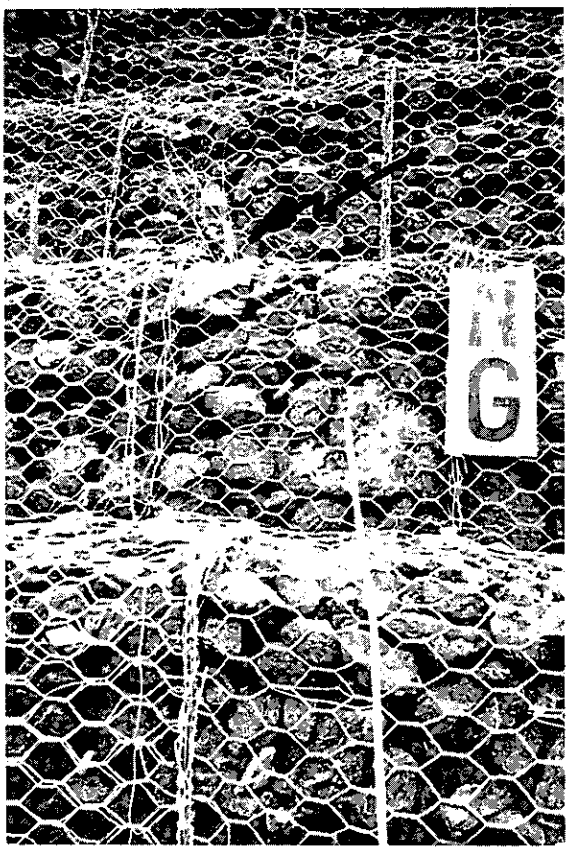
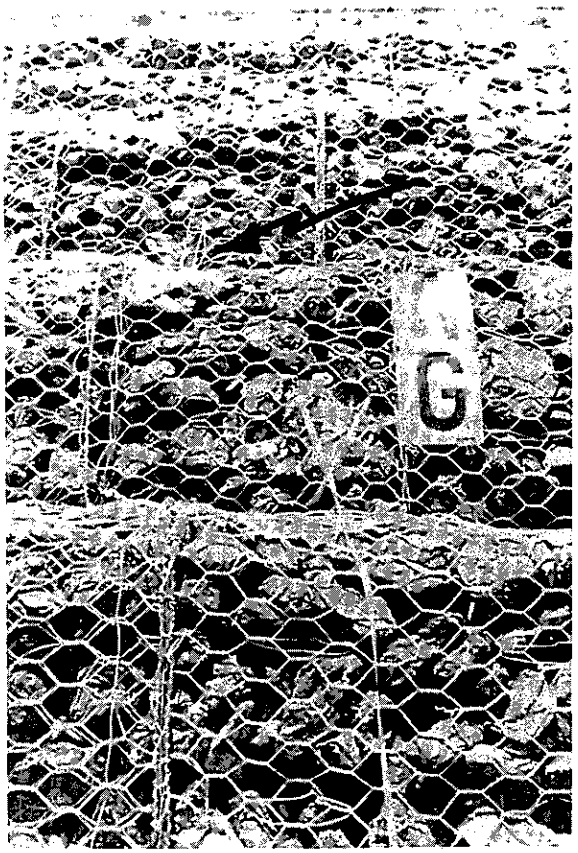
Photo Point NG
May 1987
Close perspective,
note weeds.

Photo Point NG
Close perspective
May 1988, note
weeds are still
barely visible.

Some Growth in Upper Wall Levels

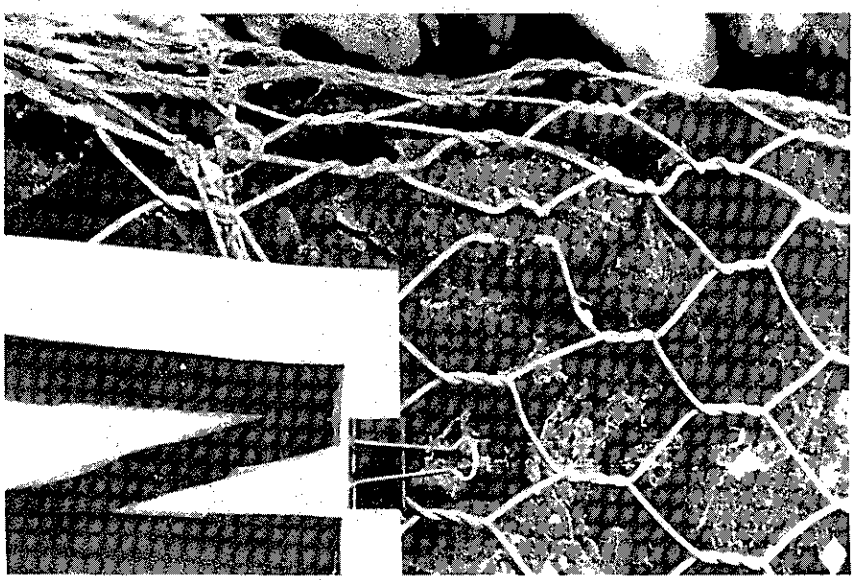
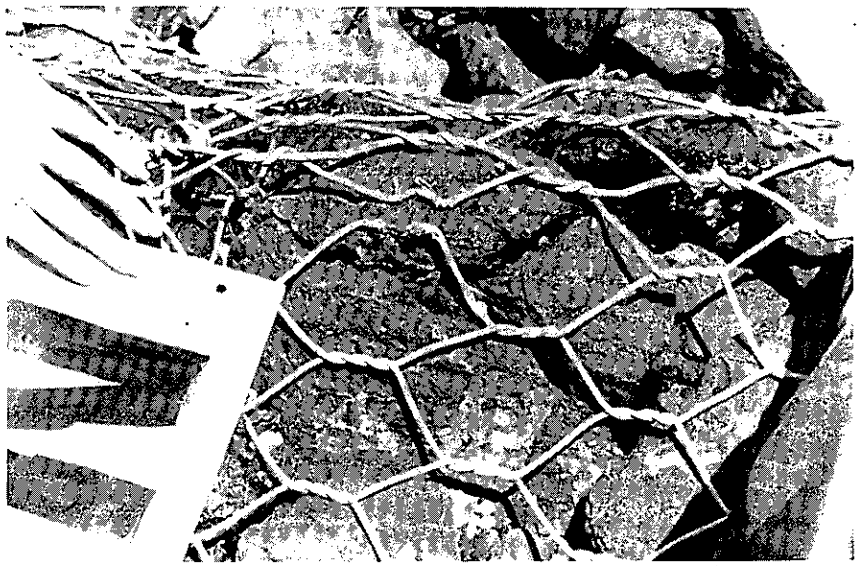
Figure C11

o Wire data suggest that coatings damaged during construction would indeed be more susceptible to corrosion than undamaged wire. Much of the contract installed wire was damaged.

Construction damage to wire May 1987

Same damage as of May 1988.

Construction Damage to Staple

Because of the short monitoring time the primary recommendations concern the completion of the research. Monitoring should continue as planned with additional topographic and wire evaluations. Near future applications should be limited and monitored since no real conclusions have been determined. Great care should be used in construction to minimize damage to the coatings.

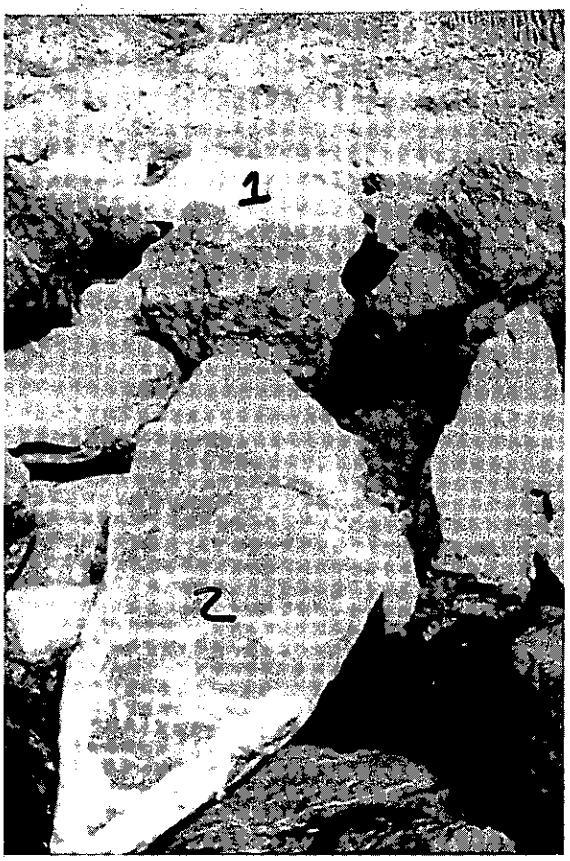
Some data and photo comparisons in figures C13 & C14 (Appendix C) indicate substantial large rock movement in the mattress installations. Topographic data indicate minor movement, but none of the points happened to be located in areas of major movement.

Rock position monitoring
October 1986

Rock position
Monitoring May 1988
with relative shift
of 1 and 2

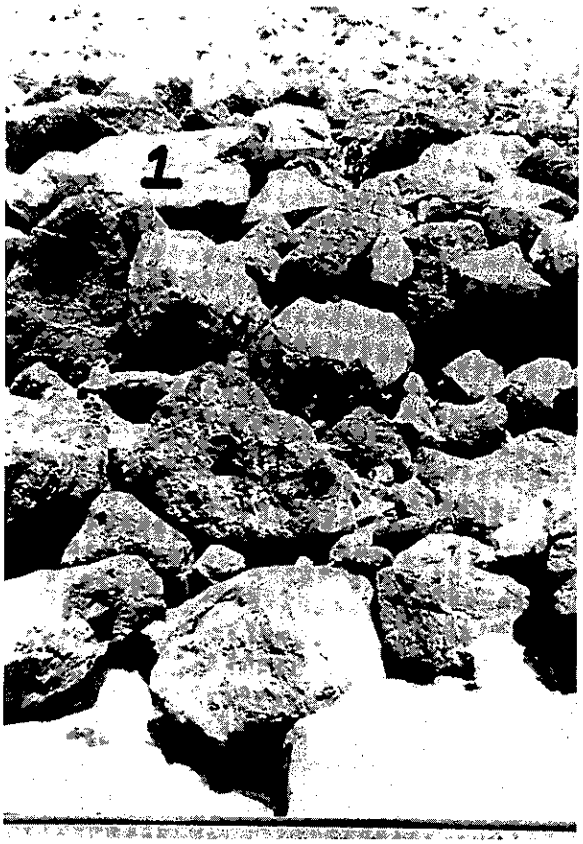
Rock position
monitoring October 1986

Rock position monitoring
May 1988.
Note rock 3 is gone, and
2 has shifted
relative to rock 1.

Relative Rock Movement from Wave Action
