4. TITLE AND SUBTITLE
Overhead Box Beam Sign

7. AUTHOR(S)
Pollock, T.L.

R & D No. 7-69

OVERHEAD BOX BEAM SIGN

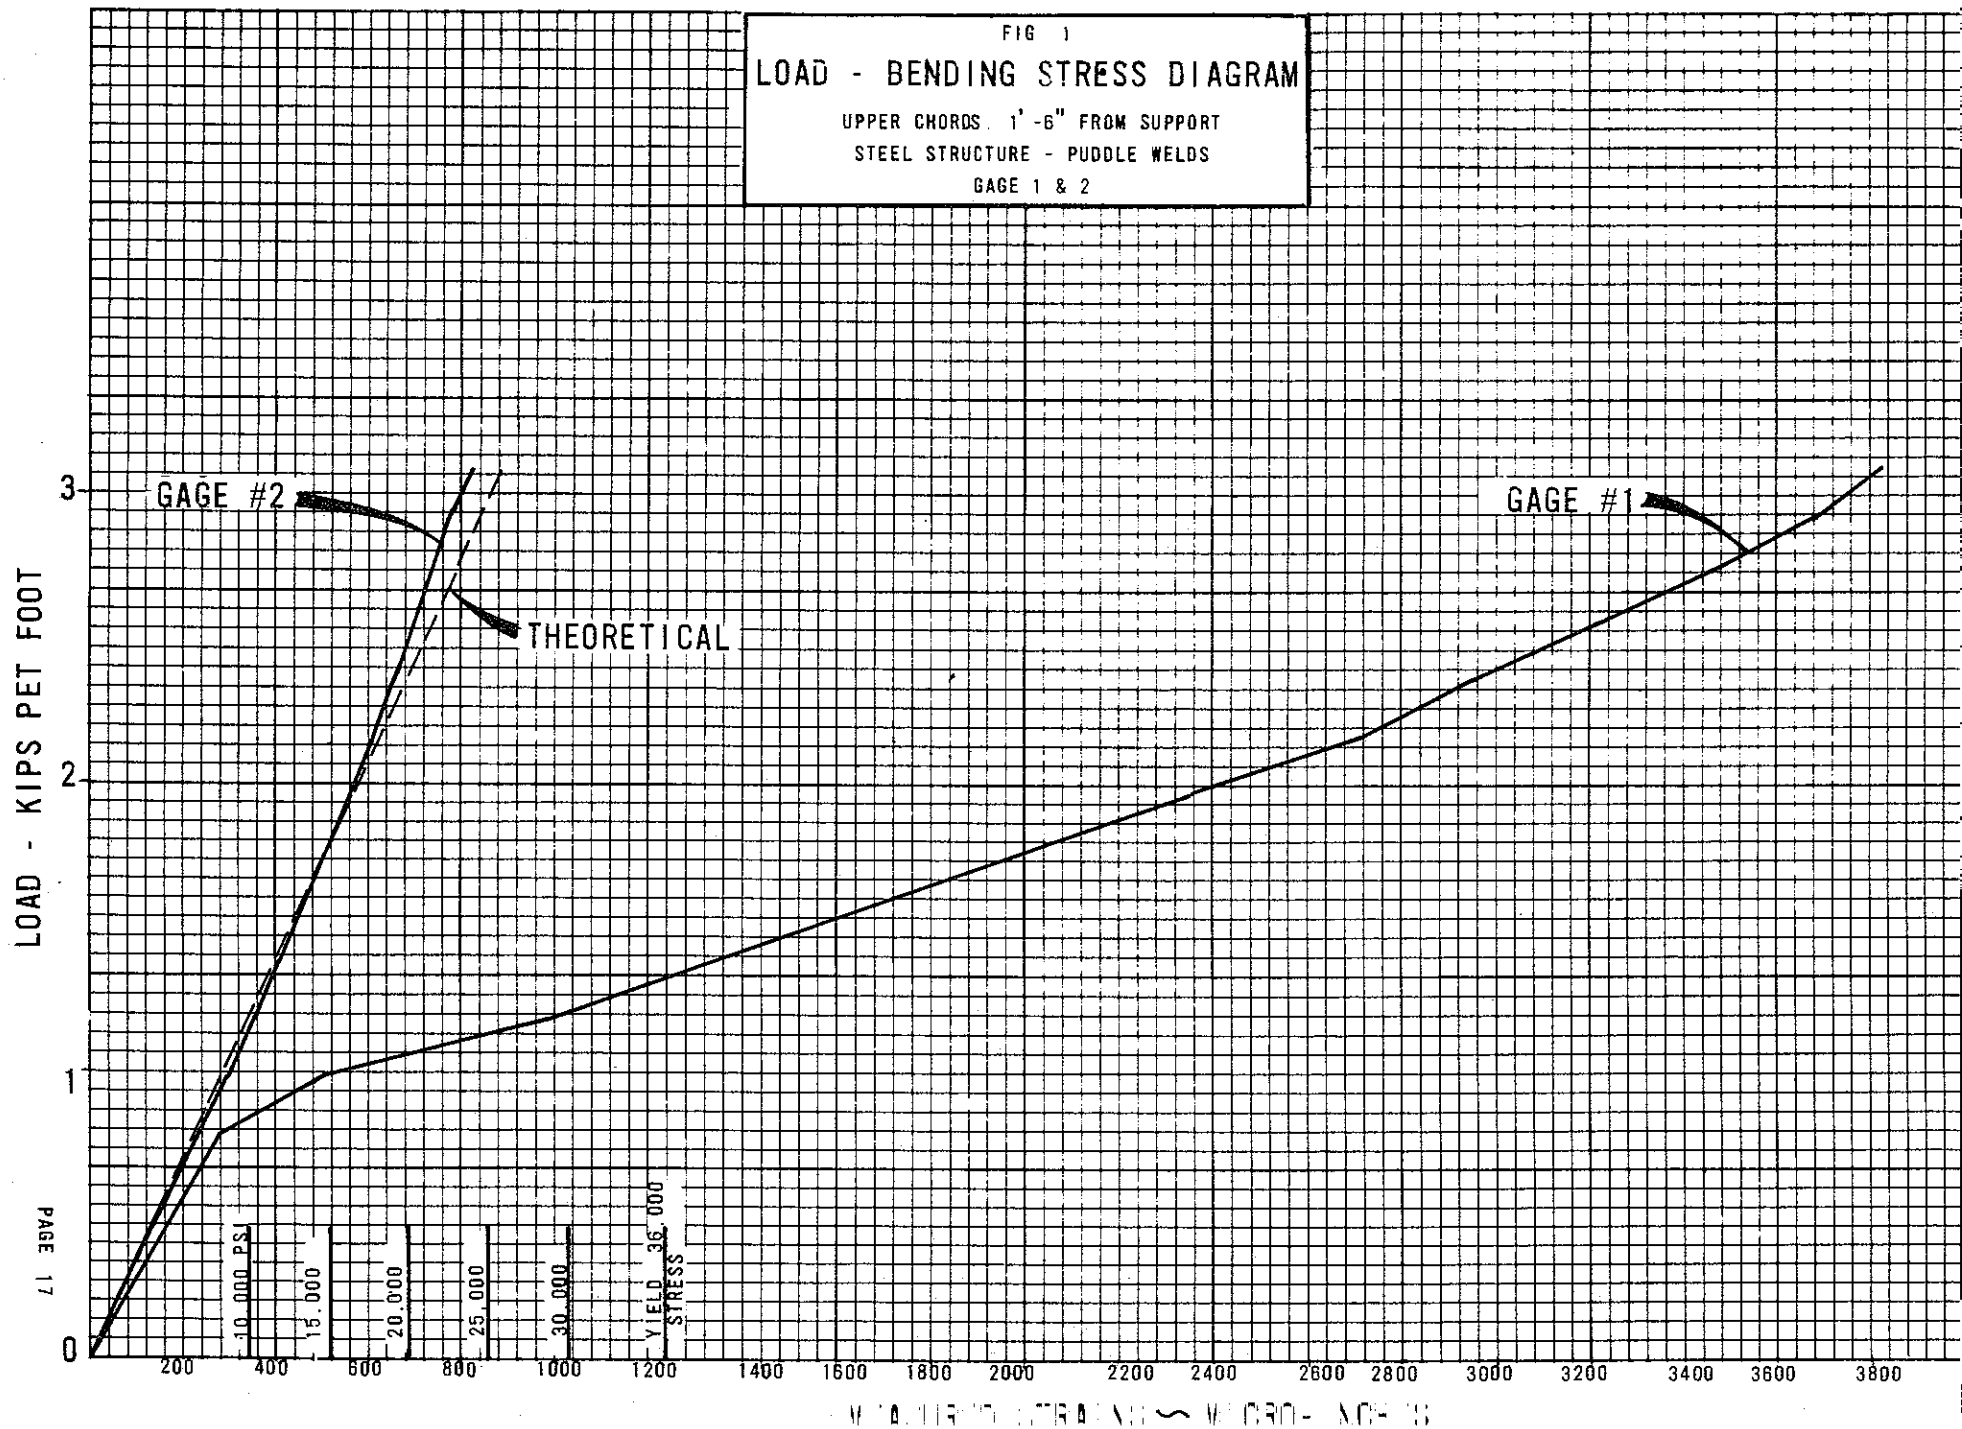
FIG 1

Figures 1 through 5 indicate a fairly good correlation between calculated and measured stress in the chord angles. An exception is the lower chord-angles of the Huck-bolted steel sign (not shown on graphs) in which gage readings indicated considerably less than calculated stress. Since there was no apparent reason for these reduced readings they were assumed erroneous.

LOAD - BENDING STRESS DIAGRAM

UPPER CHORDS 1'-6" FROM SUPPORT
STEEL STRUCTURE - PUDDLE WELDS
GAGE 1 & 2

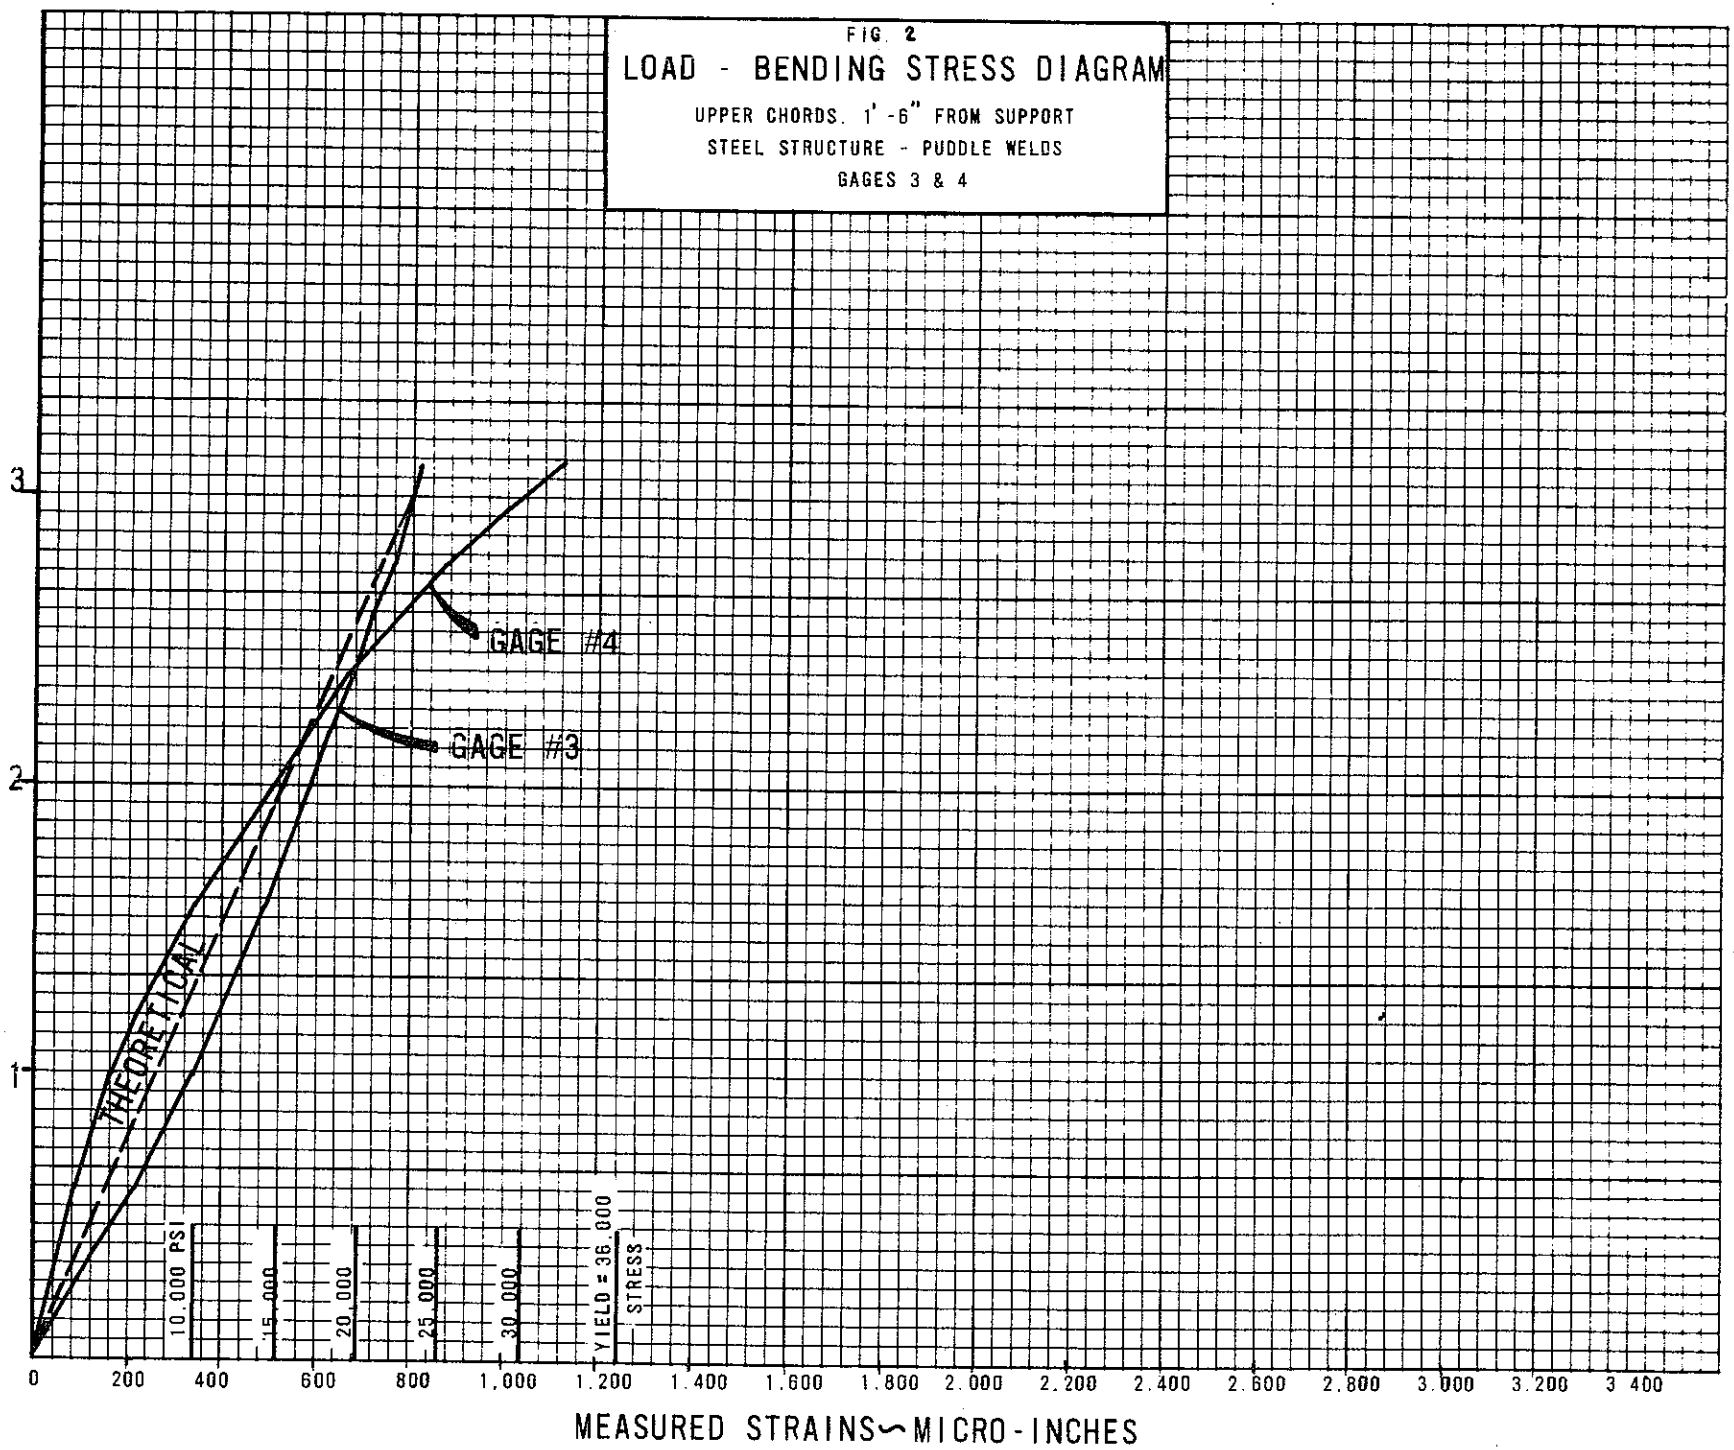
FIG. 2

LOAD - BENDING STRESS DIAGRAM

UPPER CHORDS. 1'-6" FROM SUPPORT
STEEL STRUCTURE - PUDDLE WELDS
GAGES 3 & 4

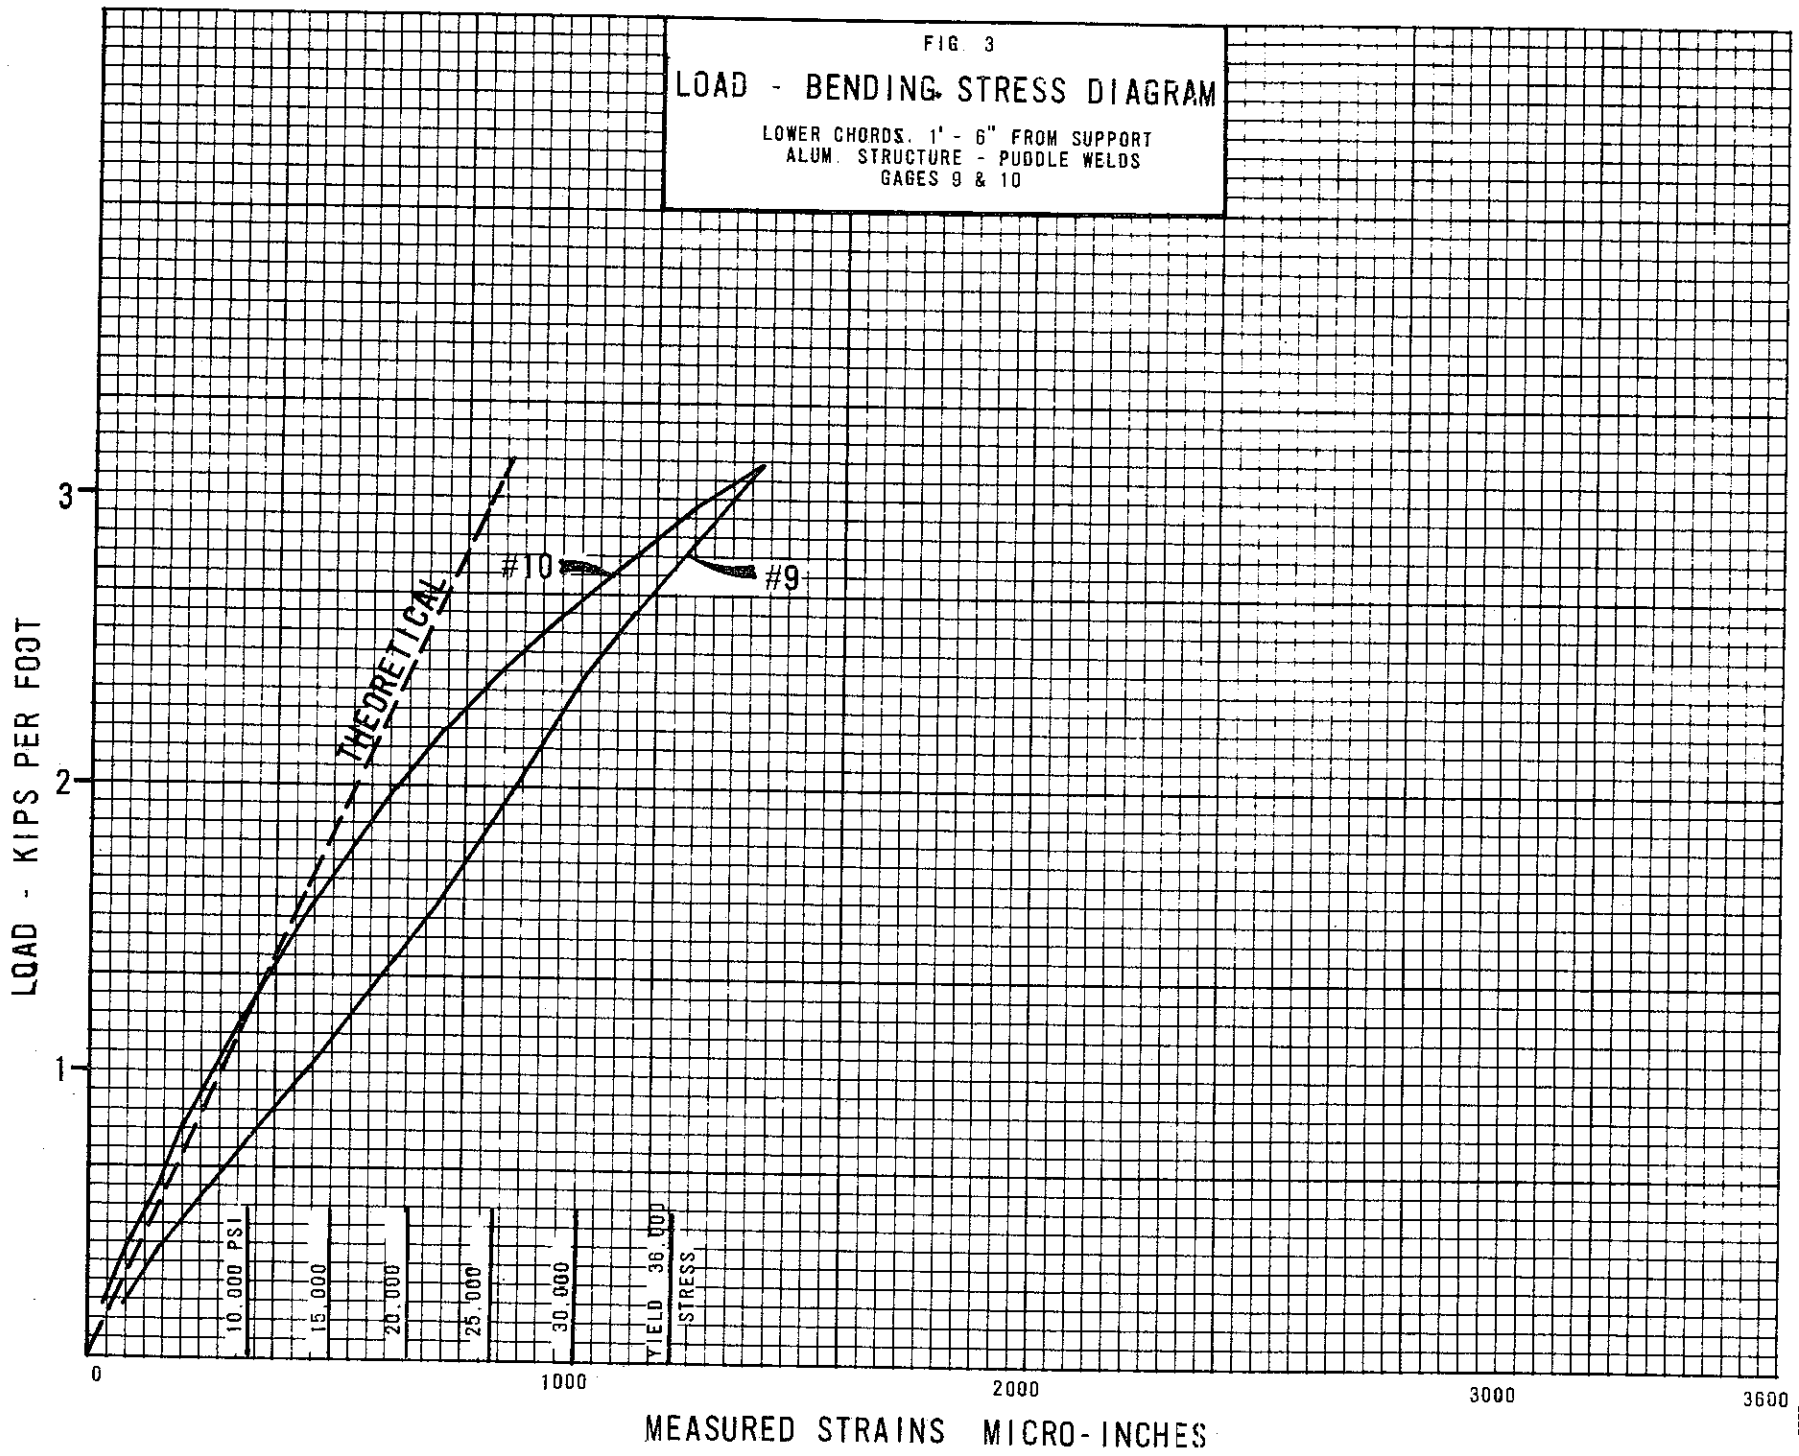
FIG. 3

LOAD - BENDING STRESS DIAGRAM

LOWER CHORDS, 1' - 6" FROM SUPPORT
ALUM. STRUCTURE - PUDDLE WELDS
GAGES 9 & 10

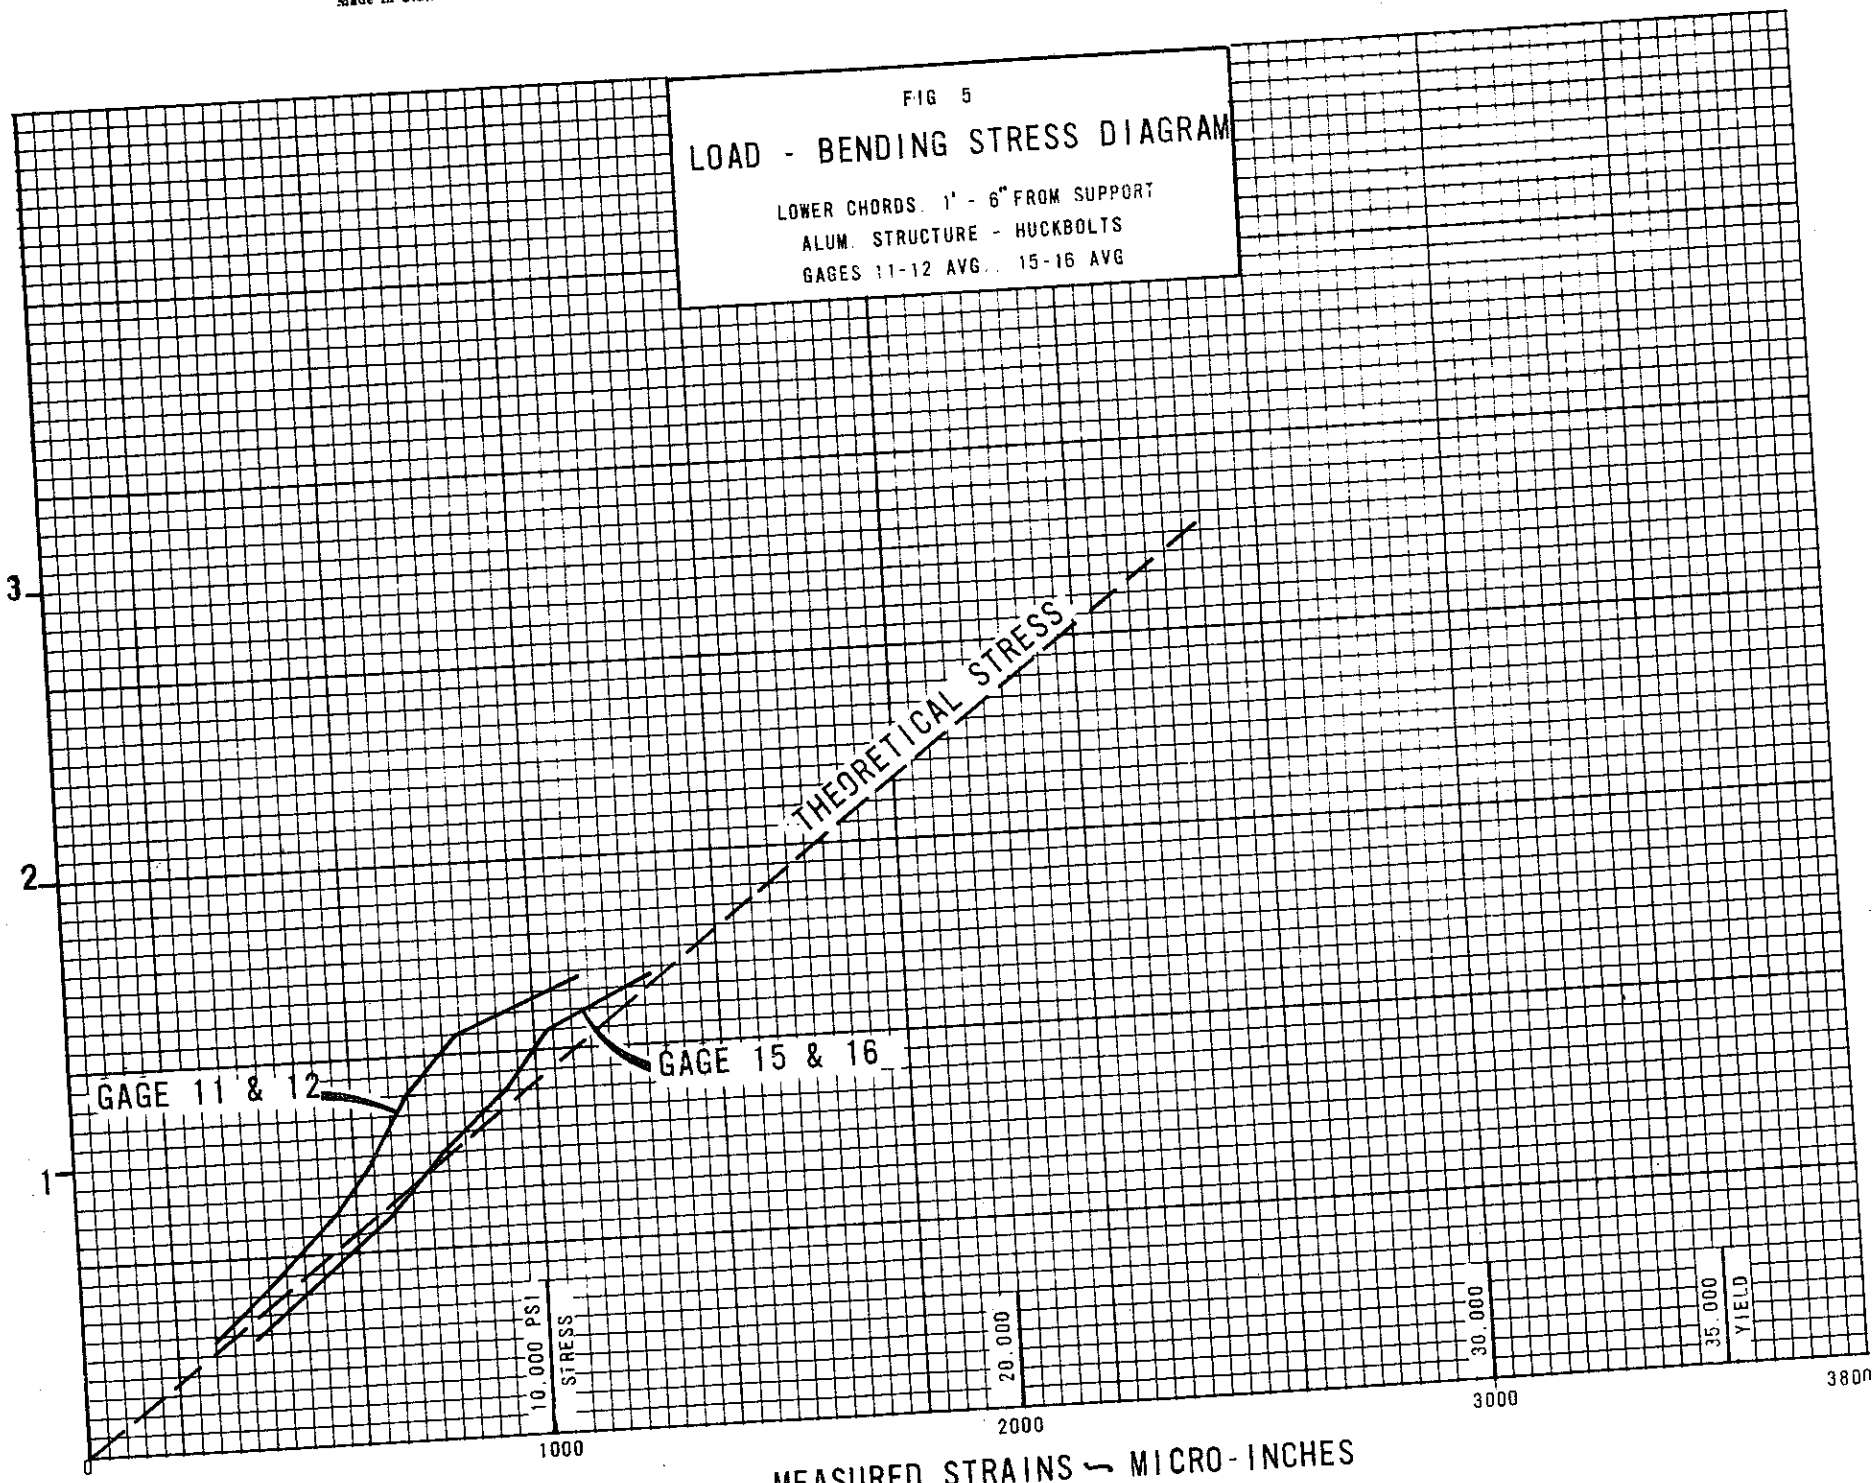
FIG 5

LOAD - BENDING STRESS DIAGRAM

LOWER CHORDS 1' - 6" FROM SUPPORT
ALUM. STRUCTURE - HUCKBOLTS
GAGES 11-12 AVG., 15-16 AVG

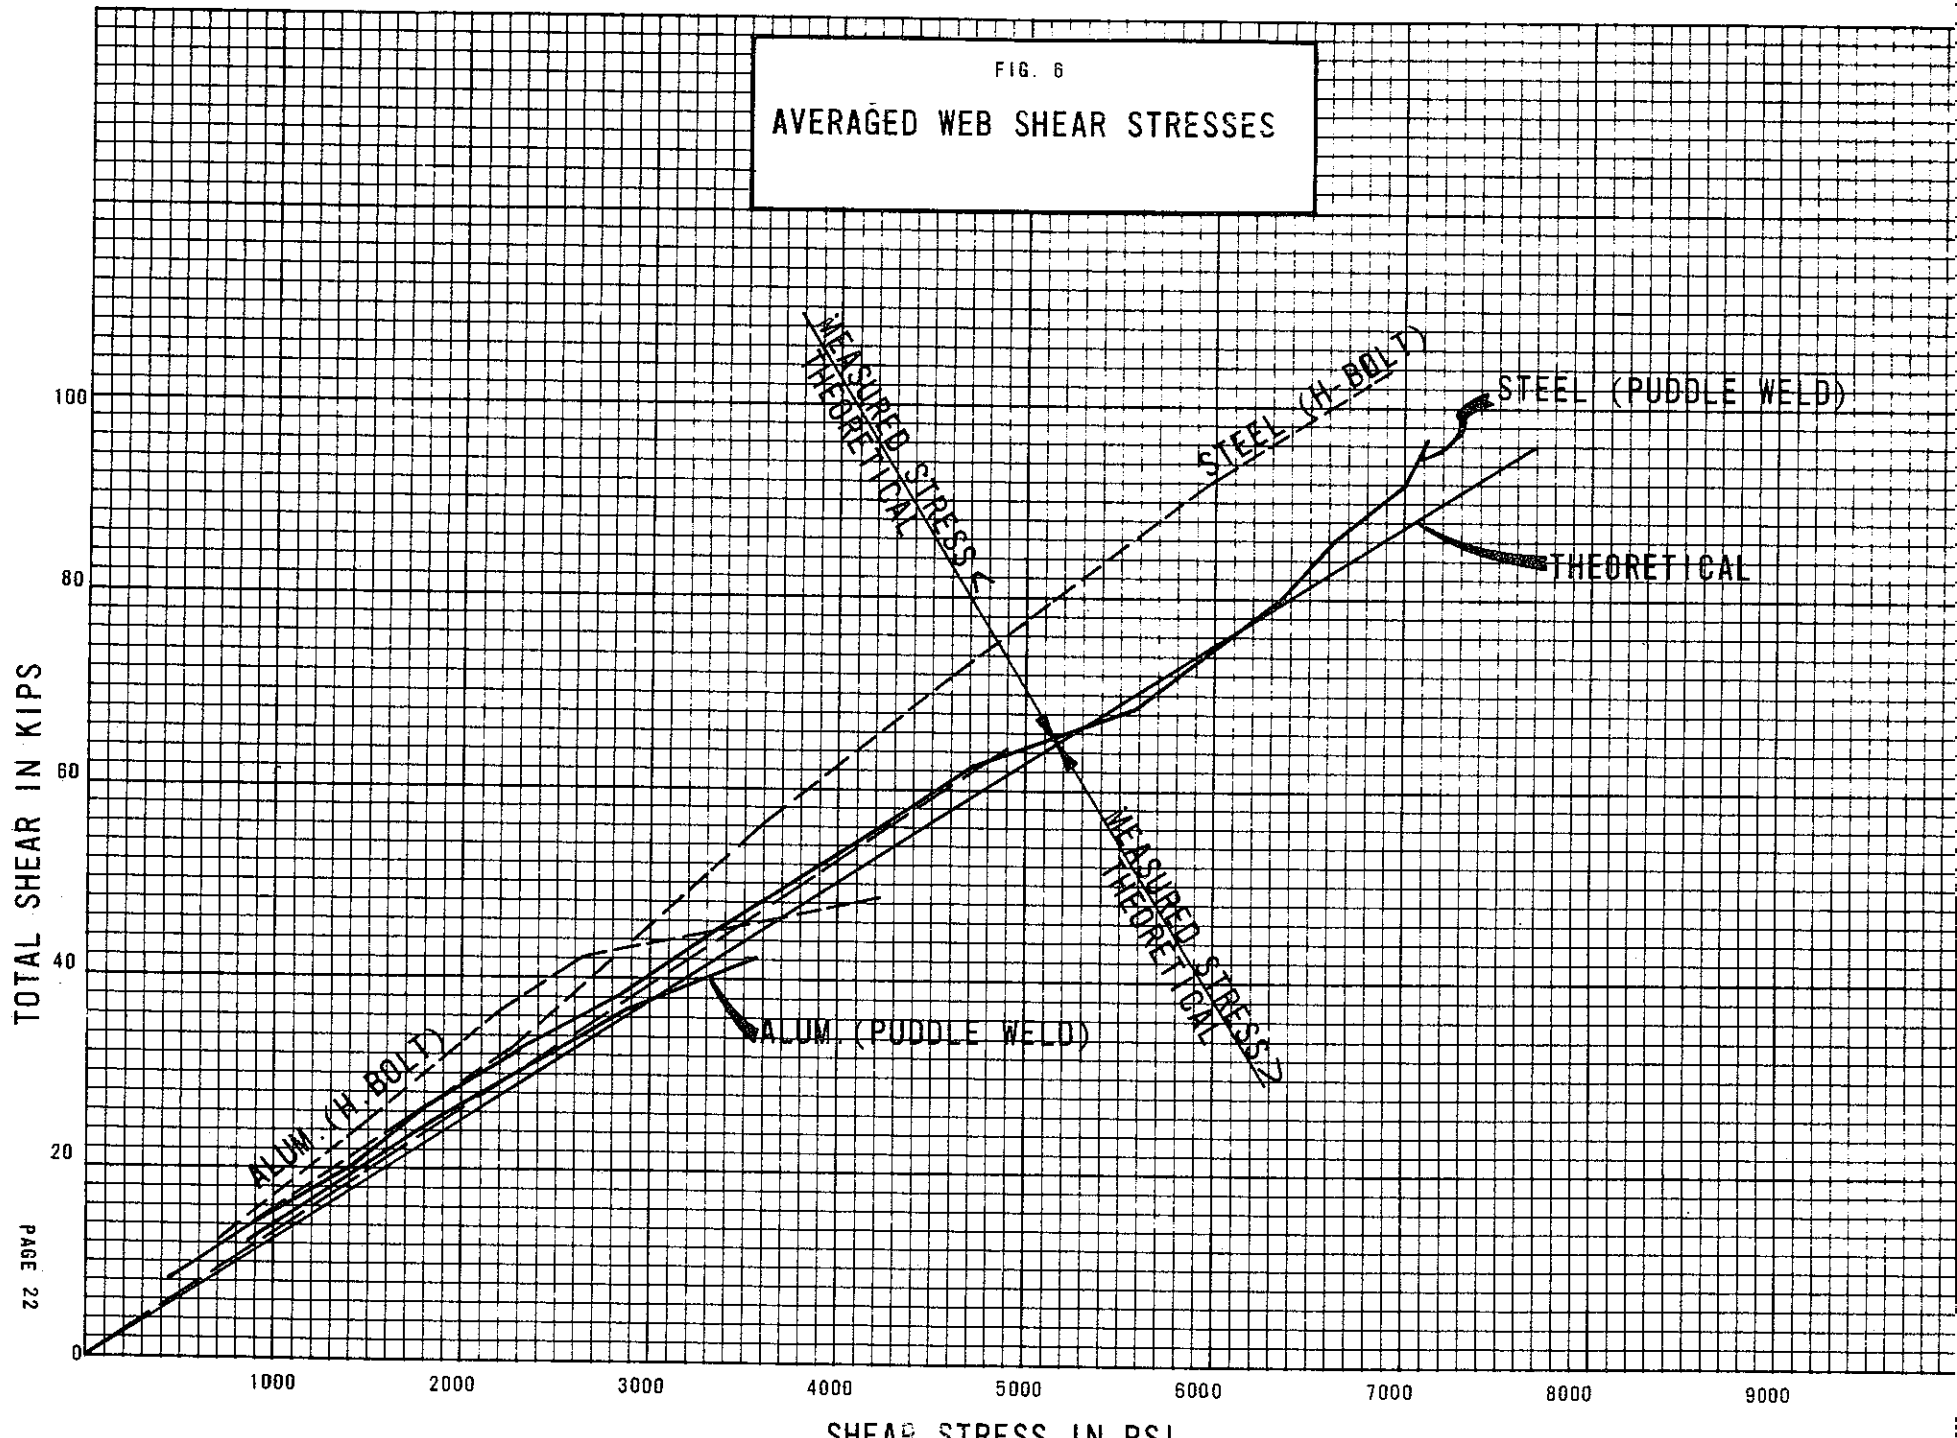
FIG. 6

Current AASHO practice uses shear divided by cross-sectional area for determining the design shear stress in a flat web plate. Although this criterion is not satisfactory for ribbed webs, figure 6, shows rather good correlation between calculated (V/A) and measured shear stress for the structure tested.

AVERAGED WEB SHEAR STRESSES

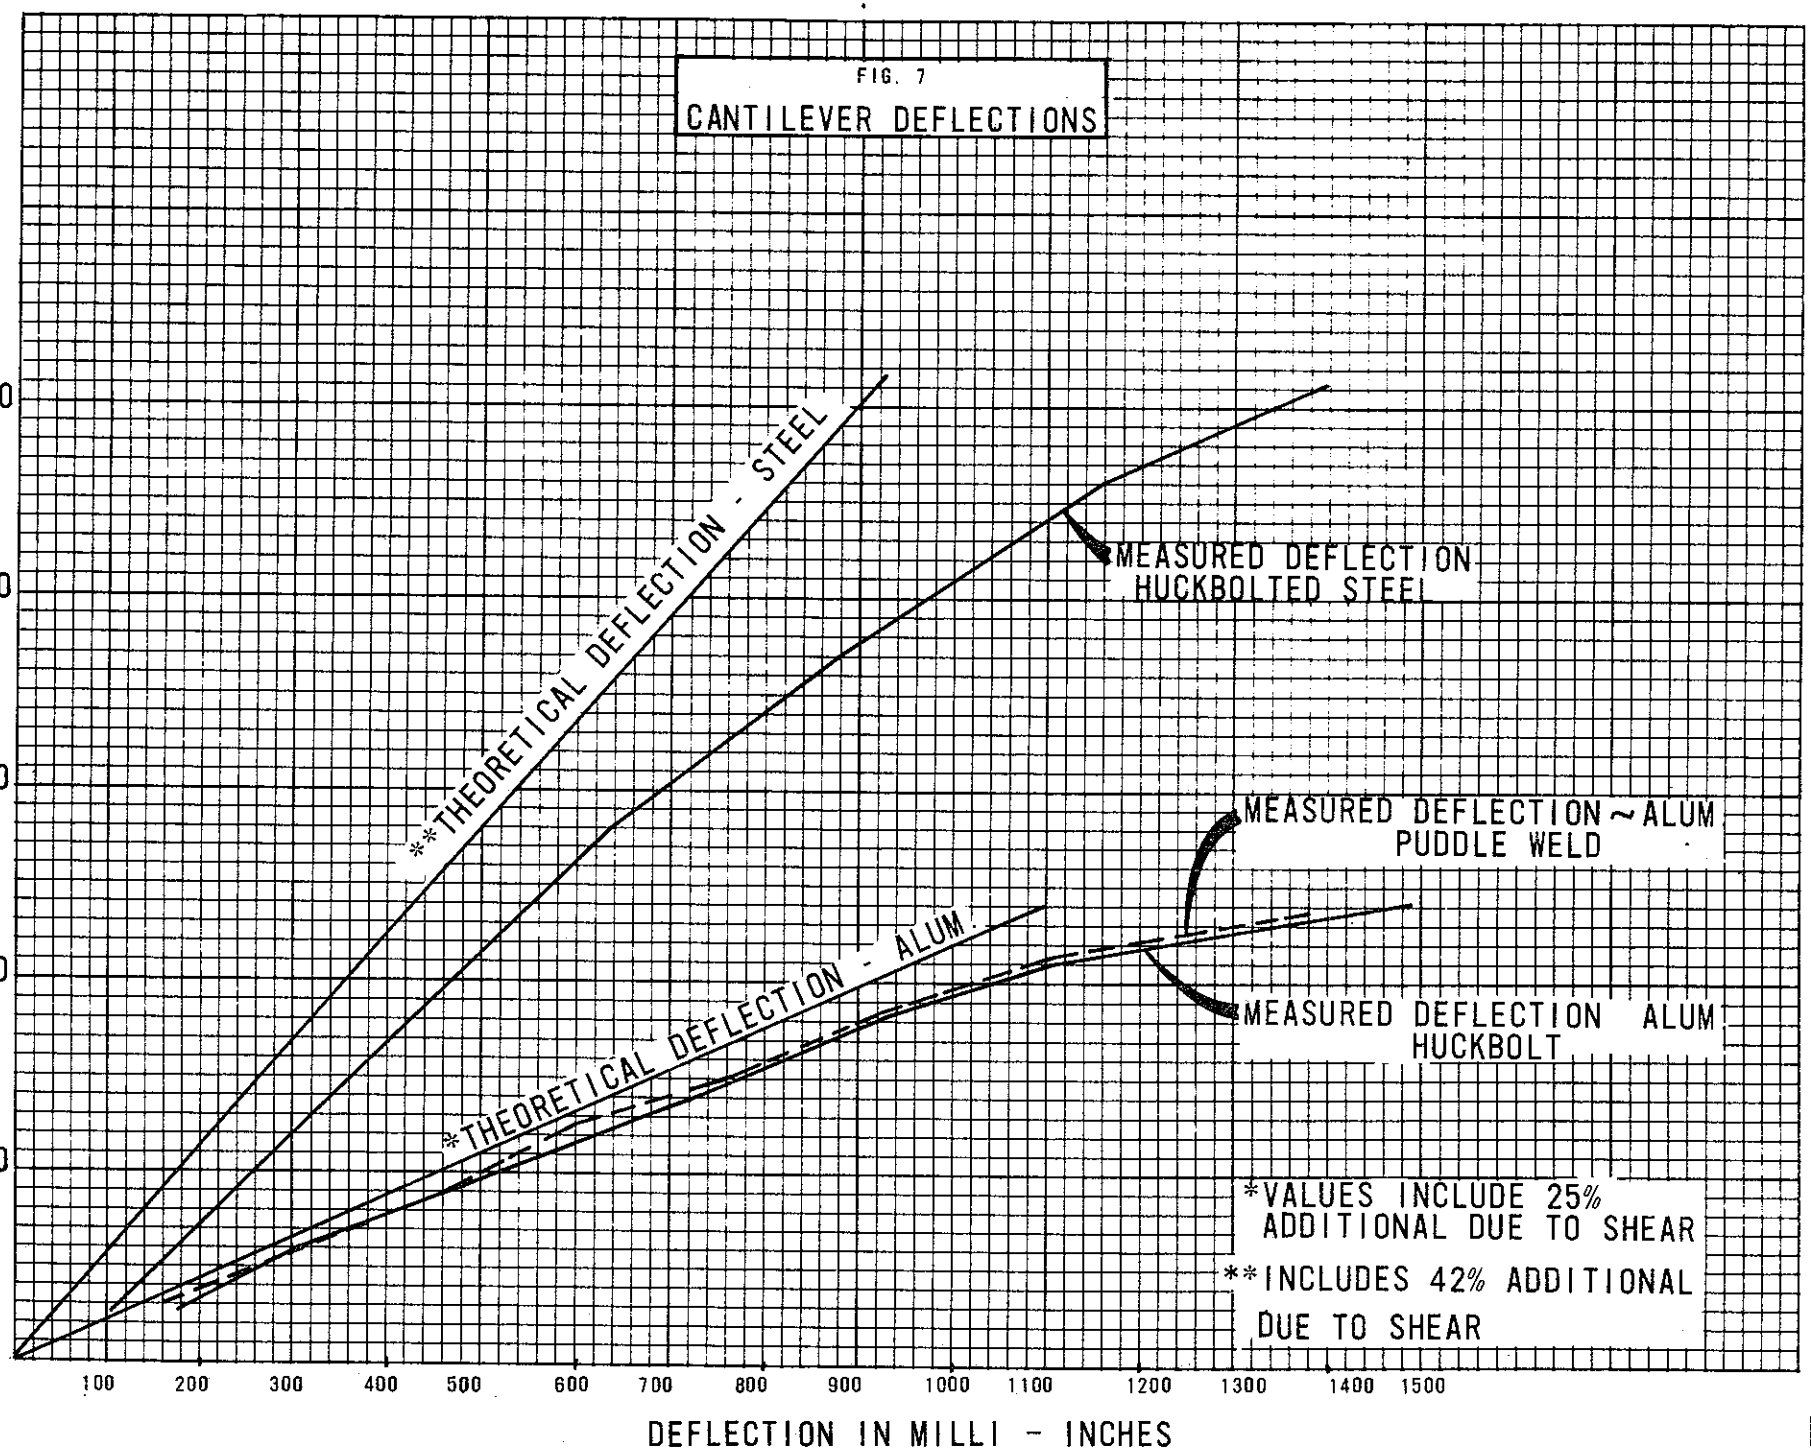
FIG. 7

3. Relative movement between chord-angles and shear web at connections. This was assumed negligible for purposes of calculation. However, it could have been significant in the Huckbolted structures and might help explain the variance of theoretical from actual deflection for the Huckbolted steel structure depicted on Figure 7.

CANTILEVER DEFLECTIONS

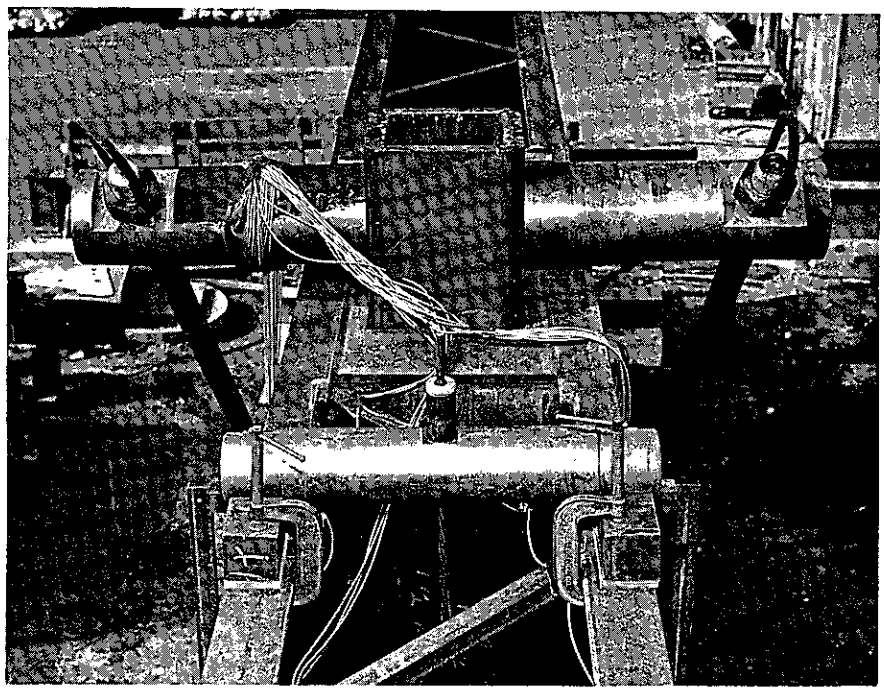
Figure 7

COLUMN TOP, UPPER BRACE CONNECTION AND ORIGINAL LOAD DISTRIBUTION MEMBERS

Originally, 3 in. x 3 in. x 12 in. bearing blocks were used in pairs to transmit testing loads from a 4½-in. diameter pin to the top flanges, as shown in Figure 7. However, the initial testing in October and November 1968 showed that significant local stress concentrations were being applied to the chord angles of the top flange and were inducing substantial outward buckling of the side webs even at low load levels. Consequently, the load distribution system was redesigned (see Figures 9 and 10 and Exhibit 2 in the Appendix). The number of bearing members was doubled, and the dimensions of the bearing surface per member was lengthened from 12-in. to 30-in. and narrowed from 3-in. to 1-in. The original bearing blocks were trimmed to a width of 2-in. and welded to the middle of 38-in. lengths of 5 I 10 bearing distribution beams. These in turn transmitted the load to the midpoint of 30-in. lengths of 14 B 17.2 bearing members by means of 2-in. x 3-in. pads of 1-in. thick layered fabric bearing material. The load was transmitted to the sign structure along the full 30-in. length of the 14 B 17.2 beam sections by 1-in. wide strips of 1-in. thick elastomeric bearing material. Figures 9 and 10 and Exhibit 2 in the Appendix show the arrangement of the members. Note that the 1-in. wide elastomeric bearing pads were located next to the outside edge of the chord angles. This placed the centerline of the load very close to the web-to-angle leg connection plane.

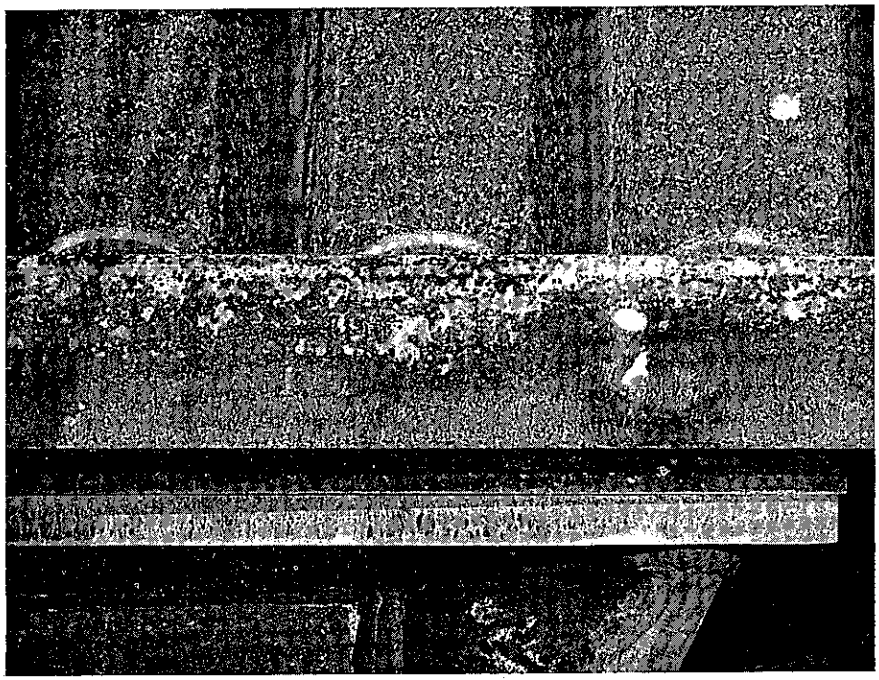
Figure 17

When the load was withdrawn, a slight warp remained in the angles. The web material, at the connections to the twisted angles, sustained permanent deformation in the form of stress rings. These rings occurred at the first 7 connections out from the center line on both web faces and are shown in Figure 17.

STRESS RINGS AT PLUG WELDS WHERE VERTICAL LEG OF CHORD ANGLE ROTATED OUTWARD ON STEEL STRUCTURE

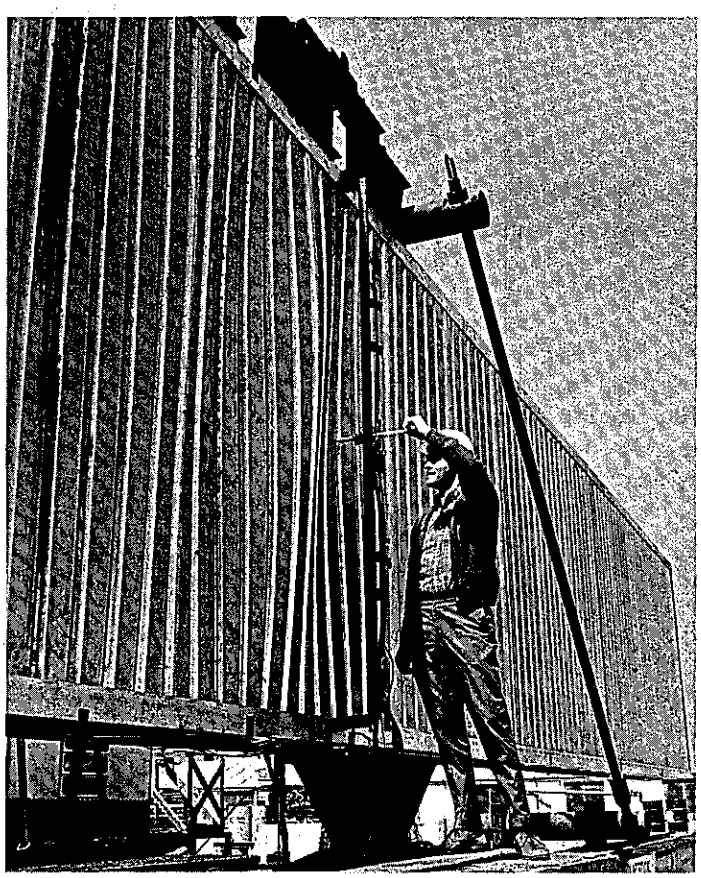
Figure 19

WEB DEFORMATIONS
OF PLUG WELDED END
ALUMINUM STRUCTURE
MAXIMUM LOAD PRIOR
TO FAILURE

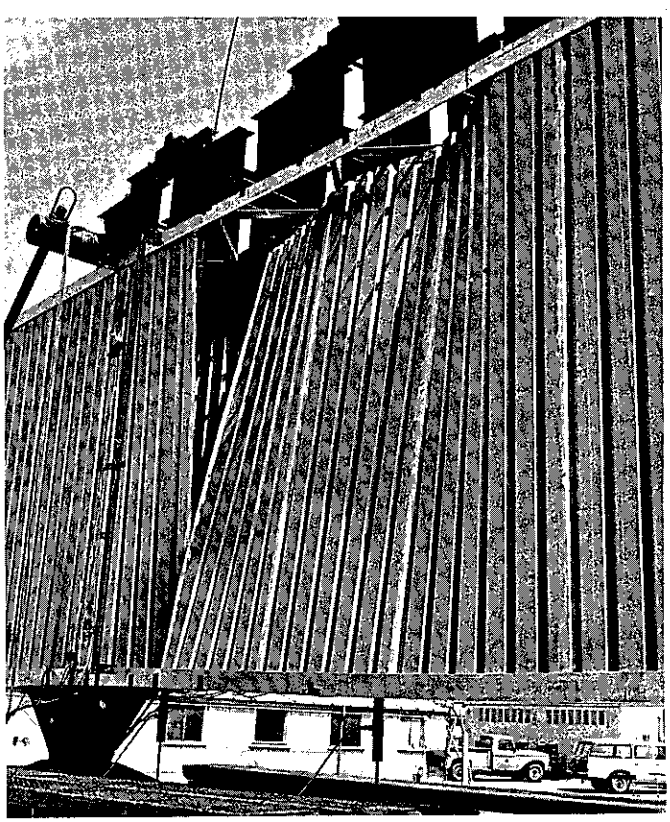
Figure 20

The plug welded portion of the aluminum structure was tested on May 13, 1969. Snapping and popping occurred more frequently as the load was increased. The web material on both sides of the post diaphragm bent inward and became more pronounced as loading increased. Vertical ripples in the web material were noticeable at a load of 0.8 kips per foot. The ripples grew to large slanted buckles which are shown in Figure 19. At a load of 1.7 kips per foot, a vertical welded web seam, located 4 ft from the centerline on one side of the sign structure, failed by cracking open 6 in. down the seam from the top of the web. The load was then released from the sign structure, which then appeared to sustain little permanent deformation. To reproduce the large buckles so that they might be photographed, the sign was again loaded to the same load level (1.7 kips per foot). The buckles regained their full depth of 2 in. (Figure 19); the tear in the web weld seam lengthened 2 in.; and a second seam 7 ft from centerline opened 4 in. down the seam at the top of the web. While holding a load of 1.7 kips per foot, the seam 4 ft from centerline failed completely, All of the plug welds connecting the top of the web to the upper chord angles failed between the failed vertical seam and a point 12 ft from centerline, and the welds connecting the bottom of the web to the lower chord angles failed from the failed vertical seam to a point 1.5 ft from the center. Intermittent weld separations occurred along the bottom flange from 4 ft to 11.5 ft from centerline. The sign deflected downward and twisted about its longitudinal axis. The sign, as it appeared after this failure, is shown in Figure 20.

WEB FASTENER AND SEAM FAILURE OF PLUG WELDED END OF ALUMINUM STRUCTURE

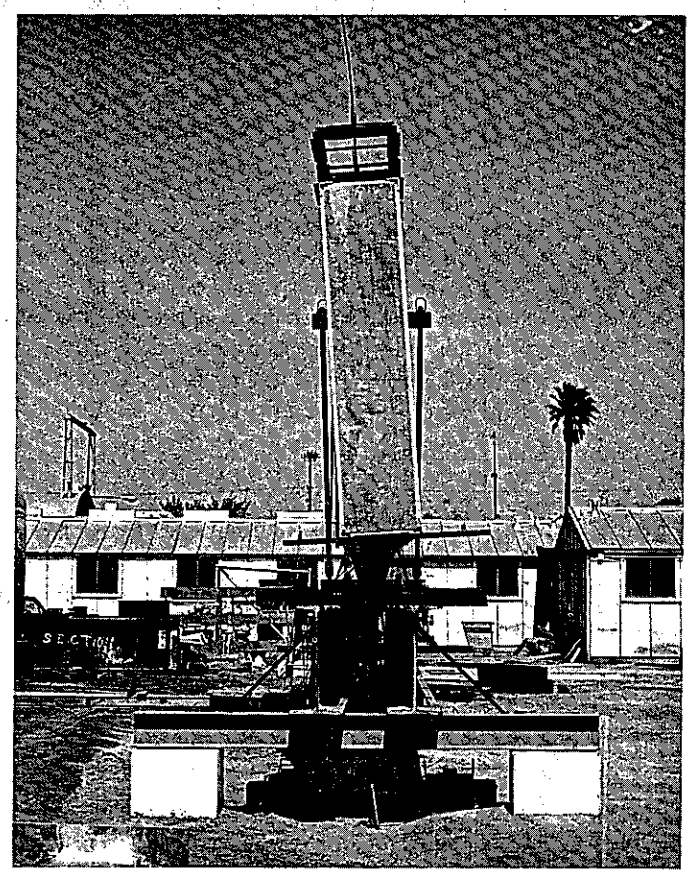
Figure 21

HUCKBOLTED END
OF ALUMINUM
STRUCTURE
AFTER TESTING

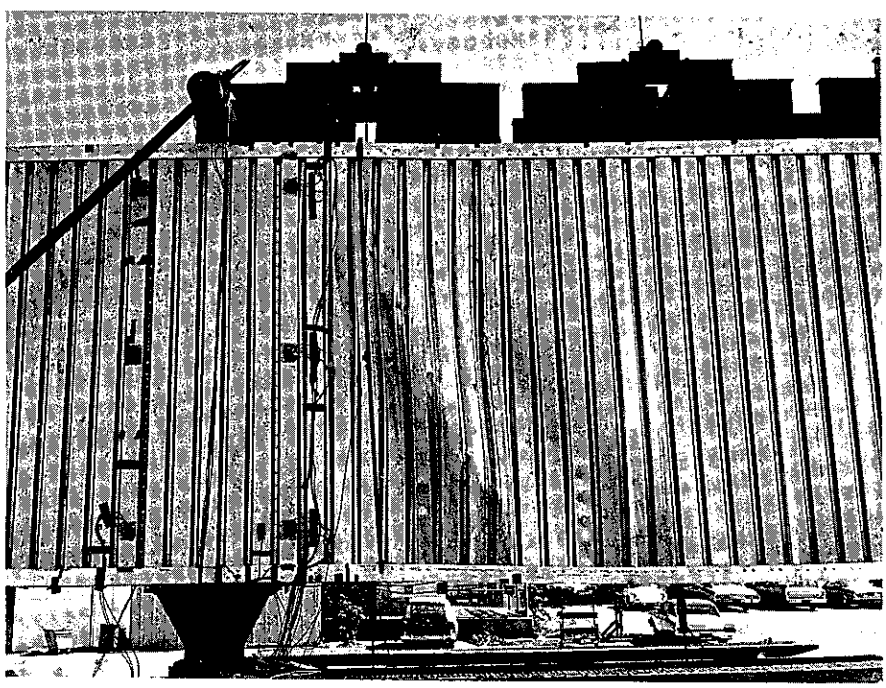
Figure 22

The Huckbolted half of the aluminum sign structure was tested on May 23, 1969. The sign was loaded to 1.2 kips per foot before any significant indications of distress were evident. Ripples then appeared in the web and grew into large buckles. At a load of 1.65 kips per foot, the load began to drop and the sign structure continued deflecting downward. The failure occurred quietly and gradually. The sign was then unloaded to determine the structure's ability to regain its original shape. One web sustained permanent deformation in the form of shallow buckles. The load was again applied, but only a magnitude of 1.35 kips per foot could be attained. The buckles on the failed side deepened, and the sign twisted further about its longitudinal axis as shown in Figure 21. The buckles consisted of two convex and two concave troughs as shown in Figure 22. The two major buckles in the middle were 6 in. deep and the other two were 3 in. deep, measured from a reference plane at the face of the chord angles.

FAILED SIDE OF HUCKBOLTED END OF ALUMINUM STRUCTURE
