4. TITLE AND SUBTITLE
Overhead Box Beam Sign

7. AUTHOR(S)
Pollock, T.L.

R & D No. 7-69

OVERHEAD BOX BEAM SIGN

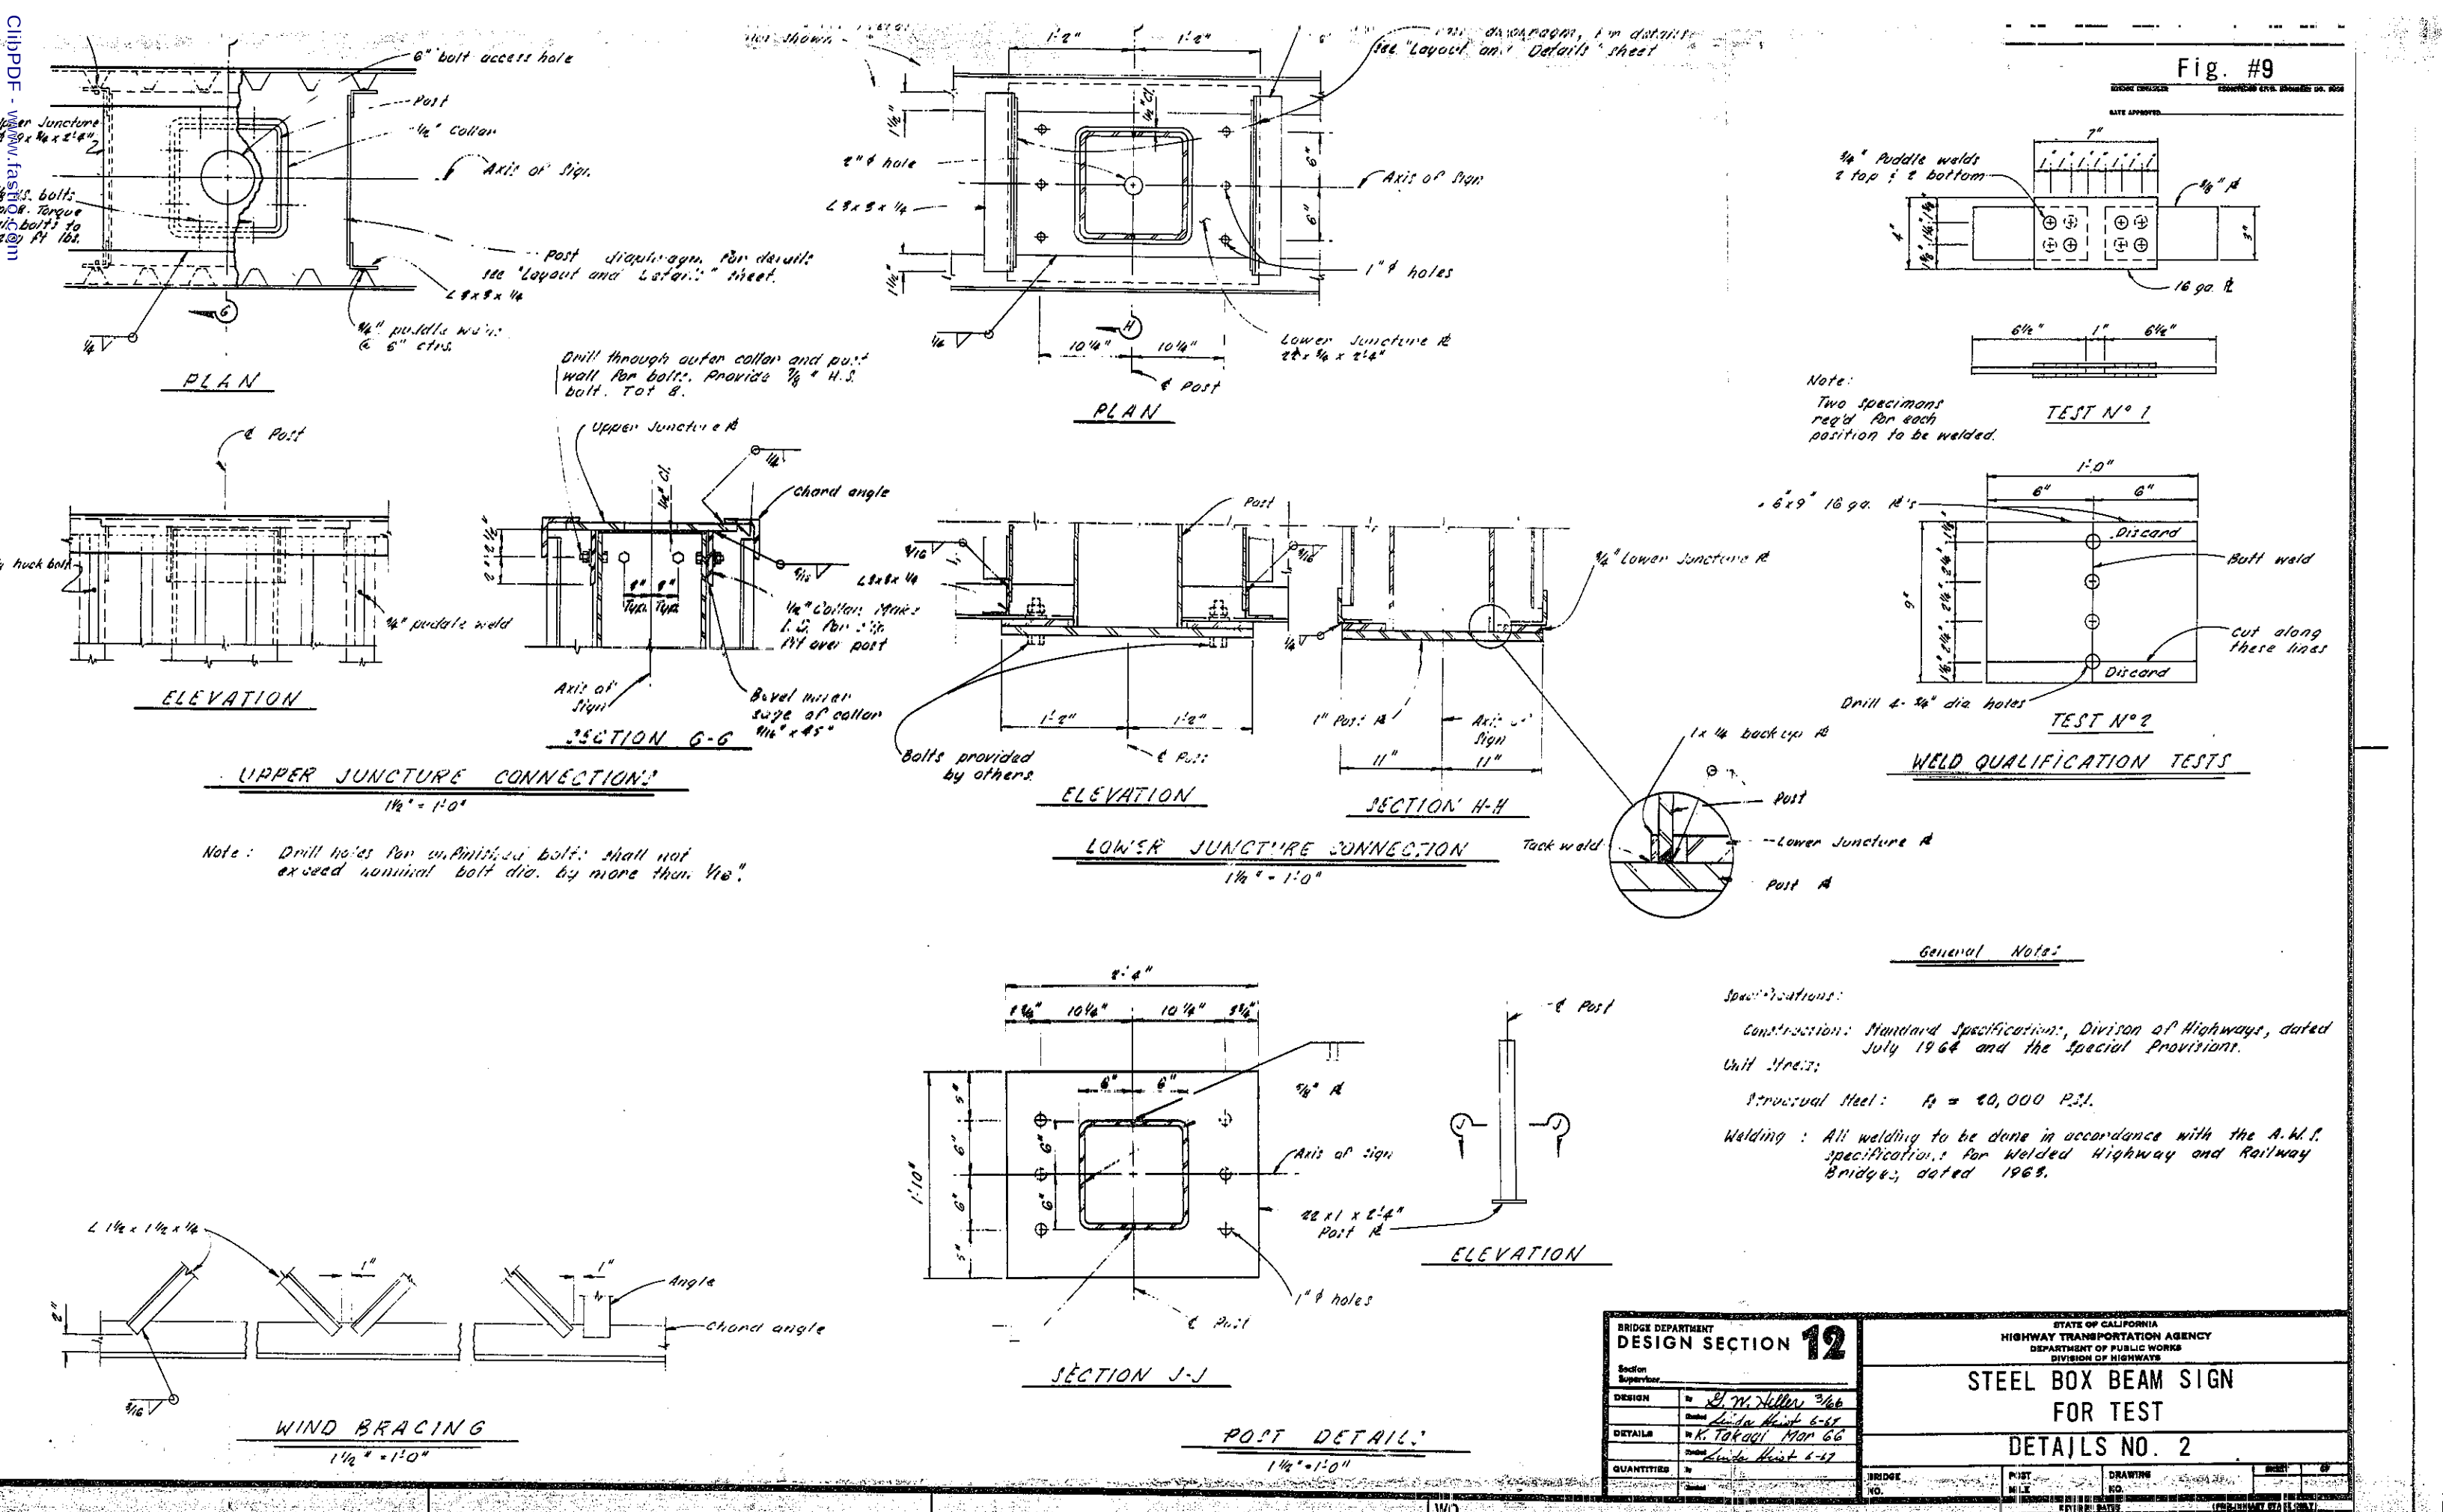
Fig. #9
6" bolt access hole
Post
1/2" Collar
Axis of Sign
Post diaphragm. For details see "Layout and Details" sheet.
L 3x3x1/4
3/4" puddle welds @ 6" ctrs.
PLAN
Drill through outer collar and post wall for bolts. Provide 7/8" H.S. bolt. Tot 8.
Upper Juncture PL
Chord angle
1/2" Collar. Make I.D. for slip fit over post
Axis of Sign
Bevel inner edge of collar 3/16" x 45°
SECTION G-G
ELEVATION
3/4" puddle weld
UPPER JUNCTURE CONNECTIONS
1 1/2" = 1'-0"
Note: Drill holes for unfinished bolts shall not exceed nominal bolt dia. by more than 1/16".
2" ϕ hole
1" ϕ holes
Lower Juncture PL
PLAN
Post
3/4" Lower Juncture PL
1" Post PL
Axis of Sign
Bolts provided by others
ELEVATION
SECTION H-H
LOWER JUNCTURE CONNECTION
1 1/2" = 1'-0"
1x1/4 back up PL
Tack weld
Post
Lower Juncture PL
Post PL
3/4" Puddle welds 2 top & 2 bottom
16 ga. PL
TEST N° 1
Note: Two specimens req'd for each position to be welded.
6"x9" 16 ga. PL's
Discard
Butt weld
Cut along these lines
