4. TITLE AND SUBTITLE
Dynamic Tests Of An Energy Absorbing Barrier Employing Water-Filled Cells

November 1970
M&R No. 636405-3
Final Report

DYNAMIC TESTS OF AN ENERGY ABSORBING BARRIER EMPLOYING WATER-FILLED CELLS

SERIES XXI

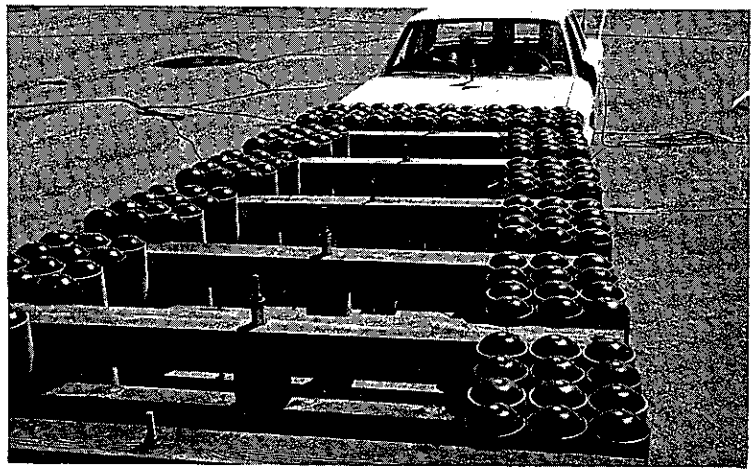
Figure 1

Barrier Description: The cells used in the barrier were plastic cylinders with a 6" outside diameter, 1/4" wall thickness, and 41" length. The tops of the cells contained several 3/4" diameter orifices. The test barrier contained ten cell-clusters of 12 cells each (see Exhibit 1). Cell-clusters were arranged in groups of two, one on each side of the barrier, and separated with timber diaphragms. A larger cell cluster, approximately 12 cells wide by 4 cells deep, formed the nose of the barrier. A total of 167 cells were used for the barrier. The barrier was 15 feet long and varied in width from 5'-6" at the nose to 8'-0" at the rear (see Figure 1, below).

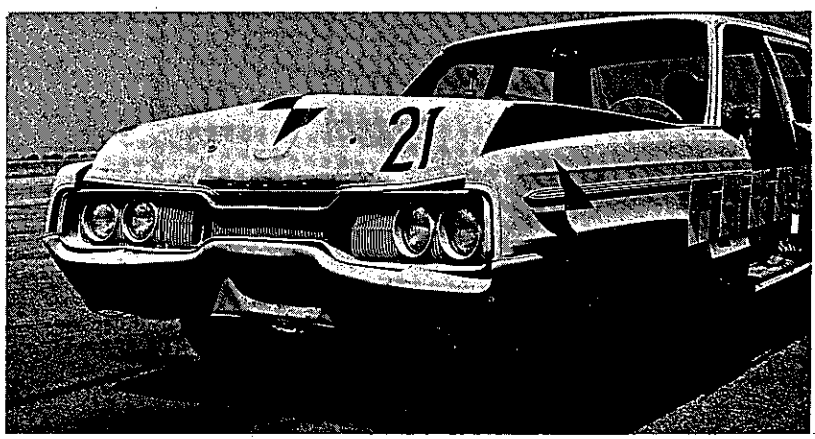
Figure 2

Results: See Plate 2 (page 14) for a summary of the test results. A 4680 lb. Dodge impacted the test barrier headon at a speed of 33.3 mph. The test vehicle did not stop quite as smoothly as it did for Test 211. Vehicle rise was 4-1/2 inches. Damage to the vehicle was moderate and included deformation of the grill, front bumper, and front of the hood (see Figure 2, below). The exhaust manifold was broken near its attachment to the engine block and the radiator was forced back into the V-belt lower pulley. The post behind the front door (removed for the test) on the drivers side failed at its connection with the roof (see Figure 3, below). The permanent deformation of the steering wheel was 2" (see Figure 4, below).

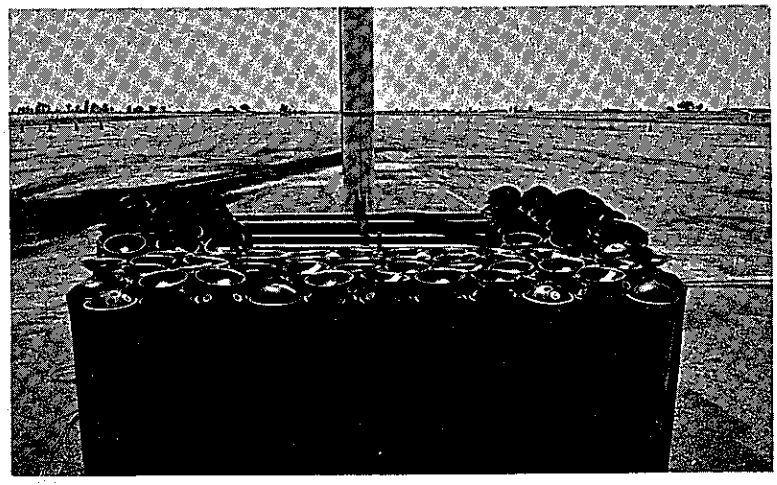
Figure 5

Only minor damage was sustained by the barrier (see Figure 5, below). Four evaporation caps were blown off water cells in the nose cluster and some crosby clips on the guide cable were jammed against the cable guide in diaphragm No. 5. The concrete backstop was shifted back one inch. Maximum vehicular displacement of the barrier was 8'-4"; the post impact location of the leading edge of the barrier was 6'-6" behind its pre-impact position. A total of 2250 lbs. of water was expelled from the cells.

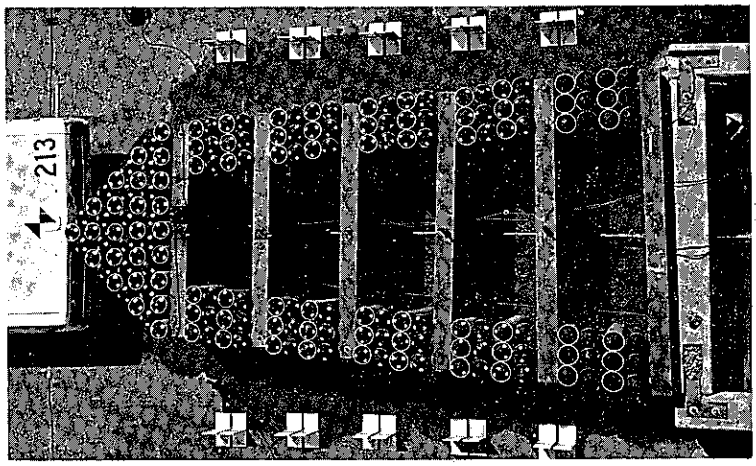
Figure 6

Barrier Description: The test barrier used was identical to that used for Test 211 and 212 with the following exceptions: (1) a triangular shaped cell-cluster was used on the nose of the barrier; (2) the back row in this cluster had alternate full and empty cells; (3) some cells had water in their upper portion only; (4) overall barrier length was increased to 16'-3"; (5) evaporation caps were removed from all the cells in the barrier; and (6) the number of orifices in some of the rear cells was increased (see Figure 6, below). The total number of cells in the barrier was 165. See Exhibit 3 for additional details of the test barrier.

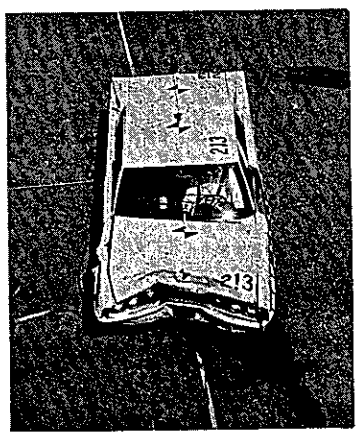
Figure 7

Results: See Plate 3 (page 18) for a summary of the test results. A 4600 lb. Dodge impacted the test barrier headon at a speed of 48.2 mph. During impact, the vehicle rode up on the barrier nose. Vehicle rise was 11 inches. The vehicle fan and radiator were jammed up against the engine block. There was severe damage sustained by the grill, front bumper, and front of the hood of the test vehicle (see Figure 7, below). The body of the vehicle was deformed over the door post and in front of the front door hinges on both sides, indicating a severe buckling failure of the vehicle chassis (see Figure 8, below). There was severe buckling of the right front fender

and minor buckling of the left front fender. There was moderate buckling of the floor board in the rear of the passenger compartment. The impact force of the dummy, restrained by both a lap belt and single diagonal shoulder harness, caused a 2-1/2 inch permanent deformation in the steering wheel. The driver's seat came loose on its guides although the guides remained firmly attached to the floorboard. There was some fraying of the shoulder harness near its connection to the lap belt. The vehicle was considered a total loss.

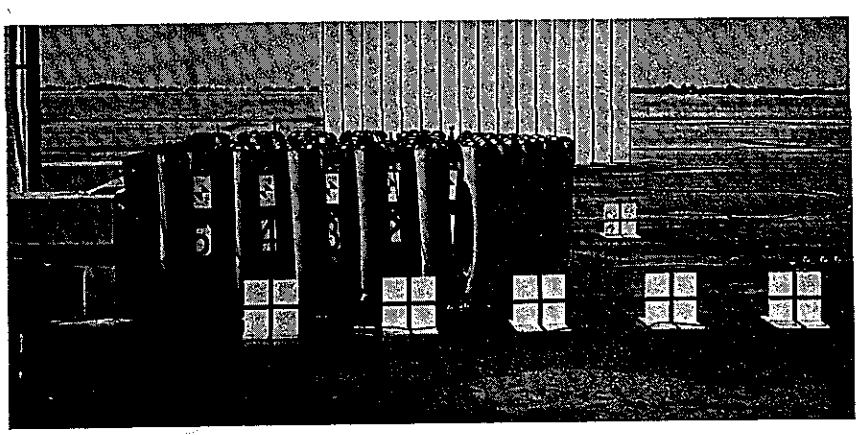
Figure 9

Barrier damage consisted of 26 orifice plugs ejected, a deformed "through" bolt at the left end of Diaphragm No. 6, splitting of the left end of the middle 6" x 6" timber on Diaphragm No. 6, and one broken pressure transducer (see Figure 9, below). Maximum vehicular displacement of the barrier was 12'-5". The post impact position of the leading edge of the barrier was 6'-2" behind its pre-impact location.

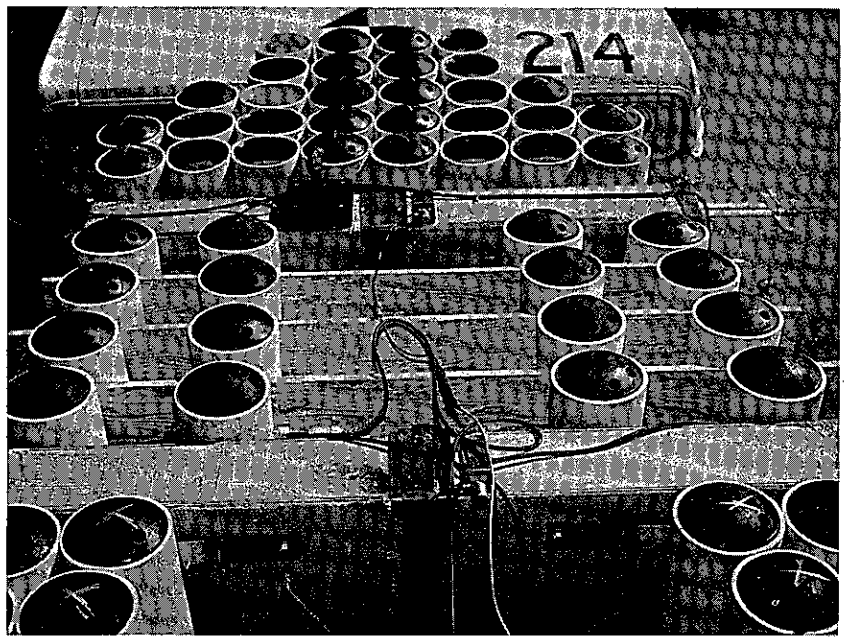
Figure 10

Barrier Description: Additional barrier modifications were made due to the severity of the impact in Test 213. The first three diaphragms were replaced with fiberglass coated plywood hollow core structures. Honeycomb paper was placed in the core to obtain a more rigid structure. A significant weight reduction (28%) in the first three diaphragms was thus realized while maintaining approximately the same rigidity. Another significant change was the use of a "sandwich" arrangement of cells and 5/8" plywood panels between Diaphragm Nos. 1 and 2 (see Figure 10, below). This arrangement was used to further decrease the mass of the barrier nose and to obtain better efficiency from the water cells placed between the leading diaphragms. The water in the nose cells was centered at the cell mid-height. The water in all the other cells was in the top portion. There was a total of 150 cells in the barrier, many of which did not contain water. See Exhibit 3 for additional barrier details.

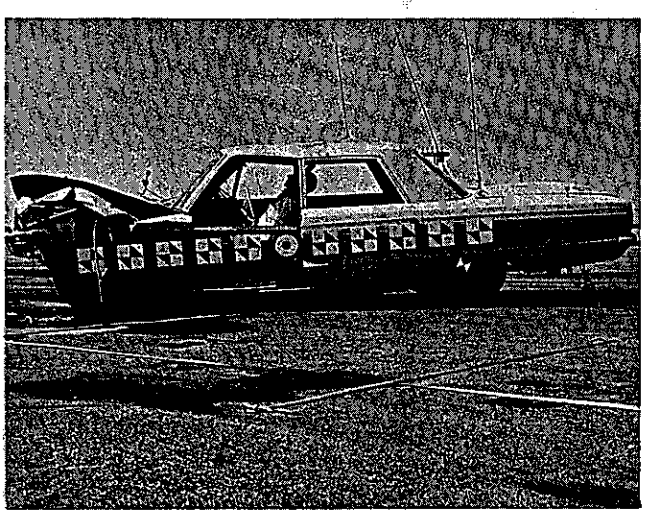
Figure 11

The following vehicular damage was sustained. The fan and radiator were jammed up against the front of the engine block, which appeared to be displaced slightly to the rear. There was severe damage to the grill, front bumper, and front of the hood of the test vehicle. The body of the vehicle buckled over the door posts and in front of the front door hinges on both sides, indicating severe buckling of the vehicle chassis. There was severe buckling of the left front fender and minor buckling of the right front fender. Maximum deformation of the front of the vehicle was 2 ft. (see Figure 11, below). There was some displacement of the dashboard into the passenger compartment and 4-1/2 inches of steering column projection into the passenger compartment. The impact force of the dummy caused a 3-3/4 inch permanent deformation in the steering wheel (see Figure 12, below). Stitching of the diagonal shoulder harness frayed near the connection of the shoulder harness to the lap belt.

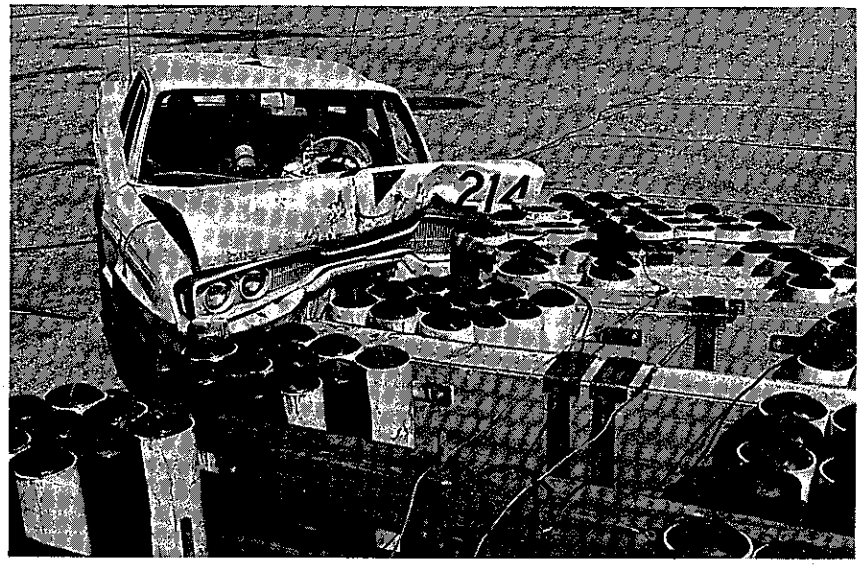
Figure 13

The barrier was twisted such that the center of the nose was displaced 3 ft. back and 2 ft. to the right of its original position (see Figure 13, below). Barrier damage consisted of separation between four pairs of cells, bending and crushing failures of Diaphragm Nos. 1, 2, and 3, splitting of spacer blocks in Diaphragms 4 and 5, failure of the legs of all three 5/8 inch plywood panels,

and failure of all the components of the "rigid" backstop. The most significant failure was of the center cable attachment to its front anchor. Slipping of the "dead" end of the cable through the cable clips was the cause of failure. Although the number and spacing of the clips was less than the industry's recommendations (due to the proximity of the barrier nose with the anchor), this same system sustained over 6000 lbs. of tensile load during Test 213. This cable failure did significantly alter the barrier performance after cable slip occurred. Also, the turnbuckle strain gage data indicates that the 4000 lb. cable preload was, for some unexplained reason, lost prior to impact. This also altered the barrier's resistance to upward movement.

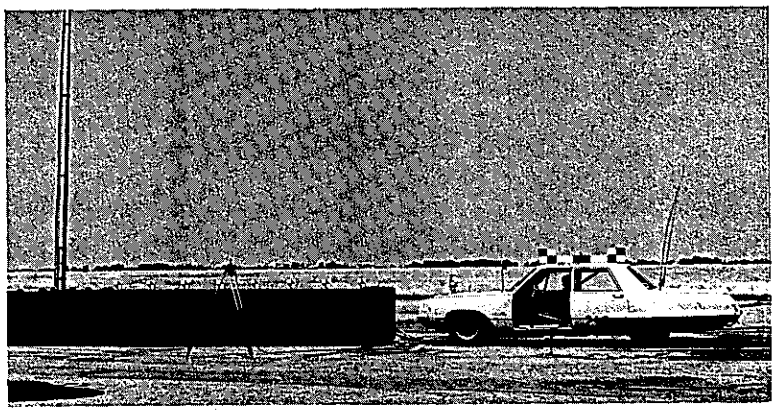
Figure 14

Barrier Description: A completely new barrier was built for Test 215 (see Exhibit 6). Overall dimensions of the barrier were a 19'-6" length, a 3'-0" width at the nose, and a 7'-0" width at the back of the barrier (see Figure 14, below). The basic module of the barrier consisted of four rows of cartridges separated by 1-1/2 inch fiberglass coated plywood diaphragms; there were eight modules in the barrier plus a cluster of cells (containing cartridges) at the nose. Between diaphragms, each row of cartridges was separated by an interior panel of 1/2 inch duraply plywood. There were three to five water-filled cartridges in each row (see Figure 15, below). Along the sides of the barrier, fender panels of 1-1/4 inch fiberglassed plywood were hinged to each diaphragm at the noseward side of the panel (see Figure 16, below). The length of these fender panels was such that they overlapped. Thus, backward movement (compression) of the barrier was not hindered. The fender panels were attached with springs to the next rearward diaphragm. Fiberglassing was used to provide not only additional strength but also a low friction surface between the fender panels and the impacting vehicle. These fender panels were developed for the purpose of redirecting vehicles that impacted the side of the barrier rather than permitting pocketing into the barrier.

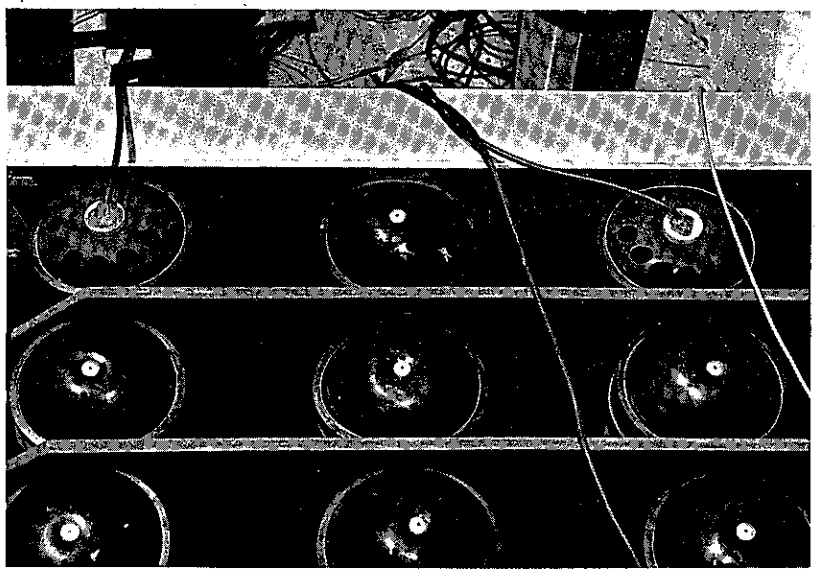
Figure 17

cartridges were slipped through 1/4 inch thick vinyl supporting rings which were fastened to the interior panels or diaphragms. The water-filled cells used in the nose of the barrier (18 total) were six inches in diameter, 41 inches long, and contained 1/4 inch thick vinyl walls. These cells were the same type as those used for tests 211-214 and they rested on the ground. All the cartridges, with the exception of those containing the pressure transducers, had solid vinyl evaporation caps permanently attached with aluminum pop rivets (see Figure 17, below). All the cartridges were filled with water but only six of the 18 nose cells contained water.

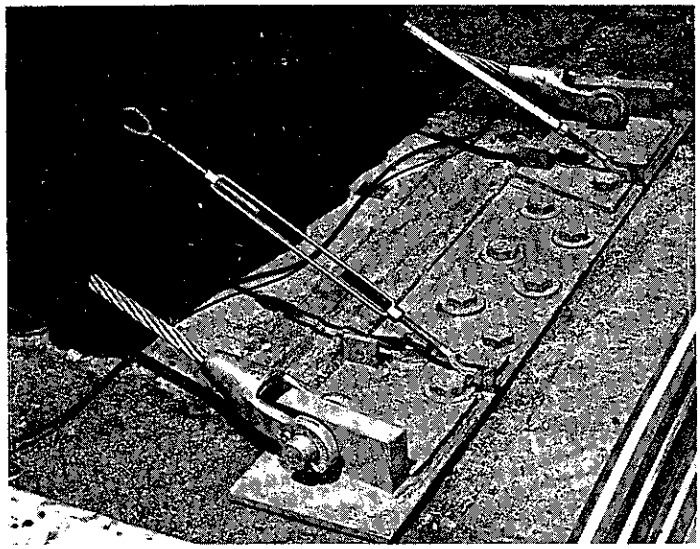
Figure 19

been compressed due to an impact, 3/8 inch wire ropes were used to stretch out the barrier and reposition it. These wire ropes were attached to the upper and lower corners of each end of each diaphragm (see Figure 19, below).

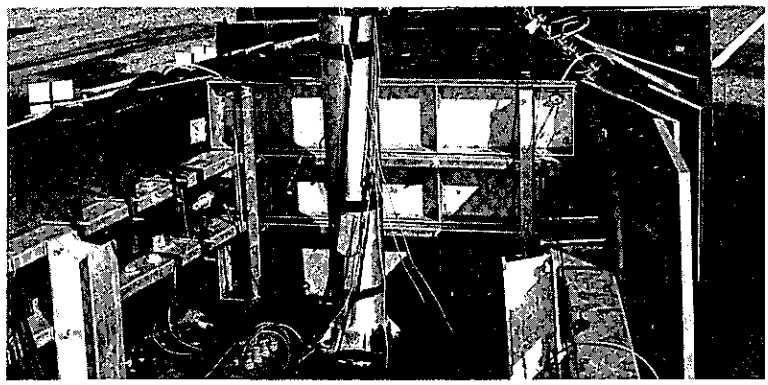
Figure 20

The test barrier required a rigid backup structure. For Tests 215 through 218, a bridge approach guardrail nose structure typical of a gore installation was used (see Exhibit 7). In addition, a fabricated steel plate backup panel was attached to the nose of the bridge rail to provide a large bearing area for the barrier during impact (see Figure 20, below).

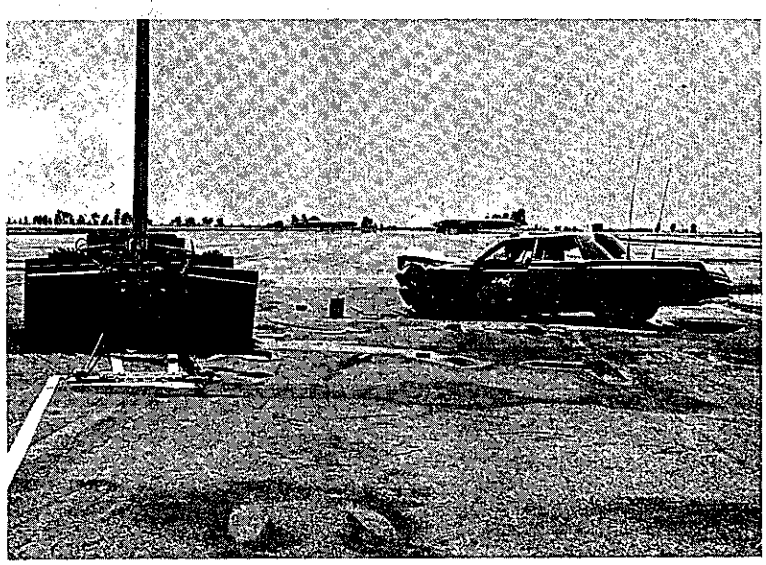
Figure 21

Results: See Plate 6, page 31, for a summary of the test results. A 1968 Dodge impacted the barrier headon at a speed of 57.5 mph. As rearward displacement of the barrier began, the fender panels rotated downward such that their lower rear corners penetrated into the asphalt concrete runway and restricted backward movement of the barrier. This, plus an 18 inch vehicle offset at impact, resulted in a lifting, rolling motion being imparted to the test vehicle. The vehicle traversed a 360° roll off to the right side of the barrier and came to rest several feet behind and to the right of the barrier (see Figure 21, below). Front end crush varied from 0 to 20 inches; maximum crush was on the left side (see Exhibit 8). The top caved in, the windshield was broken, the left rear wheel was bent, the left rear door jammed, and there were scrapes over much of the surface of the vehicle. However, off-center impacts on any barrier nose may inherently cause this type of vehicle instability due to the unsymetrical rise of the vehicle forestructure. There was no measurable deflection of the collapsible steering column.

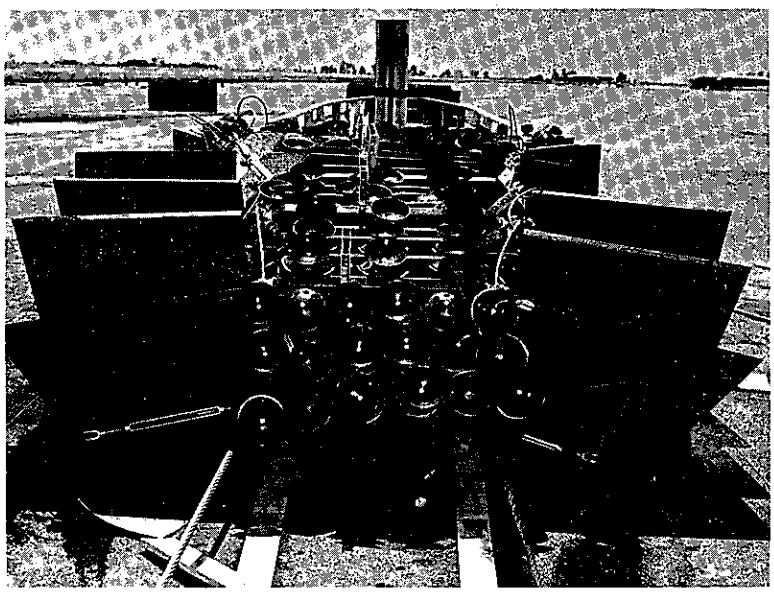
Figure 22

The barrier remained intact; however, some damage was sustained (see Figure 22, below). Many of the fender panels were scarred and most were damaged on the rear bottom corners where they were thrust into the ground as the barrier was compressed (see Figure 23, below). The edges of several diaphragms were broken or showed delamination of the plywood; hinges between fender panels and diaphragms were bent or broken in several locations. Damage was less severe towards the rear portion of the barrier. Interior panels were undamaged behind the void module (third section back of the nose). There was no damage to the steel backup structure. Barrier displacement was 9.3 feet.

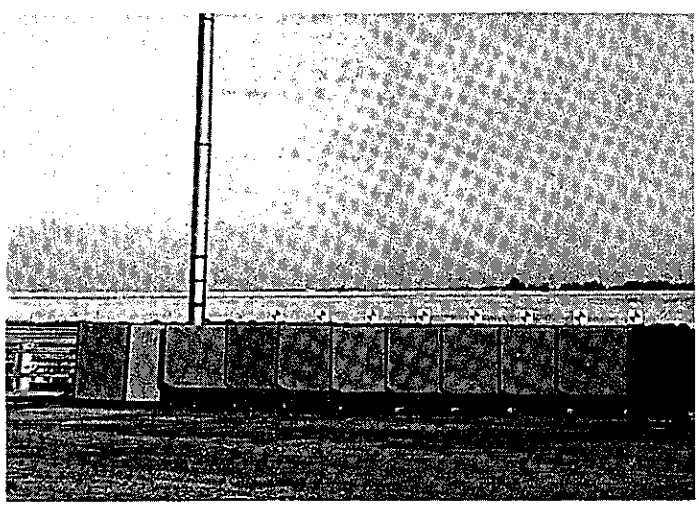
Figure 24

Barrier Description: Modifications to the barrier used for Test 215 included cutting off the lower six inches of all the fender panels and cutting the lower rear corner of the panels on a diagonal to eliminate penetration of these trailing corners into the runway as occurred during Test 215 (see Figures 24 and 25, below). Also, metallic shoes (or skids) were added to the lower edge of interior panels, heavier hinges were used to attach the fender panels to the diaphragms, and all the evaporation flaps were removed to lessen, at least to some extent, the lateral discharge of the water and danger of loss of telemetry signal.

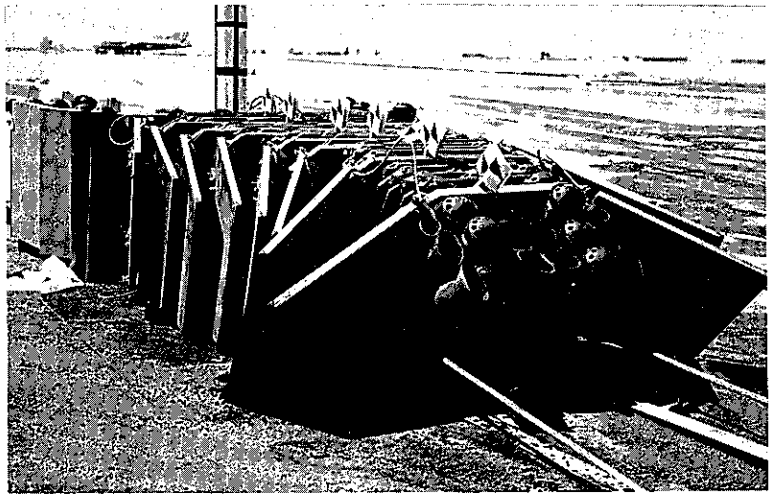
Figure 27

No barrier components were dislodged. Fender panels on the left side of the first three modules were scarred. Bottoms and/or top inserts were blown out of 16 water cells. The shear pins on the front secondary cables were sheared off. The barrier as a whole was translated straight back with negligible lateral movement or "buckling". Maximum vehicular displacement of the barrier was 16.3 feet but the permanent displacement of the barrier nose was only 10.7 feet (see Figure 27, below).

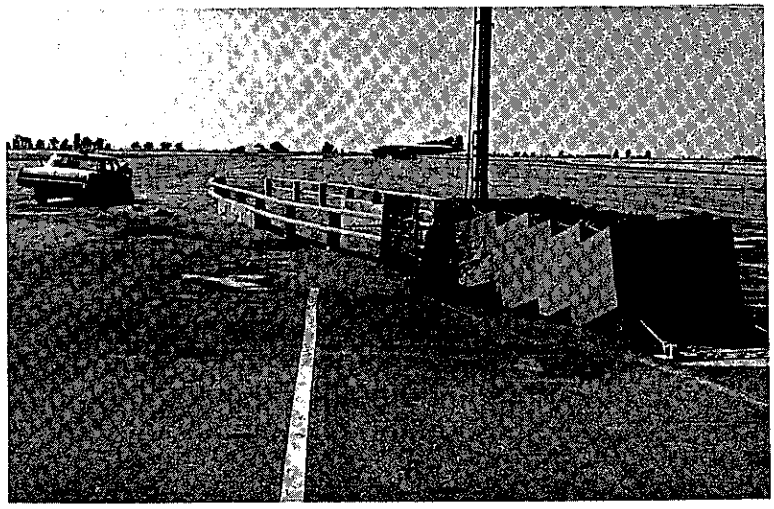
Figure 29

Several fender panels were torn off the barrier on the left side, mainly due to hinge failures. Two panels were thrown 8'-0" beyond the final position of the car and two panels were lodged in the crushed front end of the car. The five cells on the left side

of the bridge approach guardrail were all torn off and scattered along the path of the car. Shear pins in the secondary cables sheared off. Permanent displacement of the barrier nose was 1.5 feet (see Figures 29 and 30, below).

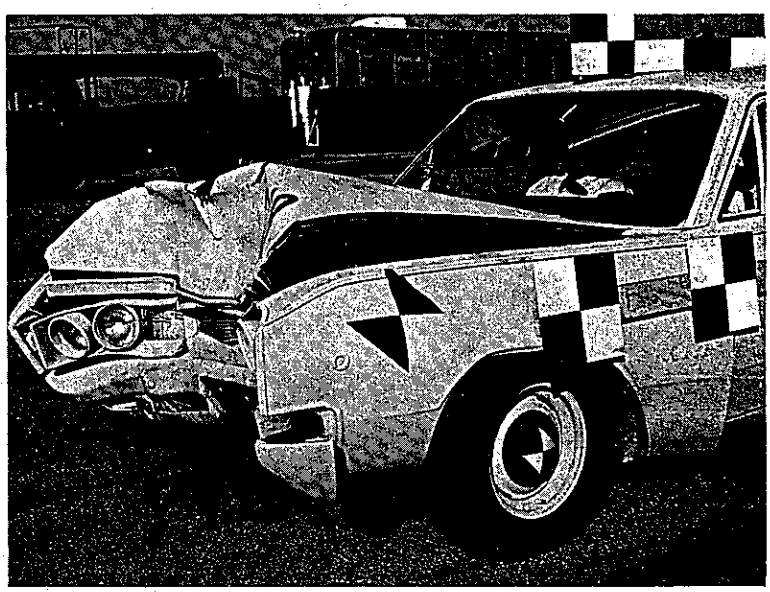
Figure 31

Results: Plate 9, page 43, contains a summary of the test results. A 4760 lb. 1968 Dodge impacted the nose of the barrier at an angle of 8° and a speed of 59.2 mph. The vehicle struck the barrier, rotated until it was nearly on line with the barrier axis, and continued to a stop in a manner similar to that of Test 216 (62 mph headon impact). The crush in the vehicle forestructure formed an arc (plan view) with least crush at the fenders. Maximum crush at the center was 19 inches (see Figure 31, below, and Exhibit 8). Once again, a crimp was noted in the roof over the door posts on both sides of the car. The left front door was jammed and the radiator buckled back towards the engine. Vehicle rise was 1'-4".

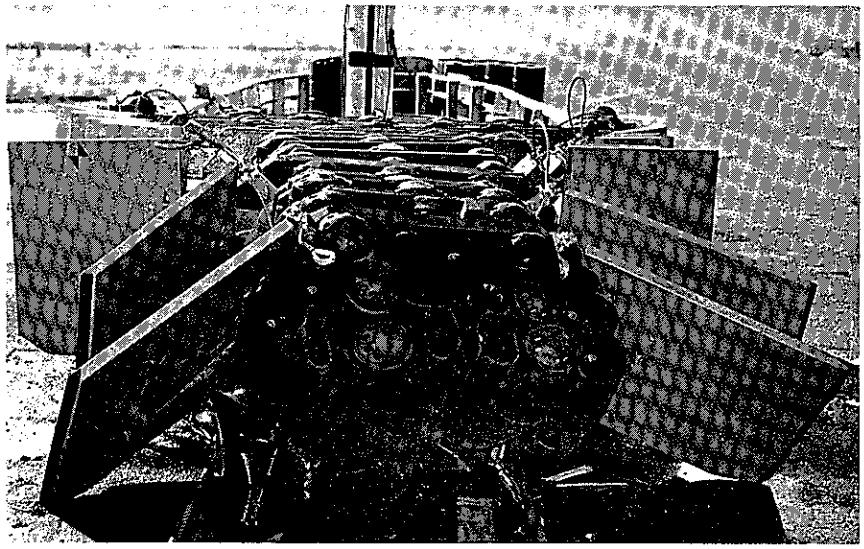
Figure 32

Maximum vehicular penetration was 15.3 feet and permanent displacement of the barrier nose was 11.7 feet. There was delamination and splitting of some of the interior panels and diaphragms, bent and broken hinges, and gouging of some of the fender panels; however, no parts became detached from the barrier (see Figure 32, below).

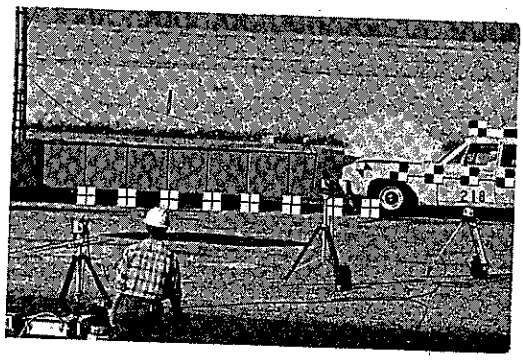
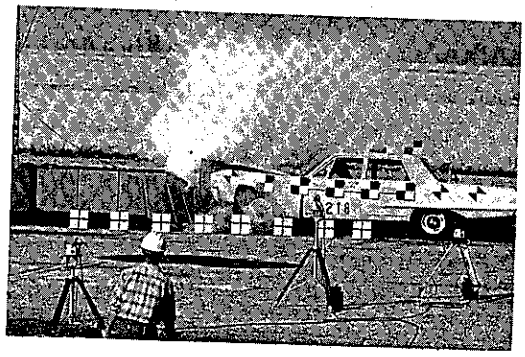
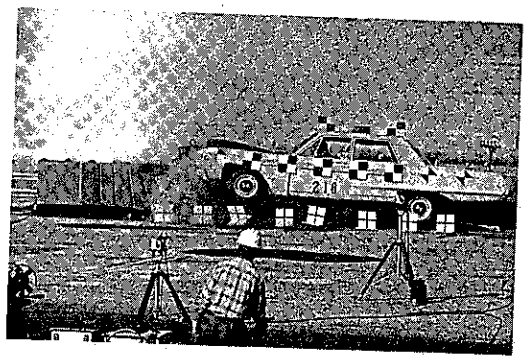
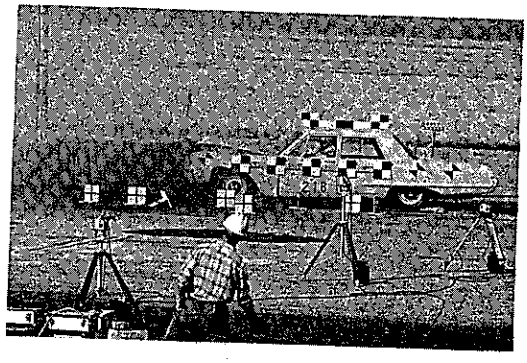
PLATE 9

Test No.	218
Date	11-12-69
Vehicle	1968 Dodge
Vehicle Weight (W/Dummy and Instrumentation)	4760 Lbs.
Impact Velocity	59.2 mph
Impact Angle	8° (nose)
Dummy Restraint	Lap belt
