4. TITLE AND SUBTITLE
Experimental Cathodic Protection Of A Bridge Deck

7. AUTHOR(S)
R.F. Stratfull

9. PERFORMING ORGANIZATION NAME AND ADDRESS
Department of Transportation
Transportation Laboratory
5900 Folsom Blvd., Sacramento, CA 95819

13. TYPE OF REPORT & PERIOD COVERED
Interim

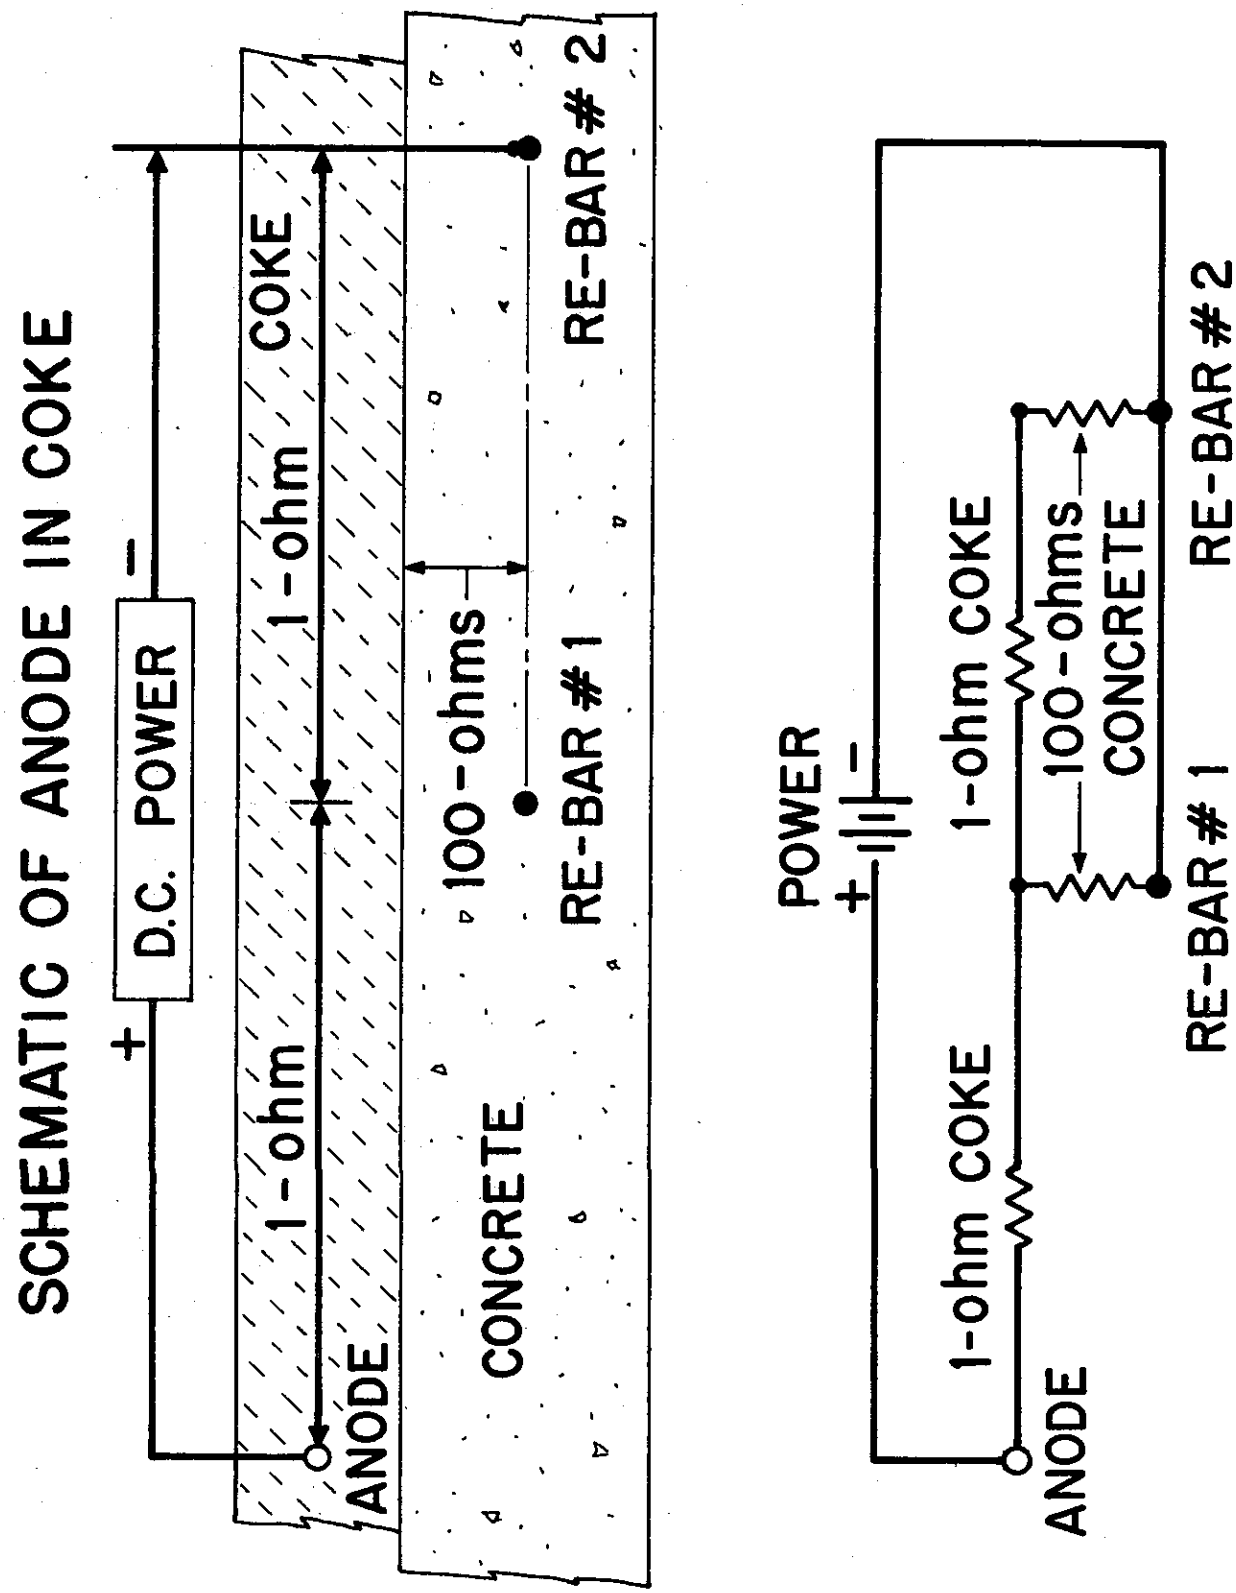
Figure 2

The feasibility of using a highly conductive overlay is shown by Figure 2, "Schematic of Anode in Coke". For purposes of illustration, it is assumed that the electrical resistance of the coke for the distance between the reinforcing steel in one ohm, while the electrical resistance of the concrete between the interface of the coke and concrete, to the surface of the steel is 100 ohms. From these assumptions and laws of electrical current flow, it is obvious that horizontal travel of electricity through coke would only be reduced by the ratio of one ohm resistance in the coke to the 100 ohms of concrete resistance to the reinforcing steel as the current spread out through the deck. Therefore, this general method of theory was chosen as the most promising method of applying cathodic protection to a deck.

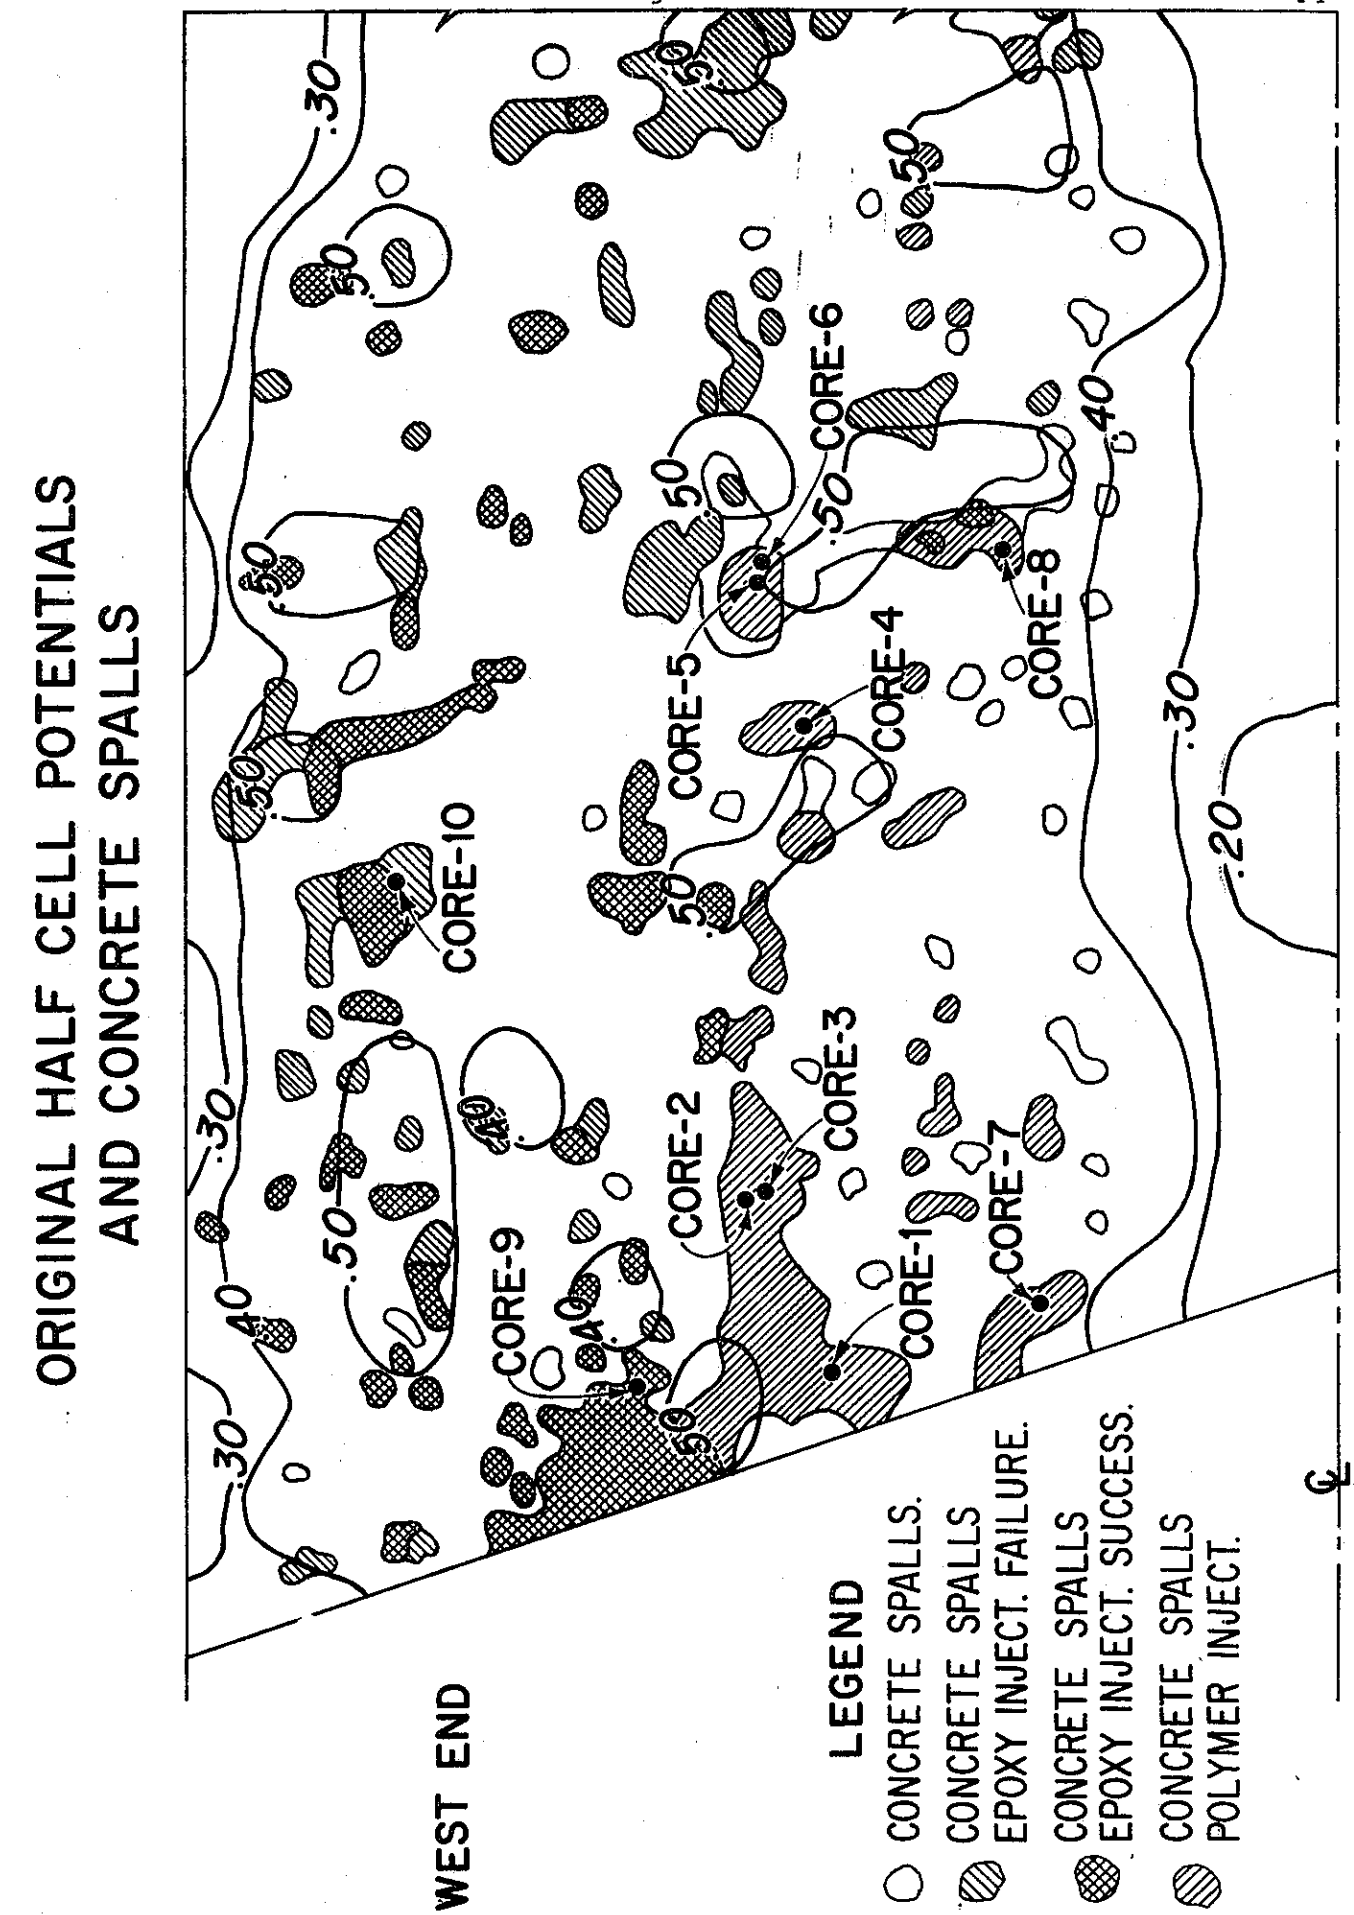
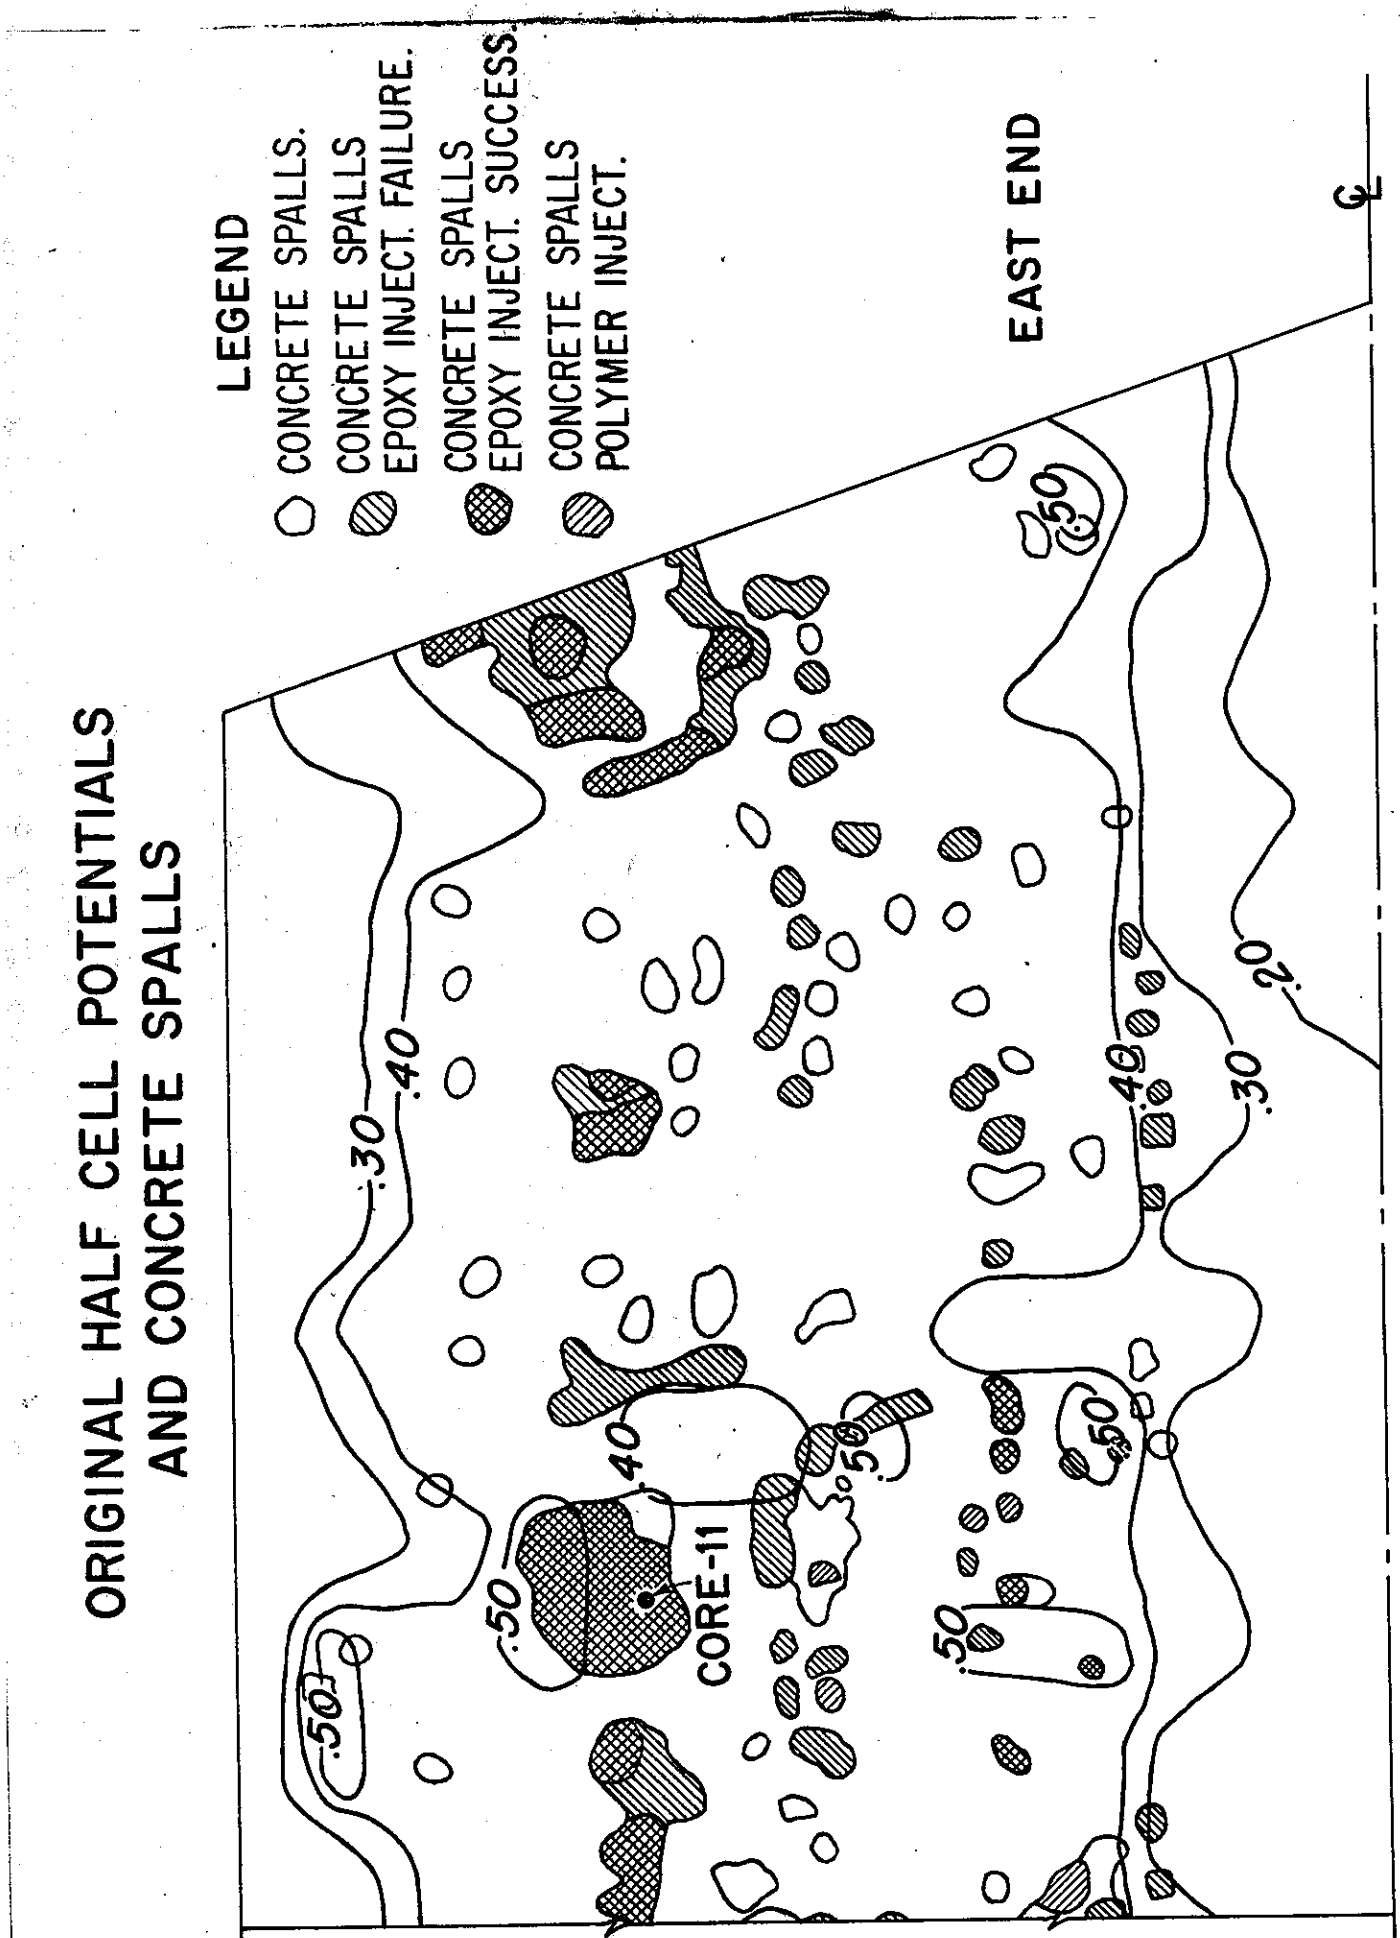
Figures 3 and 4 show the equipotential contours for the bridge deck survey made in June 1973. Also shown are the locations of the undersurface fractures. As indicated by the extent of the fractures, it was obvious that some deck repairs had to be made prior to the application of cathodic protection. Otherwise, there was a possibility that the existing concrete spalls eventually may be loosened by traffic and thus cause structural failure of the cathodic protection overlay.

As shown on Figures 3 and 4, the epoxy injection, when using a maximum pumping pressure of 160 psi, was both successful and unsuccessful. The successful cases, where the cores showed the concrete was well bonded together, were found where the concrete emitted a hollow sound when the surface was struck with a hammer. The unsuccessful locations were where the chain drag indicated a hollow sound but the hammer did not. In these latter locations, the epoxy could not be injected into the spalls at the pressures normally used. Previous but unreported work (as evidenced by concrete cores) by the author has shown that the chain drag will indicate delaminated concrete in locations where the hammer method will not.

by injection of a suitable "glue", then structural loosening by traffic would be minimized. Also, if the cathodic protection system were successful, then continued corrosion-caused spalling would be stopped. Two materials were selected to use to bond the loose concrete to the underlying deck: (1) a monomer being used recently in experimental concrete impregnation studies, and (2) an epoxy resin[32]. The locations where each material was used is shown on Figures 3 and 4. At each spall, at least one 1/2-inch (1.3 cm) diameter hole was drilled into a central area. The debris from the hole was then removed by the use of an industrial type of vacuum cleaner. All injections of monomer and epoxy resin were made via these holes as shown on Figure 5.

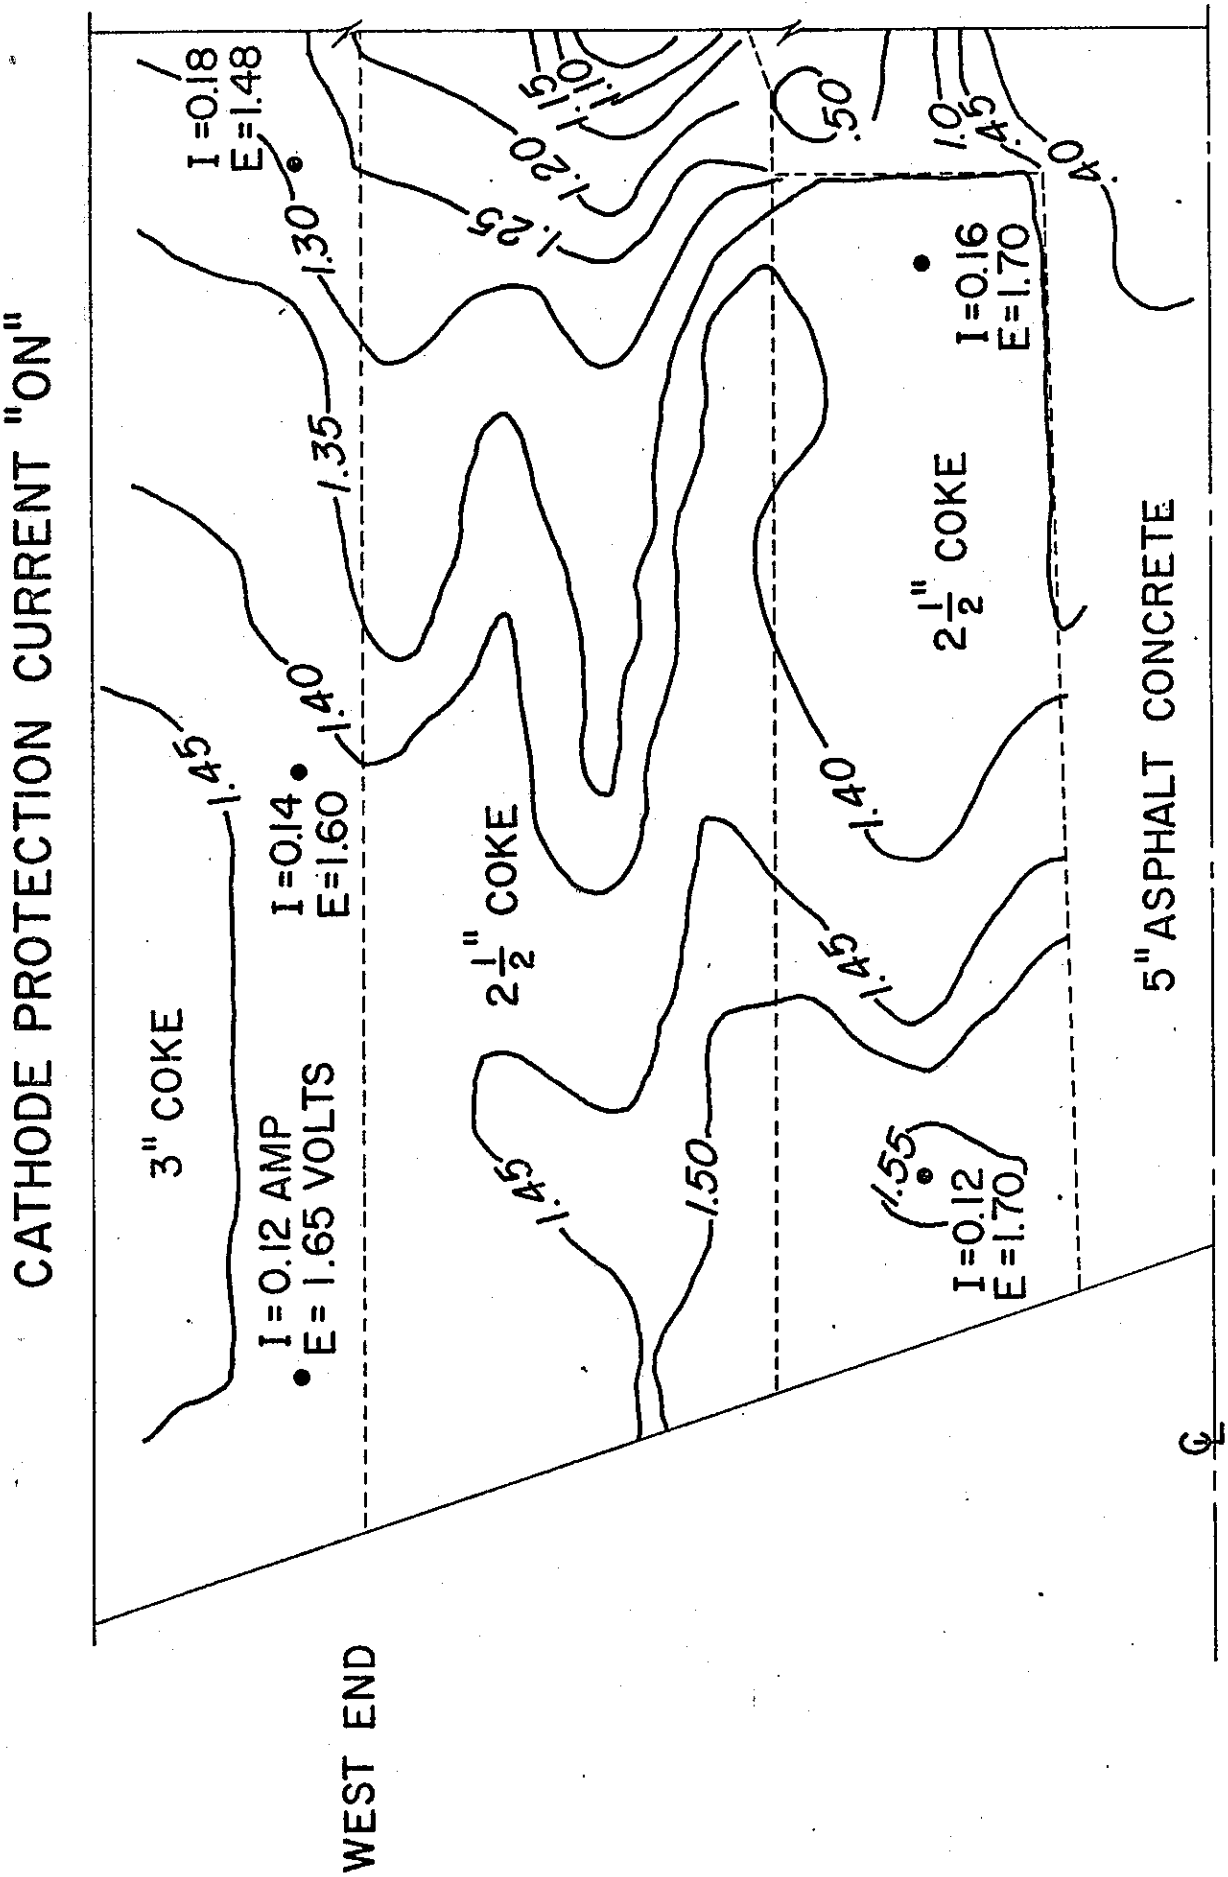
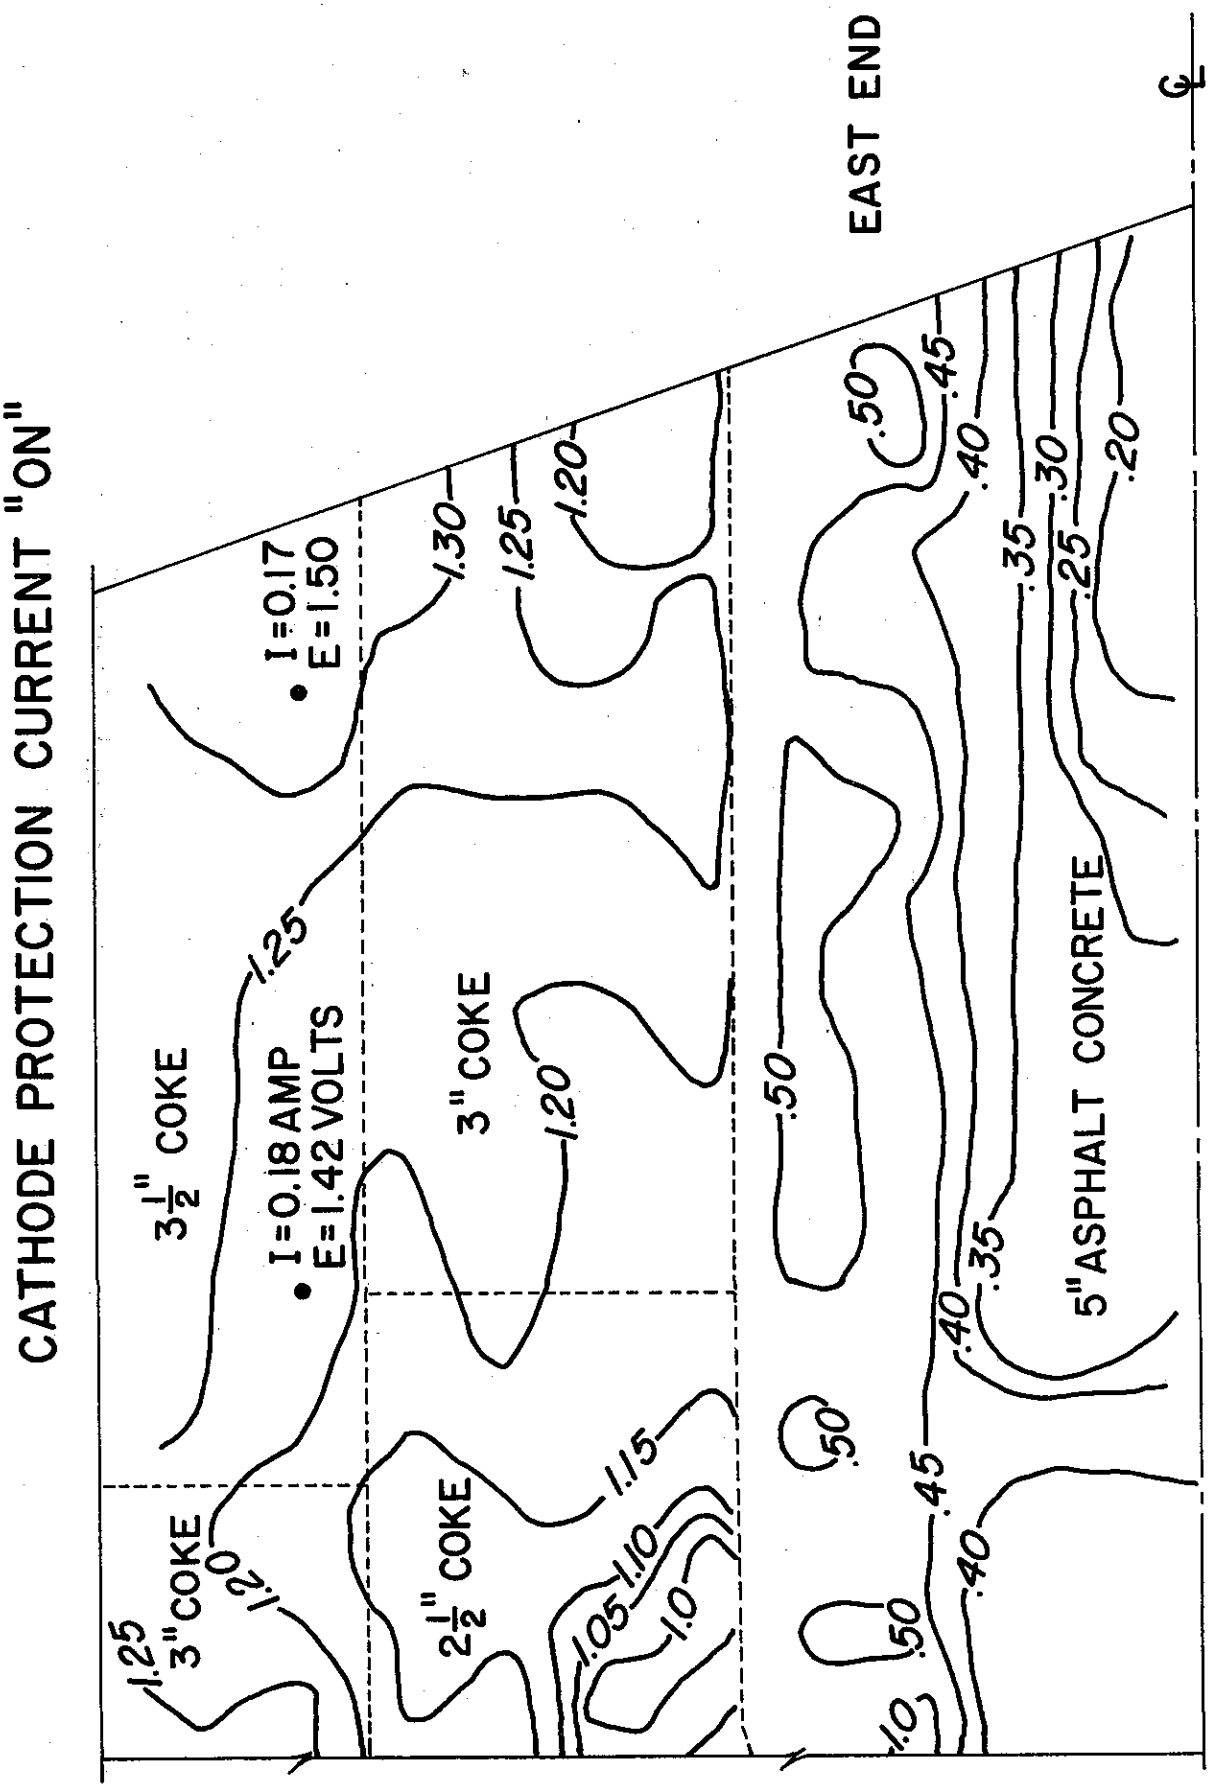
Figures 8, 9, 10, and 11 show the actual depths of the loose or uncompacted coke breeze asphalt concrete as well as

the area that contains full depth (5-inch (2 cm)) natural aggregate asphalt concrete. As will be noted on these latter figures, the thickness of various areas of the uncompacted depth of coke breeze is 3-1/2, 3, and 2-1/2 inches (8.9, 7.6, and 6.4 cm). The varying depth of coke breeze asphalt concrete was used to explore the feasibility of reducing the total depth of the composite asphalt concrete.

The locations of the seven operating anodes outside the travelled lanes are shown on Figures 8, 9, 10, and 11. The only reason that not all of the anodes are being used is that it was found during the preliminary testing it was possible to sustain the cathodic protection system without using all of the installed anodes. The location of the anodes being used have a mechanical and economical advantage over the use of anodes that were installed in the travelled lanes. These anodes would be subject to greater traffic loading as compared to those in the shoulder and median areas of the bridge.

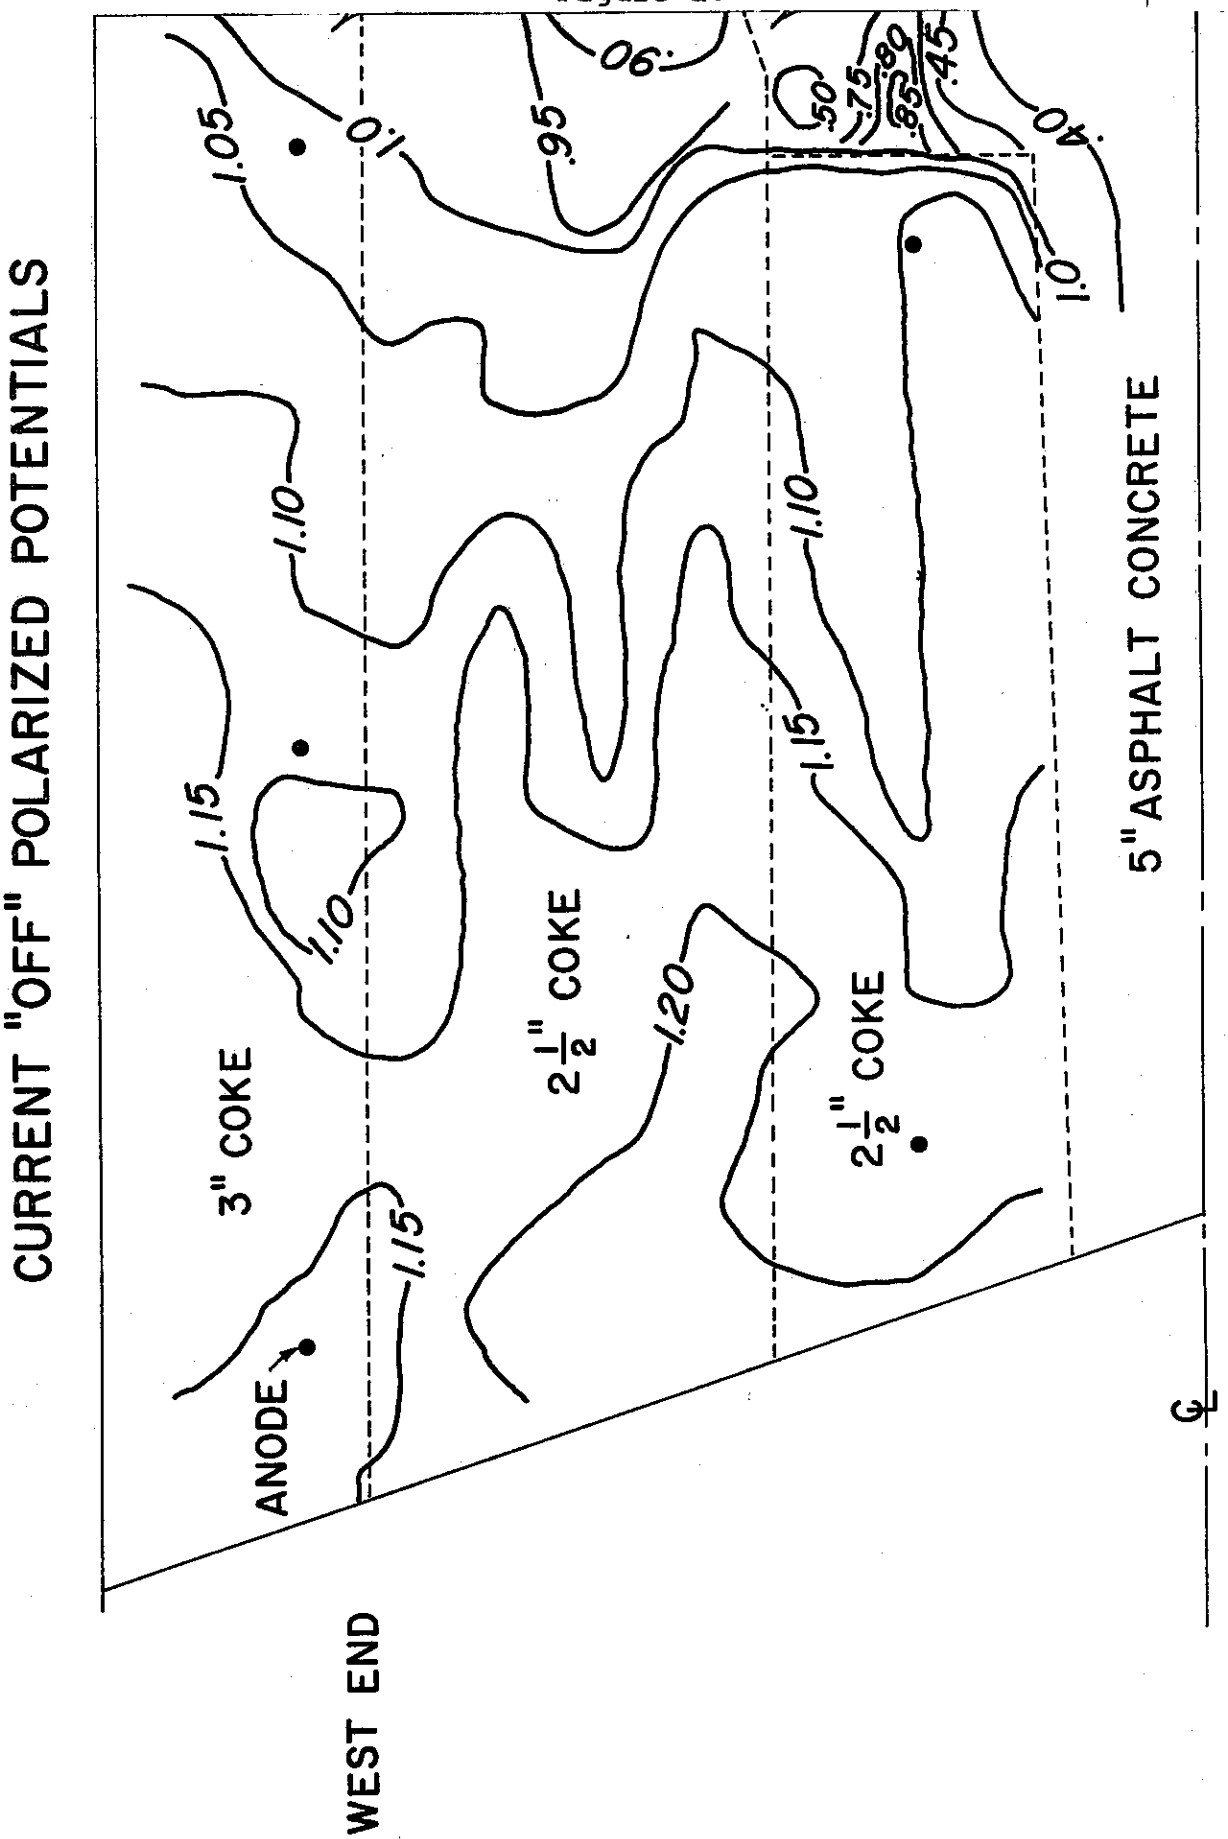
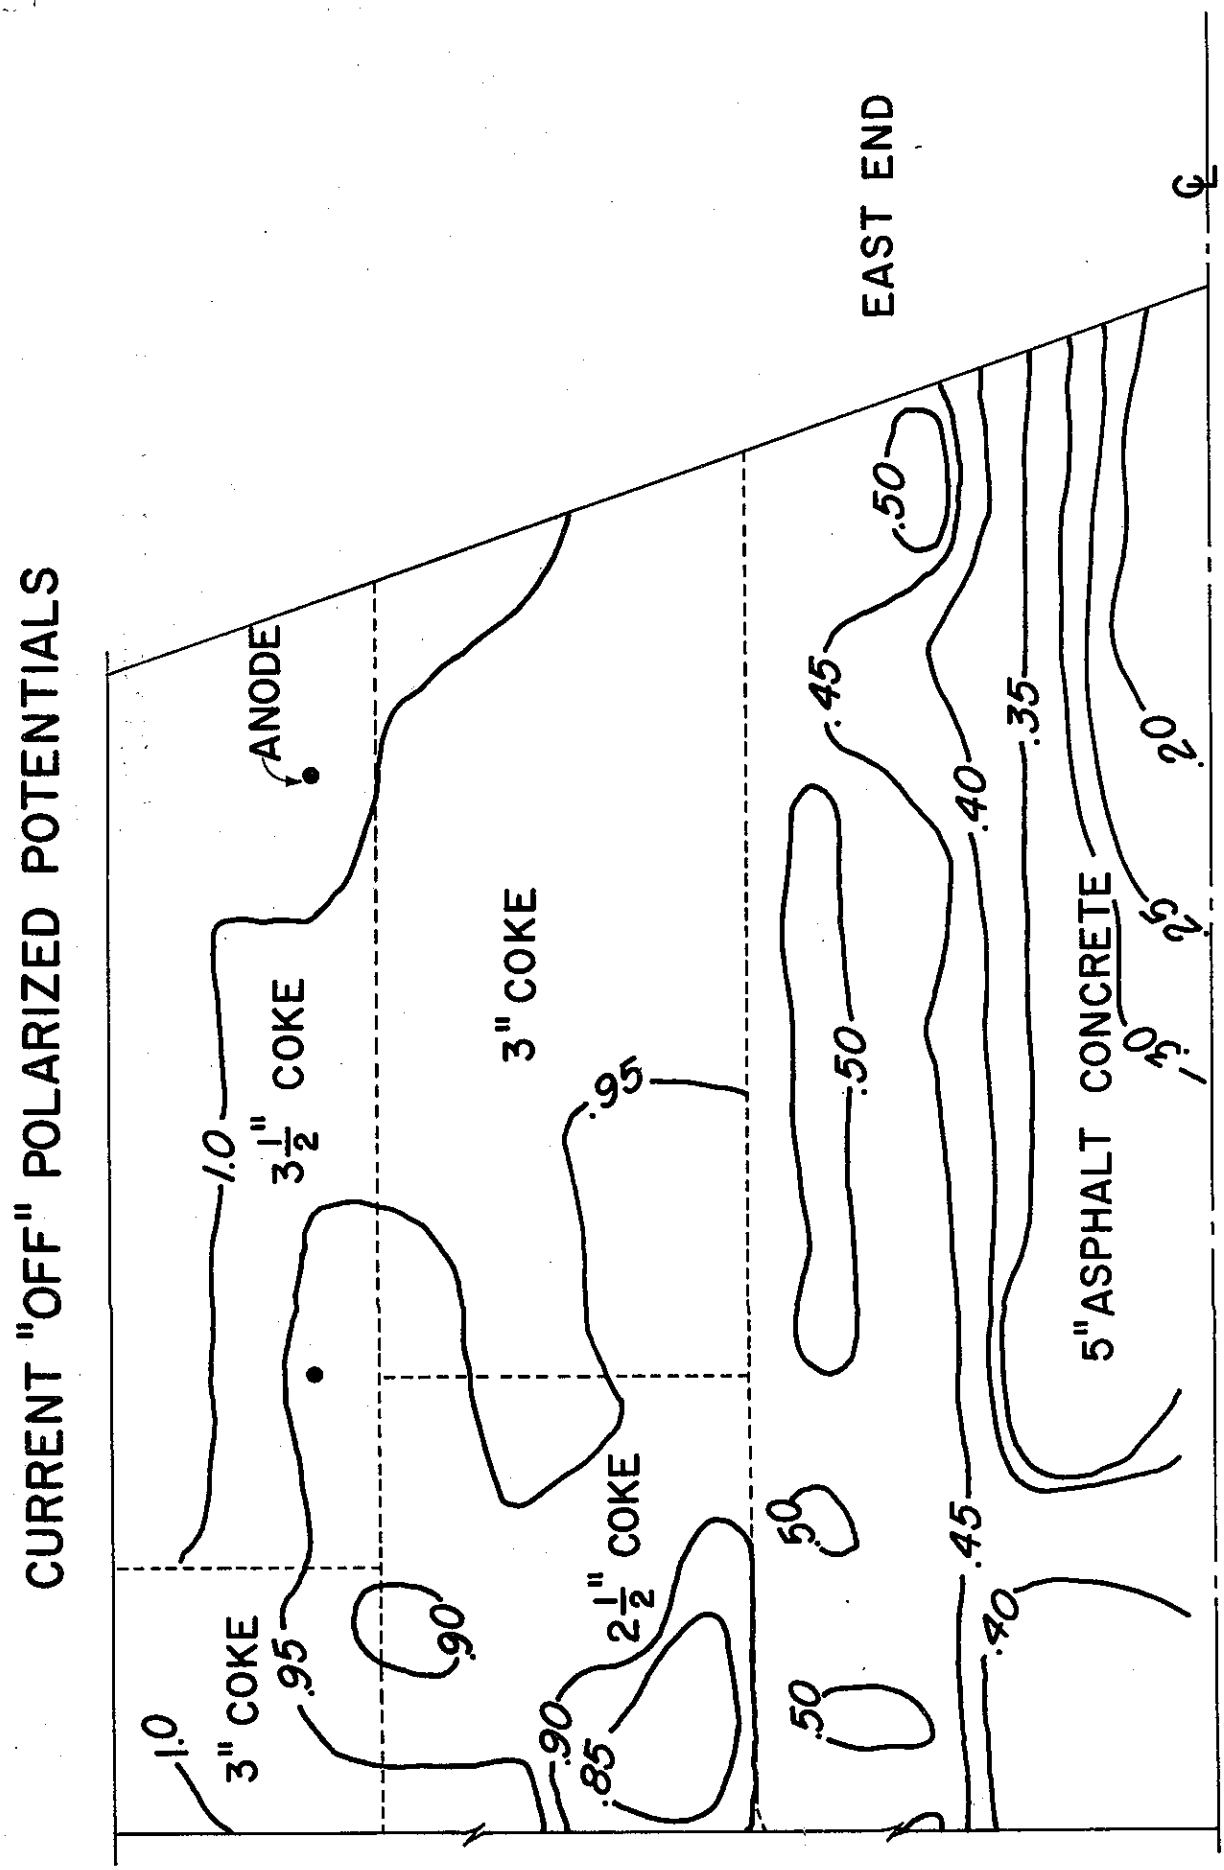
Figures 10 and 11 show the current "off" condition, or distribution of the polarized halfcell potentials of the steel.

From these latter figures, it will be noted that maximum range of the difference of polarized potentials of the steel is 0.35 volts. Also, as indicated by the potentials being more negative than -0.85 volts, the cathodic protection currents should be effectively controlling the corrosion of the steel.

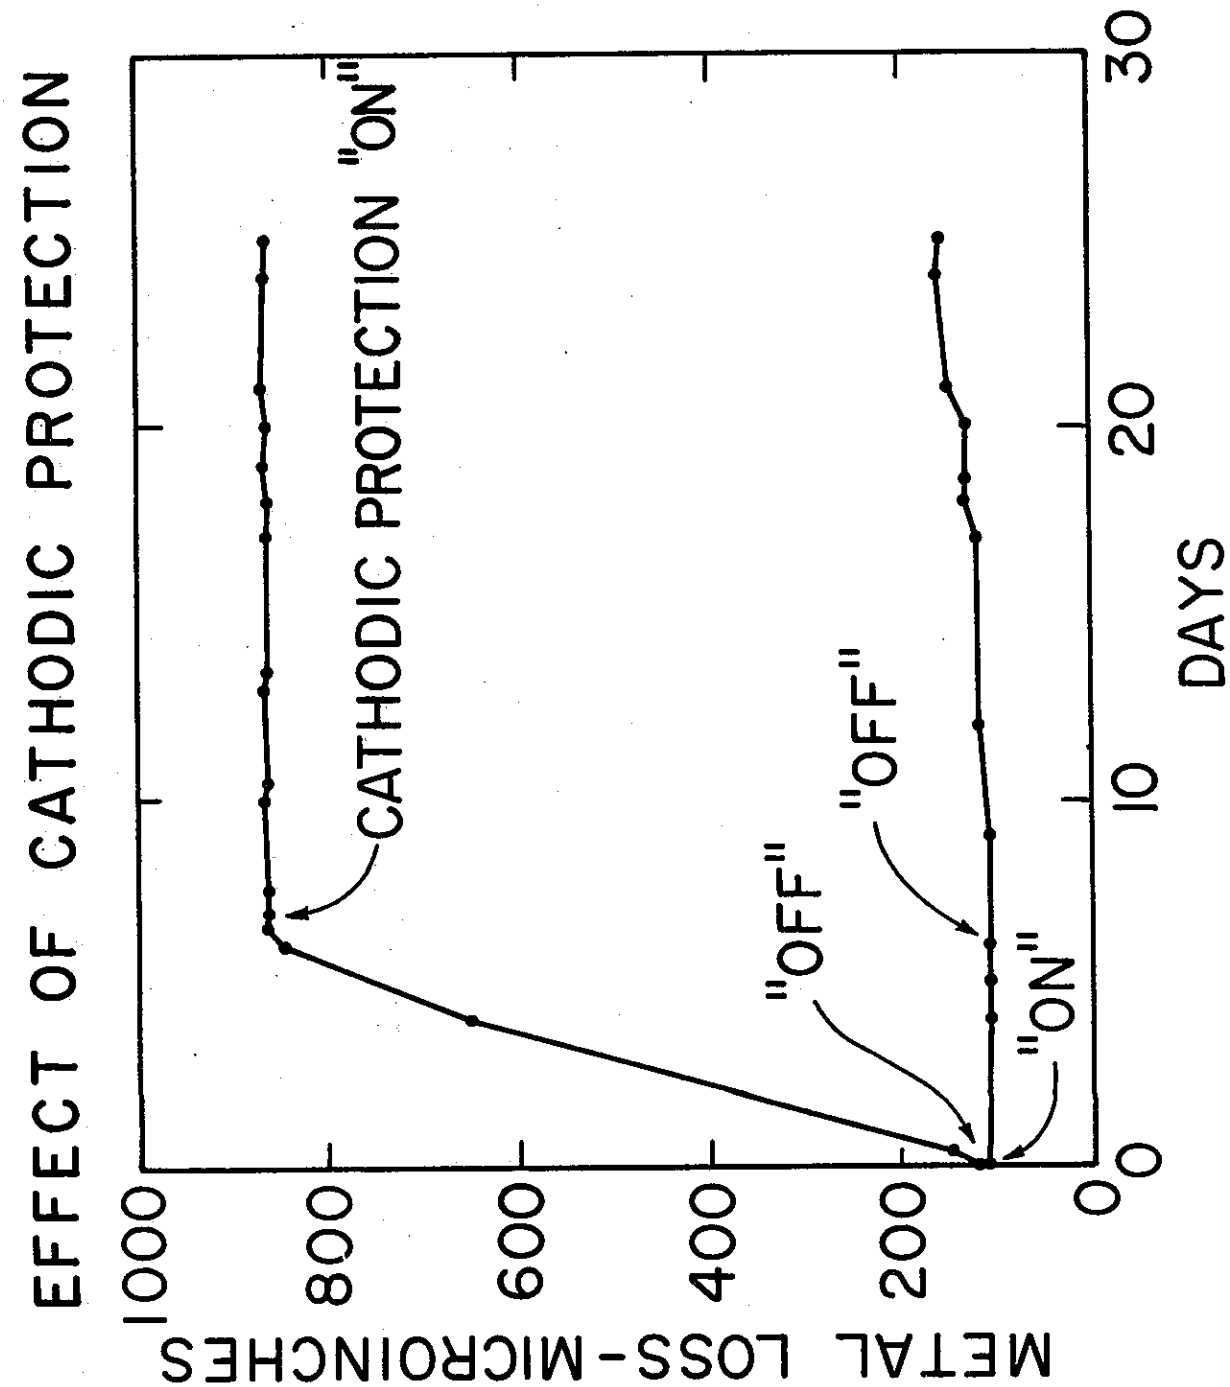
Figure 13

Referring to Figure 13, steel strip No. 1 was allowed to corrode for 6-1/2 days before being connected to the cathodic protection system. As will be noted, corrosion was essentially stopped after the application of cathodic protection current. The polarized potential of the strip was measured and found to be -1.31 volts CSE.

Steel Strip No. 2, which also was imbedded in the same kind of concrete, was placed in the electrically conductive asphalt/coke concrete and immediately connected to the cathodic protection system. As will be noted on Figure 13, essentially no corrosion occurred. After six days, the strip was disconnected from the cathodic protection system and corrosion began.

However, as shown by the performance of steel strip No. 2, the loss of cathodic protection does not result in an immediate and catastrophic corrosion rate because of the apparently long term "decay" of polarization. The halfcell potential of steel strip No. 2 was -0.67 volts CSE on the twentieth day of test.
