4. TITLE AND SUBTITLE
CALIFORNIA BANK AND SHORE ROCK SLOPE PROTECTION DESIGN
Practitioner's Guide and Field Evaluations of Riprap Methods

CALIFORNIA BANK AND SHORE ROCK SLOPE PROTECTION DESIGN

Practitioner's Guide and Field Evaluations of Riprap Methods

Final Report No. FHWA-CA-TL-95-10
Caltrans Study No. F90TL03

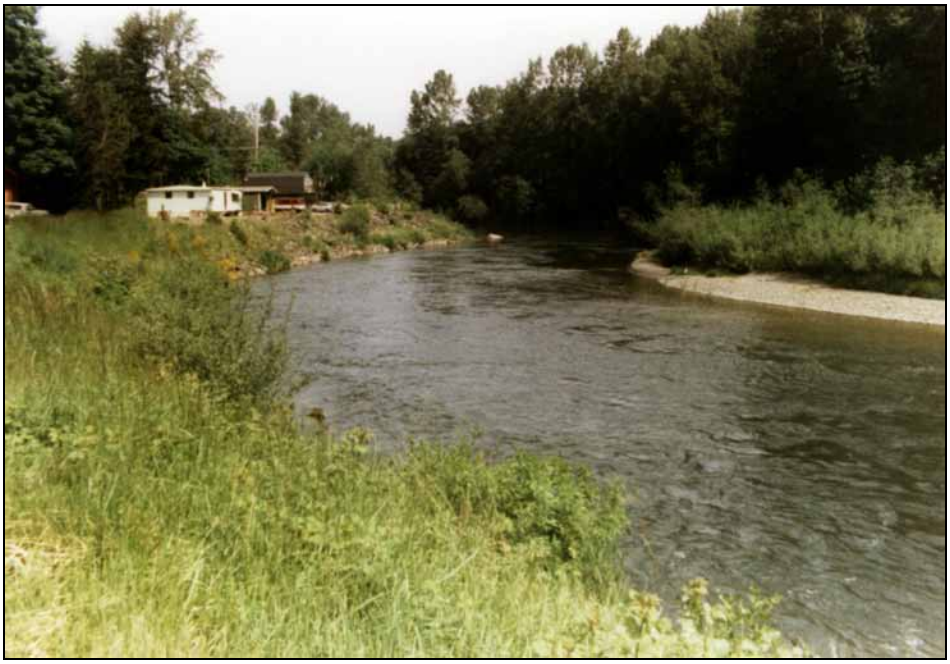
Photo C-1. Parallel and impinging flow. D/S view. Abundant vegetation where flow is parallel to riprapped bank (left foreground), as contrasted to the same bank farther downstream, where flow impinges on the outside of bend. Natural sand bar (right bank) is typical of the inside of bends of rivers.
Site 1 WA Nisqually R. May 1992

Photo C-2. Bank which gets impinging flow. D/S view. Design velocity was 16 feet per second.
Seattle Corps Class V riprap 1800#-25# W50 750#.
Observer holding white z-scale: 30-inches high by 5-inches wide.
Site 1 WA Nisqually R. May 1992

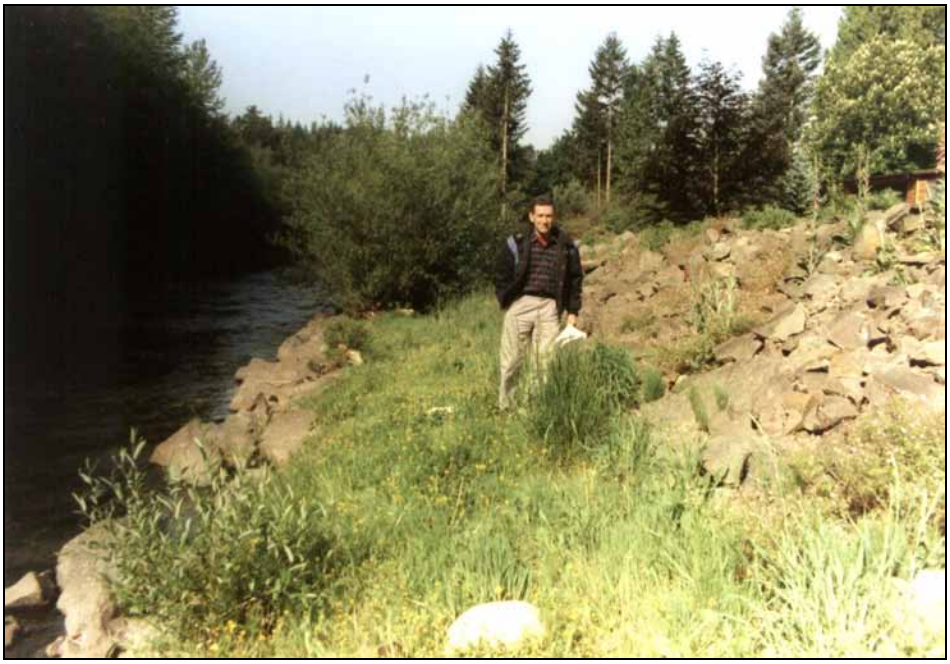
Photo C-7. Toe was mounded 3-feet vertical by 8-feet horizontal. D/S view.
Previous toe was 3'Vx4'H. Face slope of toe in river is 1V:1.5H.
Site 4 WA Cedar R. Orchard Bend May 1992

Photo C-8. Tree toppled by current. Flow is toward right. Volunteer tree is below elevation of normal high water. In WA state some dike districts require removing vegetation when it is greater than 2-inches in diameter at chest height. Site 4 WA Cedar R. Orchard Bend May 1992

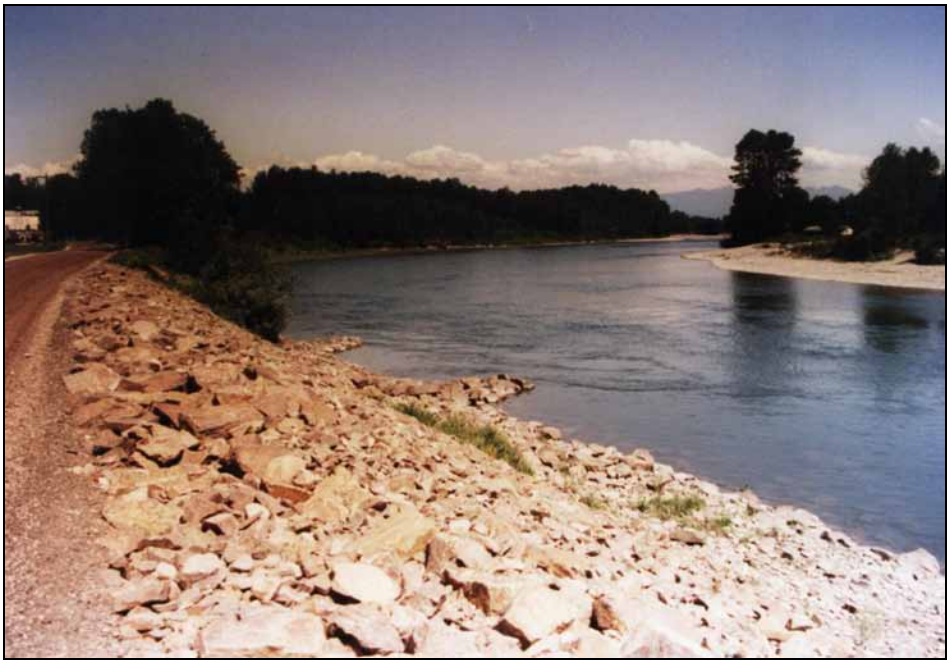
Photo C-15. Permeable rock jetties (fish habitat structures). U/S view from high flow impinging zone. Permeable jetties protect portion of bank at low and moderate flows on bends by deflecting current away from bank and back into the river, weir flow when submerged. Site 9 WA Skykomish R. May 1992

Photo C-16. Close-up of permeable rock jetty. U/S view.
30-inch high by 5-inch wide z-scale.
Silt-covered cobbles in foreground. Calm water at lower right, D/S of jetty.
Site 9 WA Skykomish R. May 1992

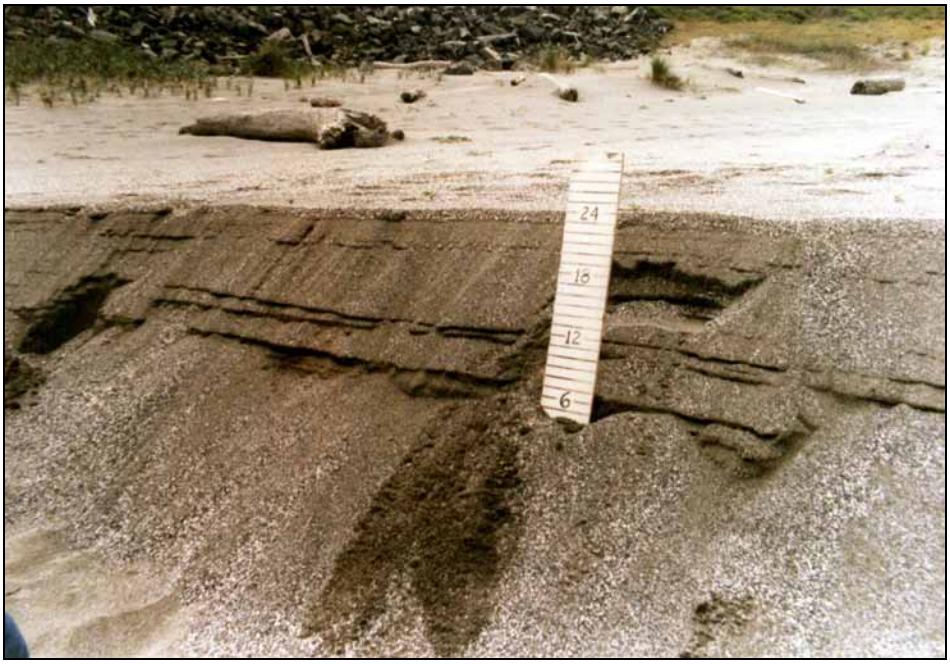
Photo C-20. Layers of deposited sand.
Side of channel shows different thicknesses of beach sand accretion.
30-inch high by 5-inch wide z-scale, inch graduations.
Site 11 OR Nesika Beach May 1992

Photo C-21. Large hydraulic opening under bridge to pass debris.
U/S view of northerly bank at low tides.
Layered RSP protects bridge abutment fill (Class 2000, Class 50, geotextile).
Site 12 OR Pistol R. and Beach 19 May 1992

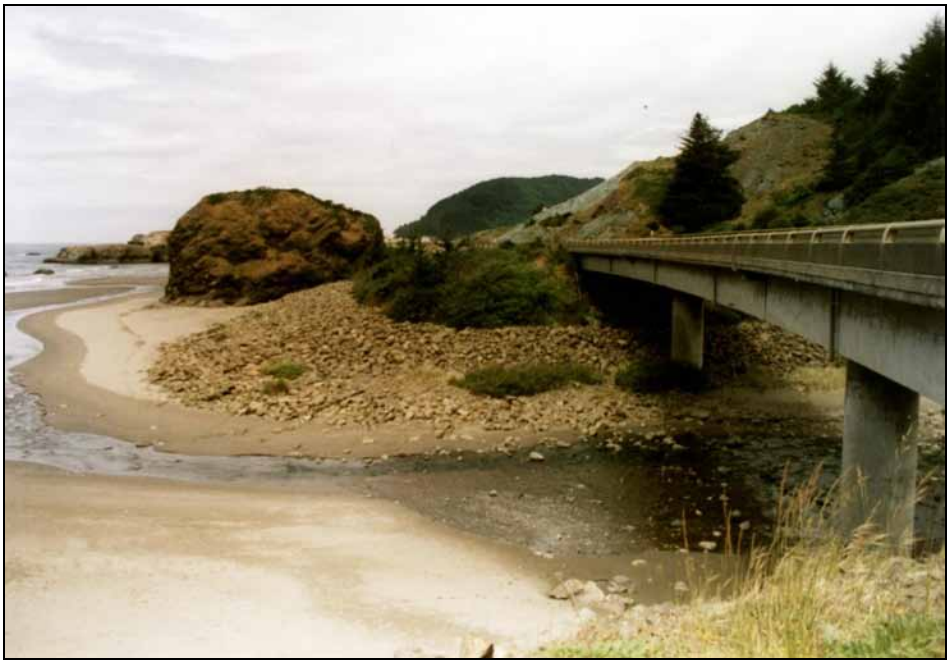
Photo C-23. Lighter rocks of well-graded mixture displaced by storm waves, 1 of 2.
View of northerly abutment fill, D/S of bridge. Class 2000 (2000#-40# W50 700#), well-graded.
Creek flows toward left at low and ebb tides. Ocean wave attack is from left.
Site 13 OR Myers Creek and Beach 19 May 1992

Photo C-24. Lighter rocks of well-graded mixture displaced by storm waves, 2 of 2.
View of northerly abutment fill, U/S of bridge. Class 2000 (2000#-40# W50 700#), well-graded.
Site 13 OR Myers Creek and Beach 19 May 1992
