California Department of Transportation (Caltrans) District 1 Pilot Fish Passage Assessment Study: Volume 1 – Overall Results

FHWA/CA/EN-2005/02

Final Report For Project:
F 2001 EN 10
Researching State Highway Culverts to Determine Impacts on Threatened and Endangered Salmon

February 14, 2005

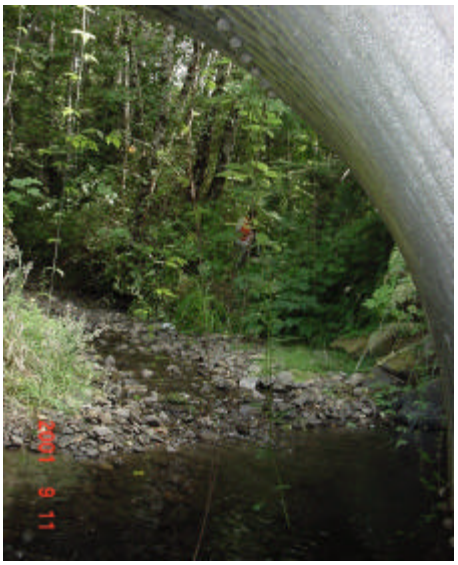
Wooden baffles in culvert
