4. TITLE AND SUBTITLE	5. REPORT DATE
CRASH TESTING OF VARIOUS ROADSIDE HARDWARE	December 2006
	6. PERFORMING ORGANIZATION CODE
7. AUTHOR	8. PERFORMING ORGANIZATION REPORT NO.
Michael White P.E., John Jewell P.E., Rich Peter P.E., Malinda Gallaher	65-680928
9. PERFORMING ORGANIZATION NAME AND ADDRESS	10. WORK UNIT NUMBER
Roadside Safety Research Group California Department of Transportation 5900 Folsom Blvd., Sacramento, CA. 95819	11. CONTRACT OR GRANT NUMBER F2003TL036
12. SPONSORING AGENCY AND ADDRESS	13. TYPE OF REPORT AND PERIOD COVERED
California Department of Transportation 5900 Folsom Blvd., Sacramento CA. 95819	FINAL
	14. SPONSORING AGENCY CODE

CRASH TESTING OF VARIOUS ROADSIDE HARDWARE

DEPARTMENT OF TRANSPORTATION
DIVISION OF RESEARCH AND INNOVATION
OFFICE OF MATERIALS AND INFRASTRUCTURE

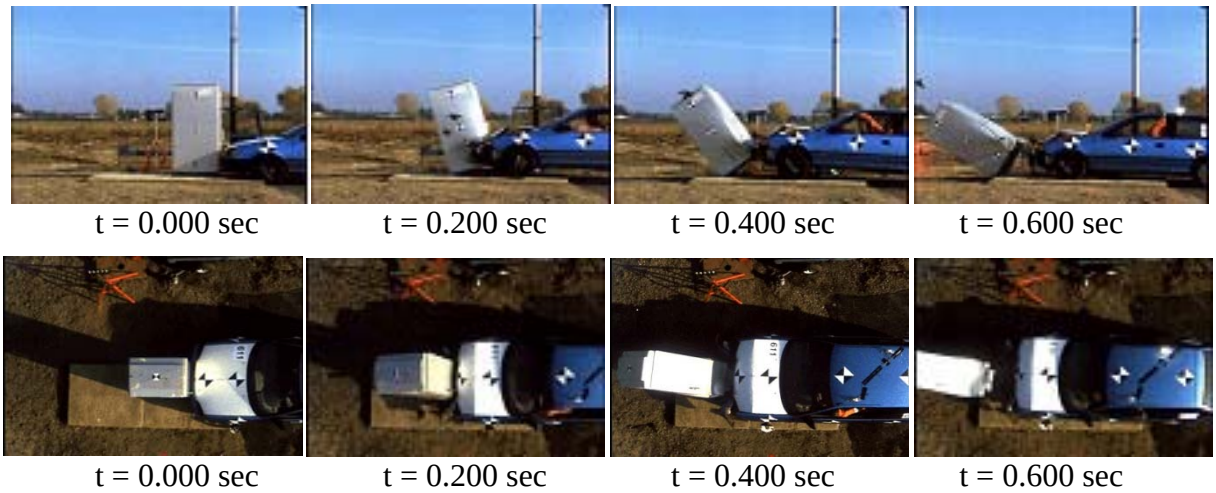
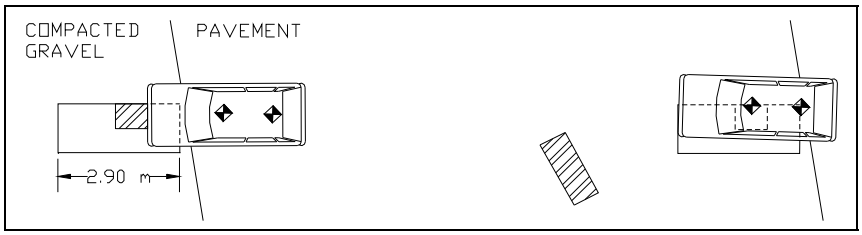
Figure 2-13. Impact Sequence and Diagram for Test 611

Article Damage: The electronic controller cabinet could not be re-used. The concrete foundation and anchor bolt system would require general repair.

The entire front of the vehicle was moderately damaged in the initial impact with the 334C controller cabinet and would not have been operable afterwards. The hood, bumper, headlamp area, grille, both front fenders, and suspension components were all affected. The radiator was ruptured and pushed back far enough that it made contact with the exhaust manifold of the transverse-mounted engine.

The damage to the test article was extensive and would require complete replacement of the cabinet. It is not known if the electronic components installed in the rack inside the cabinet would have been serviceable after the impact because non-operating units were used to simulate the weight and placement of functioning units. The cast-in-place anchor bolts were bent and damaged enough that their re-use would be questionable. There was significant spalling of the concrete pedestal on the down-stream side as a consequence of the anchor bolts being pushed rearward. The bottom of the cabinet was torn where the anchor bolts pulled through.

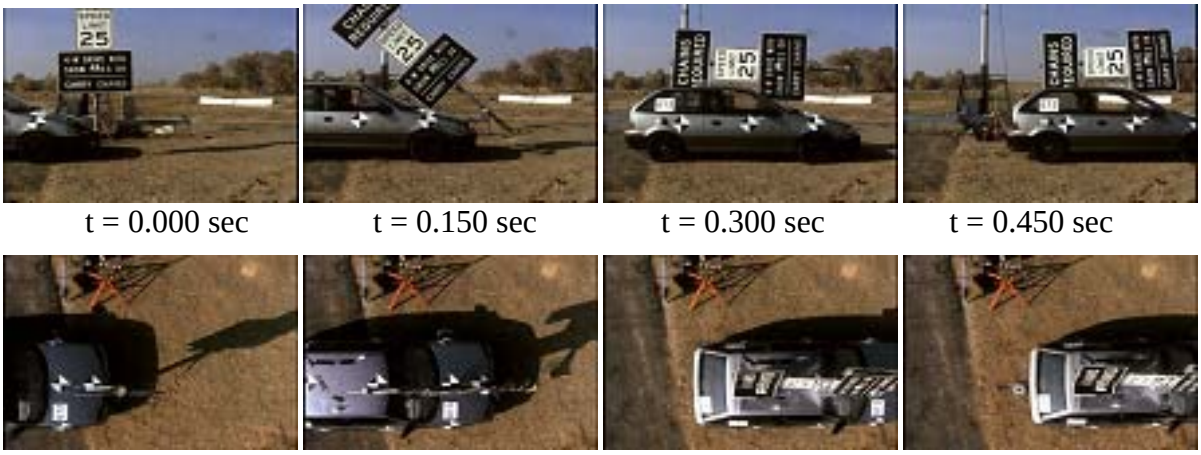
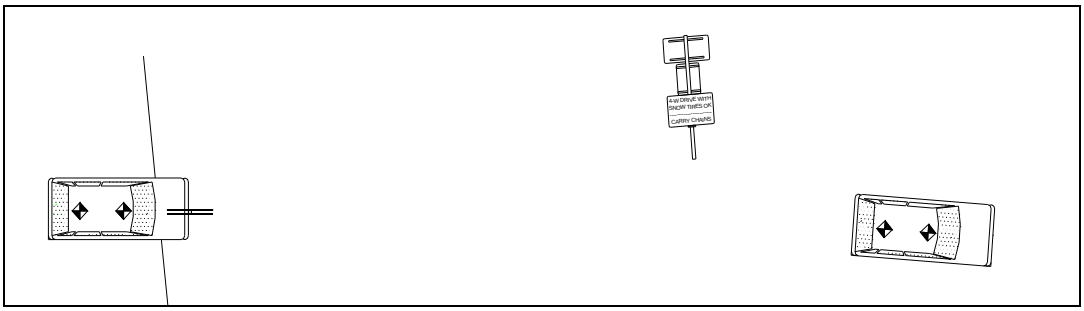
Figure 2-20. Impact Sequence and Diagram for Test 613

Article Damage: The complete sign assembly could be re-mounted in the damaged condition and would remain usable until repair could be scheduled.

The entire front of the vehicle was moderately damaged in the initial impact with the chain control sign and was drivable but not legally operable afterwards. The hood, bumper, and grille were all affected. The bottom signs penetrated the windshield approximately 50-75 mm (2.0-3.0 in) (Figure 2-21). The roof's maximum deformation was approximately 50 mm (2.0 in). The windshield penetration and roof deformation were minor enough that there would have been no significant risk of injury to vehicle occupants.

Although the sign panels were somewhat deformed, the entire post assembly could be reset on the undisturbed base and remain functional until it is deemed necessary to either replace or repair the panels.

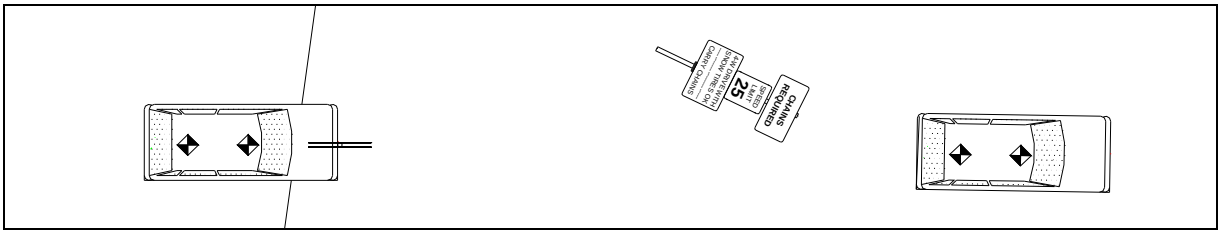
Figure 2-30. Impact Sequence and Diagram for Test 614

Article Damage: All signs were slightly damaged but reusable. The steel post and base were not damaged and could be immediately reused.

The entire front of the vehicle was slightly damaged in the initial impact with the chain control sign and was drivable, but not legally operable afterwards. The hood, bumper, and grille were all affected. The bottom signs did not penetrated through the windshield, but deformed it inward approximately 50-75 mm (2.0-3.0 in) (Figure 2-31). The roof's maximum deformation was approximately 38 mm (1.5 in) at the front-center. The rear window was penetrated near the bottom-center approximately 20 mm (0.79 in) by the top sign panel (Figure 2-32). The roof deformation and the sign penetration of the windshield and rear window were minor and would have presented no significant risk to vehicle occupants.

Although the sign panels were somewhat deformed, the entire post assembly could be reset on the undisturbed base and remain functional until it is deemed necessary to either replace or repair the panels.

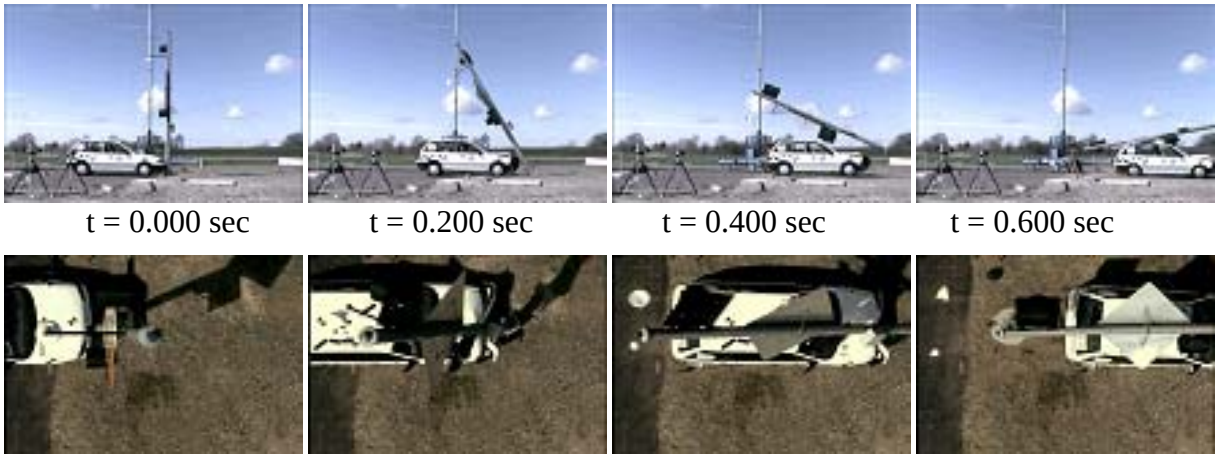
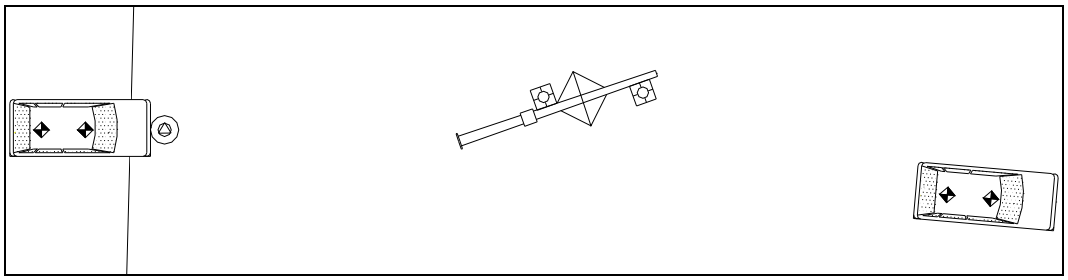
Figure 2-40. Impact Sequence and Diagram for Test 618

Article Damage: The assembly could be field-repaired by placing new components on the undamaged pole and re-erecting it on site.

The entire front of the vehicle was moderately damaged in the initial impact with the test article. The vehicle was drivable, but not legally operable after the impact. The hood, bumper, and grille were all affected. The front windshield was damaged along the roofline but was not penetrated. The greatest roof deformation was centered at the top of the windshield and was found to be approximately 90 mm (3.5 in). The extent of the deformation inside the passenger compartment is evident by comparing Figure 2-41 with Figure 2-42. Because of the location of this deformation, there would have been no significant risk to vehicle occupants.

The sign panels were somewhat deformed, the flashing beacons were damaged beyond repair, and the light fixture had broken away from the pole. The entire post assembly could be repaired in the field and reset on the undisturbed base or removed to a shop location for repair.

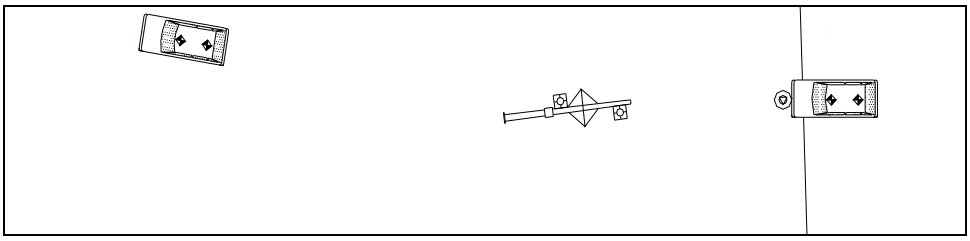
Figure 2-52. Impact Sequence and Diagram for Test 616

Article Damage: The assembly could be field-repaired by placing new components on the undamaged pole and re-erecting it on site.

The entire front of the vehicle was significantly damaged in the initial impact with the warning sign with flashing beacons and was inoperable afterwards. The hood, bumper, headlamp area, grille, both front fenders, and suspension components were all affected. The test article did not penetrate through the windshield or roof. The radiator was ruptured and pushed back far enough that it made contact with the exhaust manifold of the transverse-mounted engine.

The sign panels were somewhat deformed, the flashing beacons were damaged beyond repair, and the light fixture had broken away from the pole. The entire post assembly could be repaired in the field and reset on the undisturbed base or removed to a shop location for repair.

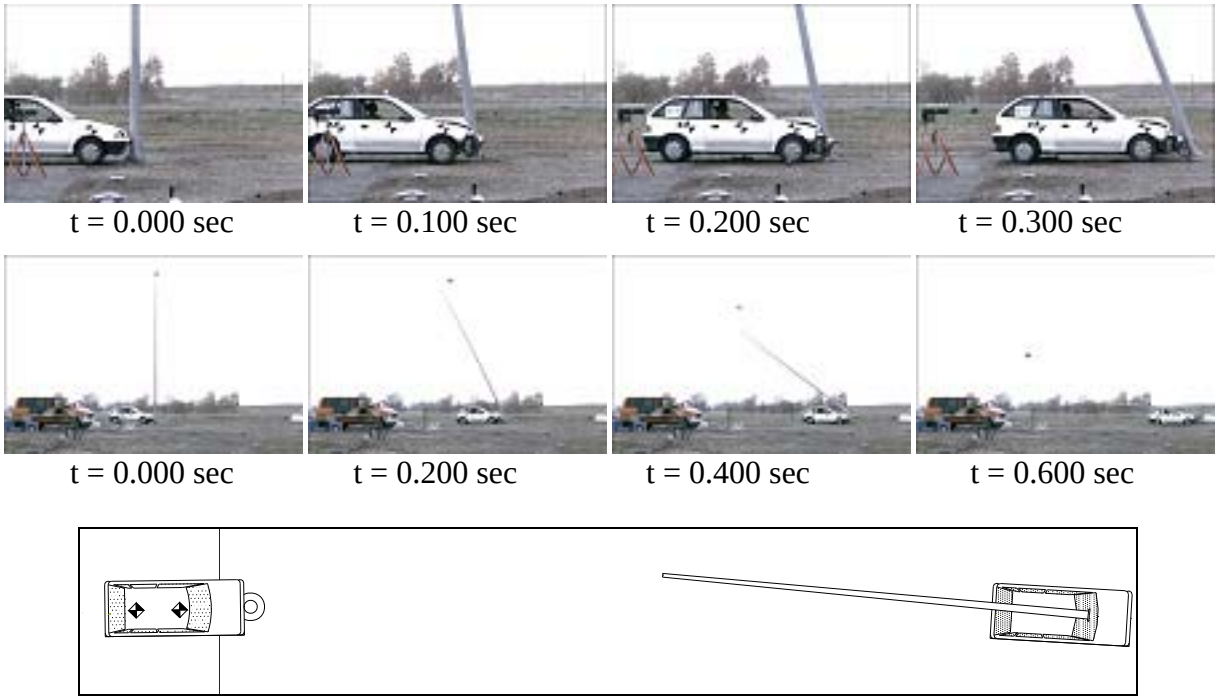
Figure 2-63. Impact Sequence and Diagram for Test 617

Article Damage: The assembly could be field-repaired by placing new components on the undamaged pole and re-erecting it on site.

The entire front of the vehicle was moderately damaged in the initial impact with the light standard and the vehicle was inoperable afterwards. The roof, hood, bumper, headlamp area, grille, both front fenders, and suspension components were all affected. The entire length and width of the roof was deformed by the secondary impact and presented risk to occupants. The roof's maximum deformation was approximately 64 mm (2.5 in) and was centered at the top of the windshield. The radiator was ruptured and pushed back far enough that it made contact with the exhaust manifold of the transverse-mounted engine.

The light standard was not damaged and could be reused. The pole-top mounted luminaire was completely destroyed. It could be field-replaced and the entire assembly could be reset on the undisturbed base.

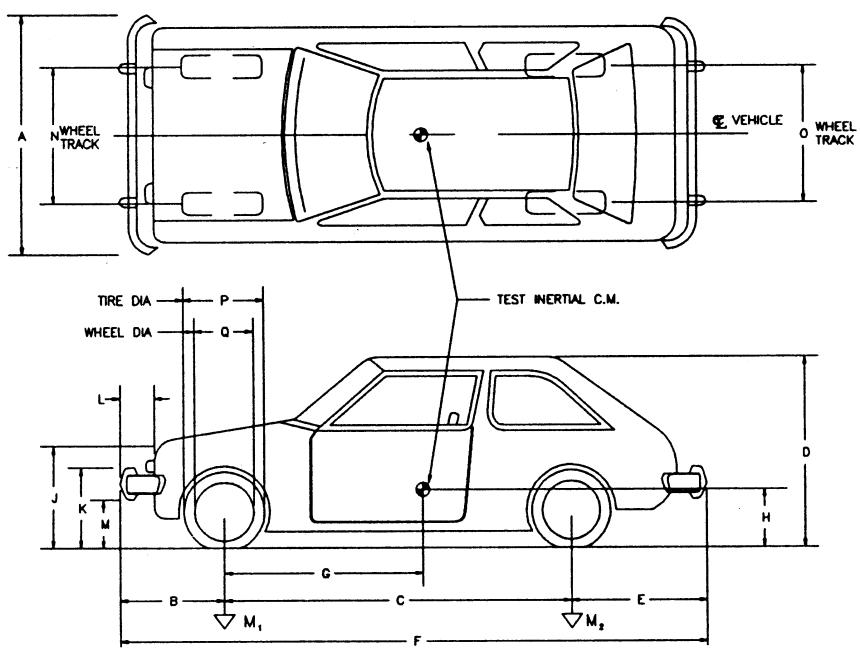
DESCRIBE ANY DAMAGE TO VEHICLE PRIOR TO TEST: Side-swipe along driver's door – documented with pictures.

Front bumper was pushed rearward 19mm from a previous minor impact.

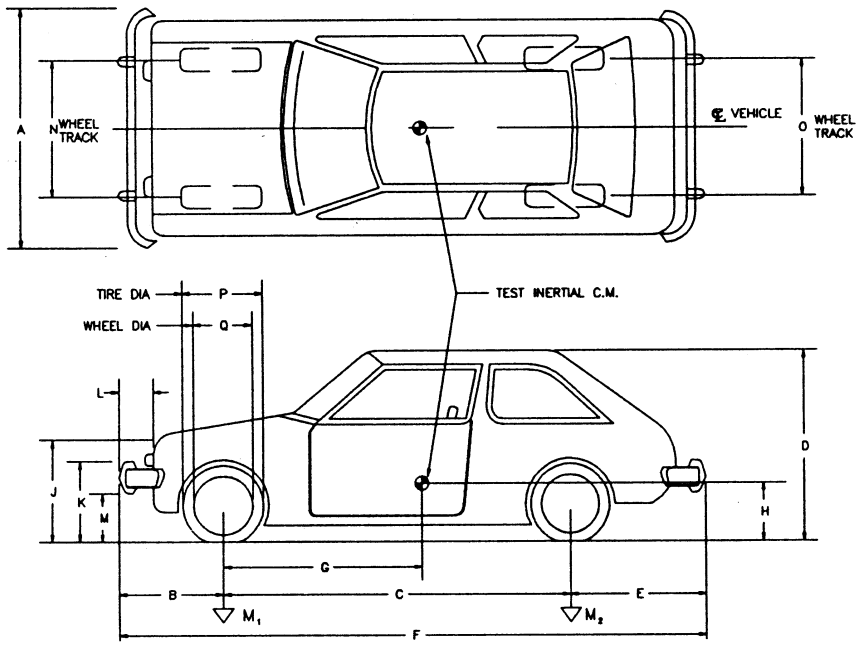
DESCRIBE ANY DAMAGE TO VEHICLE PRIOR TO TEST: small dent on hood – front and centered

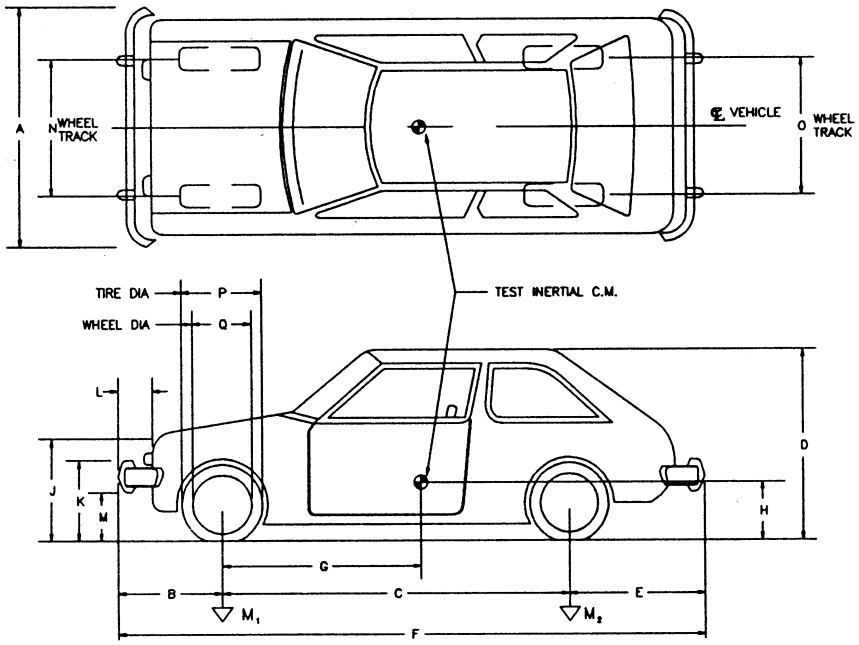
DESCRIBE ANY DAMAGE TO VEHICLE PRIOR TO TEST: small dent in driver's door, 50 mm long, 1.5 mm deep. Passenger door window molding was missing which resulted in a loose window condition – irrelevant to testing.
