December 2013
Technical Memorandum: UCPRC-TM-2013-08

Warm-Mix Asphalt Study: Field Test Performance Evaluation

Author:
D. Jones

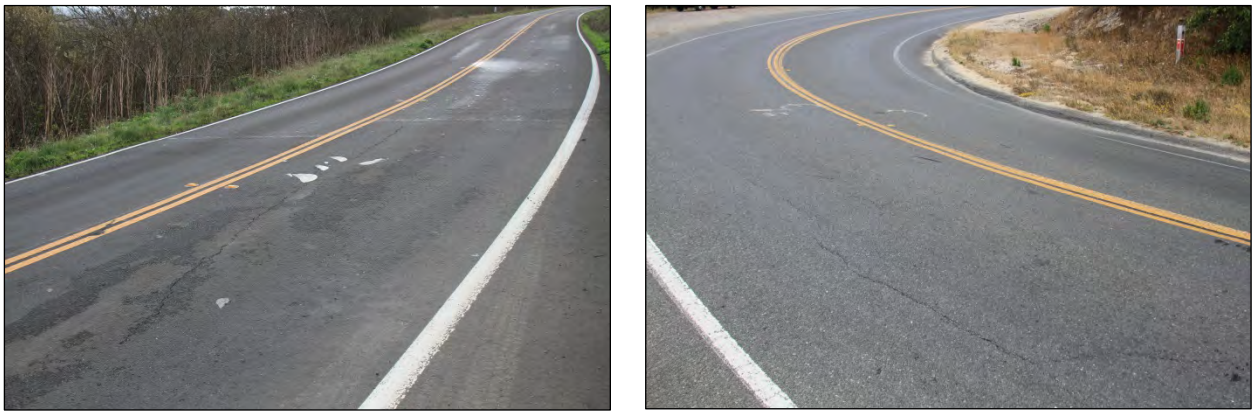
No deterioration compared to the December 2008 baseline measurements was noted on the sections after 23 months of traffic. The number and severity of the longitudinal cracks had not increased. Drainage through the OGFC was still effective.

Figure 4.2: Point Arena Evotherm, November 2010 (23 months).

Figure 4.3: Point Arena Evotherm, November 2010, showing longitudinal cracks.
