Bridge Investigation Team Report for the August 24, 2014 South Napa Earthquake

Introduction: On Sunday, August 24, 2014 at 3:20 AM PDT, a M6.0 earthquake struck south of the city of Napa (38.22° N, 122.31° W), in Napa County, at a depth (hypocenter) of 11 km. This is the third significant earthquake to impact the area over the last 25 years. On October 17, 1989 the M6.9 Loma Prieta earthquake occurred 100 km to the southwest, and damaged several bridges in the region due to amplification of long period motions in the unconsolidated soft sediments. The September 3, 2000 M5.2 Napa Earthquake caused a great deal of damage to waterlines, powerlines, and houses, but little significant damage to bridges. Experience with previous seismic events has shown bridge damage seldom occurs for earthquakes with magnitudes less than 6.0. However, it was unexpected to see such large recorded ground motion during this earthquake, especially by the Carquinez Bridge, 15 miles from the fault rupture. Additional study will be required to understand how such large recordings occurred.

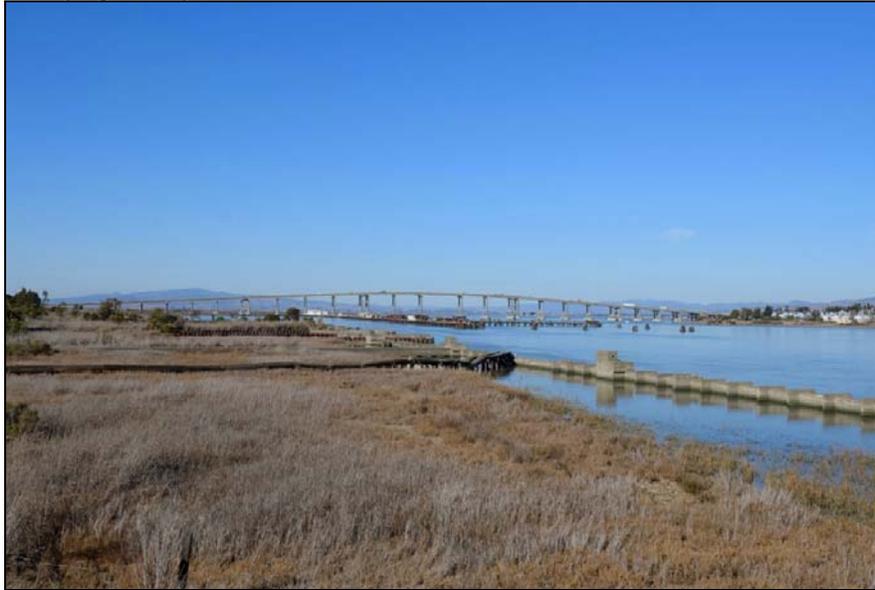
Figure 5. Napa River Bridge.

This is a 33 span precast girder bridge on flexible two column piers and stiff four column piers that was built in 1963. Like many river crossings it starts at ground level and then quickly rises to provide clearance over the river (Figure 5).

The only damage to the Napa River Bridge was that the expansion joints opened and closed enough to damage a few of the type B joint seals which are to be replaced. The hand railing at the expansion joints opened up enough (Figure 11) to cause the first responders to close the bridge as a precautionary measure. When Caltrans bridge engineers arrived at the bridge, a quick inspection showed them that there was no serious damage and they re-opened it to traffic.

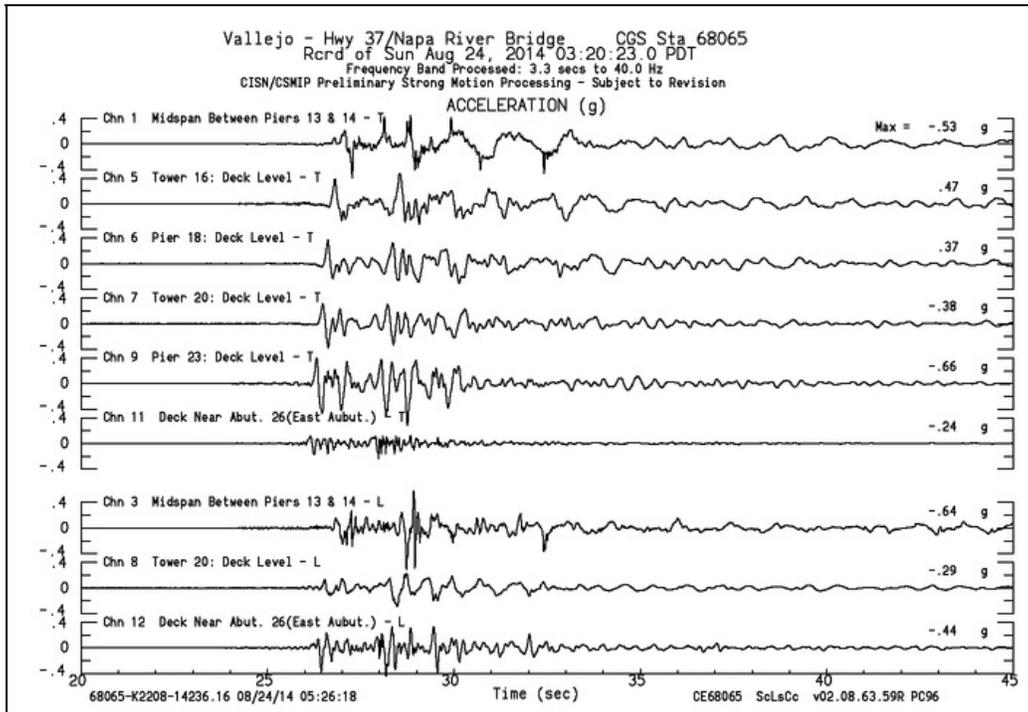
Figure 9. Acceleration records on Napa River Bridge on Route 37.

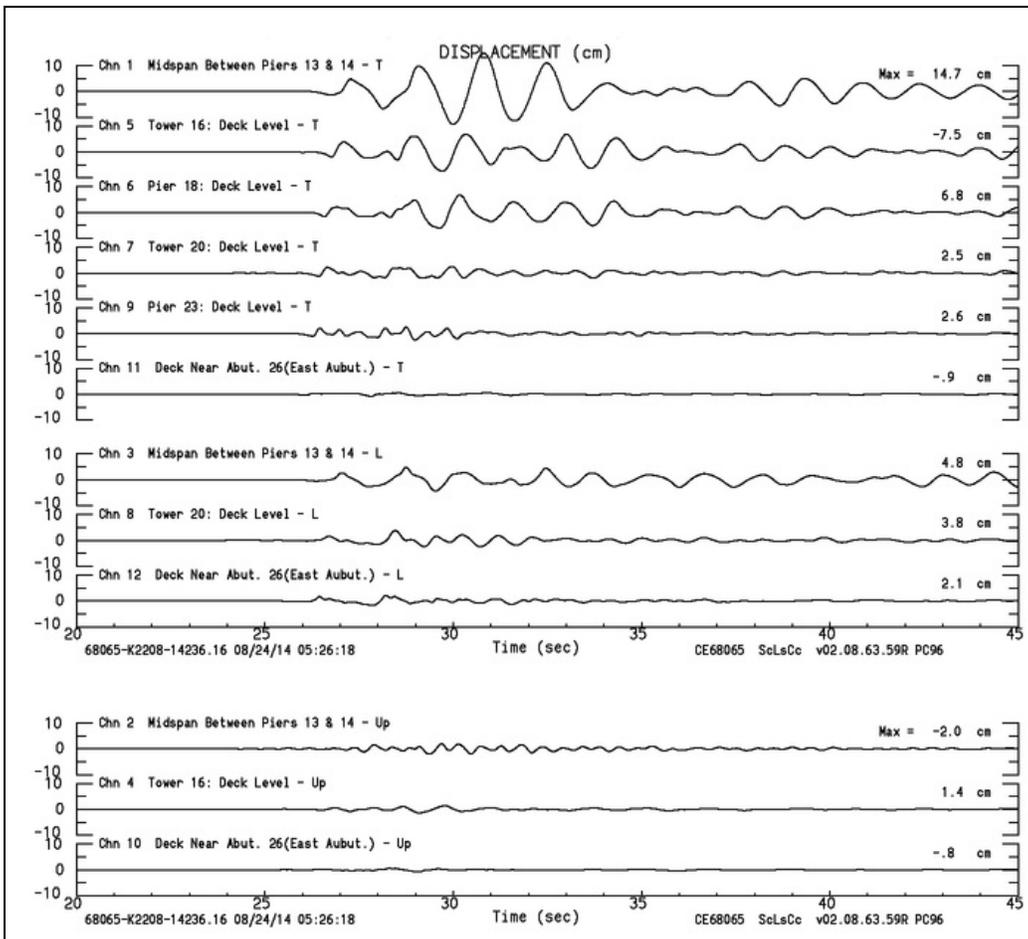
Figure 10. Displacement records on Napa River Bridge on Route 37.

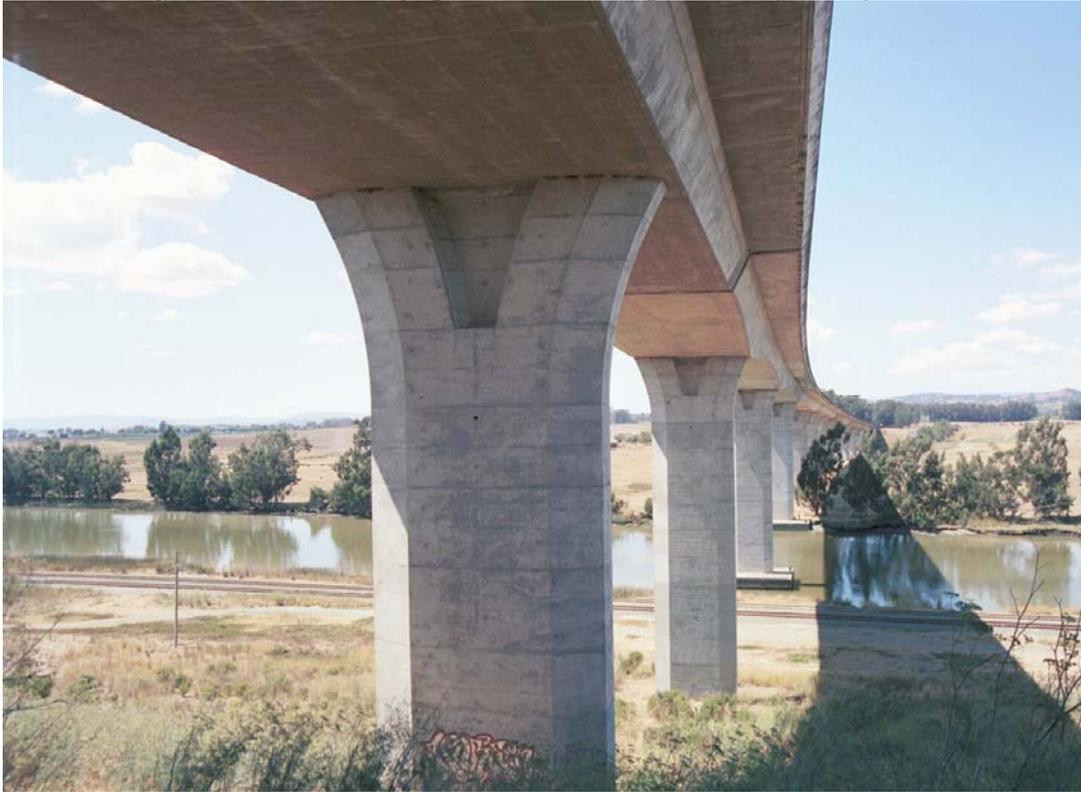
Figure 13. Napa River Bridge and Overhead.

This is a 13 span prestressed concrete continuous box girder bridge on single column bents that was built in 1977. It's 2,230 ft long with a 250 ft long span over the Napa River (see Figure 13).

The only damage to the bridge structure during the earthquake was at Abutment 14 on the west side of the river. Where the abutment was in contact with the wingwall it had a concrete spall of six inches by six feet with exposed reinforcement (see Figure 16).

21 0049	NAPA RIVER BOH	04-NAP-029-R6.99	0.31	Abutment 14, left side wingwall settled one inch and rotated outward 2 inches; abutment is spalled 6 inches x 6 feet with exposed rebar at abutment/wingwall joint	Replace wingwall and patch spall by saw cutting and recasting	8/24/2014
21 0071L	SUSCOL CREEK	04-NAP-029-R6.08	0.16			9/27/0214
21 0071R	SUSCOL CREEK	04-NAP-029-R6.08	0.16			9/27/0214
21 0077	TULUCAY CREEK (CAYETANO CREEK)	04-NAP-121-R5.71	0.18			8/24/2014
21 0086L	IMOLA AVENUE SEPARATION (29-121)	04-NAP-029-R10.38-NA P	0.15	Abutment 1, crack and delaminated concrete at corner	Remove unsound concrete and recast damaged area	8/24/2014
21 0086R	IMOLA AVENUE SEPARATION (29-121)	04-NAP-029-R10.38-NA P	0.15			8/24/2014
21 0087	OLD SONOMA ROAD OC	04-NAP-029-10.7-NAP	0.16	Existing rail and curb spalls on a rail in fair condition made worse by the EQ	Repair the bridge rail approach rail and curb spalls	8/24/2014

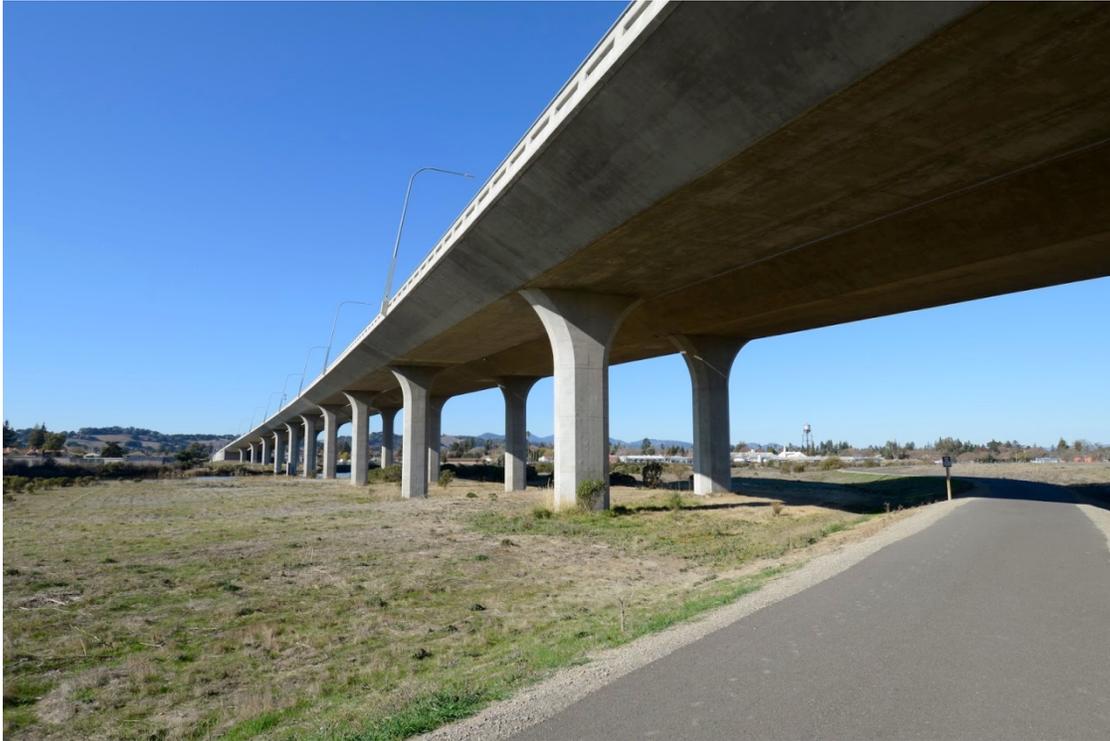
Figure 17. Napa River (West Imola Avenue) Bridges

The next structure we investigated is a pair of bridges that were built in 2007. They are 13 span (2143 ft long) prestressed concrete continuous box girder bridges on single column bents. These nearly new bridges have not been retrofitted.

This bridge is also very close to the Napa College station that recorded peak acceleration of 0.375g during the earthquake. The damage that occurred during the earthquake, cracks and spalls of the curtain walls at all the abutments, was the result of the ends of the superstructure banging against the slender curtain walls (Figures 18 and 19). More substantial abutments could have held the superstructure more securely in place. However, it is unlikely that the superstructure could unseat since the approach slab is securely attached to the end of the superstructure. Also, when Caltrans Office of Structures Maintenance and Investigations (OSMI) went inside the superstructure, they found the hinge restrainers had been poorly installed and were damaged at the swage connections or at the tension indicators (Figure 20). Restrainers must be carefully installed, which requires tightening them until the spiral washers close and then backing off to account for the variation in temperature. However, restrainers are a secondary system for earthquake protection and the hinges all had 36 inch seats.

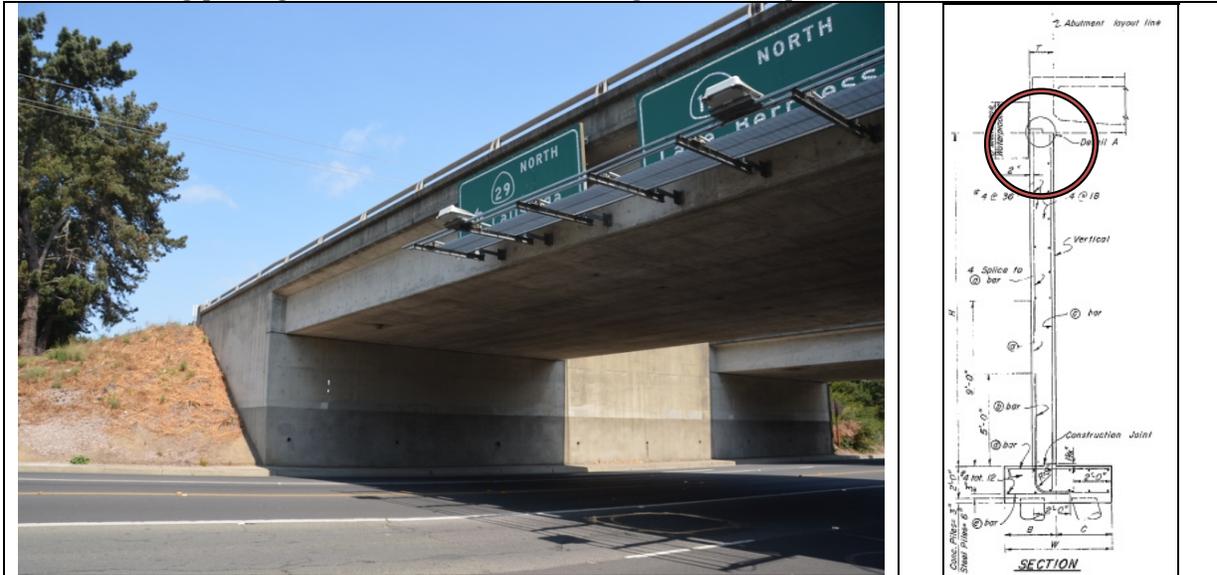
The Imola Avenue Separation is composed of parallel bridges that carry SR 29 over SR 121. They are single span (88 ft long) bridges on strutted abutments (Figure 21). This is not a particularly good seismic detail and explains why the end diaphragm on the left bridge banged against the wingwall and cracked (Figure 22). These bridges are close to the previously studied Napa River (West Imola Avenue) Bridge and saw less than 0.4g peak ground acceleration during the earthquake.

Figure 21. Strutted abutments on Imola Avenue Separation.

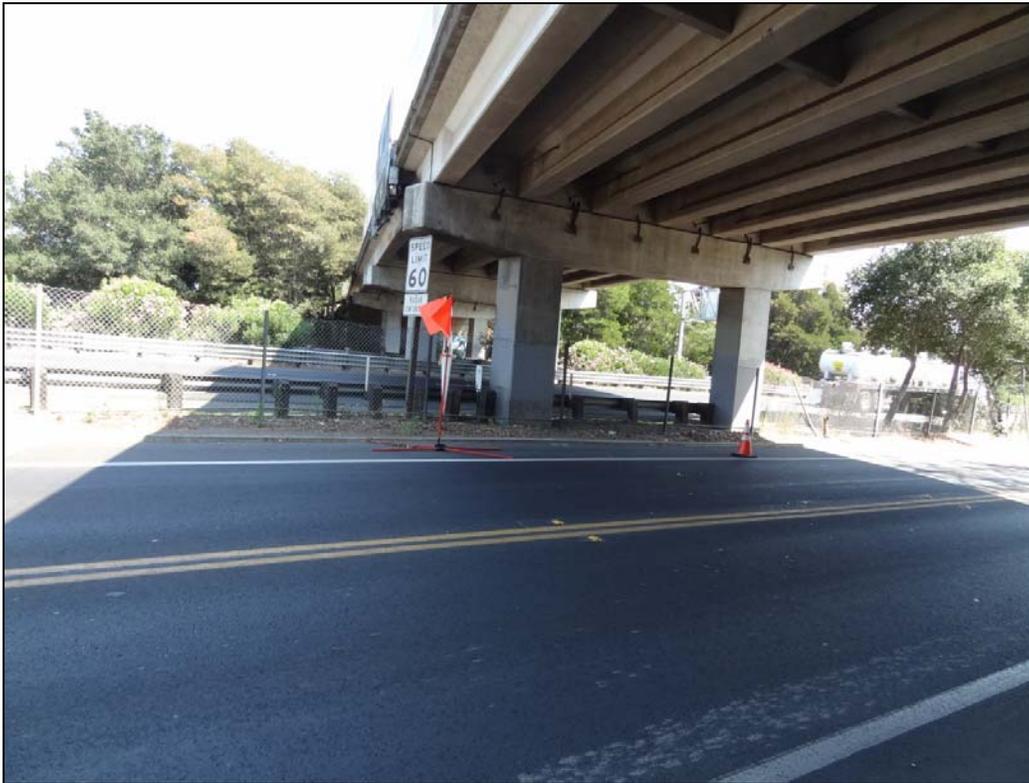
Figure 24. Photo of Old Sonoma Road Bridge after the South Napa Earthquake.

The Old Sonoma Road Overcrossing is a four span 307 ft long precast concrete girder bridge on two column bents built in 1961 across SR 29 in the City of Napa (Figure 24). The bridge was retrofitted with cable restrainers in the 1980s and it had an additional retrofit in the 1990s.

Existing damage such as banging between the railing and the curb and settlement of the bridge approaches was made worse by the South Napa Earthquake (Figure 25).

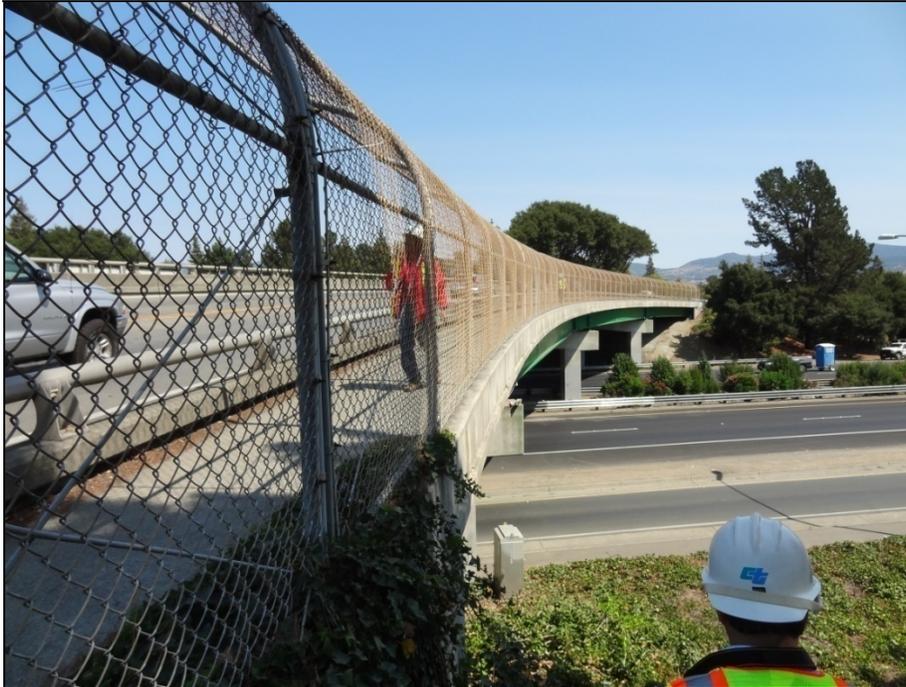
Figure 26. Photo of First Street Bridge taken after the South Napa Earthquake.

The First Street OC is a 296 ft long (4 span) steel girder bridge on a curve built in 1964 (Figure 26). The bridge was retrofitted with cable restrainers in the 1980s. Earthquake damage included spalling of the deck overhang due to banging of the expansion joint (Figure 27) as well as approach settlement similar to what occurred on the Old Sonoma Road OC.

21 0088	FIRST STREET OC	04-NAP-029-11.55-NAP	0.16	4 inch wide x 24 inch long x 4 inch deep deck soffit spall in the deck overhang on the right side of the Bent 2 expansion joint	Patch the spall in the deck overhang	8/24/2014
21 0089	LINCOLN AVENUE OC	04-NAP-029-12.04-NAP	0.14	Damage was determined to be an existing condition	no action required	9/27/0214
21 0094L	FIFTH AVENUE UC	04-NAP-029-R6.63	0.20			8/24/2014
21 0094R	FIFTH AVENUE UC	04-NAP-029-R6.64	0.20			8/24/2014
21 0098	STANLEY CREEK	04-NAP-029-R8.33	0.25			8/24/2014
21 0101	TRANCAS STREET OC	04-NAP-029-13-NAP	0.12			9/27/0214
21 0102	NORTH NAPA UP	04-NAP-029-12.91-NAP	0.12			8/25/2014
21 0107	NORTH NAPA POC	04-NAP-029-12.9-NAP	0.12			9/27/0214
21 0108L/R	NAPA RIVER (W IMOLA AVE)	04-NAP-121-R5.3-NAP	0.19	Evidence of large movements at all four abutments (bin abutments) of these parallel bridges due to foam forming material on the ground in front of the abutments; 4 ft x 6 ft concrete spall at top corner of Abutment shear keys, typical at 6 of 8 locations. Abutment 1 external shear keys broken. Type A seals at both abutments and strip seals at bin abutments are torn from transverse movement. Ends of bridge rail damaged at joints. Restrainers damaged.	Repair shear keys on each side of each of 5 abutments. Replace 4 joint seals per bridge. Rebuild bridge rail. Replace broken restrainers.	8/24/2014

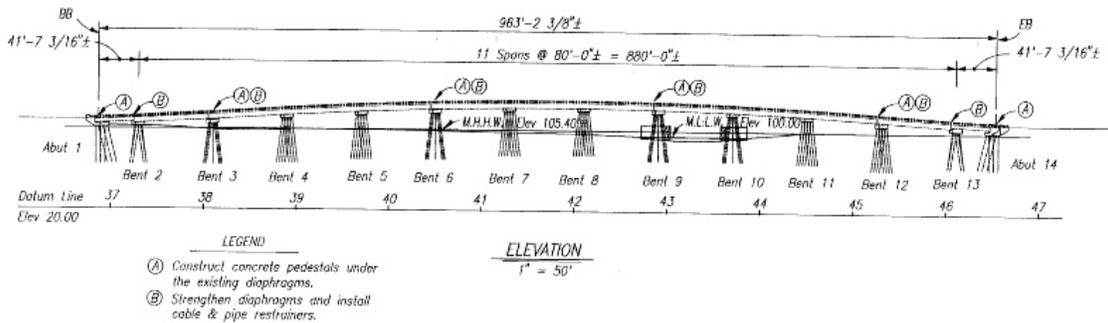
This bridge was retrofitted as part of the Local Agency Bridge Retrofit Program in 1994. The retrofit included pedestals, strengthened diaphragms with bolsters, and cable restrainers at the eight expansion joint locations on the bridge (Figure 31 and 32). However, nothing was done to strengthen or increase the ductility of the pile extensions.

Figure 31. Locations where the bridge was retrofitted to prevent unseating.

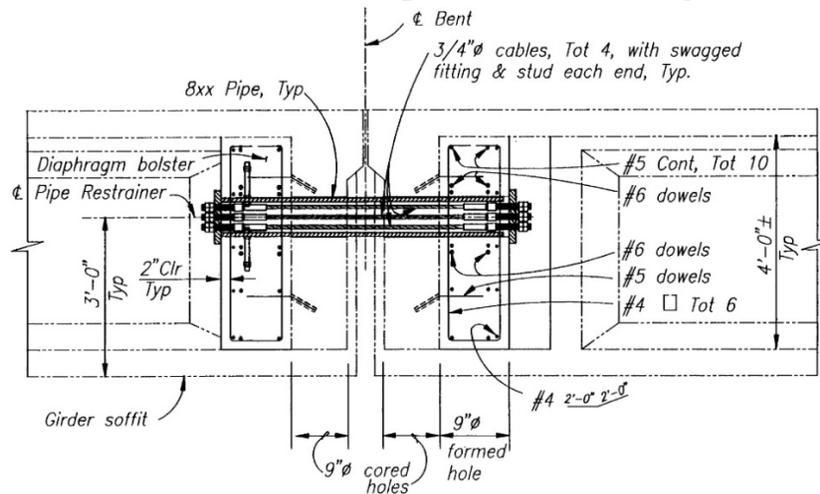
Figure 32. Retrofit at expansion joint location on Napa Slough Bridge.

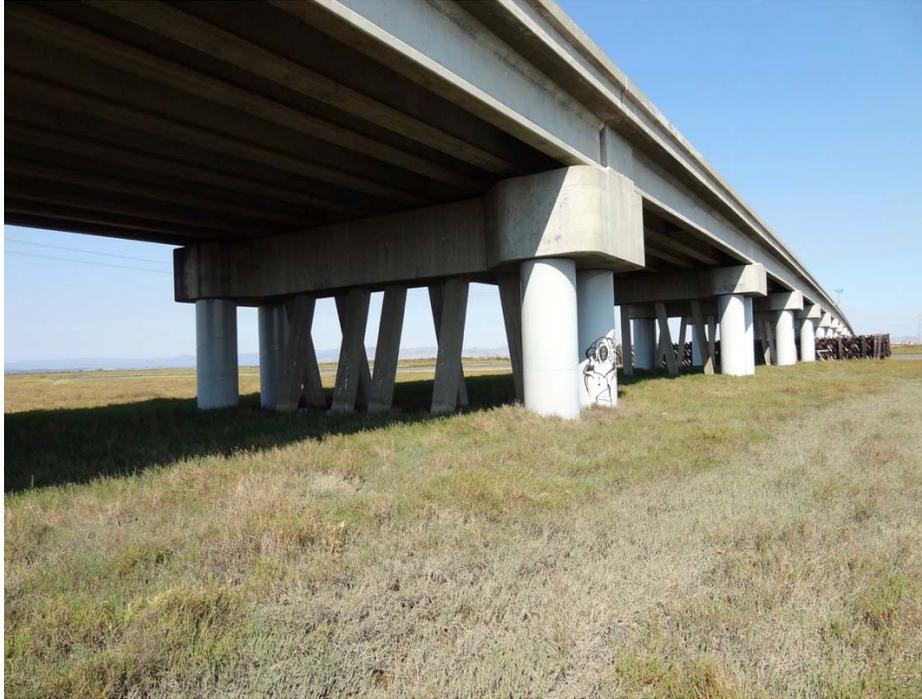
The Sonoma Creek Bridge is a twenty-two span precast girder bridge on precast pile extensions. It was seismically retrofitted with CISS Piles supporting the bent cap when it was widened in 1999 (Figure 33). The bridge is two miles from the previously studied Napa Slough Bridge and had a similar substructure and similar soil. The retrofit protected this bridge from serious damage during the earthquake.

Figure 33. Sonoma Creek Bridge with seismically retrofitted substructure.
