COMPETING AGAINST TIME

Report to Governor George Deukmejian
from
The Governor's Board of Inquiry
on the 1989 Loma Prieta Earthquake

George W. Housner, Chairman
May 1990

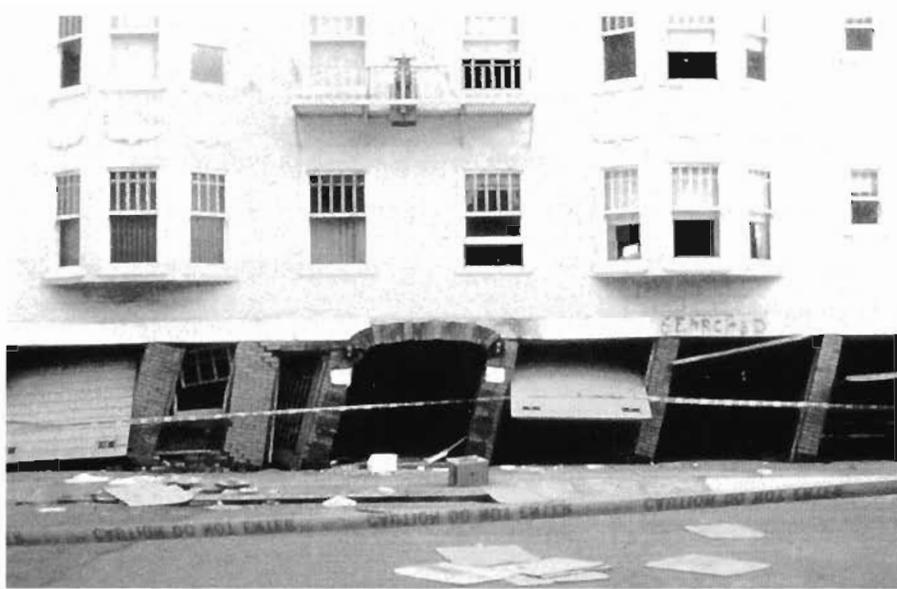
sustained major damage due to weak first stories caused by garage openings and due to poor soils (Figure 3-4). These same types of damage observations have been repeated in California earthquake after earthquake.

Figure 3-4. Many of the buildings that failed in the Marina District of San Francisco were particularly vulnerable because of the lateral weakness of the first story caused by many openings, such as for garages. Many of the most severely damaged buildings in this area were outside the original shoreline on filled areas. These soft soils experienced more severe shaking than adjacent firm soil sites and in some cases liquefied.

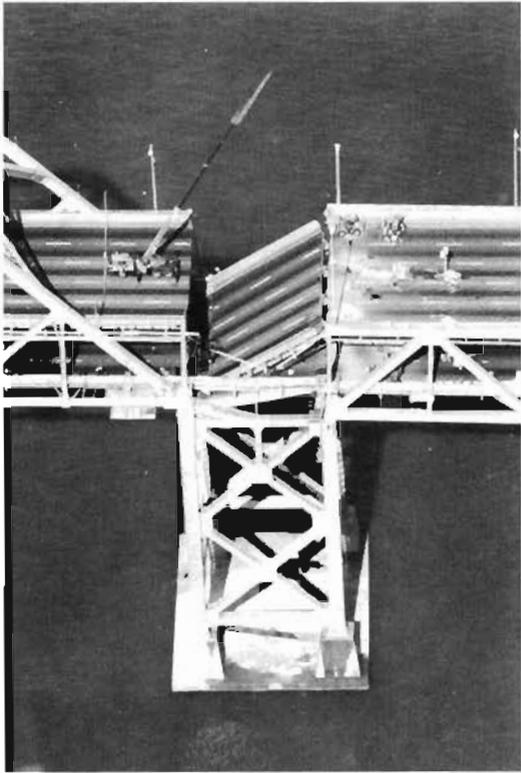
The principal earthquake damage to the bridge was the failure of the upper and lower closure spans at Pier E9. It was closed for one month for repair. These 50-foot-long upper and lower closure spans fell when the bolts failed that connected the pier and the 290' truss to the east (Figure 3-6). Another span at Pier E23, close to the eastern edge of the bridge, was near failure of a comparable type. Connections at Piers E18-E23 also failed. The concrete pedestal bases of Pier E17 cracked when the pier rocked back and forth and incurred some damage at the corners. Chapter 9 gives a detailed description of the Bay Bridge and the damage it sustained.

Figure 3-6. The upper and lower closure spans fell when the bolts attaching the east (right) truss span were severed and the truss span moved to the east, pulling the link spans off their western supports.

The closure spans linking the two long-span trusses on each side of pier E9 were supported on five inches of bearing on six-inch wide seat-type expansion joints at the west end and bolted connections at the east end. When the truss to the east broke free from its support, the closure spans were pulled with it, and the motions were large enough to slide them off the five-inch seats. As a result, the spans hinged down under gravity load, with the upper span coming down on the lower one. These hit an electrical housing before coming to rest on the west truss connection to the pier.

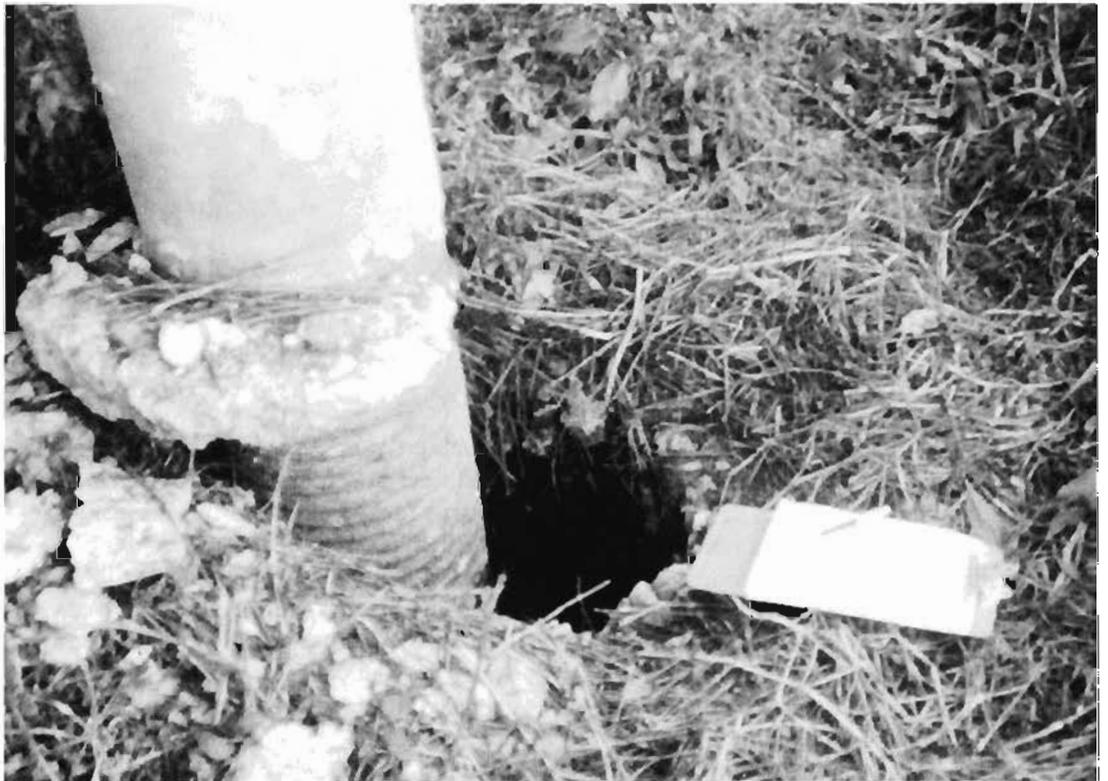
Figure 3-13. *The piles supporting the Struve Slough Bridge displaced the ground surface in several directions as much as 18°*

Some piles also apparently failed below the ground surface. Soil displacements at the ground surface around the piles in several directions were found, up to a maximum of 18" at several piles (Figure 3-13). The approach fills settled approximately 3".

The primary cause of collapse is attributed to a lack of adequate concrete confinement and shear reinforcing at the top of the columns that caused a very weak connection to the deck. This was a design deficiency by standards that were current when the bridge was designed. Current practice and standards would require ductile detailing of these members, which would have led to substantially better seismic performance.

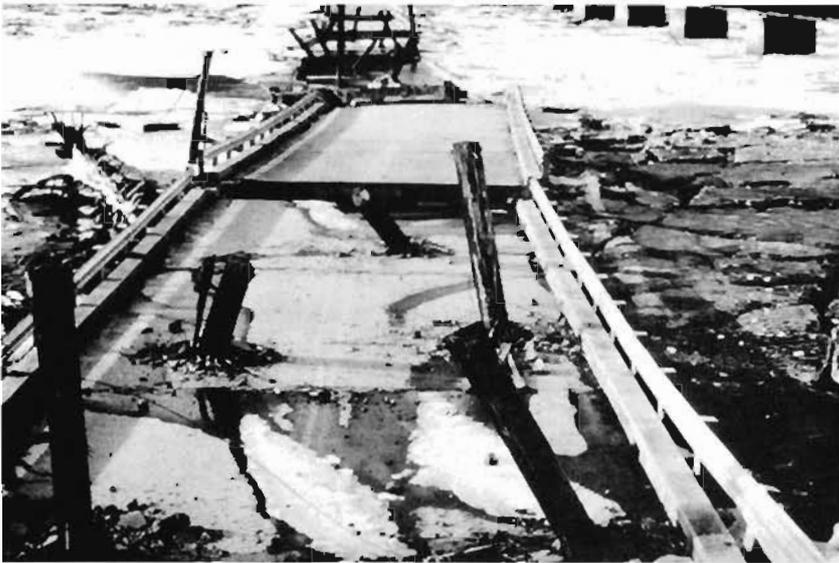
Figure 8-3. The Twentymile River Bridge was one of several that collapsed during the 1964 Alaska earthquake. Spans of this 825-foot concrete girder bridge fell off their timber pile bents into the water

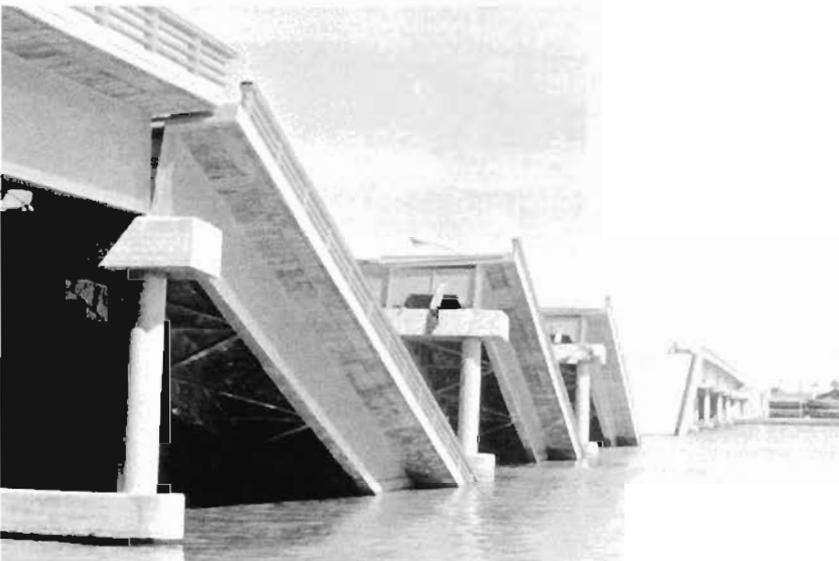
Figure 8-4. One of the bridges damaged in the 1964 Niigata (Japan) earthquake was the 12-span Showa Bridge. Two piers in the middle of the river failed, causing three spans to drop. Two other spans slipped off piers that remained upright

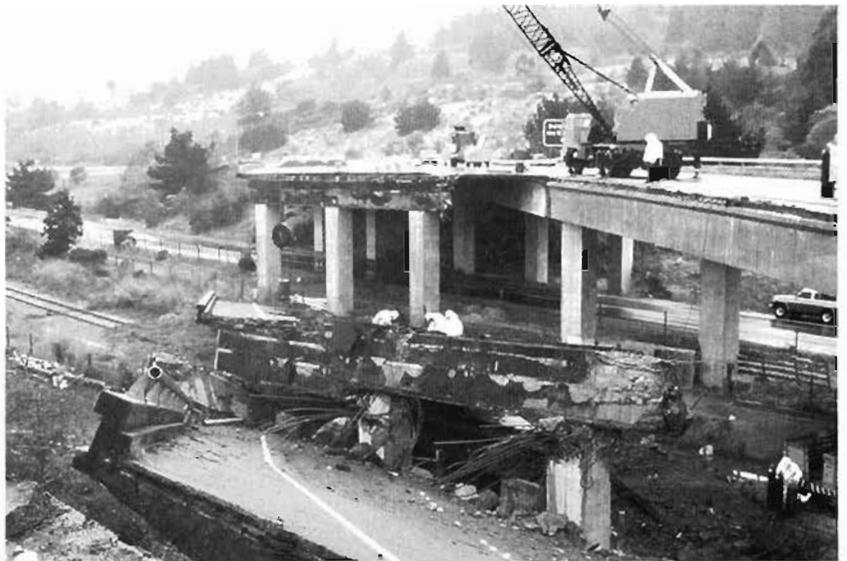
Figure 8-5. Two spans of the Fields Landing Overhead, which had not been fitted with joint restrainers, slipped off their narrow seat supports during the 1980 Ferndale earthquake

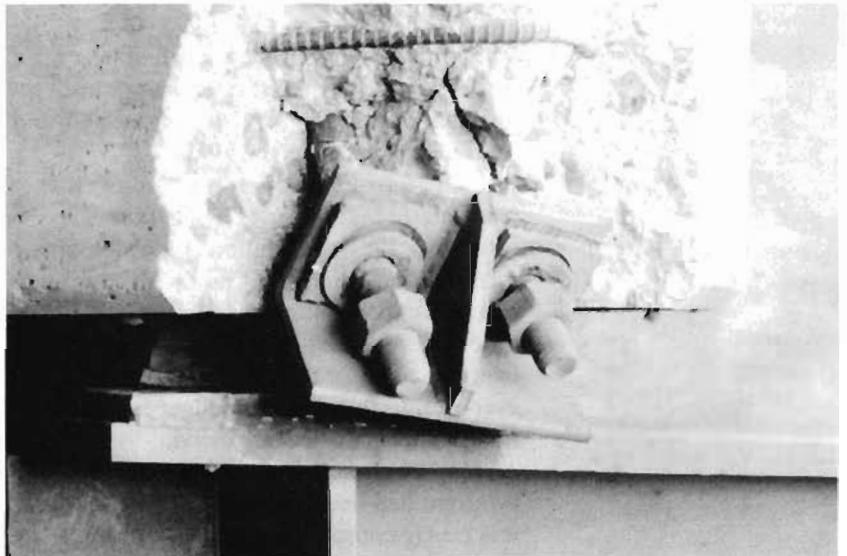
Figure 8-6. Although the Whitewater Overcrossing had been retrofitted with cable restrainers at the abutments, an improperly connected cable caused the restrainer at one abutment to fail during the 1985 Palm Springs earthquake. This permitted a movement of several inches to occur, which damaged the abutment seat support.

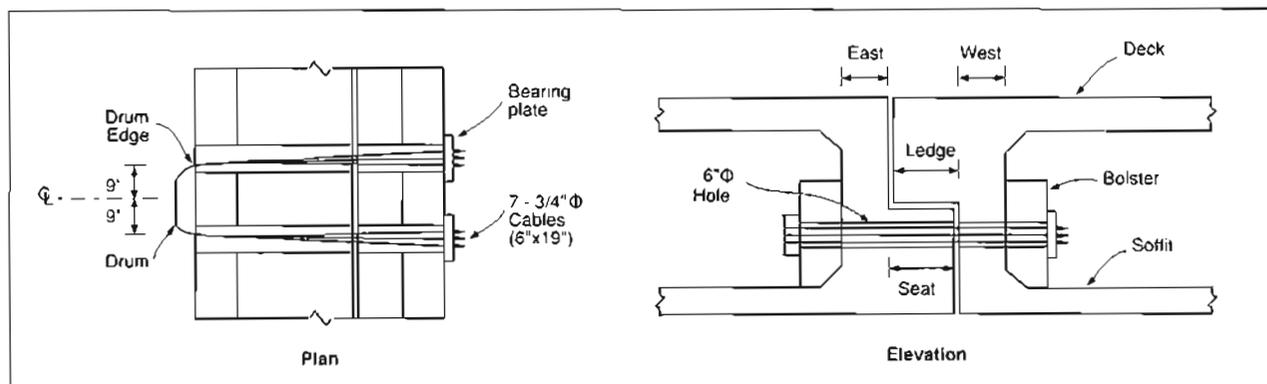
Figure 8-7. This diagram shows an example of a joint restrainer device that Caltrans developed after the 1971 San Fernando earthquake for the purpose of keeping bridges together at their expansion joints. Tests on this particular device carried out 12 years after the retrofit program began showed that it failed by pulling through at the diaphragm, rather than in the preferred mode of cable elongation

Caltrans developed several devices [Degenkolb, 1978; Mancarti, 1984] to accomplish the retrofit. They used either steel cables or bars passing through a joint and attached to each side with special anchorages (Figure 8-7). Some slack was built in that permitted thermal movements, but large openings, sufficient to move one section off the bearing seat of the second during an earthquake, were intended to be restrained by tensile forces developed in the cables or bars. These devices were designed using calculations; laboratory tests were used only to determine the stress-strain relations of the cables and bars [Degenkolb, 1978].

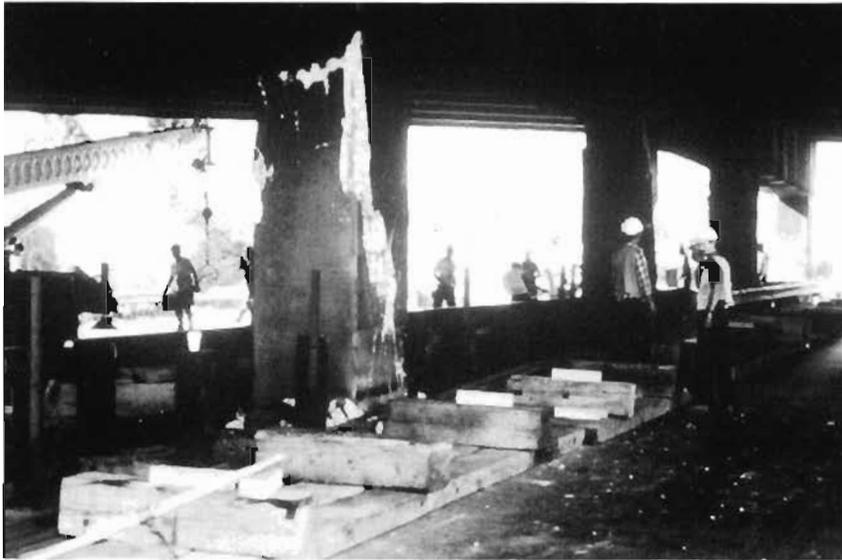
Figure 8-8. The near collapse of a 5-column bent supporting the I-605 crossing over the I-5 during the 1987 Whittier Narrows earthquake provided the impetus to initiate the state-wide program to retrofit bridge columns and other supporting elements

The Whittier Narrows earthquake of October 1987 was a significant event for the bridge retrofit program, even though it was only a Magnitude 5.9 earthquake. A five-column bent supporting the crossing of the I-605 freeway over the I-5 freeway nearly collapsed (Figure 8-8) during the morning commute. Subsequent analysis indicated that membrane tension in the deck provided by the joint restrainer cables provided the margin of seismic capacity by which collapse

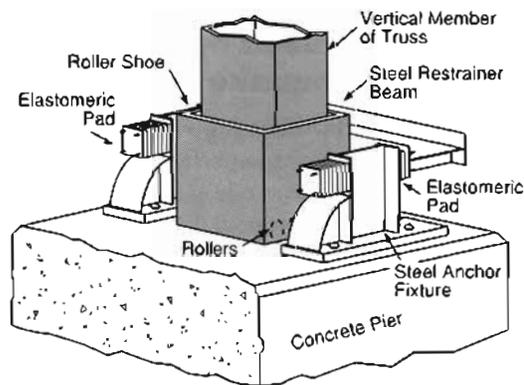
Damage only occurred to those areas where retrofit measure Number 4 was used. Figure 9-11 illustrates the basic mechanism of retrofit measure Number 4. It consists of a steel restrainer beam (21" WF 68 lbs/ft) in the transverse direction flexibly attached to two rigid anchor fixtures through four one-inch diameter steel (A325) rods placed at

Figure 9-11. Restrainer retrofit installed on the expansion sides of Piers E17 through E22, rollers are at the base of the vertical member of the truss within the roller shoe.

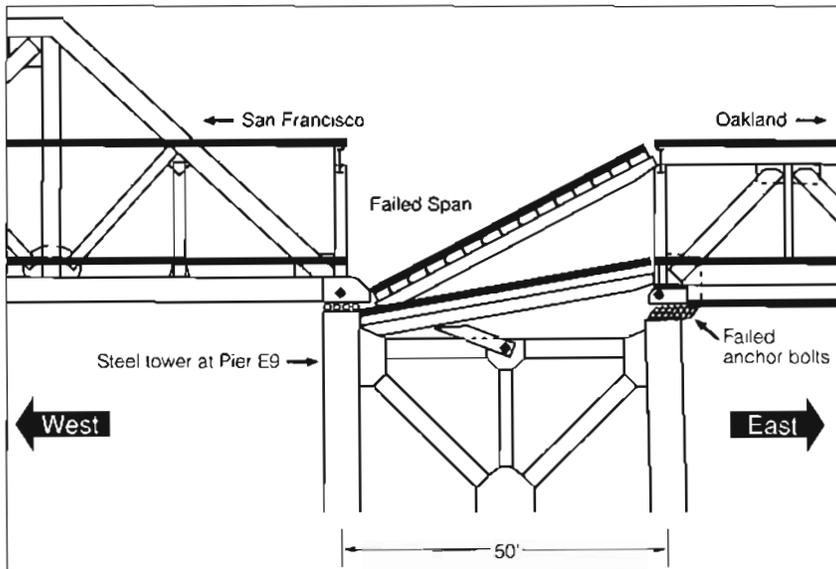
Figure 9-12. Positions of upper and lower decks at Pier E9 after the earthquake

During the earthquake, the upper and lower decks of the bridge immediately above Pier E9 collapsed as shown in Figure 9-12. As previously described, E9 serves as an anchor pier in the longitudinal direction for the entire bridge superstructure from Pier E4 to Pier E11, a distance of 3,176'. Therefore, when compared with each of Piers E4 through E11, Pier E9 is very rigid and capable of carrying very large loads. The steel tower and the top of the concrete pier at E9 are visible in the aerial photograph of Figure 9-13. The plan dimensions of the tower are 50.0' by 66.0' in the longitudinal and transverse directions, respectively, as measured center-to-center of the columns.

The collapsed upper and lower deck systems above Pier E9 (Figure 9-12) were removed in sections and new deck systems were constructed.

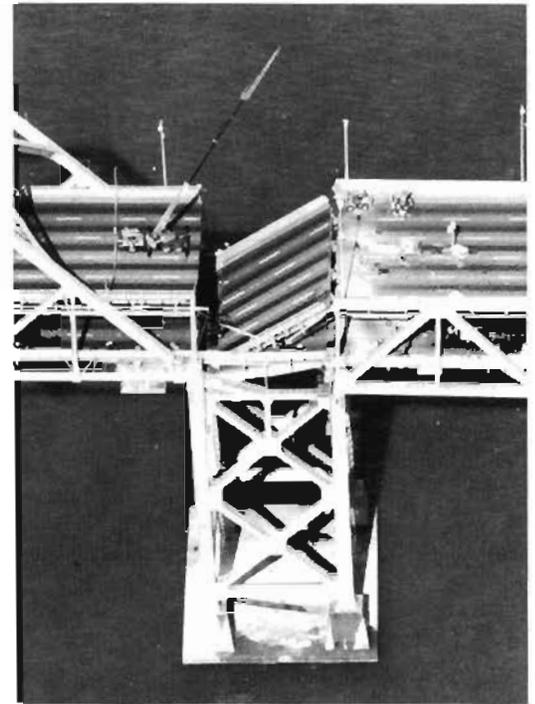
Figure 9-13. Aerial view of collapsed upper and lower decks.

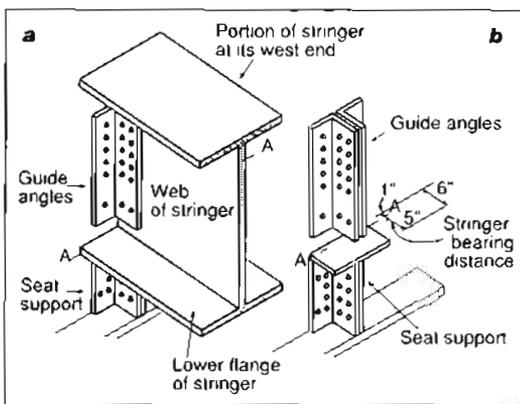
Figure 9-15. Support conditions at west end of deck stringer: view A shows stringer in position, view B shows stringer removed.

bearing seats at the west ends of all stringers have an 8" longitudinal seat width rather than the 6" width used originally as shown in Figure 9-15b. Should the fixed-shoe bolts on the east-side columns fail again during a future earthquake, the west end positive stringer attachments would most likely fail, allowing the stringers to move off their supports. Recognizing this possibility, a secondary support system is planned for installation by Caltrans that will prevent the deck systems from dropping should the stringers move eastward more than 8" relative to their seat supports.

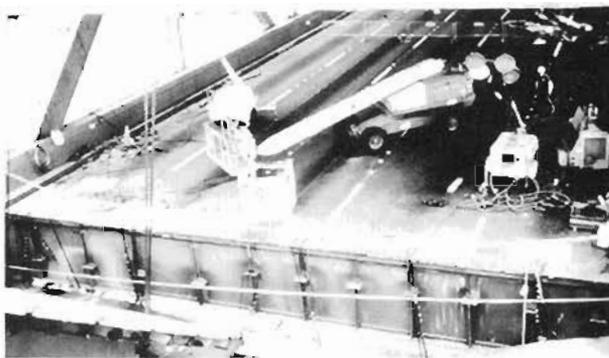
Figure 9-17. Vertical and transverse supports at west end stringer locations of both upper and lower decks.

During the earthquake, the seismically induced, resultant, longitudinal, inertia force in the 632 feet of tributary superstructure from the west side of Tower E9 to Pier E11 was transmitted into the two fixed shoes on the east side of the tower. This force was sufficiently large to shear off the 40 1-inch diameter bolts used to anchor both fixed shoes to the tower (Figure 9-12). This shear failure allowed the shoes to move eastward relative to their tower supports by an amount at least equal to the 5" stringer bearing distance shown in Figure 9-15b, thus permitting both upper and lower deck systems to fall off their west-end supports into the positions shown in Figures 9-12 and 9-13. Figure 9-15a shows the seat and transverse web supports at the west-end locations of the four upper-deck stringers immediately following the earthquake. These supports experienced various amounts of damage, as indicated by the close-up photograph in Figure 9-16b. The seat and transverse web supports at the west-end stringer locations of both the upper and lower deck systems, all of which were damaged, are shown in Figure 9-17. While the east-end

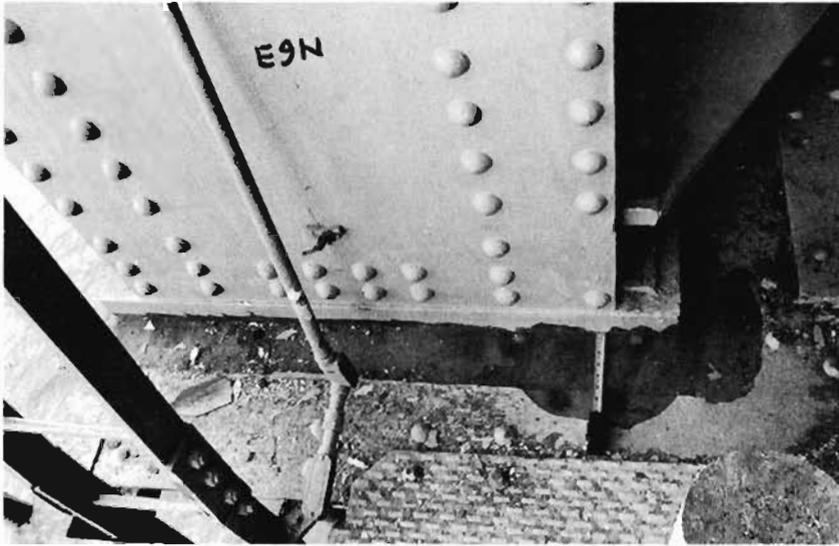
Figure 9-18. Anchor shoe on top of the northeast column of Tower E9 after the earthquake.

Figure 9-18 shows the fixed shoe on top of the northeast column of Tower E9 following the earthquake. The amount of permanent slippage of the shoe relative to its tower support was evident by the orange-colored undercoating paint exposed by the permanent displacement of the shoes. The permanent slippage was measured to be approximately 5 1/2" in the easterly direction and 1" in the northerly direction. The maximum slippage in the easterly direction was at least 7", since the surface coating of paint had been rubbed off over the entire 7" distance from the original shoe position to the easterly edge of the supporting base plate. The permanent slippages of the fixed shoe on the top of the southeast column of Tower E9 differed only slightly from those described above for the fixed shoe on top of the northeast E9 column. The maximum slippage of this fixed shoe in the easterly direction was also at least 7".

Prior to the above described deck repairs, the bridge superstructure from the east side of Tower E9 to Pier E11 was jacked back into its original position at the top of the two east columns of Tower E9, and the fixed shoes on these columns were reconnected using 1-inch diameter A325 high-strength bolts. The final repair operation at Pier E9 was the installation of new curb and railing sections.

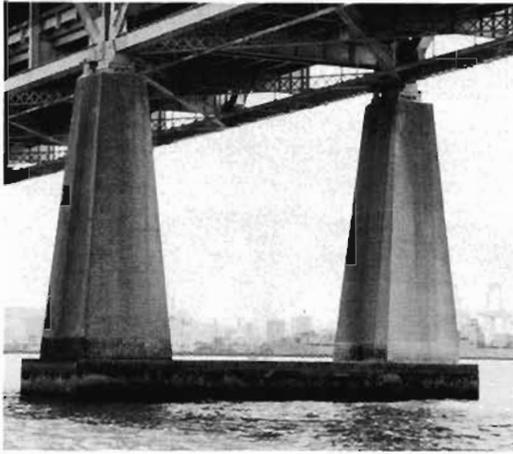
Figure 9-20. View of Pier E17 from the water.

Pier E17, which serves as an anchor pier for the bridge superstructure from Pier E11 to Pier E17, a distance of 1740', experienced damage at the bases of its two concrete pedestals during the earthquake. The photograph in Figure 9-20 shows these two tapered pedestals in their positions immediately below the superstructure and resting on a common concrete base. Figure 9-21 shows elevation and plan views of the pier with sectional views (A-A and B-B) providing structural details. The pedestals are 53'3"

During the earthquake, the tops of the two pedestals moved sufficiently in horizontal directions relative to their bases to cause serious fracturing of the concrete and yielding of the vertical reinforcing bars immediately above the bases at Elev. +8'. The fracture patterns of the concrete (Figure 9-22) were confined to the base locations indicated. Only two of the eight corner locations suffered no apparent fracturing of the concrete; while, as seen from the fracture patterns, relatively large chunks of concrete broke from the pedestals at the other six corner locations. At the southwest corner of the south pedestal, the concrete broke away sufficiently to expose two vertical reinforcing

Repair of damage to the pedestals of Pier E17 has not been done as of this writing. However, Caltrans has plans for retrofitting this pier through jacketing of the pedestals.

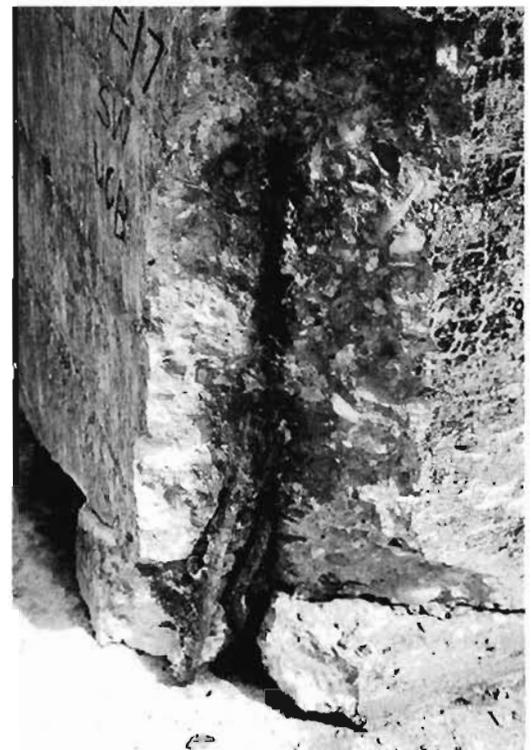
bars at a lap splice, as seen in the photograph of Figure 9-23. The spalling of the concrete at this location was caused by the outward buckling of one of these bars, which was straight before the earthquake as evidenced by the bar's corrosion-marked initial position in the concrete. In order for this bar to buckle under compression, it first had to undergo inelastic yielding in tension. The photograph in Figure 9-24 shows the buckled shape in a close-up view. The bar buckled outward about 1 1/2" over a length of about 12". To buckle in this manner it is estimated that the inelastic elongation of the bar was about 1/2". Since the concrete fractures in the pedestals were limited to the base locations, the pedestals appear to have rocked, essentially as rigid bodies, about their bases, causing bar elongations of the type described above. These elongations allowed uplift separations to occur between the bases of the pedestals and their common concrete pier support at Elev. +8'. Following the earthquake, separation cracks were clearly visible at this elevation around the entire perimeter of the south pedestal and around most of the perimeter of the north pedestal. In view of the estimated 1/2-in. inelastic bar elongation, it is reasonable to believe the uplifts were of a similar magnitude. Clearly, the pedestal base overturning moments reached yield levels during the earthquake.

Close observation of the exposed reinforcing bars reveals serious corrosion. All vertical reinforcing in the pedestals needs further investigation.

Figure 9-23. Spalled concrete and exposed bars at SE corner of south pedestal at Pier E17. Two bars are shown. The bar to the left terminated before entering the base; the other one, which buckled, passed from the base and lapped the other bar.

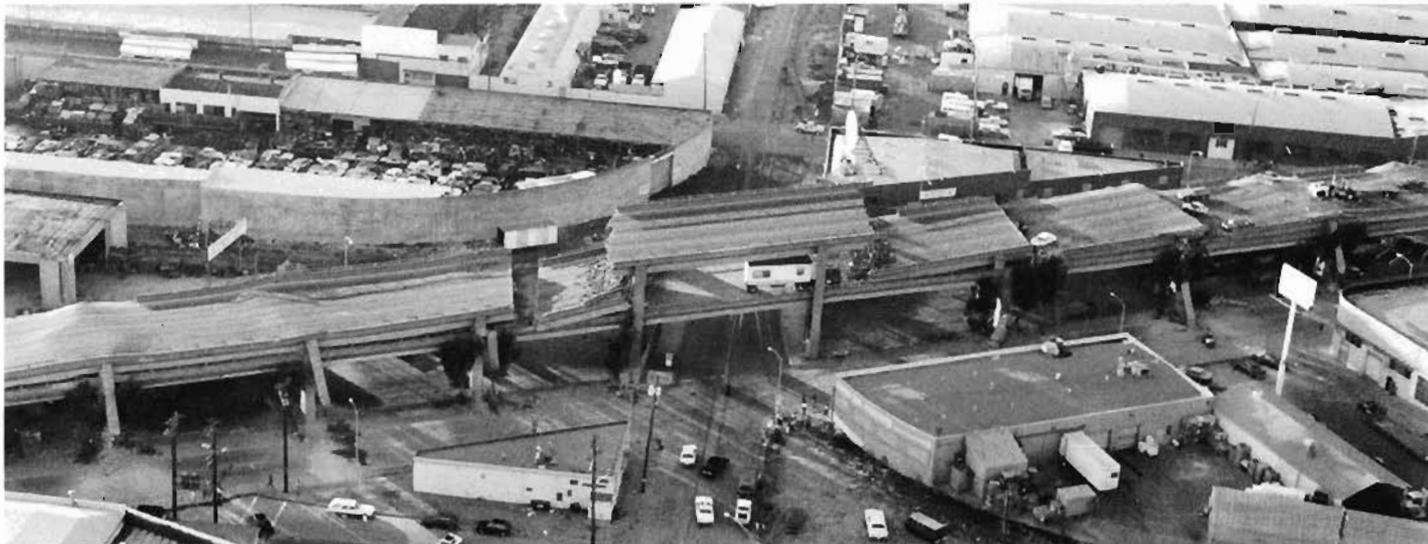
Figure 10-3. Cypress Viaduct after collapse.

Cypress Viaduct was heralded as “a solution required to provide for the passage of 50,000 vehicles per day through a congested area without undue delay, and yet make it possible to efficiently construct the relieving facility within the confined space immediately adjacent to traffic.” [*Highway Magazine*, 1958]. During the Magnitude 7.1 Loma Prieta earthquake, a large portion of the structure collapsed (Figure 10-3). The collapse extended from Bent 63 in the south through Bent 112 in the north. Only Bents 96 and 97 remained standing.

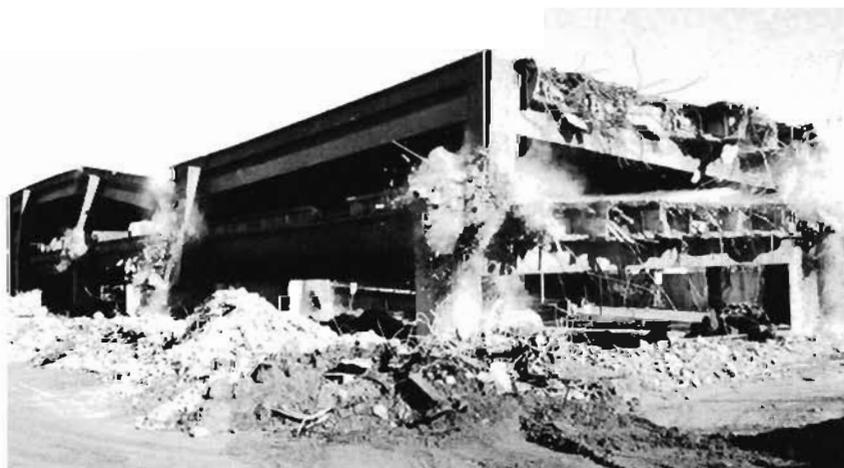
Figure 10-4. Cypress Viaduct during demolition.

Shortly after the earthquake a series of six contracts was awarded by Caltrans for demolition and removal of the Cypress Viaduct structure and resurfacing of frontage roads (Figure 10-4). The first contract was awarded on October 31, 1989 and the final contract on January 10, 1990. The total cost

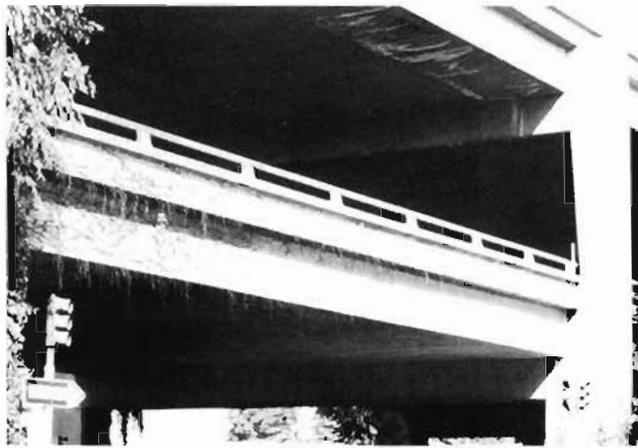
Figure 10-11. B1 bent with no external damage

bent dimensions are shown in Figure 10-10. An example of a B1 bent with no external damage is shown in Figure 10-11. The upper frame is connected to the lower frame by shear keys (“hinges”) at the base of the upper frame columns. The columns of the lower frame are connected to the pile caps by shear keys. Figures 10-12, 10-13, and 10-14 show the B1 bent reinforcement details from the as-built plans. This detailing will be referred to in subsequent sections.

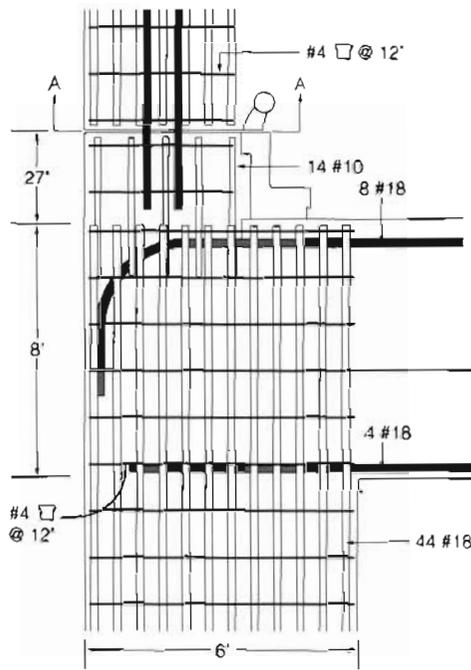
Figure 10-16b. Typical connection detail 2—B1 bent lower girder-to-column connection.

Connection Detail 2—Lower Girder-to-Column Moment Connections. The joint detail at the junction of the lower girder and the lower column, immediately below the shear keys, is shown in Figure 10-16b. These joints are found in the B1 bents below both shear keys and in the B2 bents below the lower west shear key. This region provides bearing support to the upper column. The lower girder negative reinforcement (8 #18 bars) enters the top of the joint region and bends down into the column. The bends start near the column centerline and all bars are bent in the same

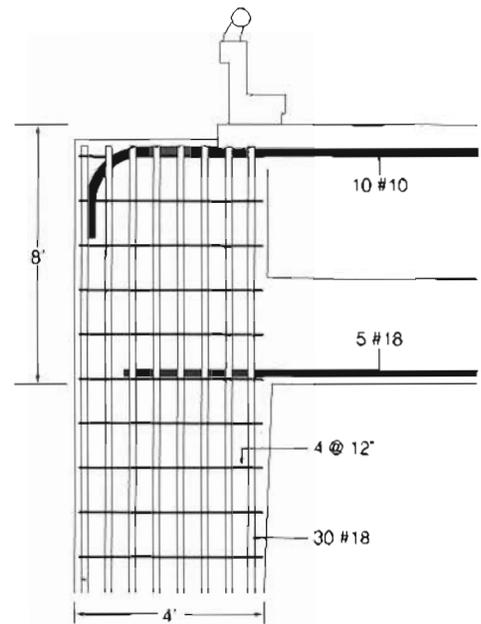
Figure 10-17. Typical connection detail 4—B1 bent upper girder-to-column connection.

Connection Detail 4—Upper Girder-to-Column Connection in the B1 Bents. The upper girder-to-column moment joint of a B1 bent is shown in Figure 10-17. The reinforcement in the top of the girder (10 #10 bars) is bent down into the column as described above for detail 2. The longitudinal reinforcement in the column terminates in the upper girder-to-column joint and is not bent over into the girder. The reinforcement in the bottom of the girder (5 #18 bars) terminates horizontally in the joint region of the column.

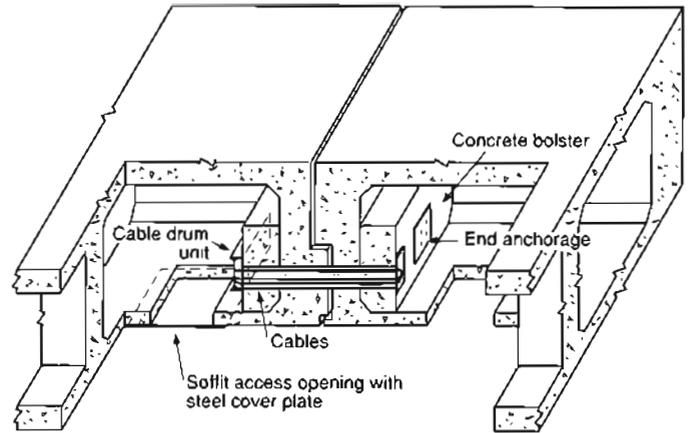
Figure 10-21.
Typical expansion
joint retrofit.

As part of the retrofitting program Caltrans instituted following the San Fernando earthquake of 1971, longitudinal restrainers were installed in the Cypress Viaduct in 1977 at all transverse joints in the box girder bridge superstructures [Gates, Dec. 11, 1989]. The retrofitting detail employed in all the expansion joints on the Cypress Viaduct surveyed by the U.C. investigative team is shown in Figure 10-21 [Nims et al., 1989].

The typical restrainer consisted of seven cables tied to anchor plates which bear on the end-diaphragm of the box cells. The anchorage consisted of a plate approximately 12" square and 1-1/2" thick. The cables and anchors were installed in three locations across the width of the deck: in the two exterior cells and in the middle cell (Figure 10-22). They were installed through man-holes cut into the soffit of the box girder. This is a typical retrofitting detail [Degenkolt, 1978], and is consistent with what was observed by the survey teams. Typically, the cables used in the California retrofitting program are 3/4" pre-formed 6x19 galvanized cables (Federal Spec. RR-W-410C), and are designed to resist (elastically) a force equal to 25% of the weight of the lighter deck section connected. The swaged end fittings are required to develop the minimum breaking strength of the cable.

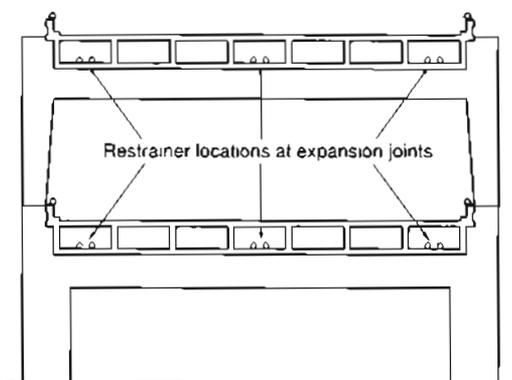
Figure 10-22. Section of a typical bent showing cable restrainer locations.

Restraining features such as keys or restrainer cables were designed to a force level equal to .25 times the contributing dead load applied to the feature. Design was at the working stress level, with an allowance of 33% overstress. It was felt that such a design provided resisting capacity up to .50g at ultimate strength. At the Cypress Viaduct the seismic retrofit consisted of the addition of cable-restrainer units to all expansion joints in the structure. The average joint restrainer configuration used 3/4" cables arranged into three separate double-cable units. At the average joint a total of 7x2x3 or forty-two cables provided restraint. Concrete bolsters were added to strengthen the diaphragms in the vicinity of the restrainer units.

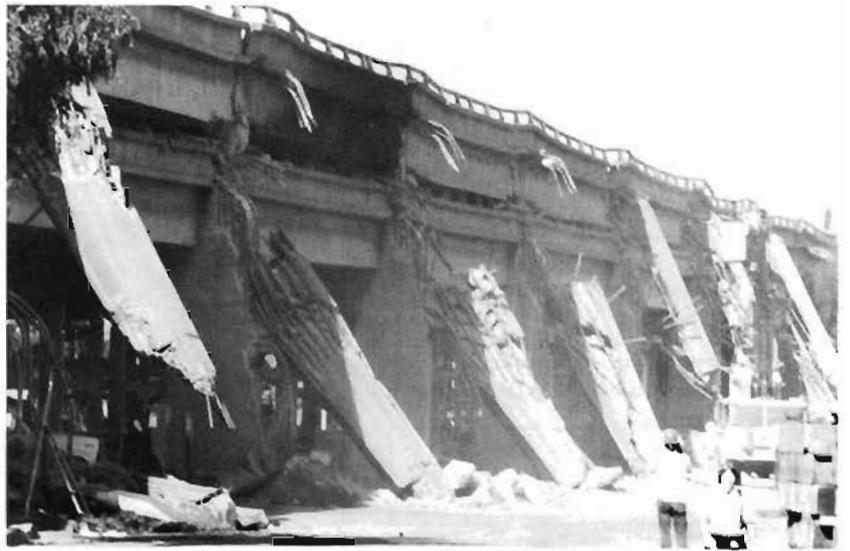
Figure 10-23.
Overall view of
the collapse
between Bents 84
and 90 (east side)

74	B8	Upper level partially collapsed, cantilever failed, transition between upper girder flat and upper girder tilted.
75-80	B2	Upper level partially collapsed, upper girder tilted, pin-ended column remained in place.
81-94	B1	Upper level collapsed, upper girder flat on lower girder, typical B1 failure.
95	B3	Upper level collapsed, upper girder flat on lower girder, east column displaced to north.
96-97	B3	Standing, extensive cracking in lower-girder lower-column joint, evidence transverse cycling.
98	B3	Upper level collapsed, upper girder flat on lower girder, east column displaced to north.
99-103	B1	Upper level collapsed, upper girder flat on lower girder, typical B1 failure.
104	B1	Upper level collapsed, extensive damage to lower girder, upper girder flat on lower girder, both upper and lower decks are on the ground at the expansion joint north of 104, typical B1 failure.
105	B1	Upper and lower levels collapsed, upper girder flat on lower girder, lower girder on ground.

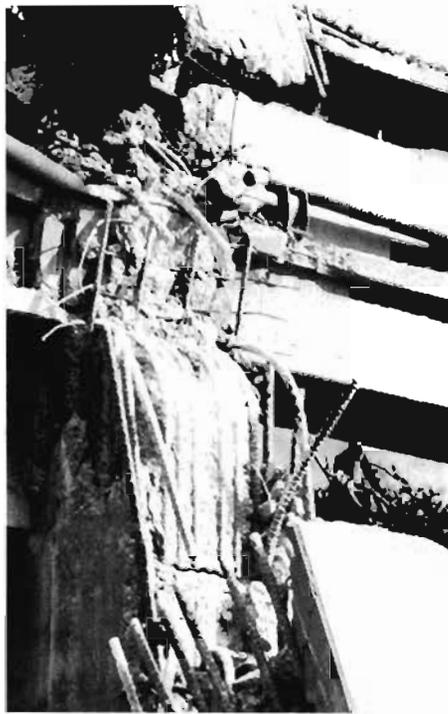
Figure 10-24. Overall view of the failure
of the west side of Bent 90

surface was defined by the curved negative reinforcement bent down into the joint (Figures 10-24 and 10-25). The shear key did not fail in pure shear, as evidenced by the cone of concrete still attached to the four #10 bars that extended through the key into the lower column (Figure 10-26). The upper girder-to-column joint sometimes failed completely, but in other cases was just severely cracked. Almost all the damage in this upper joint seems to have been produced as a result of the collapse of the upper deck onto the lower deck. The #4 transverse ties in the joint region, as well as those in the column region, either failed or were severely

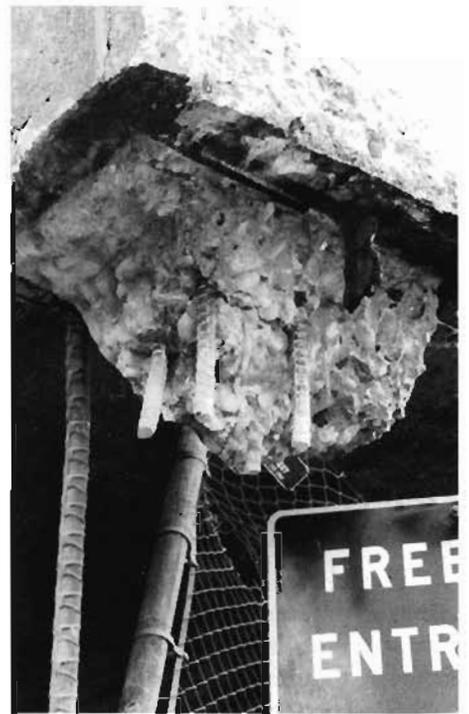
Figure 10-25. Close-up of the stub
and joint regions of Bent 90 (west side).

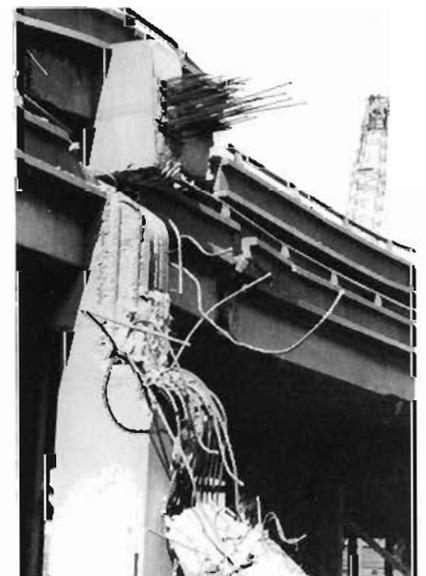
Figure 10-30. Close-up of protruding unbonded post-tensioning cables.

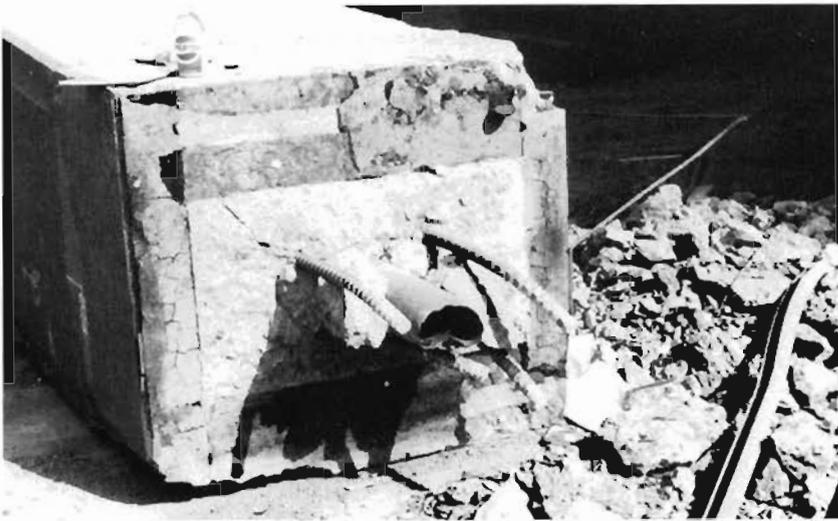
Figure 10-31. Example of failure of the continuous connection of a B2 bent.

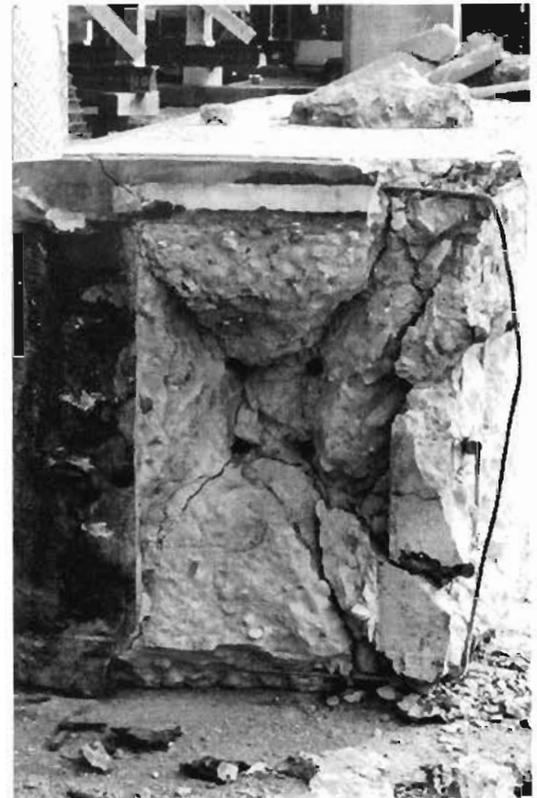
Figure 10-32. Lower shear key of the upper west column of Bent 71

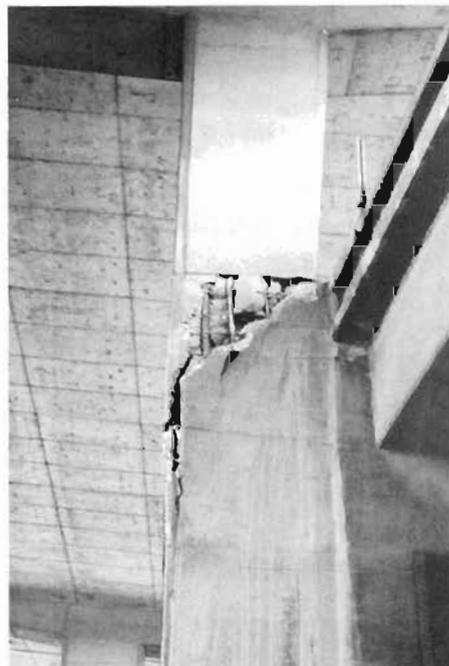
Figure 10-34. Retrofitting cables and anchorage at the expansion joint north of Bent 62

The expansion joints in the collapsed region were heavily damaged. In the uncollapsed portion, expansion joints suffered severe to minor damage. Most of the damage appeared to be secondary, and resulted from the loss of column support to the upper deck. The retrofits failed either by the anchorage pulling out or by the snapping of the cables, usually at about mid-length. In some places there was evidence of concrete crushing at the lower side of the hole through which the cables passed, indicating that the anchorage failed while resisting the downward motion of the dropping deck. During field investigation, examples of expansion joint damage or retrofitting failures were observed in the expansion joints north of Bent 24, Bent 62, and Bent 112. Figure 10-34 shows damage at the expansion joint north of Bent 62.

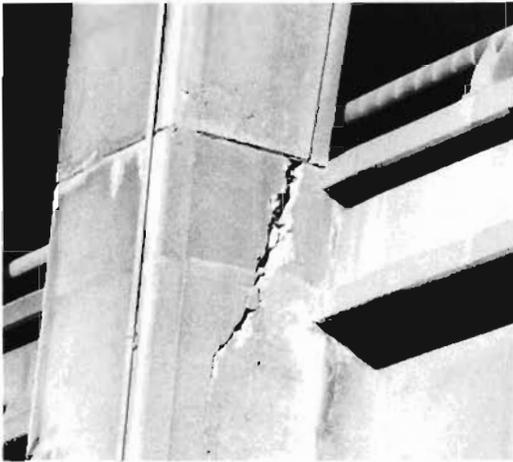
Figure 10-35. Damage below the west shear key, Bent 27

upper column (Figure 10-35). The most serious evidence of this cracking was in the uncollapsed B1 bents, where the cracks followed the same path as the eventual failure surface (Figure 10-36). This same pattern of cracking was observed in many other bents, both collapsed and standing (Figure 10-37), and was indicative of very serious damage—to the point of imminent collapse. Bents 27-29 and Bents 32-62 exhibited this type of extensive cracking.

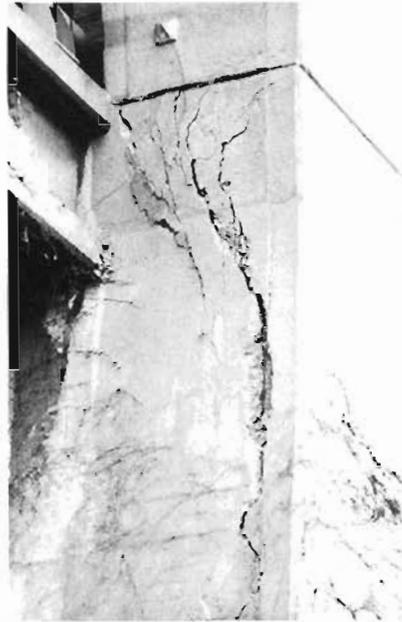
Figure 10-36. Cracking below the west shear key, Bent 55.

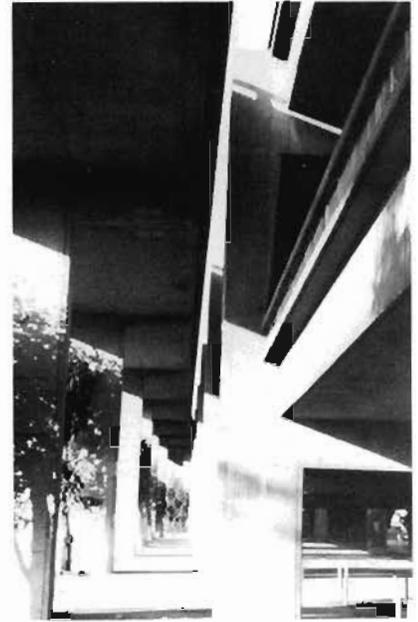
Figure 10-37. Cracking below the east shear key, Bent 56.

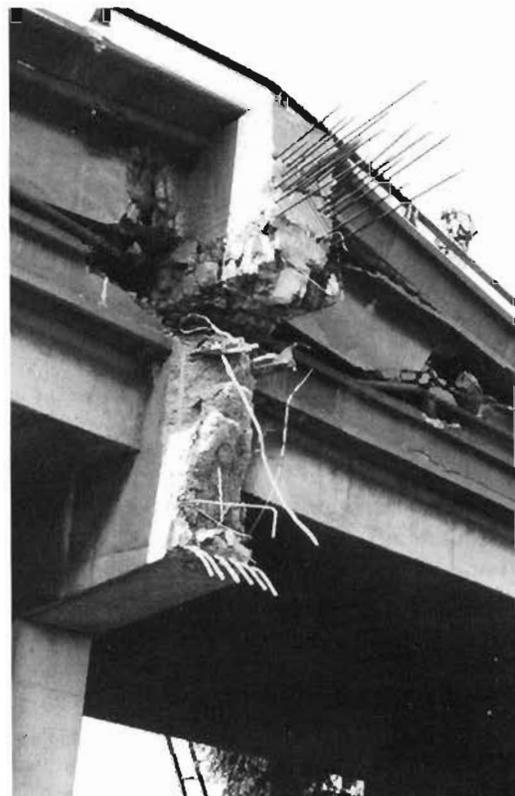
Figure 10-38. Bent 50 and off-ramp where there was evidence of pounding.

Debris was found on the ground at Bent 50 between the southbound 14th Street exit ramp and the upper roadway, suggesting pounding between the ramp and roadway (Figure 10-38). The clearance between the exit ramp and the roadway appeared to be about 6-8". Pounding was observed only at Bent 50.

Debris on the ground at Bent 50 suggested pounding between the bent at the level of the upper roadway and the adjacent exit ramp (Figure 10-38). The clearance between the exit ramp and the bent appeared to be about 6-8"; inspection showed no signs of damage consistent with this level of lateral displacement in the bent. If the bent had deformed 4" to 6" more, it would probably have collapsed. A review of the as-built drawings [State of Calif., Dept. of Trans., various dates] showed that the connection of the exit ramp column to the pile cap was a joint that incorporated a shear key. Therefore, this joint had little moment capacity. Pounding appears to be primarily the result of rigid body rotation of the exit ramp about a north-south axis at the top of the pile cap.

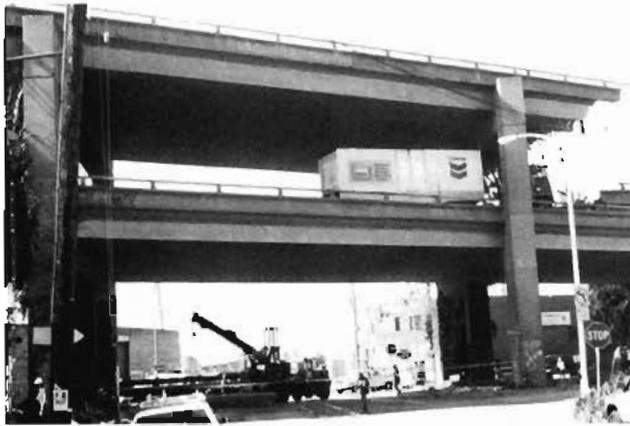
The two B8 bents, Bents 73 and 74, had three shear keys, as did the B2 bents. However, the upper east columns were not supported directly on the lower columns, but were supported on a cantilever extension of the lower girder, both of which failed completely. Figure 10-39 shows the cantilever section failure.

Figure 10-39. Failure of the cantilever section of Bent 73 (east side)

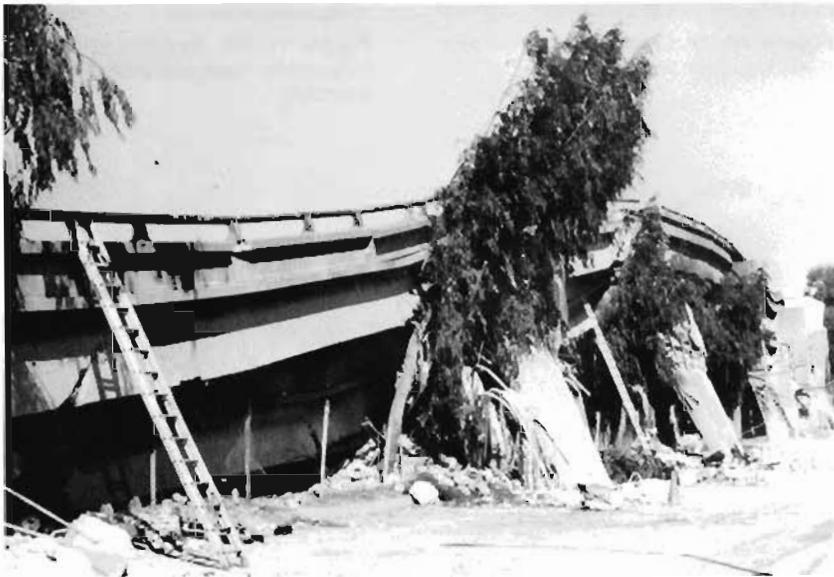
Figure 10-40. General view of standing Bents 96 and 97 (east side).

The span of the upper roadway between Bents 96 and 97 was the only portion of the upper deck between Bents 63 and 112 that survived the earthquake. Bents 95-98 were B3 bents and were skewed to the north-south axis of the Viaduct (Figure 10-40). The skew alignment of the bents was to accommodate 26th Street, which passes under the Viaduct between Bents 96 and 97. The B3 bents have three columns at the lower level and shear keys at the junction of the upper girder and upper columns. The reinforcement in

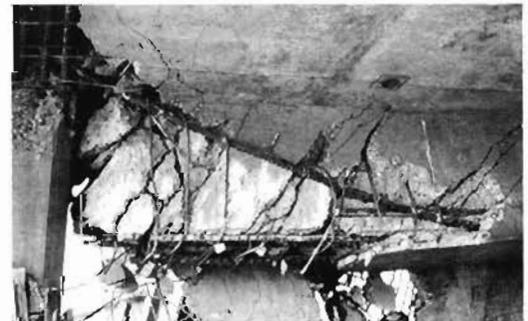
Figure 10-43. Failure of the lower girder at Bent 104

deck collapsed onto the lower deck in a typical B1 type failure. These were the only bents that exhibited this type of lower girder failure. Figures 10-43 and 10-44 show the failure of the lower girder of Bent 104 in the region west of the column joint.

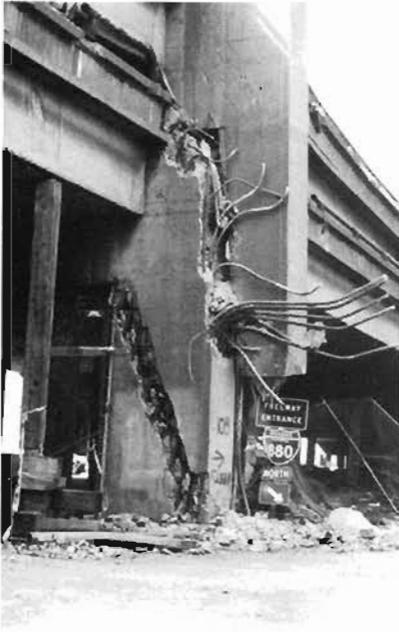
Figure 10-44. Close-up of the failure of the lower girder in Bent 104 (west side)

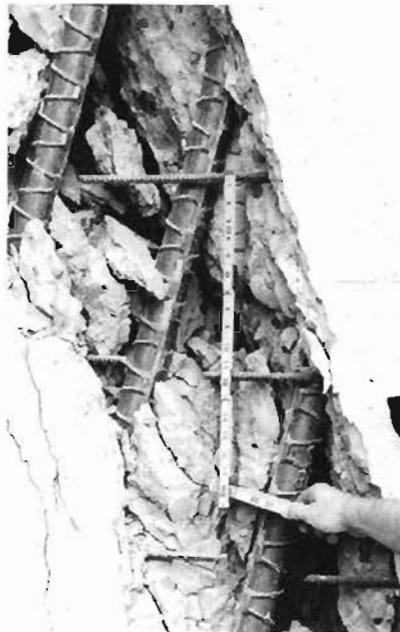
Figure 10-45. Shear failure of the east lower column of Bent 108

At only one location, Bent 108, did a column fail in shear. Bent 108 was a B9 bent, which is similar to a B1 bent but with a shorter lower column height. Figures 10-45 and 10-46 show the shear failure of the east column of Bent 108.

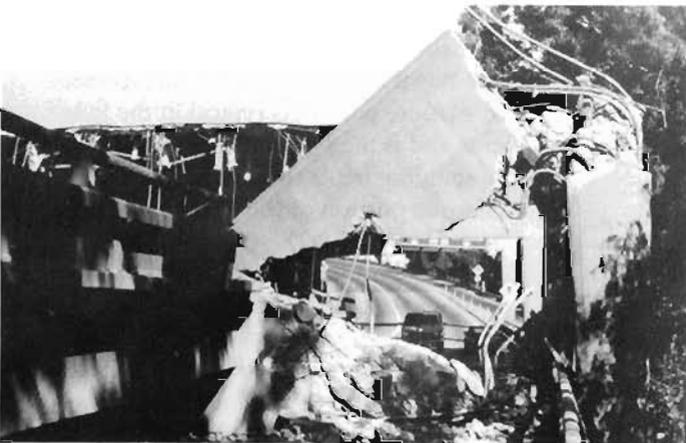
Figure 10-46. Close-up of the shear failure of the east lower column of Bent 108
