COMPETING AGAINST TIME

Report to Governor George Deukmejian
from
The Governor's Board of Inquiry
on the 1989 Loma Prieta Earthquake

George W. Housner, Chairman
May 1990

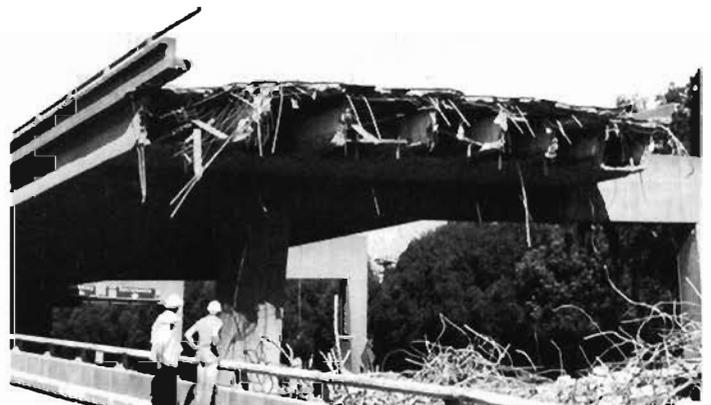
Figure 10-47. Shear failure in upper girder of Bent 112 (east side).

At only one location, the northernmost collapsed Bent 112, did the upper girder fail in shear (Figure 10-47). Bent 112 was a type B11 bent, with the bent supporting only the upper roadway. The lower deck was supported directly on the ground with rocker bearings. The upper roadway box girder deck failed in shear just to the south of Bent

Bent 112 was the northernmost collapsed bent and was a B11 bent. This bent supported the upper roadway only, and the lower roadway terminated at the north abutment. Figure 10-47 shows the east side of Bent 112 after collapse—the column remained standing but the girder failed in shear. Bent 112 was the only bent where girder failure caused the bent to collapse. The expansion joint approximately 20 feet north of Bent 112 failed during the earthquake. Three sets of U-shaped cable restraints tied the decks together longitudi-

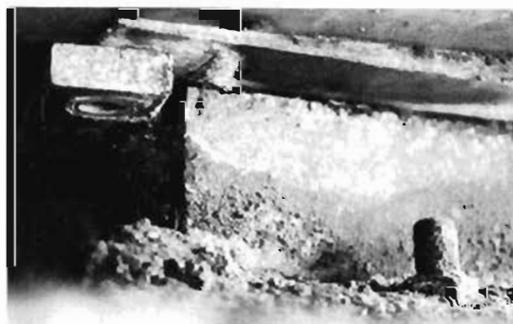
Figure 10-48. Shear failure of roadway just south of Bent 113

nally at the expansion joints. The outer two sets suffered anchorage failure, while strands in the central pair of cables snapped. North of the expansion joint, the roadway deck failed in shear (Figure 10-48).

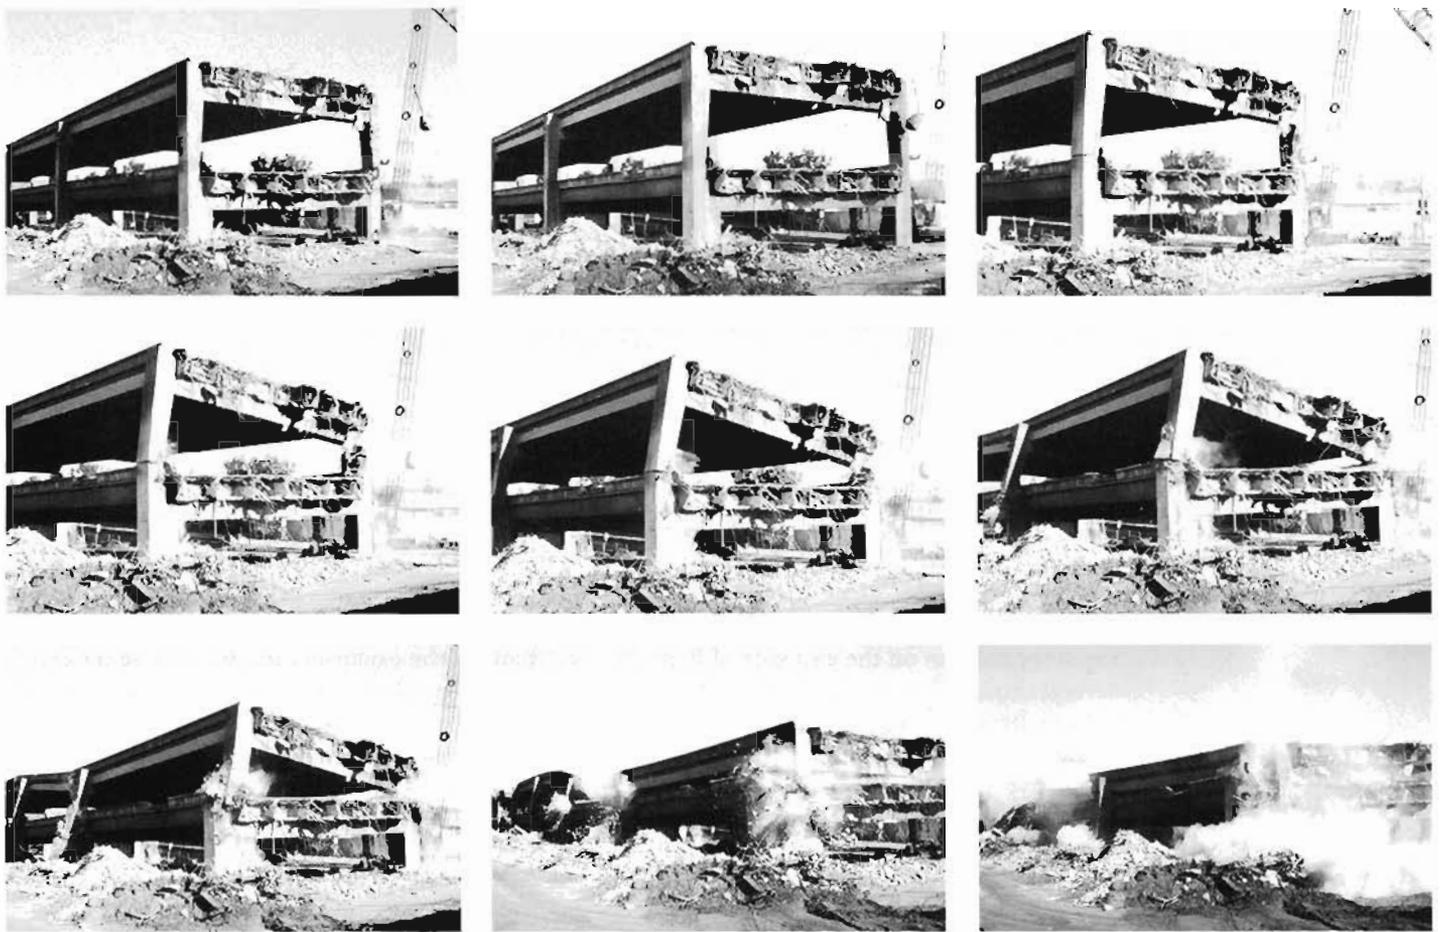
Figure 10-51. Failure sequence after demolition of a single column

This mode of failure is vividly demonstrated in the photo sequence of Figure 10-51, which was taken after the earthquake and during the demolition of an uncollapsed segment of the Cypress Viaduct. The uncollapsed segment consisted of four spans supported by five bents—Bent numbers 49, 50, 51, 52, and 53. A wrecking ball struck the

top story column on the east side of Bent 49 several times to initiate its failure. When the column began to fail, a progressive collapse ensued and resulted in total failure of the entire five-bent structure. Failure followed the typical failure mode observed in the sections that collapsed during the earthquake.

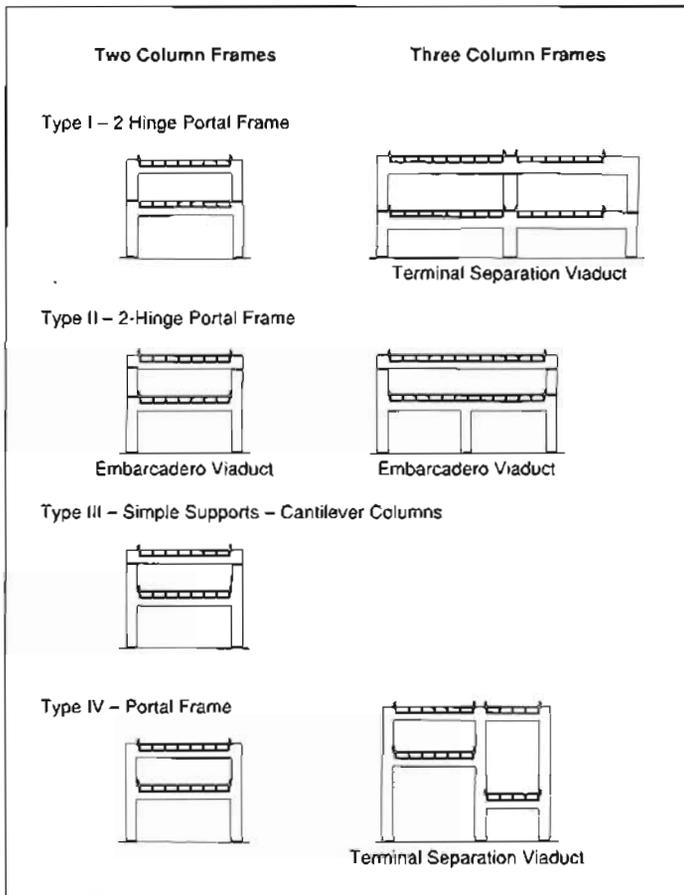
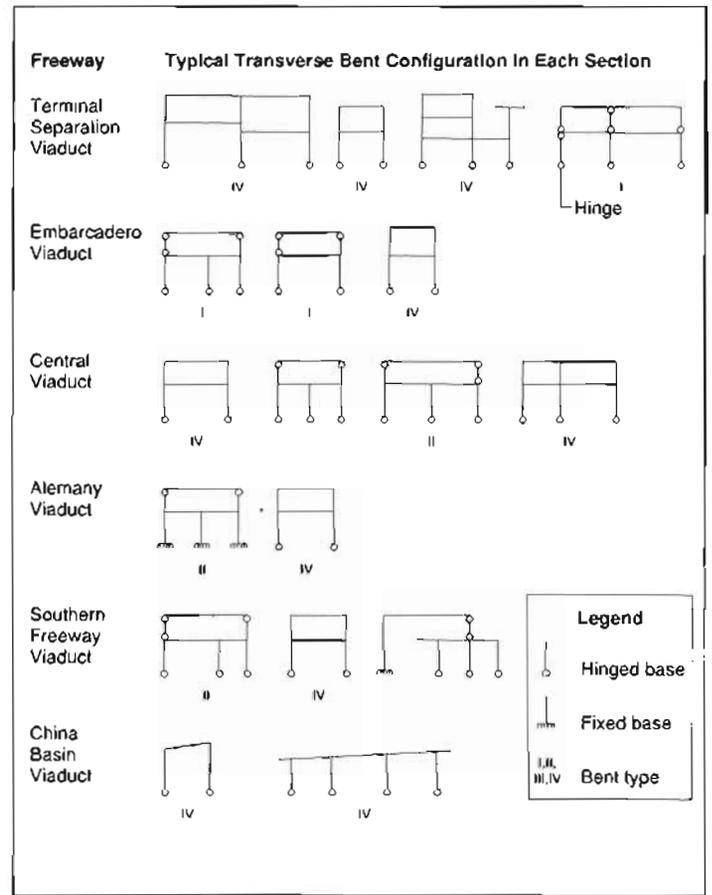
Figure 11-9. Multiple column bent types.

Figure 11-10. Configuration of two-level transverse bents.

Both two-column and three-column bents can be classified as Type I to IV (Figure 11-9). The hinges, especially in Type II, create an unbalanced frame response and force the single columns to carry all the seismic loads.

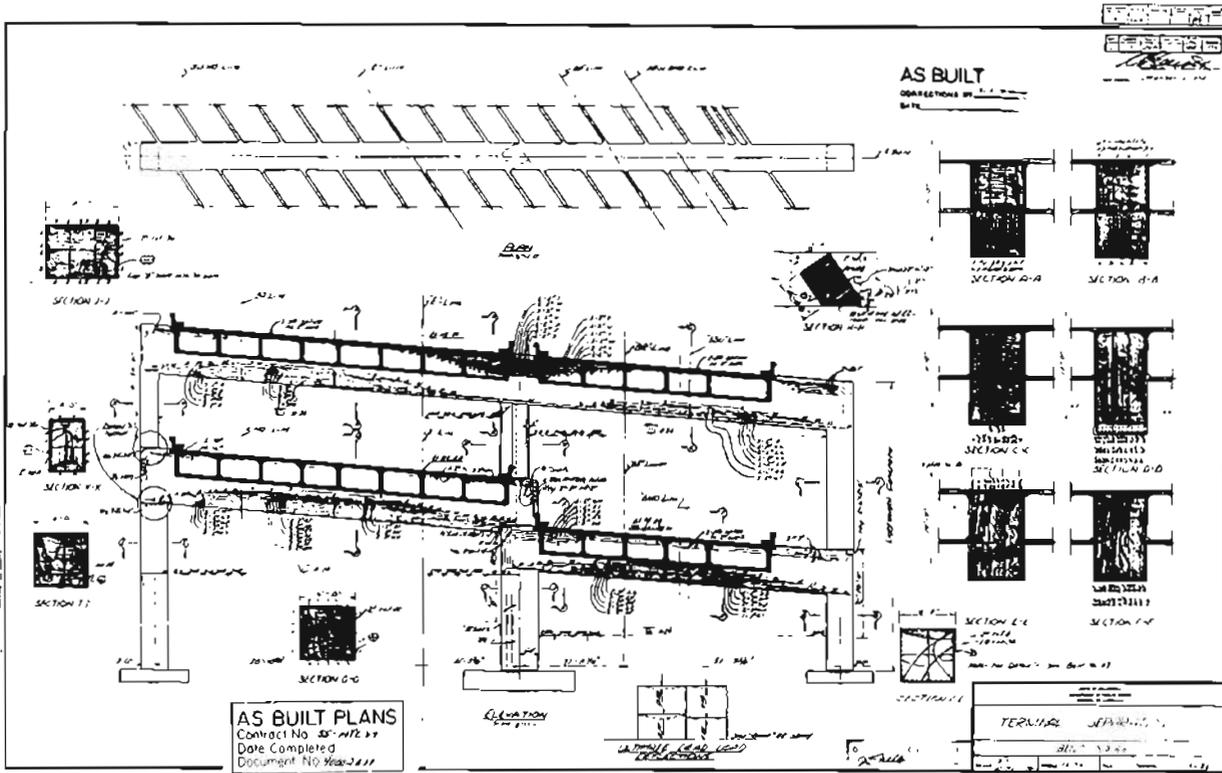
Typically the bent girders were designed for heavy vertical loads with reinforcing that is sized and positioned for these loads. Only nominal top and bottom girder reinforcing is provided for lateral load induced moments with few top bars extending into and anchored at the knee joints, and with few bottom bars also extending into the knee joints. This pattern of reinforcing was common through the 1950s and early 1960s.

Figure 11-11. Terminal Separation Viaduct, transverse Bent 44.

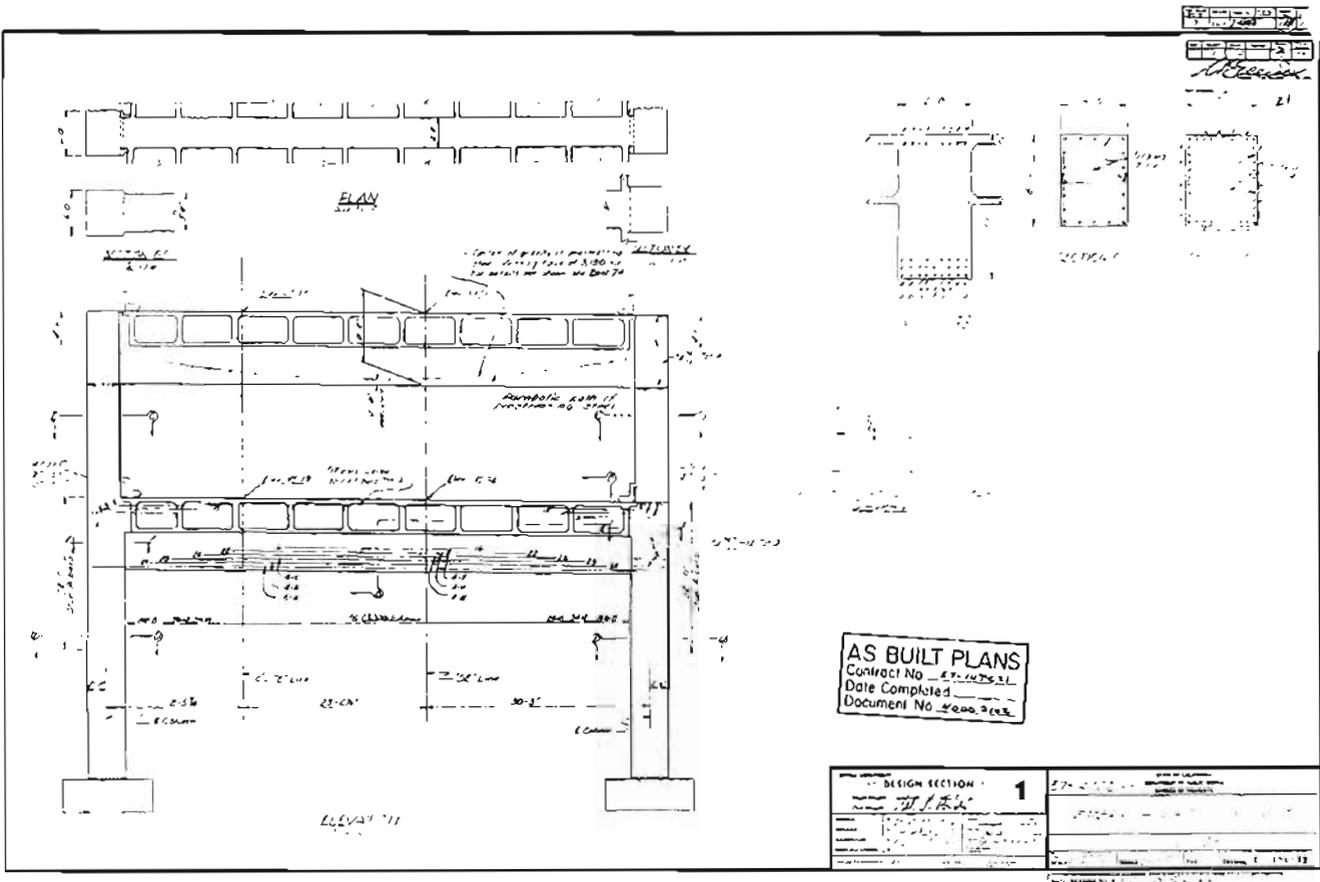
Figure 11-12. Embarcadero Viaduct, transverse Bent 78.

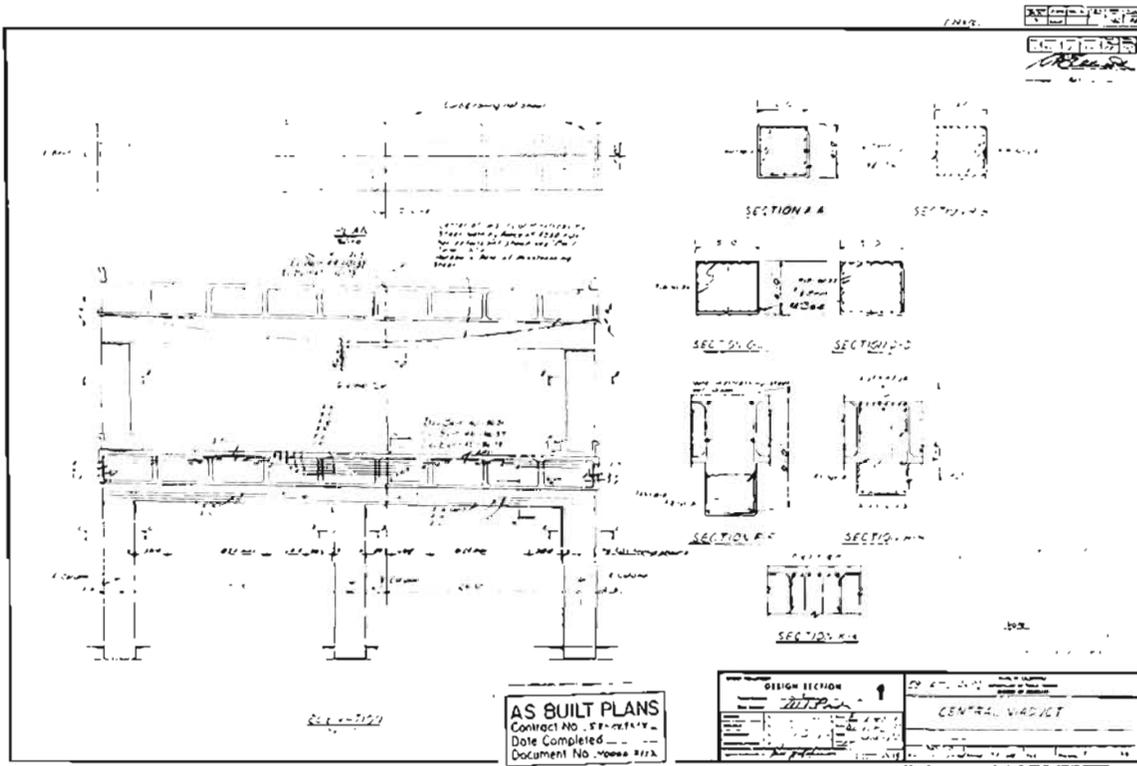
Figure 11-13. Central Viaduct, transverse Bents 43-45.

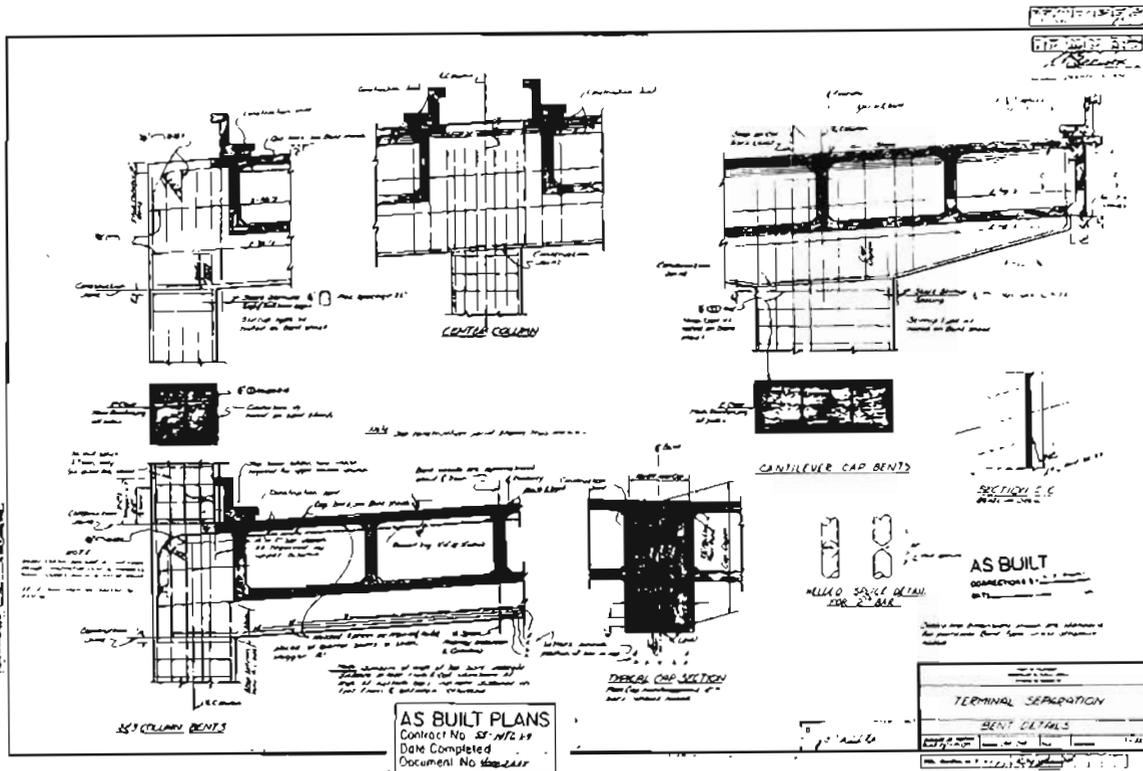
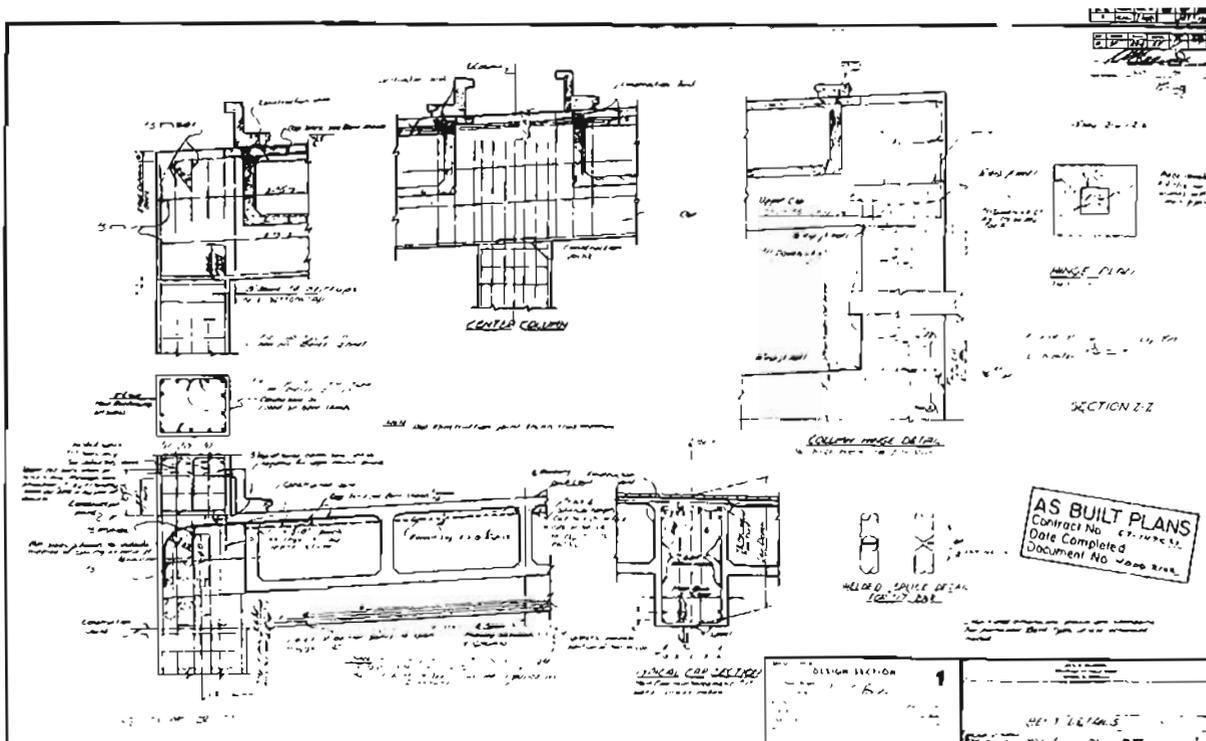
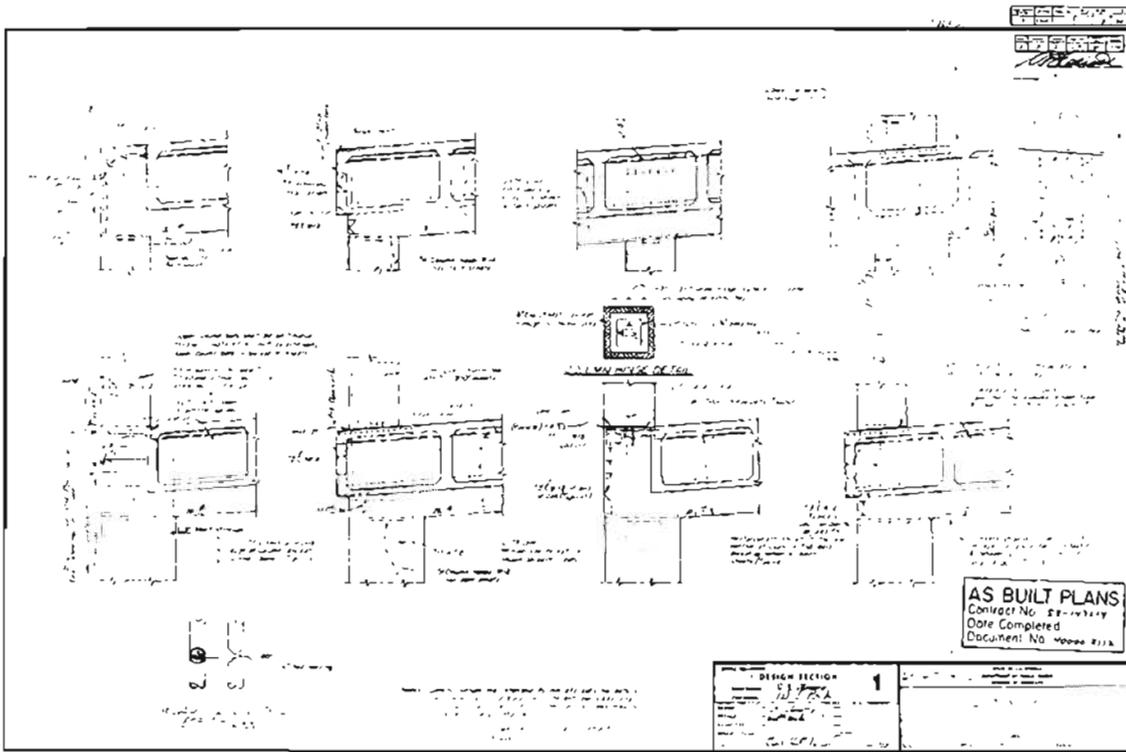
Special confining reinforcement for columns, joints and girders, important for ductility, was not used in any of the San Francisco Freeway Viaducts. The details of frame knee joints are virtually identical in the six viaducts, indicating no change in detailing philosophy during the design period of these viaducts from 1954 to 1965. Figures 11-14, 11-15 and 11-16 for the Terminal Separation Viaduct, Embarcadero Viaduct, and Central Viaduct, respectively, show little joint confinement at both top- and mid-level frame joints. Column hoop ties provided

The lack of shear reinforcement in the columns, joints, and girders resulted in the concrete members of the viaducts being weak in shear and torsion. The poor anchorage of the girder reinforcement in the columns produced sections that are weak in flexure and knee joints that have low shear capacity. In general, the bents form a weak-column strong-girder system, just the opposite of the current philosophy in design of buildings that prefers a strong-column weak-girder system. The columns and joints in the viaduct frames will generally fail first in a nonductile manner during an earthquake, prior to girder yielding, which increases the likelihood of collapse.

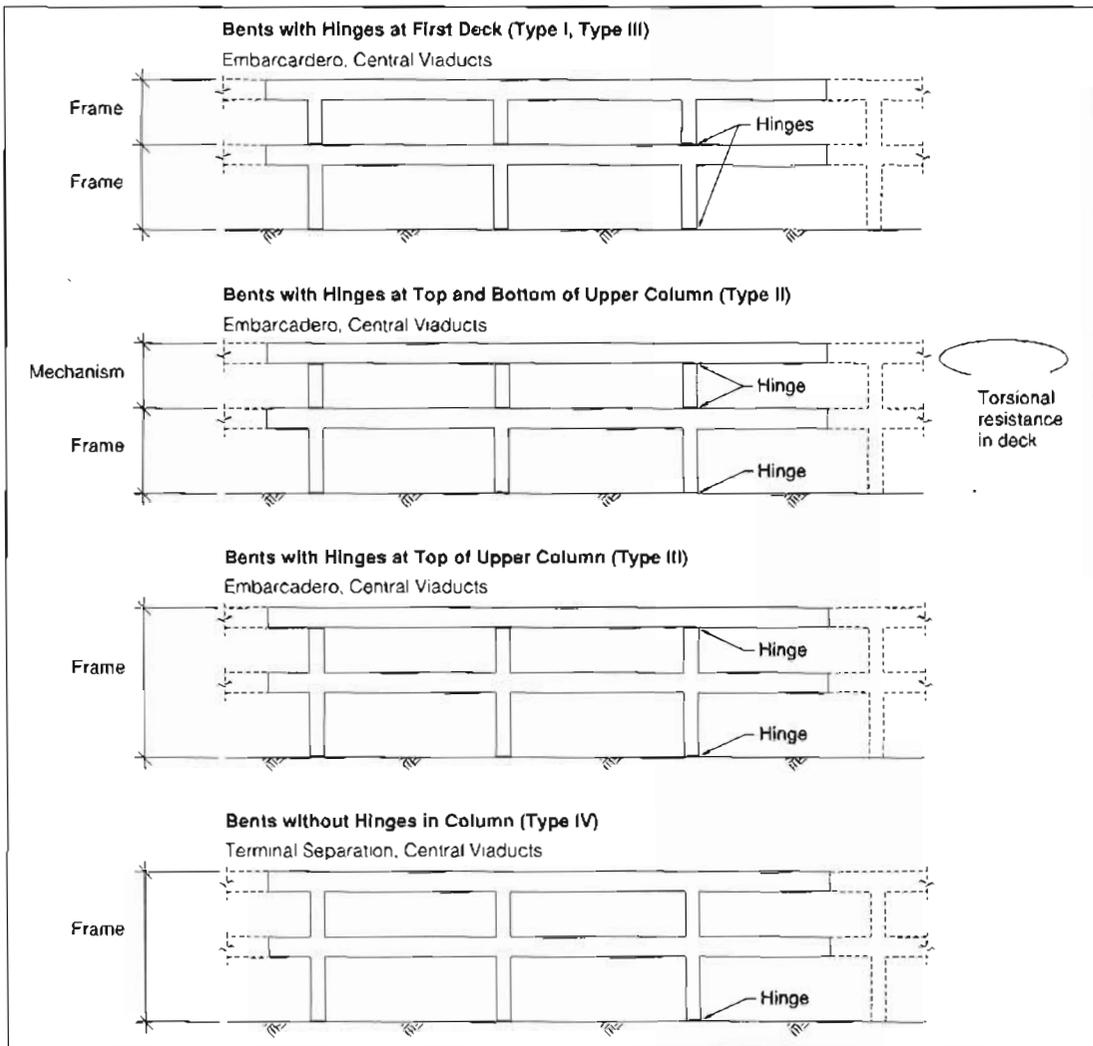
of column hinges, form frames of somewhat unconventional configuration. Figure 11-17 illustrates four different frame geometries resulting from the hinge locations. Frames of bent type II, with hinges at the top and bottom of the upper level columns, produce a frame with unbalanced moment resisting capacity. Tributary longitudinal loads to this unstable frame are transferred to the frame on the other side of the roadway through in-plane action of the deck, which relies on the cable restrainers to prevent large in-plane twisting of the deck. The load transfer increases the ductility demand on the cantilever columns. Longitudinal frames for other bent types are stable, but their strength and ductility are insufficient.

Figure 11-17.
Configuration of two-level longitudinal frames.

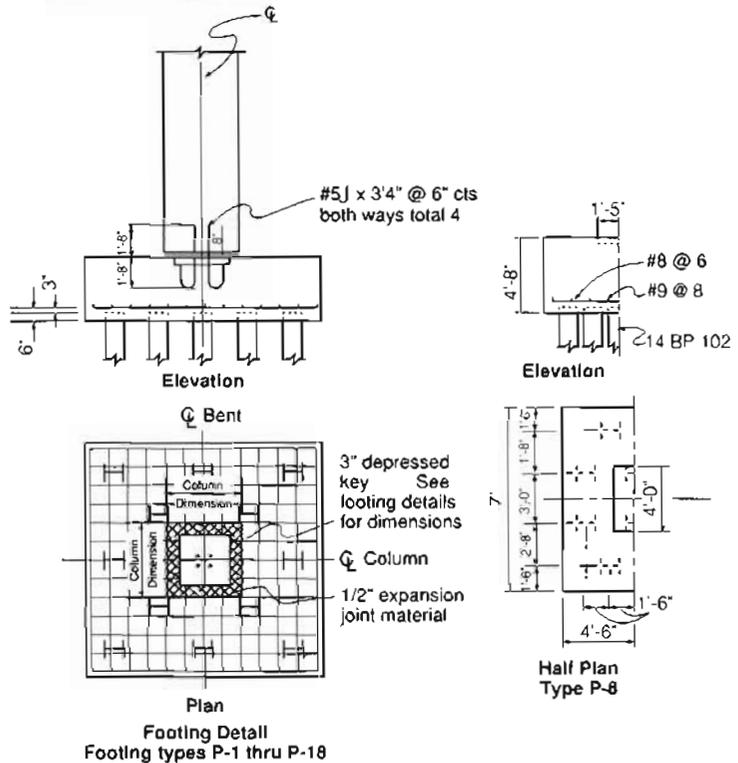
All San Francisco Freeway Viaduct two-story bents are supported on pile caps that are founded on piles. The bent column base is usually hinged at the footing cap preventing moment transfer to the cap and piles. Shear transfer is accomplished by a shear key and by nominal vertical reinforcing dowel bars (4 #5 bars) located at the center of each column, Figure 11-18. The lateral load capacity of the column at the foundation connection is limited to the capacity of the shear key and dowels.

Figure 11-18. Bent foundation details.

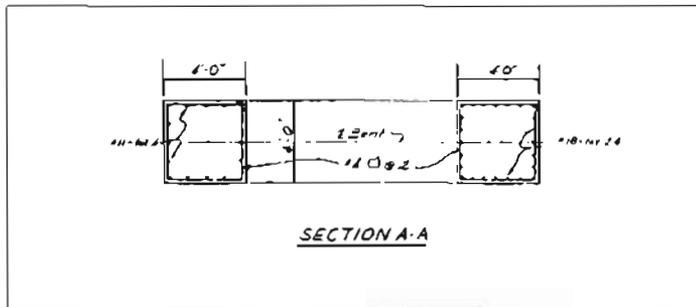
The Central Viaduct was damaged between Bent 42 and Bent 48. All of these bents are of type II configuration, each with one cantilevered upper level column. Figure 11-22 provides an isometric view of the structure between Bents 40 and 48. The damage was a midheight shear fracture occurring in the upper level single cantilevered columns at Bents 42, 43, 44, 45, and 48. Figure 11-23 illustrates the damage at Bent 43.

Figure 11-23. Earthquake damage to Central Viaduct Bent 43

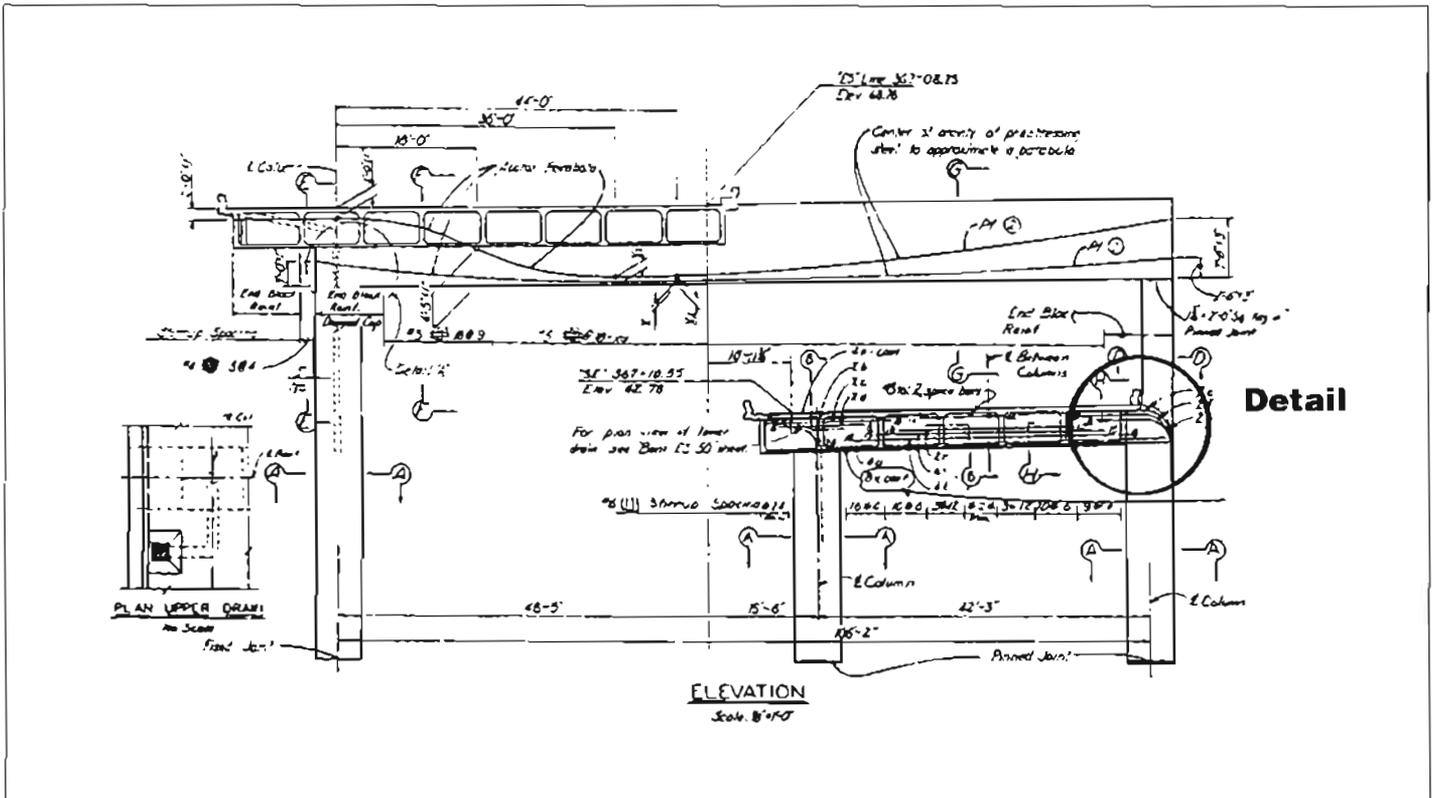
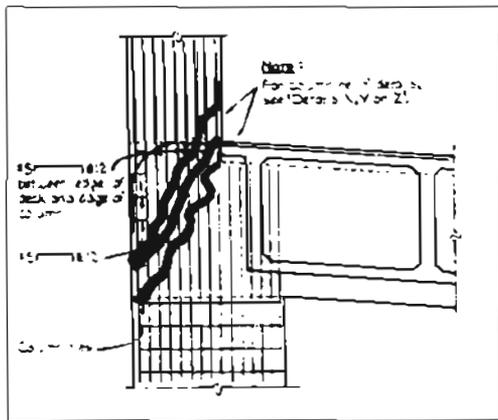
Detail (reverse view)

Figure 11-25. Earthquake damage to Southern Freeway Viaduct, Bent 51

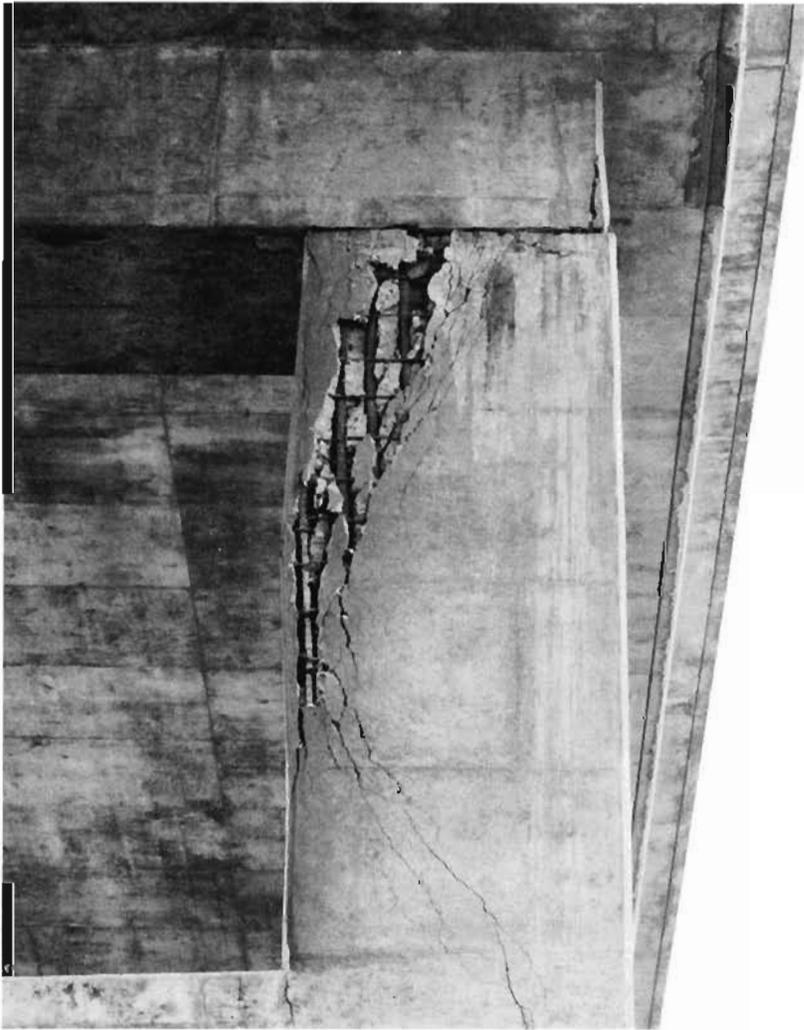
primarily limited to Bent 32 and to Bent N1-35, which is shown in Figure 11-27. Both bents show shear fractures of the upper outrigger knee joint.

Figure 11-27. Earthquake damage to China Basin Viaduct Bent N1-35. lower photo shows reverse view of upper figure

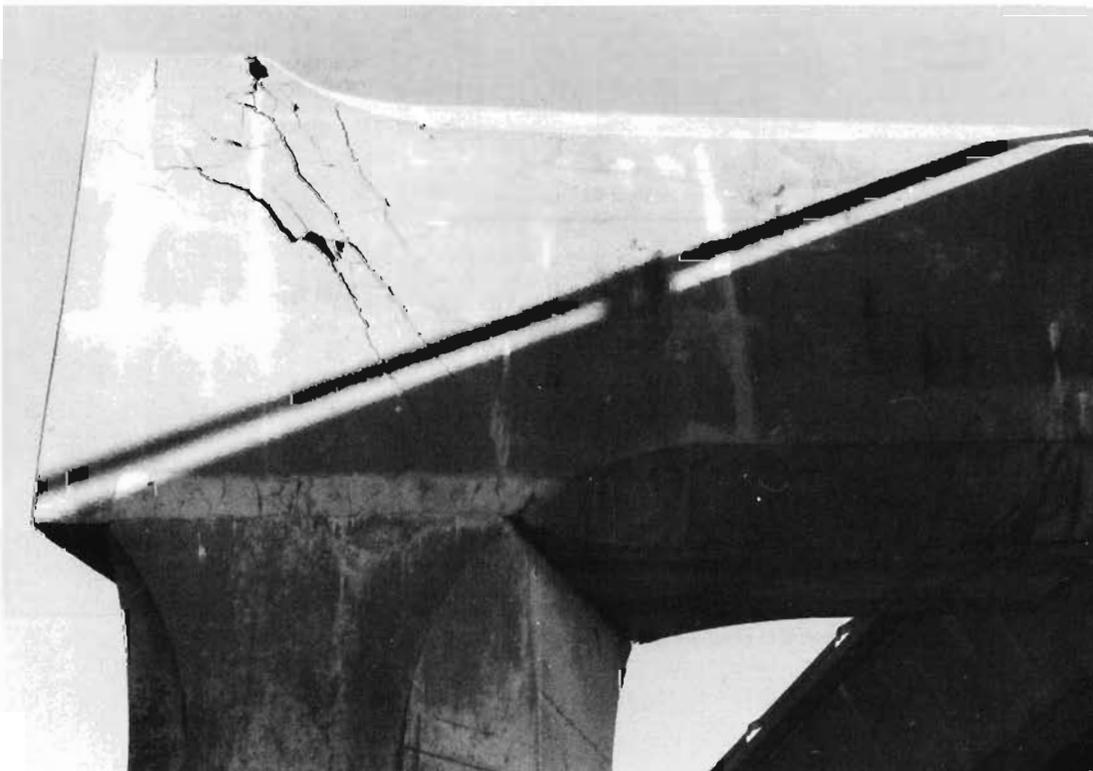
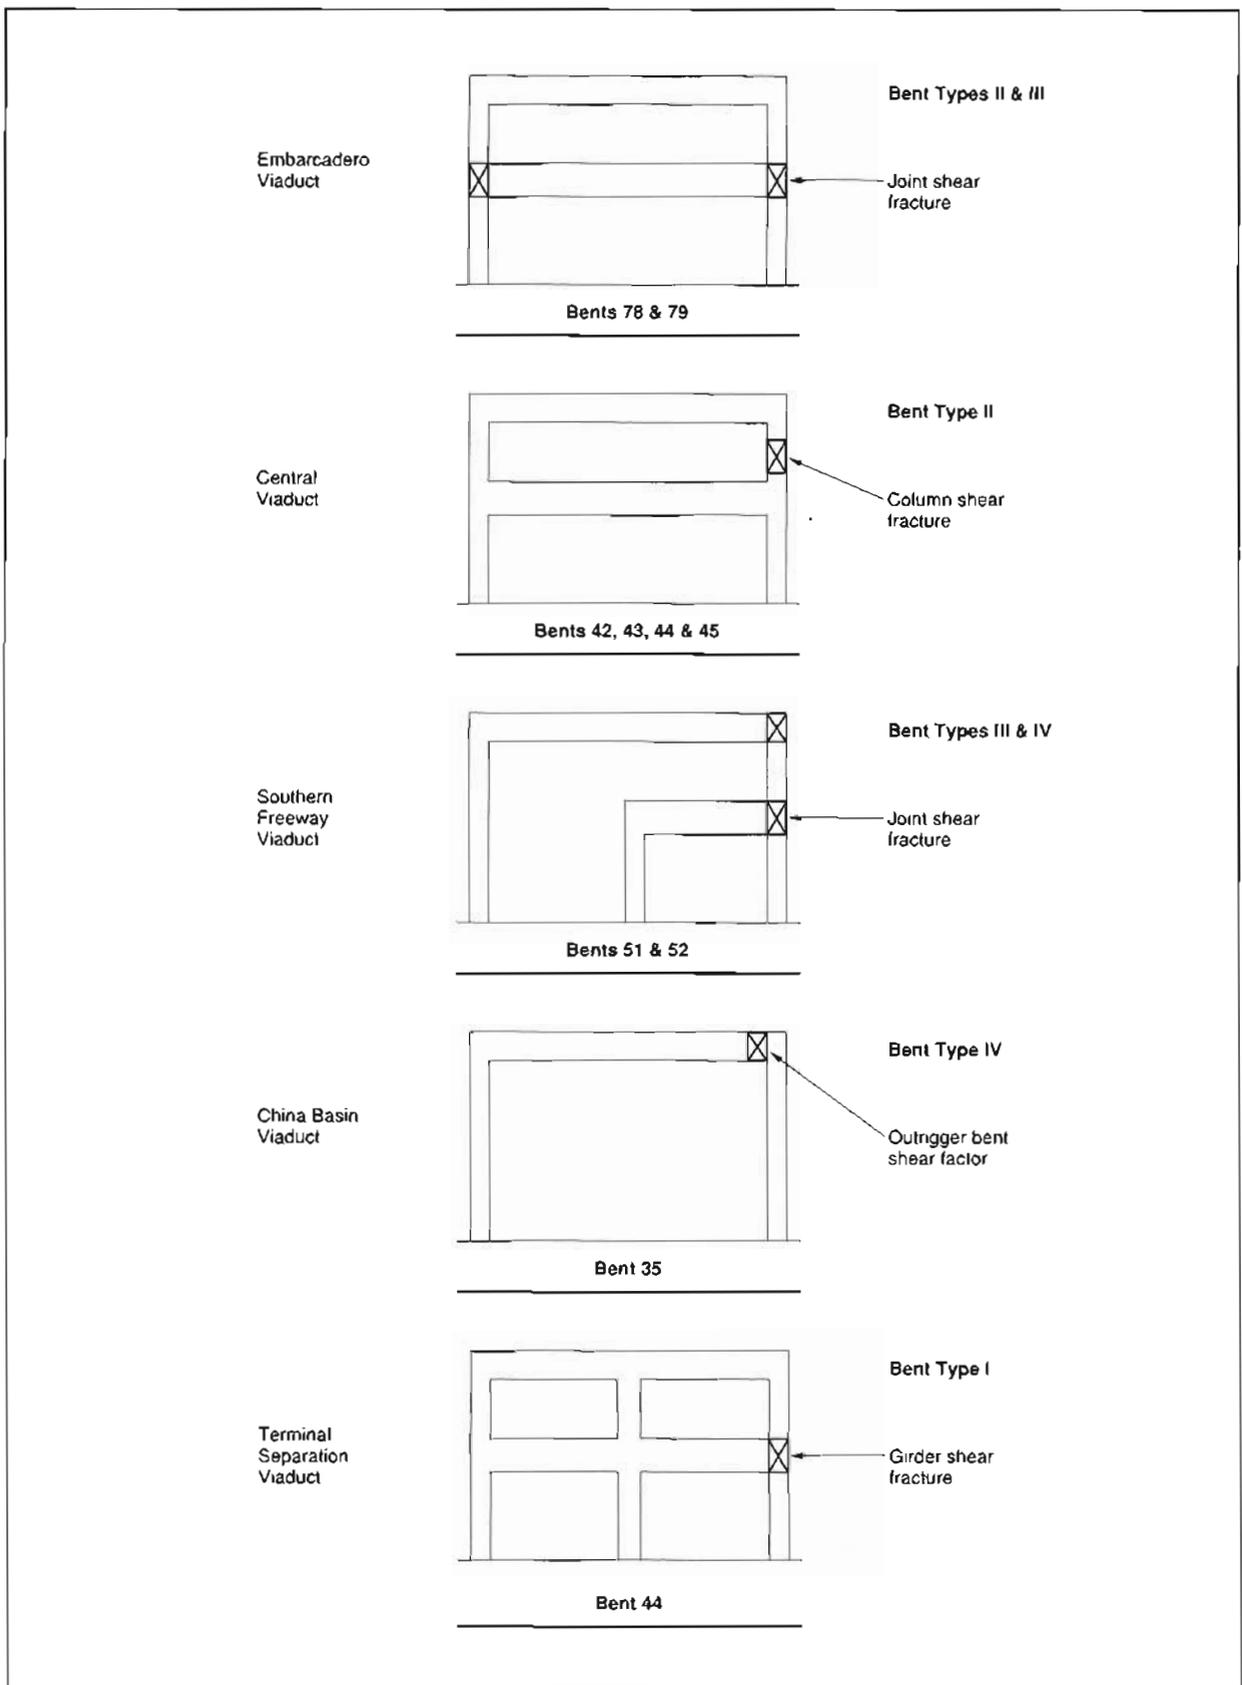
A summary of significant bent damage is shown in Figure 11-28, where it can be seen that all failures were shear failures either of columns or of frame knee joints. These failures are indicative of inadequate shear capacity caused by insufficient and poorly anchored transverse ties in both the columns and the knee joints. The location of damage also correlates well with site conditions, particularly areas of soft soils or fills where ground motions were intense.

Figure 11-28. Summary of damage patterns in double-deck San Francisco Freeway Viaducts.
