THE NORTHRIDGE EARTHQUAKE OF JANUARY 17, 1994

Report to the Director,
California Department of Transportation

by the
Seismic Advisory Board

George W. Housner, Chairman
October 1994

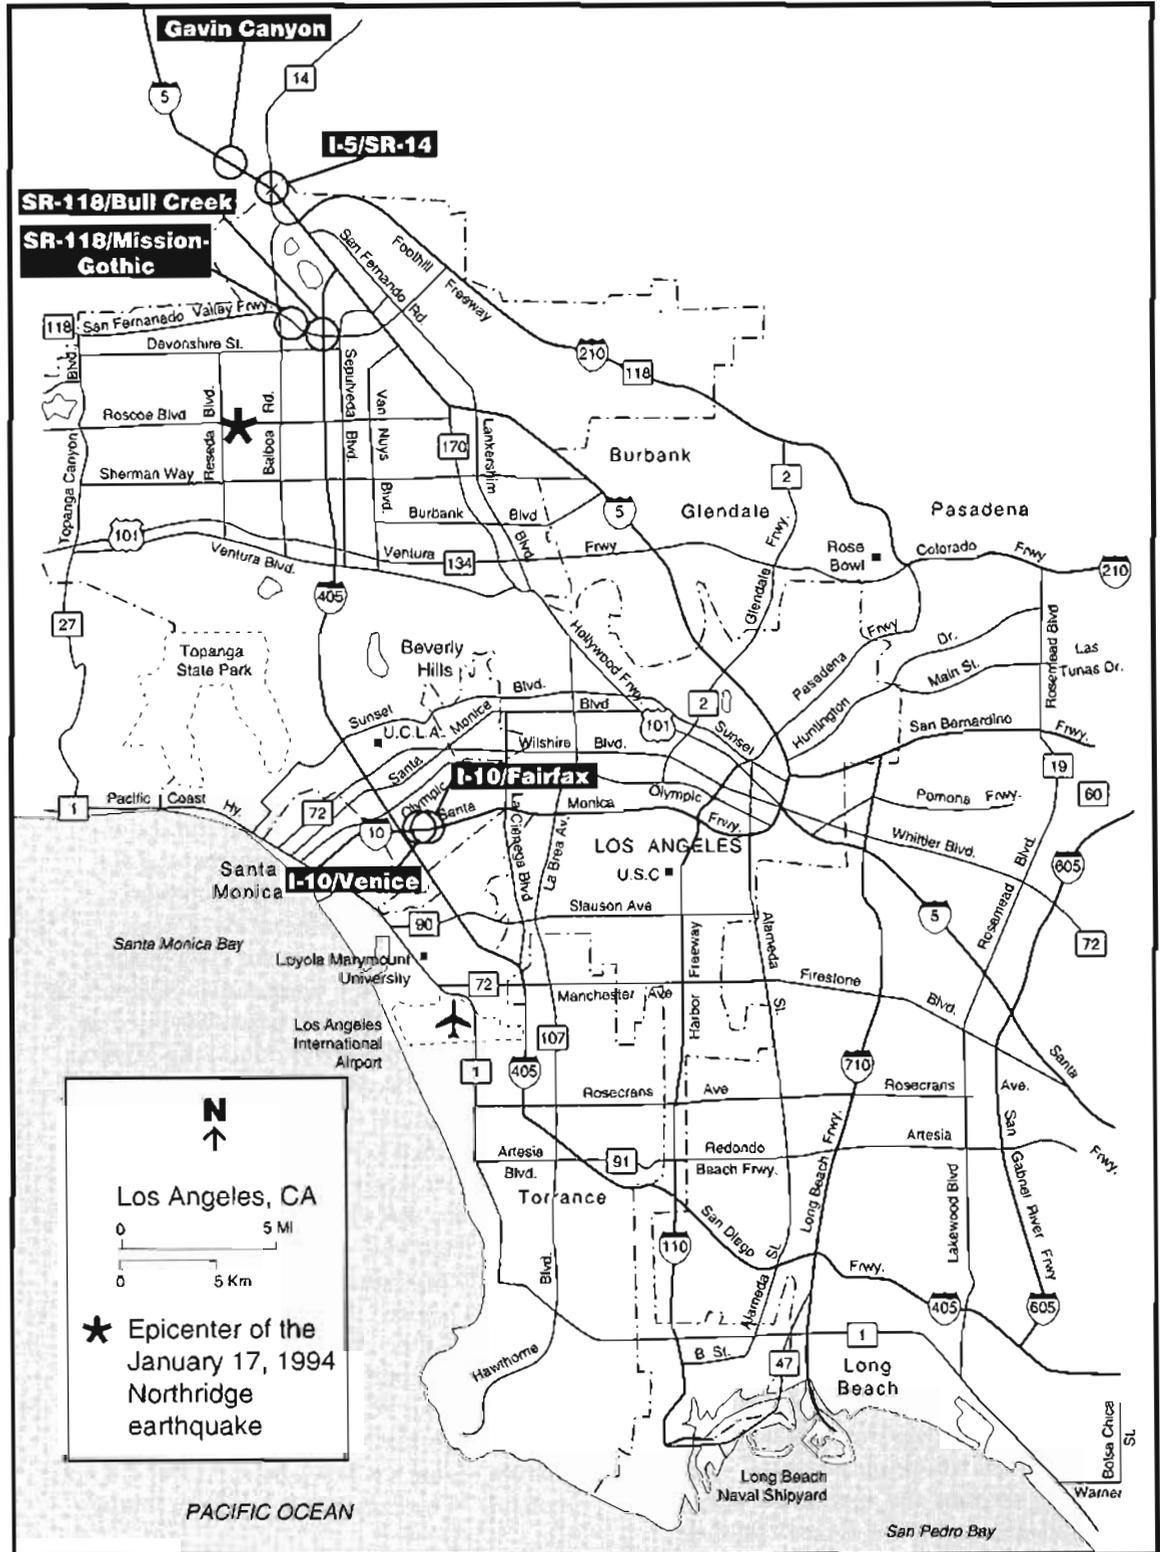
The Northridge earthquake of January 17, 1994 ($M_w=6.7$; M_w is the moment magnitude) caused the collapse of seven highway bridge structures and the consequent disruption of a large portion of the northwest Los Angeles freeway system. Figure 1-1 shows the locations of these bridges in relationship to the earthquake source. Of the seven bridges that collapsed in the earthquake, five had been scheduled as requiring retrofit. Two bridges, the Mission & Gothic Undercrossing and Bull Creek Canyon Channel on State Route 118, had been identified as not requiring retrofit. The collapsed structures can be classified by vintage into three groups: three bridges designed and built before the 1971 San Fernando earthquake ($M_w=6.6$); two bridges designed before 1971, but construction completed after 1971; and, two bridges designed and built a few years after San Fernando, but not to current standards.

Figure 1-1. The location of bridges that collapsed in the Northridge earthquake of January 17, 1994; two bridges, the north and south connector overcrossing, collapsed at the I-5/SR-114 Interchange.
