CUT SLOPE DESIGN AND LANDSLIDES
SOME CASE HISTORIES

T. W. Smith and H. R. Cedergren

Prepared for
A.S.T.M. Meeting
Los Angeles

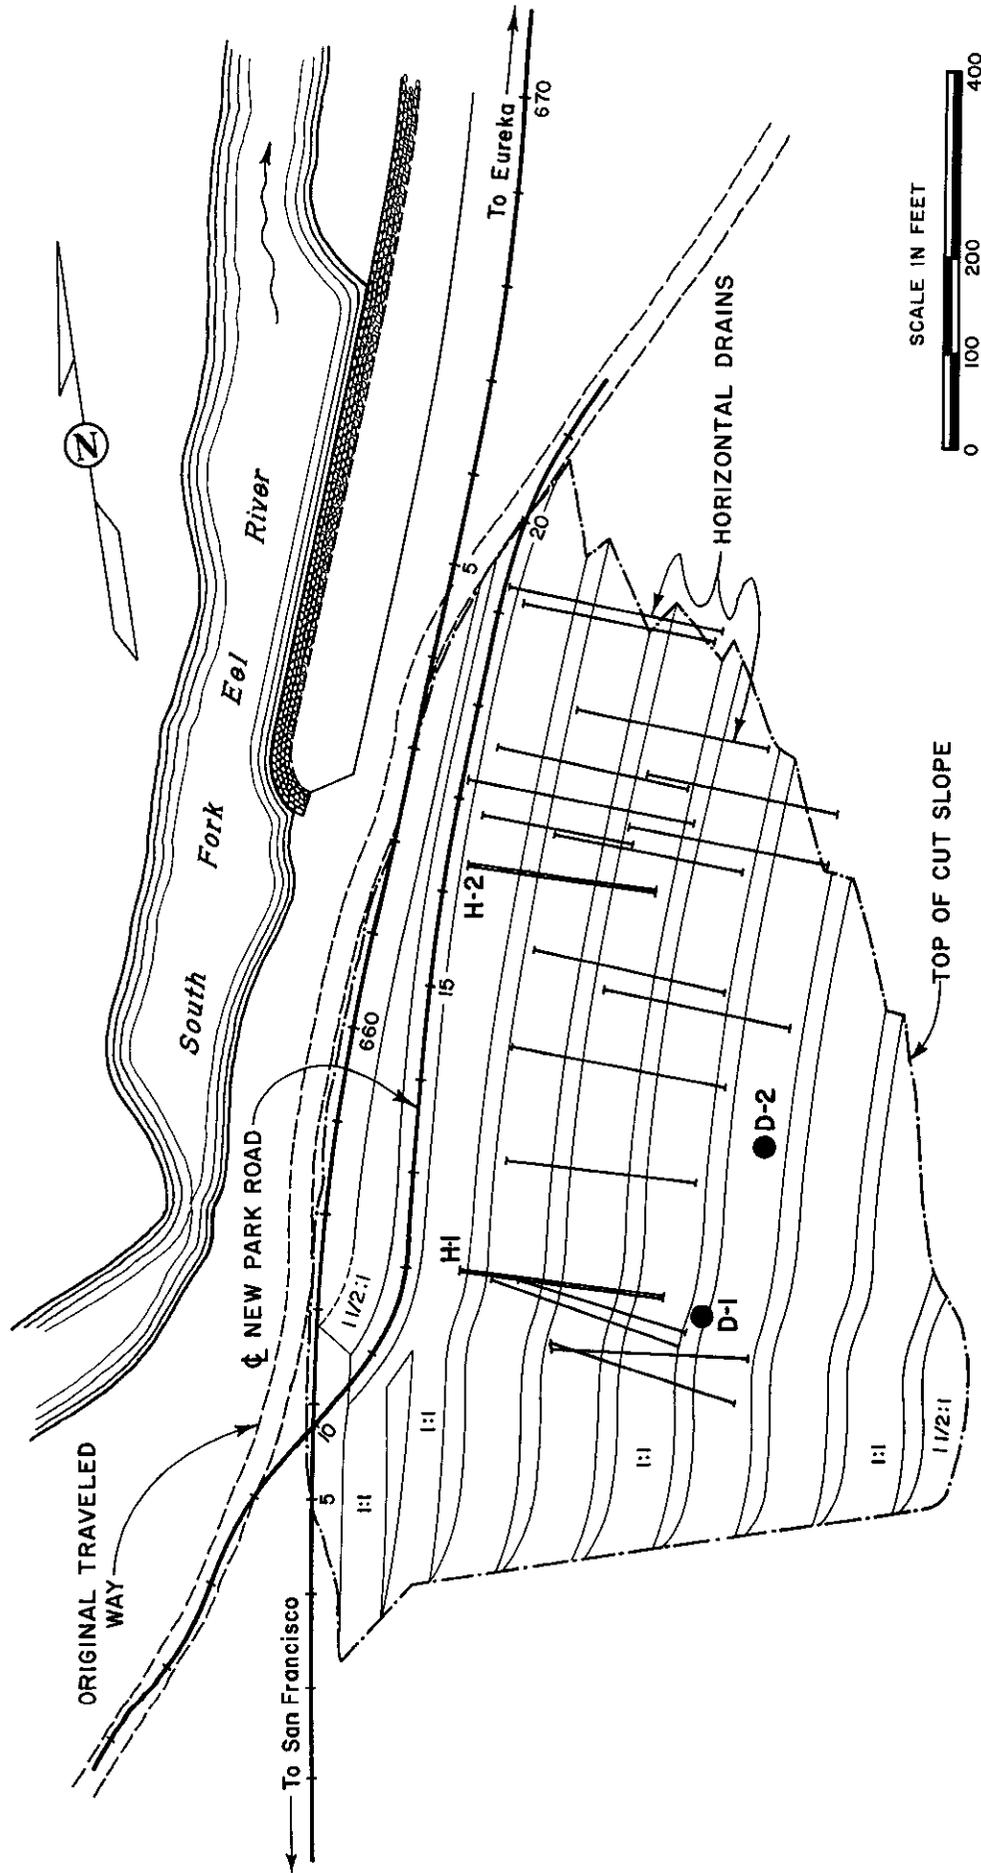
FIG. 2 PLAN OF DYERVILLE CUT SHOWING HORIZONTAL DRAINS AND BORINGS

A plan of the cut area is given in Fig. 2 and a typical cross-section in Fig. 3. The locations of the borings are shown on the plan. Their logs, in simplified form, are given in the cross-section sheet. The horizontal boring (H-1) furnished useful information; however, it penetrated the hill nearly parallel to the dip and gives a distorted picture of the thick-

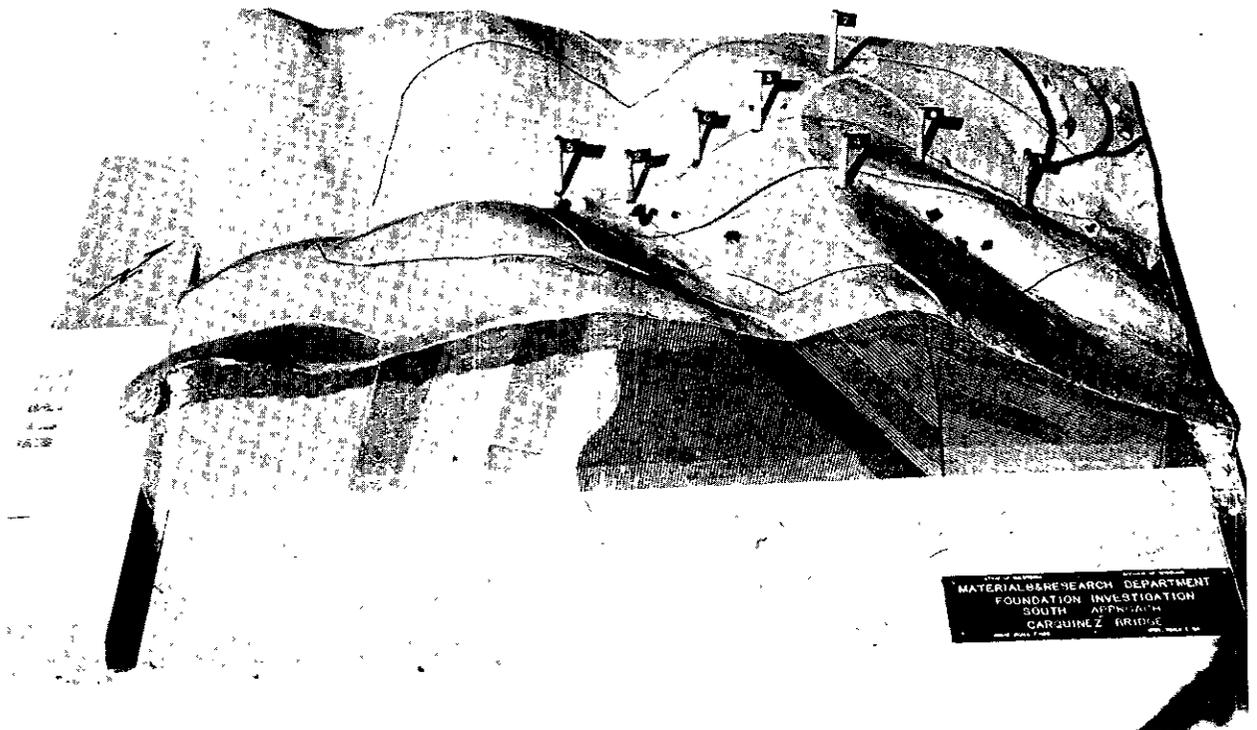
Fig. 8 - View of Model Showing Original Topography
of Site of Carquinez Cut

deduced and actual geological conditions shown on various surfaces of the model. Photographs of this model are reproduced in Figs. 8 and 9.

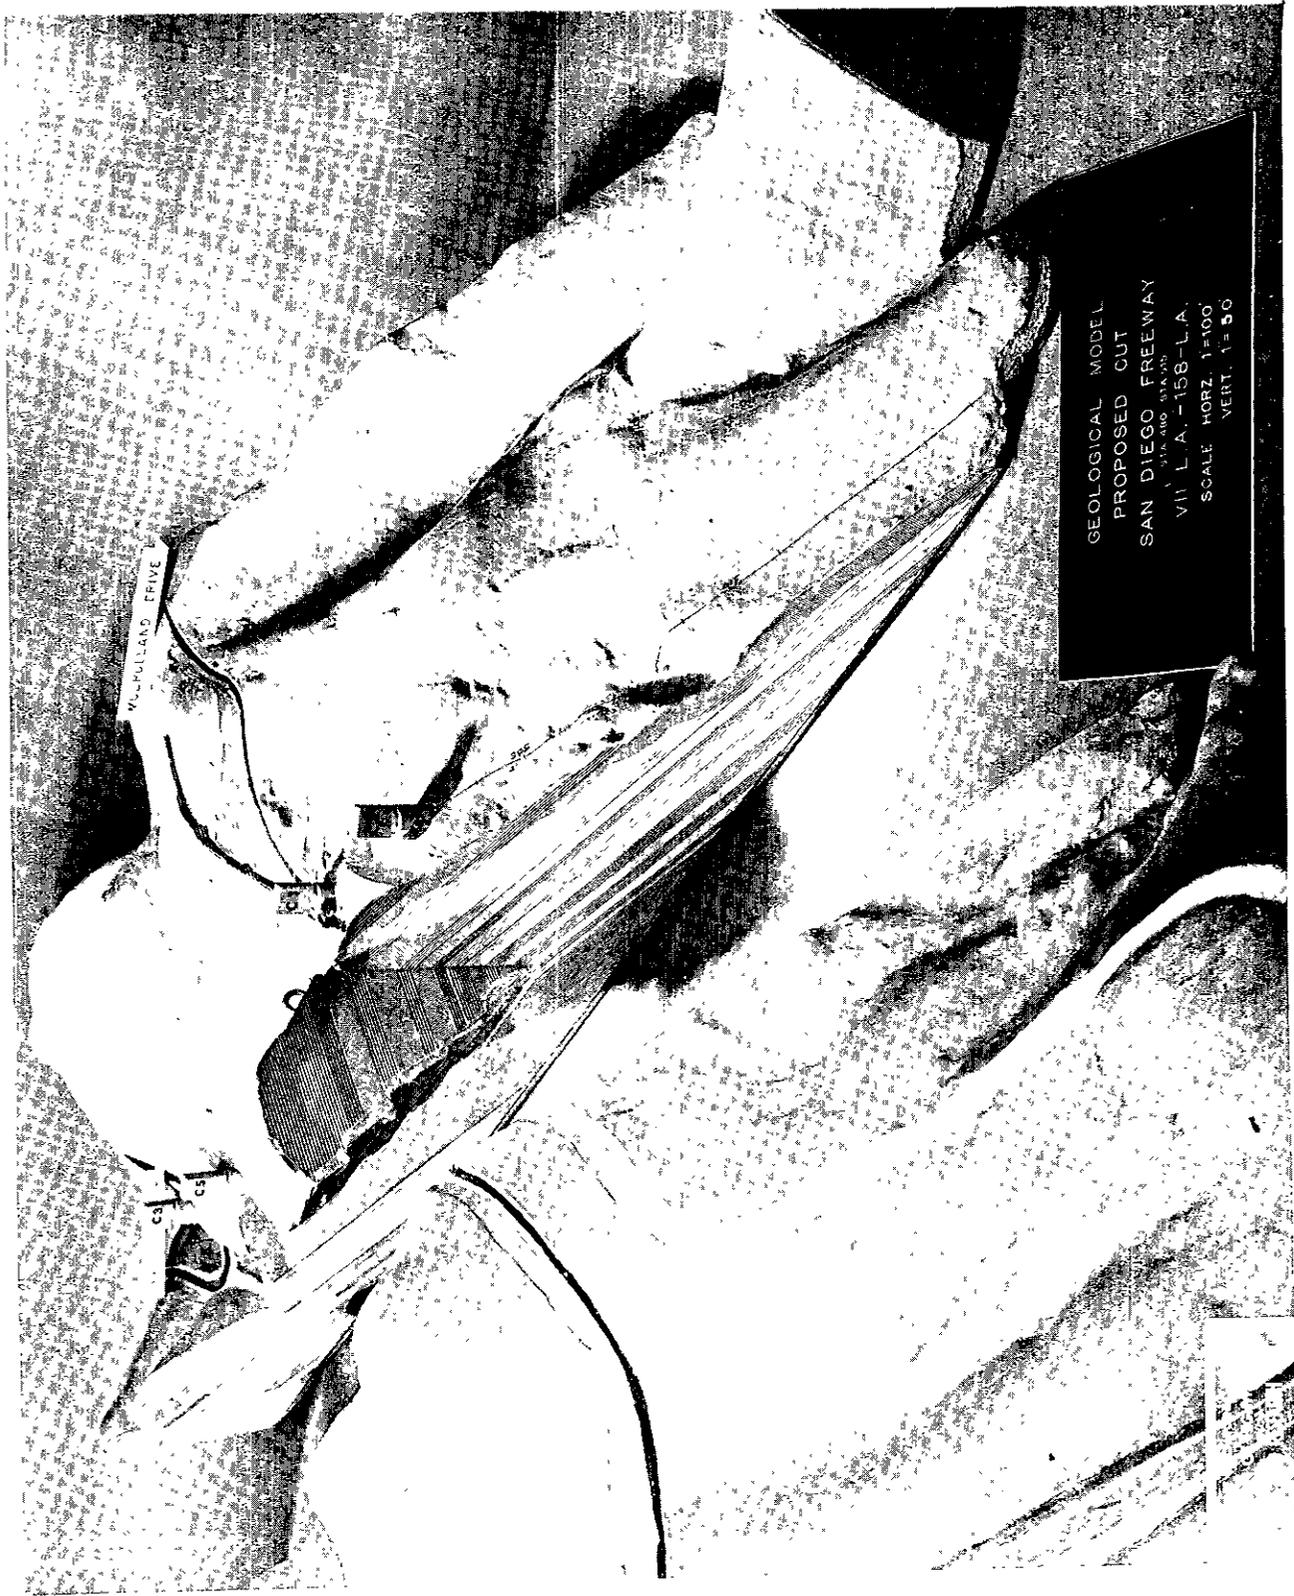
Fig. 13 - Photograph of Model Separated to Show Geologic Formations at Site of Mulholland Cut

Minor cracking had occurred in the east side of the cut as early as July 1961, but this was not considered serious until early in October when cracks began to develop in the floor slabs of the private dwellings on Scadlock Lane, as noted above, and more definite cracking occurred through the contractor's yard and in the pavement of old Mulholland Drive. The extent of the slide may be seen in the photograph in Fig. 12. To aid in analyzing the geological conditions and the slide movement, a geological model was constructed (See Figs. 13 and 14).

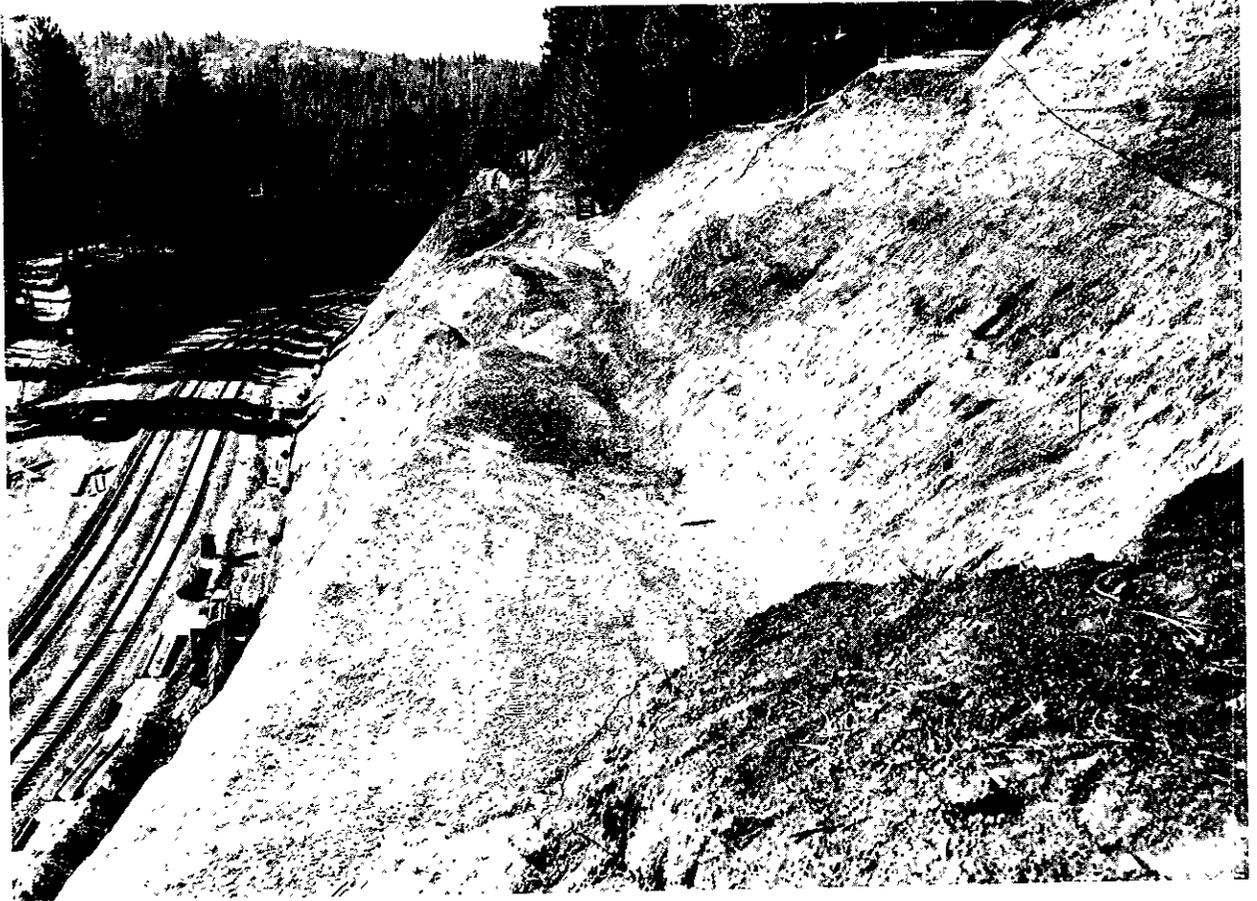
Fig. 17 - View Showing Excavation for Railroad at Towle

In order for the railroad to relocate the tracks and get them back in operation, it was necessary that they do considerable excavation above the tracks in what appeared to be fairly stable terrain. In order to expedite this operation, the excavated material was cast across the tracks into the head of the landslide. It developed that the slope above the tracks was somewhat unstable, and considerable ground water was encountered. Hence, considerably more excavation was necessary than had originally been anticipated. This excavation, when relatively completed, can be seen in Fig. 17. The slide continued to move; and it was necessary that the toe of the slide, as it spilled onto the highway, be excavated as rapidly as possible in order to carry traffic through the area. Traffic was disrupted on the highway for periods of a few hours to several days, and the railroad's operation was seriously curtailed. It should be evident that the operations of wasting excavation into the upper part of the slide and removing debris on the roadway at the toe were certainly not conducive to stabilization of the slide. However, with more favorable weather and completion of the excavation at the upper part of the slide, movement ceased or diminished. Considerable slide removal was done by contract the following summer. This resulted in a further reduction in movement.
