M&R 636392

Dynamic Tests of Corrugated Metal Beam Guardrail

State of California
Department of Public Works
Division of Highways

Presented at the 46th Annual Meeting of the Highway Research Board

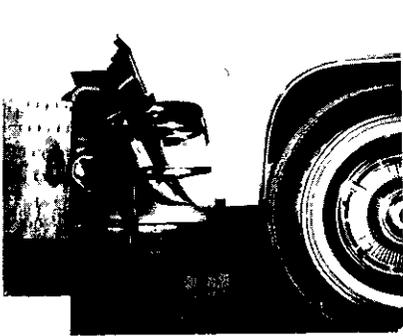
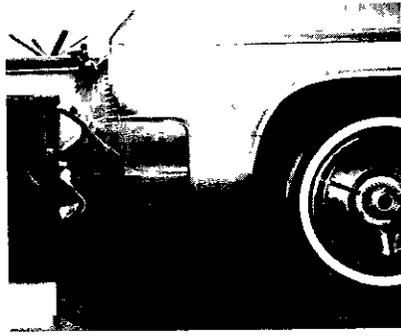
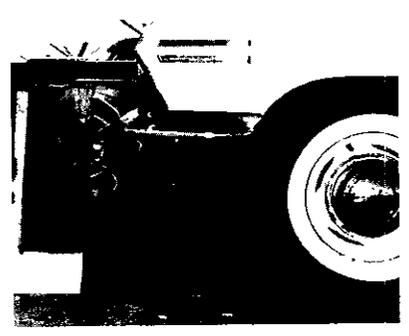
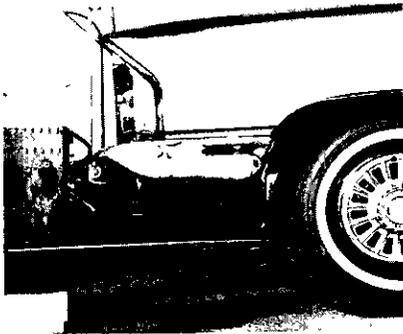
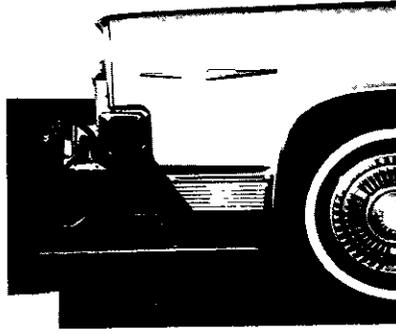
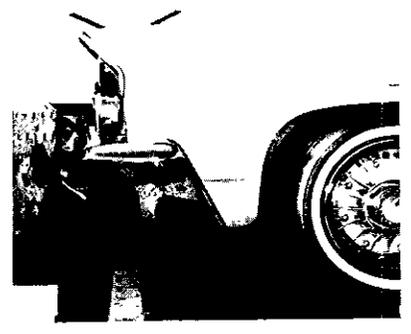
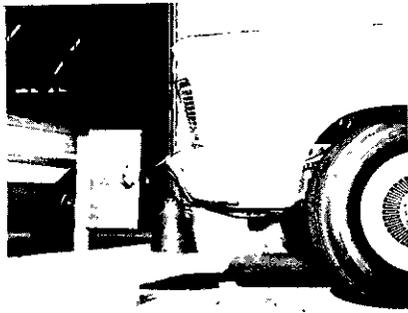
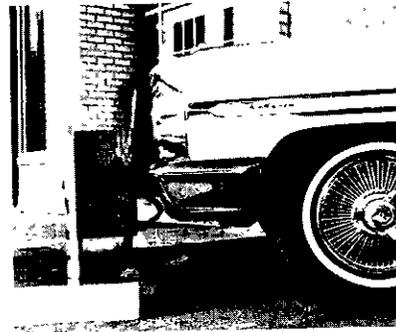
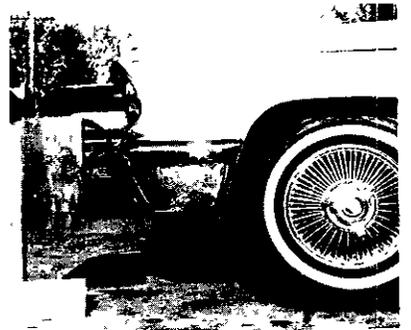
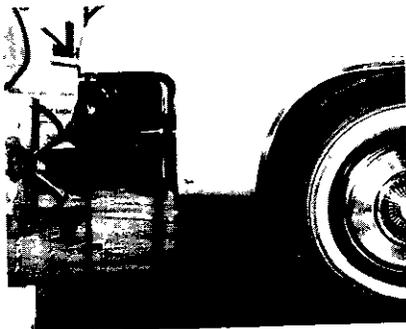
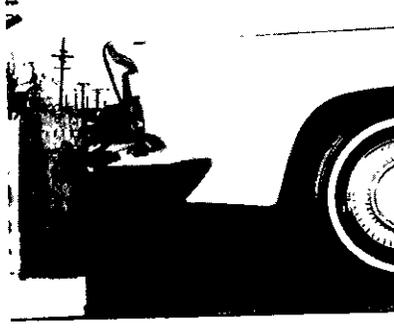
Investigation of bumper geometrics revealed that a majority of the U. S. manufactured vehicles for the years 1962-65 were equipped with bumpers having characteristics similar to those of the 1962 Chrysler test vehicle (Plate 1). It is possible that this feature of the newer vehicles has contributed to the high incidence of guardrail vaultings reported by our operational departments. It may be noted in Plate 1 that the bumpers of the newer automobiles from the four leading manufacturers would strike a 24-in.-high guardrail above the center of the beam. This point of impact, in conjunction with the curved, sloped-back bumper design, increases the possibility of vaulting due to the eccentric loading about the beam's longitudinal axis of rotation.

Comparison of vehicle
bumper heights to
24-in.-high guardrail.

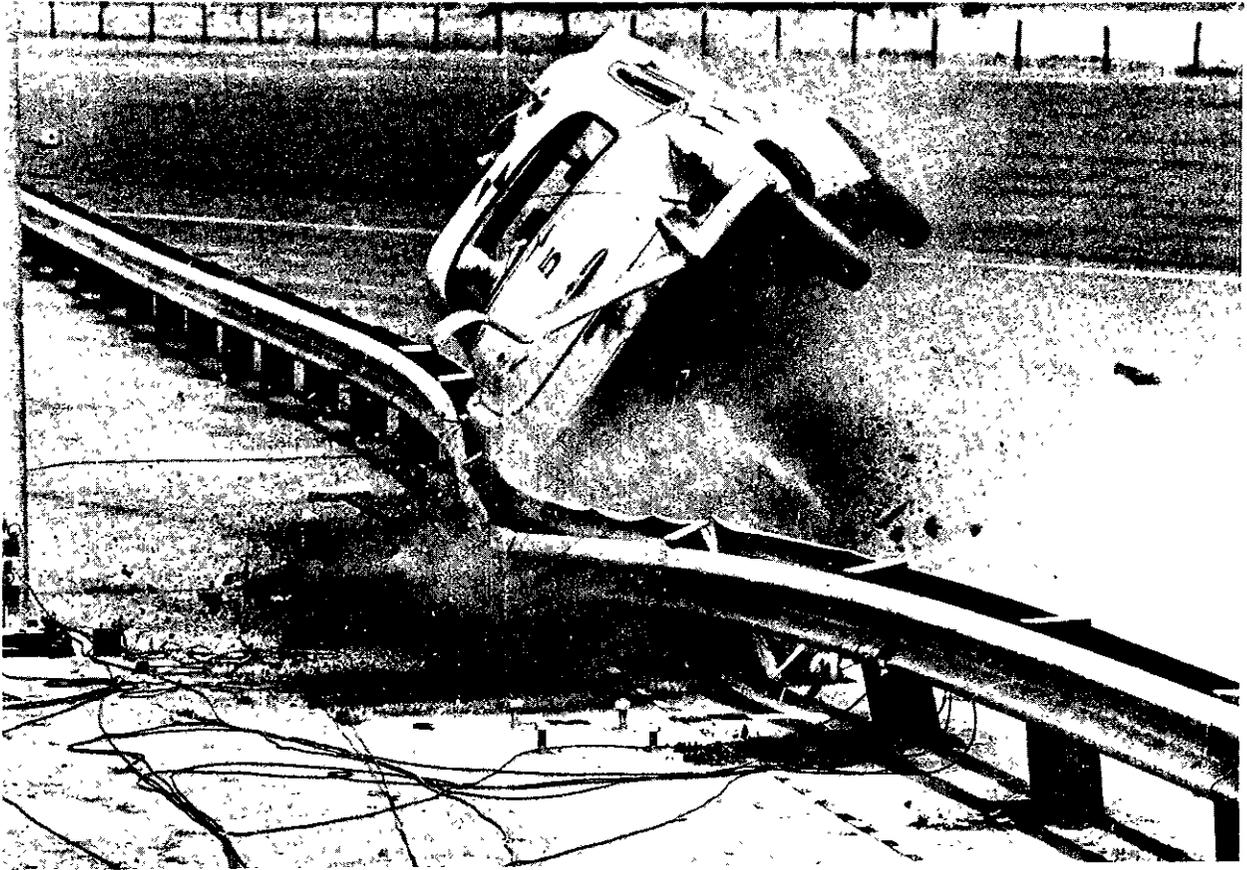
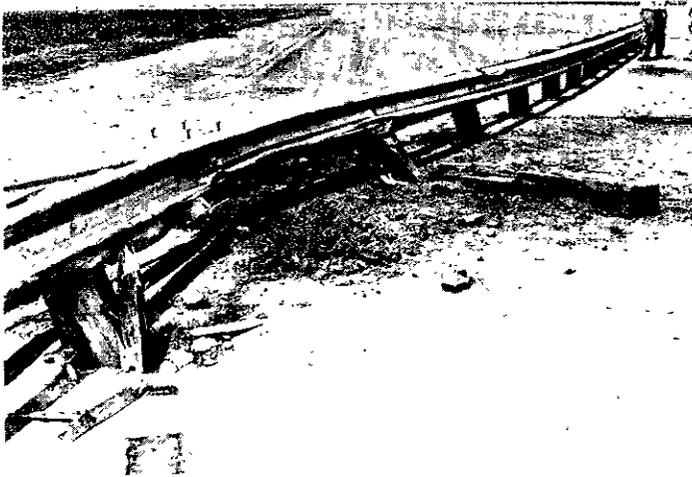
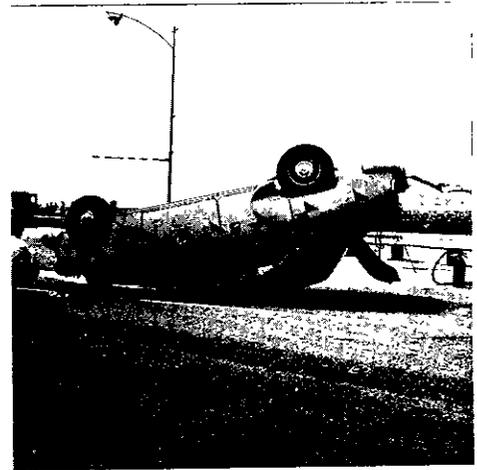
PLATE 2

The relative effectiveness of the blocked-out barrier design in preventing excessive vehicular roll may be seen by comparing Test 505 conducted in 1958 (see Plate 2) with Test 108 (Plate C). Even with the additional rigidity provided by the double beam, the design used in Test 505 was ineffective in preventing vehicle roll-over. During contact with any semi-rigid beam-type barrier, an impacting vehicle tends to roll toward the barrier. Resistance to this roll is provided by the weight of the vehicle acting downward and is either helped or hindered by the moment couple between the horizontal center of gravity of the car and the center of gravity of the beam. Since the most critical time of any barrier collision occurs during the first few hundredths of a second after impact as the beam is being deflected but before axial tension has become effective, it is important that the beam height be maintained or increased slightly as the post rotates, as shown in Figure 4. The effect of blocking-out the beam is to minimize vehicular roll by providing restraining forces above the center of gravity of the vehicle during the early and most critical time of collision. In contrast, the height of the nonblocked-out beam immediately decreases during post rotation thereby decreasing the effectiveness of the barrier's restraining forces. This can result in the beam acting as a ramp before it has an opportunity to start resisting axially.

TEST 505 1958

Double Metal Beam Median Barrier with galvanized steel corrugated beam mounted on 8- by 8-in. D. F. posts spaced 6-ft 3-in. on centers.

Impact Speed	58-mph
Impact angle	31°
Beam Height	25-in.

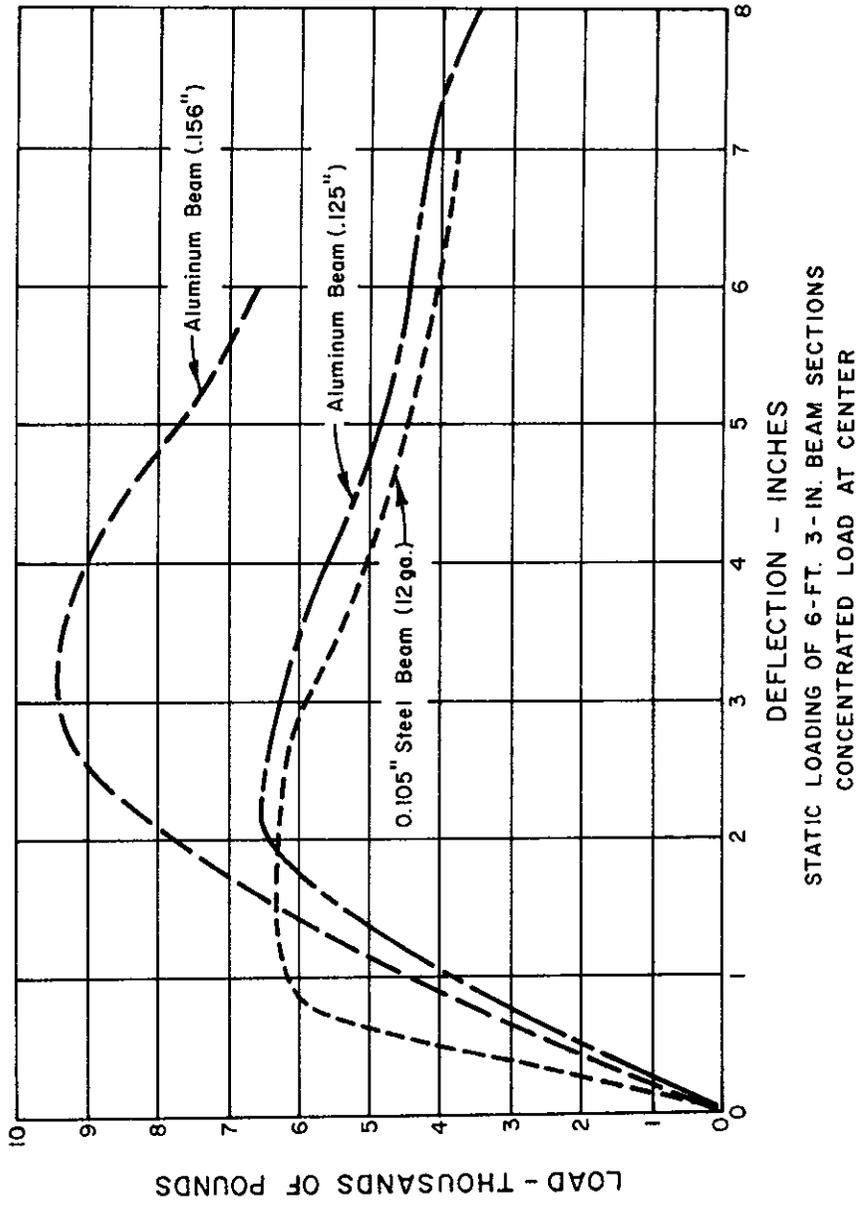
FIGURE 5

to high dynamic stress concentrations. These bending stresses, present with large beam deflections, cause local buckling at the top and bottom of the beam. The buckled areas, appearing as ripples, are more apparent in steel sections although they do not cause tears as in the aluminum. The difference in performance of steel and aluminum appears to stem from the difference in stress-strain relationships and ductility of the two materials (see Figure 5 and Table 2).

BEAM DEFLECTIONS

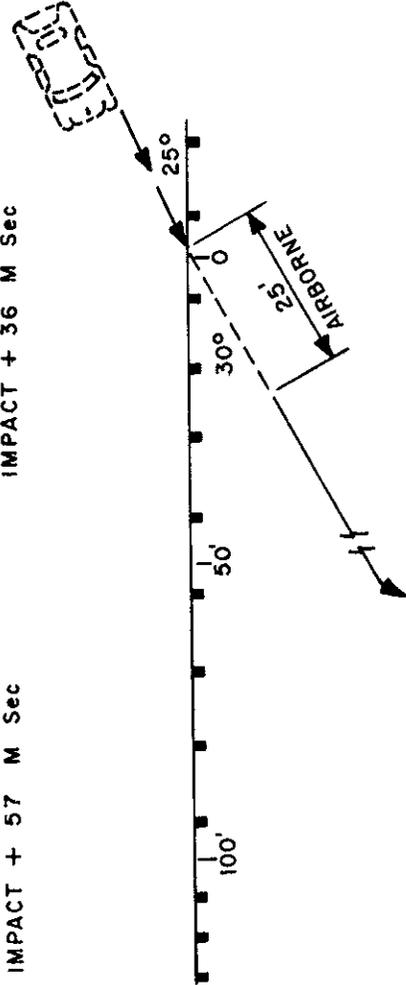
BARRIER DAMAGE: Two sections of beam were damaged. Three posts were knocked out of alignment, one of which was shattered. One block-out block was splintered and one was split.

VEHICLE DAMAGE: The vehicle sustained moderate front end damage. This vehicle was repaired for \$250 and used as the impact vehicle in Test 109.

BEAM RAIL	12 ga. Galv. Steel x 13'-6.5"	TEST NO.	105
RUBBING RAIL	None	DATE	9-9-64
POST	8" x 8" Rough D. F. x 5'-6"	VEHICLE	1962 Chrysler Sedan
POST EMBEDMENT	4"	VEHICLE WEIGHT	4570 #
POST SPACING	12'-6"	(W/DUMMY & INSTRUMENTATION)	
LENGTH OF INSTALLATION	175'	IMPACT SPEED	58 mph
GROUND CONDITION	DRY	IMPACT ANGLE	25°
BEAM RAIL DEFLECTION-PERMANENT	5"	EXIT ANGLE	30°
		DUMMY RESTRAINT	Type 4

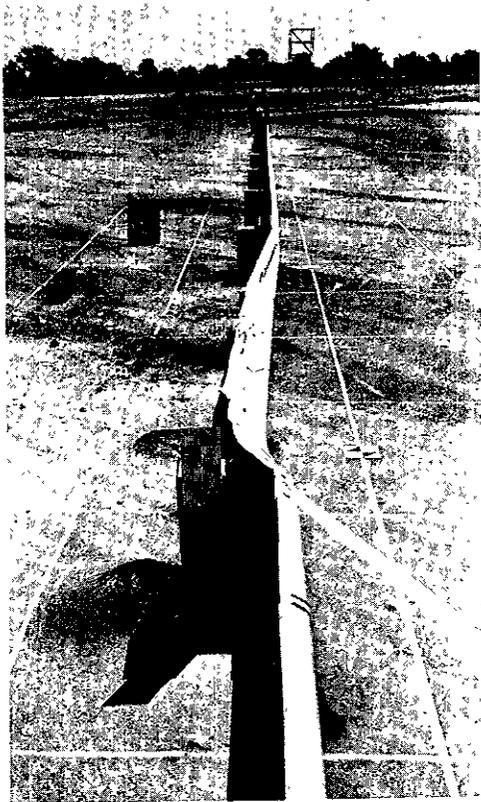
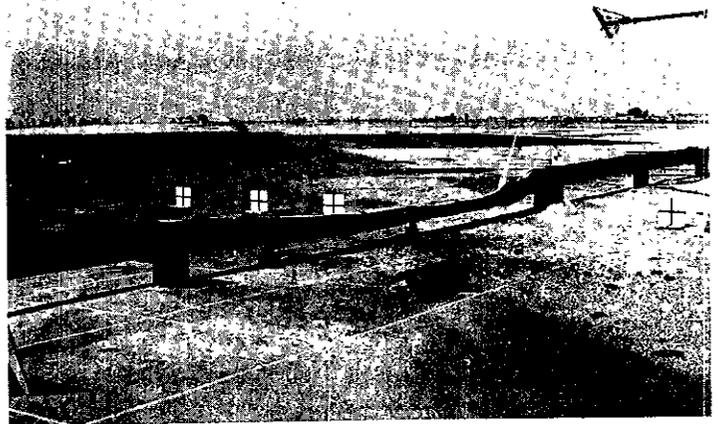
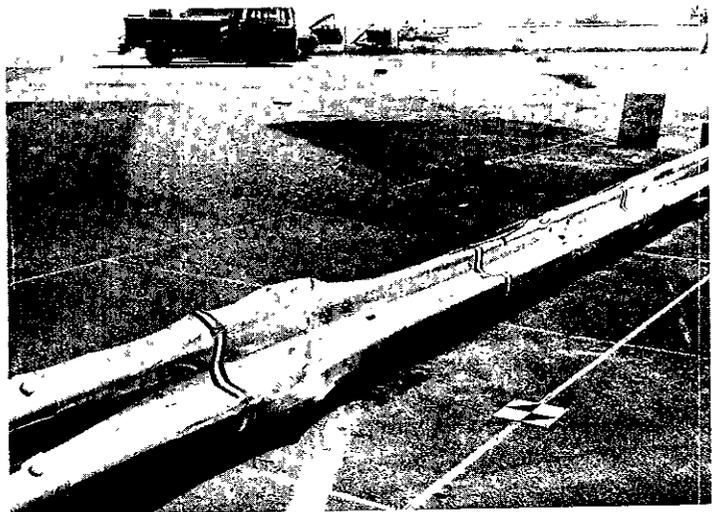
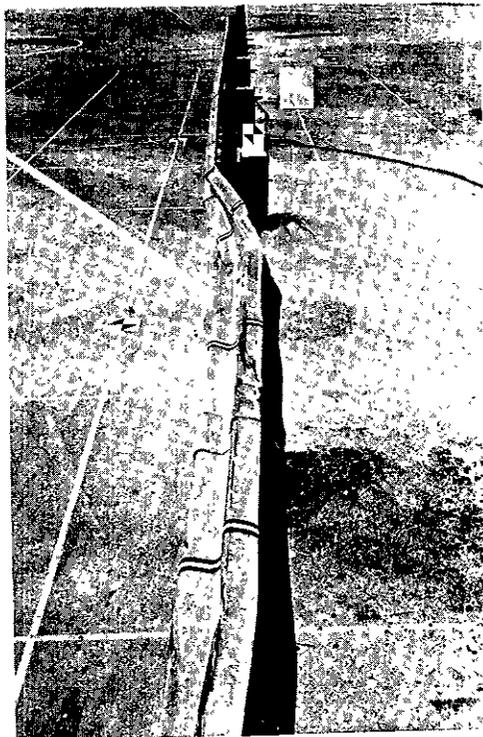
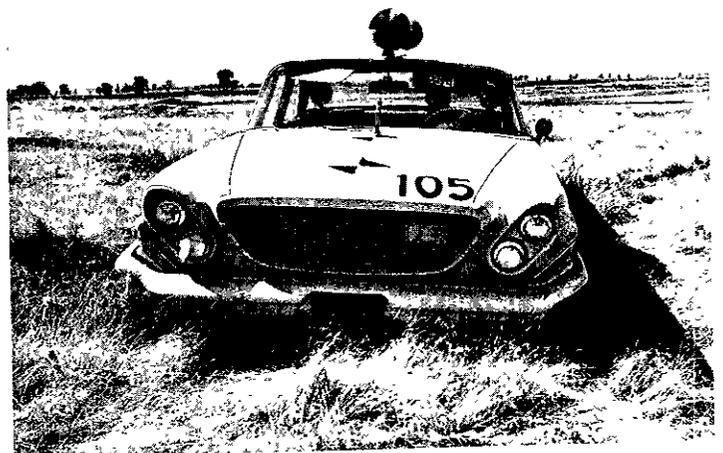
TEST 106 PLATE A

The 30-in.-high beam in Test 106 and the 27-in.-high beam in Test 107 deflected laterally and upward (Table 1). This upward deflection is caused by the "riding under" tendency of the vehicle. In this manner vehicular roll was held to a

minimum value as the guardrail provided a restraining force to the upward movement of the adjacent vehicle side. The 30-in.-high beam provides added insurance against vehicle roll-over or penetration, particularly where uneven or sloping terrain could cause a vehicle to vault immediately in advance of impact.

A moderate amount of post damage caused by wheel entrapment was evident in the guardrail tested in Test 107, which indicated that 27-in. is the maximum beam height that should be used without a rubbing rail. The rubbing rail was found to be effective in installations with beam heights exceeding 27-in. In Test 106 the rubbing rail sustained considerable damage and materially aided the barrier in redirecting the vehicle. Although this function is secondary to that of preventing wheel entrapment, the rubbing rail on the 30-in.-high guardrail gives added strength to this system.

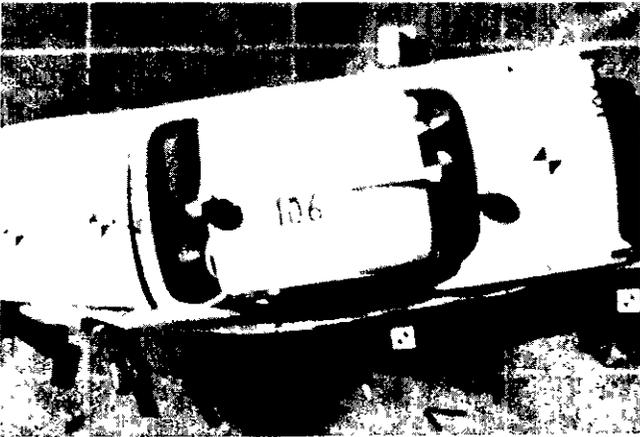
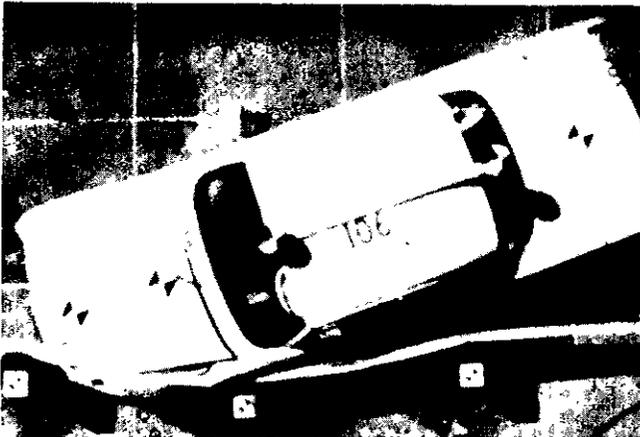
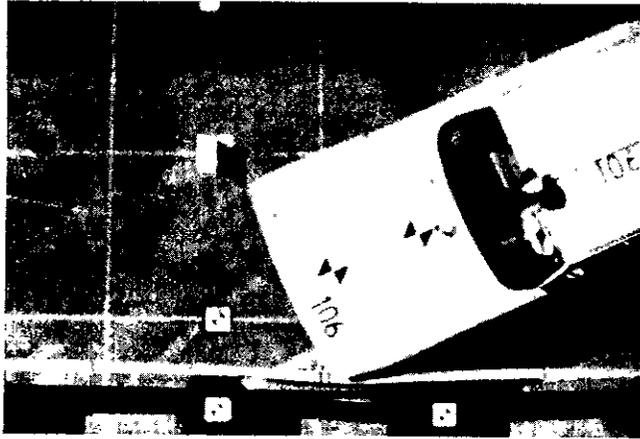
BARRIER DAMAGE: Three sections of beam and two sections of rubbing rail were damaged. Six posts were knocked out of alignment, one of which was broken and one was split. Three block-out blocks were splintered, and two were split.

VEHICLE DAMAGE: The vehicle sustained major front end damage and was considered a total loss.

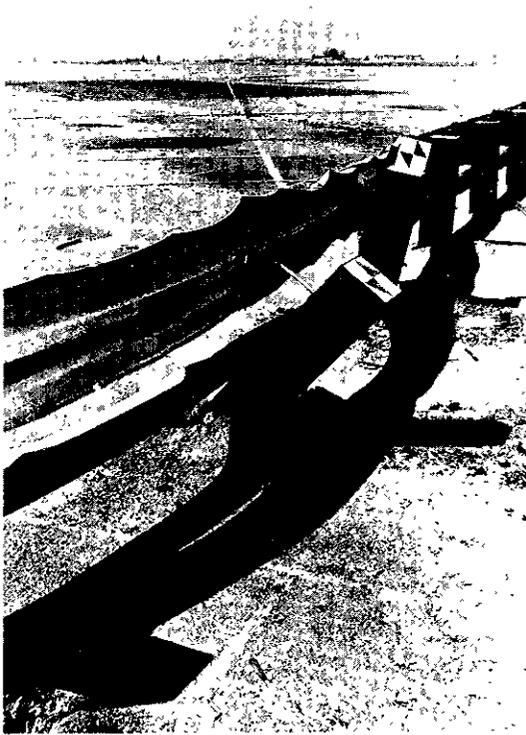
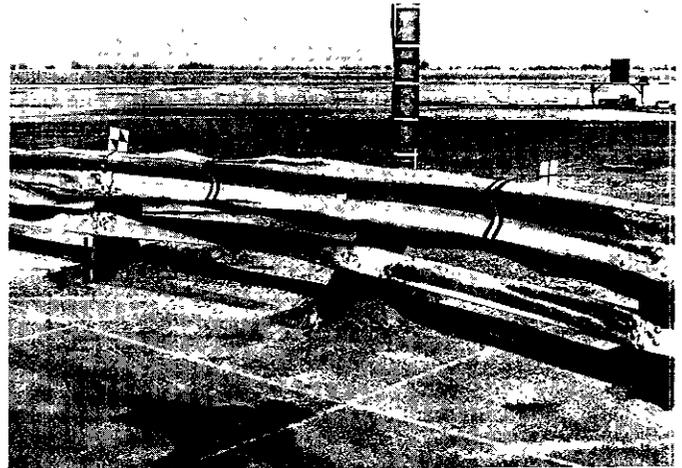
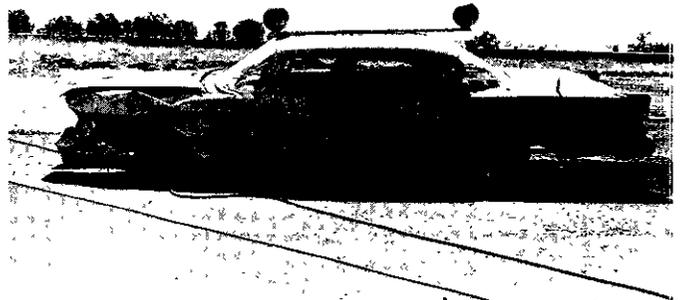
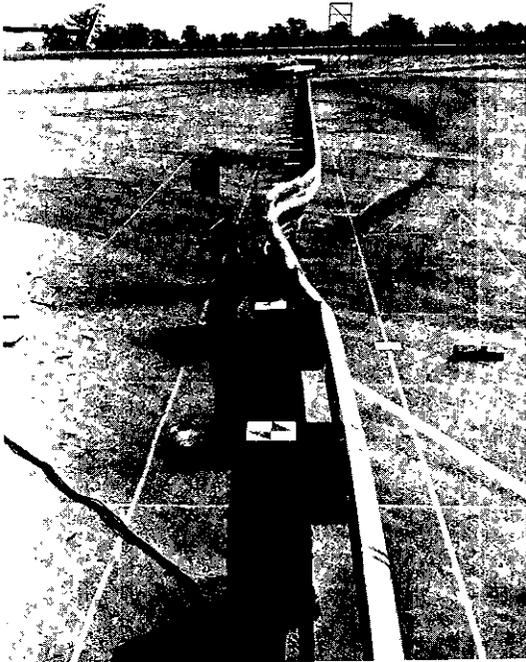
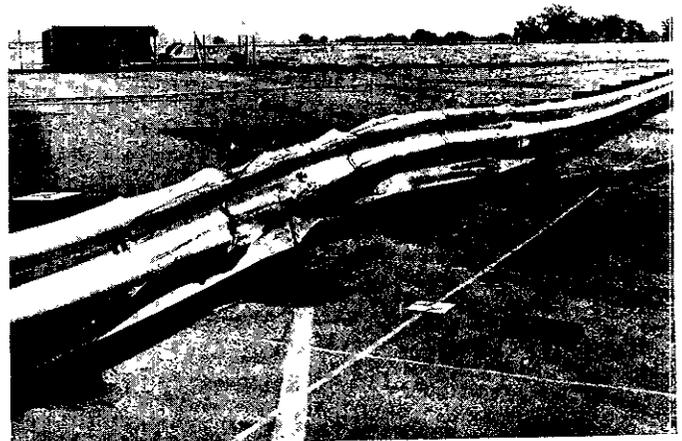
TEST 107 PLATE A

BARRIER DAMAGE: Three sections of beam were damaged. Four posts were knocked out of alignment and two were split. Two block-out blocks were splintered and three were split.

VEHICLE DAMAGE: The vehicle sustained major front end damage and was considered a total loss.

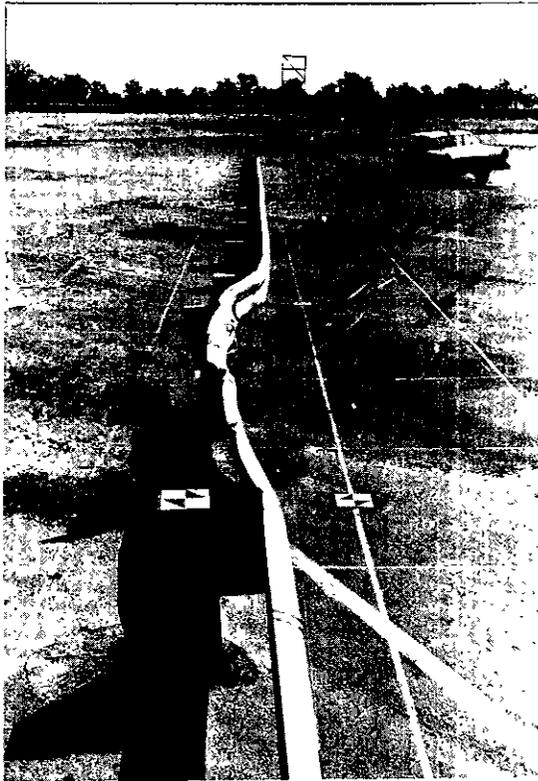
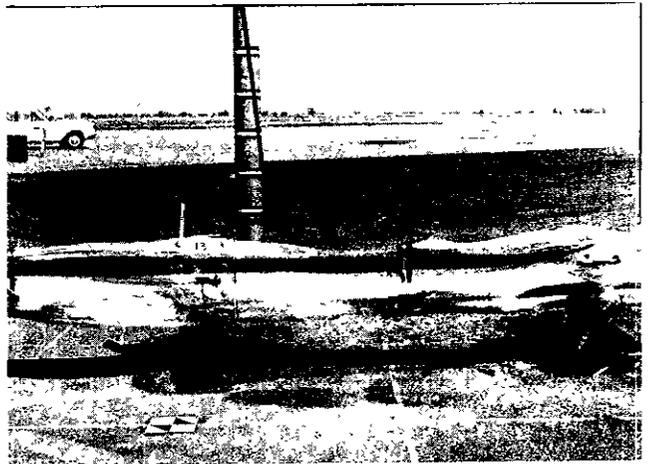
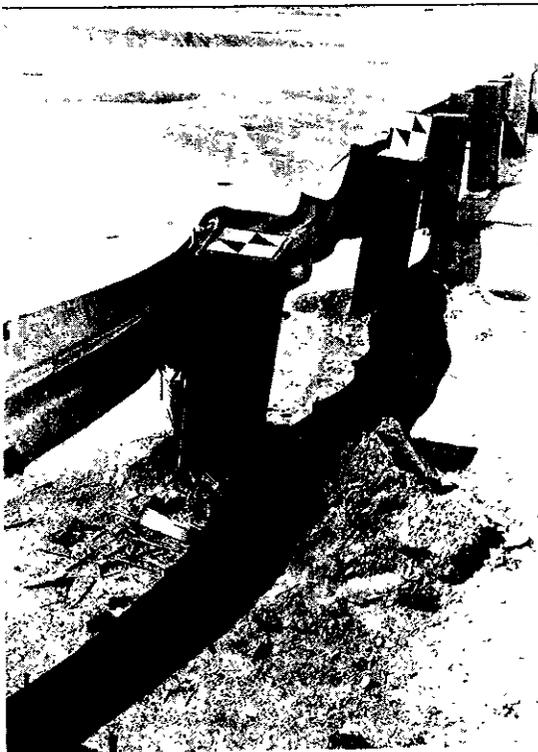
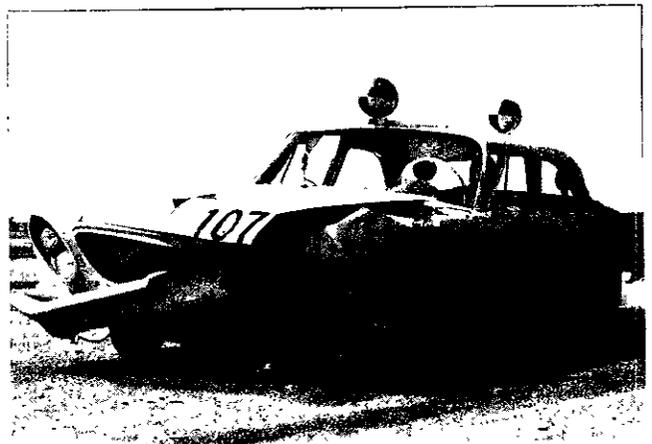
TEST 108 PLATE A

BARRIER DAMAGE: Three sections of beam were damaged. Five posts were knocked out of alignment and five were split. Two block-out blocks were splintered and four were split.

VEHICLE DAMAGE: The vehicle sustained major front end damage and was considered a total loss.

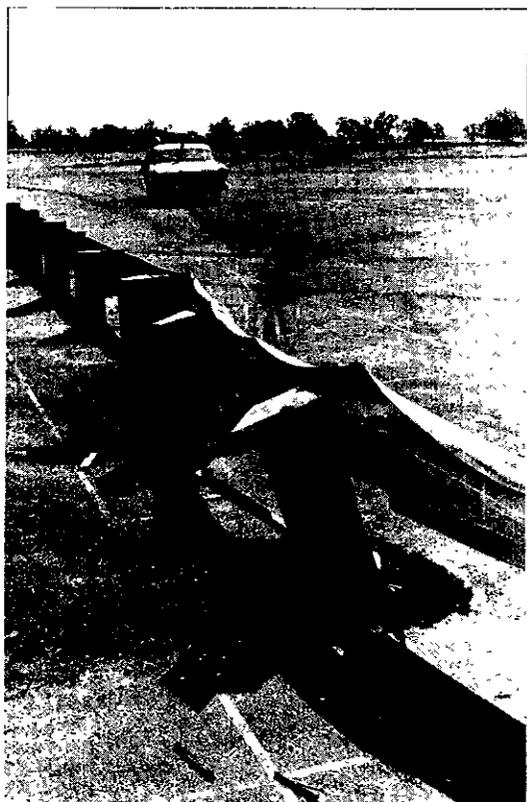
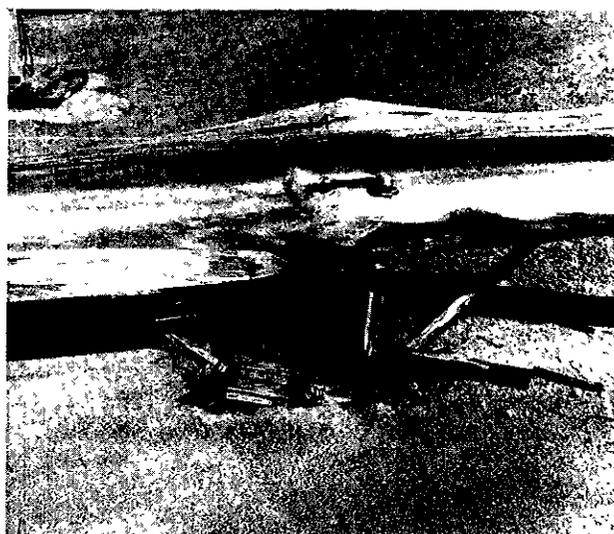
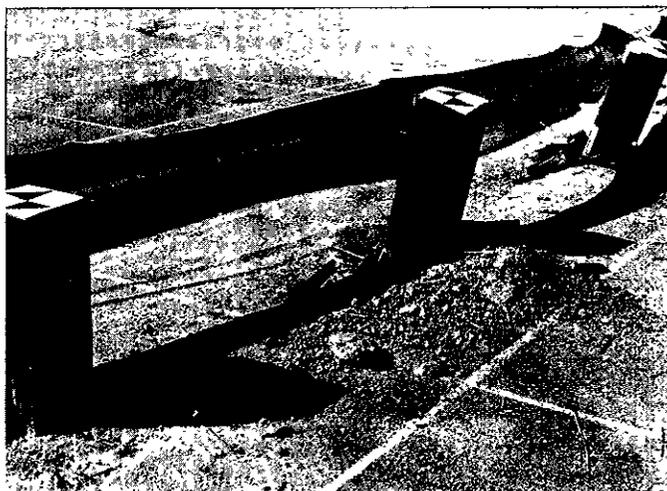
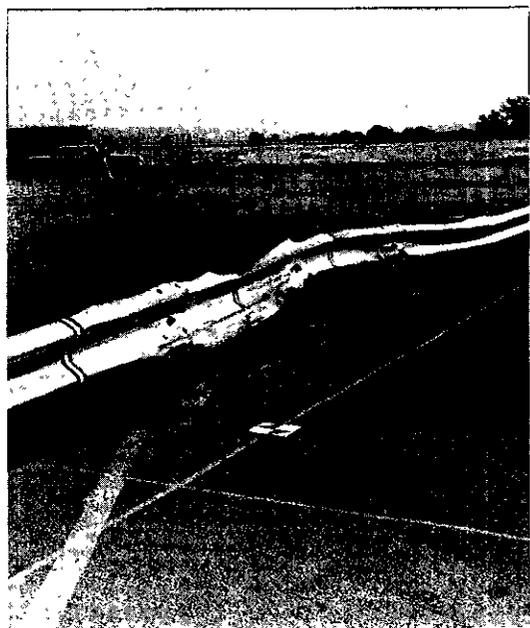
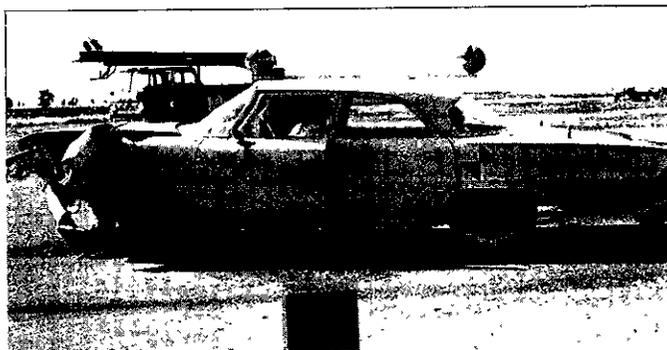
TEST 109 PLATE A

BARRIER DAMAGE: Two sections of beam were destroyed. The beam failed completely in three places. Five posts were knocked out of alignment, three of which were split. Three block-out blocks were splintered and six were split.

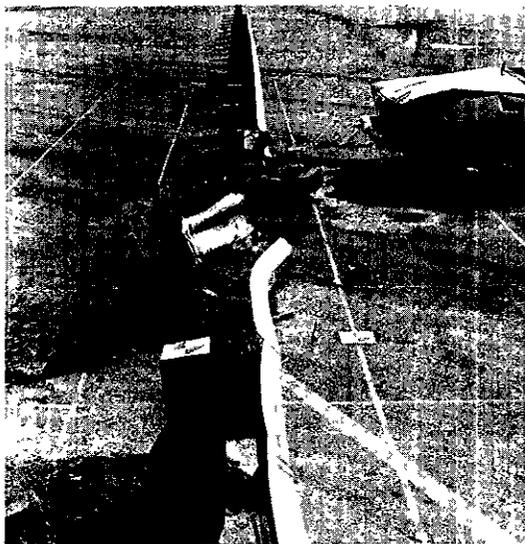
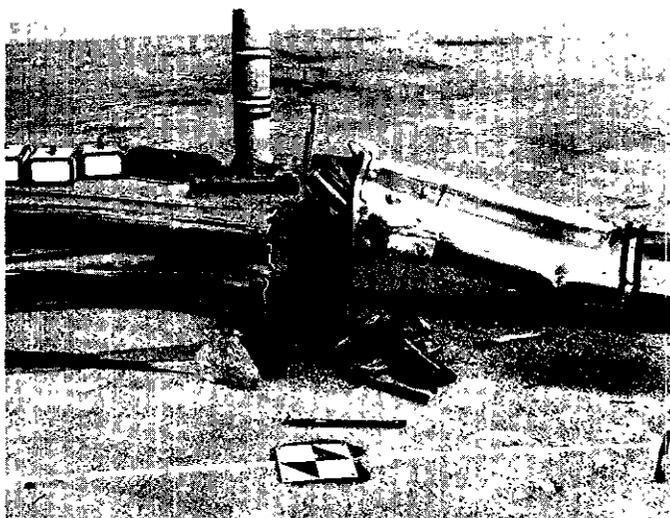
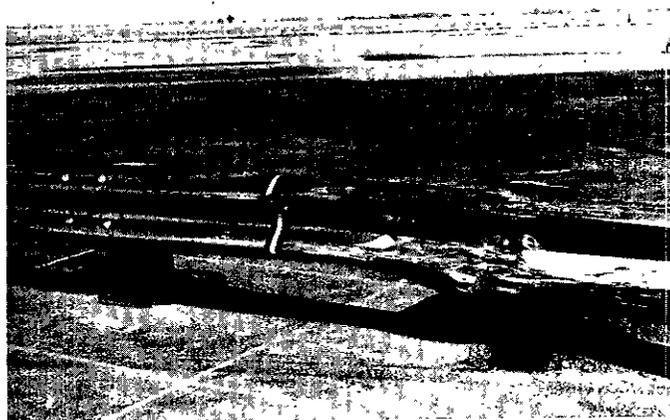
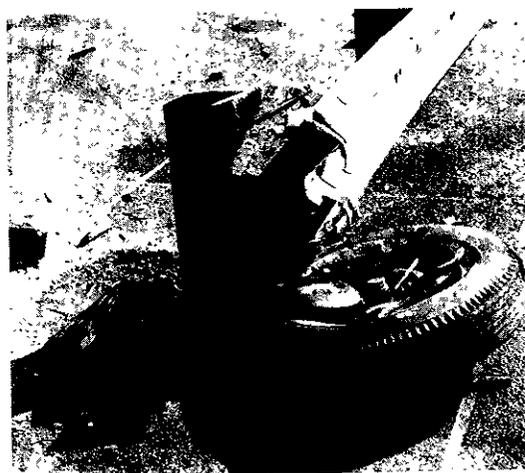
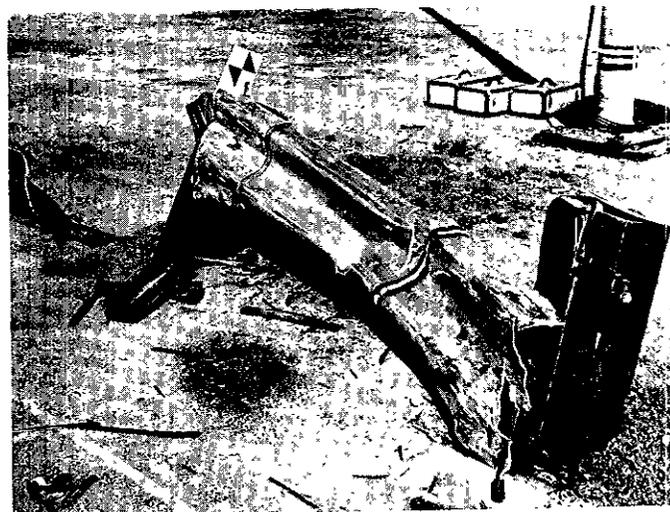
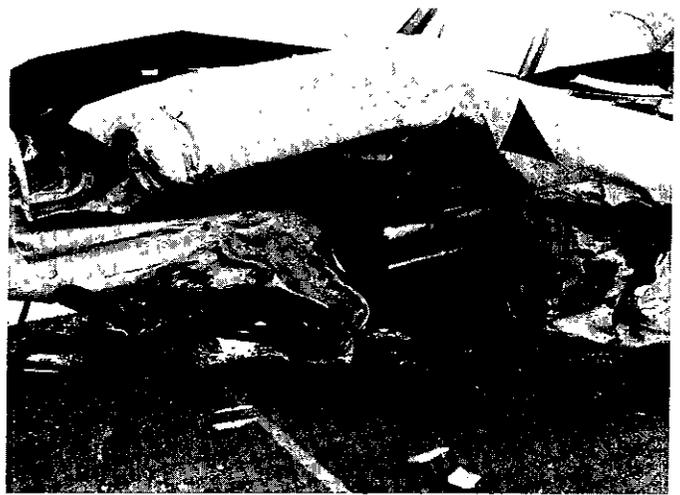
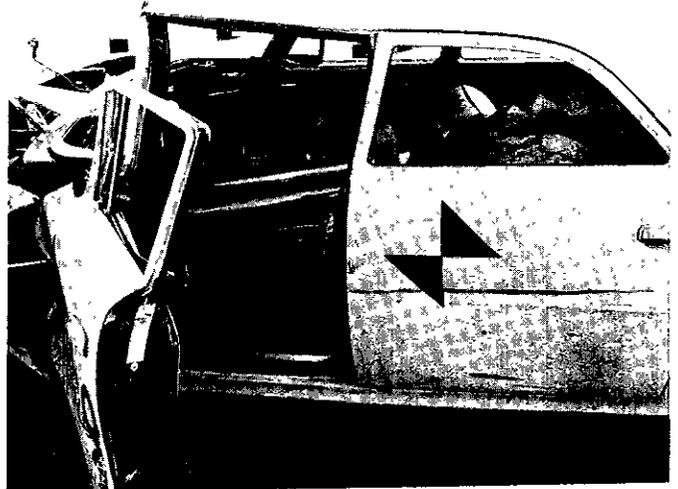
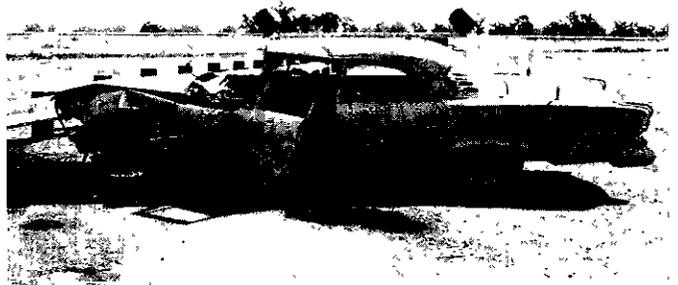
TEST 131 PLATE A

BARRIER DAMAGE: All three beam sections and all seven posts and blocks were damaged. Posts one, two, three, four, and seven were split as the bolts were pulled through the post by the beam. Post six split but partially retained the bolt, causing the beam to pull free of the bolt. Post five pulled out of the ground and remained attached to the beam. One post bolt failed at the beam bearing point. There was no indication of failure at the beam splices.

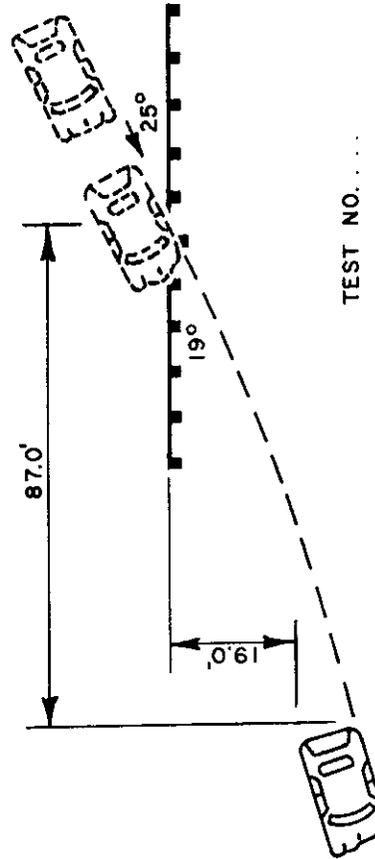
TEST NO. 132
 DATE 6-15-66
 VEHICLE 1964 Dodge Sedan
 VEHICLE WEIGHT 4540 #
 (W/DUMMY & INSTRUMENTATION)
 IMPACT SPEED 61 mph
 IMPACT ANGLE 25°
 EXIT ANGLE 19°
 DUMMY RESTRAINT Lap Belt

BARRIER DAMAGE: All five beam sections, ten of eleven posts and eight of nine blocks were damaged. Posts one, three, five, nine, ten, and eleven were split as the bolts were pulled through the posts by the beam. Posts six and seven were shattered to ground level. Posts two, four, and eight retained the bolt causing it to pull through the beam. Extreme bending caused three cracks to occur in the beam. There was no indication of failure at the beam splices.
