DYNAMIC TESTS OF WOOD POST AND TIMBER POLE SIGN SUPPORTS SERIES XV

MATERIALS AND RESEARCH DEPARTMENT
RESEARCH REPORT
NO. M & R 636398

December - 1967
Final Report
No. M & R 636398

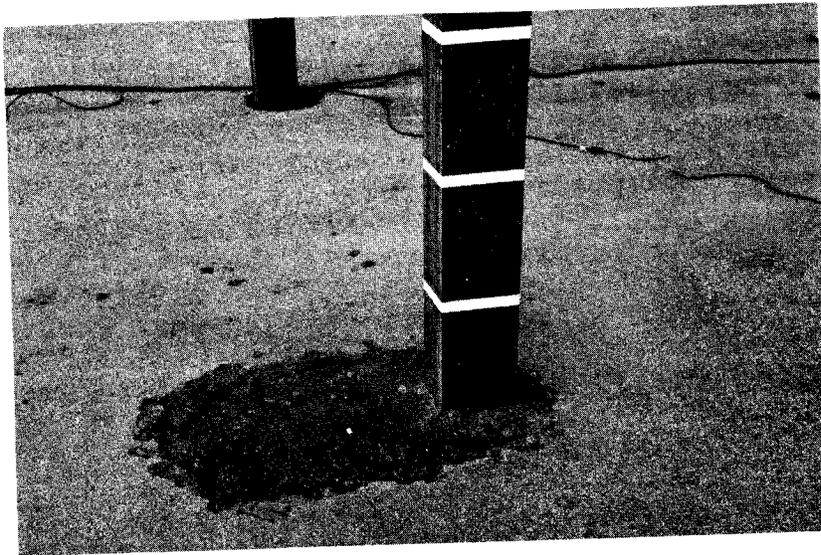
FIGURE 1

The test site for this study was a portion of an unused airport runway (Exhibit 1). The runway is surfaced with a two inch thick asphalt pavement with no imported base material. To simulate a typical operation installation, the asphalt surfacing was removed from behind each wood post or timber pole support to be impacted for a minimum distance of 24 inches as shown in Figure 1 below.

This allowed the impacted support to dynamically deflect horizontally on impact and transmit shear forces to the soil with no interference from the surrounding asphalt pavement.

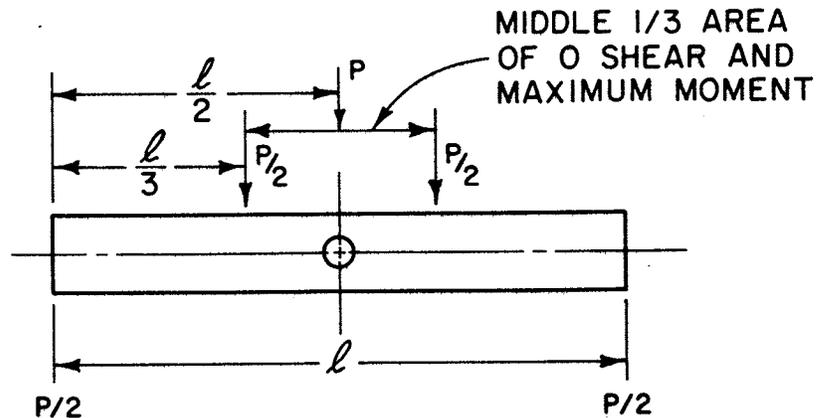
FIGURE 4

As a laboratory check of the theoretical effect a reduction in cross sectional area has on ultimate moment carrying capacity, six static load tests were performed on 8" x 8" x 6' D.F. posts. The cross sectional areas of two of the posts were reduced 30% by drilling a 2½" diameter hole through the post along its neutral axis. The remaining four posts were not altered. Third point loading, as shown in Figure 4 below, was used to minimize the effect of shear. Theoretically the middle one third of the beam will resist maximum moment and shear forces will be negligible.

On this basis it appears that the drilling of holes in wood sign supports can be recommended as a method of reducing impact resistance without significantly reducing its sign supporting capacity.

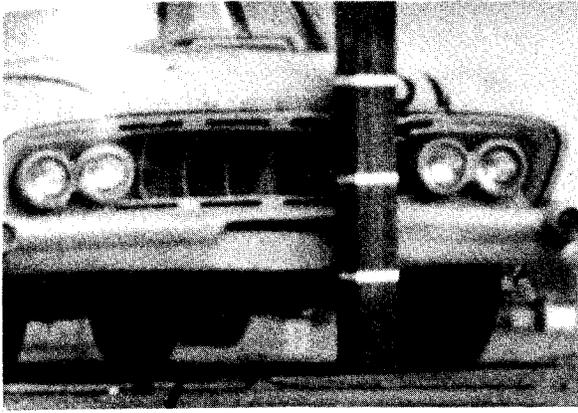
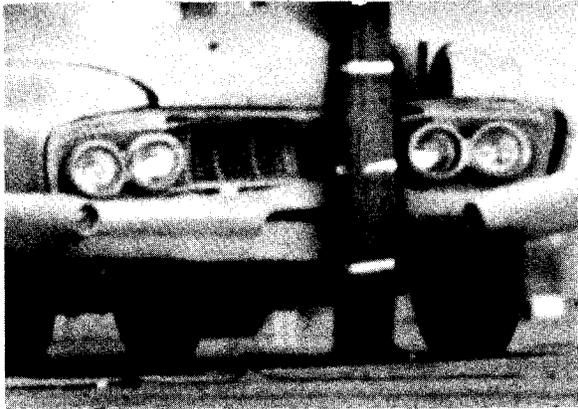
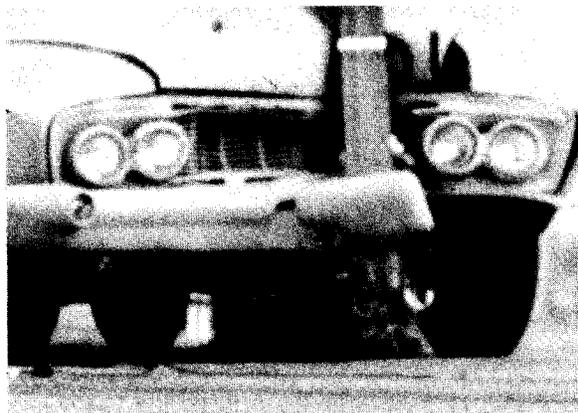
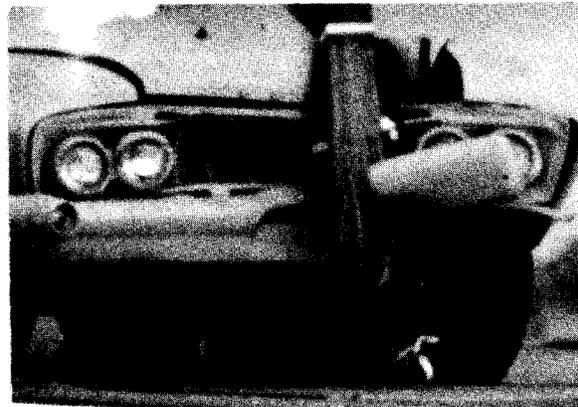
TEST 151 PLATE A

The impacted post sheared at ground level and was propelled upward and to the right by the force of impact. The pole tore loose from the lower panel, pulling the mounting bolts through the sign panel, but remained attached to the upper panel which it twisted and bent as it swung in an arc down and to the right of the right support post. Neither sign panel could be salvaged.

The vehicle sustained moderate front end damage.

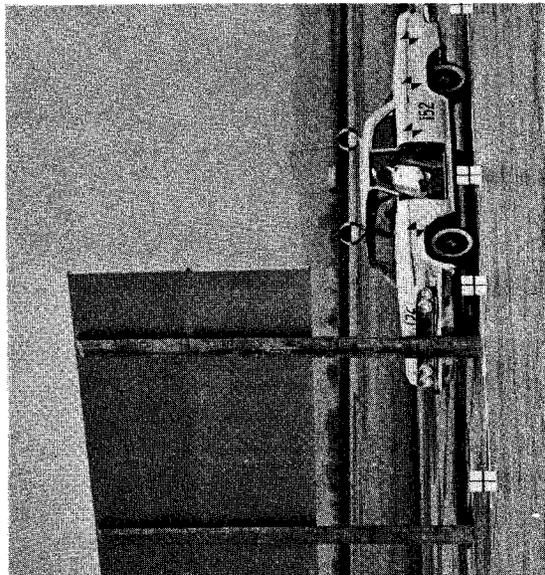
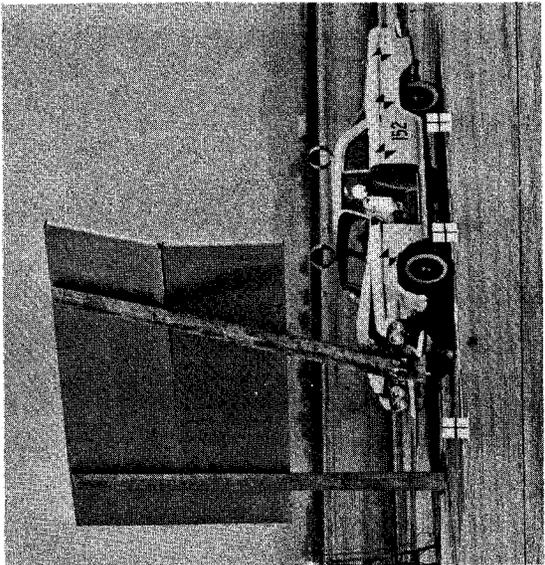
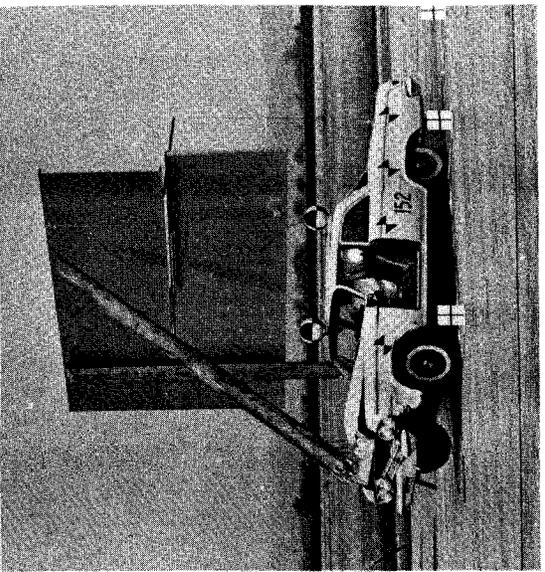
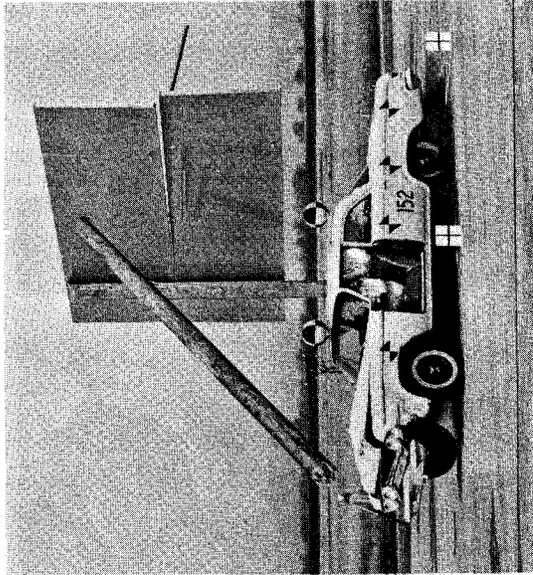
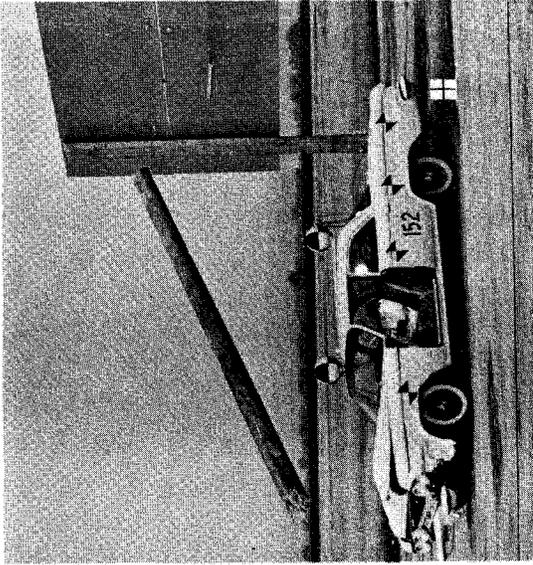
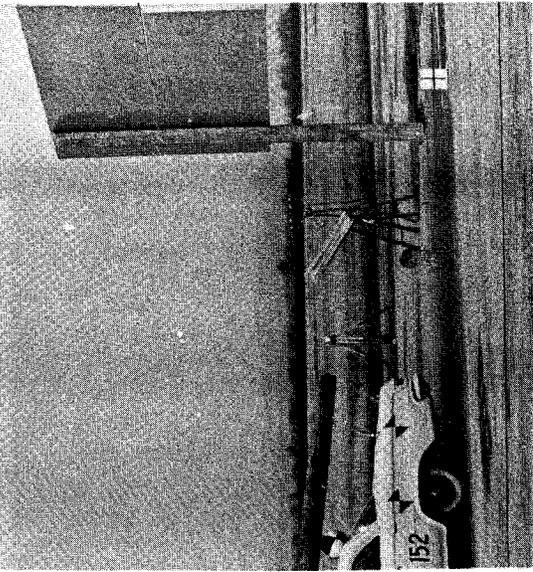
TEST 152 PLATE B

Upon impact the pole broke off 11 in. below ground level and 24 in. above the ground. The upper 15 ft. section of pole tore loose from both sign panels, was flipped up and came down on the crash vehicle deforming the roof and shattering the rear window. The four lag bolts, attaching the sign panels to the pole, pulled out of the impacted pole without damaging the sign panels. The panels remained attached to the right support pole and were used in the subsequent test without repairs.

A review of the high speed data film indicated that the pole failure resulted primarily from excessive bending

The vehicle sustained moderately severe front end sheet metal damage in addition to the aforementioned deformed roof and shattered rear window.

It was concluded that a medium to heavyweight vehicle colliding with a Class 2 timber pole in a manner similar to this test would generally result in tolerable deceleration rates and be a survivable accident. However, because the impact severity of this test did approach marginal magnitudes and the specific conditions of this test were probably less severe than would generally be expected under certain operational conditions, a reduction in impact resistance was considered desirable. It was therefore decided to attempt to reduce the impact resistance of the Class 2 timber pole to make it safer for all conditions of impact. It was considered essential, however, that this be accomplished without sacrificing the ability of the pole to withstand design wind loadings.

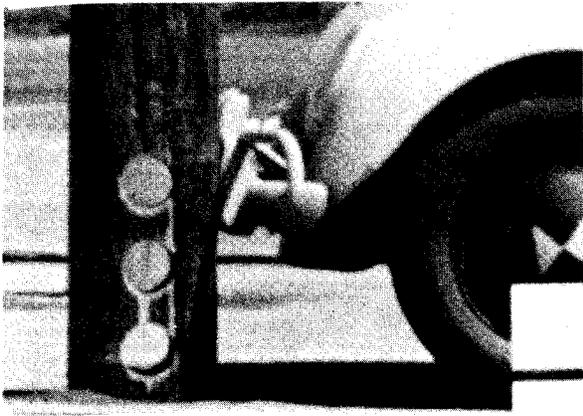
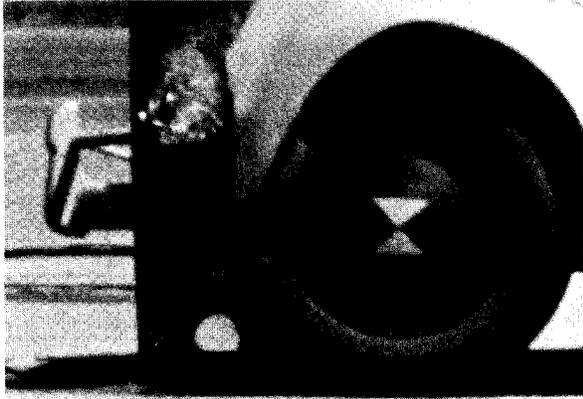
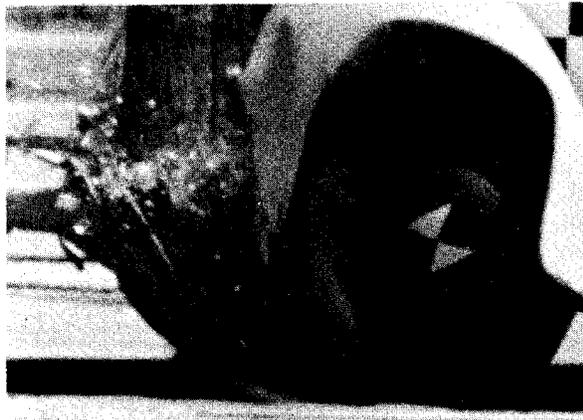
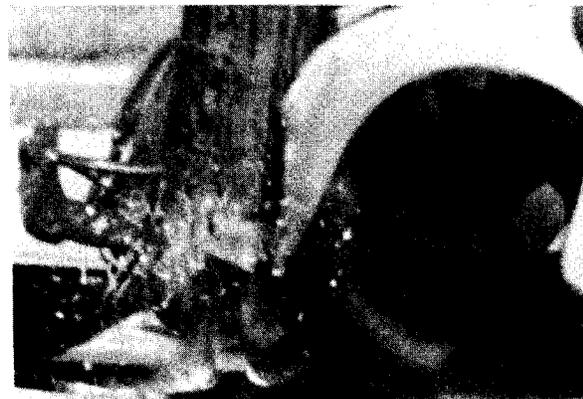
Prior to this test it was felt that failure would result primarily from excessive shear stress and produce a clean break through one of the weakened planes where the cross sectional area had been reduced. However, the high speed data film revealed that a beam type failure occurred with the wood material splitting between the holes, thus allowing vertical slippage. This let the two sides of the pole break independently of one another. Sequence pictures illustrating this failure are shown in Plate A, Test No. 153, of the Appendix. The appearance of the broken pole after impact is shown in Figure 3.

The test vehicle impacted "head-on" into the modified post, at a speed of 39 mph. The vehicle's exit speed was 27 mph. The vehicle was redirected approximately 5 degrees to the left, probably as the result of impact being approximately 1.5 ft. to the left of the vehicle center. The impacted pole fractured at the bottom hole approximately 2 in. above the ground and the section

containing the three holes split in two and was crushed by the force of impact. The remaining 15 ft. of pole was kicked ahead and up, and it tore loose from the sign panels. Had the vehicle not been redirected slightly, it is probable that this section, as it fell, would have struck the vehicle top as in the previous test. The sign panels pulled loose from the other support post and fell to the ground directly below.

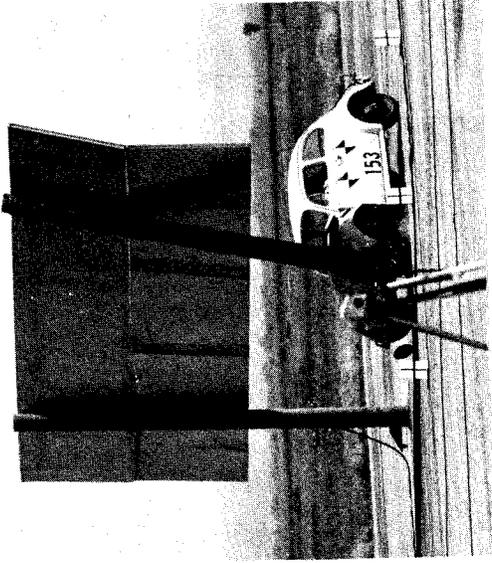
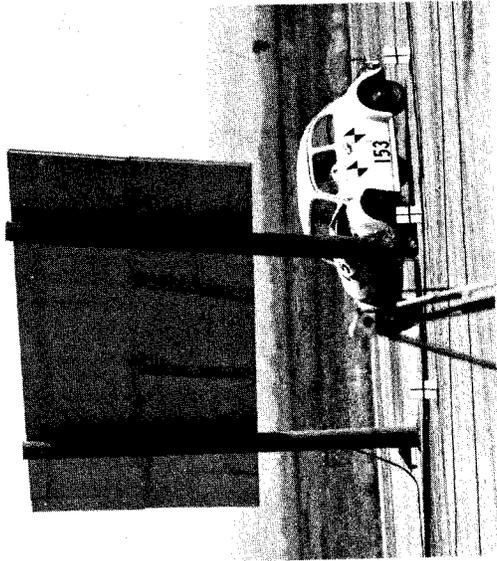
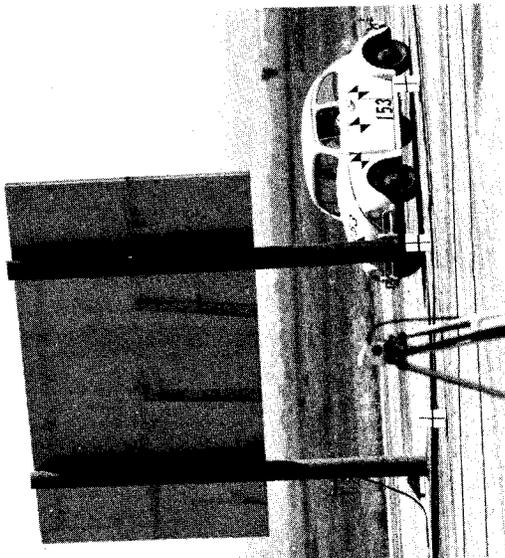
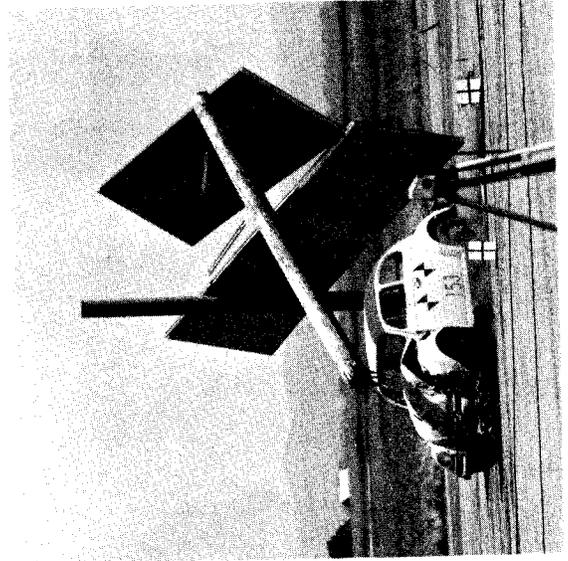
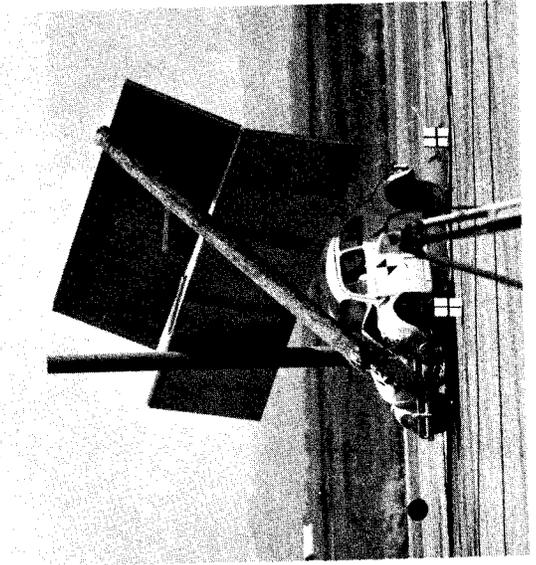
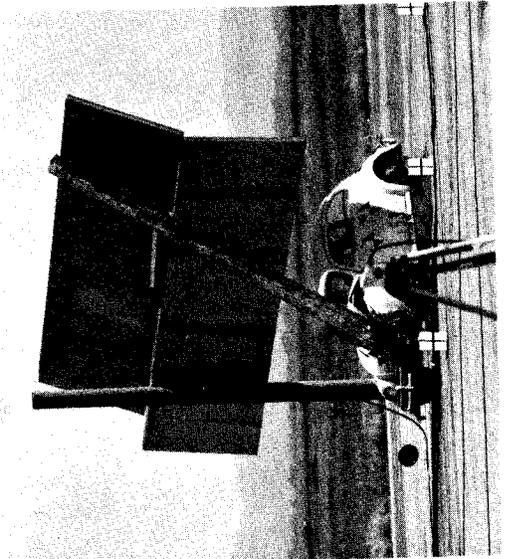
TEST 153 PLATE B

Data film and impactograph recordings of the dummy driver indicate that deceleration rates were approximately of the same magnitude as those observed in the previous test. This is felt to be significant when considering the substantial weight differential between the two vehicles. It is apparent that the drilled hole modification effectively reduced the impact resistance of the pole. A live driver would probably have sustained minor injuries from this impact.

The vehicle sustained moderate front end and under-carriage damage with the left front wheel pushed back approximately 6" and the steering column 3". Repair costs were estimated at \$250.

For 6" x 8" dimensioned posts 2½" dia. holes are recommended and for timber poles the hole dia. should conform to those listed in Table II below:
