Pinole Slide I-80, California

1970

Materials and Research Department
Division of Highways
Sacramento, California

PINOLE SLIDE
I-80, CALIFORNIA

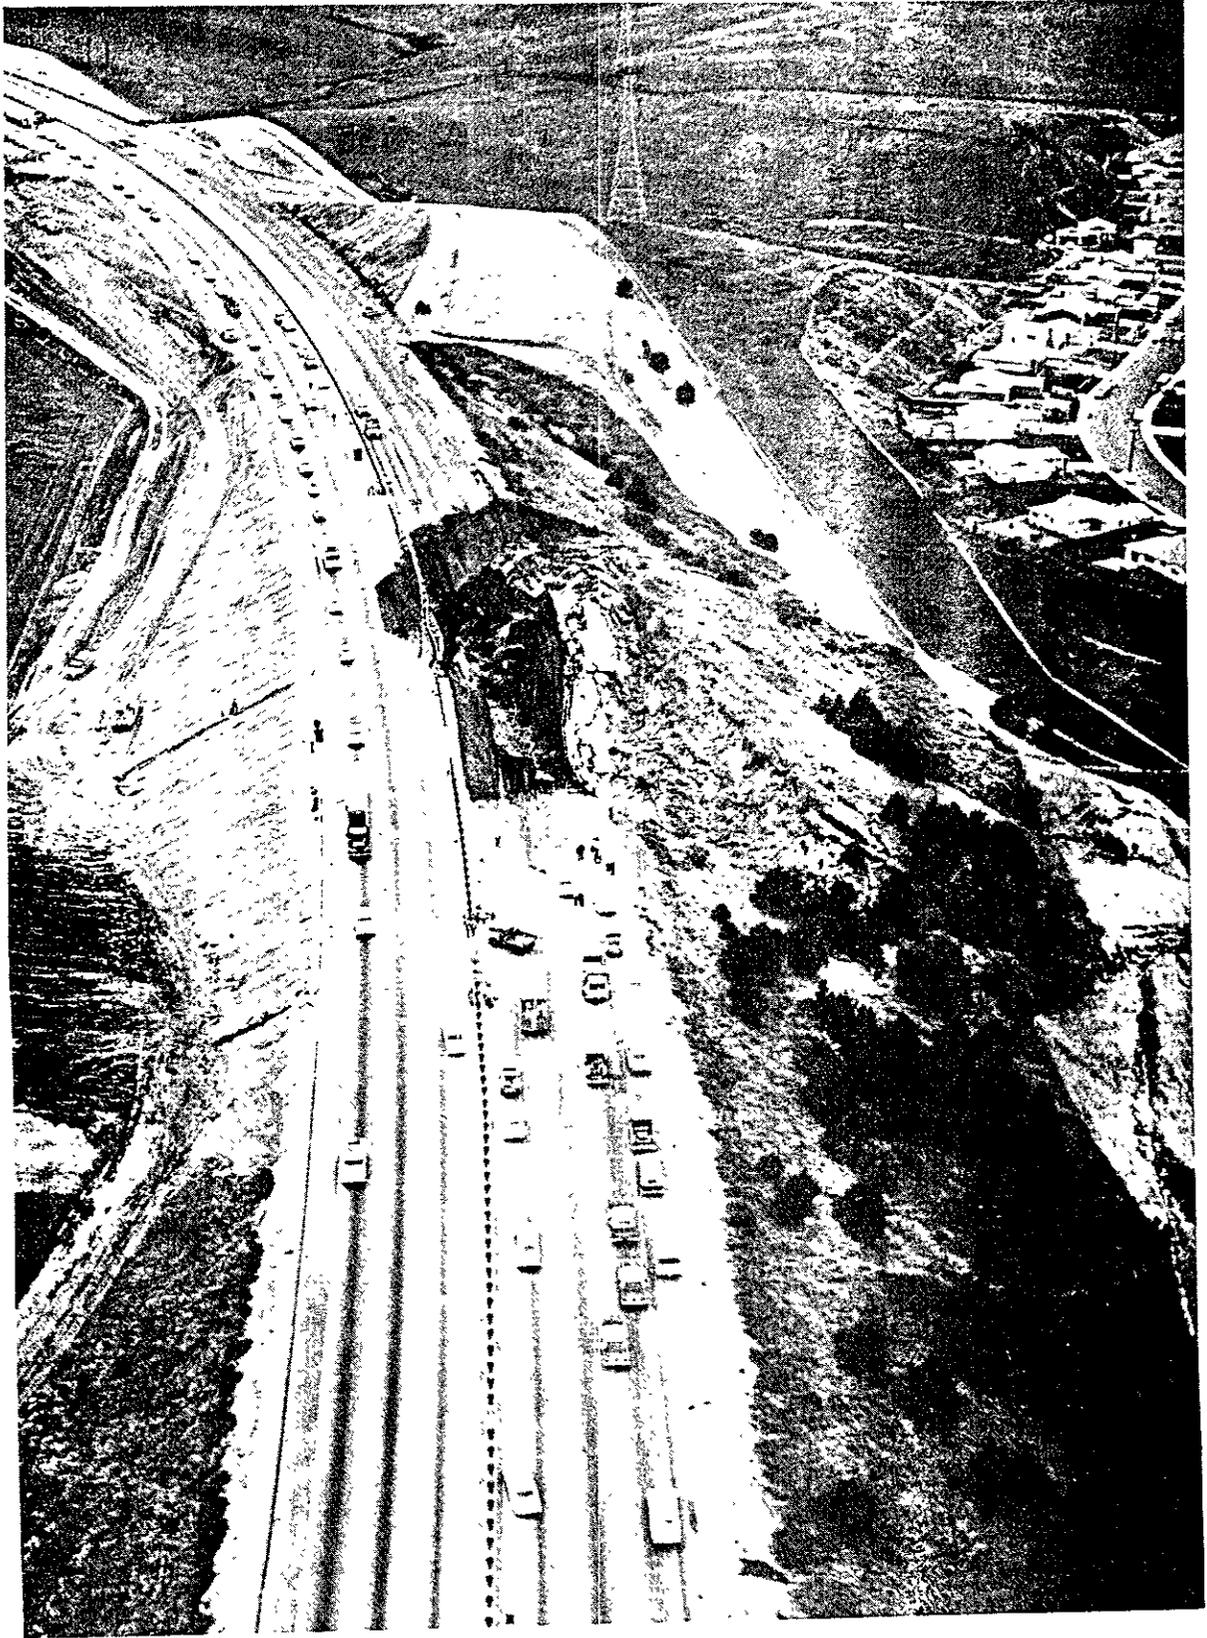
On Tuesday, May 6, 1969, indications of distress in the form of cracking and settlement appeared on a portion of the pavement of Interstate Route 80 near Pinole, California. Efforts to restore the damaged surface of the heavily traveled freeway during the next few days were ineffective as the deterioration of the roadway progressively worsened. It soon became apparent that the distress reflected an unstable condition within the embankment or its underlying foundation, and by Sunday morning, May 11, the prospect of a massive failure appeared imminent. It was therefore decided to close the road at midday in the interest of public safety. The Highway Patrol was notified, traffic was diverted, and police forces in nearby cities were alerted to prepare for unusual traffic over alternate routes. A few hours after these precautions were taken, over 400 feet of embankment slid out leaving a single lane of the roadway in place, as shown in Photographs 1 and 2.

Photograph No. 1 - Aerial photo of slide, looking westerly
