Landslide Investigation Near Forest Glen

January 1976

R.H. Prysock

State of California
Department of Transportation
Division of Structures & Engineering Services
Office of Transportation Laboratory

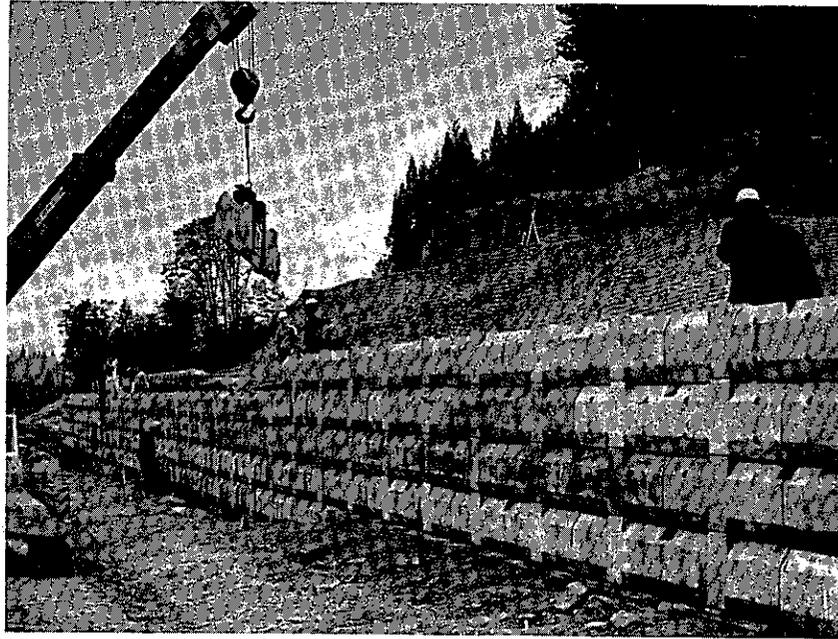
PHOTO 1-a: Concrete Beam Facing of the Mechanically Stabilized Embankment on Interstate Highway 5 at Dunsmuir, California.

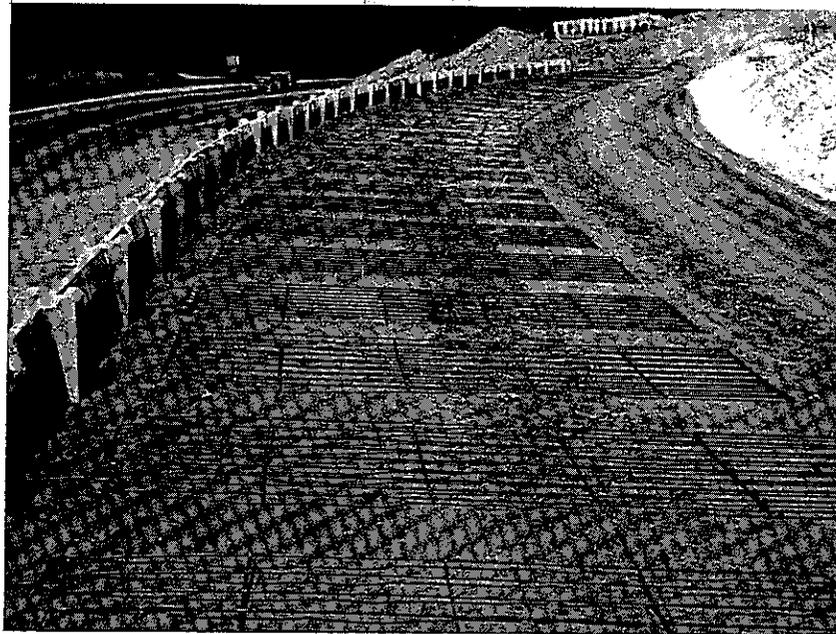
PHOTO 1-b: Reinforcing Bar-mesh in the Mechanically Stabilized Embankment on Interstate Highway 5 at Dunsmuir, California
