1. REPORT NUMBER  CA/TL-87/06	2. GOVERNMENT ASSOCIATION NUMBER	3. RECIPIENT'S CATALOG NUMBER	
4. TITLE AND SUBTITLE A Seat Belt Efficacy Demonstration: A Large Angle Moderate Speed Impact Into a Concrete Median Barrier		5. REPORT DATE April 1987

A SEAT BELT EFFICACY DEMONSTRATION:  
A LARGE ANGLE MODERATE SPEED IMPACT  
INTO A CONCRETE MEDIAN BARRIER

STATE OF CALIFORNIA  
DEPARTMENT OF TRANSPORTATION  
DIVISION OF FACILITIES CONSTRUCTION  
OFFICE OF TRANSPORTATION LABORATORY

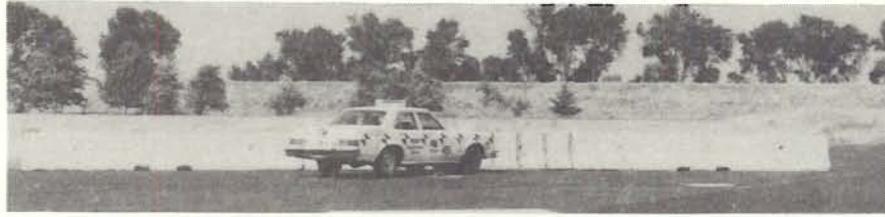
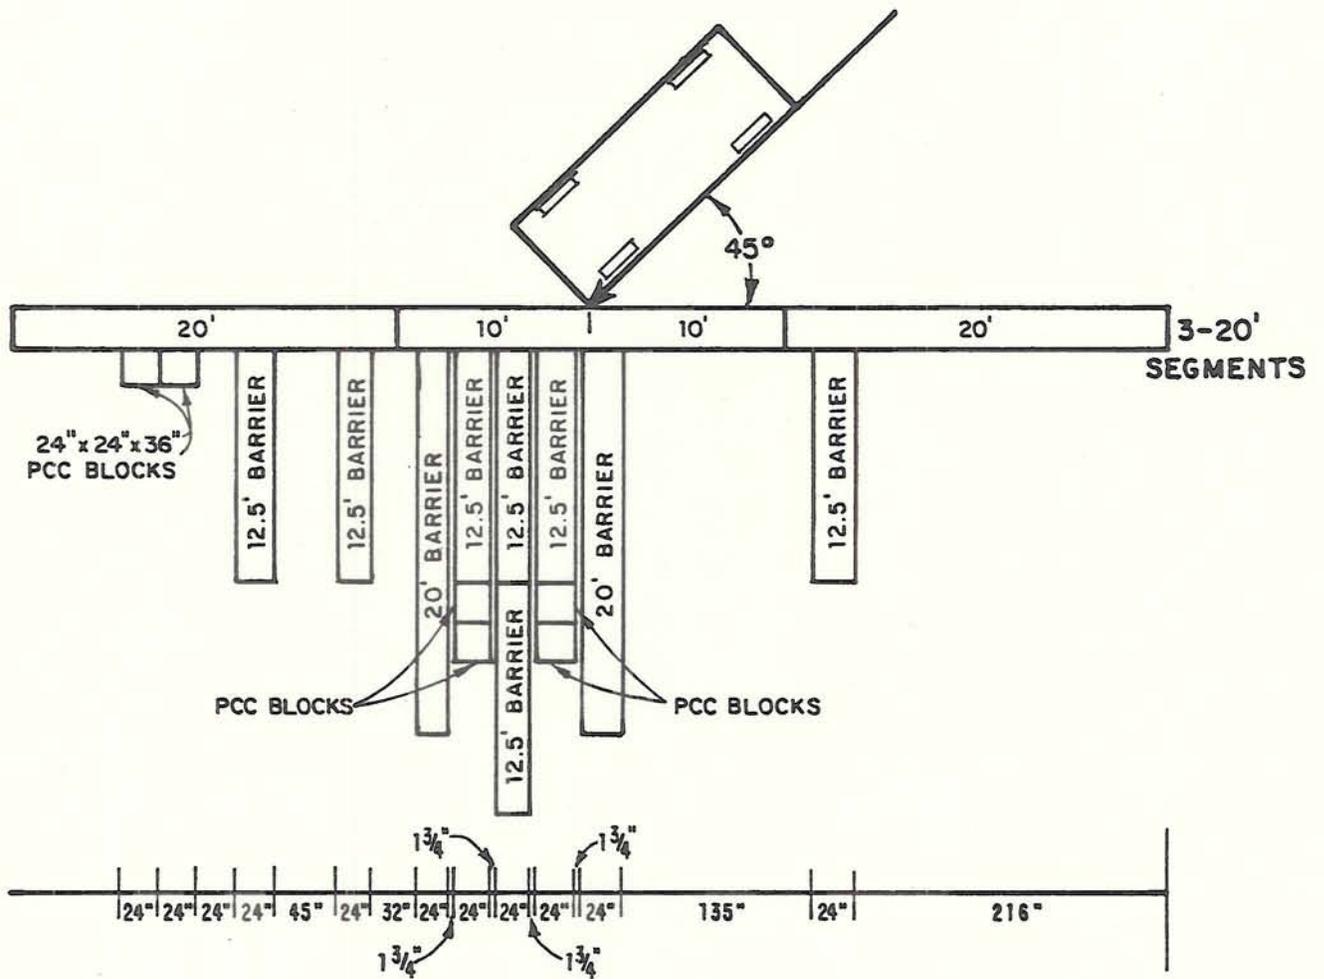
Figure 1. Barrier Installation

The test barrier consisted of three 20-foot-long temporary concrete barrier segments linked together with a pin joint. They had a safety-shaped "New Jersey" profile. The barrier was backed up with several other barrier segments and concrete blocks to prevent lateral movement. Wood wedges were placed between the sloping back of the impacted barrier and some of the backup segments to prevent rotation upon impact. Thus, the test barrier simulated a standard cast-in-place, continuous median barrier. Figure 1 shows the test barrier layout.

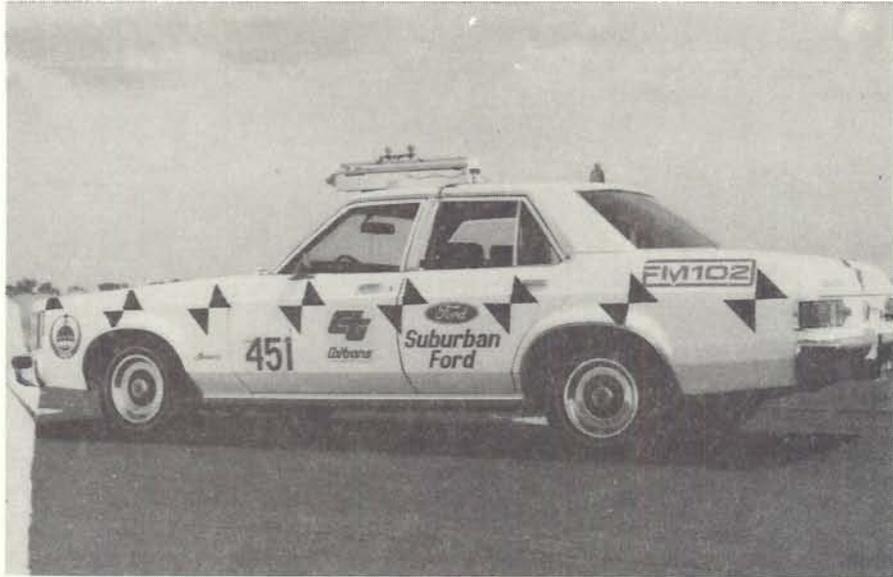
Figure 2. Test Vehicle - 1975 Ford Granada

The vehicle conformed with the requirements of NCHRP Report 230(1)\* in the following respects: It was in good condition, had no major body damage and had no missing structural parts. The vehicle fuel tank was purged. The engine was front mounted (see Figure 2).

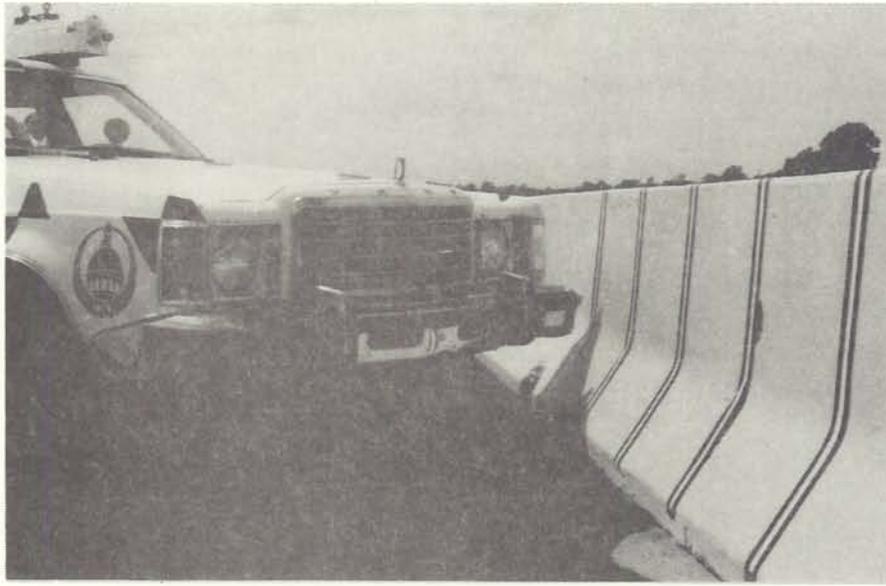
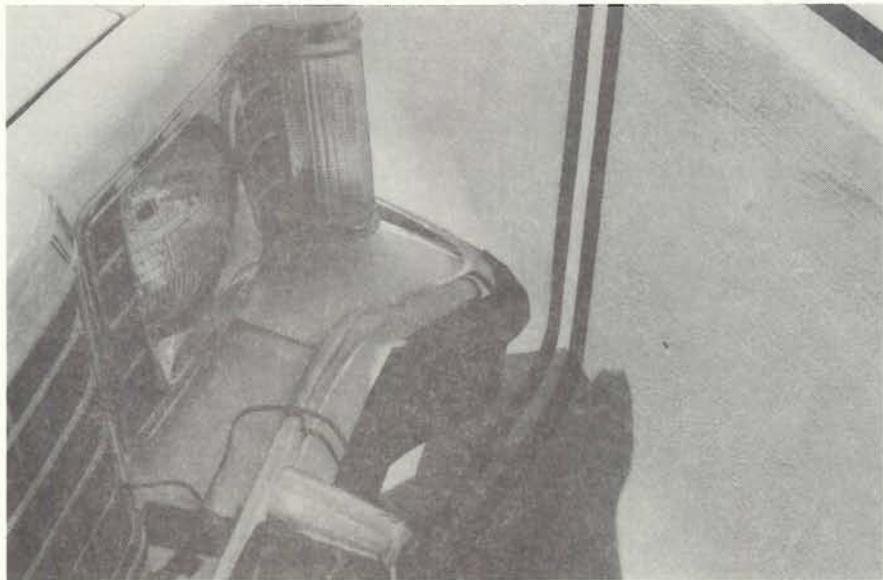
Figure 3. Test Vehicle at Impact Position

The test vehicle, a 1975 Ford Granada weighing about 3575 lbs, excluding the dummies, impacted the barrier at an angle of 45° and a speed of 40.3 miles per hour. Figure 3 shows the vehicle in the impact position.

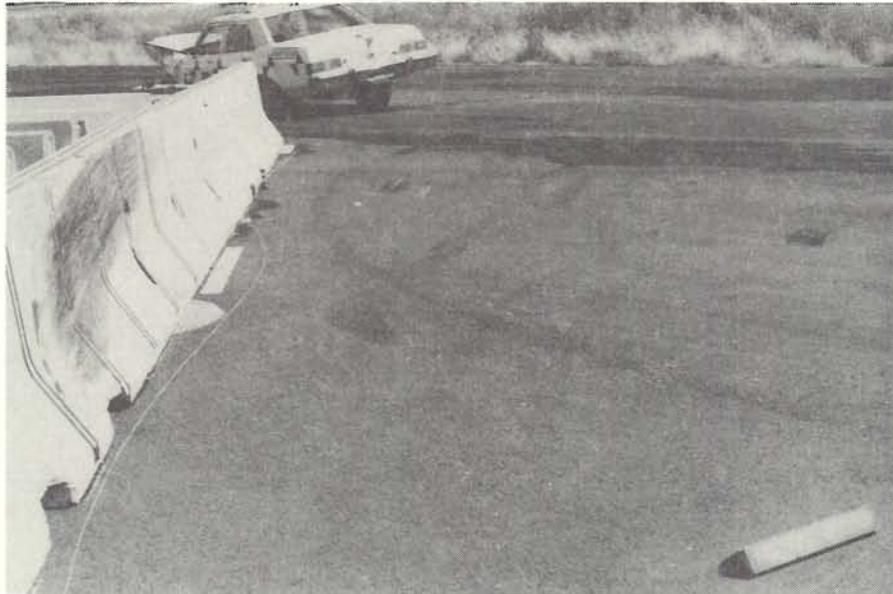
Figure 5. Postimpact Position of Vehicle

The vehicle continued away from the barrier at a speed of about 21 mph and exit angle of 9-1/2°. It then turned to the left (toward the barrier) and came to rest 11.8 feet downstream from the end of the barrier. The left rear tire was roughly centered on the centerline of the barrier and the longitudinal axis of the car was at an angle of 36-1/2° with respect to the barrier. The data summary sheet, Figure 4, and Figure 5, show the final position of the vehicle with respect to the barrier.

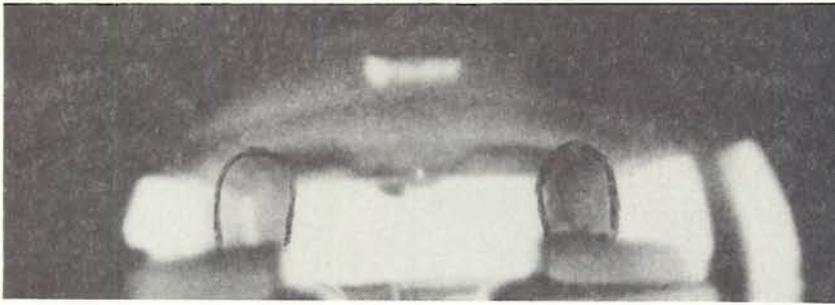
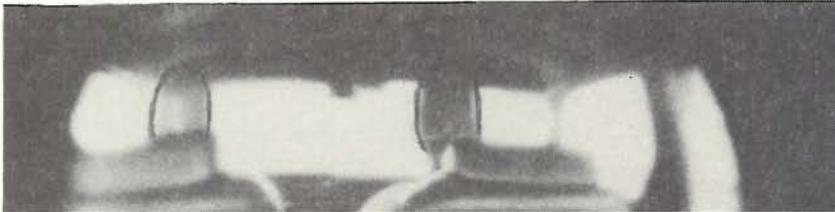
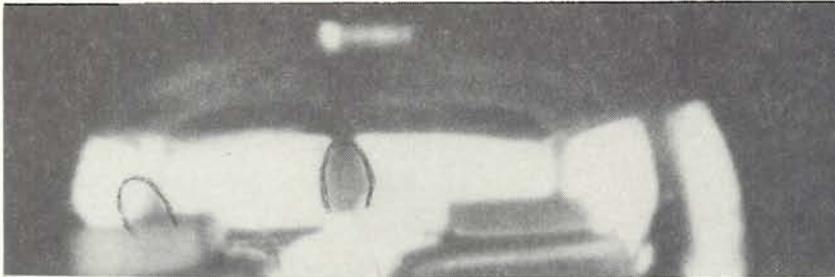
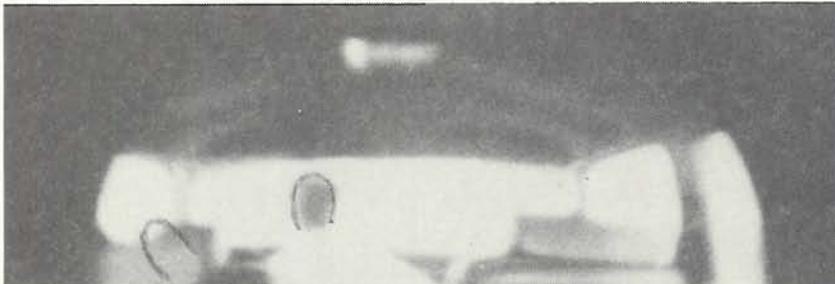
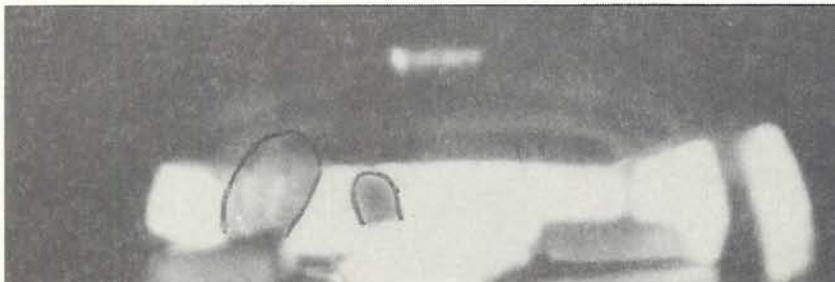
Figure 16. Interior View of Dummy Motion

1. Shortly after impact the dummies have not yet begun to move.

2. Willie begins to move forward and to the left.

3. Rex's head bends forward due to torso restraint, Willie's head hits rearview mirror.

4. Willie's head penetrates the windshield, Rex's head bends to the left, not hitting anything.

5. Rex bounces back to an upright position while Willie continues to penetrate windshield.

After forward and lateral movement relative to the car reached a maximum, Rex Karrs bounced back into the driver's seat, slightly to the right of the center of the seat, and then shook in the seat. Willie Makit remained in contact with the windshield, dash and steering wheel until the vehicle came to rest. The left shoulder and arm were stuck in front of the steering wheel. Figure 16 shows the dummies' motions as viewed by the interior high-speed camera. Figure 17 shows the final position of the two dummies.

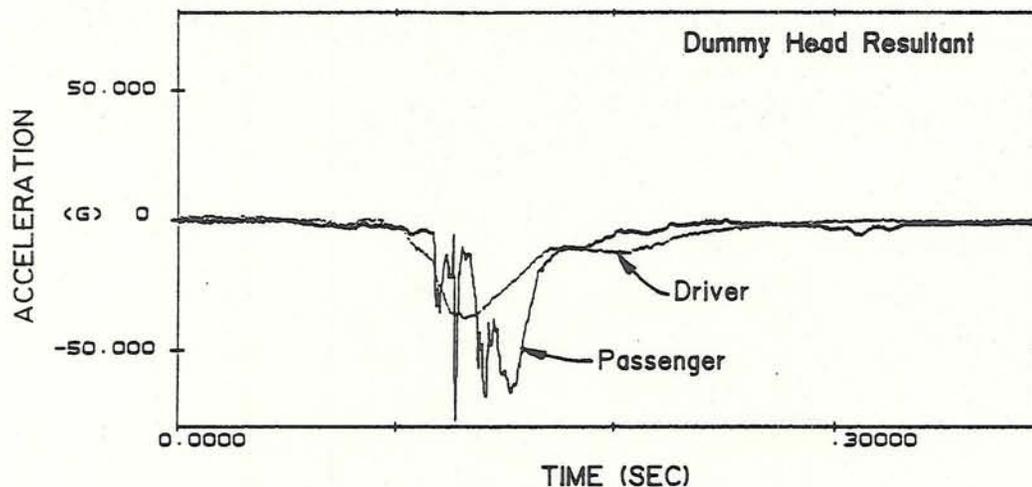
Figure 18. Comparison of Dummy Head Accelerations

The dummies also experienced different head accelerations and Head Injury Criteria (HIC). The HIC for Rex Karrs and Willie Makit were 242 and 468 respectively. The difference can be attributed to the fact that Rex Karrs' head did not contact any of the vehicle structure whereas Willie Makit's head did. Figure 18 clearly shows the difference in head accelerations of the two dummies. Willie Makit's head experienced sharp spikes in acceleration due to contacts with the vehicle. Rex Karr's head experienced smooth increase and decrease in acceleration with a peak value of about one half of that of Willie Makit's head.
