FHWA/CA/TL-87/07

Guidelines for Using Recycled Tire Carcasses in Highway Maintenance

May 1987

FINAL REPORT # FHWA/CA/TL-87/07

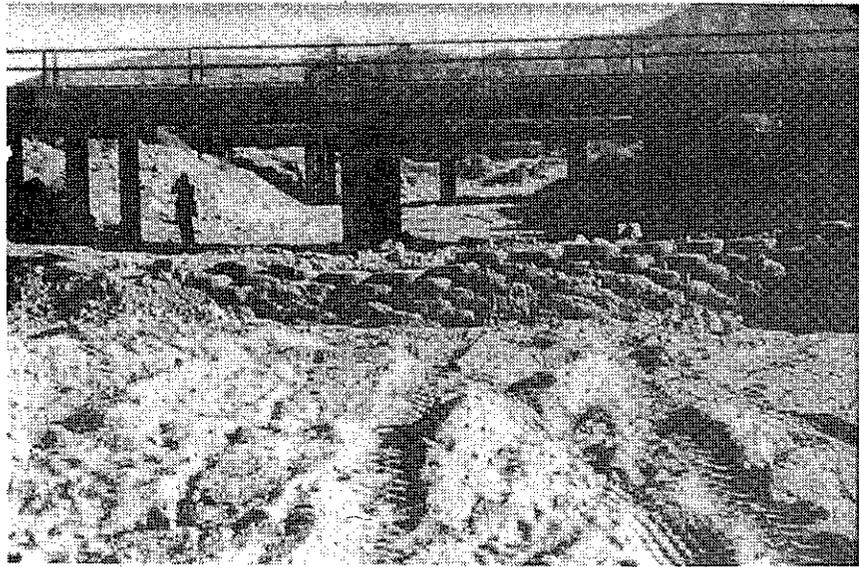
The construction of similar reinforced shoulder projects at various locations such as minor contract projects, a channel weir and shoulder reinforcement on Routes 10 & 247 in Riverside County (Photo 5.1 & 5.2) and other maintenance constructed projects using automobile tires on Route 70 in Plumas County (Photo 5.3) indicates a general acceptance of discarded tires for shoulder reinforcement.

Photo 5.1 - 11-Riv-10 - Channel Weir - Minor Project

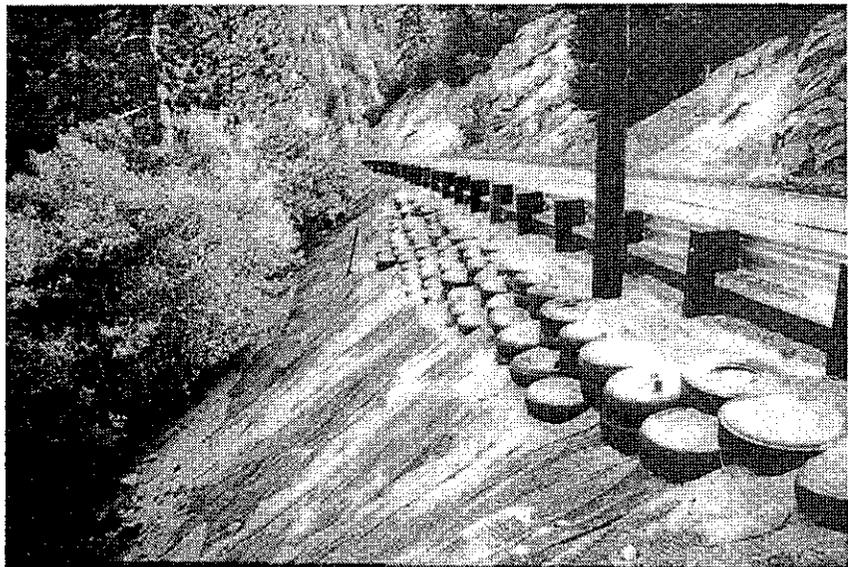
Photo 5.2 - 08-Riv-247 - Minor Contract

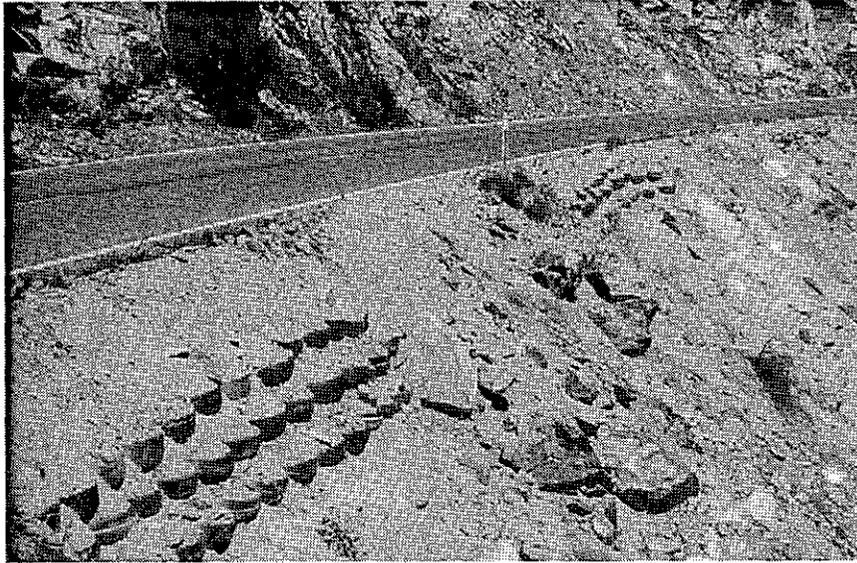
Photo 5.3 - 02-Plu-70
Installed By Maintenance Forces

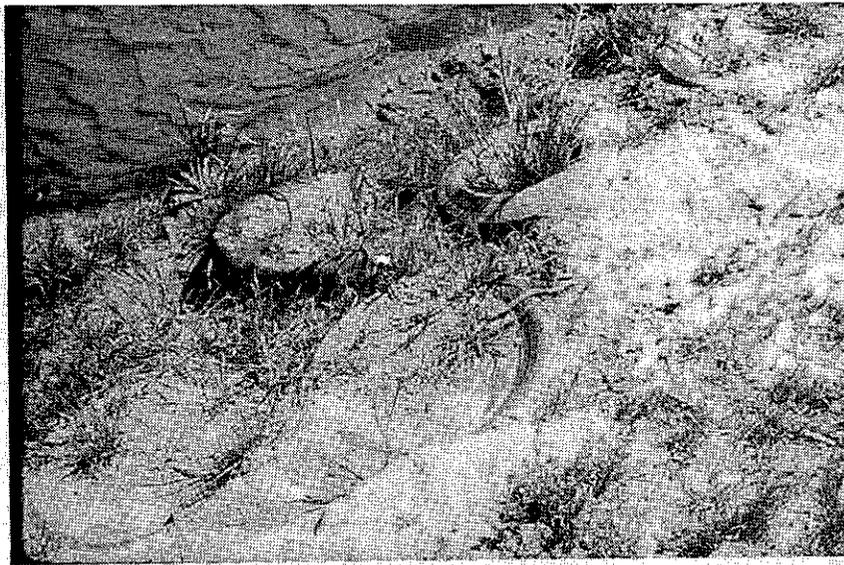
The proper installation procedures for tires is very important. The slope protection projects shown in Photos 5.4 & 5.5 reflect a lack proper engineering practices for installations.

Photo 5.4 - Slope Protection In San Luis Obispo Co.

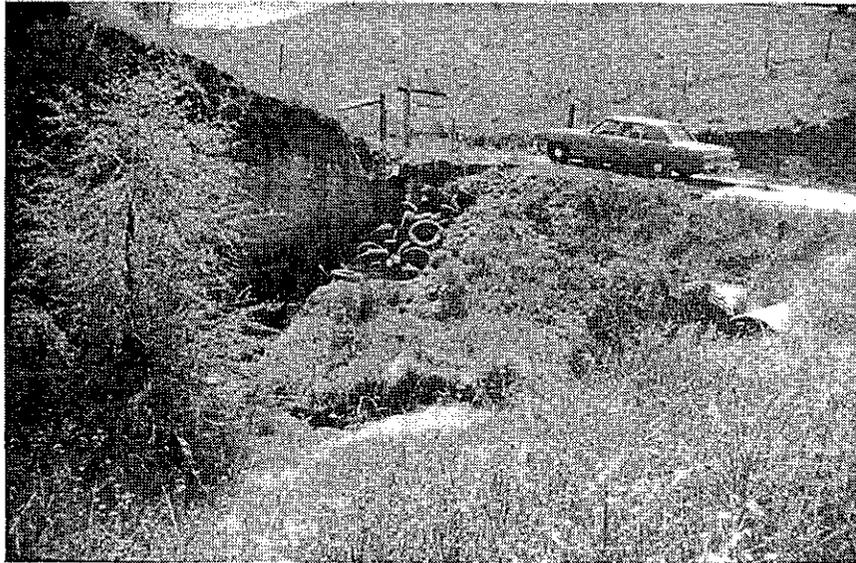
Photo 5.5 - Fresno County - 06-Fre-46

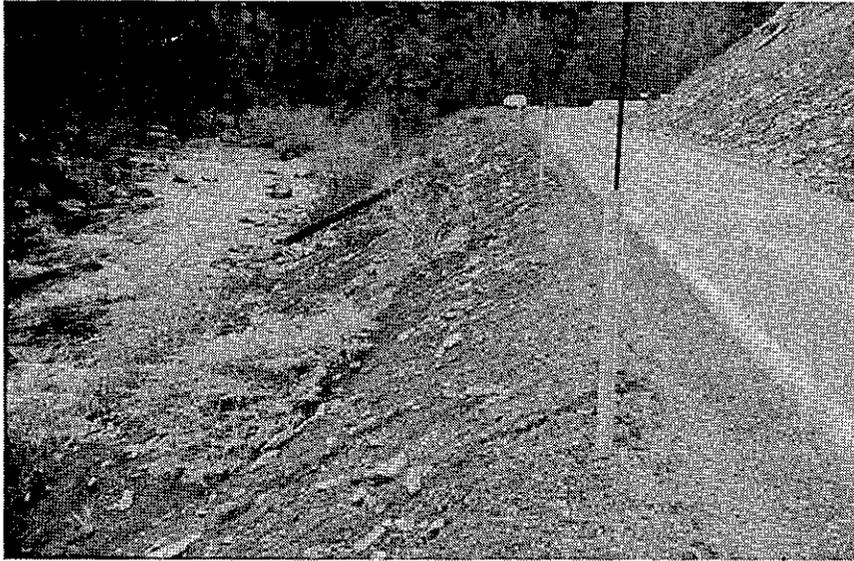
Photo 7.1 - Site Before Installation Of Tires

Route 32 is a narrow winding mountain roadway whose shoulders were being eroded by both rainfall and snowmelt. The water was overtopping the embankments and causing erosion so severe that, in some locations, embankments had eroded back to the pavement edge (Photo 7.1).

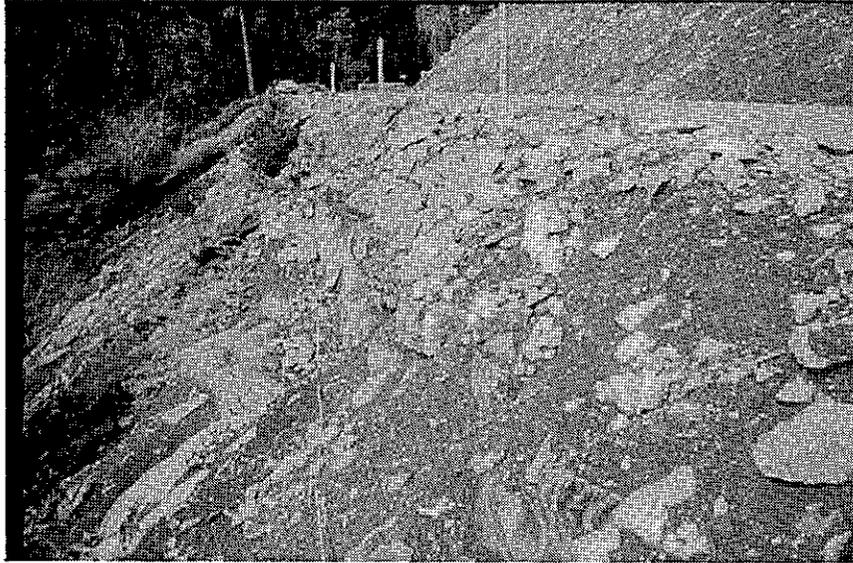
Photo 7.2 - Unit "A" Installation

A bench was cut about five feet below the top of the pavement (Photo 7.4) and sloped slightly (-5%) towards the traveled way. The width of the cut was the width of the truck tire mat plus a minimum of six inches. This extra width was to prevent undercutting of the tire unit by erosion. On Unit "A" engineering fabric was placed behind, under and over the tires to prevent soil from eroding (Photo 7.5 & Figure 7.2). As a comparison (control section) fabric was not used in Unit "B".

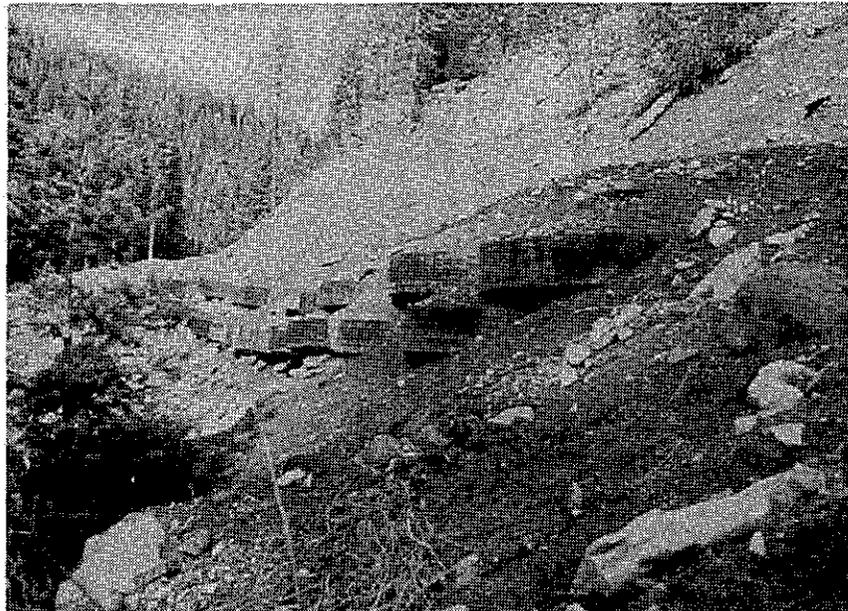
Photo 7.3 - Unit "B" Installation

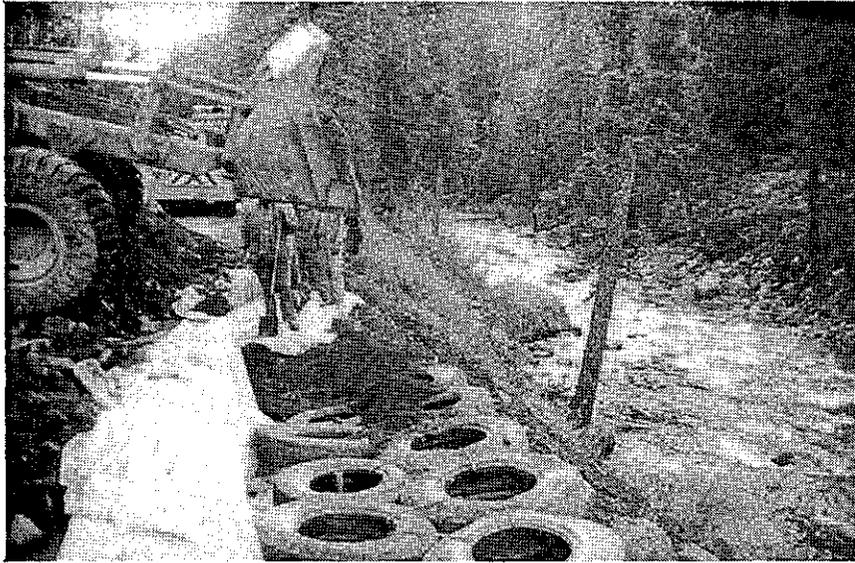
Photo 7.6 - Backfilling With Permeable Backfill

driven through the hole of every fourth tire in the inside row (Photos 7.6 & 7.7 and Figure 7.3). The top of the pole was driven flush with the top of the second layer of tires. The tires were placed in parallel rows and backfilled with imported permeable material (Photo 7.6). A 12 inch layer of permeable material was placed on top of the first layer of tires. Then the second layer of tires was placed and backfilled. To provide an unpaved shoulder an 18 inch layer of native soil was placed on top of the tires and compacted.

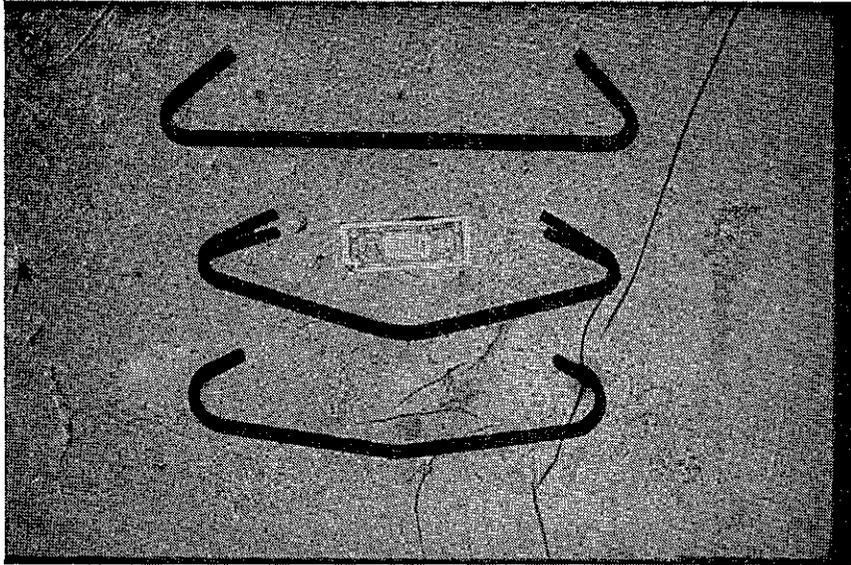
Photo 7.8 - 1/2" Rebar Tire Clips

Originally, the use of heavy duty commercial staples was considered as a method for connecting the tires in the mats. However, as part of a previous research project (3), it was found that the staples failed to develop sufficient resisting force to mobilize the inherent tensile strength of the tire sidewalls. The method chosen for connecting the tires was the use of 1/2 inch steel reinforcing bar

bent into the form of a clip (Photo 7.8). These clips provide a strong connection and a longer corrosion life.

The effect of corrosion on the tire clips was considered in determining the size of the rebar required. The Translab estimates soil corrosivity by combining the relative influences of the hydrogen-ion concentration (pH) and the minimum resistivity of the soil. Samples of soil scheduled for an embankment were tested for potential corrosivity. The material was found to have a pH of 5.5 and an average minimum resistivity of 2400 ohm centimeters. This data indicated that the metal loss would be approximately 10 mils per year. This was interpreted as a weight loss of about 0.8 ounces per year. Based on this information, a 3/8 inch rebar was estimated to have an effective life of over 40 years. Therefore, the decision to use 1/2 inch rebar clips was made in order to provide an extra safety factor. Photo 7.9 shows the formation of a tire mat by using clips on the truck tires.

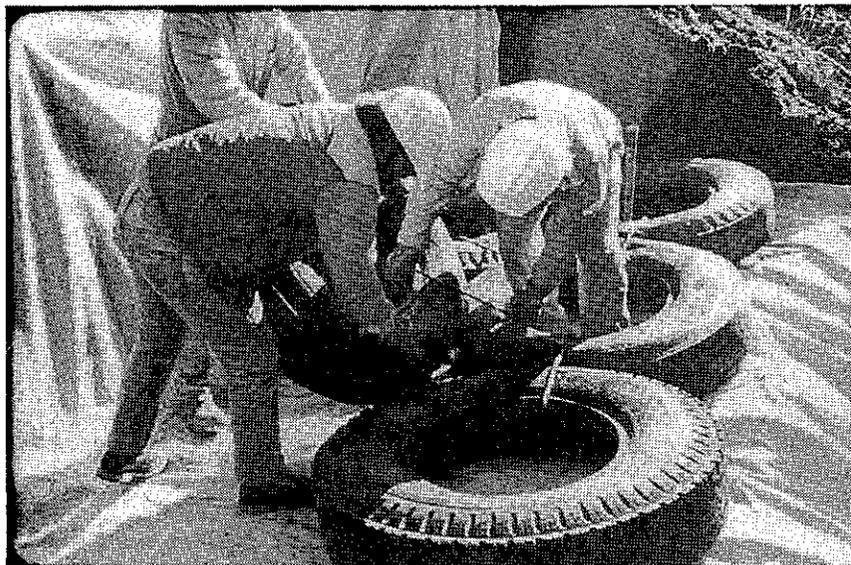
Photo 7.9 - Assembling Truck Tire Mat

Truck tires were used extensively for this project. They were obtained from local tire shops at no cost and stockpiled at the Chester Maintenance Station. As the two projects developed, additional tires were obtained and transported to the project. The truck tires varied in outside diameter from 40 inches to 42 inches. This variation in size tended to create some difficulty in developing a uniform installation. However, most of the irregularities can be overcome by adjusting the tire clips (Photos 7.8 and 7.9) to obtain the desired configuration of the tire mat.

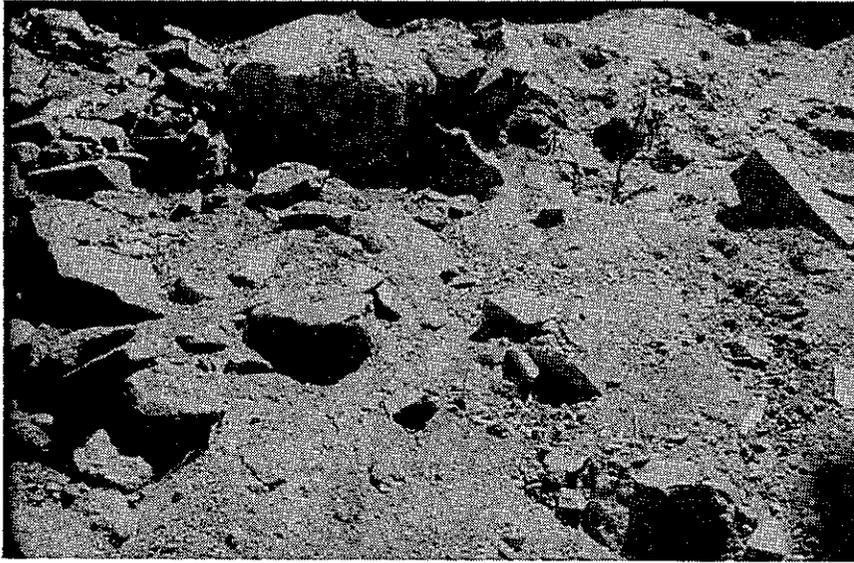
Photo 7.12 - Project Site Material

The lower slope used for vegetation test plots consisted of slopes ranging from 1:1 to 2:1, 30 feet high and west-facing at an elevation 4500 feet. The surface of the slopes was a rocky, brown, silty sand (Photo 7.12). The slope was slightly rilled with very little vegetation present.

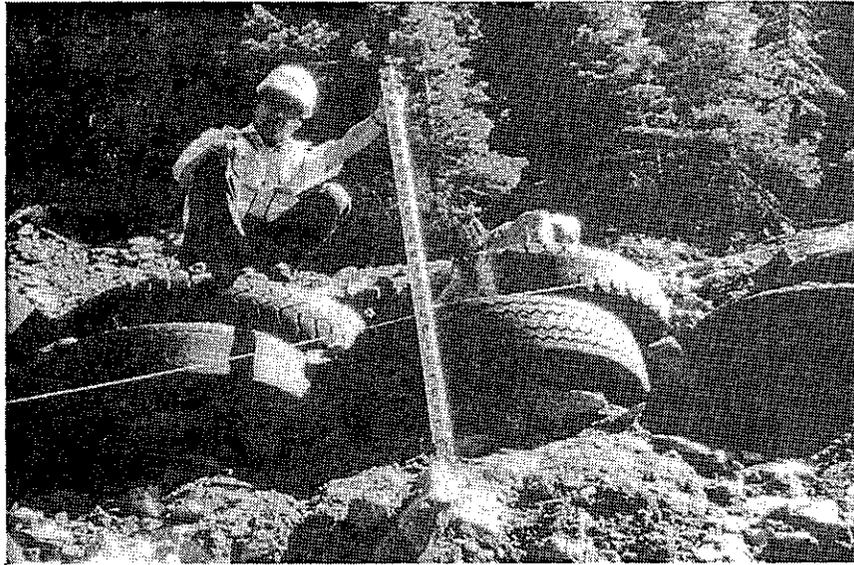
Photo 7.13 - String line And Elevations On Tires

Survey points were established by driving masonry nails into the sidewalls of the tires at their outside edge. The nails were placed approximately every ten feet along the tire installation to document vertical and lateral movement. Elevation reference points were placed along the centerline of the traveled way, on the edge of pavement and on the tires. They were monitored to detect vertical displacement during the study. During the initial monitoring, a string line was used to measure the offset resulting from vertical or horizontal movements. String line and elevations (Photo 7.13) taken during and at the conclusion of the study indicated there had been neither significant settlement nor horizontal movement.

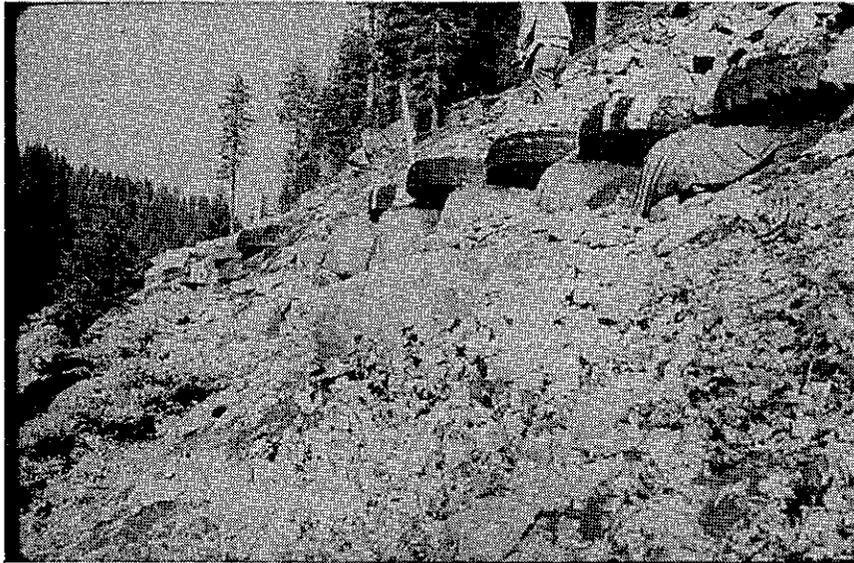
Photo 7.15 - Unit "A" Site (1983)

Erosion was monitored visually as well as by string line stretched across the area below the tires. There was considerable undermining due to erosion at the outside edge of the bottom row of tires on both sections. However, the tire-earth system remained stable during the entire study. Engineering fabric was placed under and behind the tires in Unit "A". This was done to prevent soil erosion from behind the tires and in the event that the tires were severely undermined it would prevent the backfill material from washing out. There was less erosion and undermining in Unit "A" with the engineering fabric than with Unit "B" without engineering fabric (Photos 7.15 & 7.16).

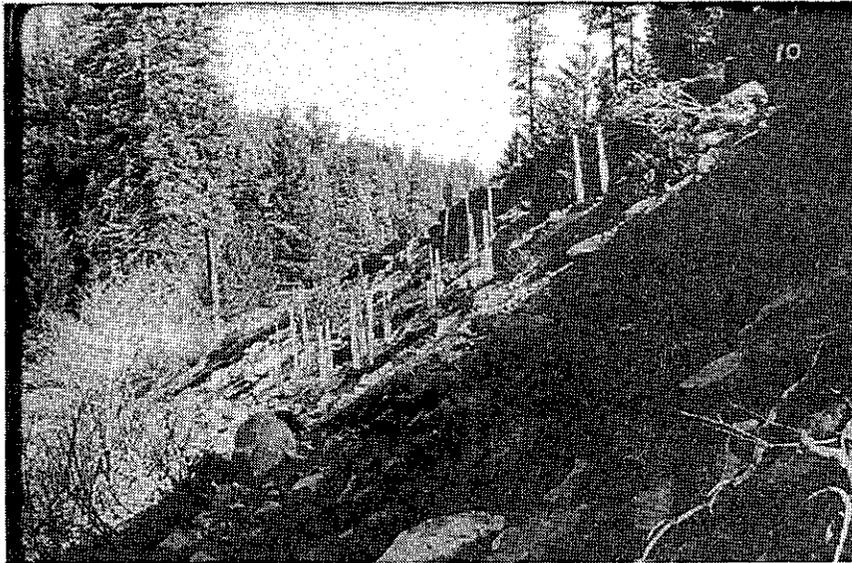
Photo 7.17 - Fall Plant (1983) - Plastic Cages

Evaluation of the fall 1983 and spring 1984 plantings indicated marginal success. This lack of success is believed to be the result of winter roadway cleanup debris overtopping the plants.

In summary, at the conclusion of this research (Photos 7.17 & 7.18), manzanita from the one gallon containers that were protected from animals and erosion by wire cages showed the best survival rate. The study period was 19 months for the fall plant and 13 months for the spring plants. This is a relative short duration for obtaining conclusive data for revegetation research. A larger, more extensive planting project, extending over a longer period of time would provide more conclusive results.

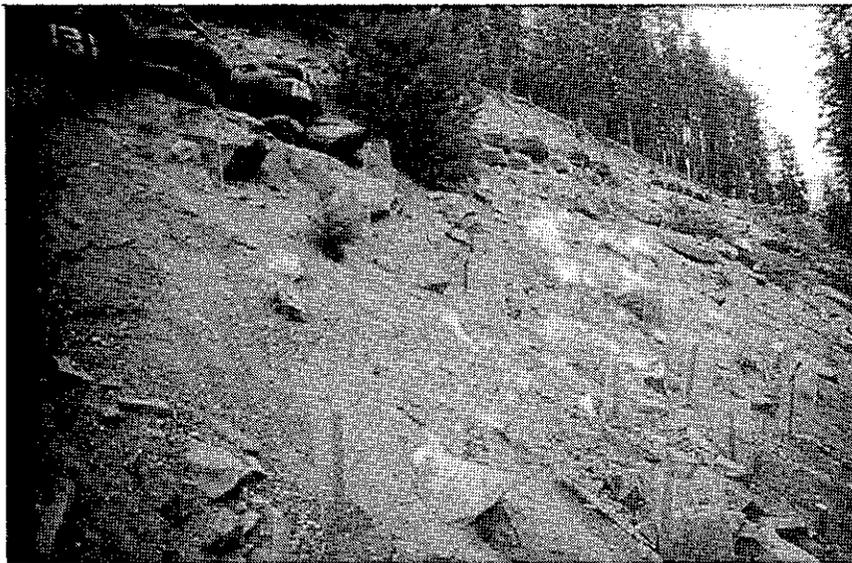
Photo 7.18 - Spring Plant (1984) - Metal Cages

In the spring 1984 Planting, 32% of the manzanita remained and 25% of the deer brush. Initially in the spring planting half of the plants were protected from animals by the installation of plastic cages (later these were replaced with metal cages). Although there is fauna in the area, there was no browsing during the course of the study. The plant cages primarily protected the plants from erosion.

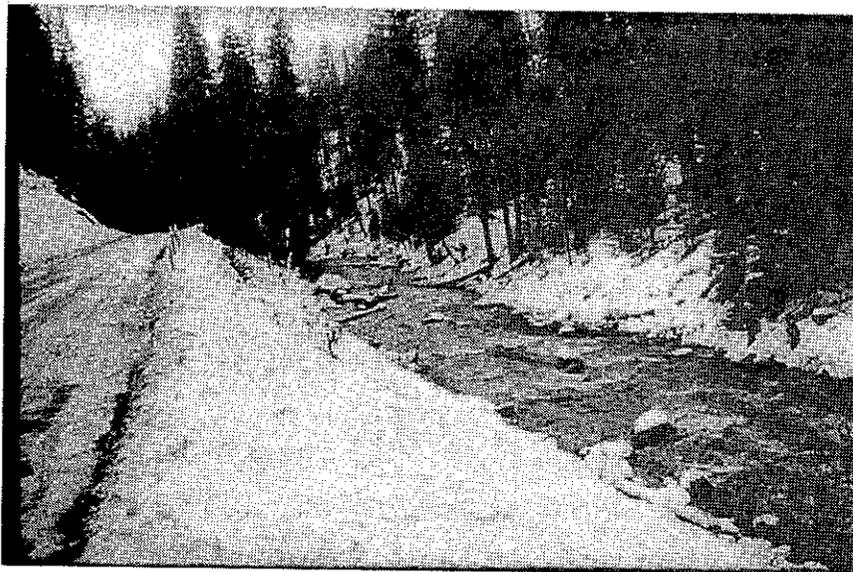
Photo 7.22 - Site In Winter

There was approximately 12 to 30 inches of snow cover between December and February 1983 at the project (Photo 7.22). Average snow depths ranged from 12 to 48 inches on the project site during the winter months.

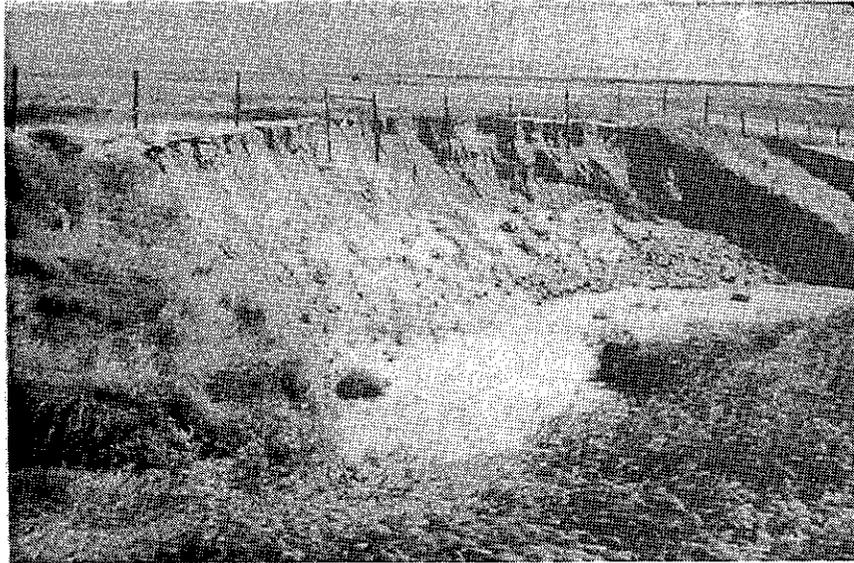
In 1978, Caltrans District 06 maintenance forces installed discarded tires to provide channel bank protection at the Lassen Avenue Overcrossing interchange. The channel banks in this area had severely eroded up to the adjacent private property (Photos 8.1 & 8.2). Maintenance installed two discarded tire units (Figure 8.2, Units "A" & "B") along the lower portions of the drainageway. These installations were necessary to restore the channel banks downstream from a 66 inch reinforced concrete pipe culvert. The waterway before the discarded tires were installed consisted of a 275 foot length of channel 20 feet wide with approximately 2:1 side slopes. At this point the channel widens to an undetermined width until it reaches a 54 inch culvert at Lassen Avenue approximately 500 feet downstream.

Photo 8.1 - Unit "A" - Eroded Channel Slope (1978)

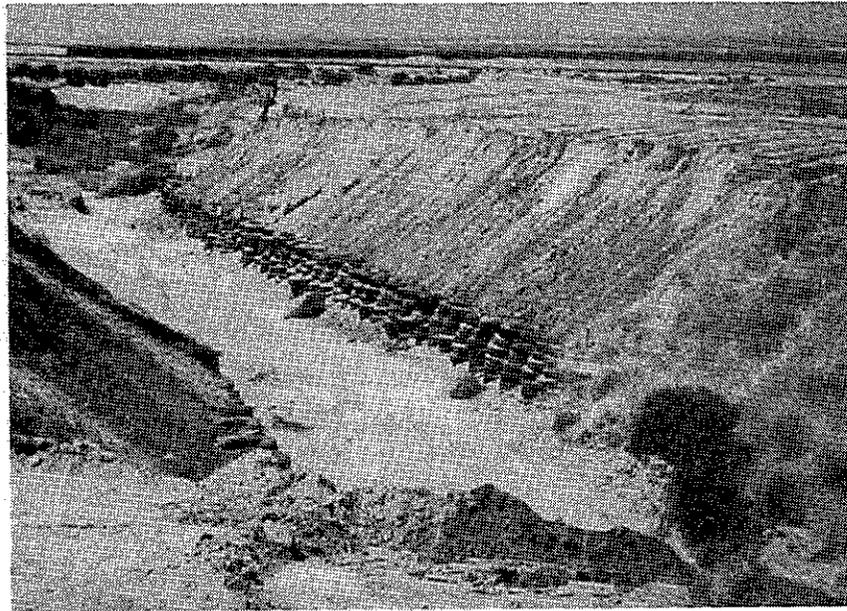
Photo 8.2 - Unit "A" - Channel After Tire
Installation (1978)

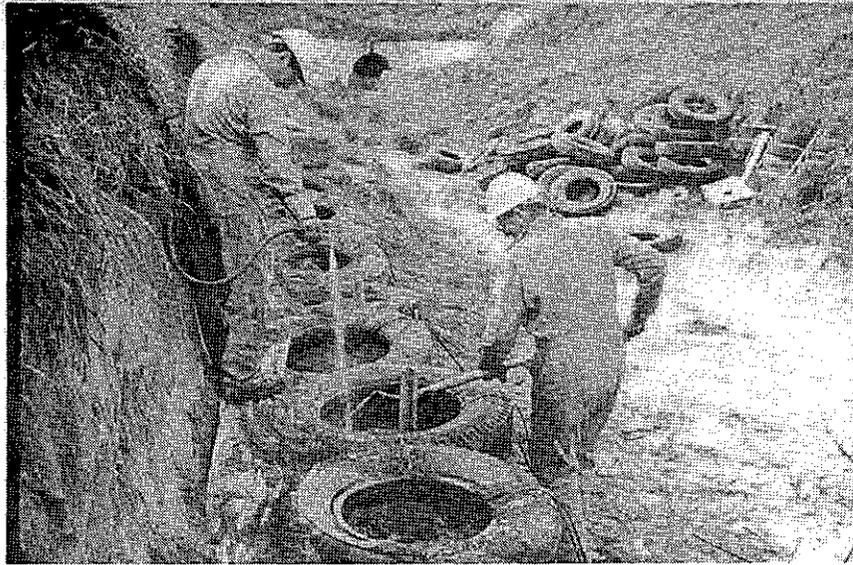
After placement of the tire assemblages, backfill material was dumped into the tires (Photos 8.6 & 8.7) and compacted. The excavated material was selected for backfill as it was felt that the sandy loam would readily fill the space inside the tires and easily compact. The first row of tires was placed and backfilled. This was done to provide a stable and level base to build upon. Difficulty was encountered in the backfilling operation in that the soil did not easily flow into the tires thus leaving large voids. A vibratory compactor was used in an attempt to assist the movement of the soil into the voids. This procedure proved to be ineffective. Ponding and jetting was then tried and this method proved to be somewhat successful. The backfill material had a tendency to flow out of the interstices in the installation. This backfilling difficulty occurred most often when the tires were stacked when the staggered fashion.

Photo 8.6 - Unit "C" Backfilling With Excavated Material

It is felt that, with the assistance of a vibrator, of a more granular backfill material would flow into the tires more readily.

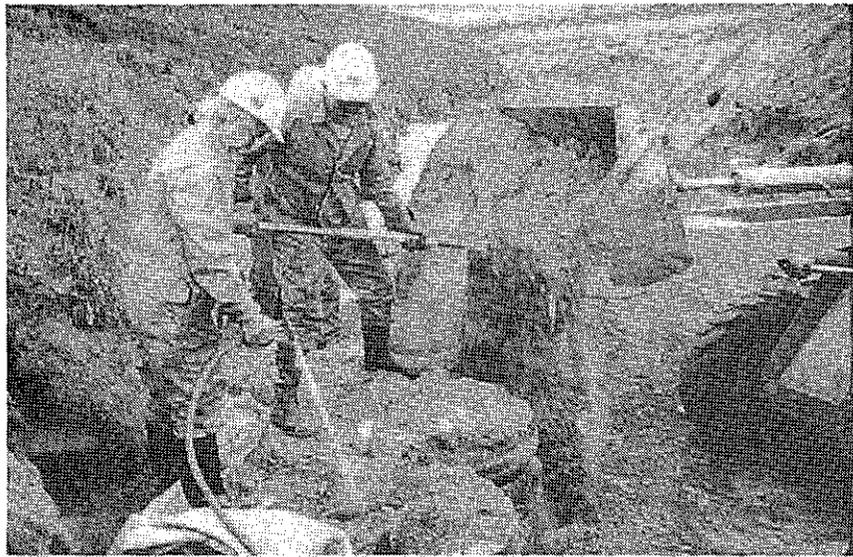
Photo 8.7 - Unit "D" Backfilling With Excavated Material

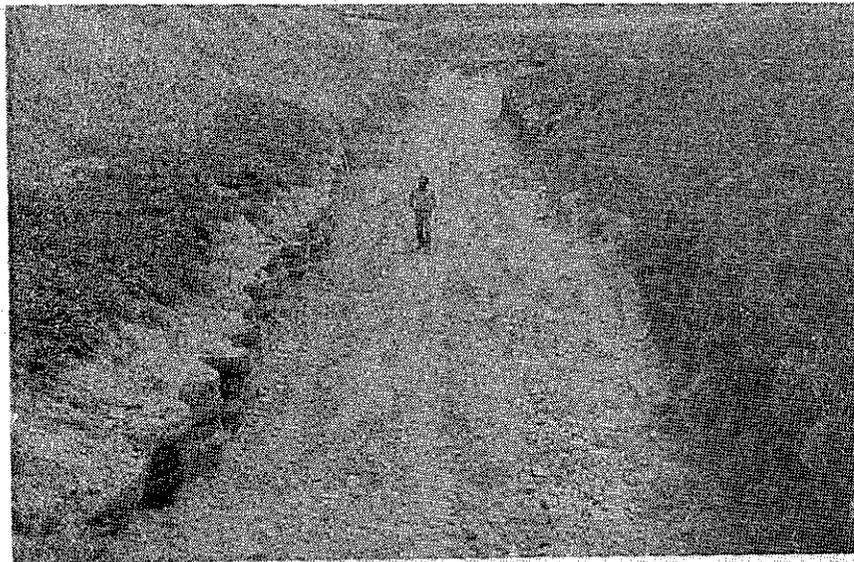
Although some settlement occurred on both Unit "C" and "D", the settlement was not enough to cause concern (Photos 8.8 & 8.9). There were no stability problems on either unit.

Photo 8.9 - Settlement - Unit "D"

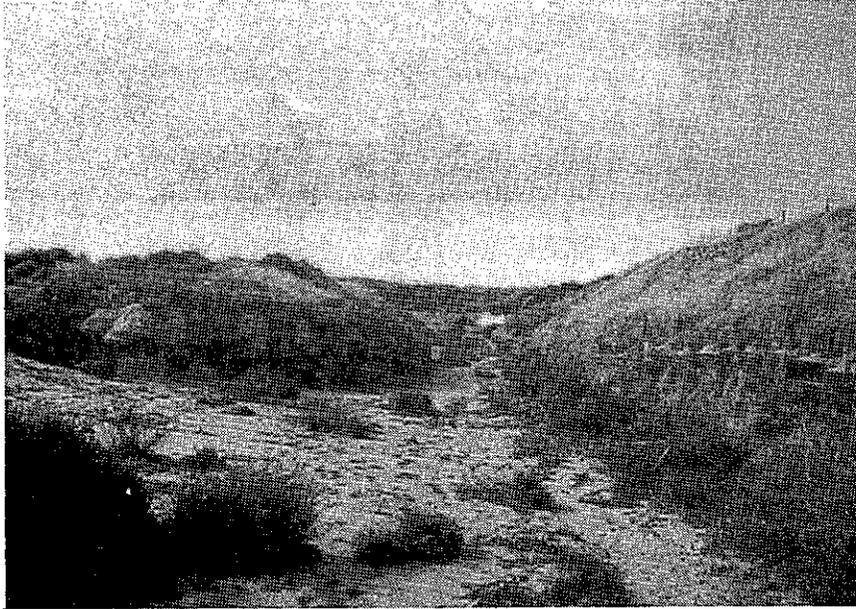
Portion of the channel downstream from the tire installations were selected as control sections (Photos 8.10 & 8.11). Prior to and during the course of the project some bank slope erosion occurred on the control sections.

Photo 8.10 Control Section - Channel East Of Unit "C"

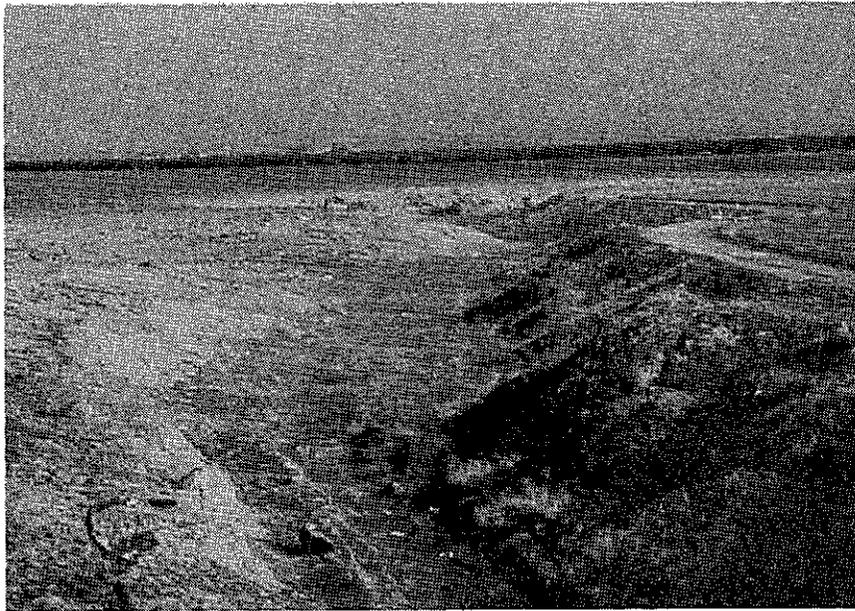
Photo 8.11 Control Section - South Of Lassen Avenue

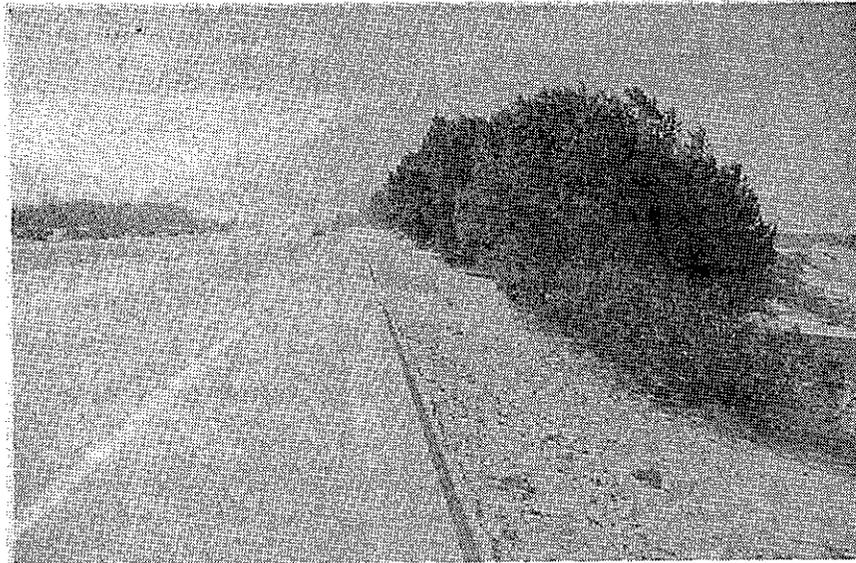
Photo 9.2 - Blowsand Impoundment On Pavement
