1. REPORT NUMBER CA12-1200 A	2. GOVERNMENT ASSOCIATION NUMBER	3. RECIPIENT'S CATALOG NUMBER
4. TITLE AND SUBTITLE Quieter Pavement Research: Concrete Pavement Tire Noise	5. REPORT DATE 05/30/2011

7. AUTHOR John T. Harvey and Erwin Kohler		6. PERFORMING ORGANIZATION CODE
9. PERFORMING ORGANIZATION NAME AND ADDRESS University of California, Davis & Berkeley Partnered Pavement Research Center 1353 S. 46th Street, Bldg. 452 Richmond, CA 94804		8. PERFORMING ORGANIZATION REPORT NO. UCPRC-RR-2010-03

Quieter Pavement Research: Concrete Pavement Tire Noise

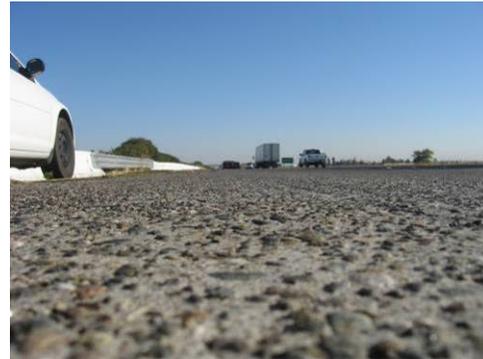
QP-116.1 (107.8 dB[A])

The oldest concrete pavement sections evaluated in this study have burlap drag texture, with sections on Interstate 80 in Solano County having been in service for over 60 years according to the available records (QP-116). Due to their long service life, some of the sections in this category had pavements that showed no signs of applied surface texture, and were then categorized as *worn out* texture. Burlap drag sections are not constructed in California highways any more, which is why no “young” sections, other than one built for a field evaluation experiment, were included in the experiment. This young section, which was about five years old when first tested, yielded an OBSI level of about 102 dB(A). Other than the experimental section, all burlap drag sections were older than 30 years, and had OBSI levels ranging between 101 and 108 dB(A). These values indicate that the actions of traffic, often combined with rainfall, will tend to polish some concrete surfaces and remove positive texture (stones protruding from the surface) without damaging the paste around the stones. The same combination of traffic and environment will tend to ravel asphalt surfaces and cause loss of paste around the aggregates in some concrete surfaces, creating positive texture by leaving the stones protruding from the surface. The quieter sections seem to be, judging from the pictures, those with shallow texture, as shown in Figure 4.1. Therefore, a possible reason for variability of OBSI for the burlap drag sections is variation in the macrotexture caused by the protrusion of aggregates. A summary of the information for burlap drag sections is presented in Table 4.1.

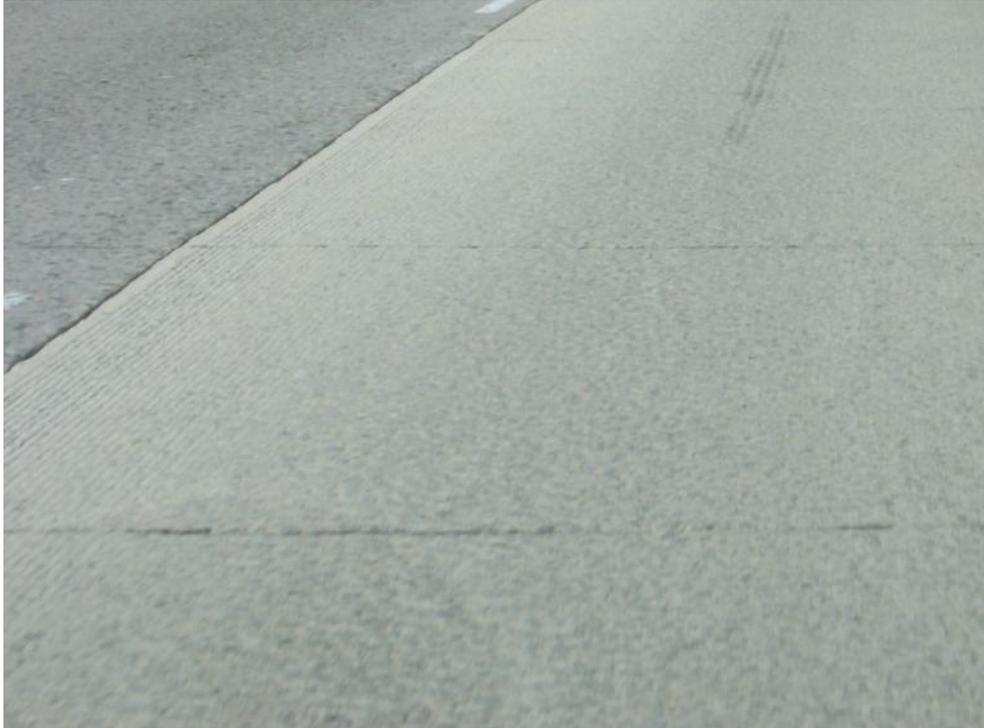
The pavement at Sections QP-142.1, 142.2, and 142.3 all experienced a large increase in noise level from Year 1 to Year 2. The increase was due to an unusual rapid wearing of the longitudinal texture, which disappeared completely, leaving a surface where the concrete paste was recessed and the aggregates were exposed and protruding. The average OBSI values of these sections changed from 104.4 dBA (104.9, 104.5, and 103.9) to 111.8 dBA (111.4, 111.2, and 112.6), an increase of 7.4 dBA.

Images of the surface texture of Sections QP-142.1 and QP-142.3 at approximately the same spots are shown in Appendix D, with the pictures on the left taken in November 2008 and the ones on the right in September 2009. This pavement was new—it had been opened to traffic in the summer of 2008—and is located at 5,900 feet above sea level, where it was subjected to chain wear during snow season. Appendix D shows that the longitudinal tining remains outside the wheelpath, while it has been completely obliterated in the wheelpaths by the chains.

Figure C.2: Evidence of original longitudinal tines outside of the wheelpaths of Section QP-142.2 after one year of traffic.

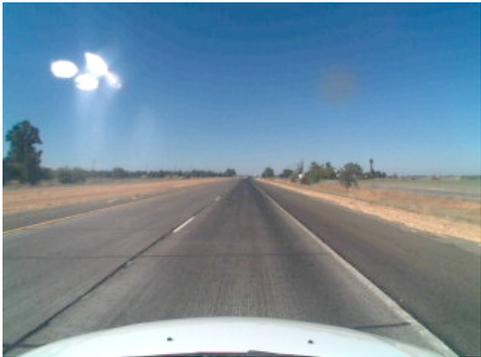
QP-100.1

Type of section: Pavement Field testing Year 1: 9/3/2008 15:09
 Location: 03Yol113N3.0 Field testing Year 2: 9/4/2009 14:07
 Comments: Longitudinally tined. Aggressive texture, sealed joints.
 Surface Year: 1976

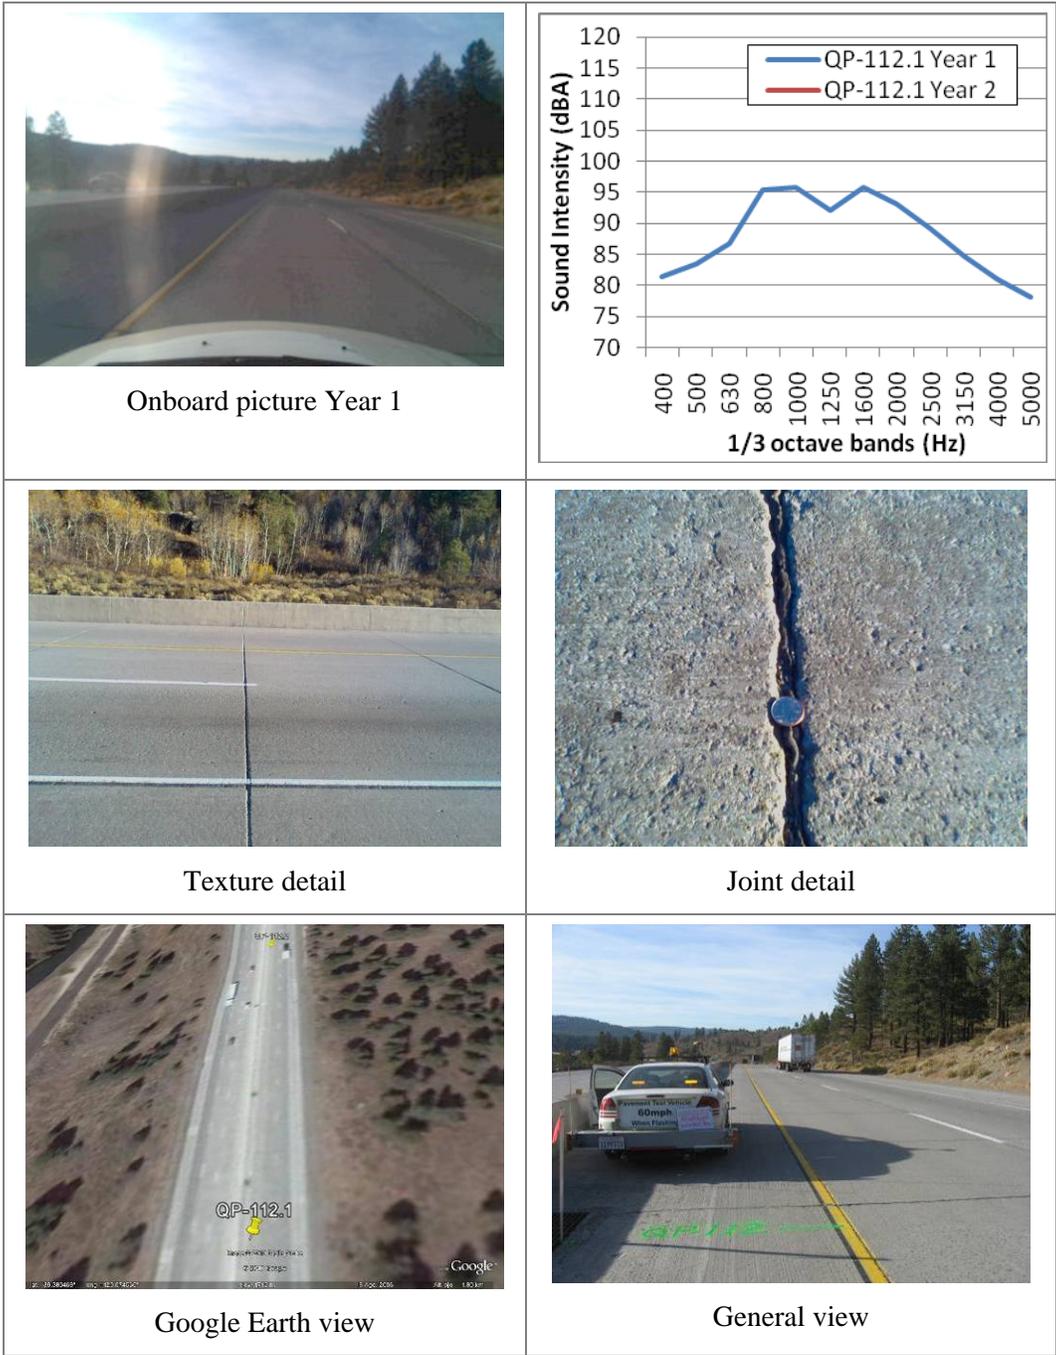
QP-112.1

Type of section: Pavement Field testing Year 1: 10/21/2008 17:21
 Location: 03Nev80W23.0 Field testing Year 2:
 Comments: Longitudinally broomed. Uneven wear along section. Wide joints.
 Surface Year: 1989

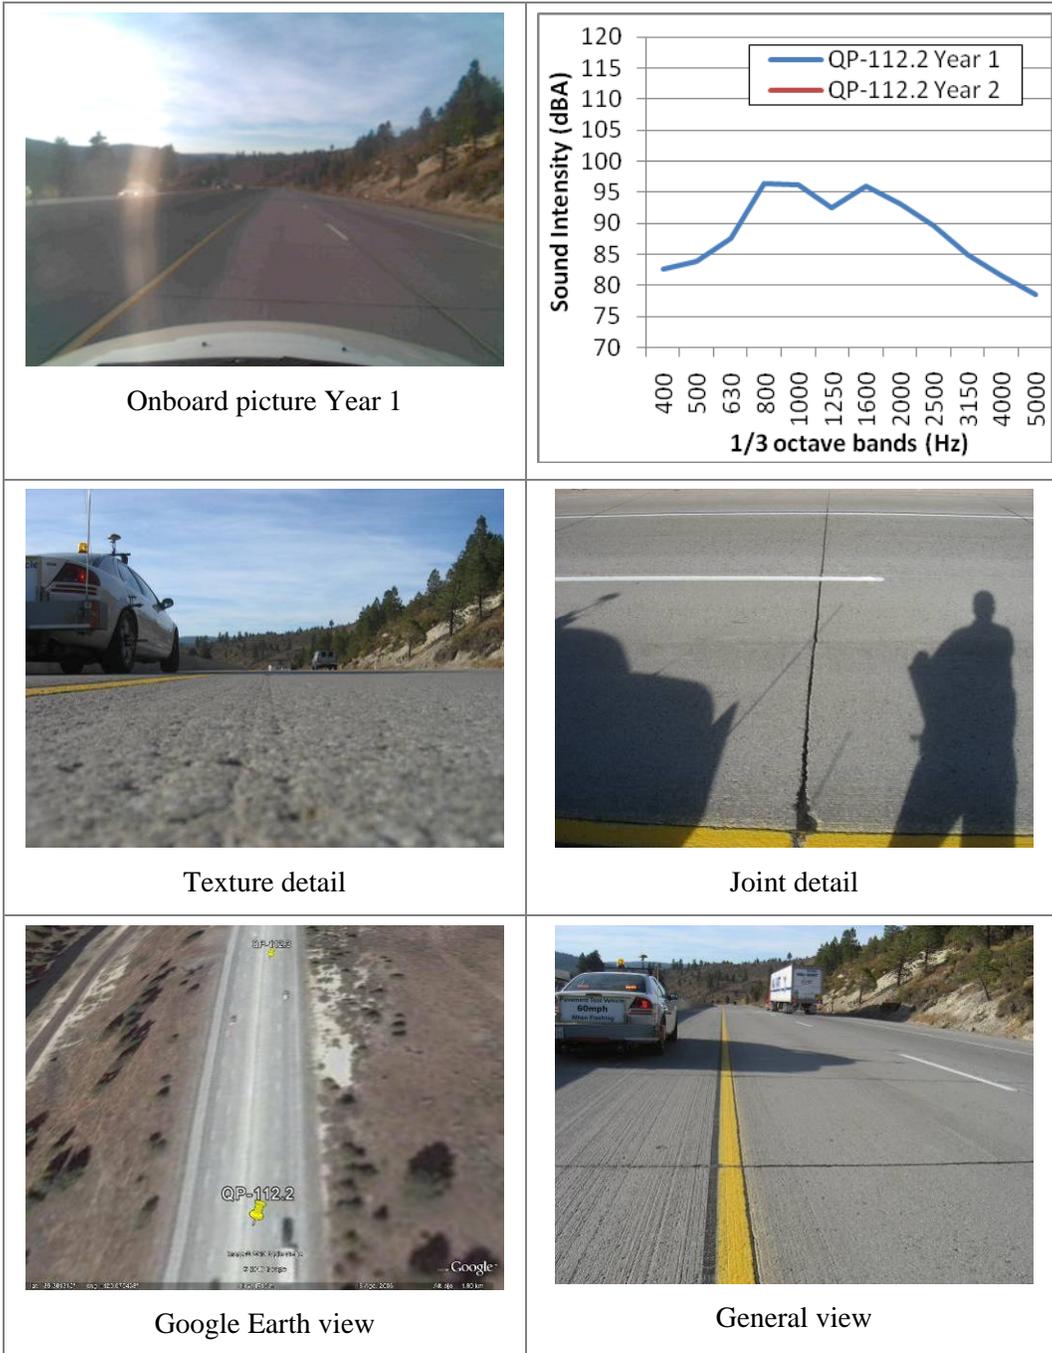
QP-112.2

Type of section: Pavement Field testing Year 1: 10/21/2008 17:33
 Location: 03Nev80W22.9 Field testing Year 2:
 Comments: Longitudinally broomed. Uneven wear along section. Wide joints.
 Surface Year: 1989

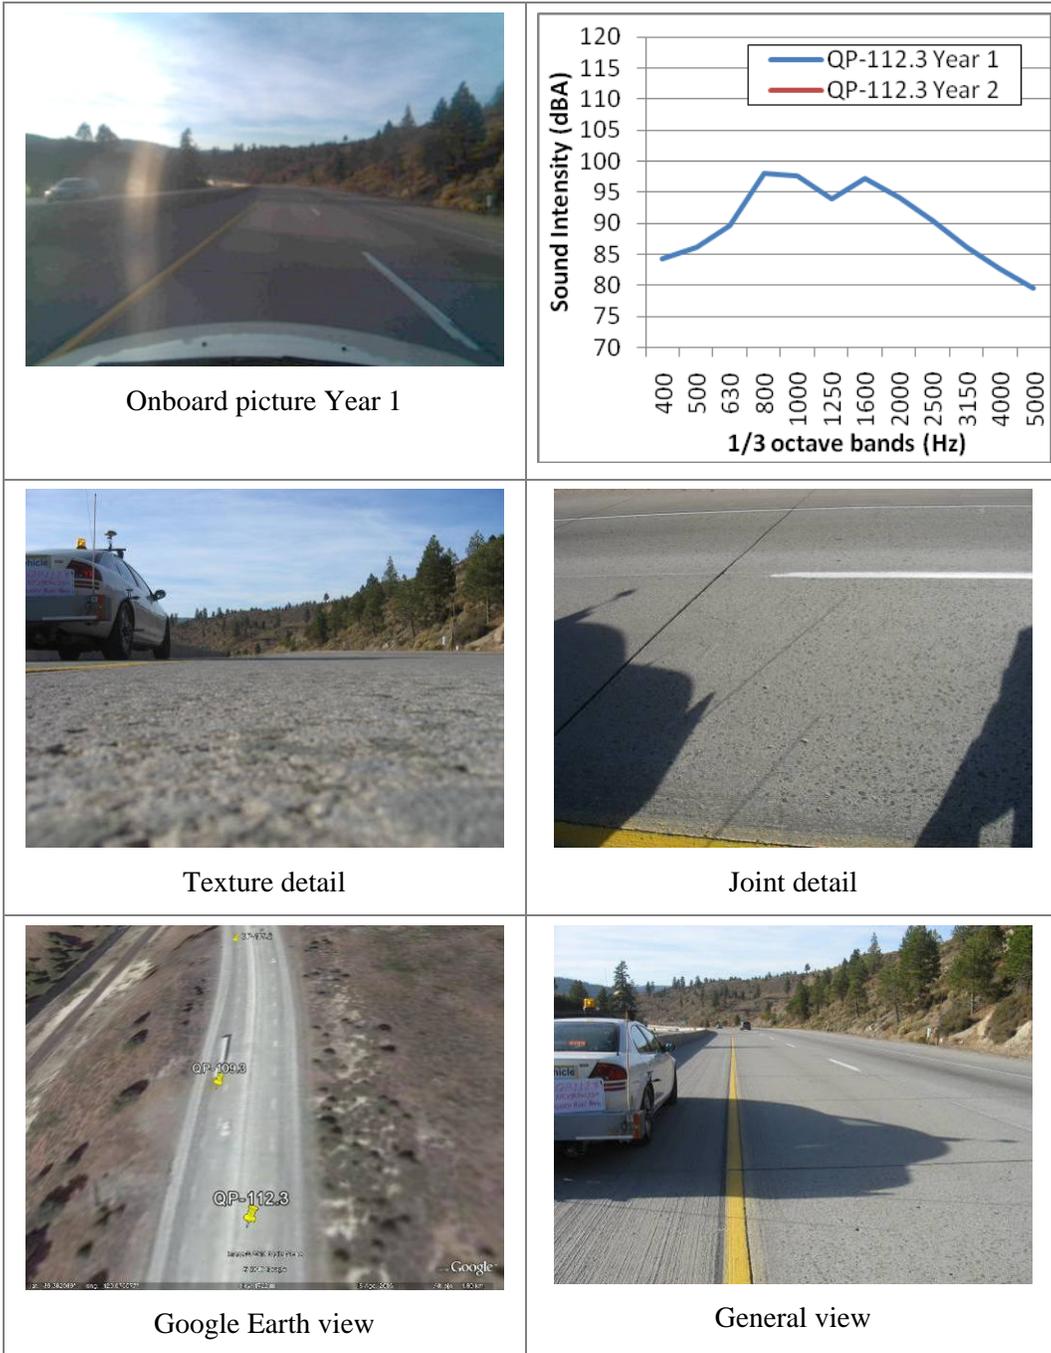
QP-112.3

Type of section: Pavement Field testing Year 1: 10/21/2008 17:45
 Location: 03Nev80W22.8 Field testing Year 2:
 Comments: Longitudinally broomed. Uneven wear along section. Wide joints.
 Surface Year: 1989

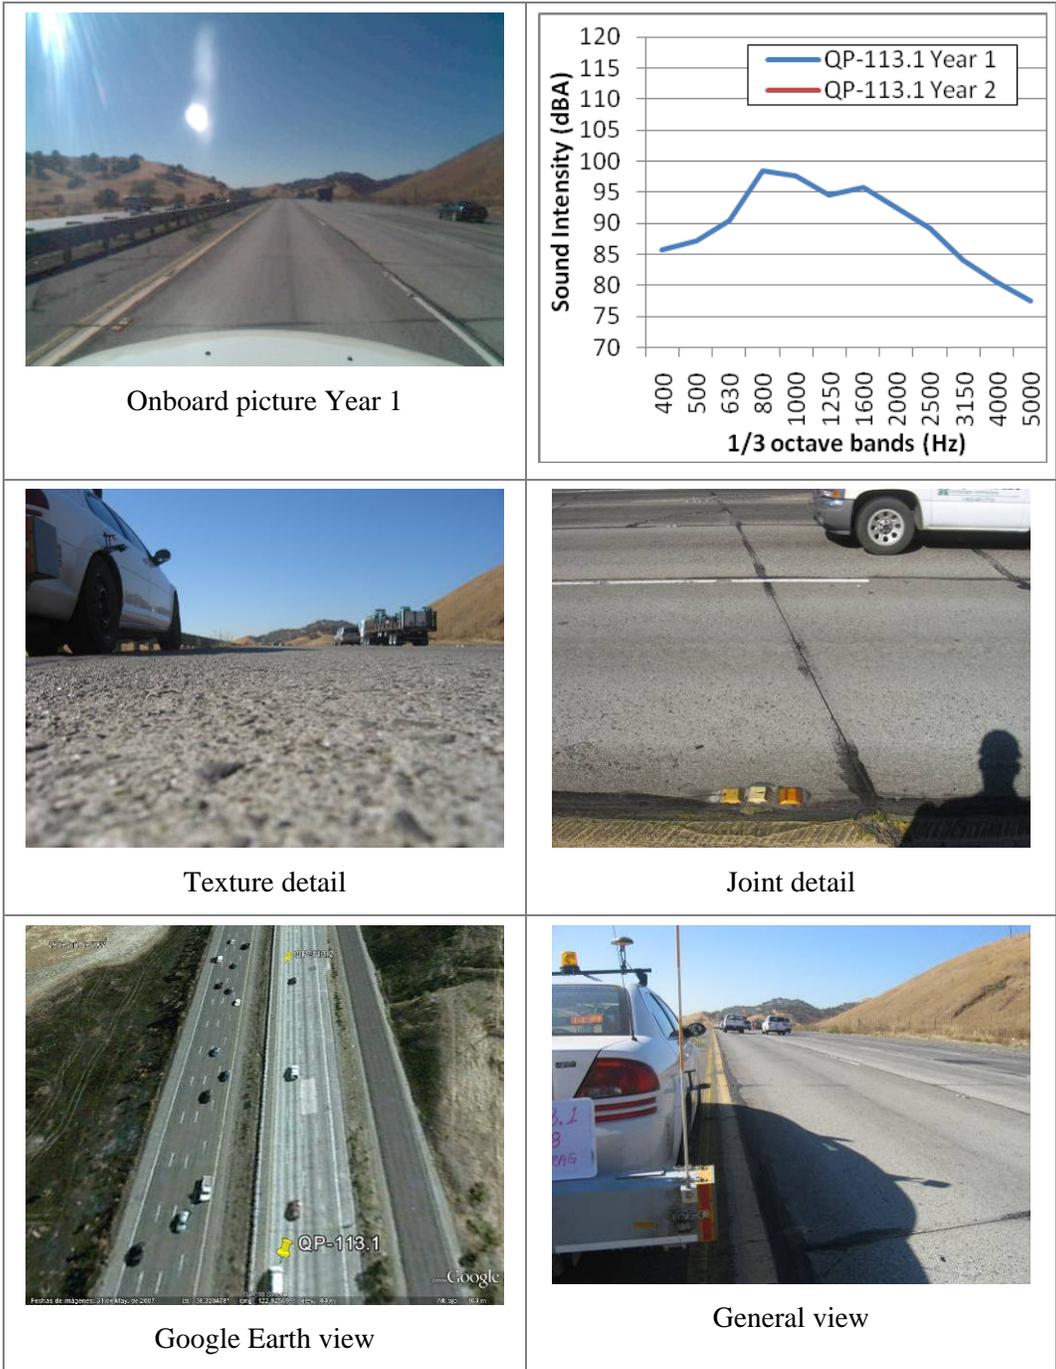
QP-113.1

Type of section: Pavement Field testing Year 1: 10/23/2008 12:37
 Location: 03Yol80W22.9 Field testing Year 2:
 Comments: Burlap drag. Worn out texture.
 Surface Year: 1965

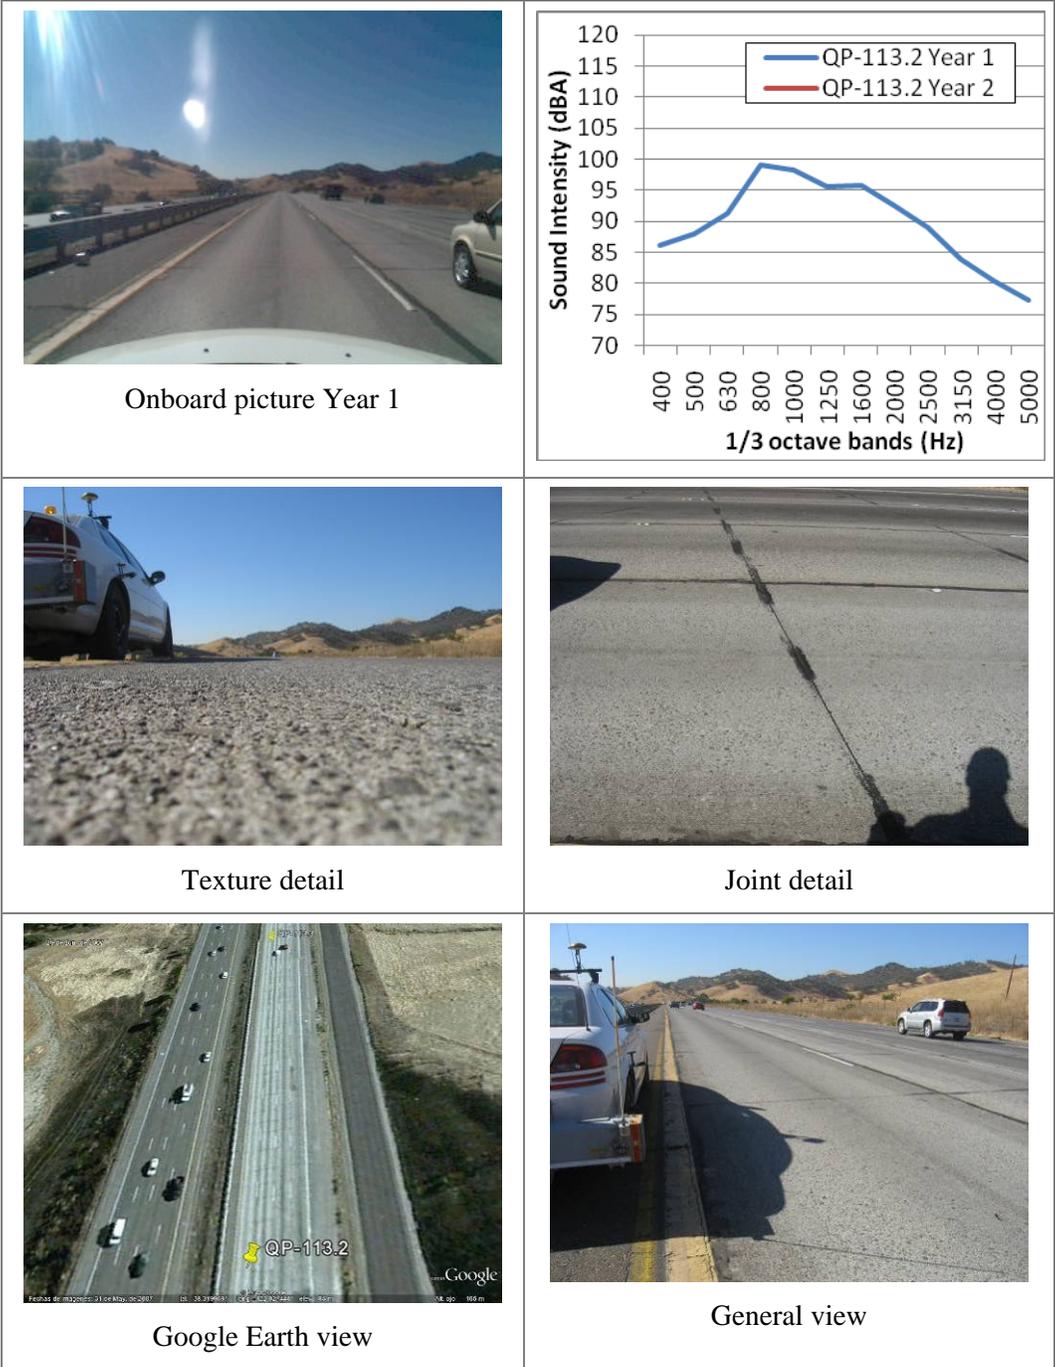
QP-113.2

Type of section: Pavement Field testing Year 1: 10/23/2008 12:45
 Location: 03Yol80W22.8 Field testing Year 2:
 Comments: Burlap drag. Worn out texture.
 Surface Year: 1965

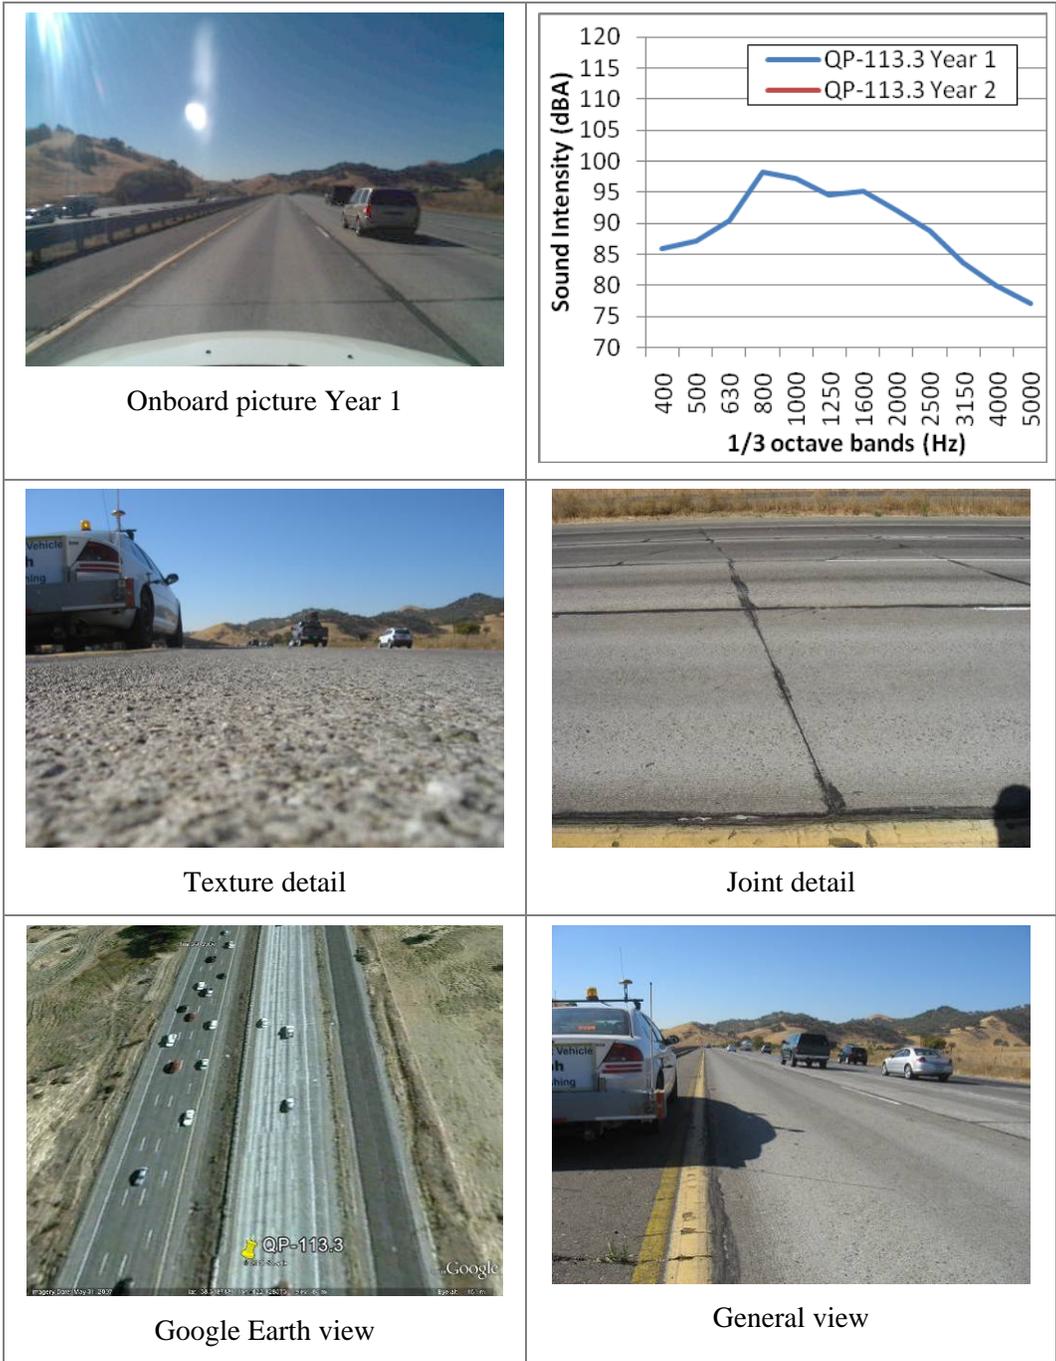
QP-113.3

Type of section: Pavement Field testing Year 1: 10/23/2008 12:54
 Location: 03Yol80W22.7 Field testing Year 2:
 Comments: Burlap drag. Worn out texture.
 Surface Year: 1965

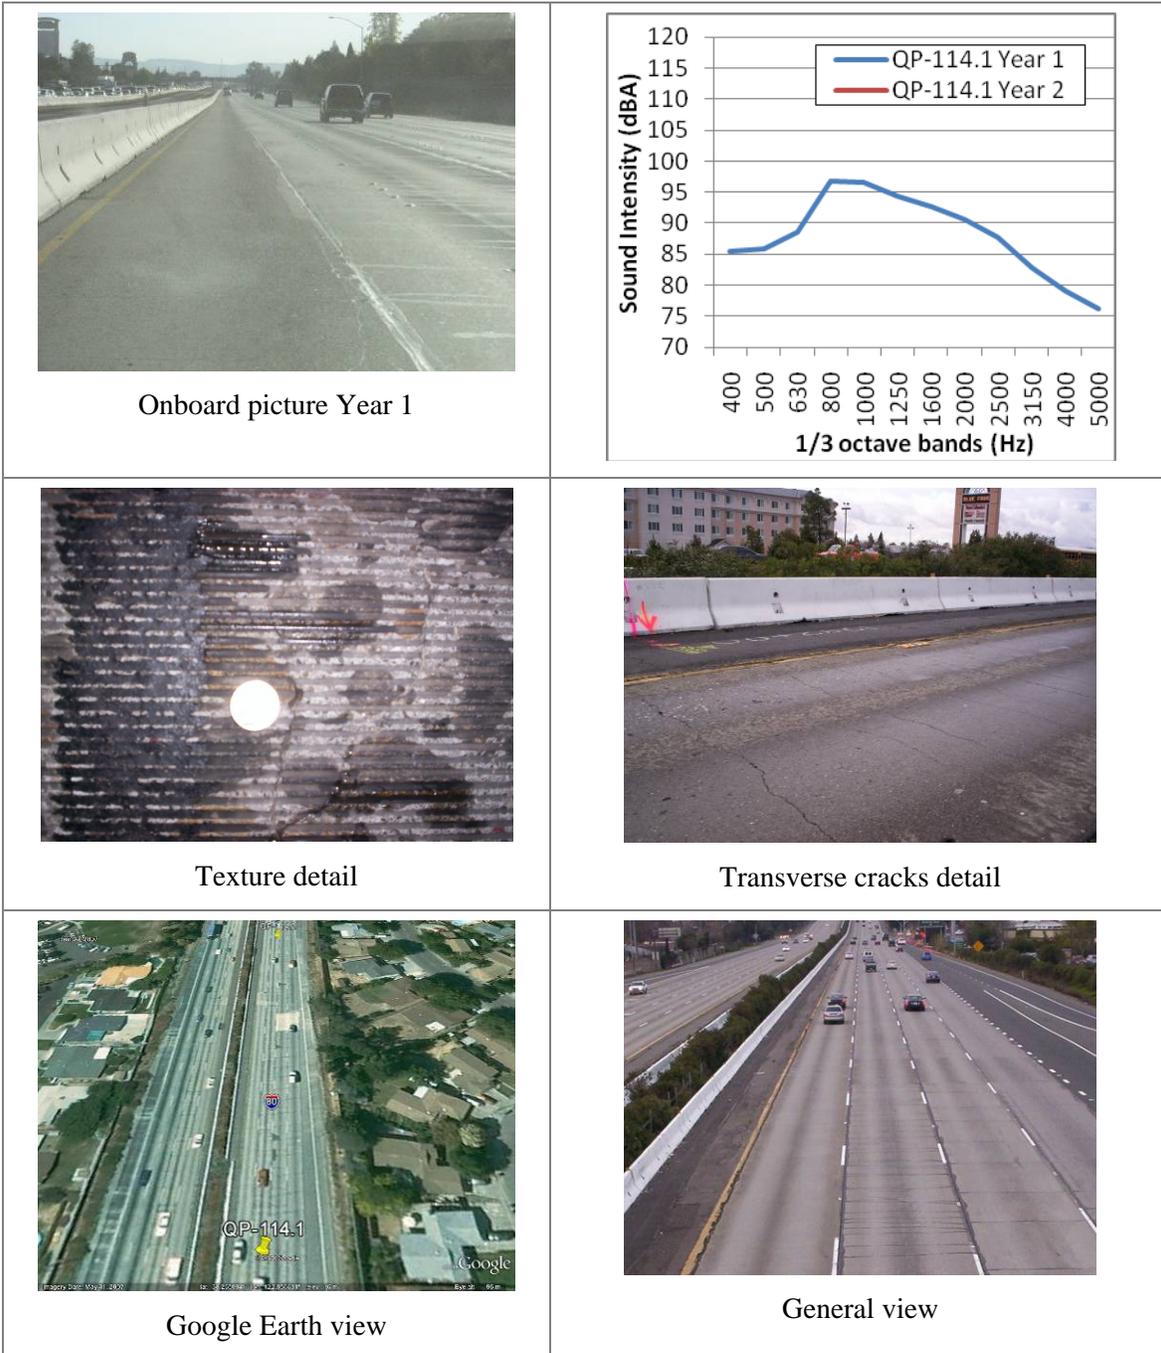
QP-114.1

Type of section: Pavement Field testing Year 1: 10/23/2008 14:45
 Location: 04Sol80W18.7 Field testing Year 2:
 Comments: Diamond ground. Right wheelpath on DG CRCP.
 Surface Year: 1999

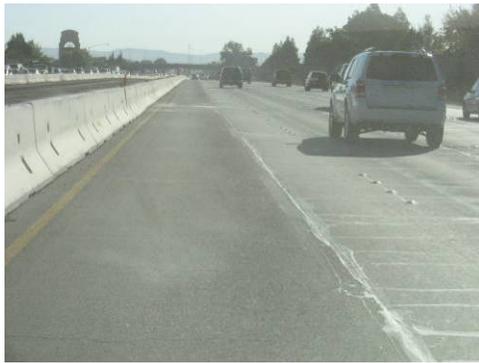
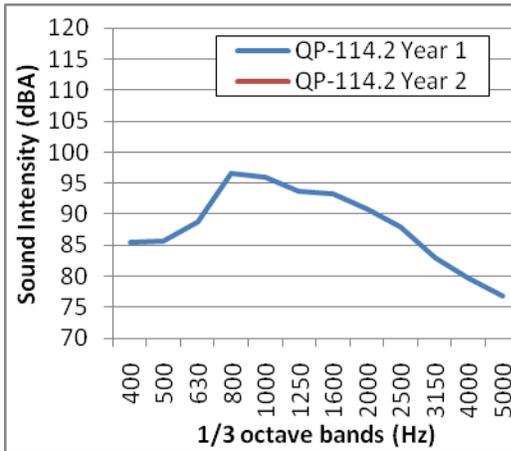
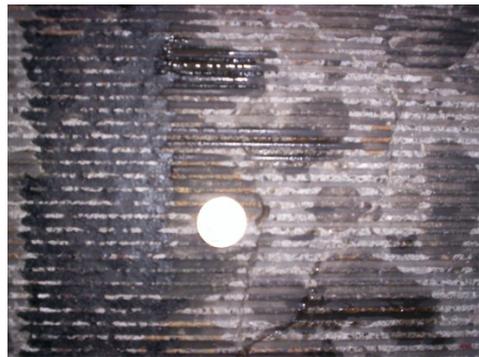
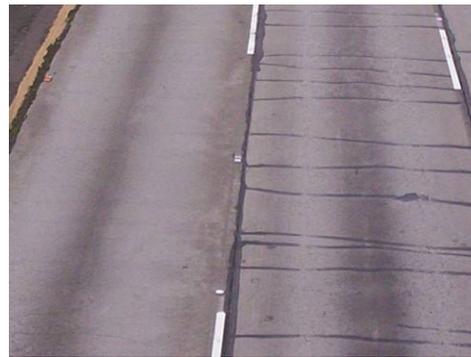
QP-114.2

Type of section: Pavement Field testing Year 1: 10/23/2008 15:11
Location: 04Sol80W18.6 Field testing Year 2:
Comments: Diamond ground. Right wheelpath on DG CRCP.
Surface Year: 1999

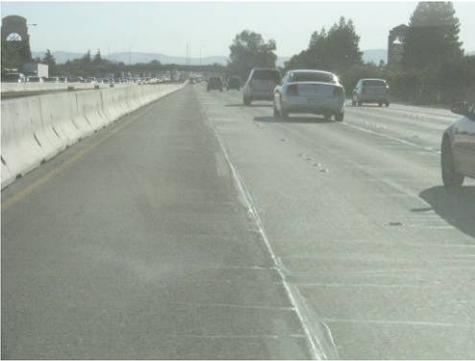
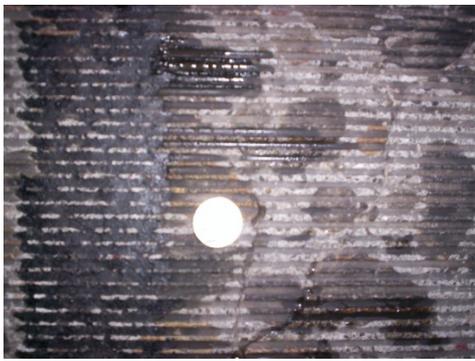
QP-114.3

Type of section: Pavement Field testing Year 1: 10/23/2008 15:31
Location: 04Sol80W18.5 Field testing Year 2:
Comments: Diamond ground. Right wheelpath on DG CRCP.
Surface Year: 1999

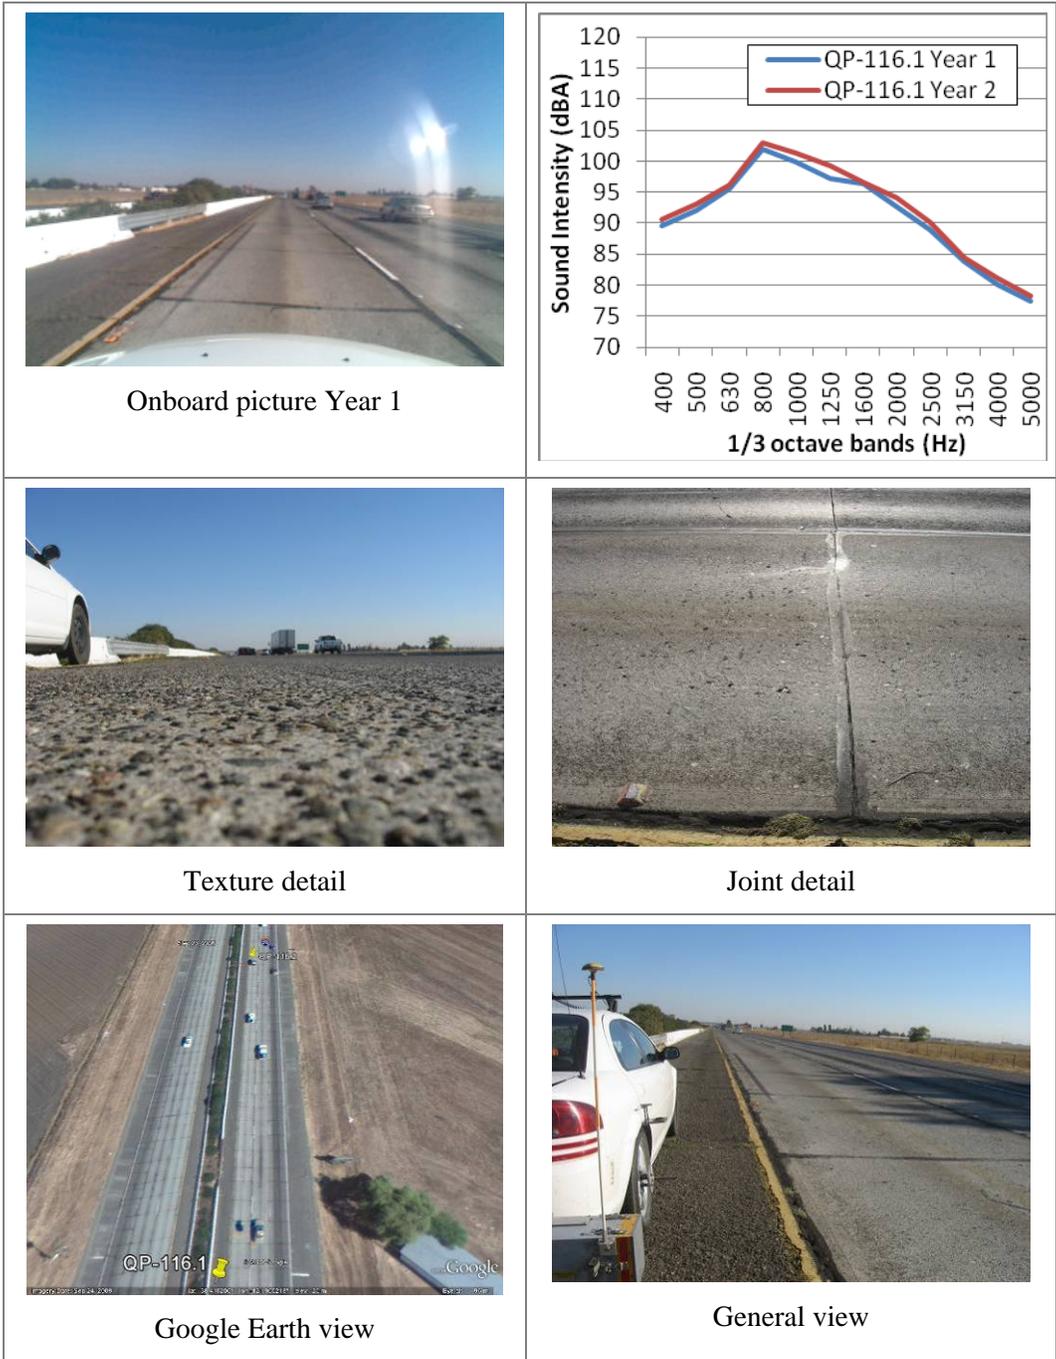
QP-116.1

Comments: Burlap drag. Looks like aggressive exposed agg. Maybe no original texture.

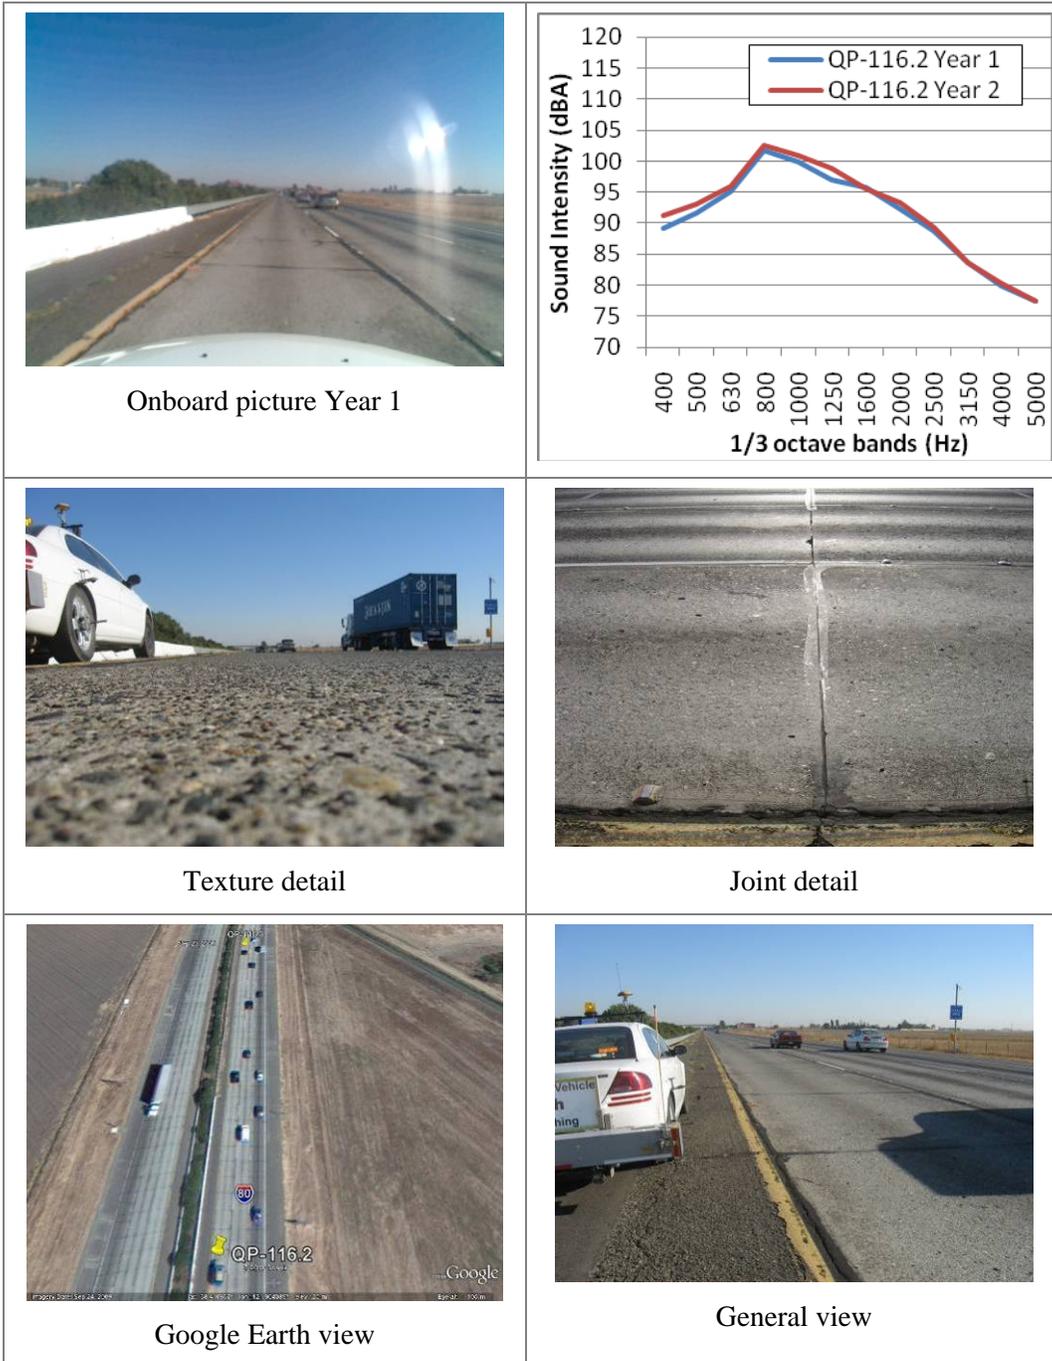
QP-116.2

Type of section: Pavement Field testing Year 1: 10/28/2008 11:06
 Location: 04Sol80E32.1 Field testing Year 2: 9/10/2009 11:20
 Comments: Burlap drag. Looks like aggressive exposed agg. Maybe no original texture.
 Surface Year: 1946

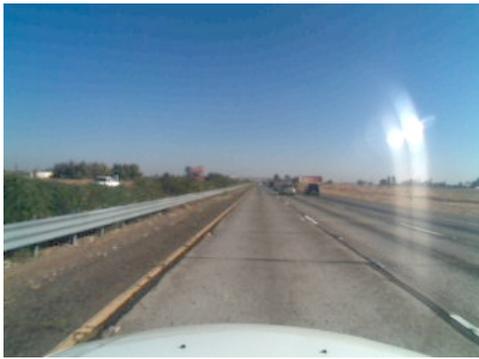
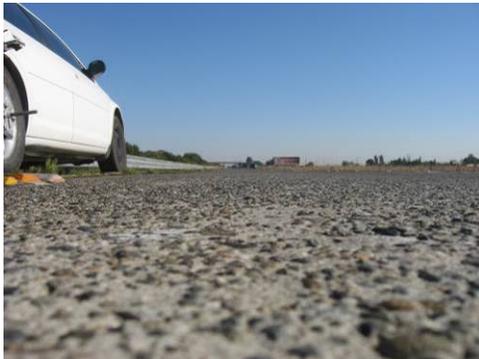
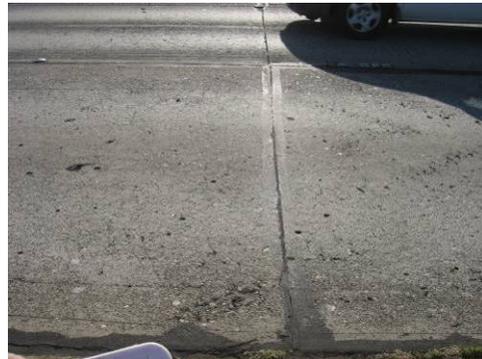
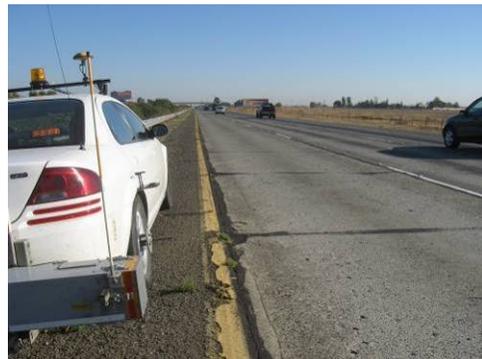
QP-116.3

Comments: Burlap drag. Looks like aggressive exposed agg. Maybe no original texture.

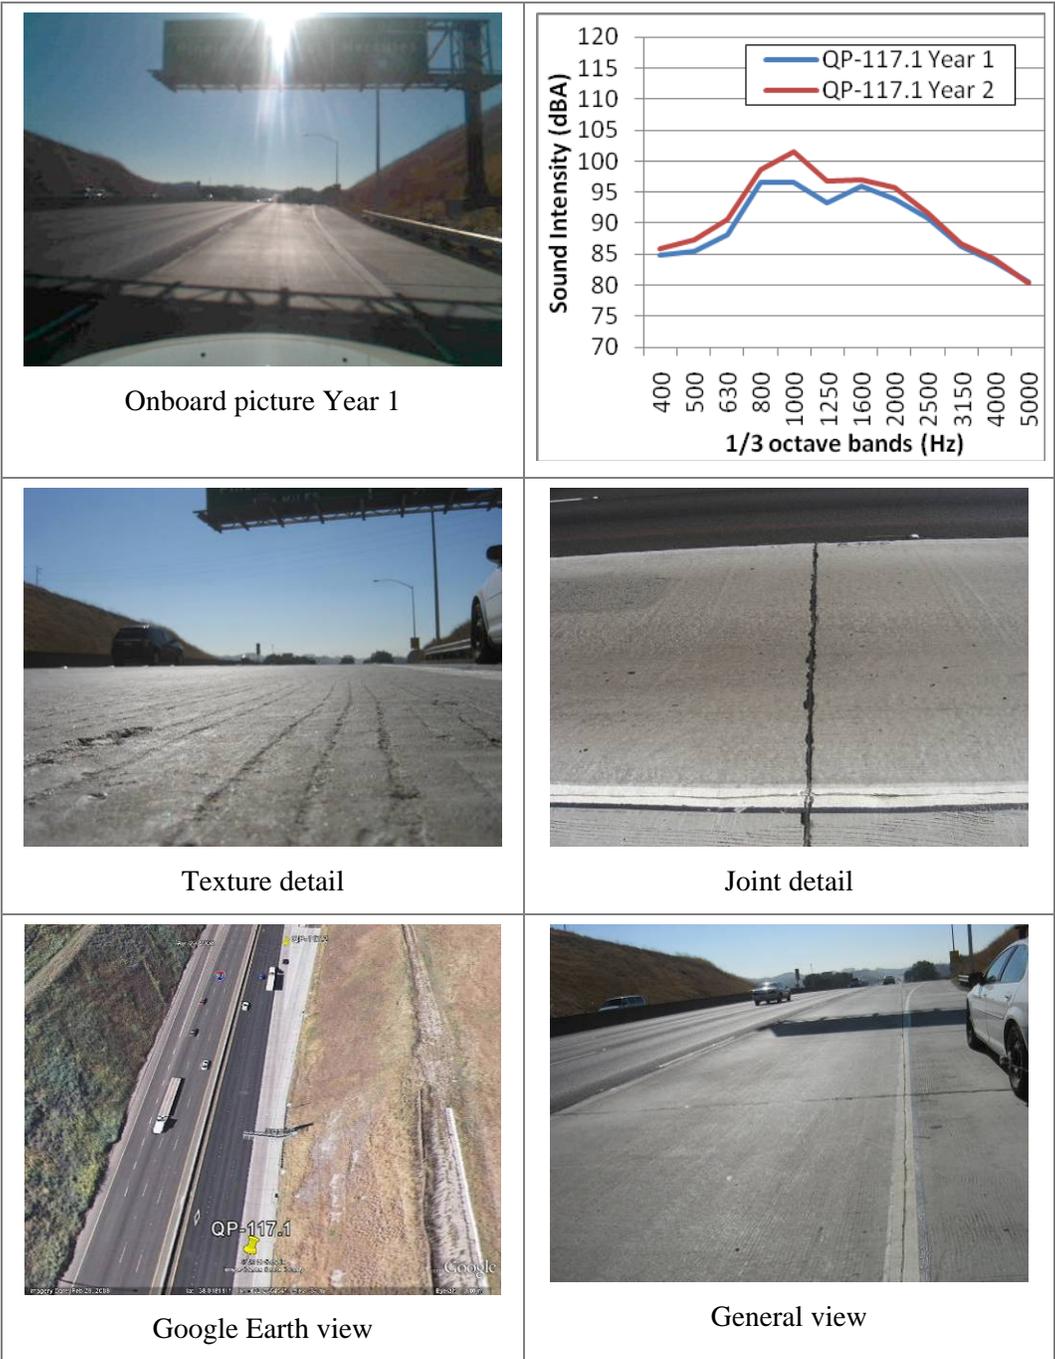
QP-117.1

Type of section: Pavement Field testing Year 1: 10/28/2008 14:14
 Location: 04CC80W10.3 Field testing Year 2: 10/29/2009 14:57
 Comments: Longitudinally tined. Shallow and squiggly LT.
 Surface Year: 2007

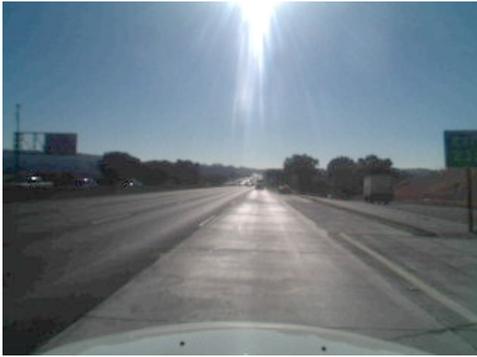
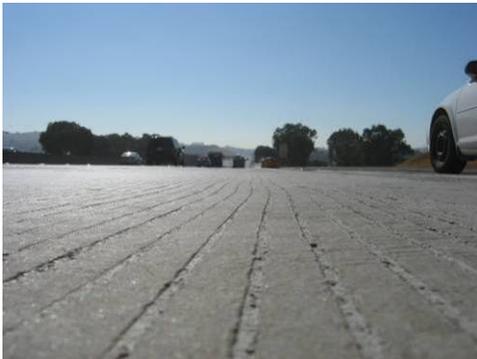
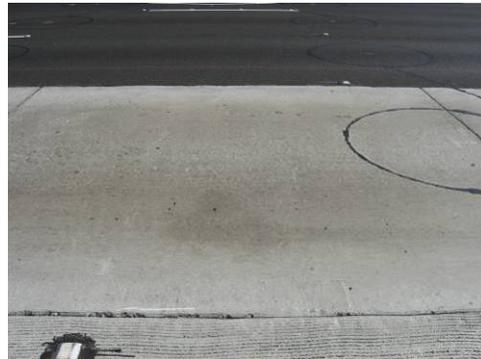
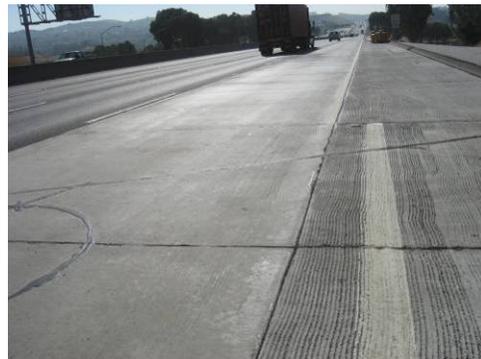
QP-117.2

Type of section: Pavement Field testing Year 1: 10/28/2008 14:45
 Location: 04CC80W10.2 Field testing Year 2: 10/29/2009 15:03
 Comments: Longitudinally tined. Shallow and squiggly LT.
 Surface Year: 2007

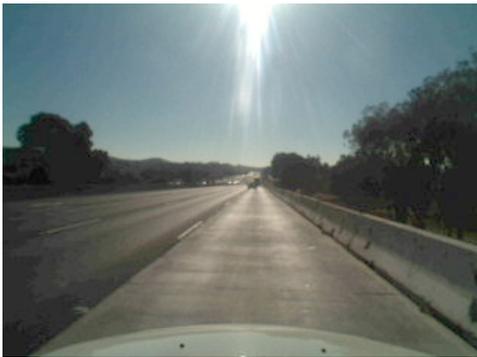
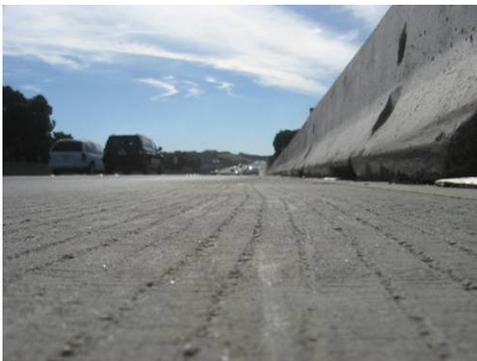
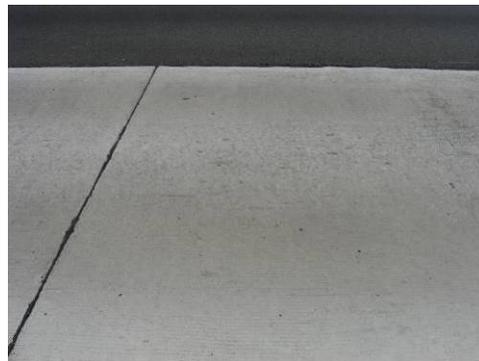
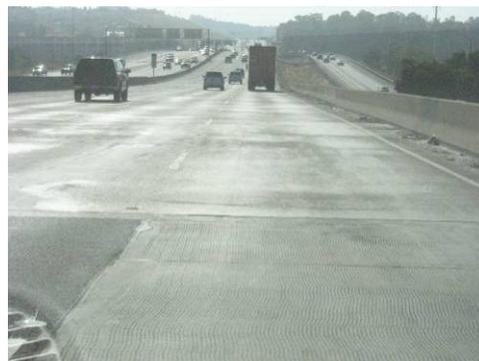
QP-117.3

Type of section: Pavement Field testing Year 1: 10/28/2008 14:54
 Location: 04CC80W10.1 Field testing Year 2: 10/29/2009 15:12
 Comments: Longitudinally tined. Shallow and squiggly LT.
 Surface Year: 2007

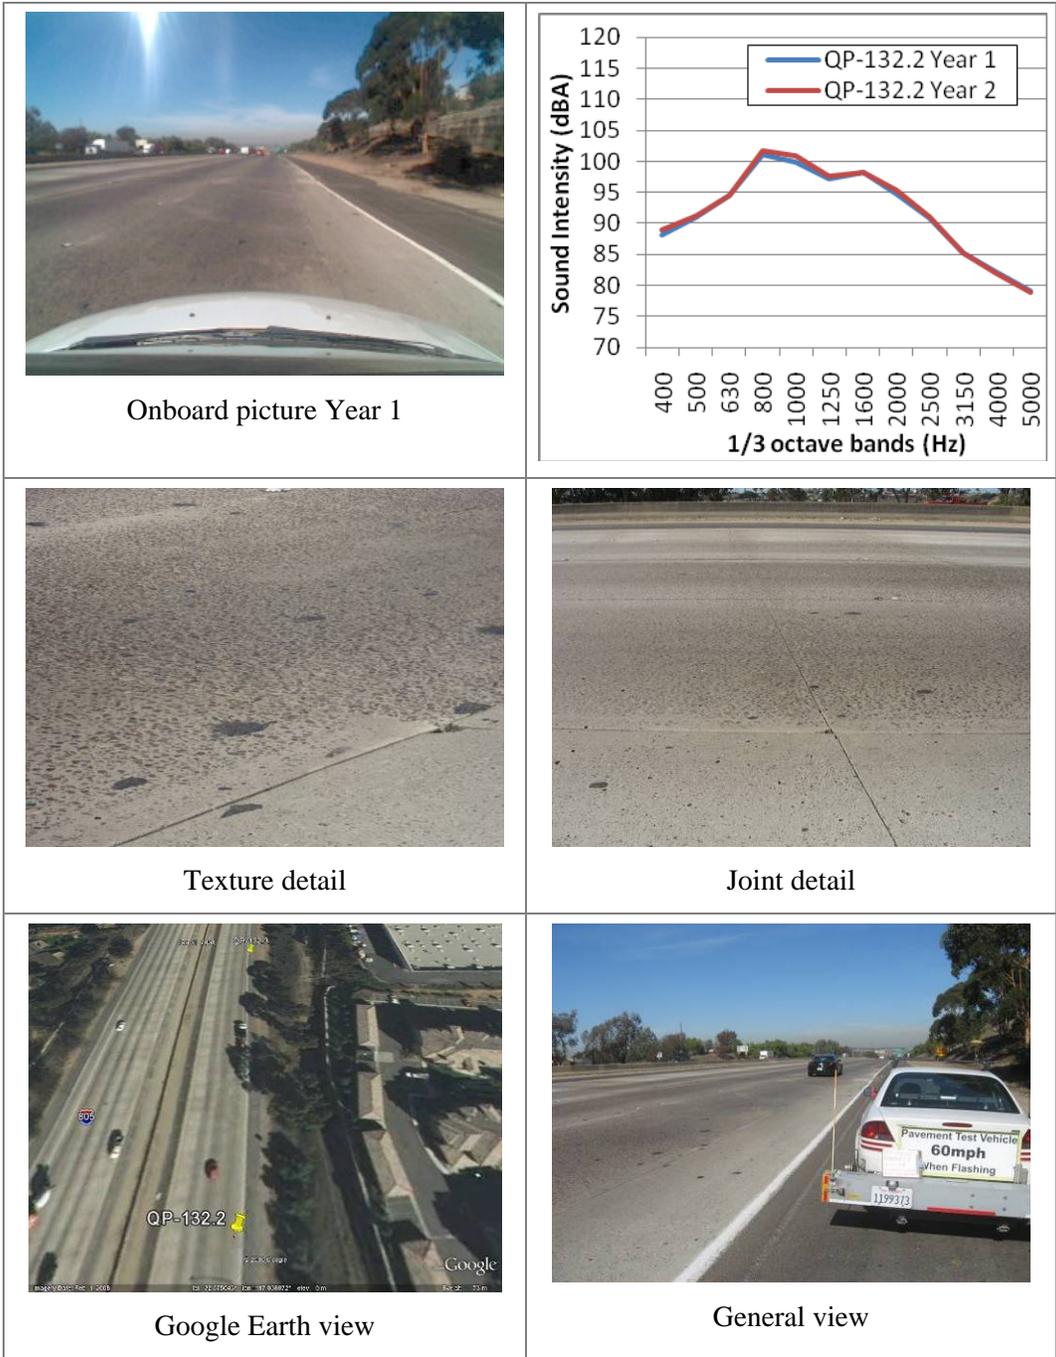
QP-132.2

Type of section: Pavement
 Location: 11SD805N2.2
 Comments: Diamond ground.
 Surface Year: 1998
