1. REPORT NUMBER CA12-1200 A	2. GOVERNMENT ASSOCIATION NUMBER	3. RECIPIENT'S CATALOG NUMBER
4. TITLE AND SUBTITLE Quieter Pavement Research: Concrete Pavement Tire Noise	5. REPORT DATE 05/30/2011

7. AUTHOR John T. Harvey and Erwin Kohler		6. PERFORMING ORGANIZATION CODE
9. PERFORMING ORGANIZATION NAME AND ADDRESS University of California, Davis & Berkeley Partnered Pavement Research Center 1353 S. 46th Street, Bldg. 452 Richmond, CA 94804		8. PERFORMING ORGANIZATION REPORT NO. UCPRC-RR-2010-03

Quieter Pavement Research: Concrete Pavement Tire Noise

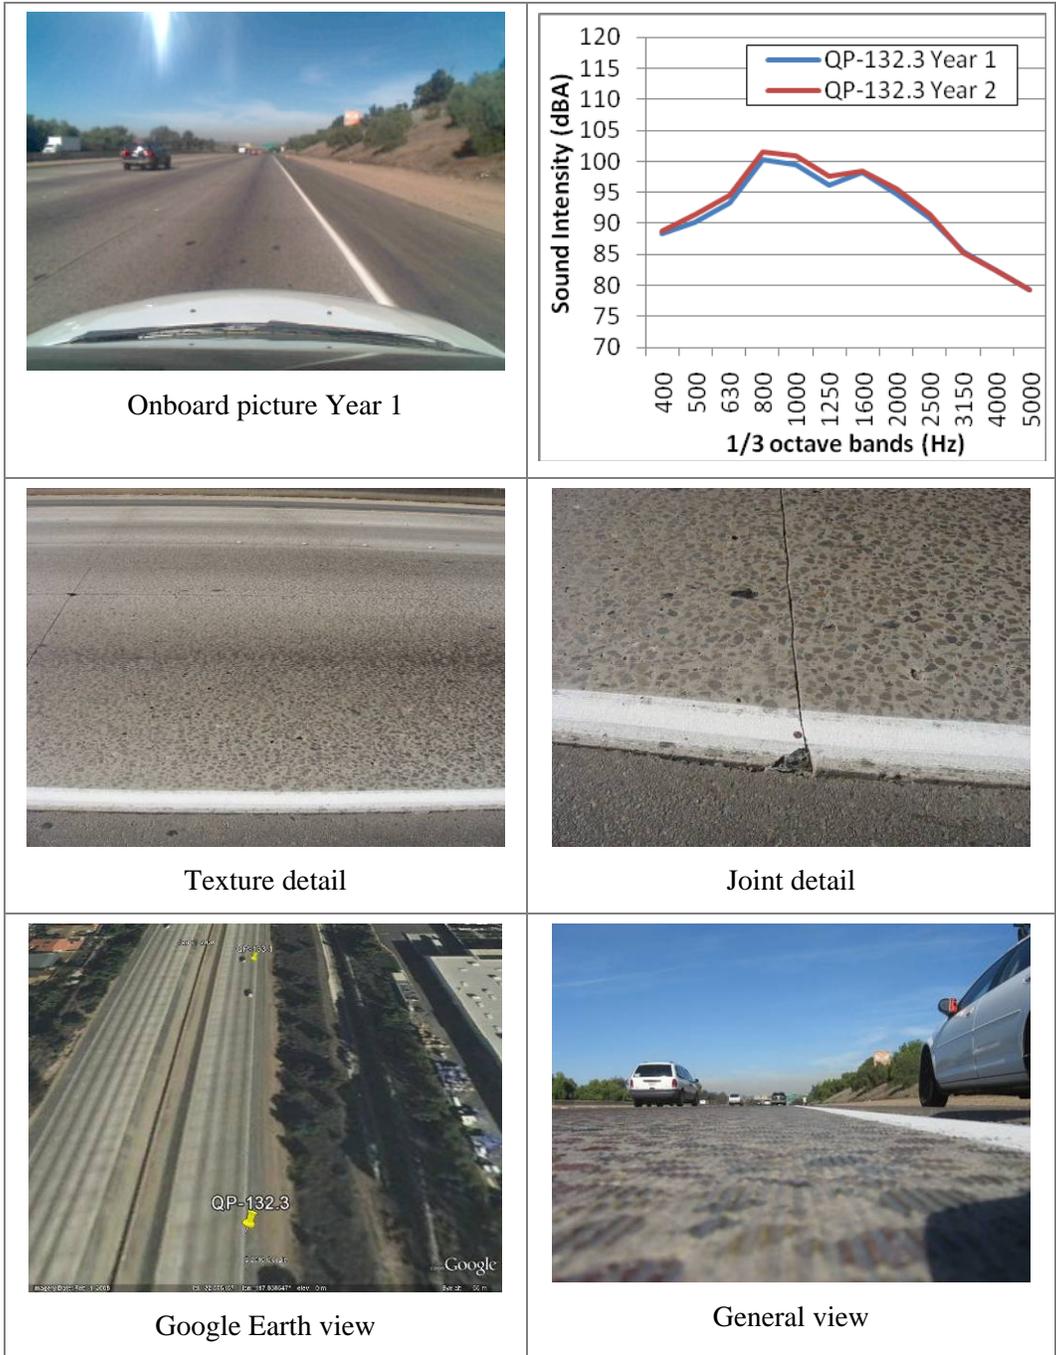
QP-132.3

Type of section: Pavement
 Location: 11SD805N2.3
 Comments: Diamond ground.
 Surface Year: 1998

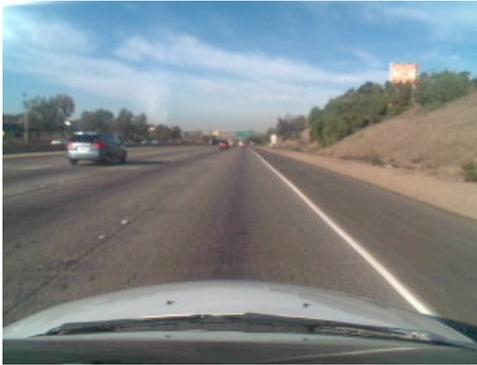
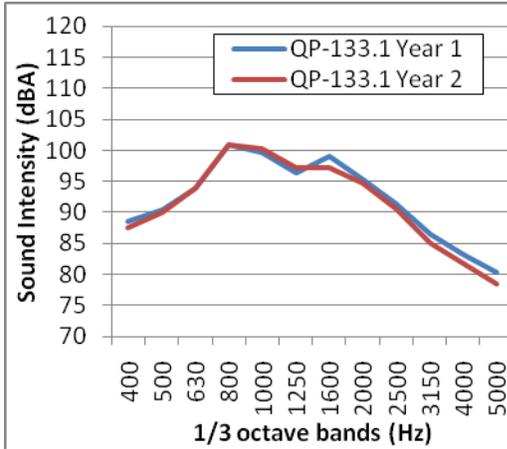
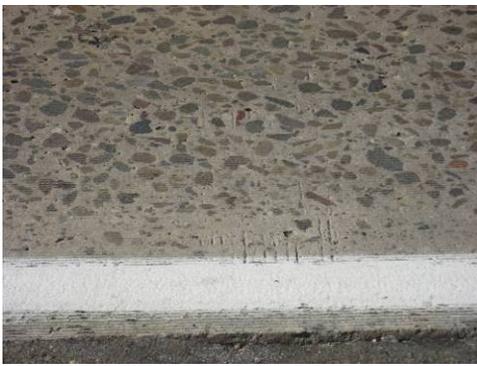
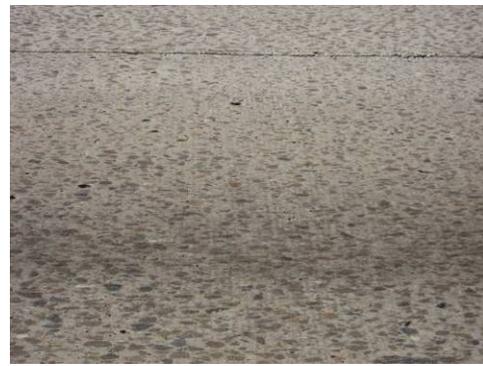
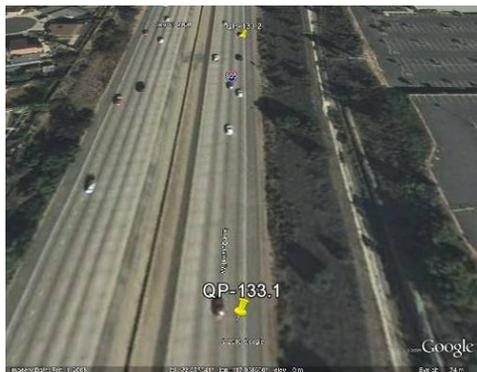
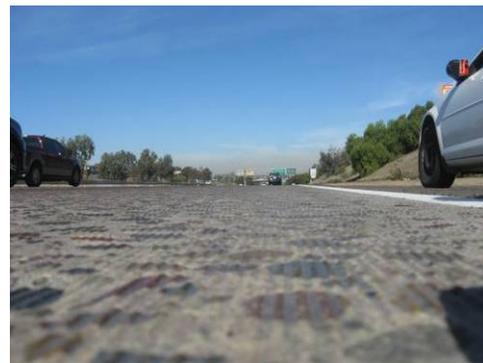
QP-133.1

Type of section: Pavement Field testing Year 1: 11/12/2008 14:36
 Location: 11SD805N2.3 Field testing Year 2: 11/24/2009 11:50
 Comments: Diamond ground. DG on transverse tining.
 Surface Year: 1998

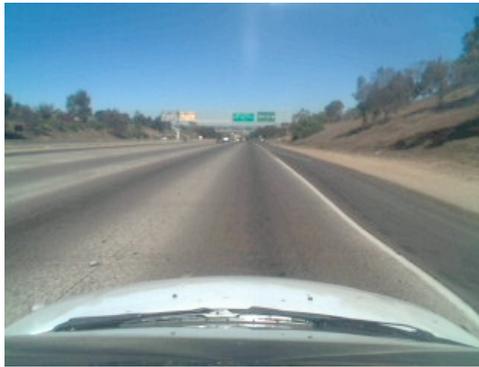
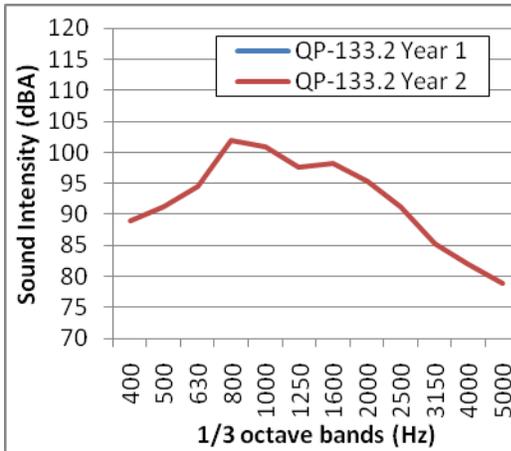
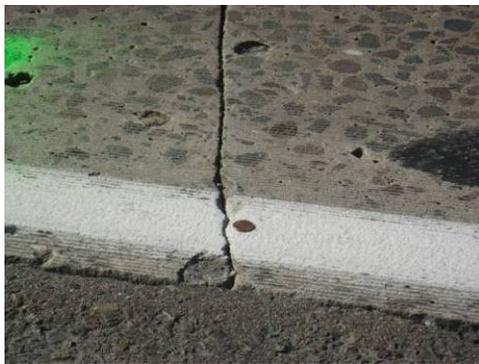
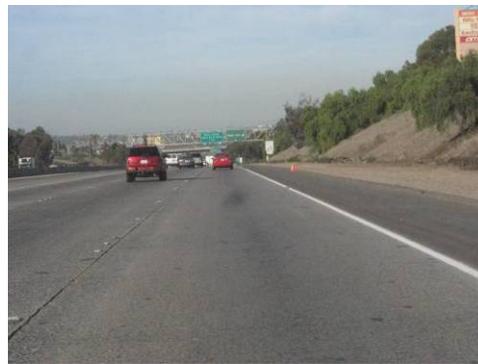
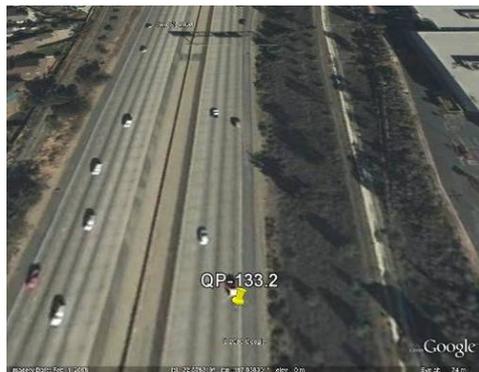
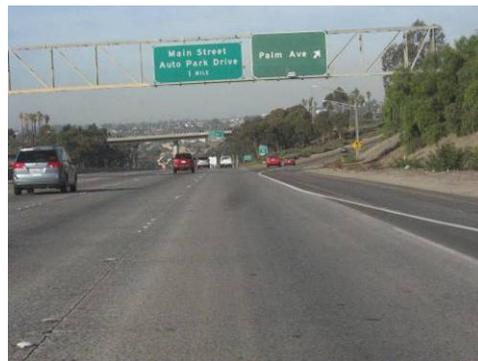
QP-133.2

Type of section: Pavement
 Location: 11SD805N2.4
 Comments: Diamond ground.
 Surface Year: 1998

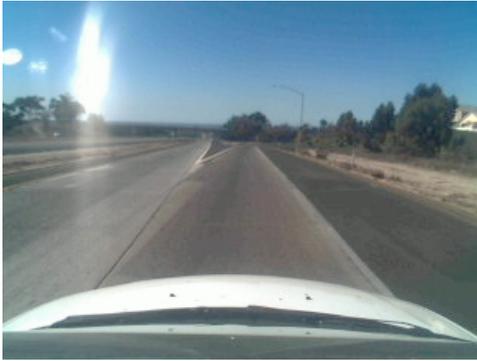
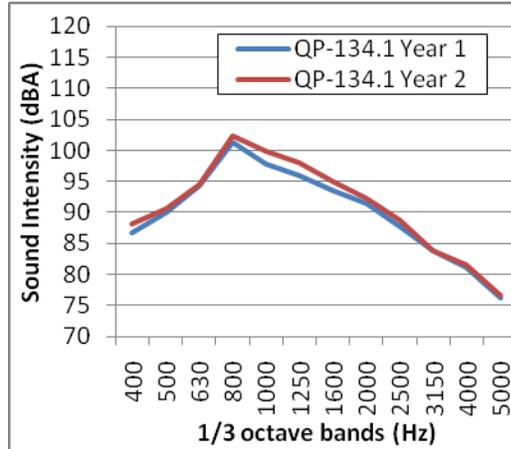
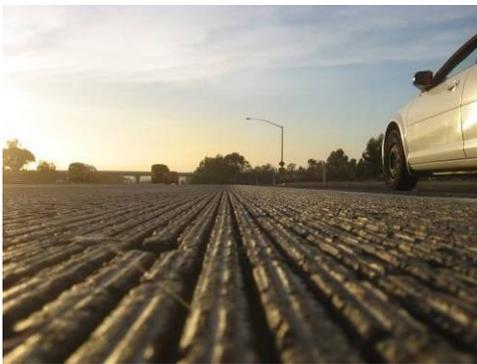
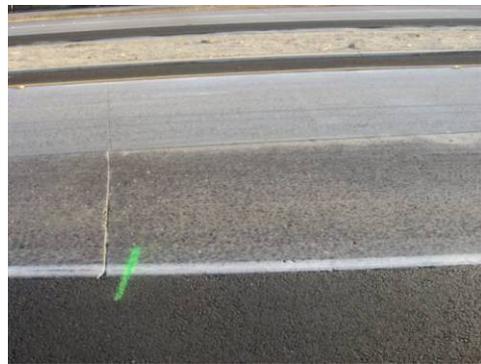
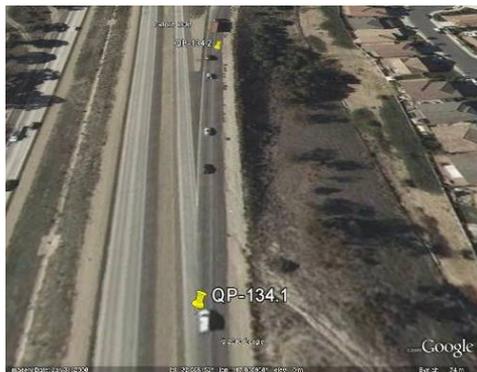
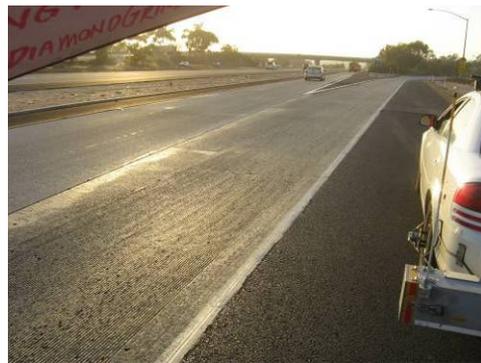
QP-134.1

Type of section: Pavement Field testing Year 1: 11/12/2008 16:03
 Location: 11SD905W5.2 Field testing Year 2: 11/24/2009 12:21
 Comments: Diamond ground. DG on deep longitudinal tining. Off-ramp.
 Surface Year: 2000

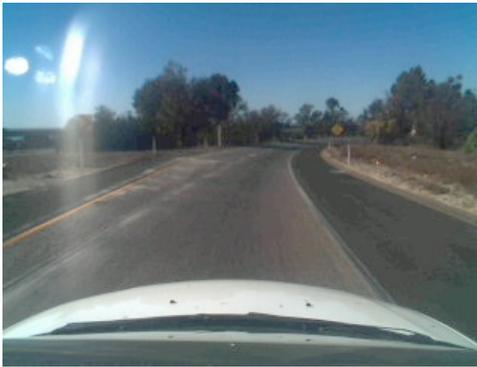
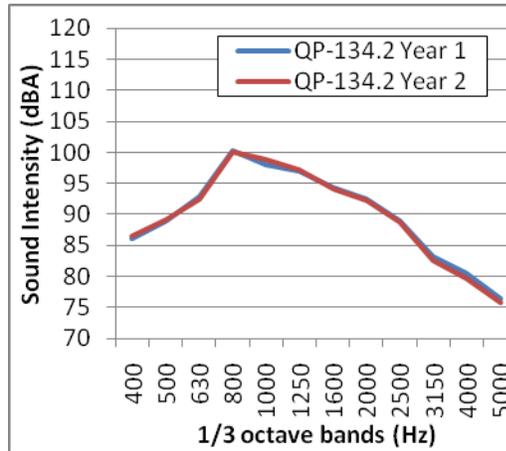
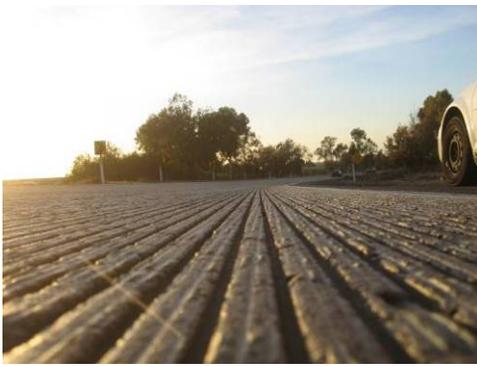
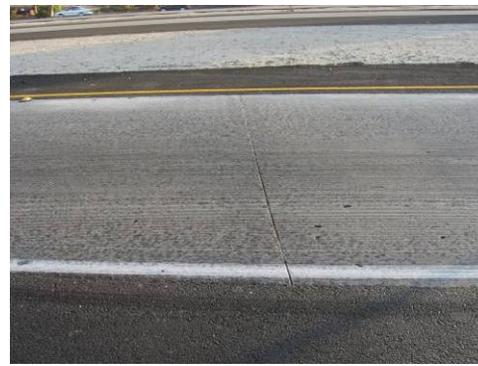
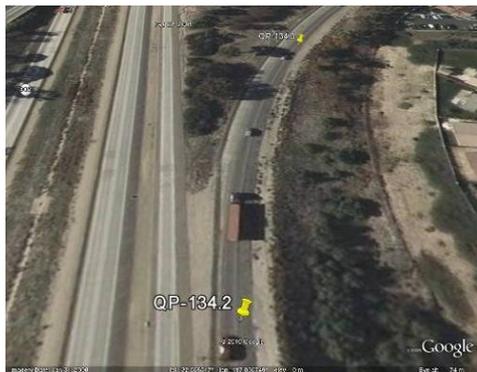
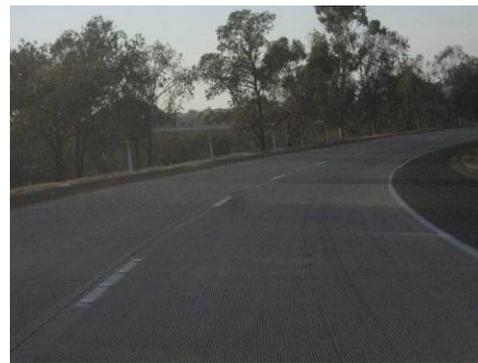
QP-134.2

Type of section: Pavement Field testing Year 1: 11/12/2008 16:35
 Location: 11SD905W5.1 Field testing Year 2: 11/24/2009 12:31
 Comments: Diamond ground. DG on deep longitudinal tining. Off-ramp.
 Surface Year: 2000

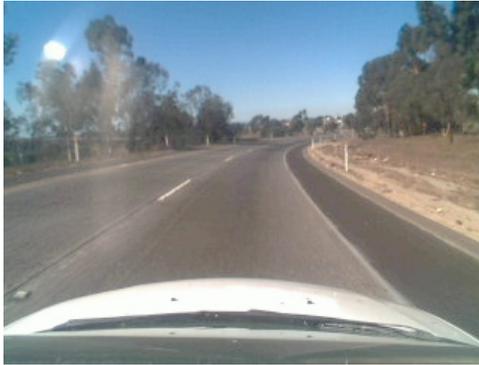
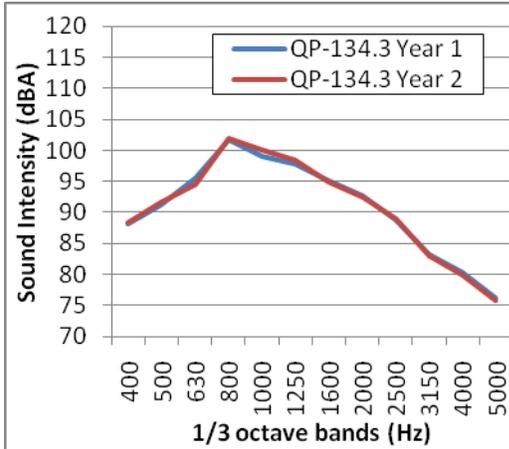
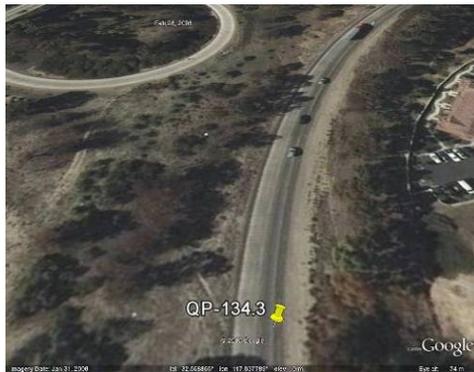
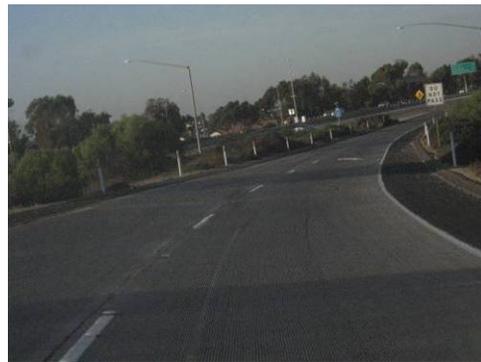
QP-134.3

Type of section: Pavement Field testing Year 1: 11/12/2008 16:39
 Location: 11SD905W5.0 Field testing Year 2: 11/24/2009 12:35
 Comments: Diamond ground. DG on deep longitudinal tining. Off-ramp.
 Surface Year: 2000

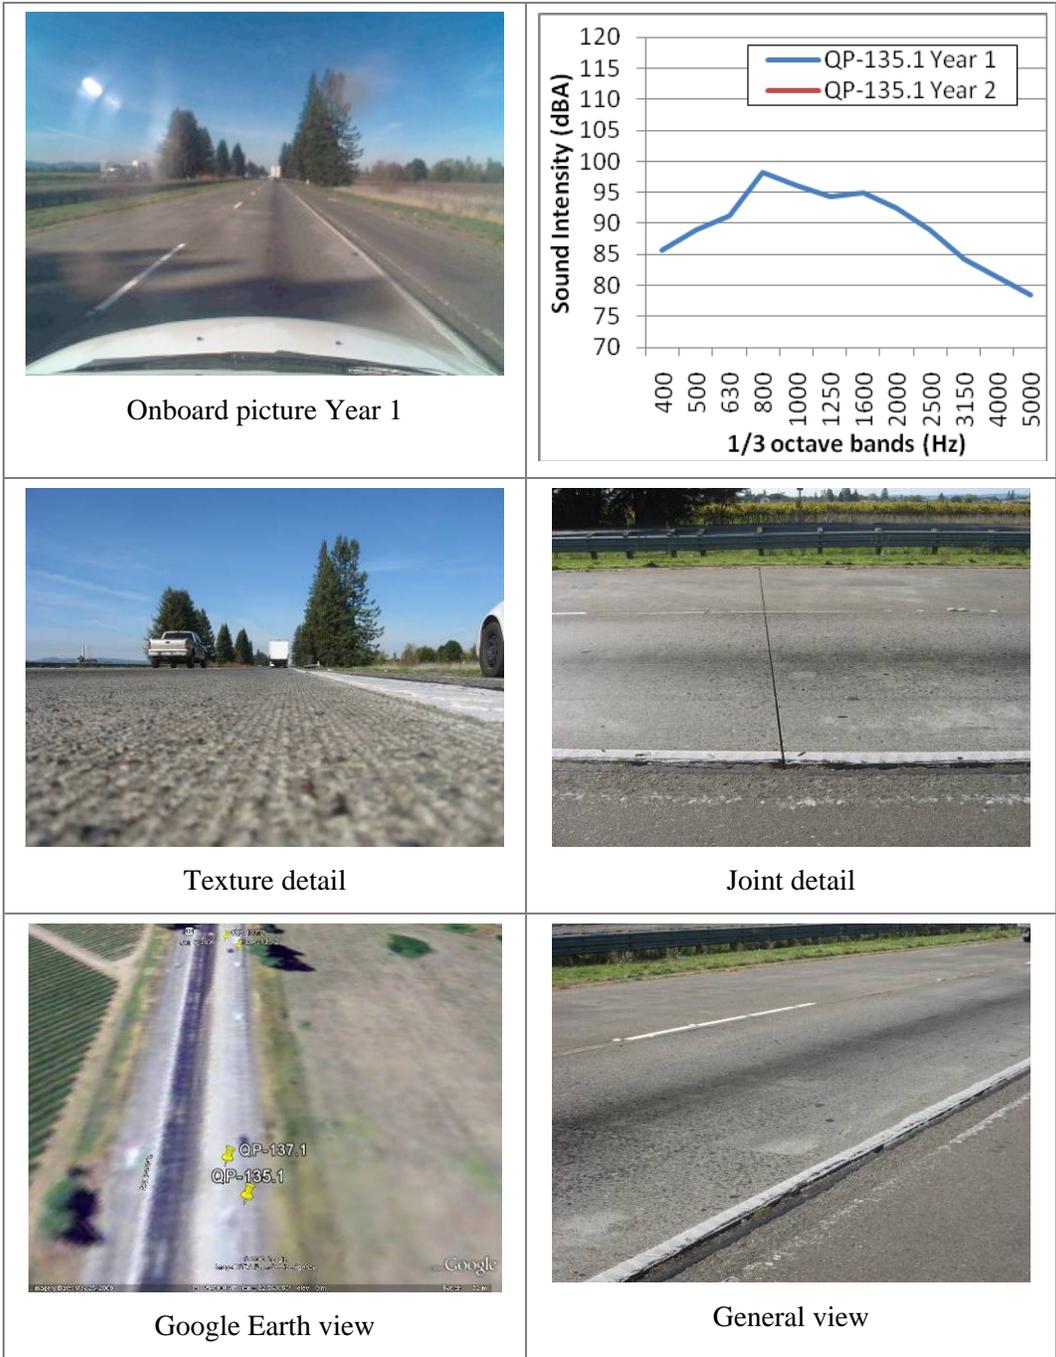
QP-135.1

Type of section: Pavement
 Location: 04SON101N25.4L2
 Comments: Diamond ground.
 Surface Year: 2006

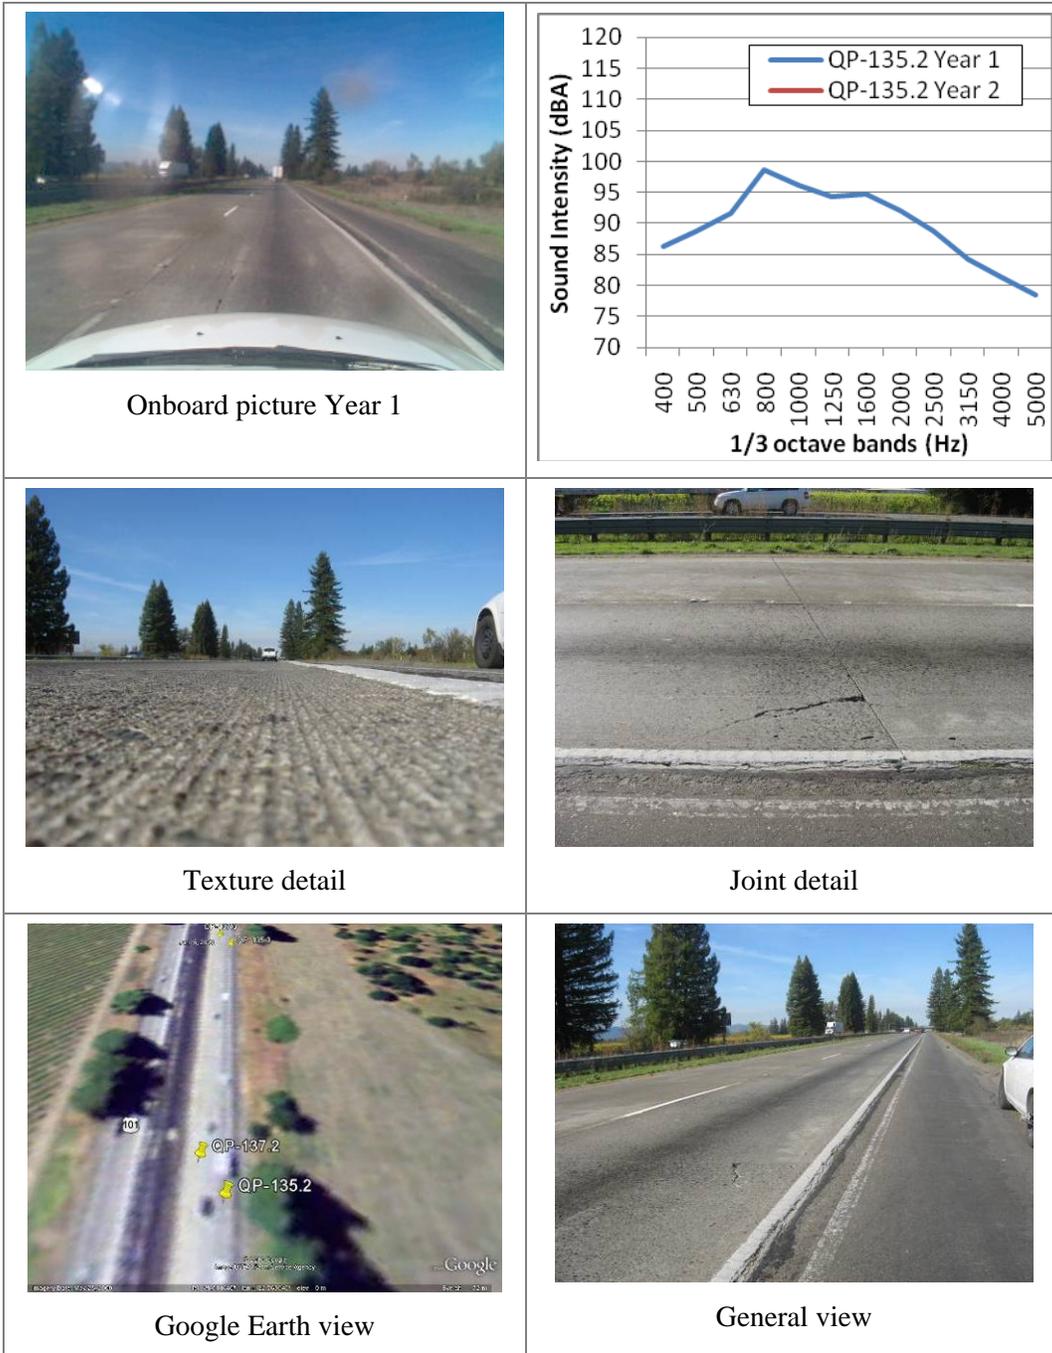
QP-135.2

Type of section: Pavement
Location: 04SON101N25.5L2
Comments: Diamond ground.
Surface Year: 2006

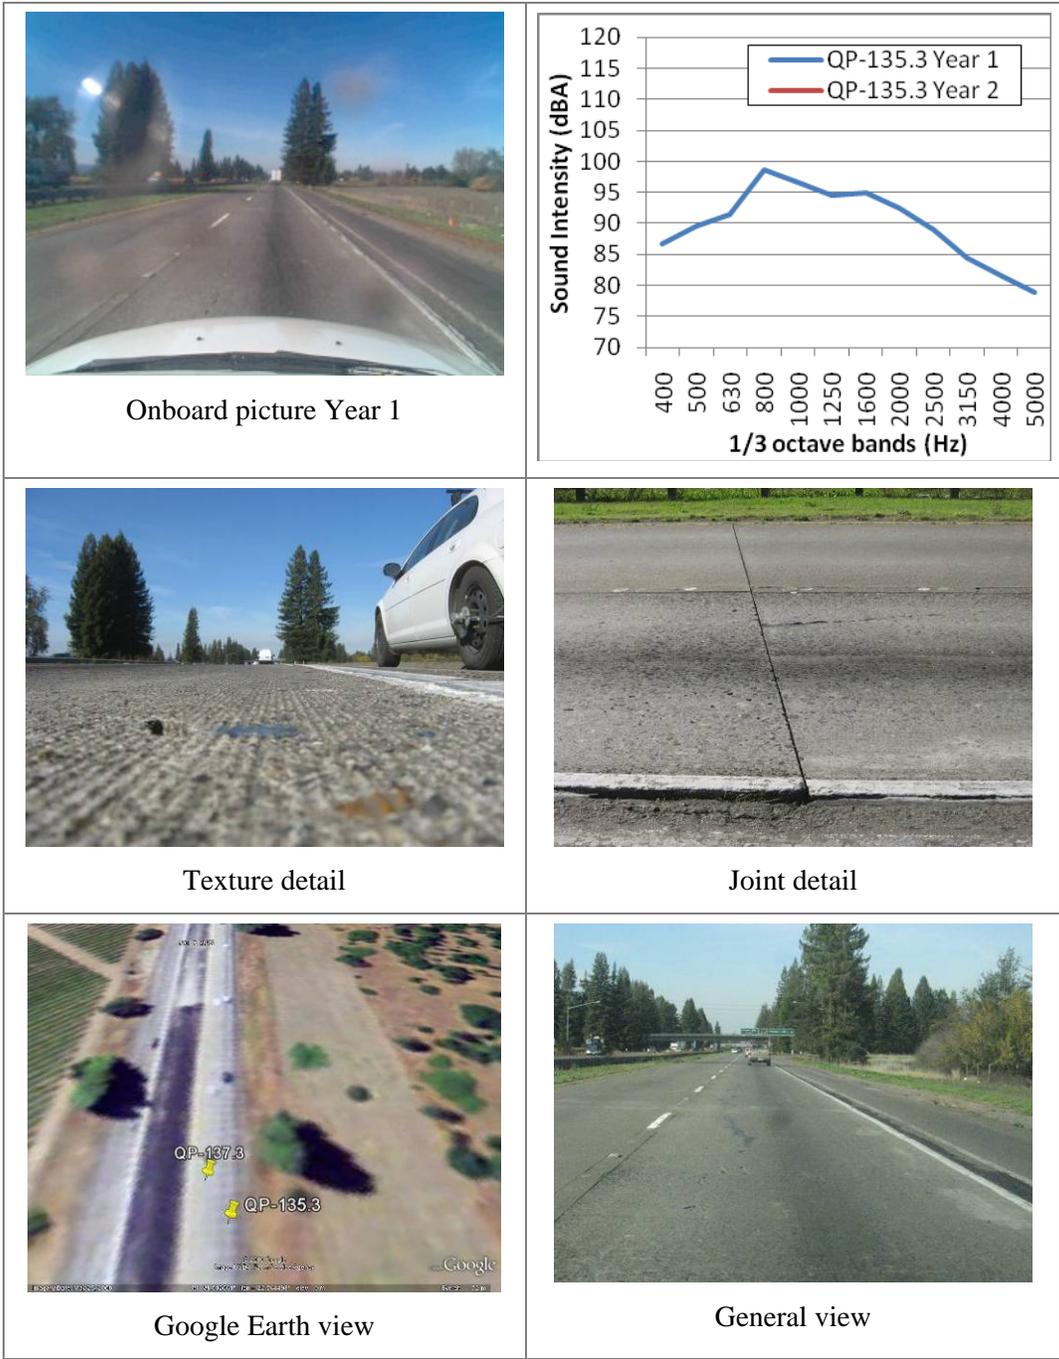
QP-135.3

Type of section: Pavement
 Location: 04SON101N25.6
 Comments: Diamond ground.
 Surface Year: 2006

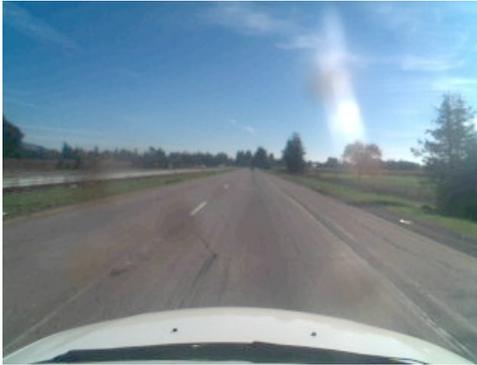
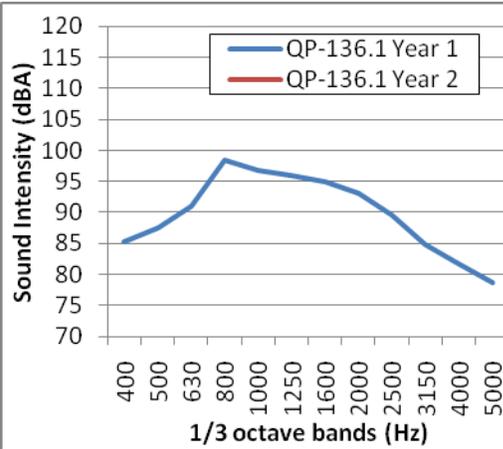
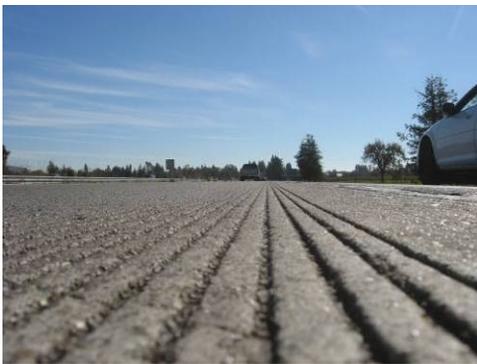
QP-136.1

Comments: Diamond grooved.
