Progress Report on Median Barrier Test Program

November 1958

F.N. Hveem

Subject: Progress Report on Median Barrier Test Program

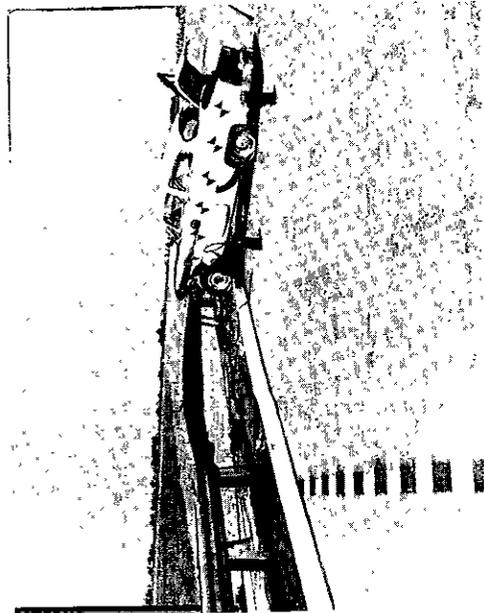
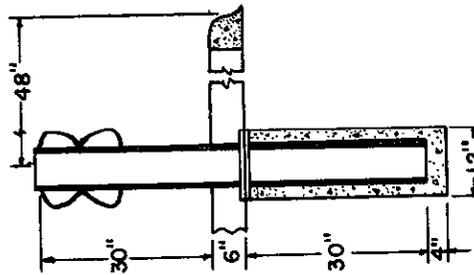
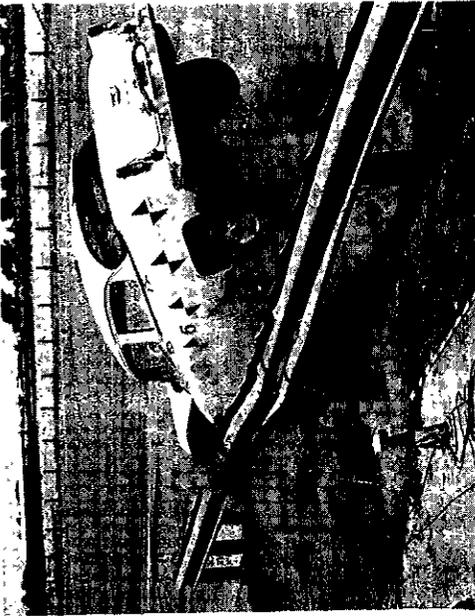
POST IMPACT

GUARDRAIL W Section
 BRACKET None
 POST 6" WF Beam
 POST SPACING 6'-3" O.C.
 LENGTH OF INSTALLATION ... 100'
 GROUND CONDITION Dry

DUMMY INJURY Possible neck injury & concussion.
 GUARDRAIL DAMAGE 4 Sections damaged beyond repair.
 POST DAMAGE 3 Posts knocked out.
 VEHICLE DAMAGE 2 Posts out of alignment.
 MAX. DYNAMIC DEFLECTION OF RAIL ... 36"
 VEHICLE DECELERATION (PEAK) Long. Transv.

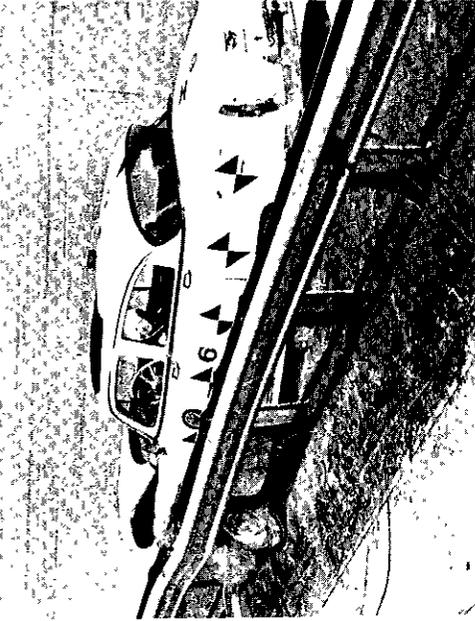
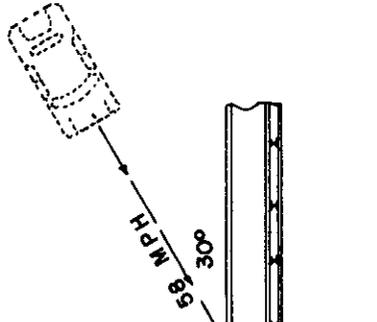
IMPACT + 100 M SEC.

TEST NO. 6
 DATE 9-10-58
 VEHICLE Chev. 54 Sedan
 SPEED 58 M P H
 IMPACT ANGLE 30°
 VEHICLE WEIGHT 4000
 (W/DUMMY & INSTRUMENTATION)

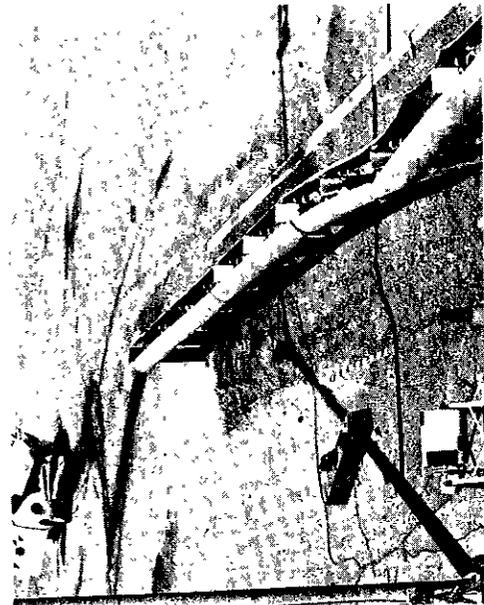
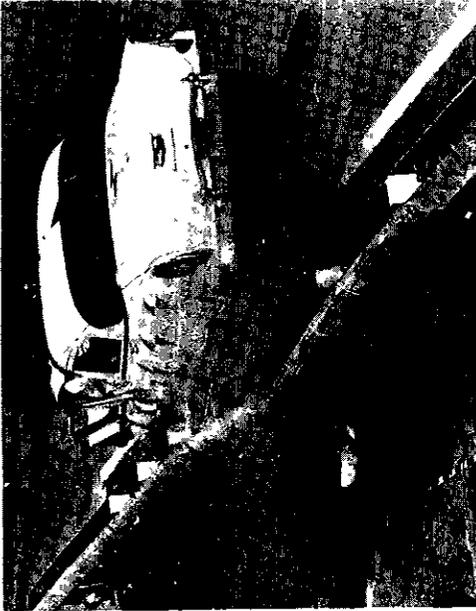
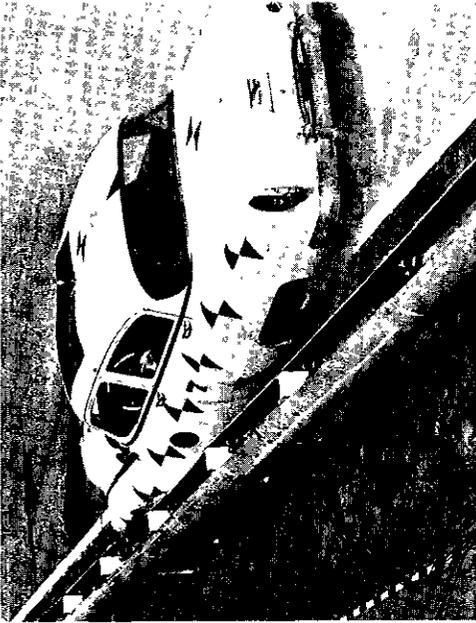
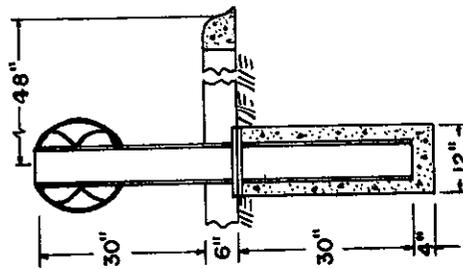
POST IMPACT

GUARDRAIL Tuthill
 BRACKET HG 32 N
 POST 6" WF Beam
 POST SPACING 6'-3" O.C.
 LENGTH OF INSTALLATION...100'
 GROUND CONDITION.....Dry

DUMMY INJURY..... Multiple scalp lacerations. Possible internal injury. TEST NO.....7
 GUARDRAIL DAMAGE 2 Sections damaged beyond repair. DATE 9-18-58
 POST DAMAGE 2 Posts damaged beyond repair. VEHICLE Chev. 54 Sedan
 VEHICLE DAMAGE 2 Posts out of alignment. SPEED 63 M P H
 MAX. DYNAMIC DEFLECTION OF RAIL...19" IMPACT ANGLE.....19°
 VEHICLE DECELERATION (PEAK) Long.Transv. (W/DUMMY & INSTRUMENTATION)
 Total loss. VEHICLE WEIGHT.....4050

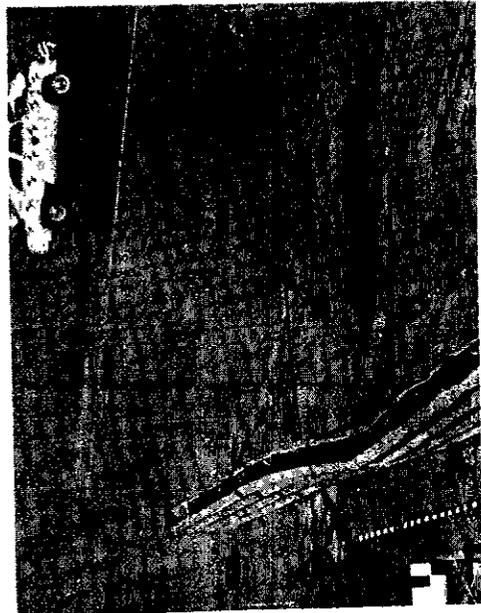
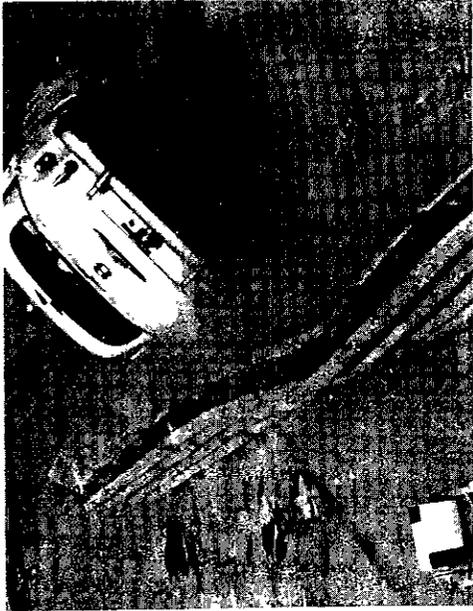
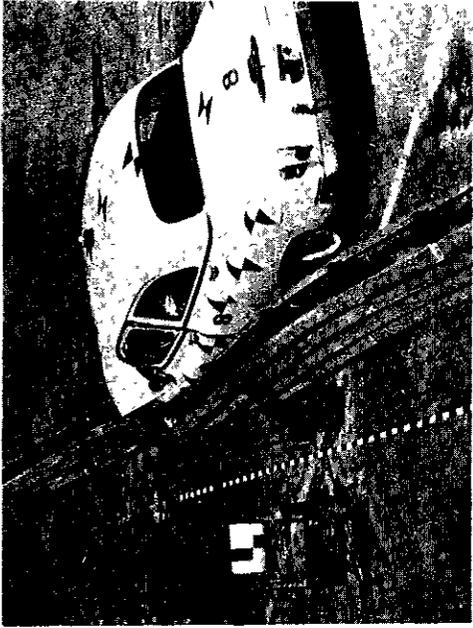
POST IMPACT

GUARDRAIL..... W Section
 BRACKET..... None
 POST..... 6" WF Beam
 POST SPACING..... 6'-3" O.C.
 LENGTH OF INSTALLATION... 100'
 GROUND CONDITION..... Dry

DUMMY INJURY..... Scalp lacerations. Possible concussion.
 GUARDRAIL DAMAGE..... 2 Sections damaged beyond repair.
 POST DAMAGE..... All can be repaired.
 VEHICLE DAMAGE..... 5 Posts out of alignment.
 MAX. DYNAMIC DEFLECTION OF RAIL... 15"
 VEHICLE DECELERATION (PEAK)..... Long. Transv.

TEST NO..... 8
 DATE..... 10-2-58
 VEHICLE..... Chev. 52 Sedan
 SPEED..... 58 M.P.H
 IMPACT ANGLE..... 29°
 VEHICLE WEIGHT... 4050
 (W/DUMMY & INSTRUMENTATION)

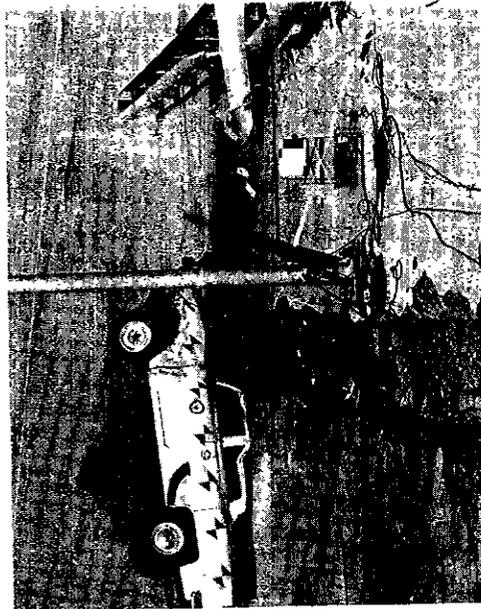
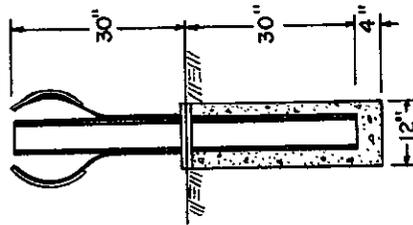
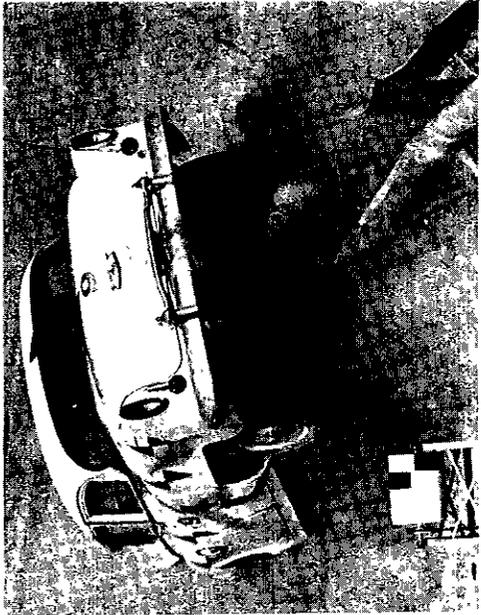
POST IMPACT

GUARDRAILTuffhill
 BRACKETHG15N
 POST6" WF Beam
 POST SPACING6'-3" O.C.
 LENGTH OF INSTALLATION...100'
 GROUND CONDITIONDry

DUMMY INJURY Possible chest and internal injuries.
 GUARDRAIL DAMAGE 4 Sections damaged beyond repair.
 POST DAMAGE Both rails failed.
 VEHICLE DAMAGE 2 Posts damaged beyond repair.
 MAX. DYNAMIC DEFLECTION OF RAIL... 15" Before failure.
 VEHICLE DECELERATION (PEAK)..... Long. Transv.

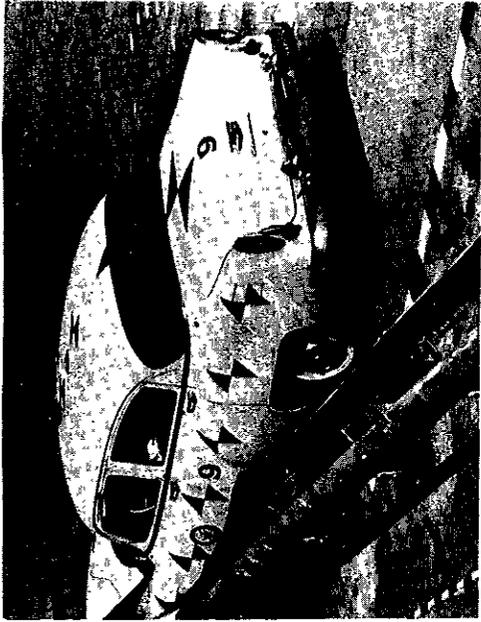
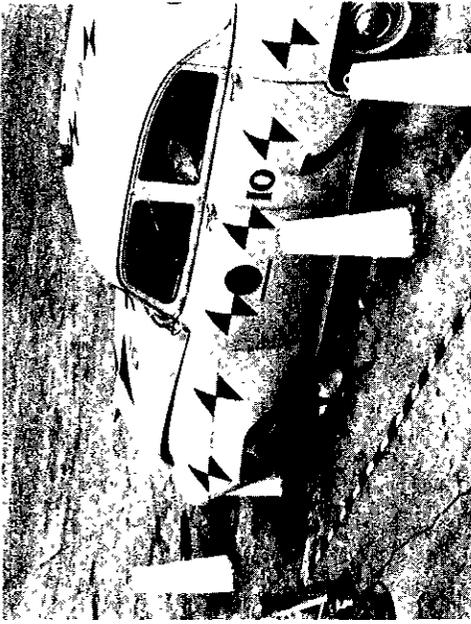
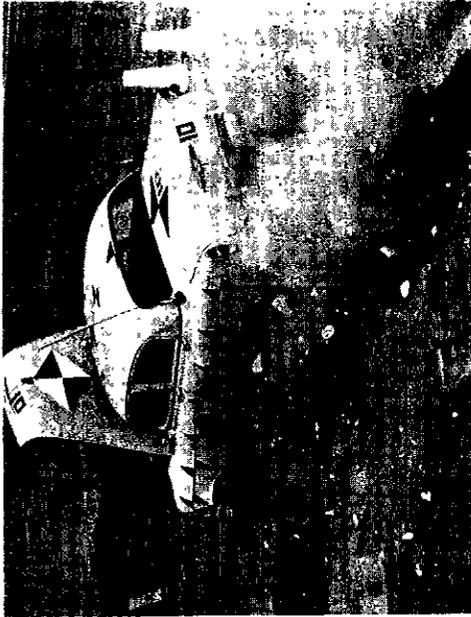
TEST NO. 9
 DATE10-15-58
 VEHICLEChev. 54 Sedan
 SPEED60 MPH
 IMPACT ANGLE28°
 VEHICLE WEIGHT...3970
 (W/DUMMY & INSTRUMENTATION)

GUARDRAIL.....None
 BRACKET.....None
 POST.....P.C.C.
 POST SPACING.....5' O.C.
 LENGTH OF INSTALLATION...60'
 GROUND CONDITION.....Dry

DUMMY INJURY.....No apparent injuries.
 GUARDRAIL DAMAGE.....No rail.
 POST DAMAGE.....3 Posts demolished.
 VEHICLE DAMAGE.....Est. \$ 200.
 MAX. DYNAMIC DEFLECTION OF RAIL...No rail.
 VEHICLE DECELERATION (PEAK).....Long.....Transv.

TEST NO.10
 DATE10-23-58
 VEHICLEChev. 53 Sedan
 SPEED57 MPH
 IMPACT ANGLE.....20°
 VEHICLE WEIGHT...3970
 (W/DUMMY & INSTRUMENTATION)

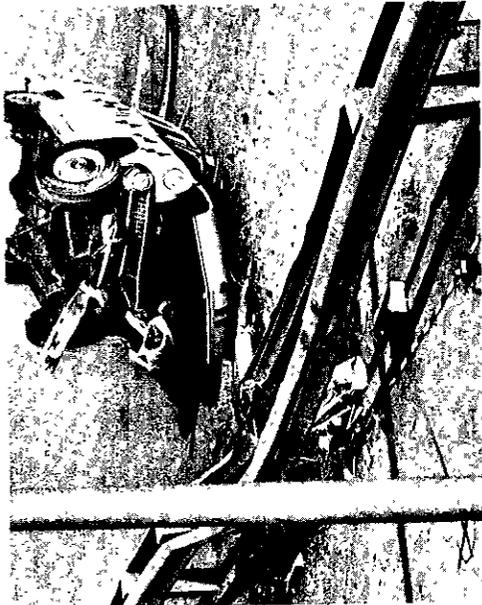
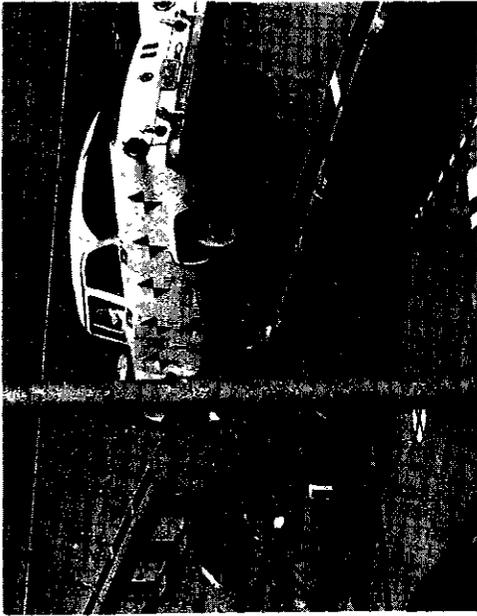
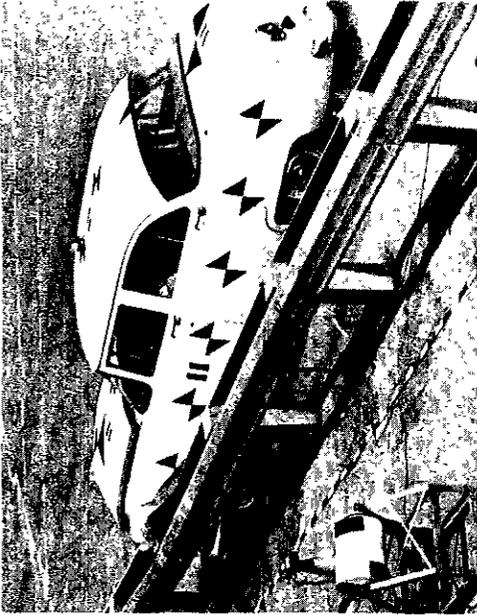
POST IMPACT

GUARDRAIL W Section
 BRACKET None
 POST 8x8 DF.
 POST SPACING 6'-3" O.C.
 LENGTH OF INSTALLATION... 200'
 GROUND CONDITION Dry

DUMMY INJURY Scalp lacerations. Possible internal injuries.
 GUARDRAIL DAMAGE 6 Sections damaged beyond repair.
 POST DAMAGE 3 Posts damaged beyond repair.
 VEHICLE DAMAGE Total loss.
 MAX. DYNAMIC DEFLECTION OF RAIL... 40"
 VEHICLE DECELERATION (PEAK) Long. Transv.

TEST NO. 11
 DATE 10-30-58
 VEHICLE Ford 55 Sedan
 SPEED 59 MPH
 IMPACT ANGLE 26°
 VEHICLE WEIGHT... 4050
 (W/DUMMY & INSTRUMENTATION)

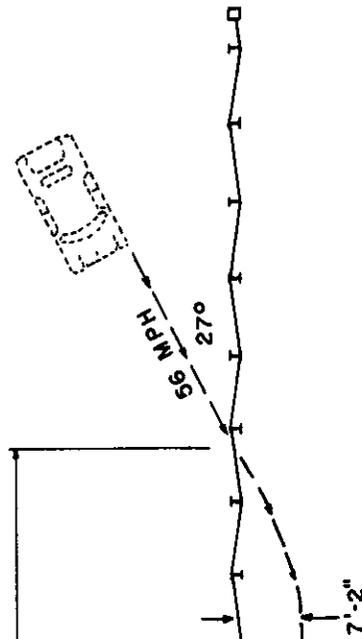
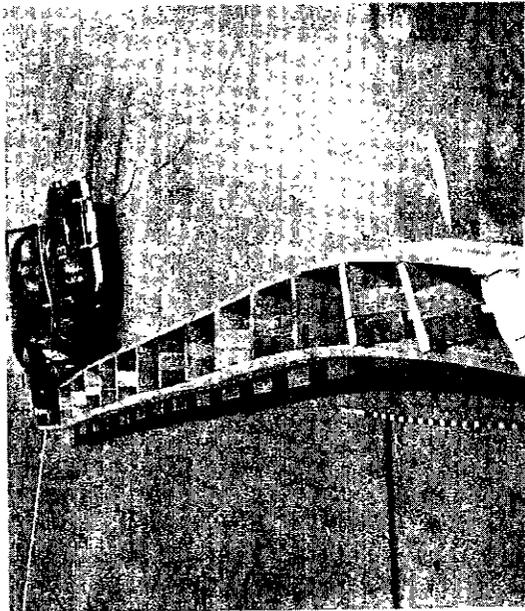
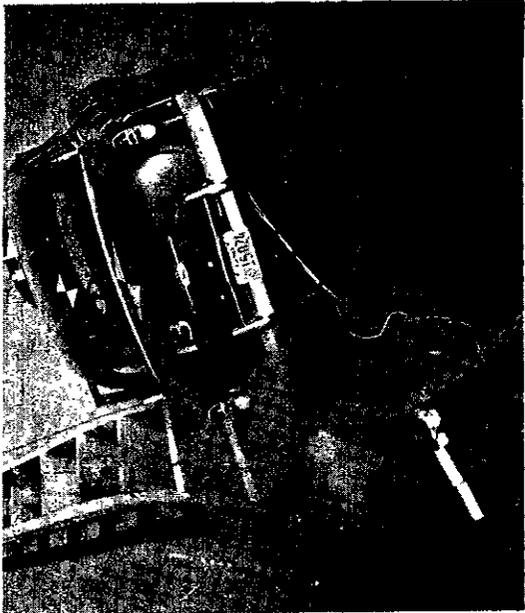
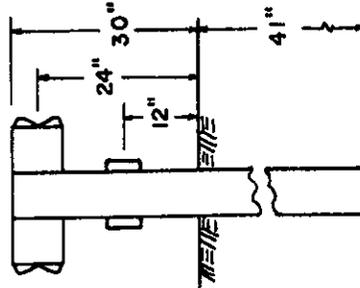
TEST NO. 12
 DATE 11-13-58
 VEHICLE Ford 52 Sedan
 SPEED 56 MPH
 IMPACT ANGLE 27 °
 VEHICLE WEIGHT ... 4002
 (W/DUMMY & INSTRUMENTATION)

GUARDRAIL W Section
 CHANNEL 6" Γ 8.2 #
 BRACKET 8x8x12DF Block
 POST 8x6 D.F.
 POST SPACING 6'-3" O.C.
 LENGTH OF INSTALLATION ... 125'
 GROUND CONDITION Dry

DUMMY INJURY Minor head injury.
 GUARDRAIL DAMAGE 4 Sections damaged beyond repair.
 CHANNEL DAMAGE 4 Sections damaged beyond repair.
 POST DAMAGE 3 Posts damaged beyond repair.

VEHICLE DAMAGE Total Loss
 MAX. DYNAMIC DEFLECTION OF RAIL ... 37"
 VEHICLE DECELERATION (PEAK) Long. ... Transv.

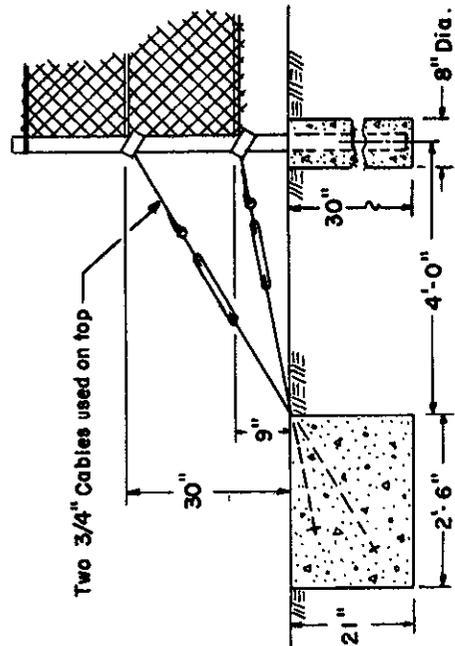
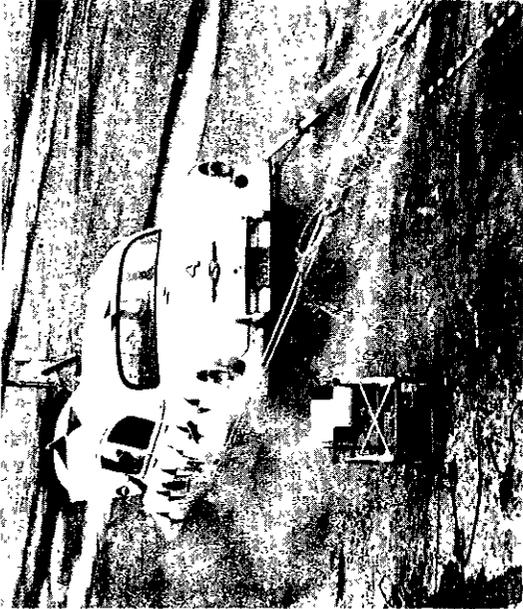
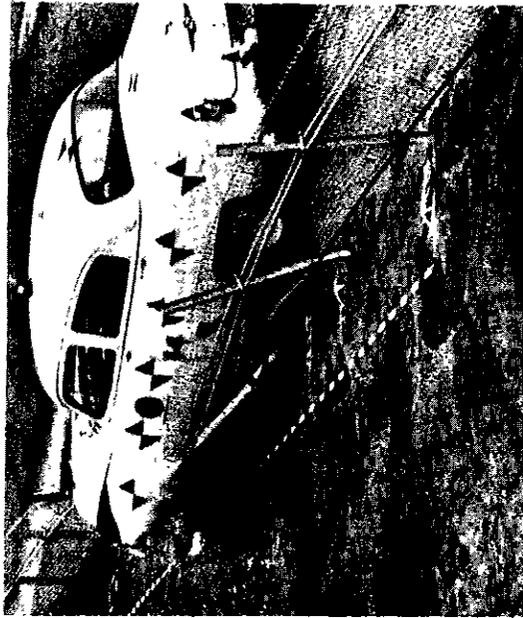
POST IMPACT

GUARDRAIL 36" Chain Link
 Fence w/ 3/4" cables 9" @ 30" above Pymt.
 POST 2 1/4" - 4.1 #
 H Section Fence Post.
 POST SPACING 8' O.C.
 LENGTH OF INSTALLATION ... 192'
 GROUND CONDITION Dry

DUMMY INJURY Minor Bruises
 GUARDRAIL DAMAGE 80' of Fence knocked out. No damage to Cables.
 POST DAMAGE 11 Posts damaged beyond repair.
 VEHICLE DAMAGE \$400.
 MAX. DYNAMIC DEFLECTION OF RAIL ... 8'-6"
 VEHICLE DECELERATION PEAK Long Transv.

TEST NO. 14
 DATE 12-26-58
 VEHICLE Chev. 53 Sedan
 SPEED 61 MPH
 IMPACT ANGLE 31°
 VEHICLE WEIGHT ... 4000
 (W/DUMMY & INSTRUMENTATION)
