Evaluation of Cold Planers For Grinding PCC Pavements

September 1978

B.F. Neal and J.H. Woodstrom

EVALUATION OF COLD PLANERS FOR GRINDING PCC PAVEMENTS

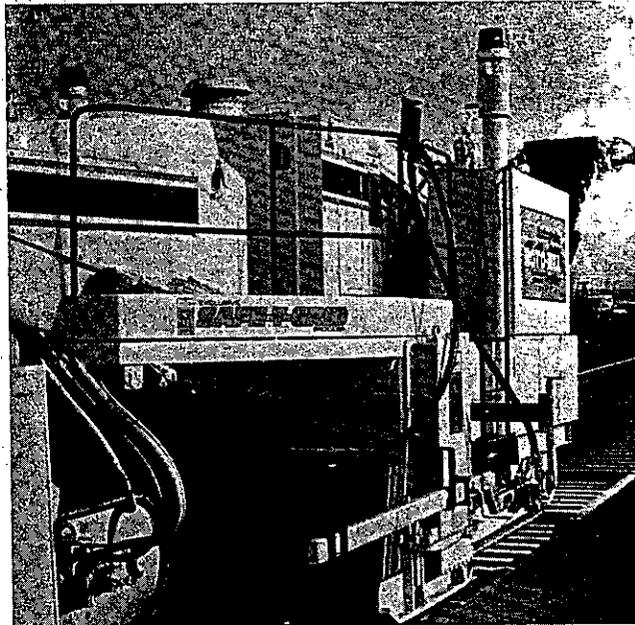
Fig. 1
PR 375 Rotomill

The equipment used by PR Systems was a CMI Rotomill PR-375 (see Figure 1) with a cutting head length of 9 ft 2 in. (2.8 m) which was equipped with new cutting points before the test began. The location was on the outside, or number 3 lane, of westbound I-80 at approximately Post Mile 4.0 in Yolo County. The pavement in this area was faulted only about 0.13 inch (3.3 mm) but was considered to be suitable for a fair trial of the equipment (see Figure 2).

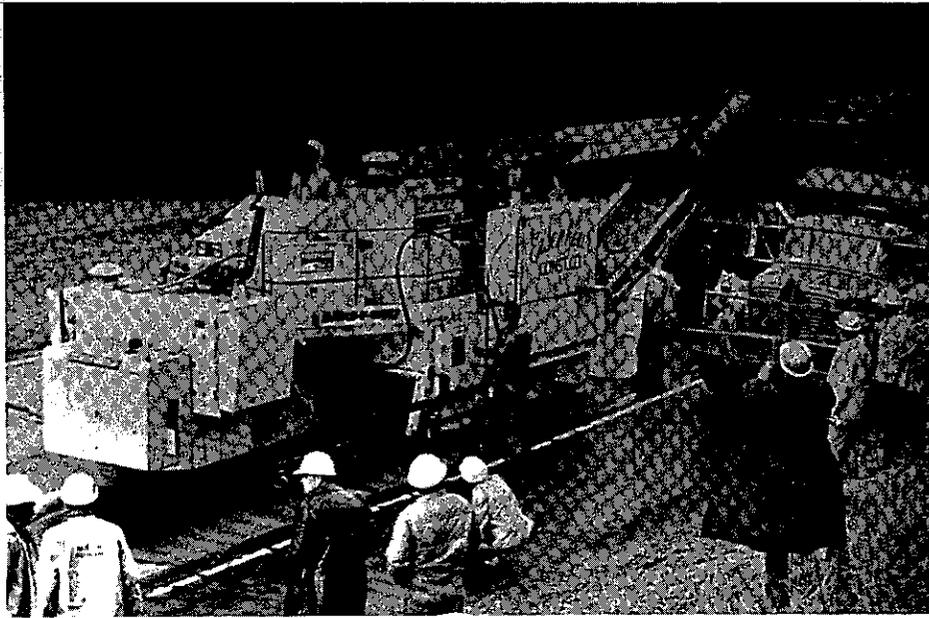
Fig. 9
PR-575 Rotomill

The equipment used on this project by Eisenhower was a CMI Rotomill PR-575 (see Figure 9). The cutting head was the same length as the other machine and was also equipped with new cutting points. Two locations were selected on northbound SR-101, one near Post Mile 62, the other near Post Mile 73, both in Santa Barbara County. Transverse joints on both sections were badly faulted (see Figure 10), averaging about 0.25 in. (6 mm) with some joints faulted about 0.4 in. (10 mm).

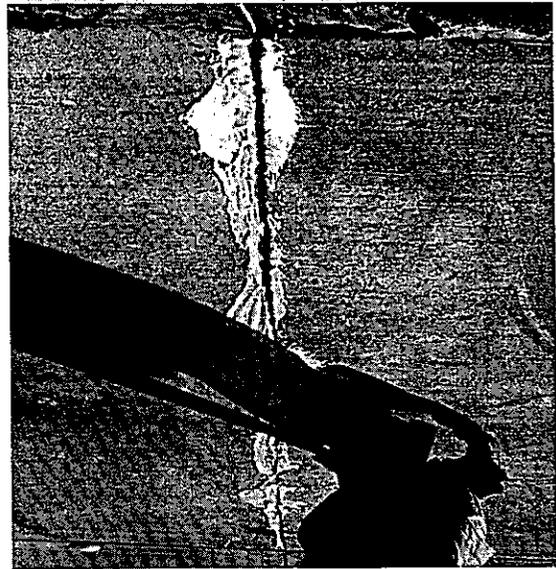
Results of the milling were approximately the same as the previous tests. While the filled joints show less damage than those unfilled, it is still considered that damage is too severe. Figures 14 through 21 show prepared joints and one random crack before and after milling. Figure 22 shows a diamond grinding operation, with no damage being incurred at the joint edges.

Fig. 15
Joint Filled With Casting Plaster

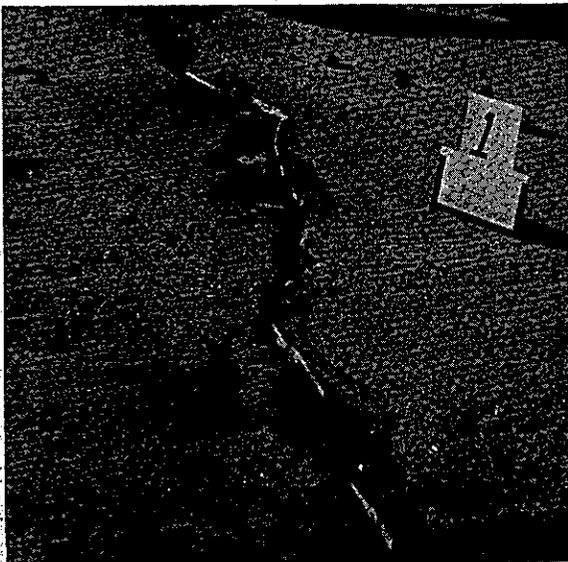
Fig. 16
Routed Random Crack
