CA-TL-78-30

Tests of Flexible Plastic Guide Marker and Clearance Marker Posts

September 1978

Office of Transportation Laboratory
California Department of Transportation
Sacramento, California 95819

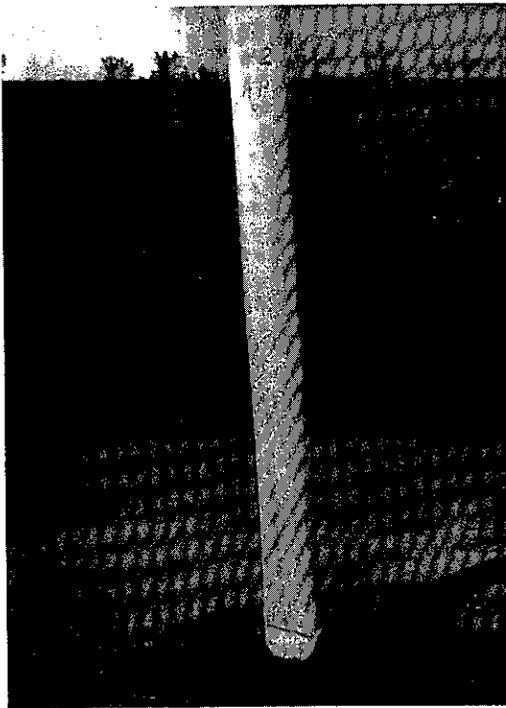
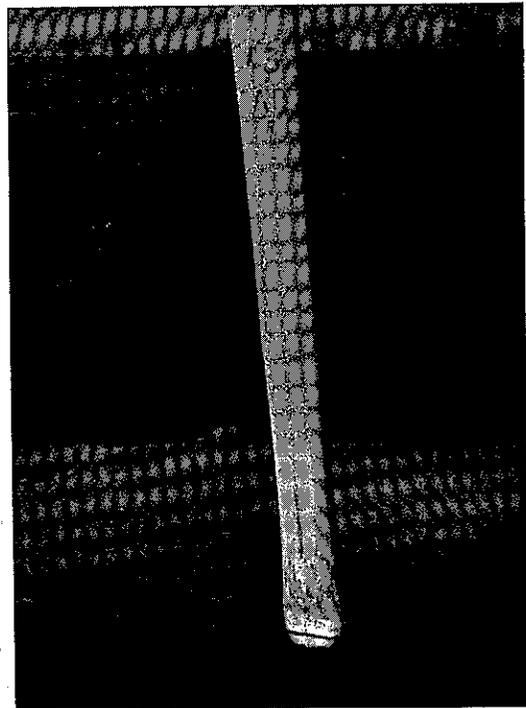
After 10 Impacts

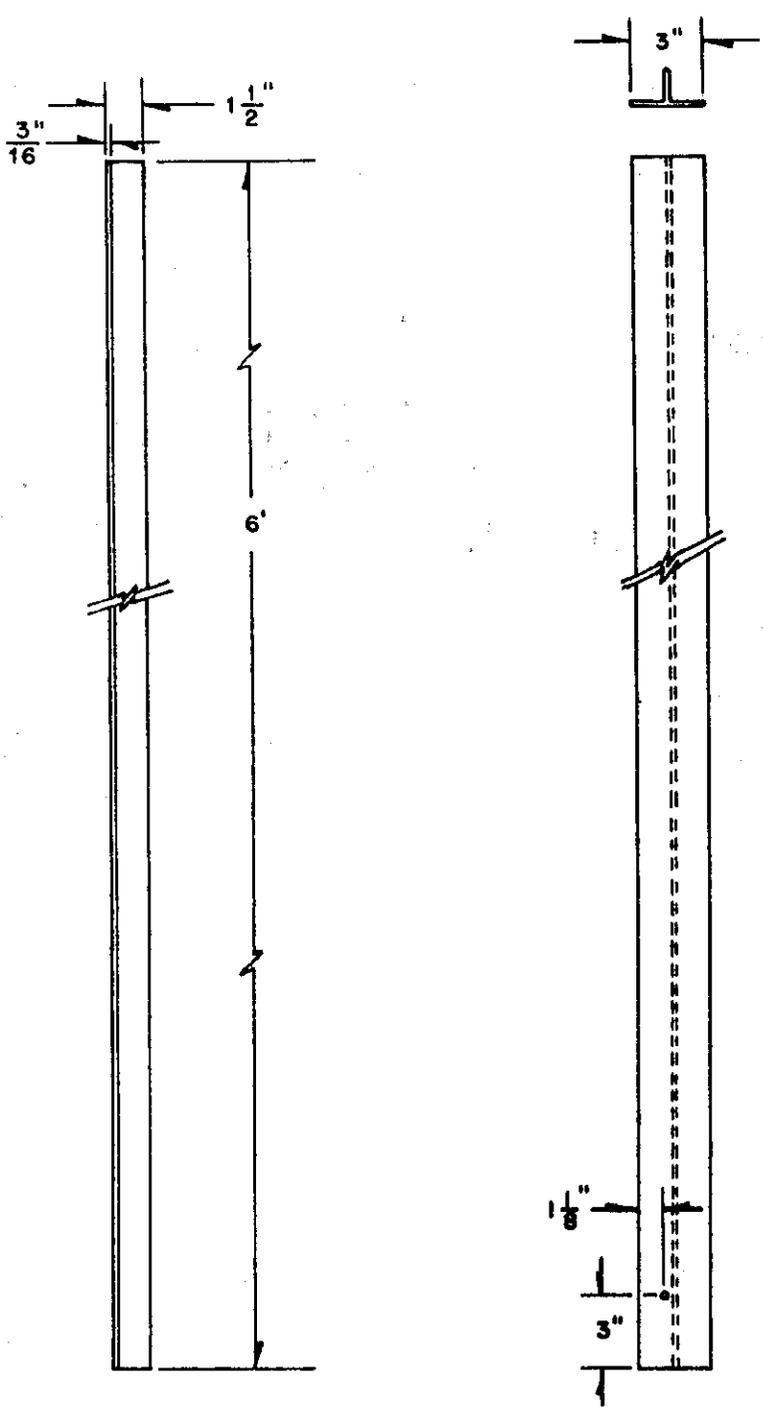
**LANCO LDP-8 "TEE"
FLEXIBLE PLASTIC GUIDE MARKER &
CLEARANCE MARKER POST**

There was little or no damage to the vehicle from any of the 55 mph impact tests. The guide marker post tended to return to an approximate vertical position after each impact with a pullout of 0 to 1/2" from the ground. After the first vehicular impact the marker canted 5 to 20° from the vertical. After 10 impacts the post approached a canted position of 30° from the vertical. During the vehicular impacts the post developed an S-shaped curve as can be seen in one of the photos. It is considered that this shape and appearance would not be acceptable even though the marker returned to a semi-upright position. Due to this deformed shape, this marker is not considered acceptable.

It is recommended that no further testing be performed with the LDP-8 Lanco T-post design as a flexible guide marker post. Its performance does not compare with the other flexible guide marker posts being evaluated.

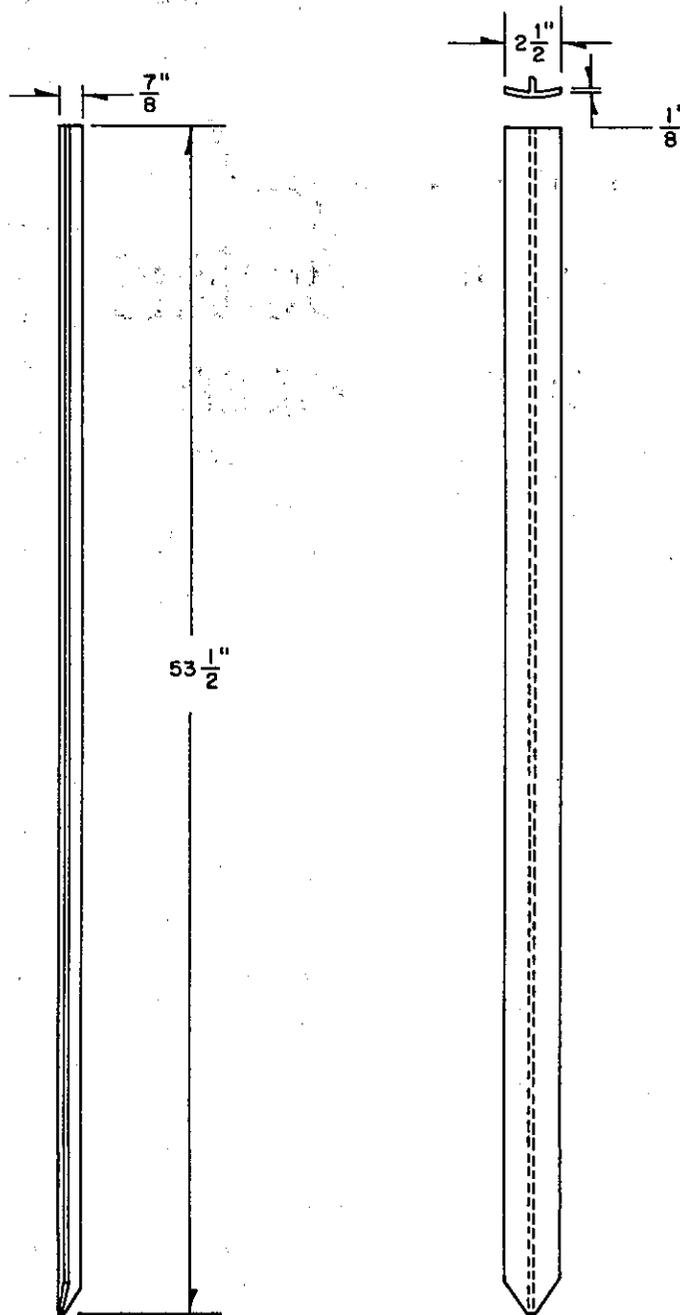
were two designs. The first consisted of a T section with a face width of 2 1/2" and a web width of approximately 3/4". Figure 13 shows the details of this post and Figure 14 shows photos. This model was developed from an earlier model that had a face width of approximately 1". The 1" wide model was never evaluated nor considered a likely candidate for a flexible guide marker.

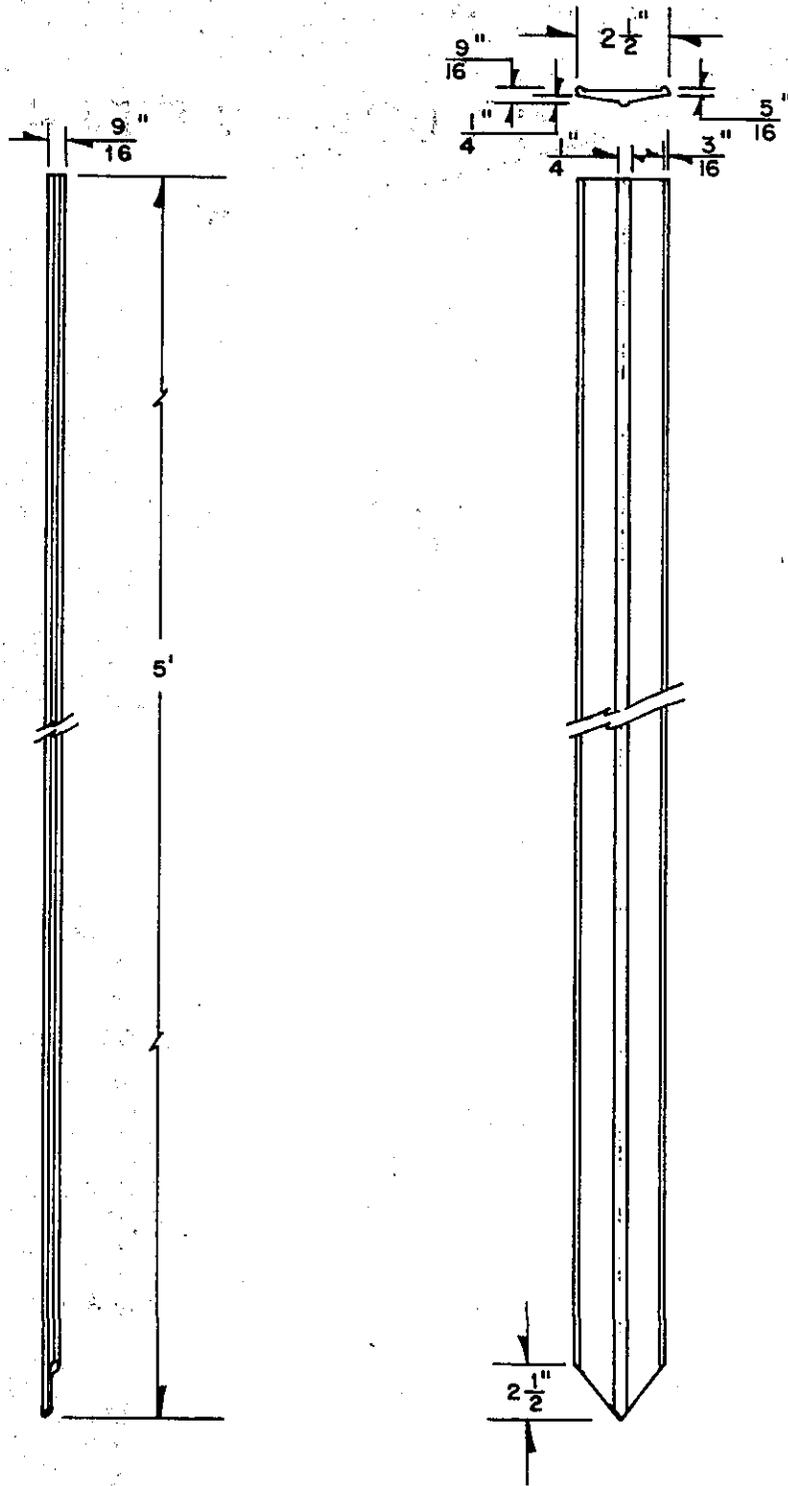
**CARSONITE $2\frac{1}{2}$ " WIDE "RIBBED"
FLEXIBLE PLASTIC GUIDE MARKER &
CLEARANCE MARKER POST**

The 2 1/2-inch wide ribbed post failed at an initial impact speed of 55 mph. However, subsequent tests with an initial impact speed of 35 mph followed by additional impacts at 55 mph resulted in a satisfactory performance. The damage to the tops of the posts became significant when the number of vehicular impacts on a given post was between 5 and 10.

The lower speed impact reported above resulted in the formation of a plastic hinge at the base of the post which increased the flexibility of the post. Thus with the introduction of the plastic hinge the post was able to withstand further higher speed impacts without failure. This phenomenon is manifested by both of the Carsonite ribbed post designs.

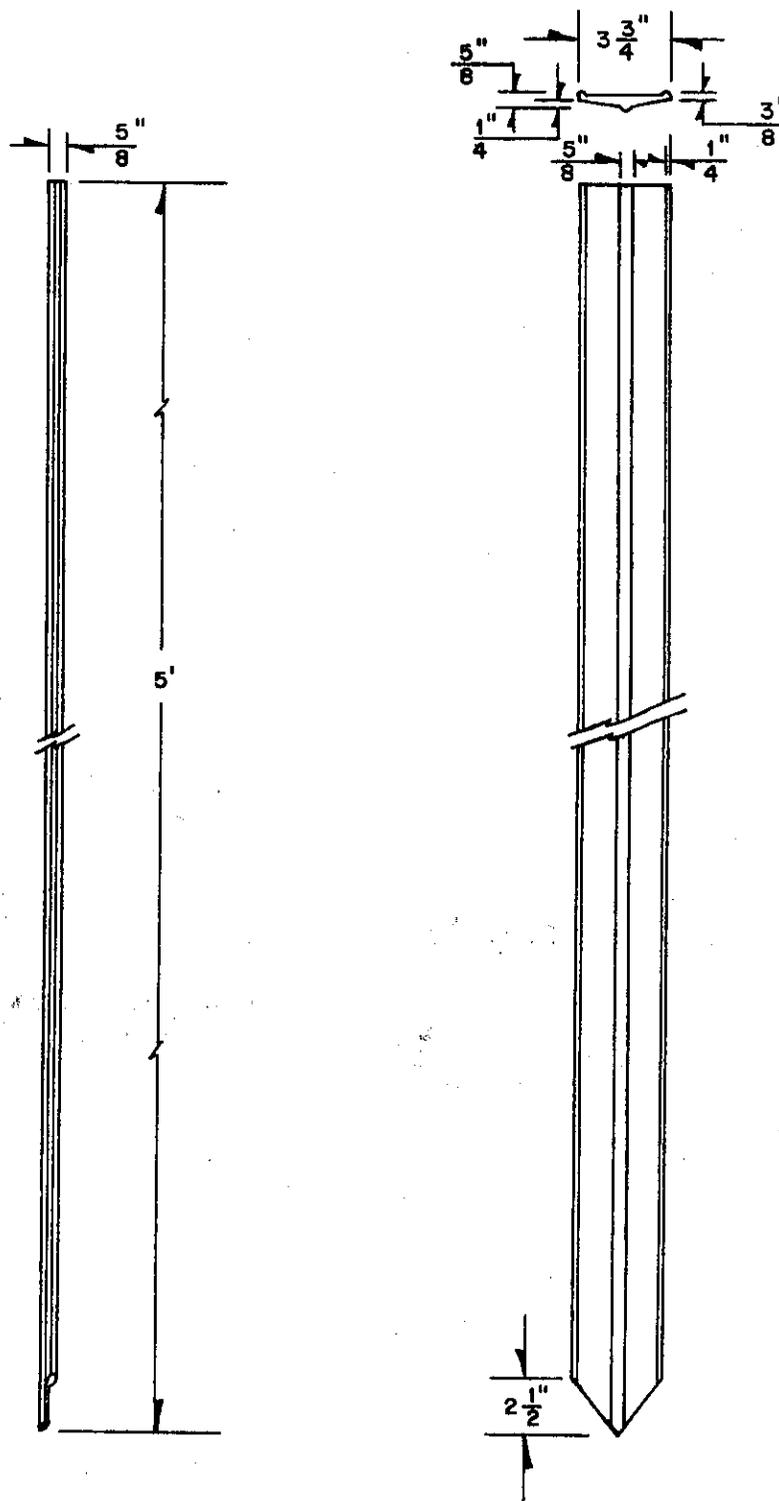
**CARSONITE $3\frac{3}{4}$ " WIDE "RIBBED"
FLEXIBLE PLASTIC GUIDE MARKER &
CLEARANCE MARKER POST**

The 3 3/4-inch wide ribbed post is capable of being hit repeatedly - in excess of 10 times - at 35 mph with very little damage to the post. This may be considered a more typical impact condition in actual operation.

A third design tested in a second series on April 29, 1977 by the Laboratory consisted of a flat 3 3/4" wide ribbed post. This shape is the final design evaluated in this study. It is detailed in Figure 18 and pictured in photos in Figure 19.

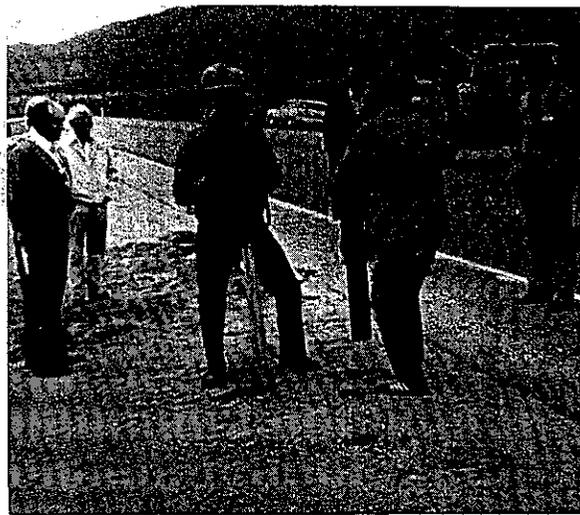
Figure 19C
Installing the Posts

The manufacturer also demonstrated comparable ease in driving the post as shown in the photo in Figure 19C. This demonstration consisted of driving both a steel post and the Carsonite post. The Carsonite post was as easily driven as the steel post at this particular location.
