1. REPORT NUMBER CA08-0766	2. GOVERNMENT ASSOCIATION NUMBER	3. RECIPIENT'S CATALOG NUMBER
4. TITLE AND SUBTITLE Development and Crash Testing of an Aesthetic, See-Through Bridge Rail, Type 92 "		5. REPORT DATE December 2008
		6. PERFORMING ORGANIZATION CODE
7. AUTHOR David Whitesel, John Jewell, Robert Meline		8. PERFORMING ORGANIZATION REPORT NO. FHWA/CA08-0766
9. PERFORMING ORGANIZATION NAME AND ADDRESS Roadside Safety Research Group California Department of Transportation 5900 Folsom Blvd., Sacramento, CA. 95819		10. WORK UNIT NUMBER
		11. CONTRACT OR GRANT NUMBER In-house H Y C ICA08-0766
12. SPONSORING AGENCY AND ADDRESS California Department of Transportation 5900 Folsom Blvd., Sacramento CA. 95819		13. TYPE OF REPORT AND PERIOD COVERED Final Tgr qt v< 29 B 4226 "q" 28 52 422: "
		14. SPONSORING AGENCY CODE

**DEVELOPMENT AND CRASH TESTING OF AN AESTHETIC,
SEE-THROUGH BRIDGE RAIL, TYPE 90**

DEPARTMENT OF TRANSPORTATION
DIVISION OF RESEARCH AND INNOVATION
OFFICE OF SAFETY INNOVATION AND COOPERATIVE RESEARCH

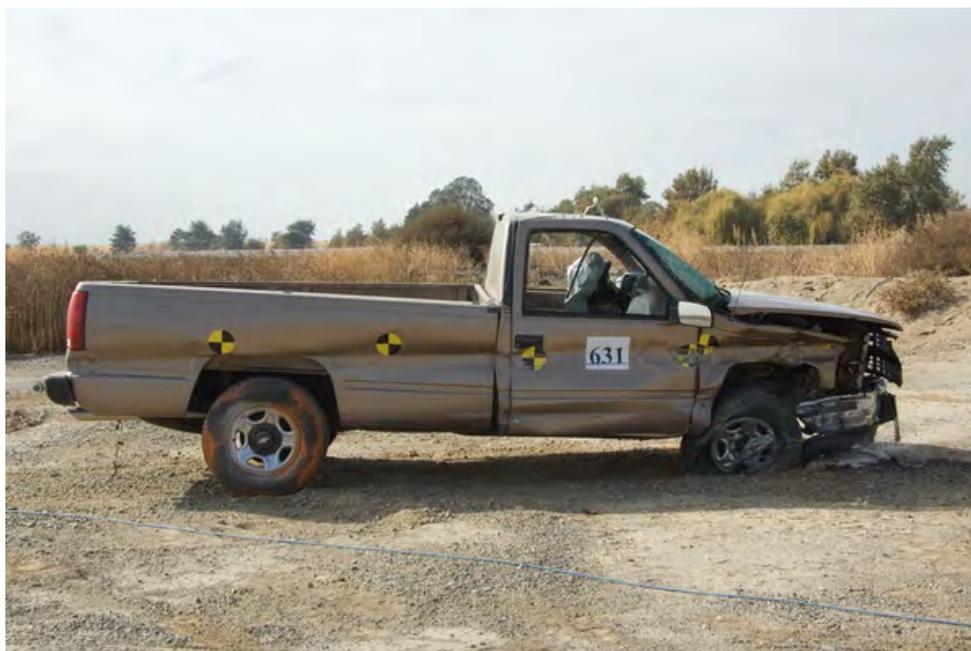
Figure 2-7 – Test vehicle after Test 631

The right front corner of the vehicle was moderately damaged in the initial impact with the barrier. The right front fender, hood, bumper, headlamp area, grille, and suspension components were all affected. The passenger side doorframe was deformed outward but the door remained latched. The right front tire was also ruptured. The steel rail caused denting along the entire length of the passenger side as the vehicle continued to contact the barrier after the initial impact. The right front tire was pushed rearward and slightly into the passenger side foot well area. The maximum amount of passenger compartment deformation was 124 mm¹, which occurred in the floorboard². The entire windshield spider-cracked but did not separate or enter the occupant compartment. However, this cracking was not caused entirely by the test. The windshield was inadvertently damaged (see Figure 2-10) on the impact side shortly before the test was run and it was decided that the damage was not significant enough to warrant postponing the test. Post-crash photos show the initial crack to be the weak point and the source of future cracking.

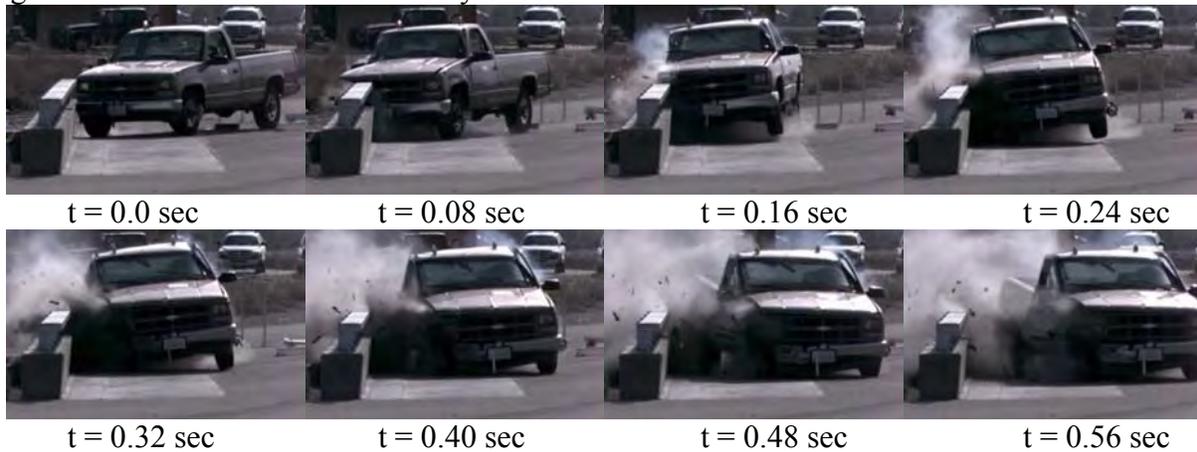
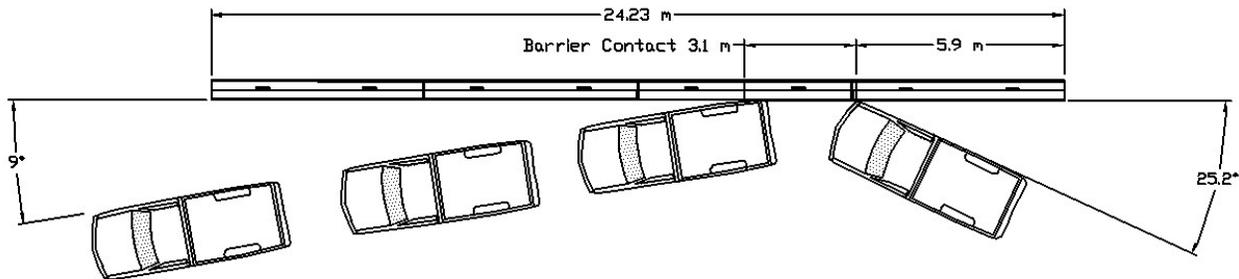
Figure 2-14 – Test 631 Data Summary Sheet

Barrier Damage: Maximum dynamic deflection in steel rail of 38 mm, superficial concrete spalling, and no permanent lateral deflection.

There was only minimal permanent damage to the barrier during Test 631. The steel rail scraped a small amount of paint off the vehicle along the length of contact. The vehicle caused some minor concrete spalling at the downstream vertical face of the expansion joint near the impact point and along the top of the curb for approximately 1.5 m. No rebar was exposed so there was no structural damage to warrant immediate repair. For aesthetic reasons and because the concrete cover over the rebar has been compromised, the damage should be repaired by maintenance crews.

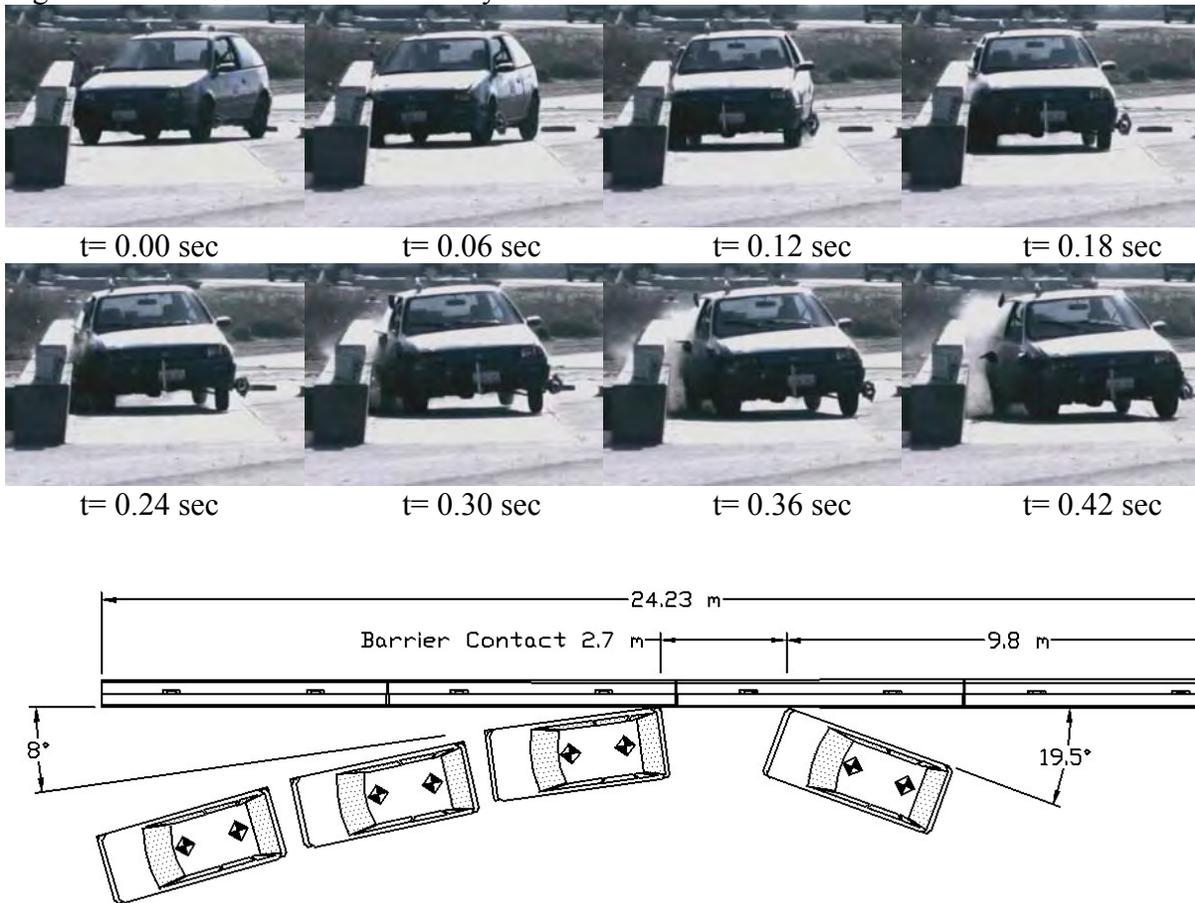
Figure 2-22 – Test 632 Data Summary Sheet

Barrier Damage: No dynamic deflection in steel rail, minor superficial concrete spalling.

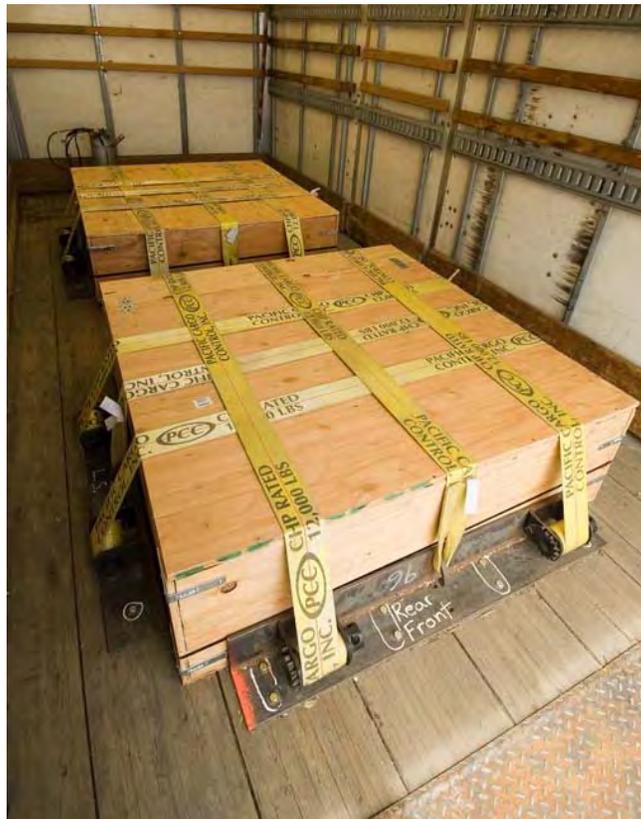
Figure 2-38 – Ballast strapped down in cargo bed of test vehicle after Test 634

The 2041 kg of ballast was comprised of two separate plywood boxes and the associated mounting hardware all bolted and strapped down to the cargo floor. The boxes were constrained by 150-mm angle iron. The sandbags were held down by 100-mm nylon straps as shown in Figure 2-38. The sandbags shifted slightly, but did not brake lose during the test.

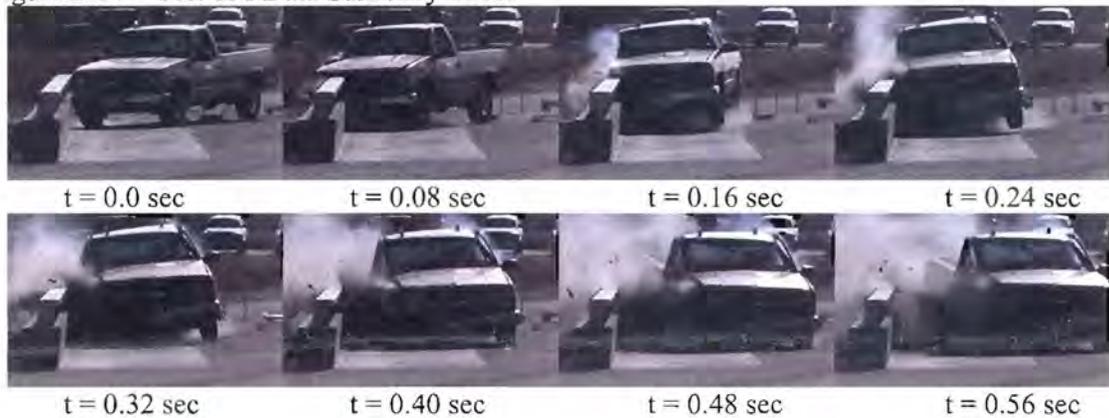
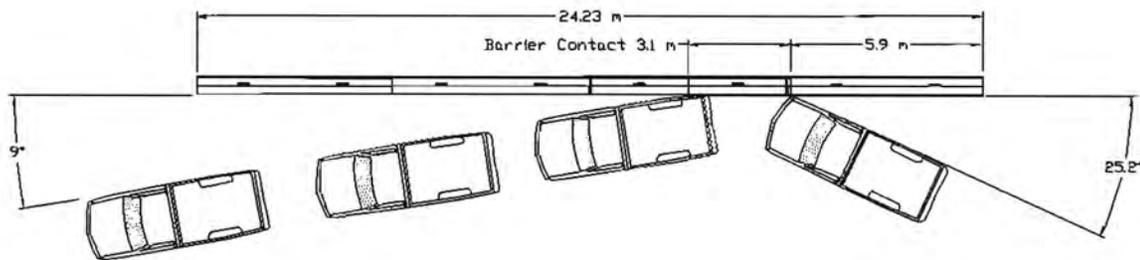
Figure 2-14 – Test 631 Data Summary Sheet

Barrier Damage: Maximum dynamic deflection in steel rail of 38 mm, superficial concrete spalling, and no permanent lateral deflection.
