VISUAL IMPACT ASSESSMENT

**Yerba Buena Island
Ramps Improvement Project**

**District 04-SF-80
KP 12.3/13.2
EA 04-3A640**

**Caltrans District 4
Landscape Architecture**

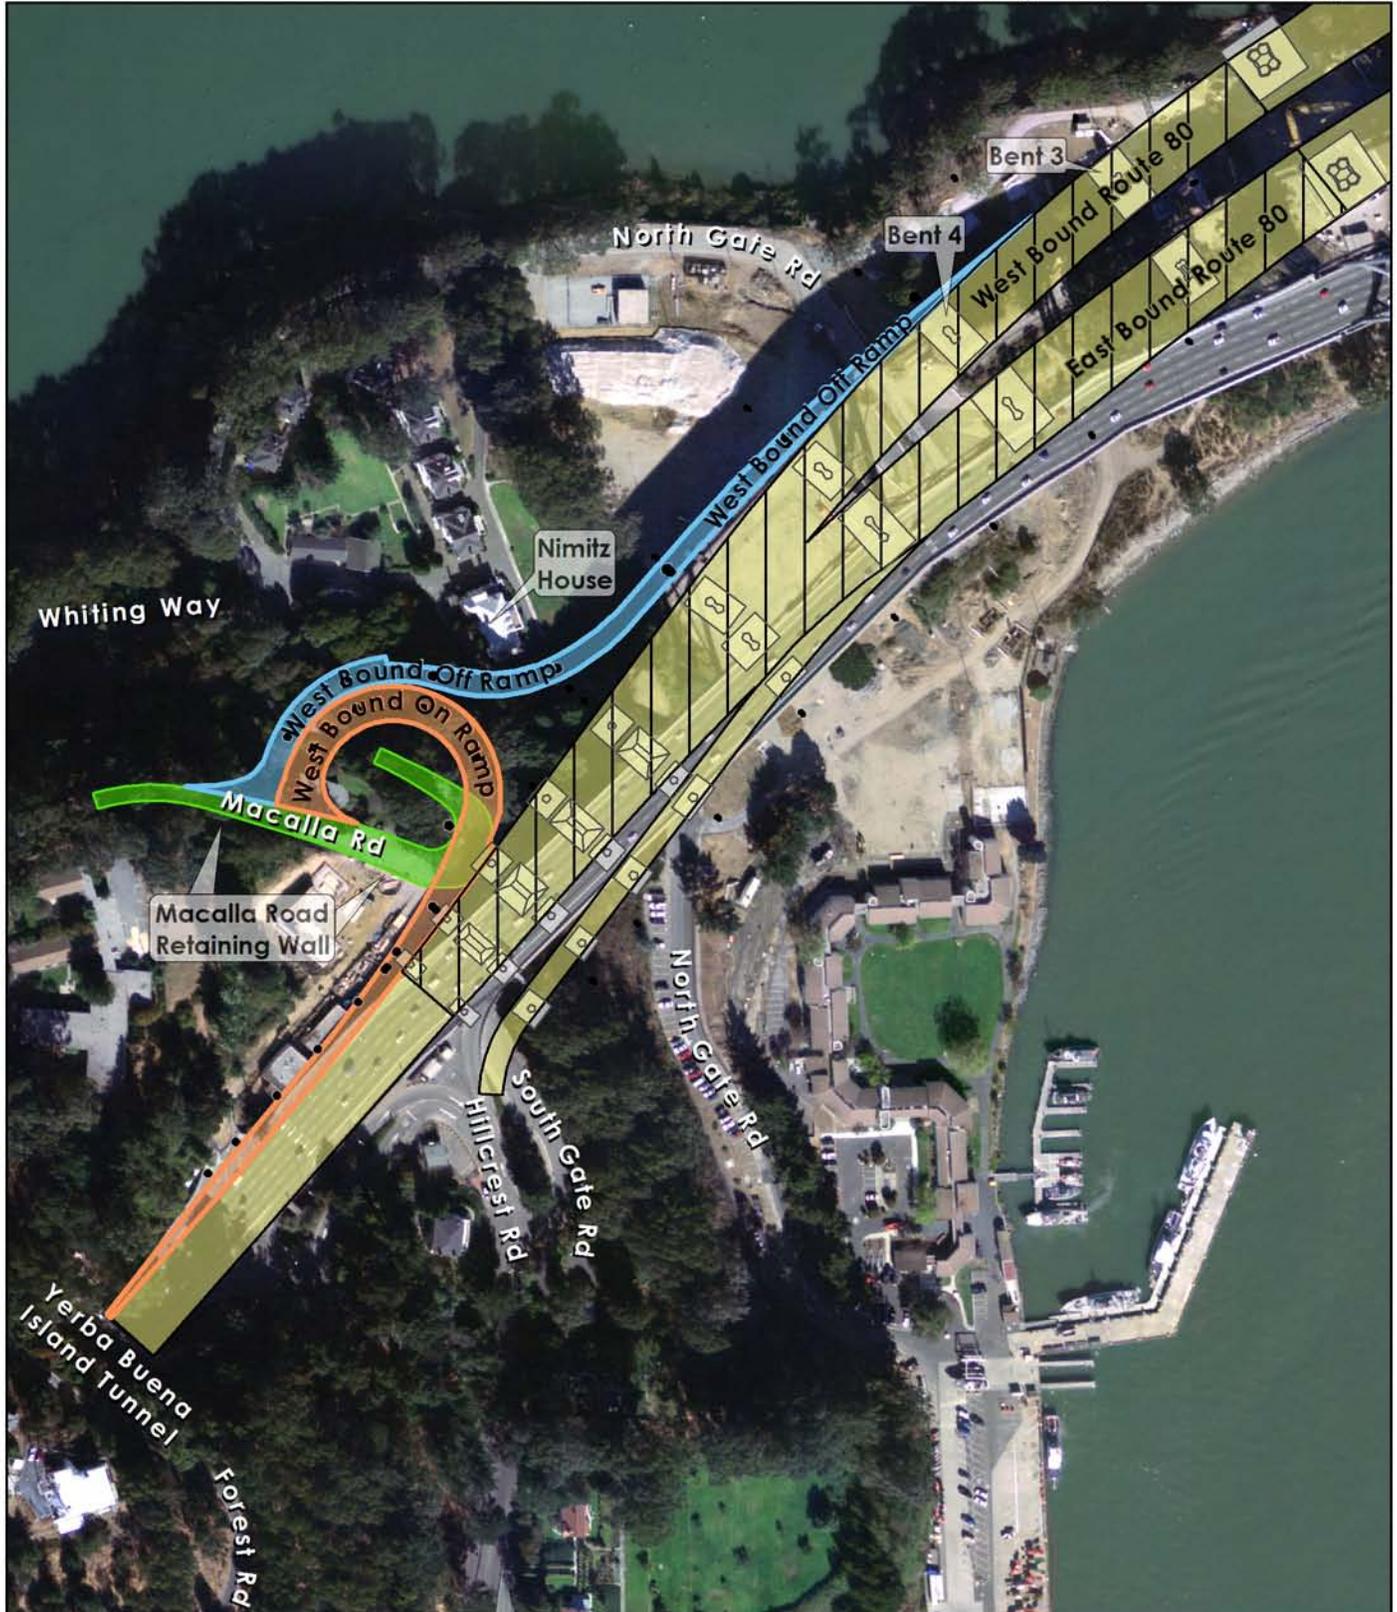
**Figure 2:
Alternative 2b**

Alternative 2b Proposed Ramps

- Proposed West Bound Off-Ramp
- Proposed West Bound On-Ramp
- Proposed Macalla Road Improvements

The Alternative 2B design, shown in **Figure 2**, would include removal of the existing westbound on- and off-ramps on the east side of YBI, construction of a westbound loop on-ramp from Macalla Road on the east side of YBI, and construction of a westbound off-ramp to Macalla Road on the east side of YBI.

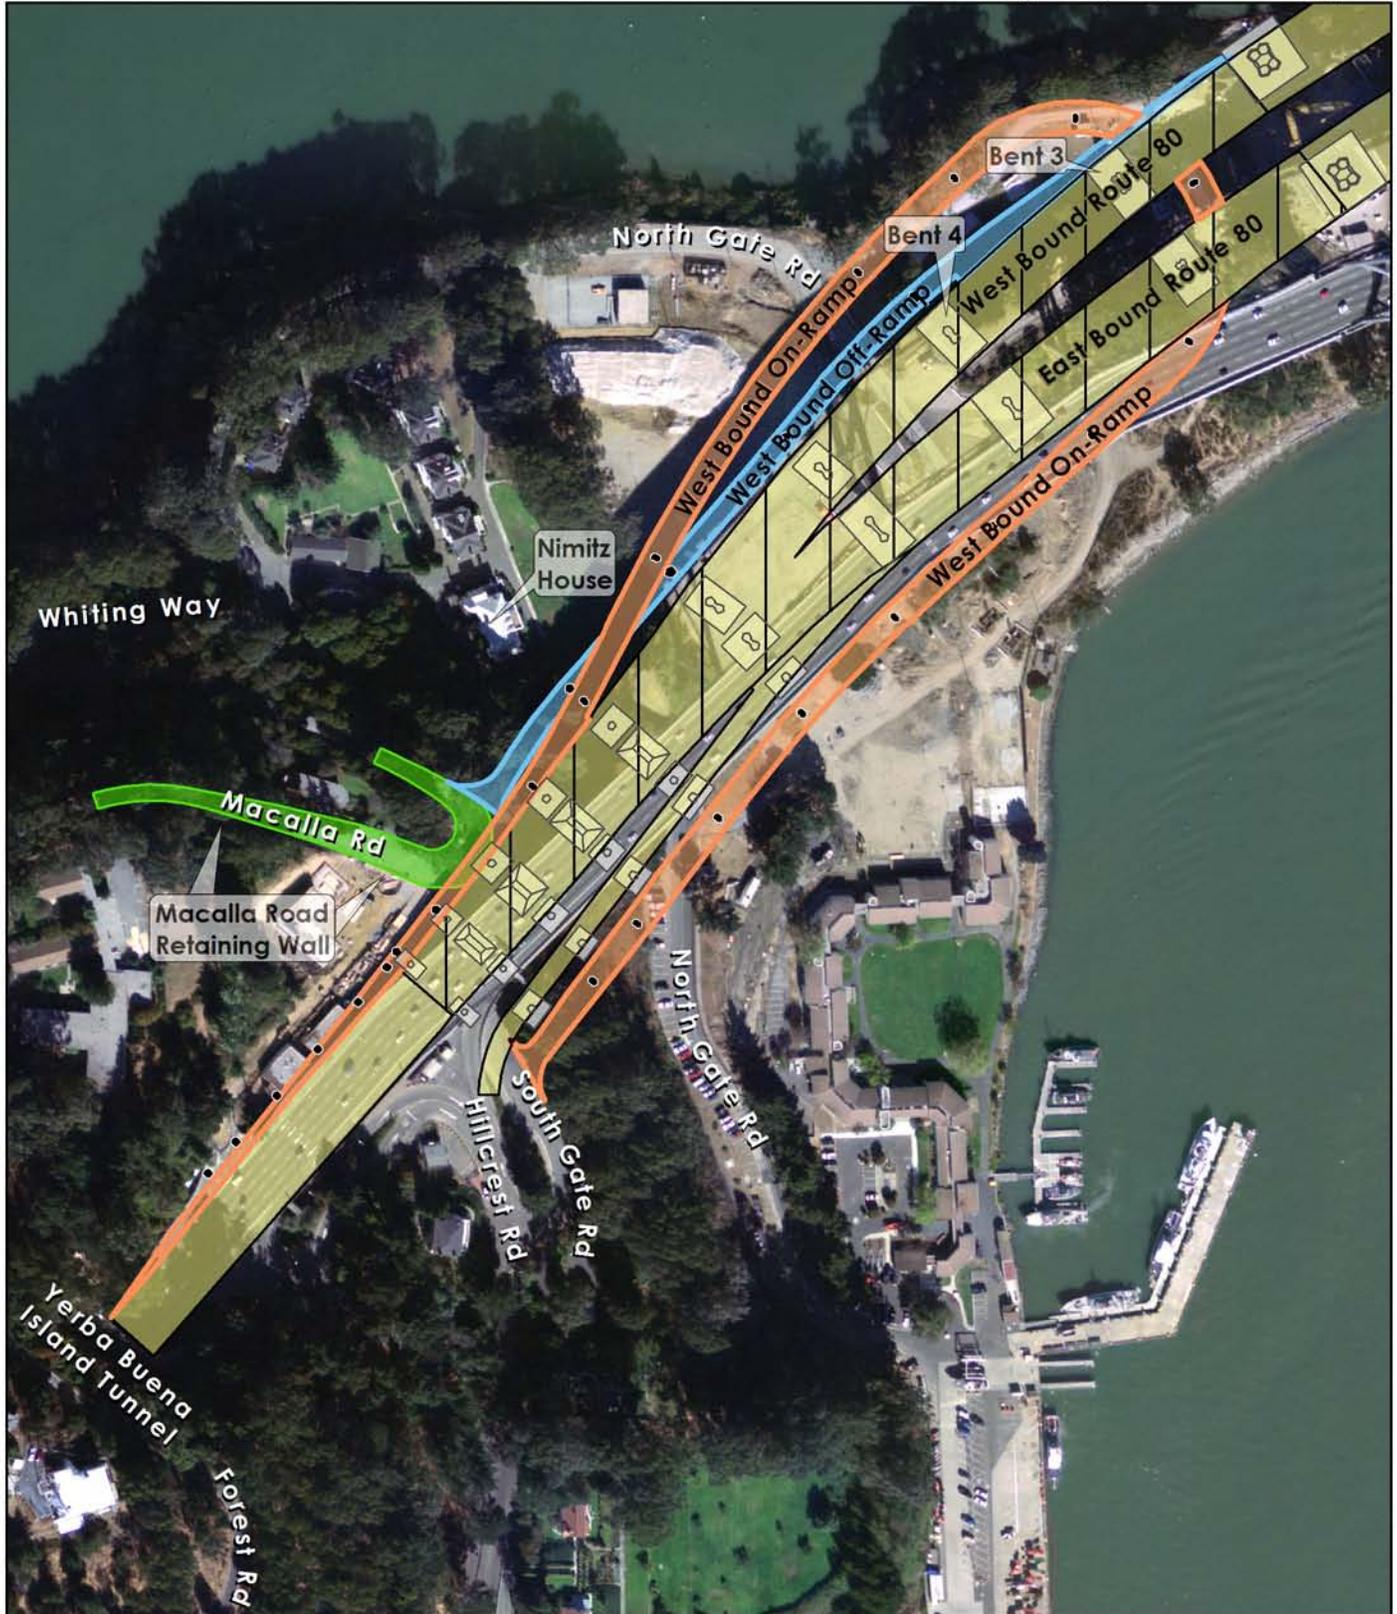
**Figure 3:
Alternative 4**

Alternative 4 Proposed Ramps

- Proposed West Bound Off-Ramp
- Proposed West Bound On-Ramp
- Proposed Macalla Road Improvements

The Alternative 4 design, shown in **Figure 3**, would include the removal of the existing westbound on- and off-ramps on the east side of YBI, construction of westbound on-ramp from South Gate Road, and construction of westbound off-ramp to Macalla Road on the east side of YBI.

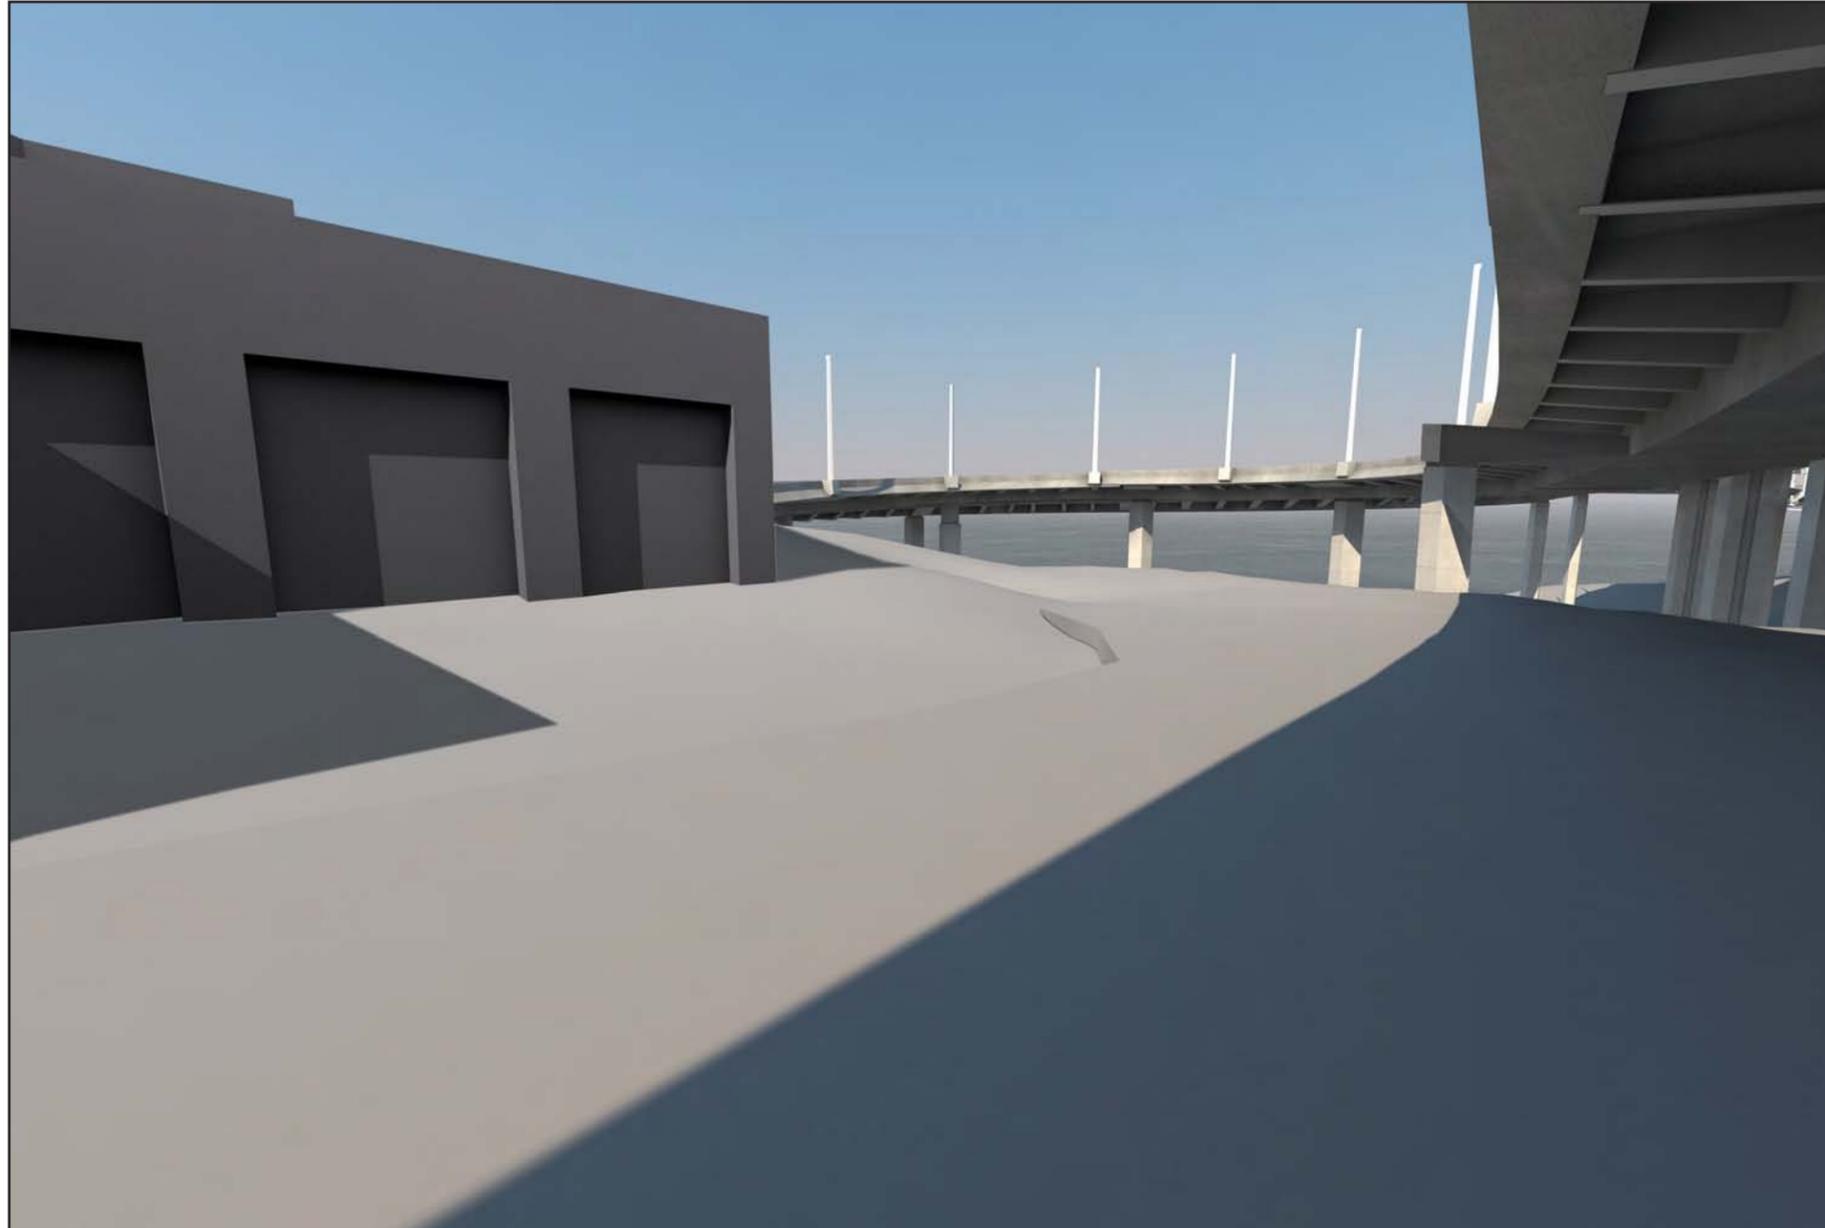
Figure 6: Alternative 2B
Key Viewpoint 1: Macalla Road at North Gate Road Intersection

Rendered View

This key viewpoint is toward the northeast from the intersection of Macalla Road and North Gate Drive. **Figure 6** depicts a rendering of Alternative 2B. In order to provide site context, the figure also presents photos of Quarters 10 and Building 267.

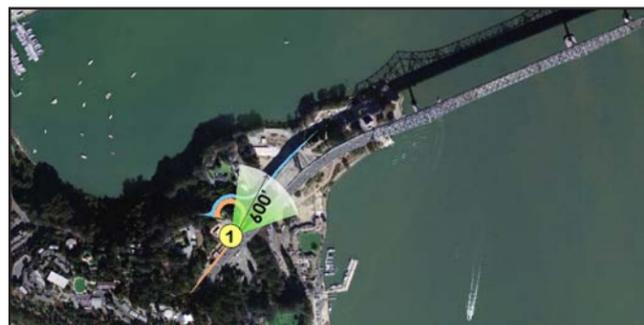
Geographic Context
Indicates distance from viewpoint to
Alternative 2B ramp components

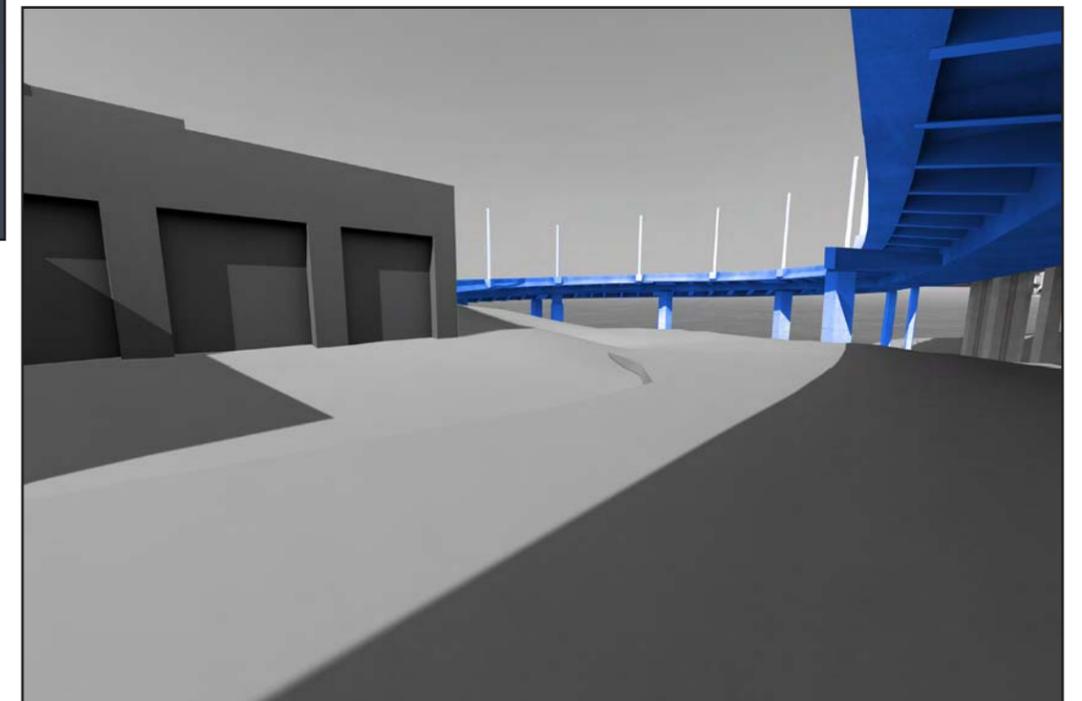
Alternative 2B Ramp Components: Blue highlighting distinguishes Alternative 2B ramp components from SFOBB East Span project components

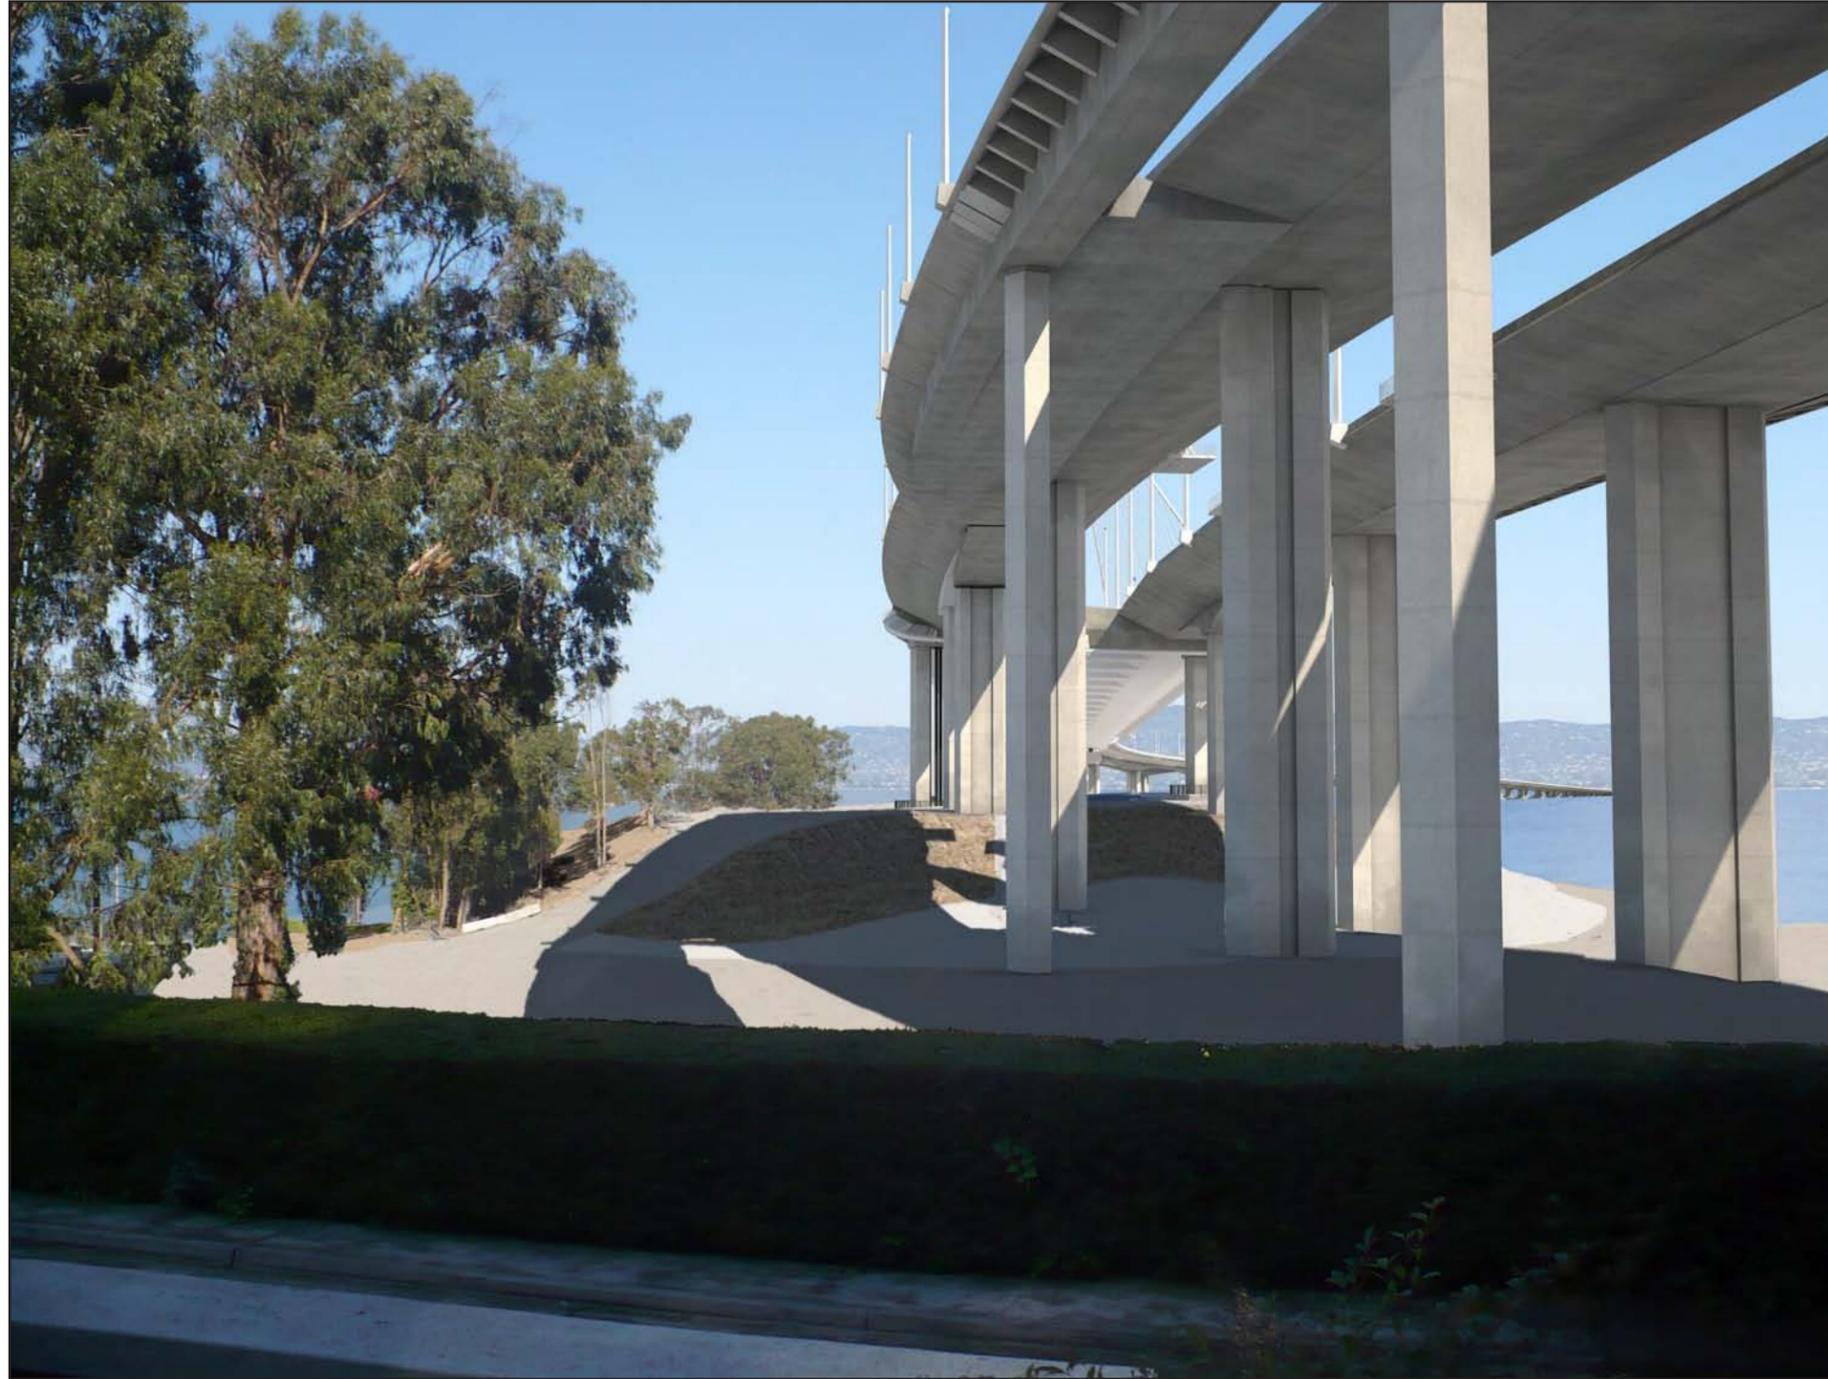
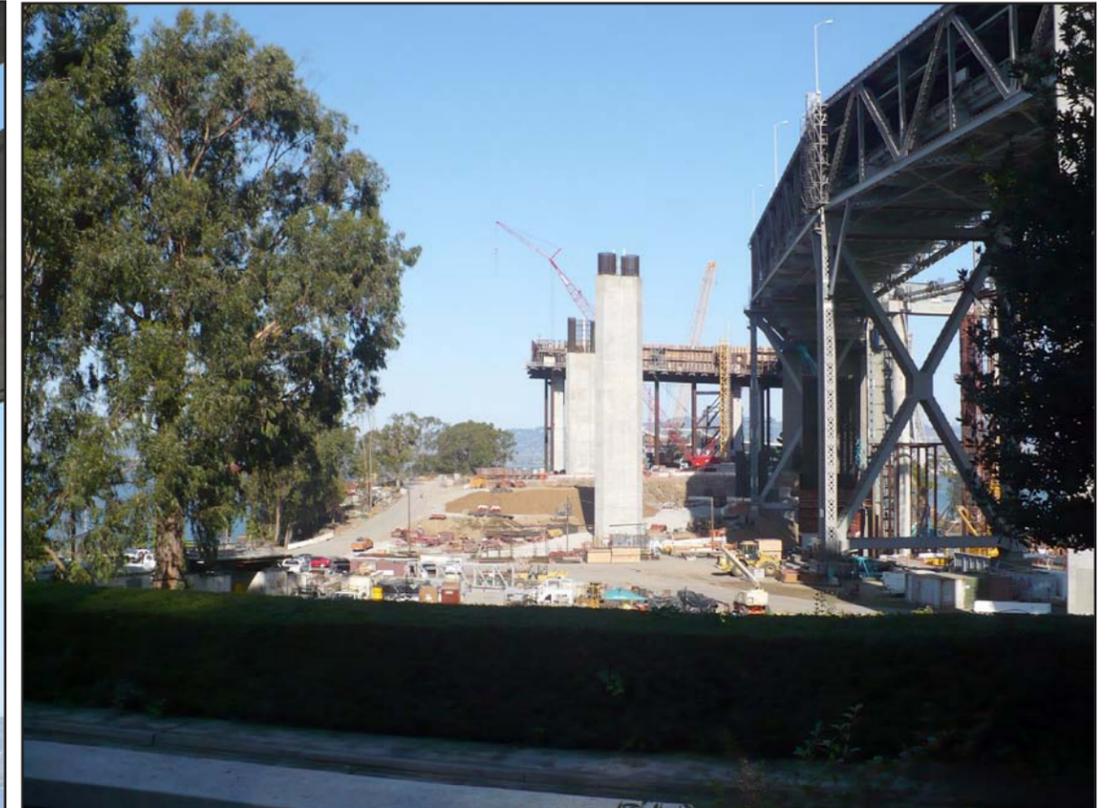
Figure 7: Alternative 2B
Key Viewpoint 2: Nimitz House

Simulated View

Existing View

This key viewpoint looks northeast from the patio of the Nimitz House, one of the historic US Navy structures located on the island. **Figure 7** depicts a photo-simulation of Alternative 2B from this viewpoint.

Visual Dominance: The structural elements added under Alternative 2B would contribute to the overall dominance of the new SFOBB Transition Structure. The project's on-ramp and off-ramp structures would visually dominate other objects in the setting.

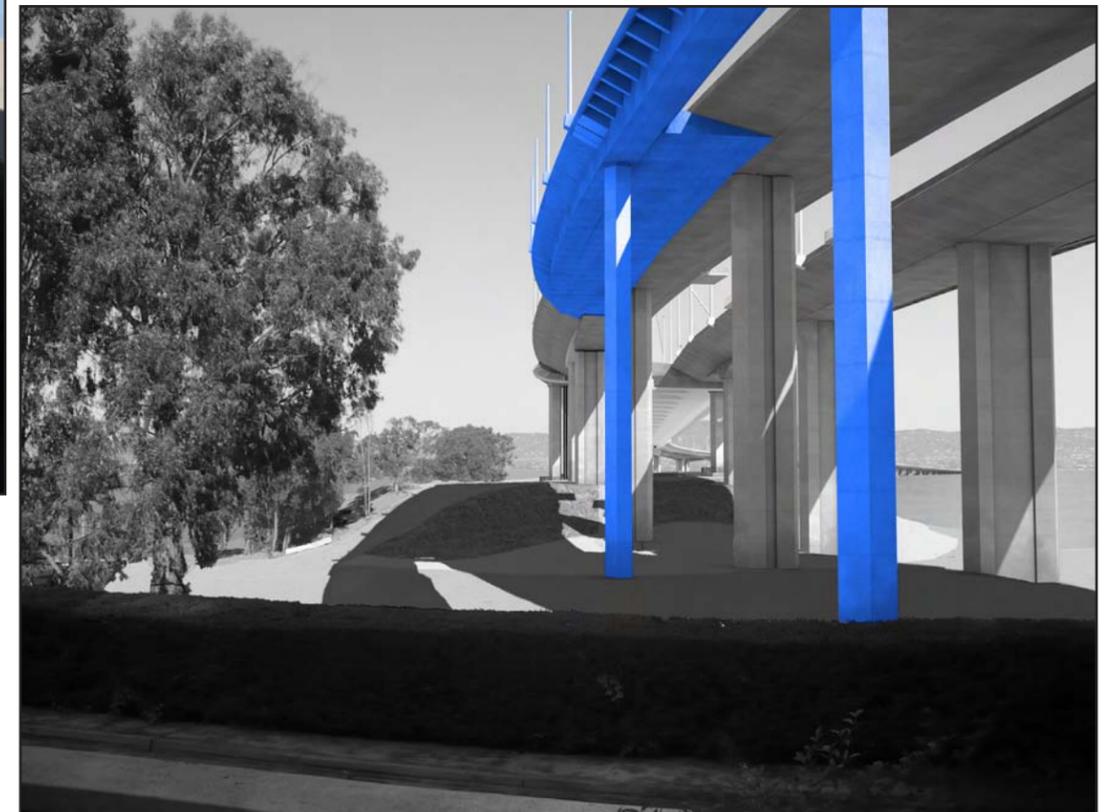
Alternative 2B Ramp Components: Blue highlighting distinguishes Alternative 2B ramp components from SFOBB East Span project components

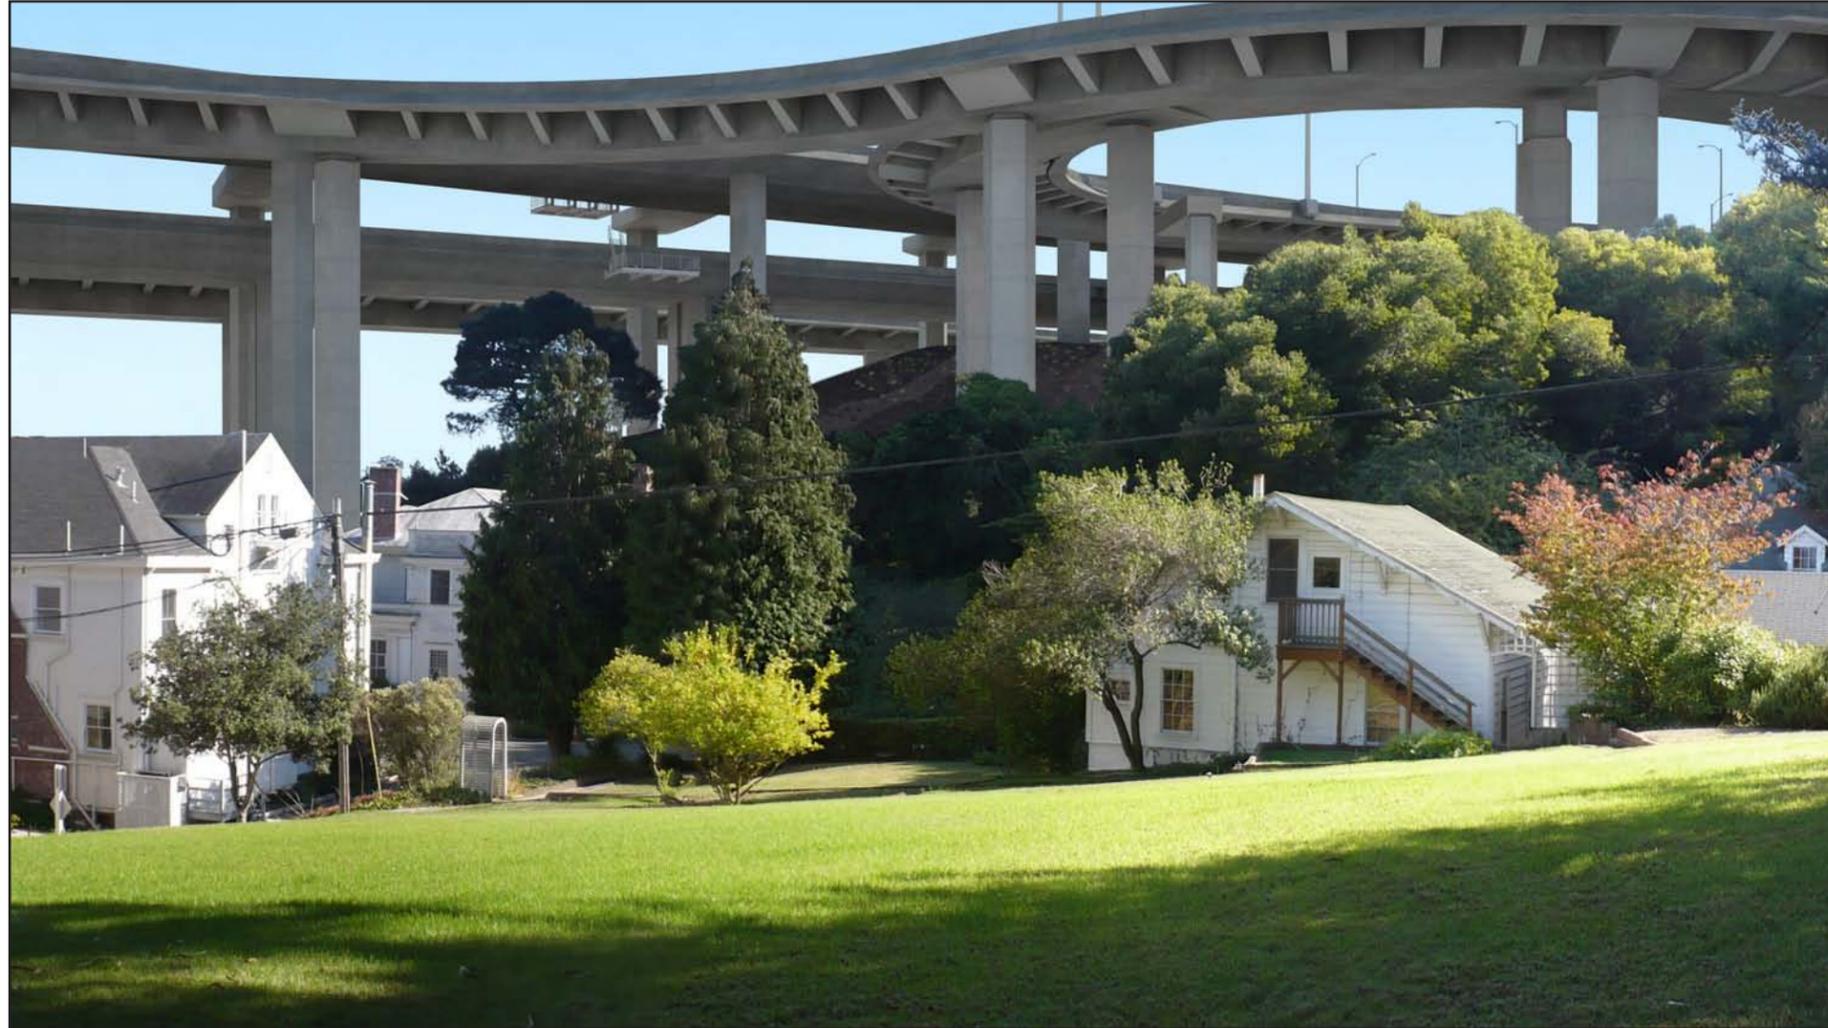
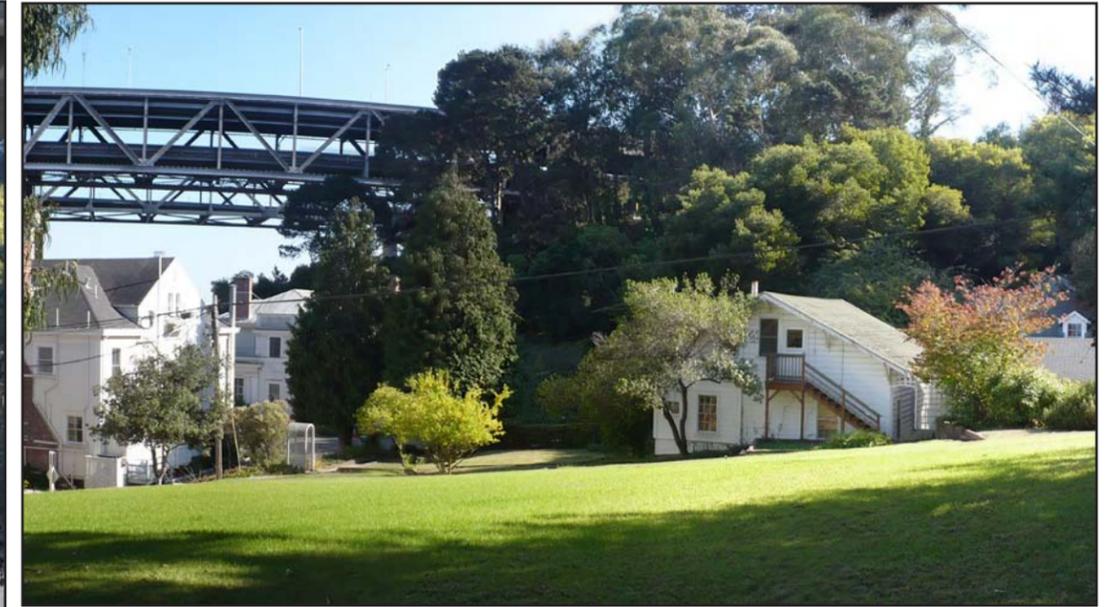
Figure 8: Alternative 2B
Key Viewpoint 3: Officers' Quarters Open Space

Simulated View

Existing View

This key viewpoint looks southeast from a large open space area between Quarters 4 and Quarters 7 toward other historic US Navy structures that include the Nimitz House (Quarters 1), Quarters 2, Building 83 and Building 205. **Figure 8** depicts a photo-simulation of Alternative 2B from this viewpoint.

View Obstruction: New columns and other structural elements of the on-ramp and off-ramp built as part of this alternative would obstruct views of the SFOBB East Span structure, but would not obstruct views of the US Navy structures, which would remain visible in the foreground.

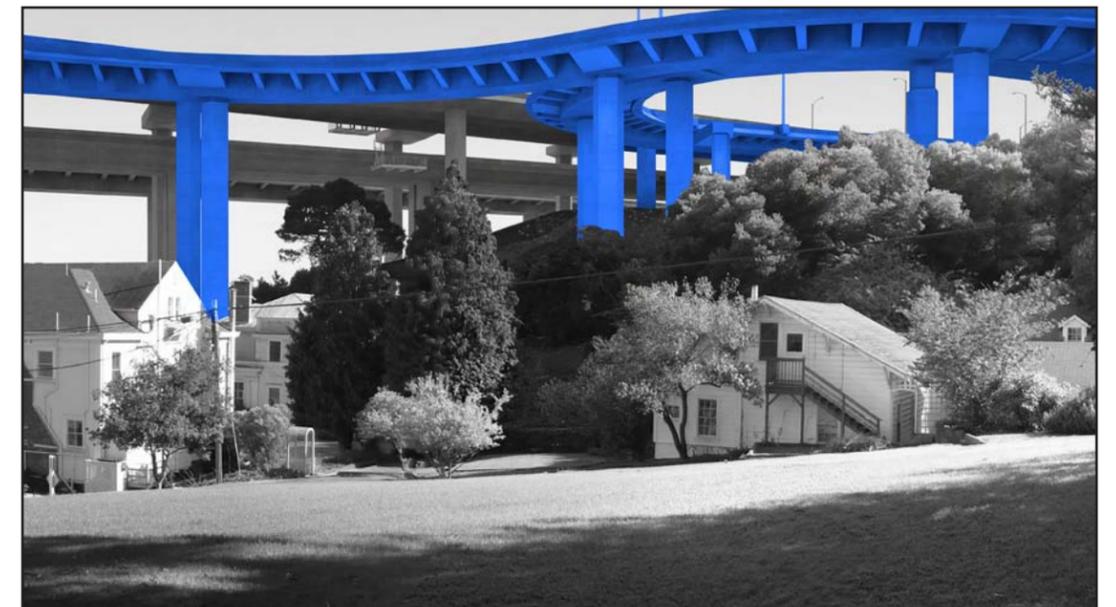
Alternative 2B Ramp Components: Blue highlighting distinguishes Alternative 2B ramp components from SFOBB East Span project components

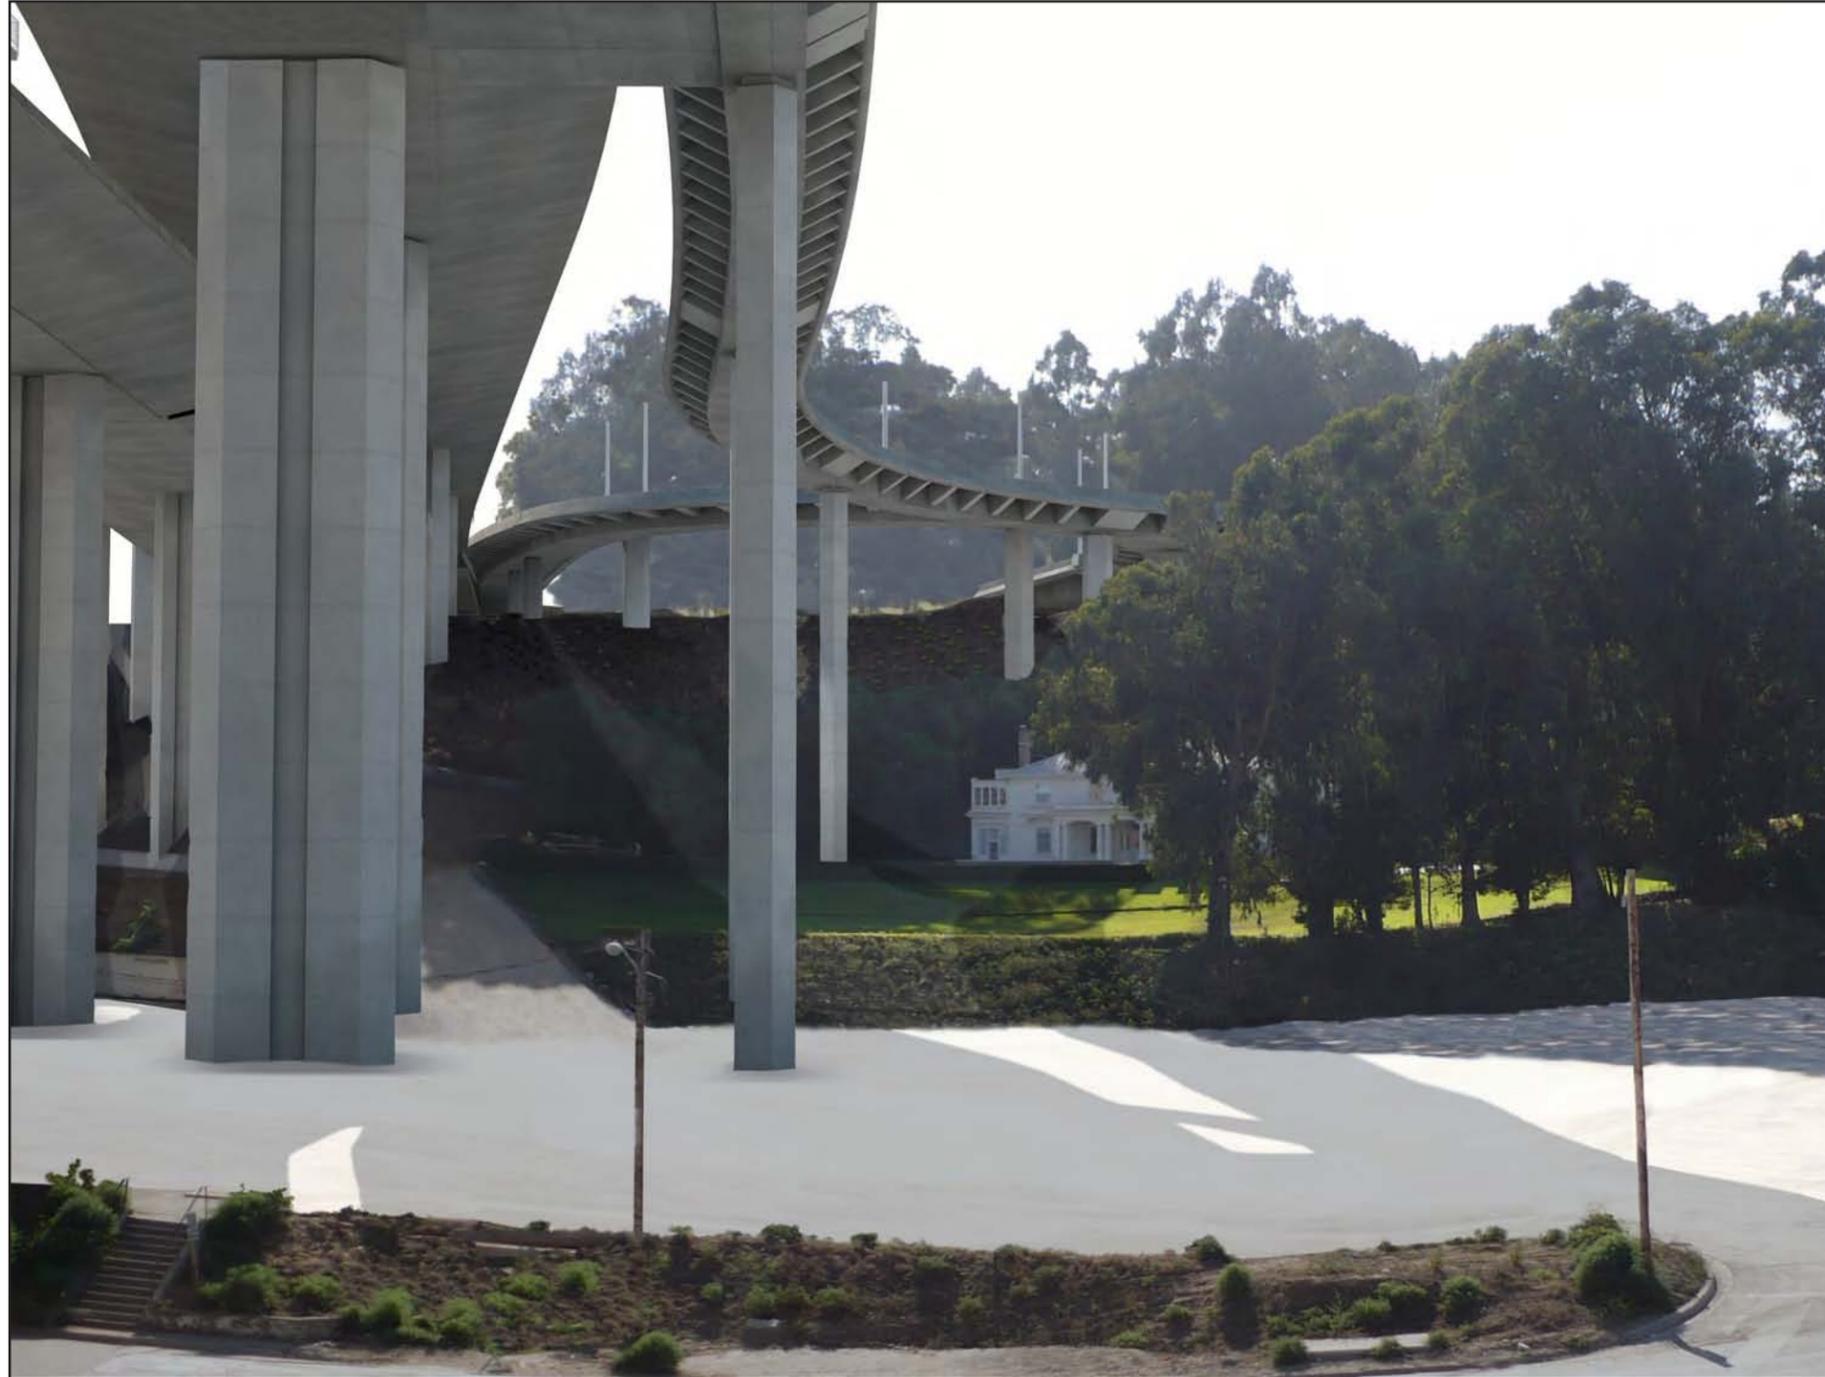
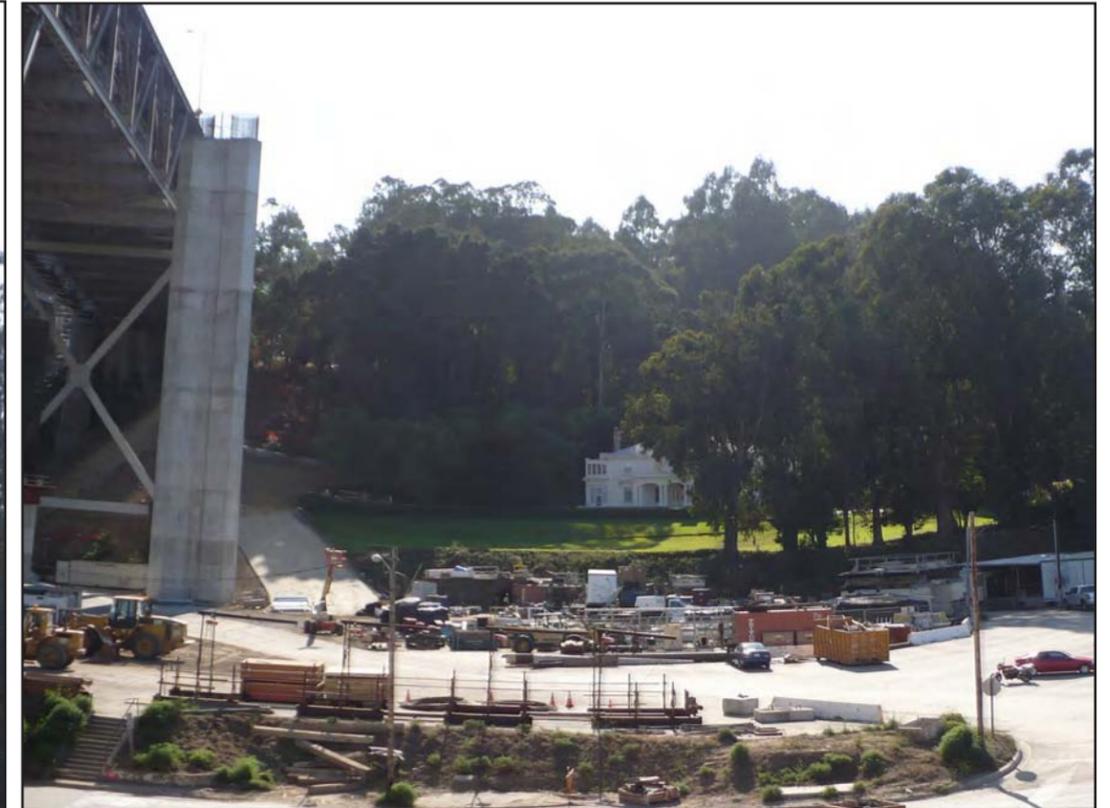
Figure 9: Alternative 2B
Key Viewpoint 4: North Gate Road Staging Area

Simulated View

Existing view is a composite of two images, resulting in natural lens and perspective distortion. Perspective correction was used to produce the simulated view.

This key viewpoint looks southwest across a construction staging area just northeast of North Gate Road that is being used for the SFOBB East Span construction project. The Nimitz House and thick vegetation in its vicinity are visible in the background. **Figure 9** depicts a photo-simulation of Alternative 2B from this viewpoint.

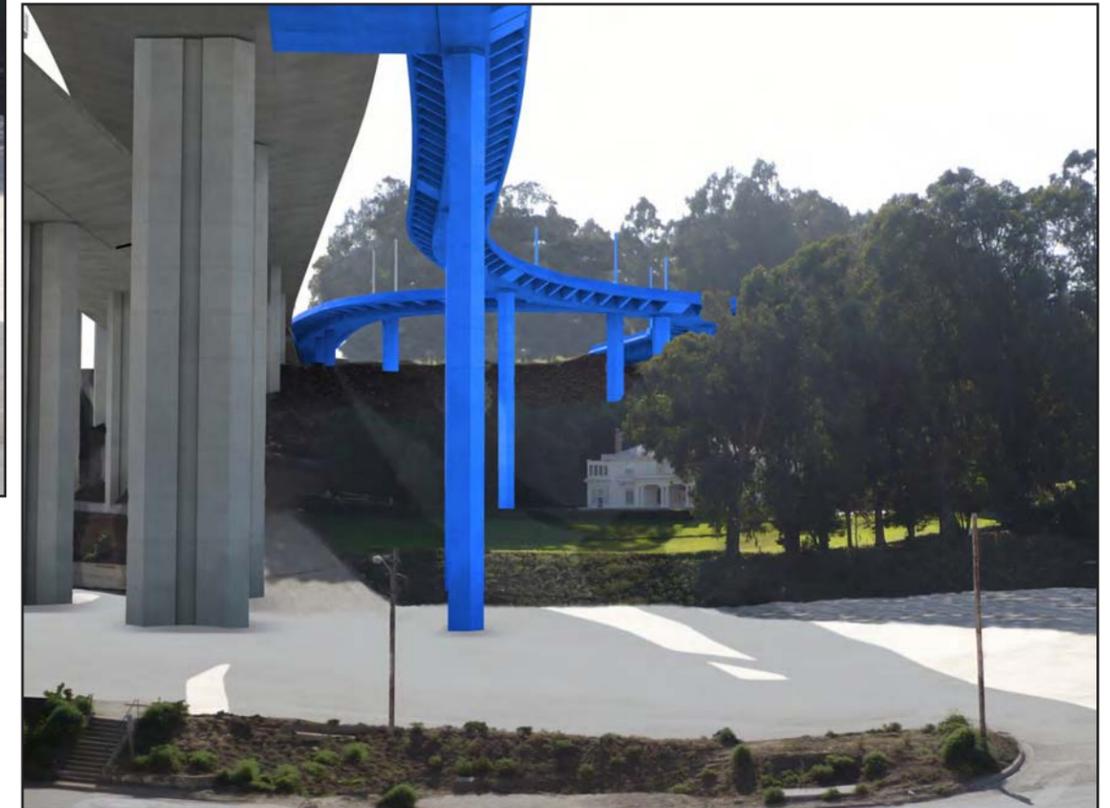
Alternative 2B Ramp Components: Blue highlighting distinguishes Alternative 2B ramp components from SFOBB East Span project components
