VISUAL IMPACT ASSESSMENT

**Yerba Buena Island
Ramps Improvement Project**

**District 04-SF-80
KP 12.3/13.2
EA 04-3A640**

**Caltrans District 4
Landscape Architecture**

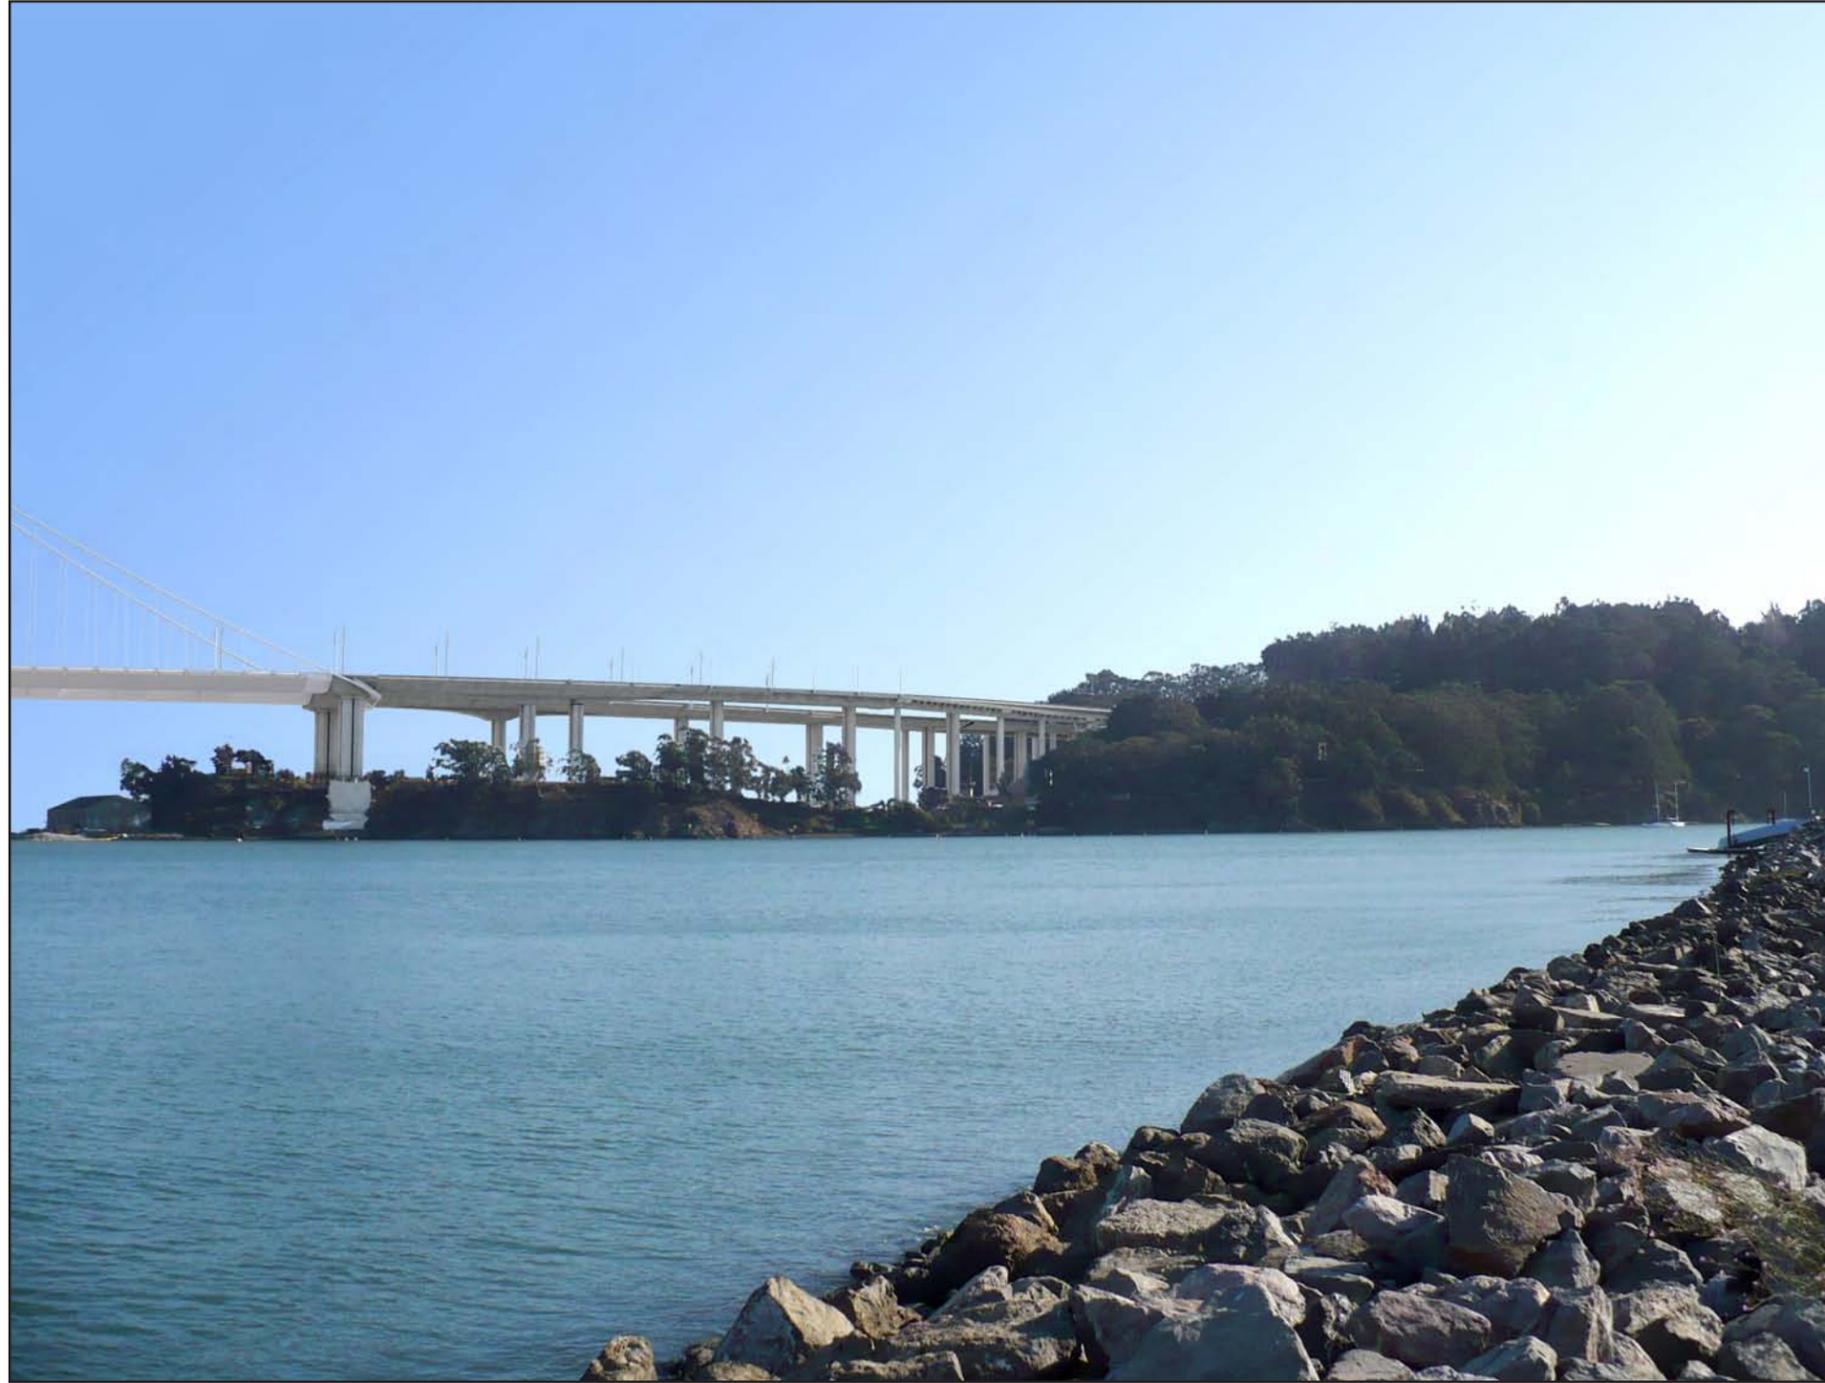
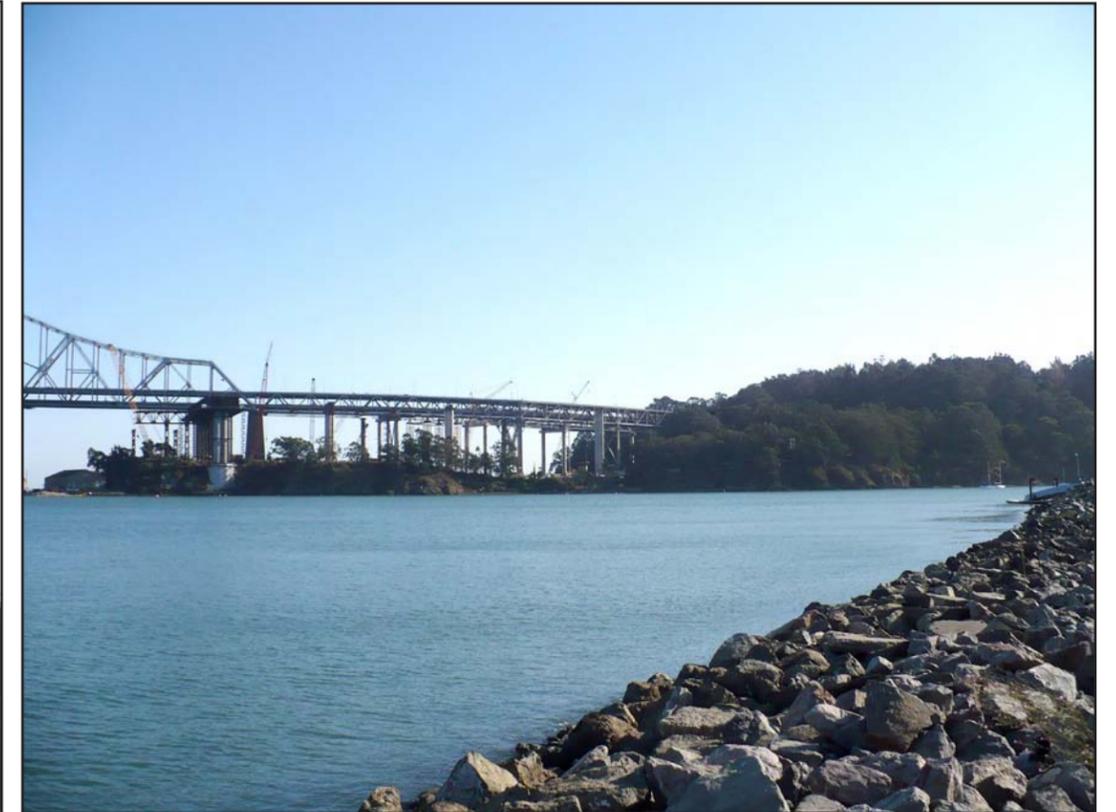
Figure 10: Alternative 2B
Key Viewpoint 5: Treasure Island

Simulated View

Existing View

Figure 10 depicts a photo-simulation of Alternative 2B from this viewpoint.

The view from Treasure Island to YBI from this location is moderately vivid. Due to the distance from the bridge, its structural lines are not as evident compared to views seen from locations on YBI. Also, the island's vegetation appears more homogeneous because it isn't possible to

distinguish between different types of vegetation from this distance. However, the contrast between the form of YBI and the line of the Bay shore touching the island is a vivid characteristic of this view, as is the image of the SFOBB touching down on the island.

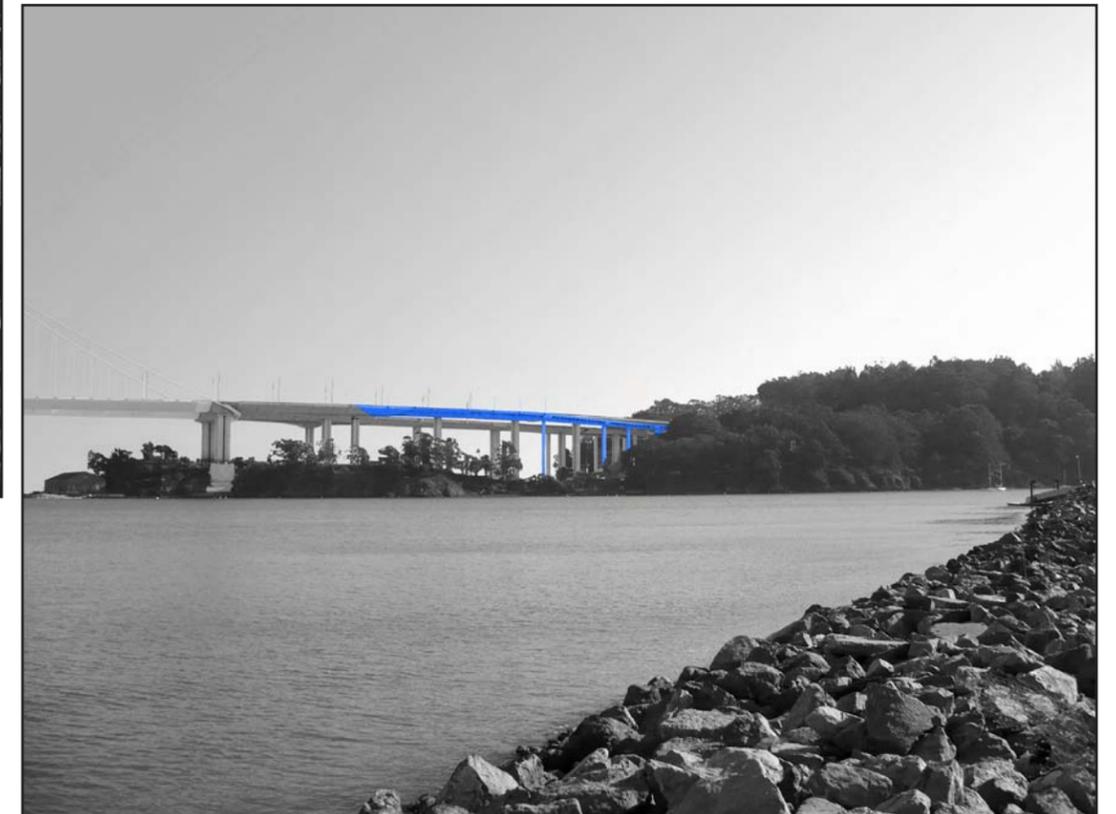
Alternative 2B Ramp Components: Blue highlighting distinguishes Alternative 2B ramp components from SFOBB East Span project components

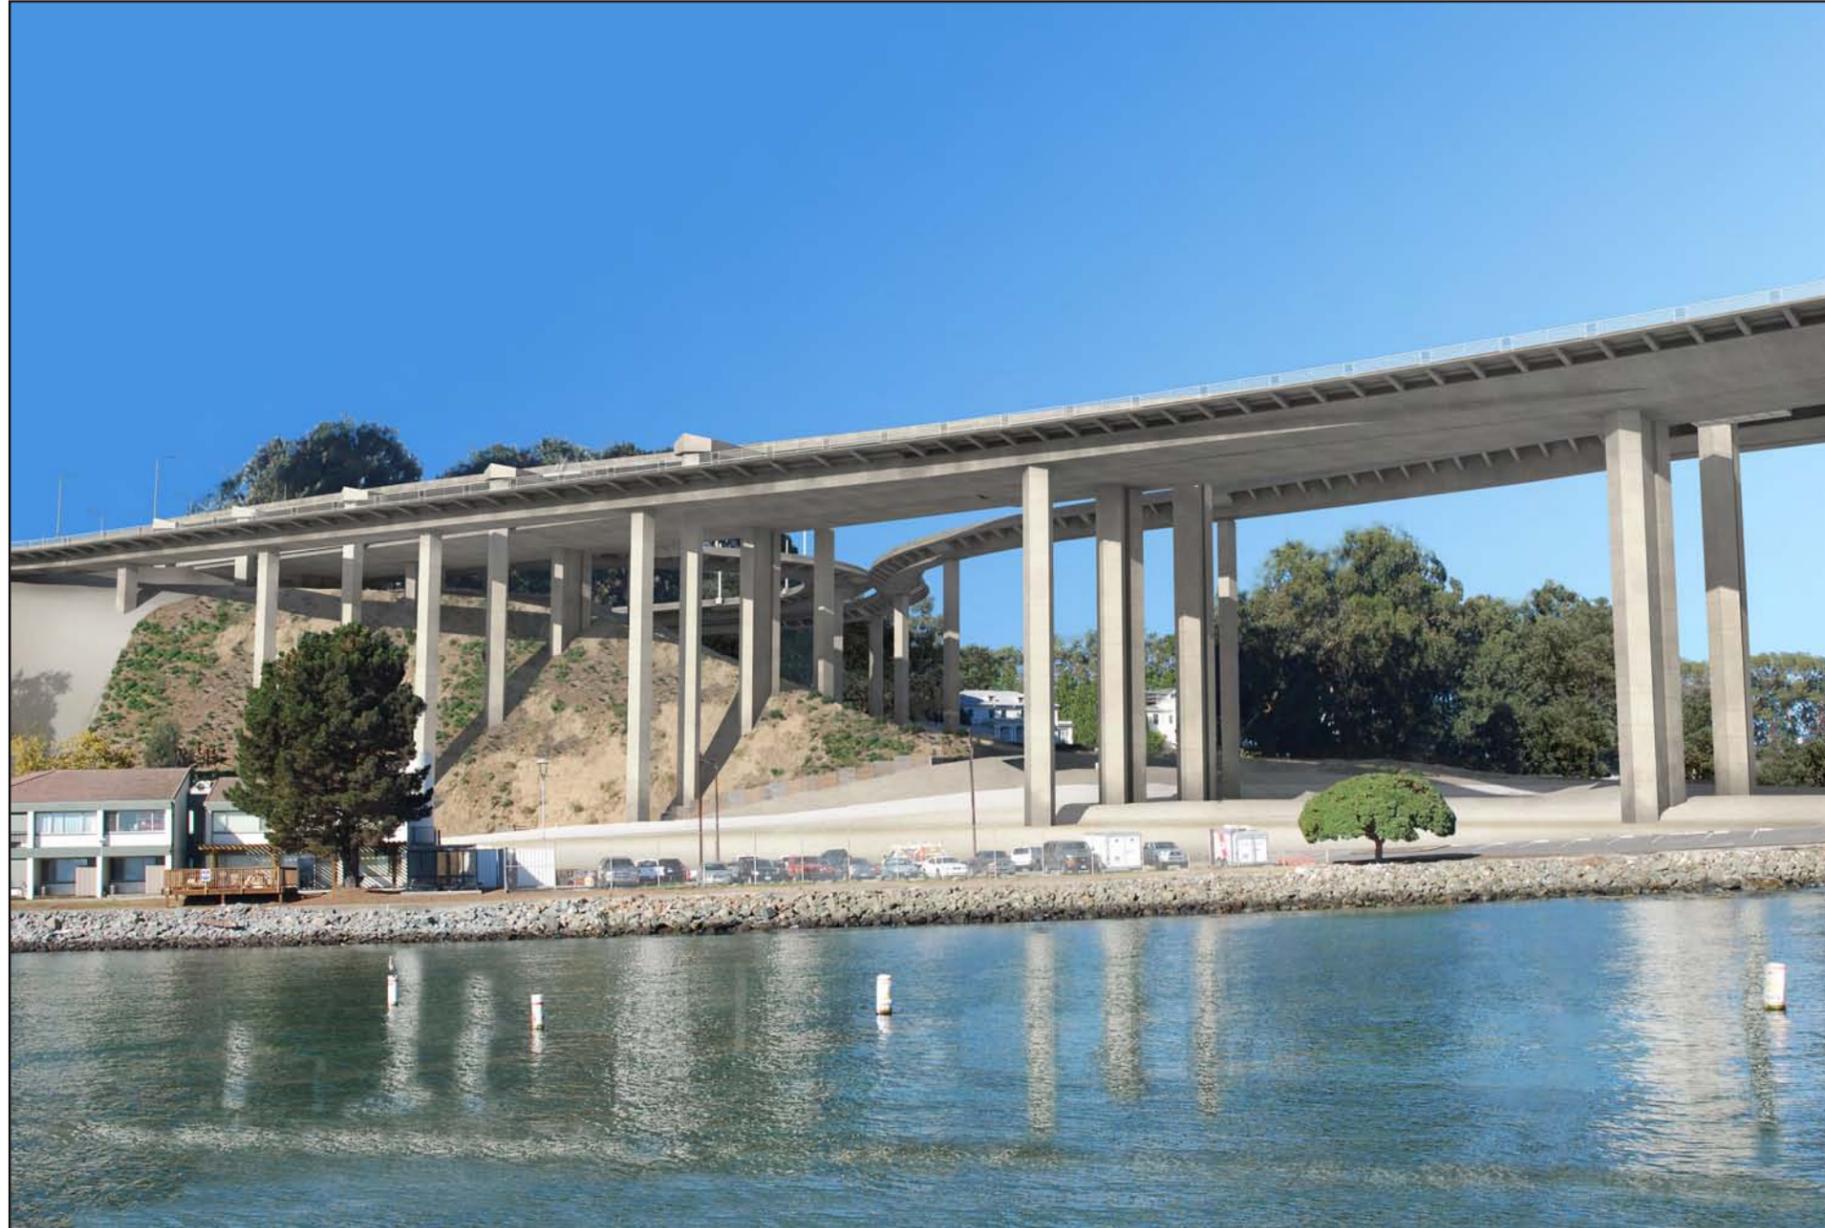
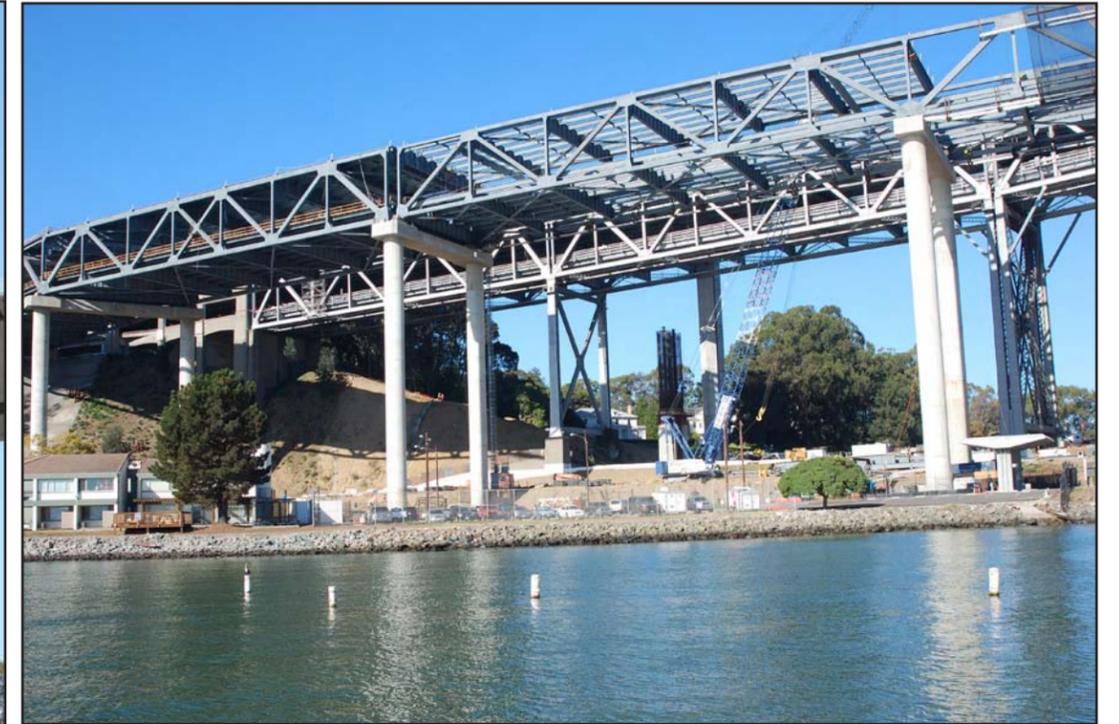
Figure 11: Alternative 2B
Key Viewpoint 6: Eastern Yerba Buena Island Waterborne Approach

Simulated View

Existing View

This viewpoint illustrates a westward view of YBI as if on a waterborne approach to the island. This viewpoint is based about 500 feet east of the island. **Figure 11** depicts a photo-simulation of Alternative 2B from this viewpoint.

Overall Visual Quality: The YBI ramps would be noticeable but not dominant from this viewpoint. They would have a minimally adverse effect on the area when observed from this viewpoint.

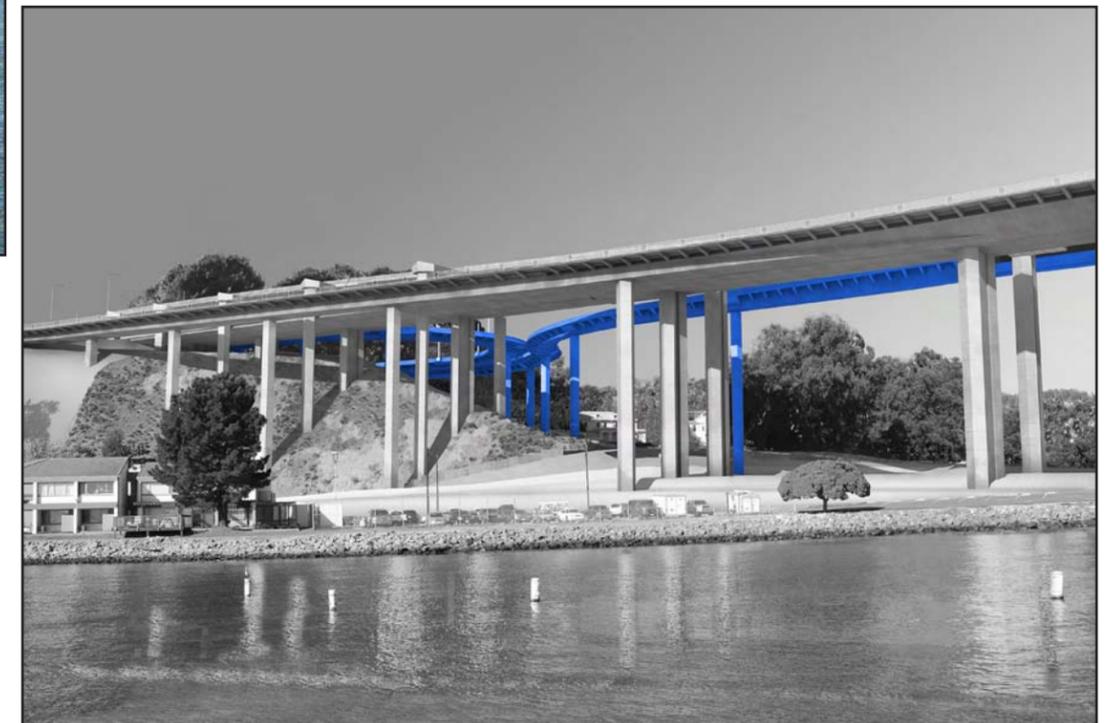
Alternative 2B Ramp Components: Blue highlighting distinguishes Alternative 2B ramp components from SFOBB East Span project components

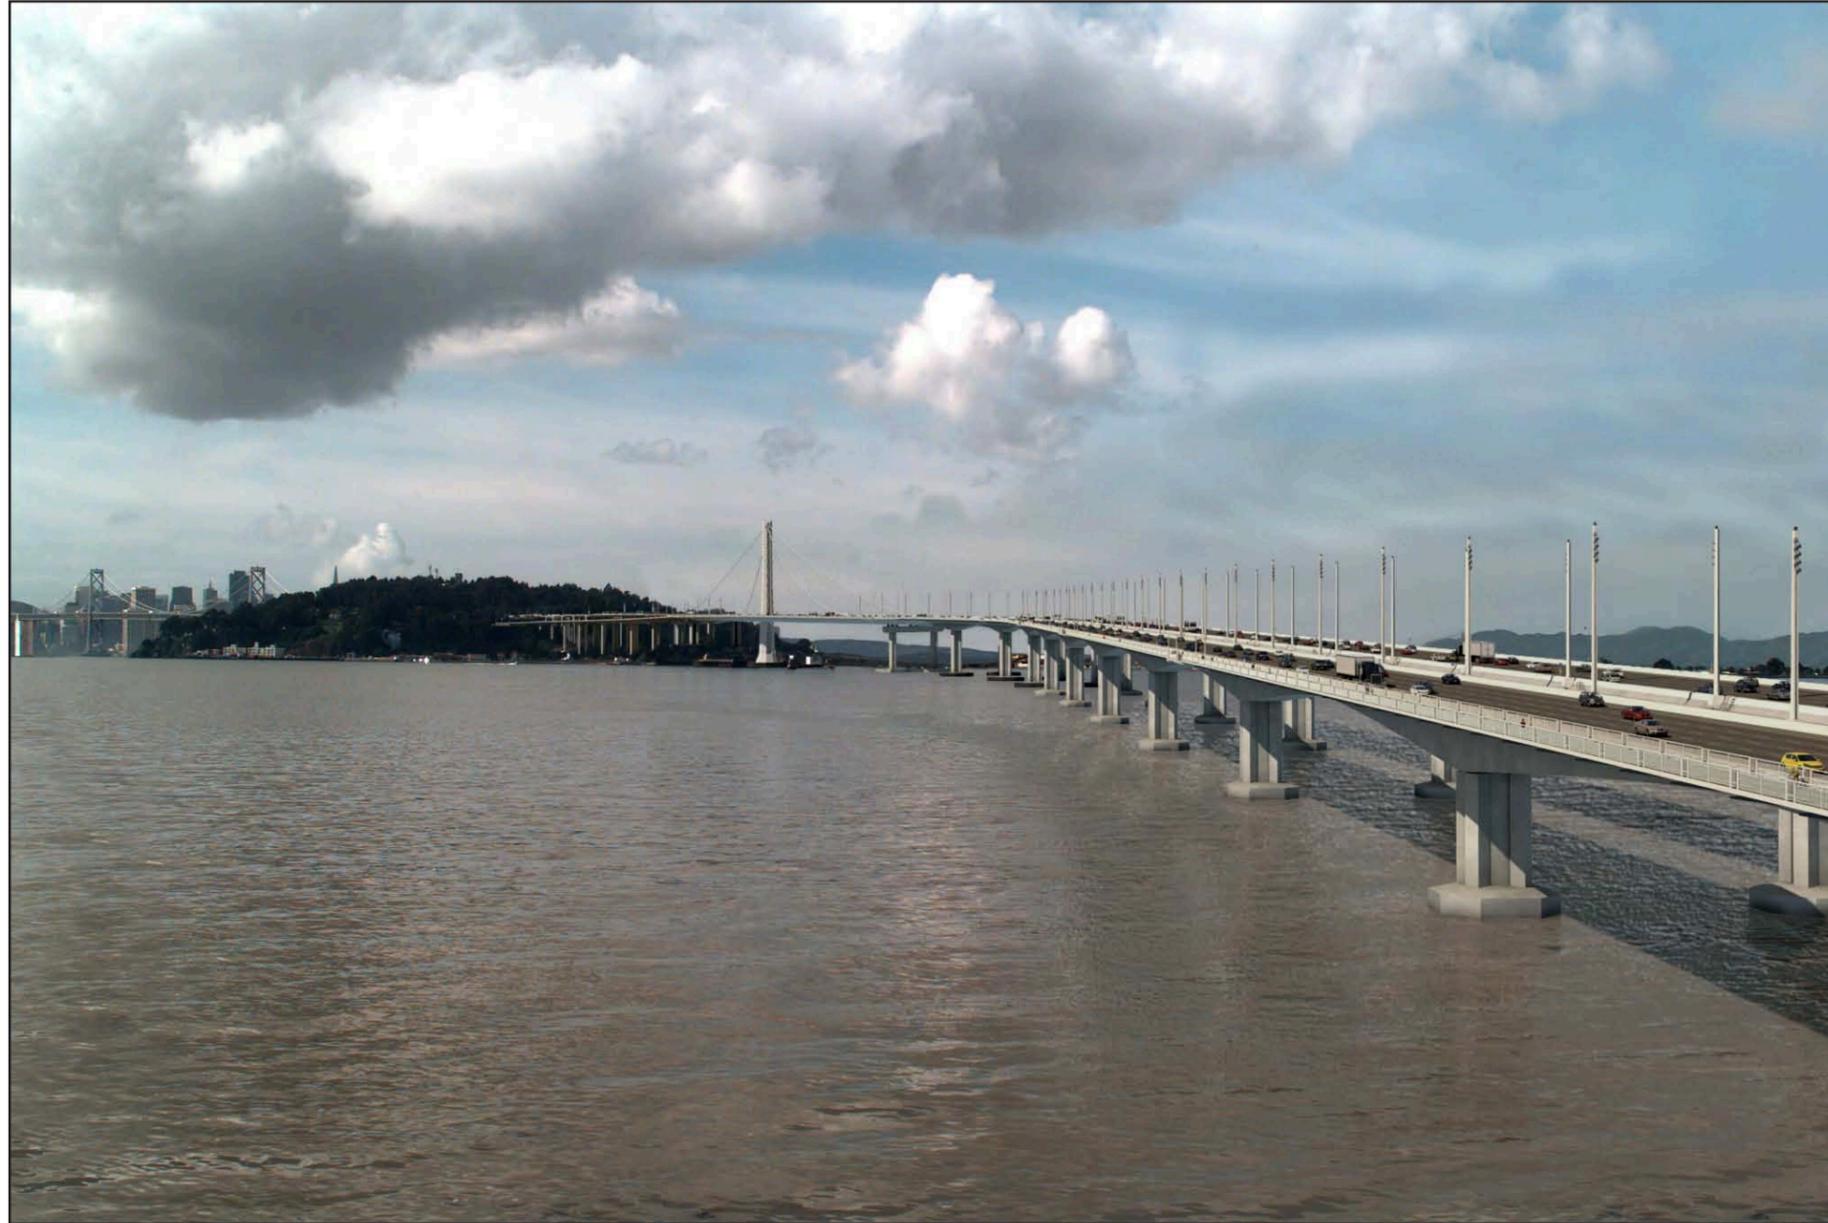
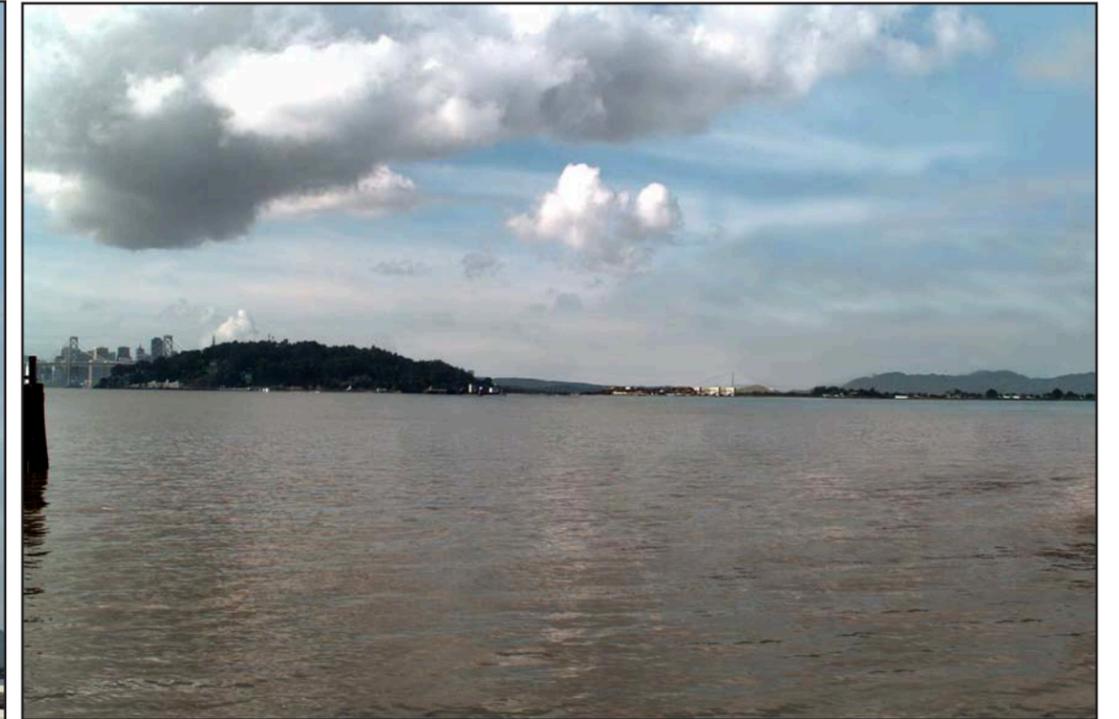
Figure 12: Alternative 2B
Key Viewpoint 7: Oakland Touchdown

Simulated View

View prior to SFOBB east span and Alternative 2B construction

This key viewpoint looks west toward YBI from the SFOBB Oakland Touchdown area, which is located at a distance of about 1.25 miles from the island. **Figure 12** depicts a photo-simulation of Alternative 2B from this viewpoint.

Visual Dominance: Alternative 2B's ramps would be in-evident from the Oakland Touchdown area, due to the relatively long distance to YBI. From this vantage point, the ramps would be difficult to discern by the casual viewer. As shown in the Alternative 2B Ramp Components inset of Figure 12, the ramps would be so indiscernible that the blue highlighting used to distinguish the ramps is not visible.

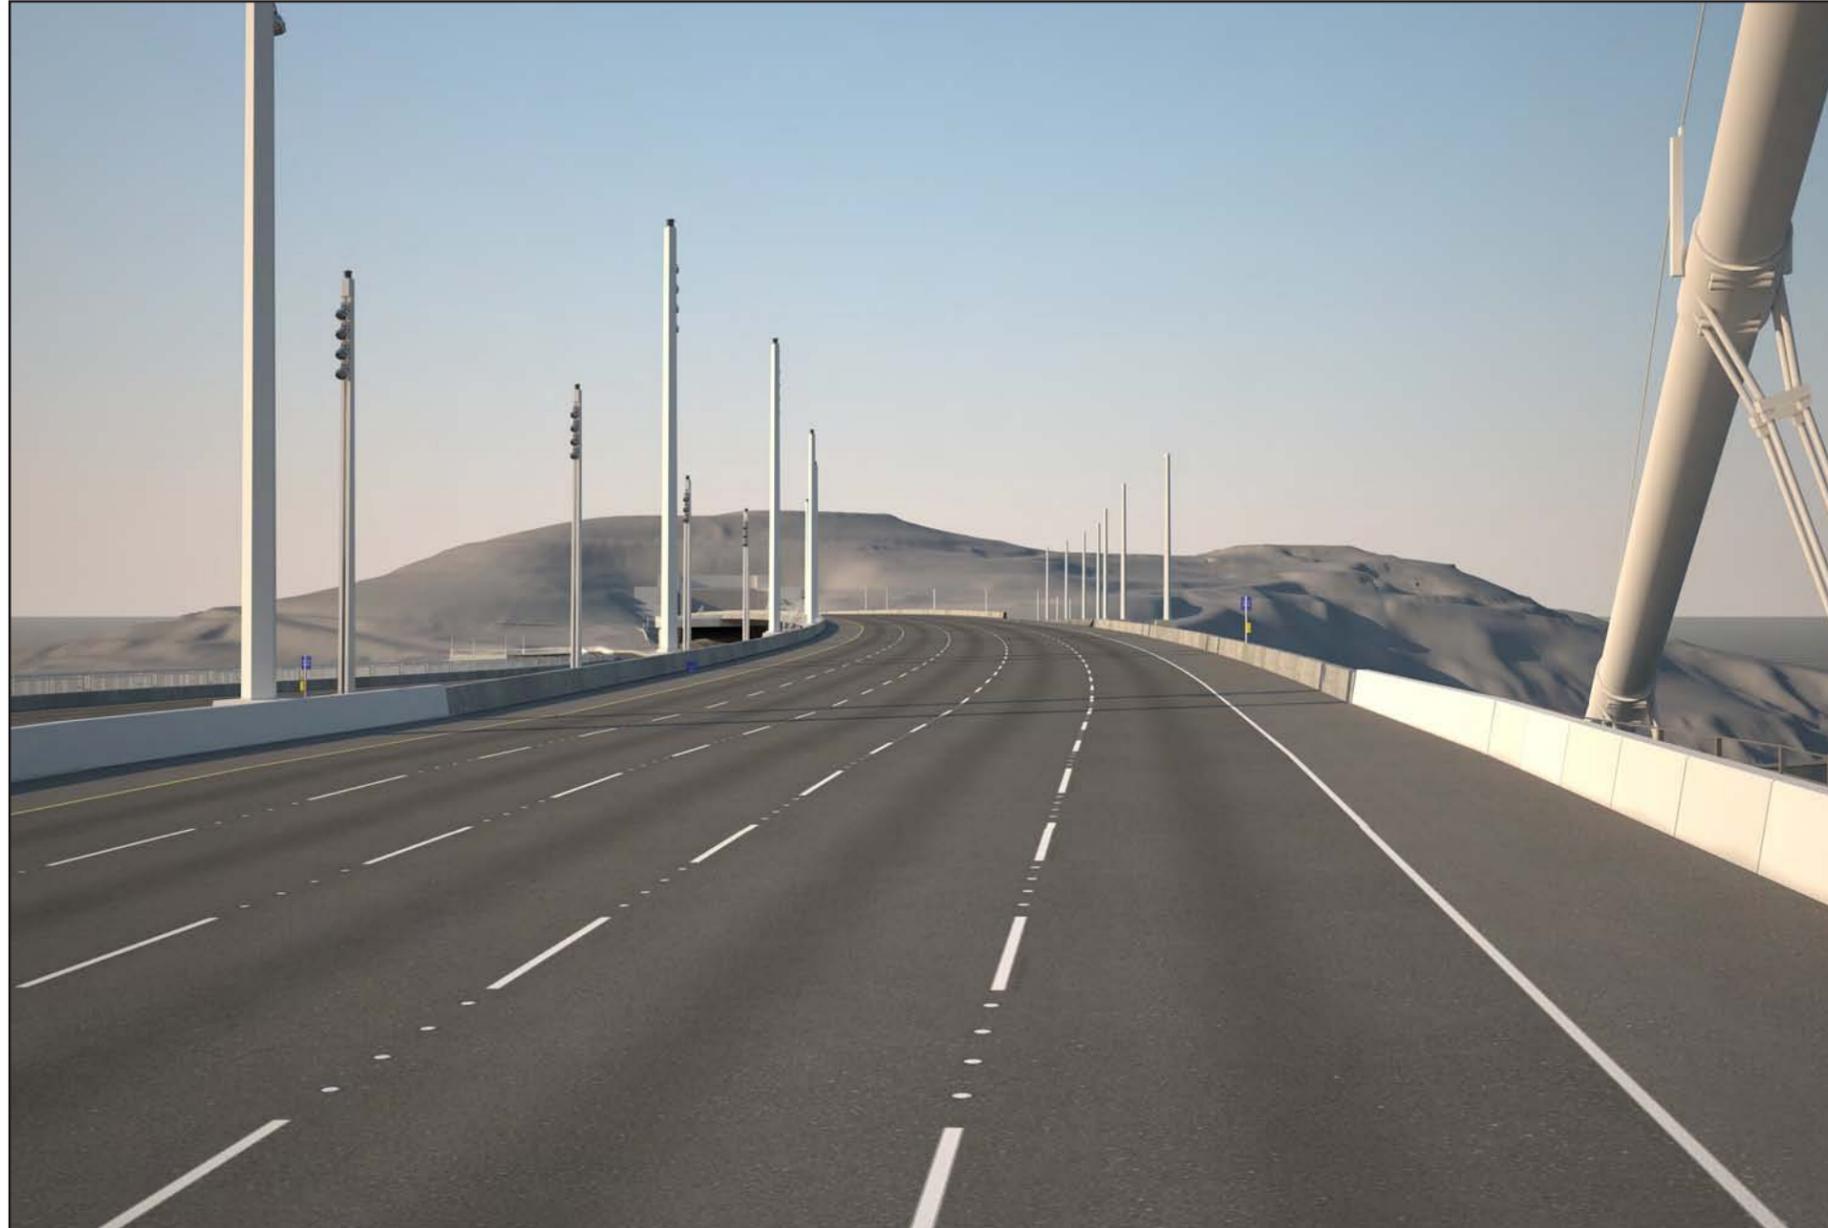
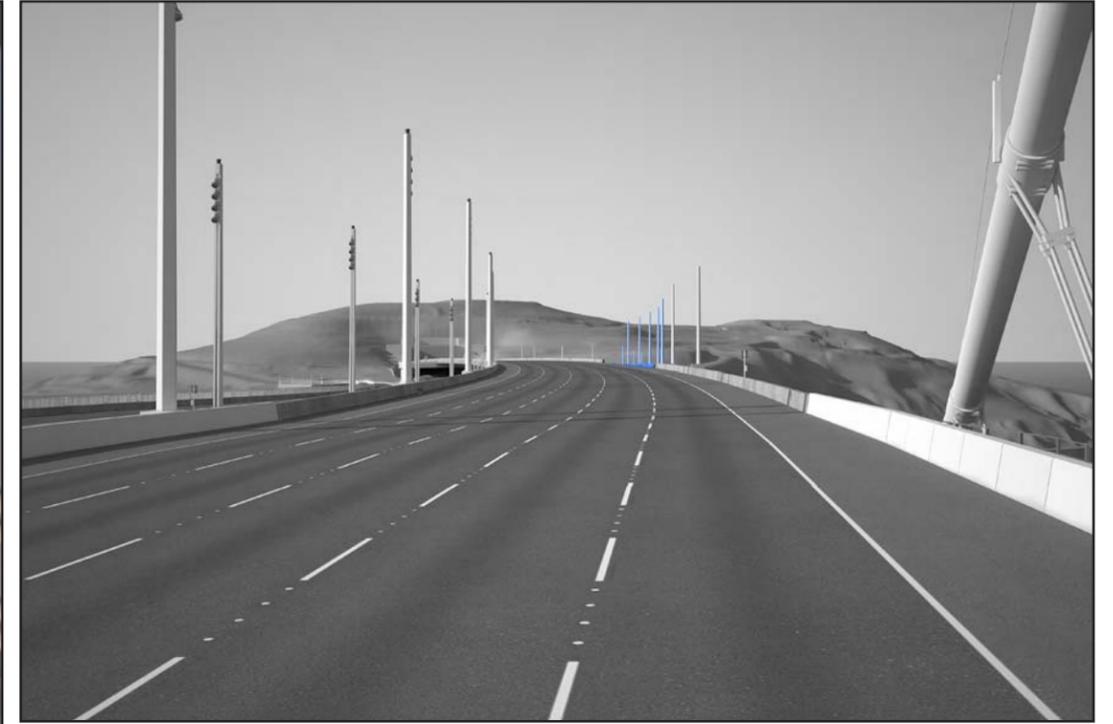
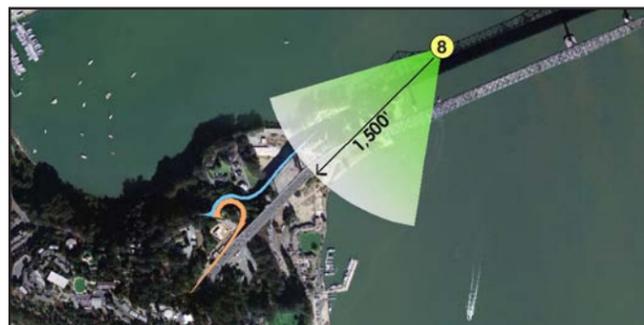
Figure 13: Alternative 2B
Key Viewpoint 8: San Francisco-Oakland Bay Bridge Transition Structure

Alternative 2B Ramp Components: Blue highlighting distinguishes Alternative 2B ramp components from SFOBB East Span project components

Rendered View

Geographic Context
Indicates distance from viewpoint to
Alternative 2B ramp components

Resulting Visual Impact: Overall change in viewer response and visual character would be negligible. The resulting visual impact would be negligible.

This viewpoint is toward the southwest from the future roadway of the SFOBB East Span as it approaches the YBI tunnel. **Figure 13** depicts a rendering of Alternative 2B from this viewpoint.

Because construction of the new SFOBB East Span is not yet complete, and this vantage point is from the future East Span roadway, it is not possible to describe the existing visual character of this viewpoint. Therefore, Figure 13 shows only a rendering of the future vantage point, rather than a before image and a photo-visual simulation of the viewpoint.

Overall Visual Quality: This is a view illustrating the perspective of a motorist crossing the SFOBB East Span Transition Structure and approaching the YBI Tunnel. From this location, the off-ramp would not be a prominent element of the view seen by motorists. The off-ramp would be a subordinate element in the view, and any effect this alternative would have on the overall visual quality of the area would be negligible.

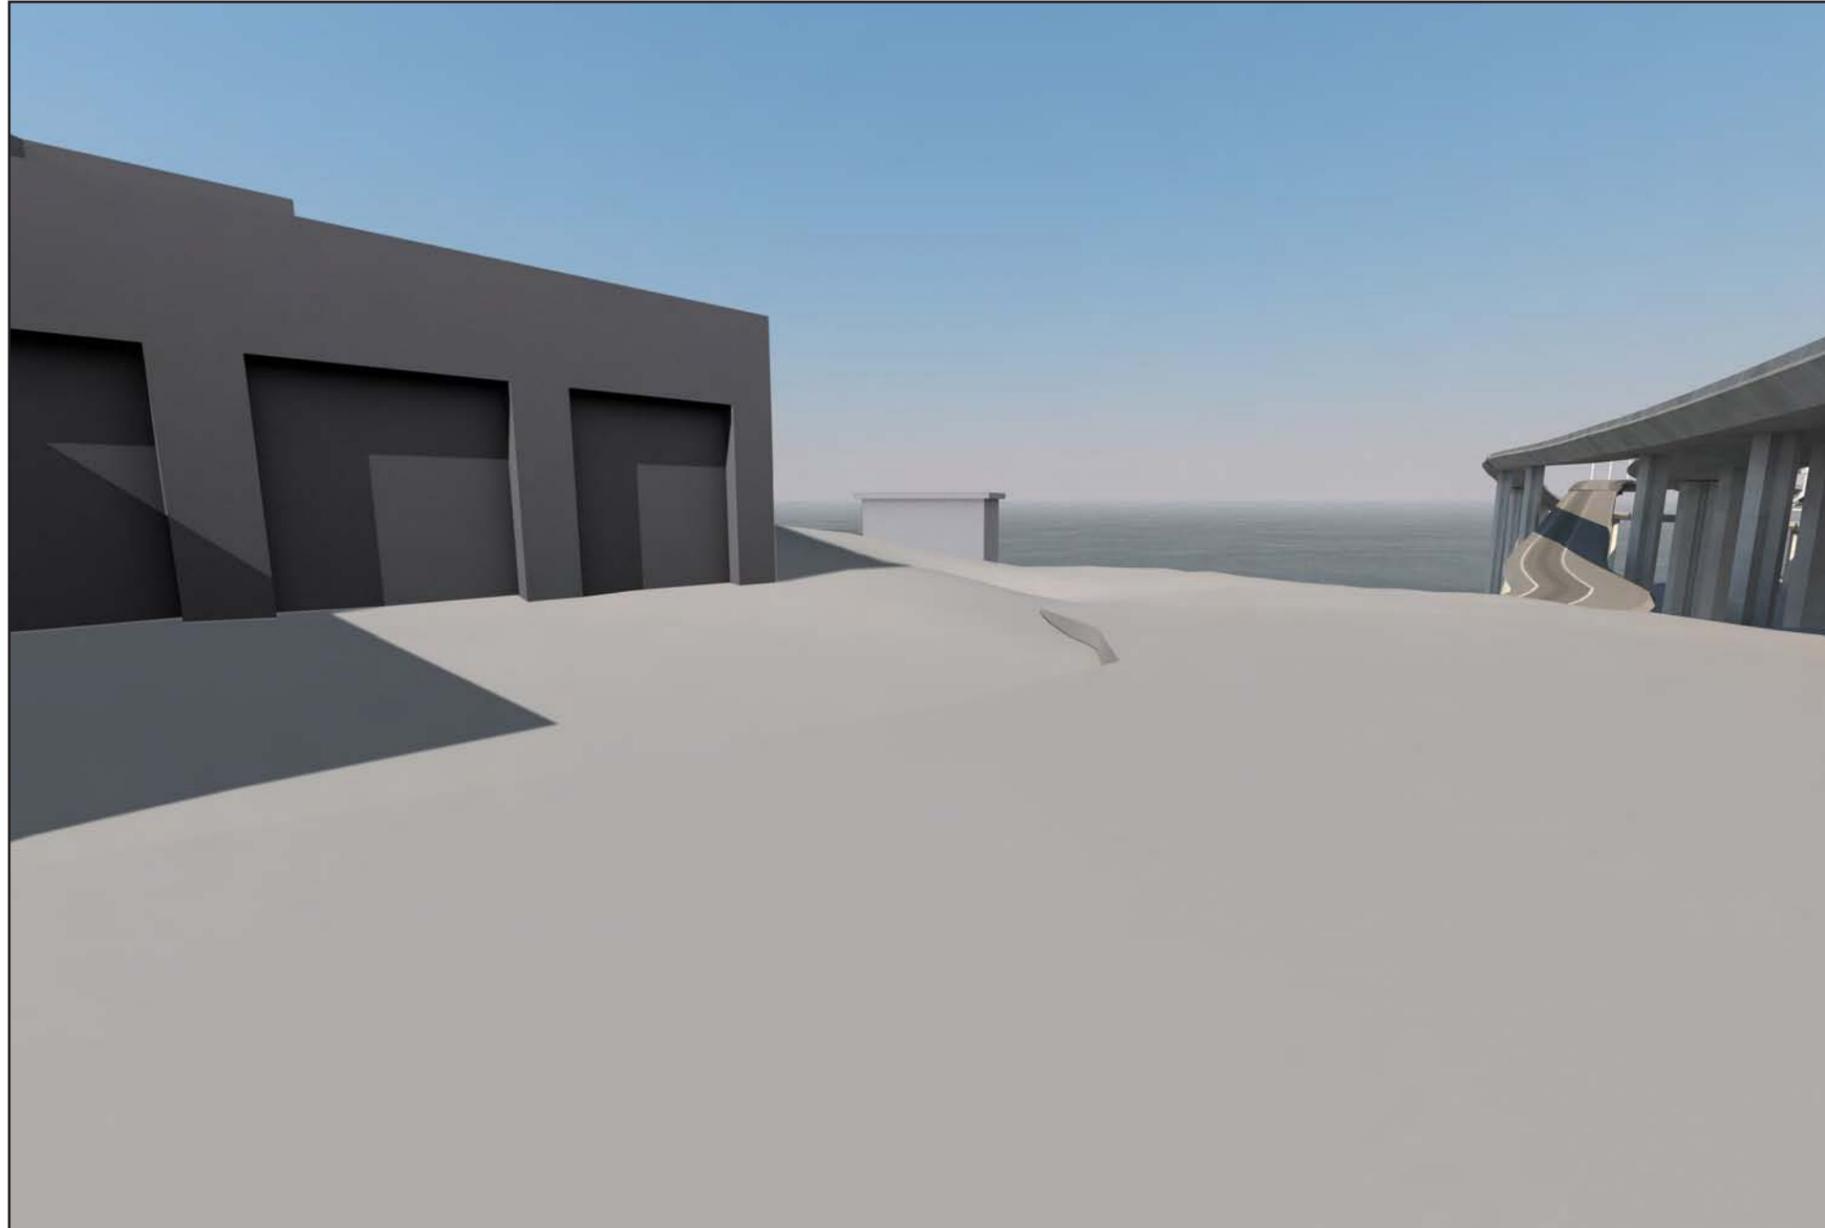
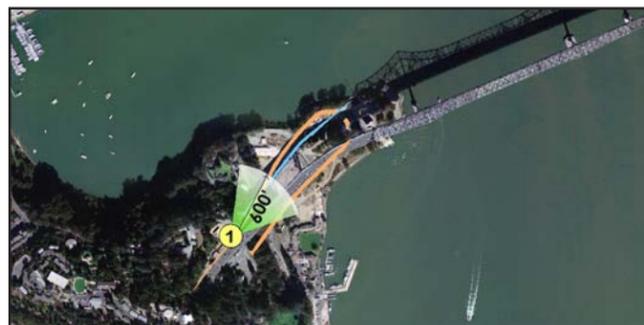
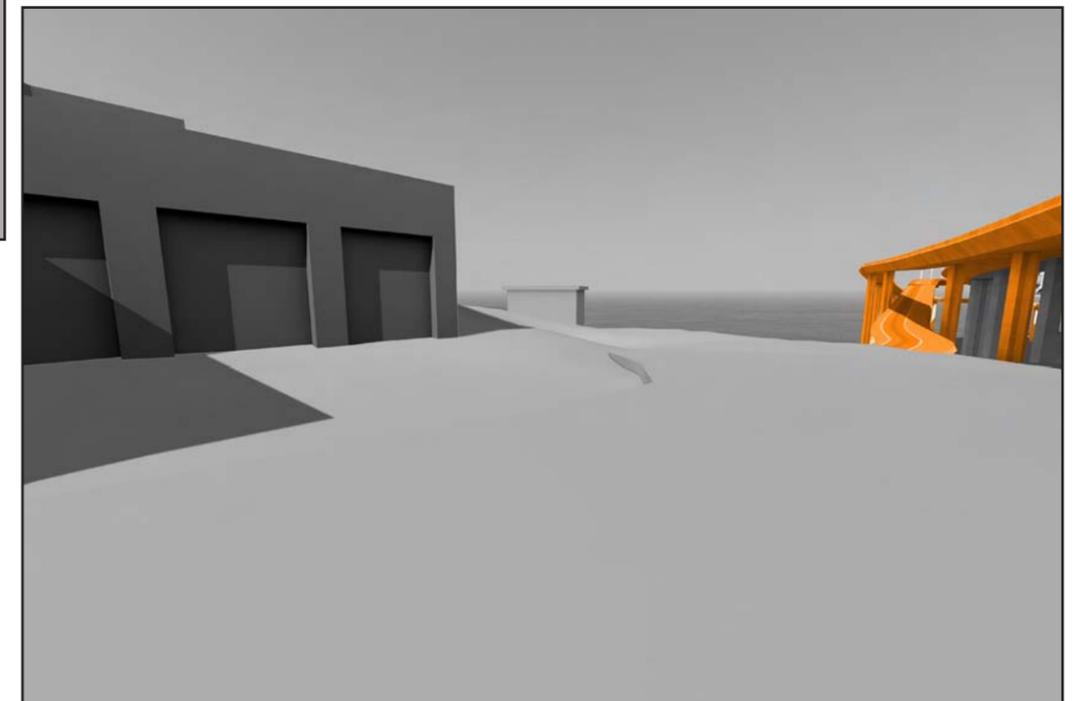
Figure 14: Alternative 4
Key Viewpoint 1: Macalla Road at North Gate Road Intersection

Rendered View

Geographic Context
Indicates distance from viewpoint to
Alternative 4 ramp components

Alternative 4 Ramp Components: Orange highlighting distinguishes Alternative 4 ramp components from SFOBB East Span project components

This key viewpoint looks northeast from the intersection of Macalla Road and North Gate Drive. **Figure 14** depicts a rendering of Alternative 4. Implementation of this alternative would not affect Quarters 10 or Building 267, as would occur if Alternative 2B is implemented.
