VISUAL IMPACT ASSESSMENT

**Yerba Buena Island
Ramps Improvement Project**

**District 04-SF-80
KP 12.3/13.2
EA 04-3A640**

**Caltrans District 4
Landscape Architecture**

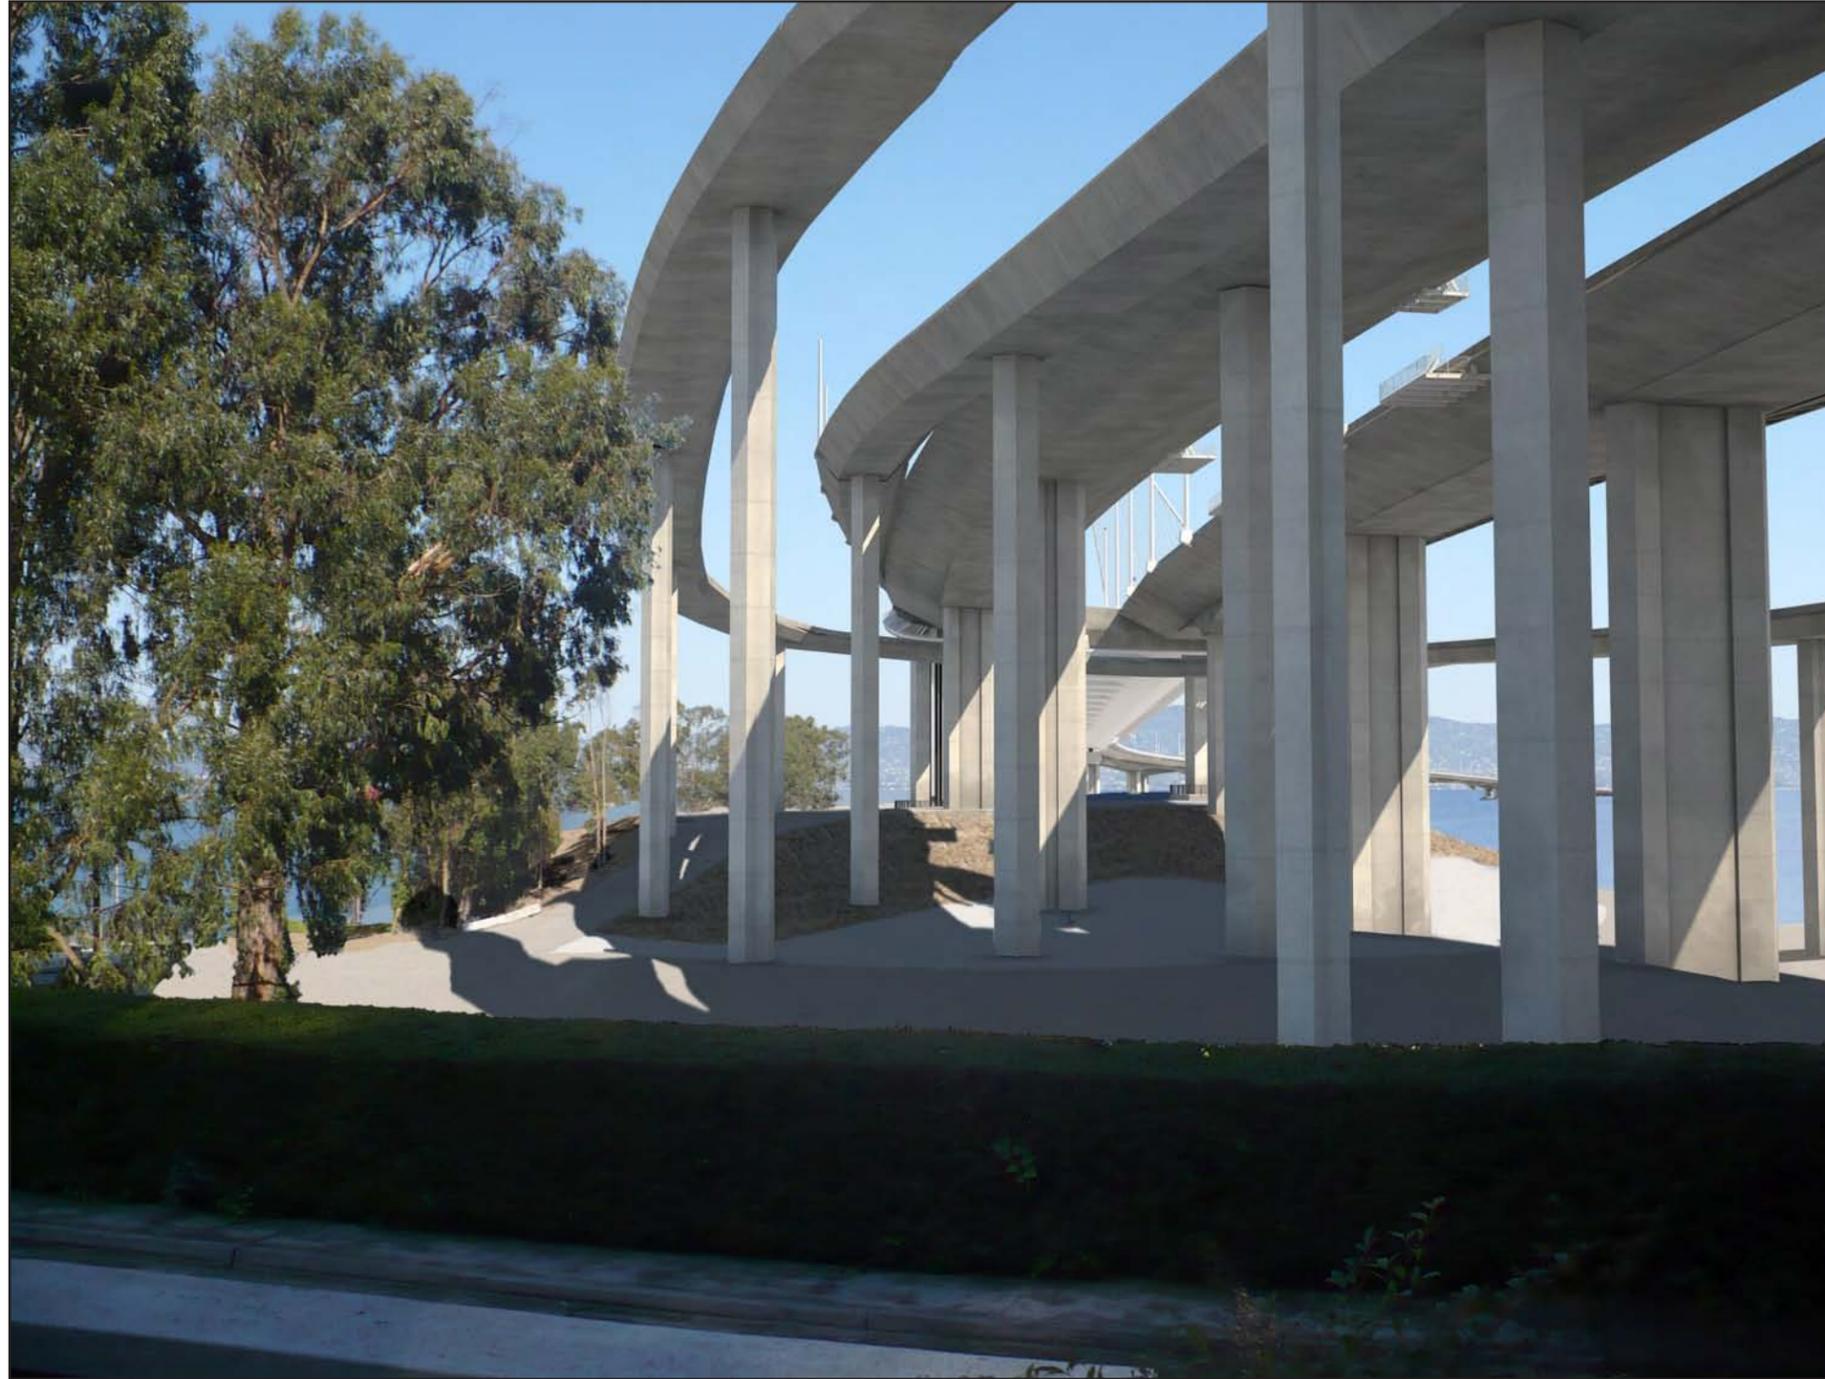
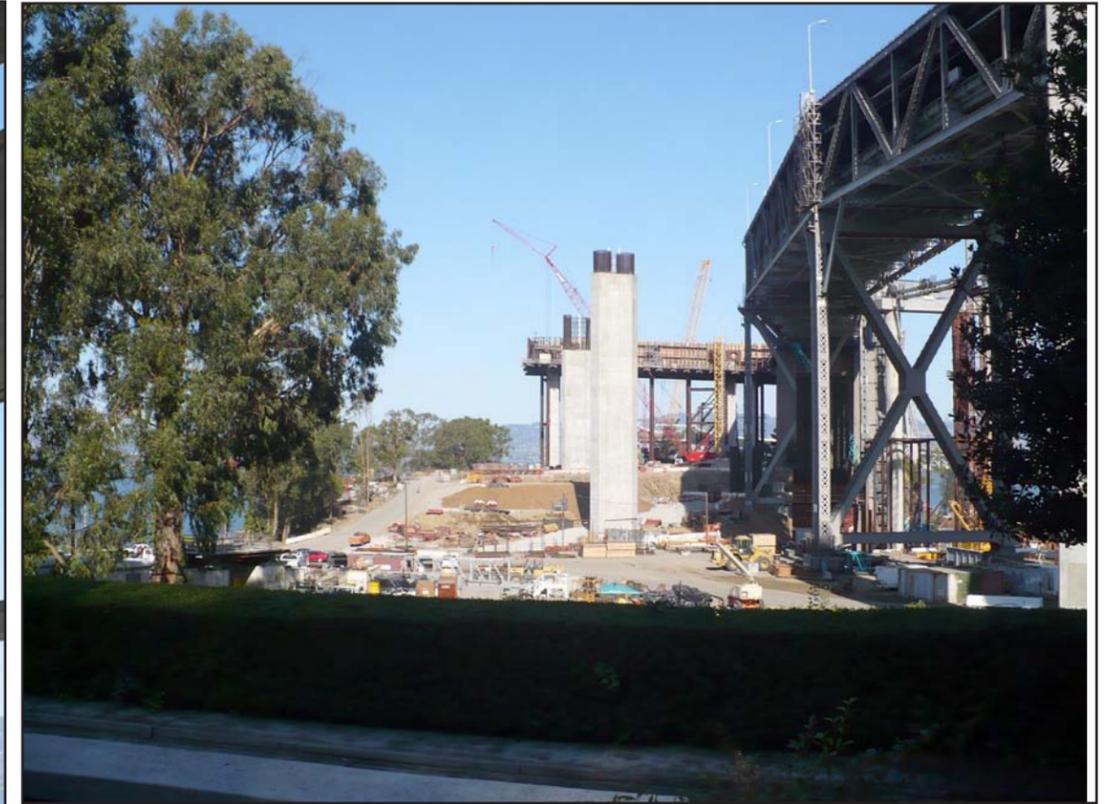
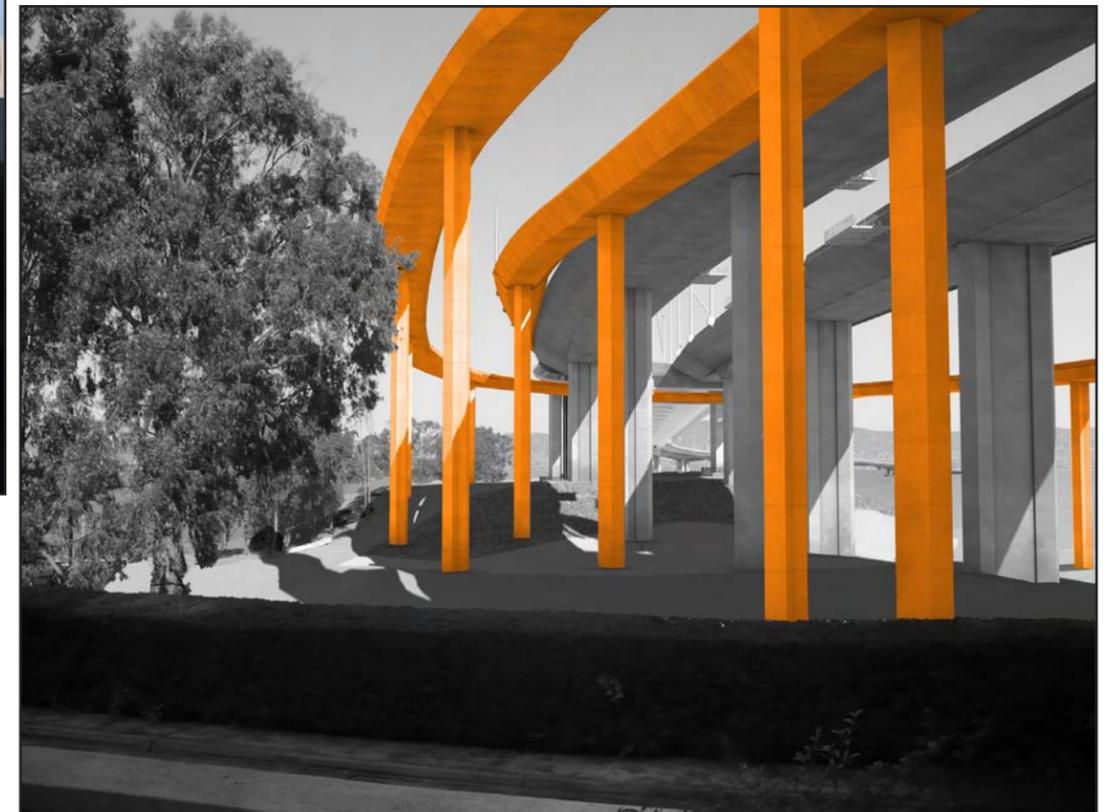
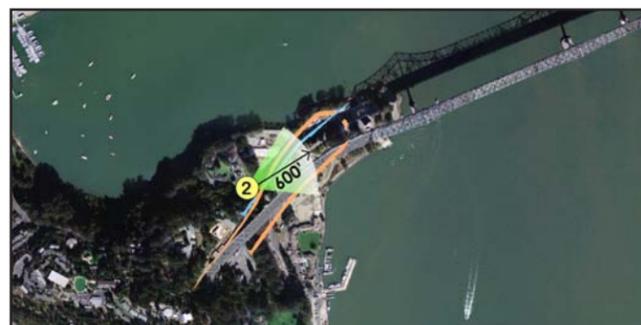
Figure 15: Alternative 4
Key Viewpoint 2: Nimitz House

Simulated View

Existing View

Alternative 4 Ramp Components: Orange highlighting distinguishes Alternative 4 ramp components from SFOBB East Span project components

Geographic Context
Indicates distance from viewpoint to
Alternative 4 ramp components

This key viewpoint looks northeast from the patio of the Nimitz House, one of the historic US Navy structures located on the island. **Figure 15** depicts a photo-simulation of Alternative 4 from this viewpoint.

From this viewpoint the bridge and tree frame a distant view of the East Bay hills, providing a low degree of unity and intactness, given that this view is now markedly diminished as a result of the SFOBB Transition Structure construction activity occurring in the center of the view.

View Obstruction: This alternative would result in a partial obstruction of views toward the East Bay Hills. However, the level of obstruction would be considered less than that caused by the road decks and columns of the SFOBB East Span project visible from this vantage point.

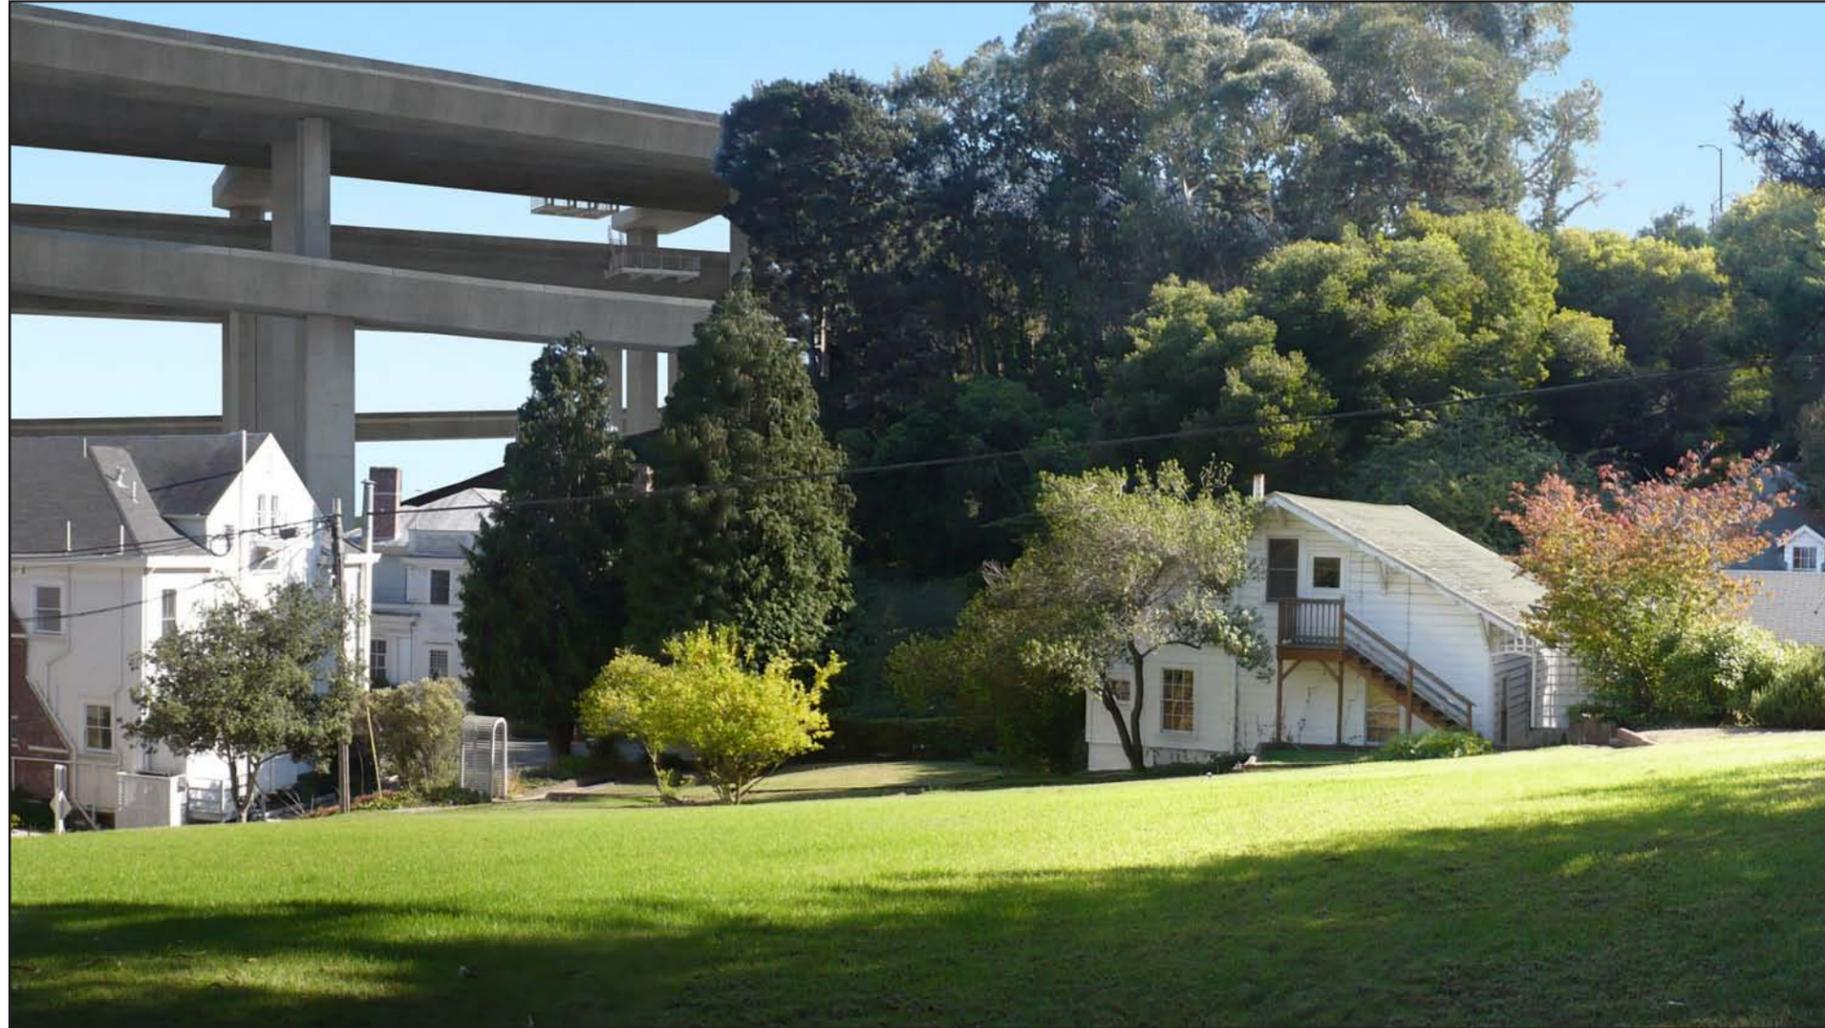
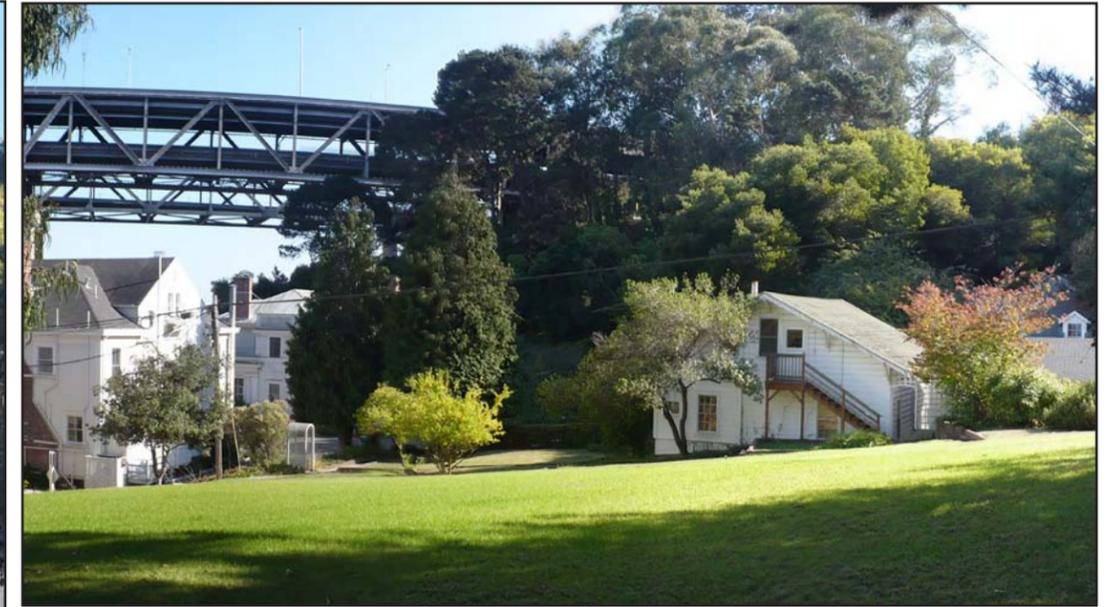
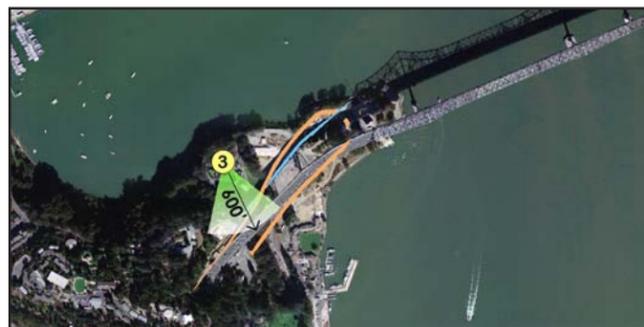
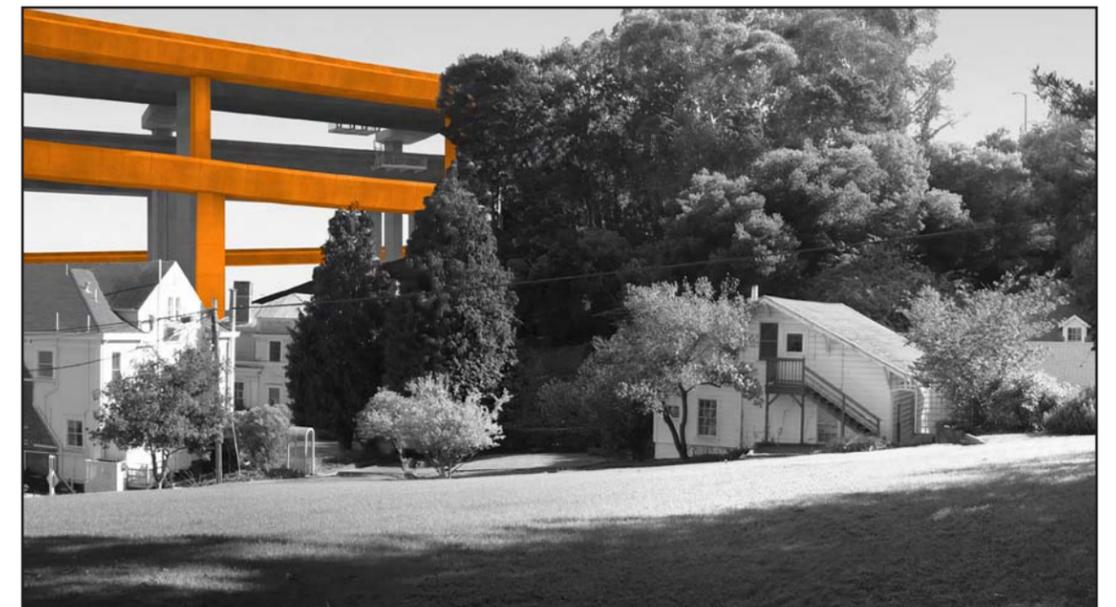
Figure 16: Alternative 4
Key Viewpoint 3: Officers' Quarters Open Space

Simulated View

Existing View

Geographic Context
Indicates distance from viewpoint to
Alternative 4 ramp components

Alternative 4 Ramp Components: Orange highlighting distinguishes Alternative 4 ramp components from SFOBB East Span project components

Resulting Visual Impact: Overall change in viewer response and visual character would be strongly adverse. The resulting visual impact would be strongly adverse.

This key viewpoint looks southeast from a large lawn area between Quarters 4 and 7 toward the other historic US Navy structures, including the Nimitz House (Quarters 1), Quarters 2, Building 83 and Building 205. **Figure 16** depicts a photo-simulation of Alternative 4 from this viewpoint.

This viewpoint presents a moderate to highly vivid scene of typical image types that can be found on YBI. Various former US Navy structures stand among lush vegetation, while a segment of the SFOBB East Span is present in the background. Design elements of the Navy structures can be clearly distinguished and the lines of the East Span structure are also vivid.

Overall Visual Quality: This alternative would result in an overall minimally adverse effect on the visual quality of the viewpoint. Under current conditions, the SFOBB East Span passes over and behind the US Navy structures, with a left to right movement of massing that appears to float elegantly in mid air. The Alternative 4 design would involve construction of ramp road decks and columns behind and in front of the SFOBB Transition Structure that would not on the whole present a bulkier image. However, elements of the new design would lend it an overall wider vertical (ramp decks) and horizontal (columns) profile when compared to the image presented by the current bridge structure.

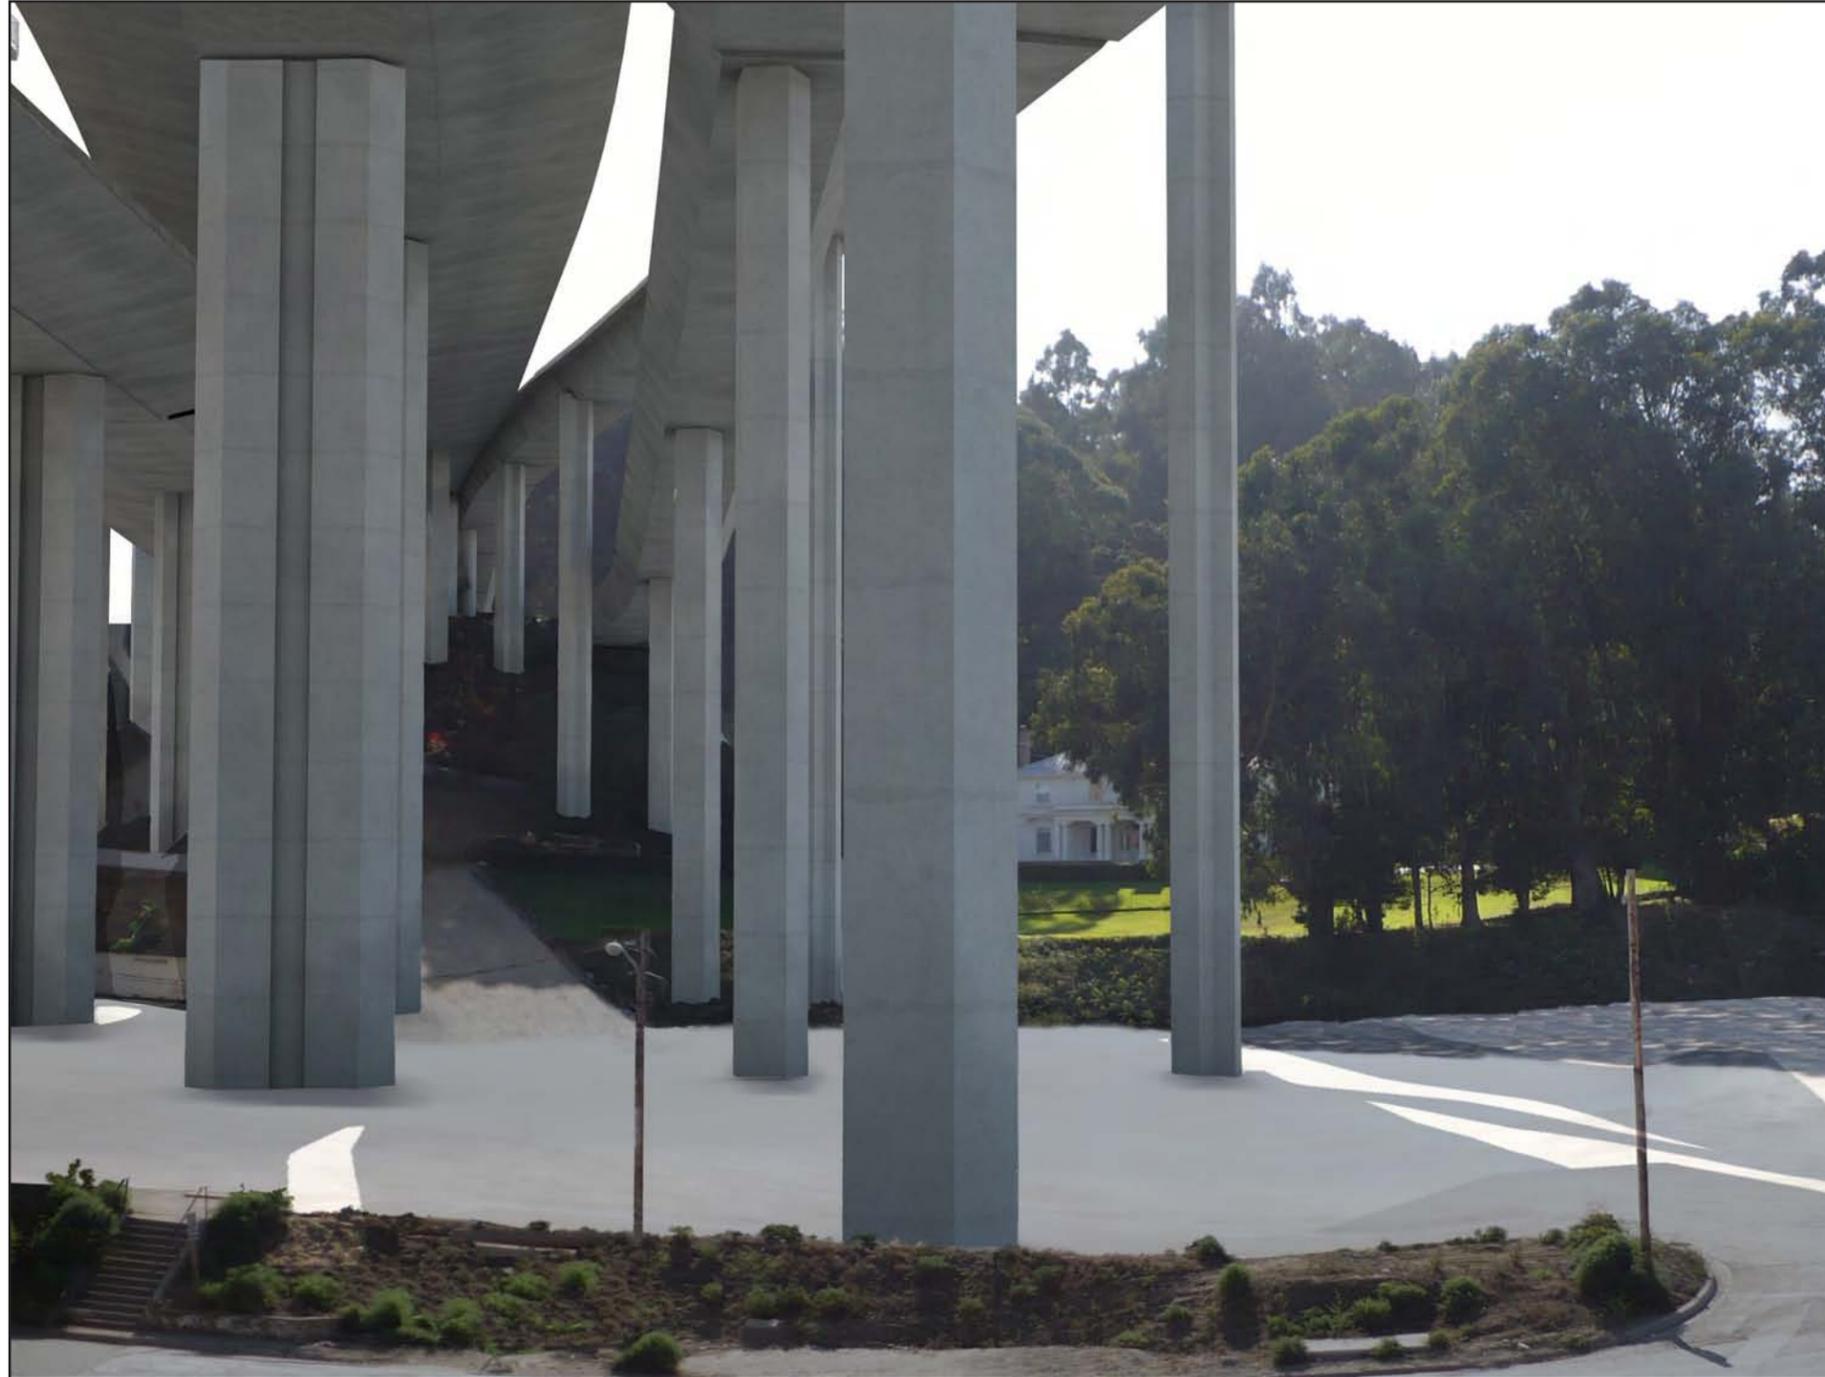
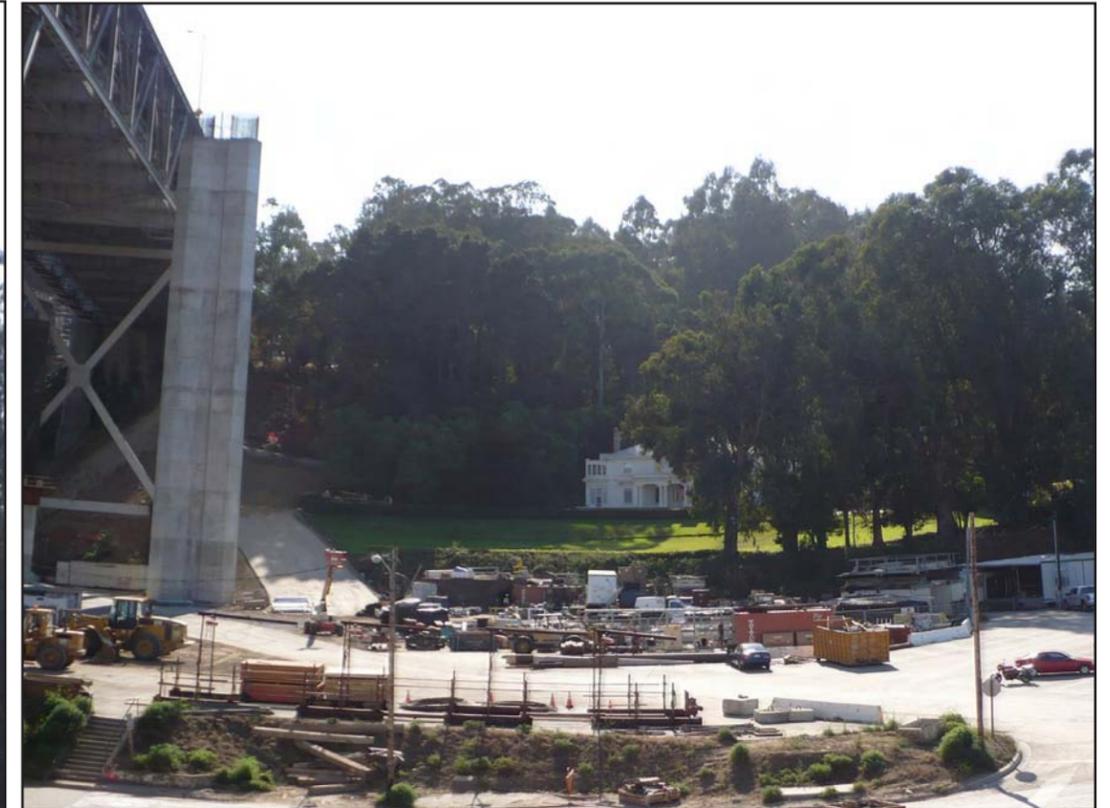
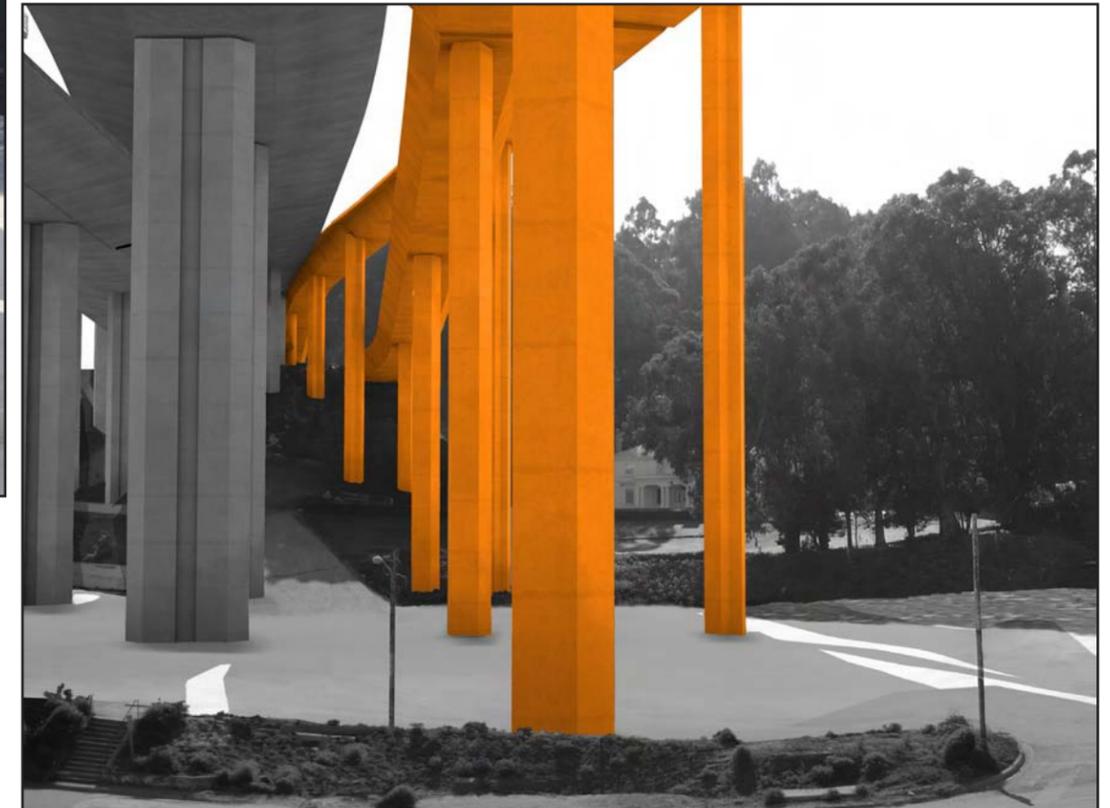
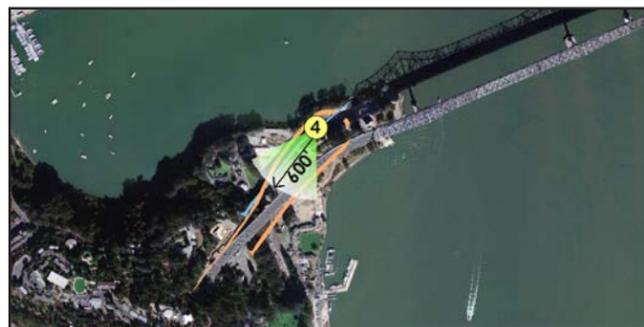
Figure 17: Alternative 4
Key Viewpoint 4: North Gate Road Staging Area

Simulated View

Existing view is a composite of two images, resulting in natural lens and perspective distortion. Perspective correction was used to produce the simulated view.

Alternative 4 Ramp Components: Orange highlighting distinguishes Alternative 4 ramp components from SFOBB East Span project components

Geographic Context
Indicates distance from viewpoint to
Alternative 4 ramp components

This key viewpoint is toward the southwest across a construction staging area located northeast of North Gate Road that is being used for the SFOBB East Span construction project. The Nimitz House and thick vegetation in its vicinity are visible in the background. **Figure 17** depicts a photo-simulation of Alternative 4 from this viewpoint.

In its present state, this viewpoint is characterized as having low unity and intactness. The disturbed nature of the area, which is attributed to construction of the SFOBB East Span, degrades the intactness and unity of the scene.

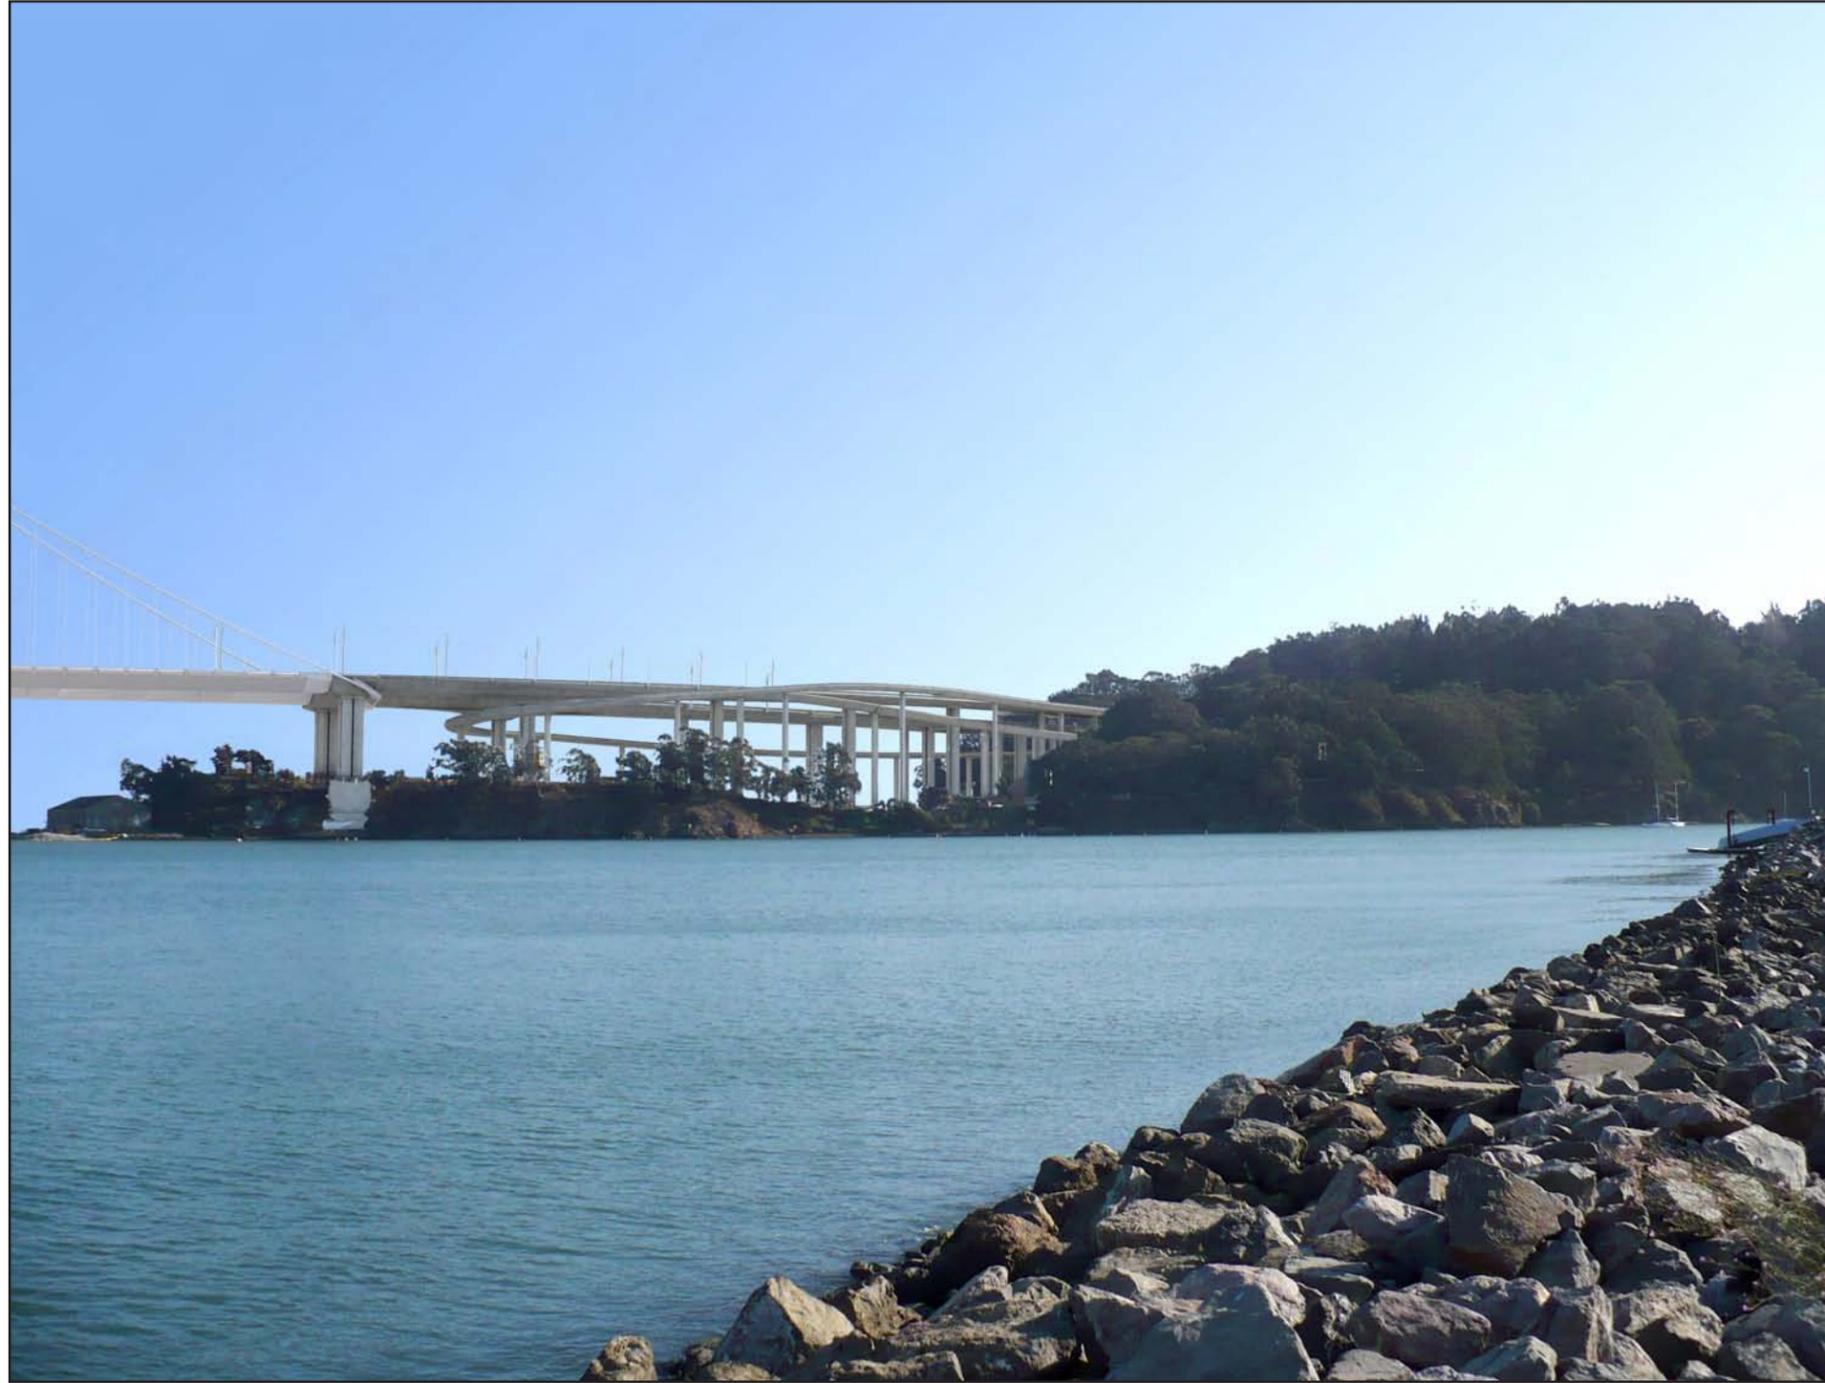
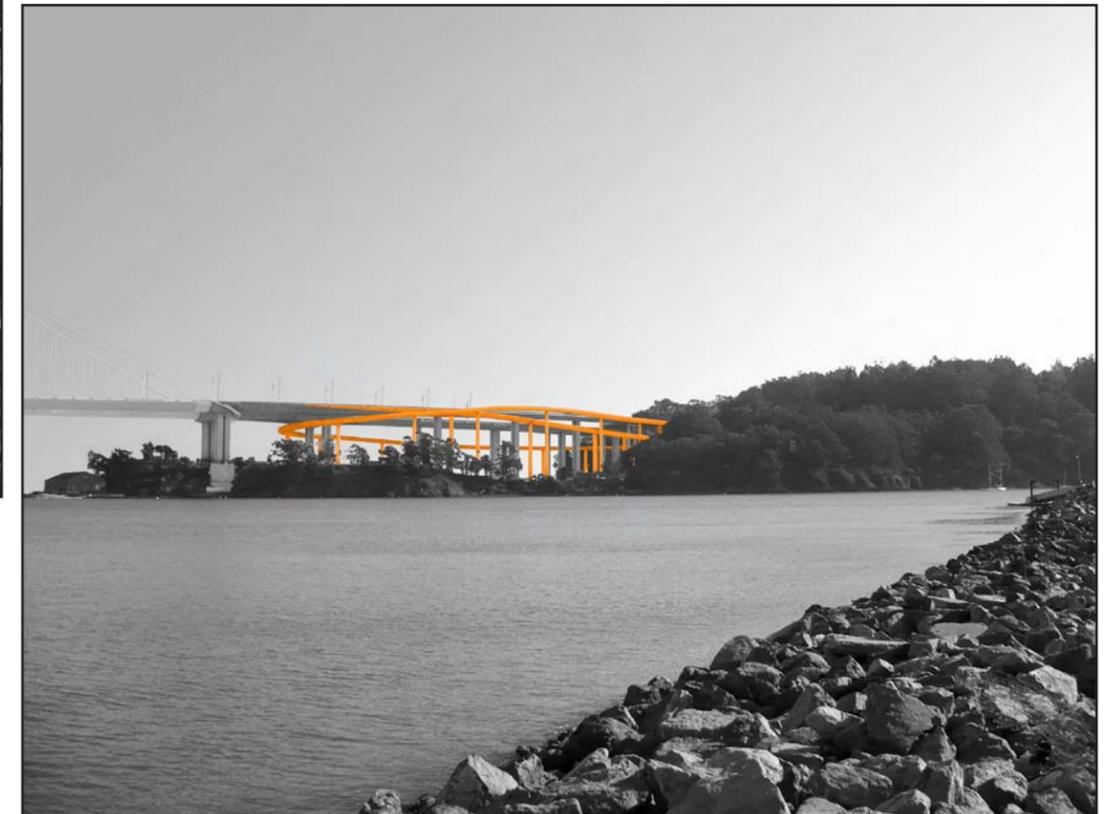
Figure 18: Alternative 4
Key Viewpoint 5: Treasure Island

Simulated View

Existing View

Alternative 4 Ramp Components: Orange highlighting distinguishes Alternative 4 ramp components from SFOBB East Span project components

Figure 18 depicts a photo-simulation of Alternative 4 from this viewpoint.

From this viewpoint, the island has moderate intactness and unity. Only portions of the island and the SFOBB East Span are visible to the viewer. However, the Bay waters do provide some sense of visual coherence and compositional harmony, balancing the lack of complete images of the island and the SFOBB.

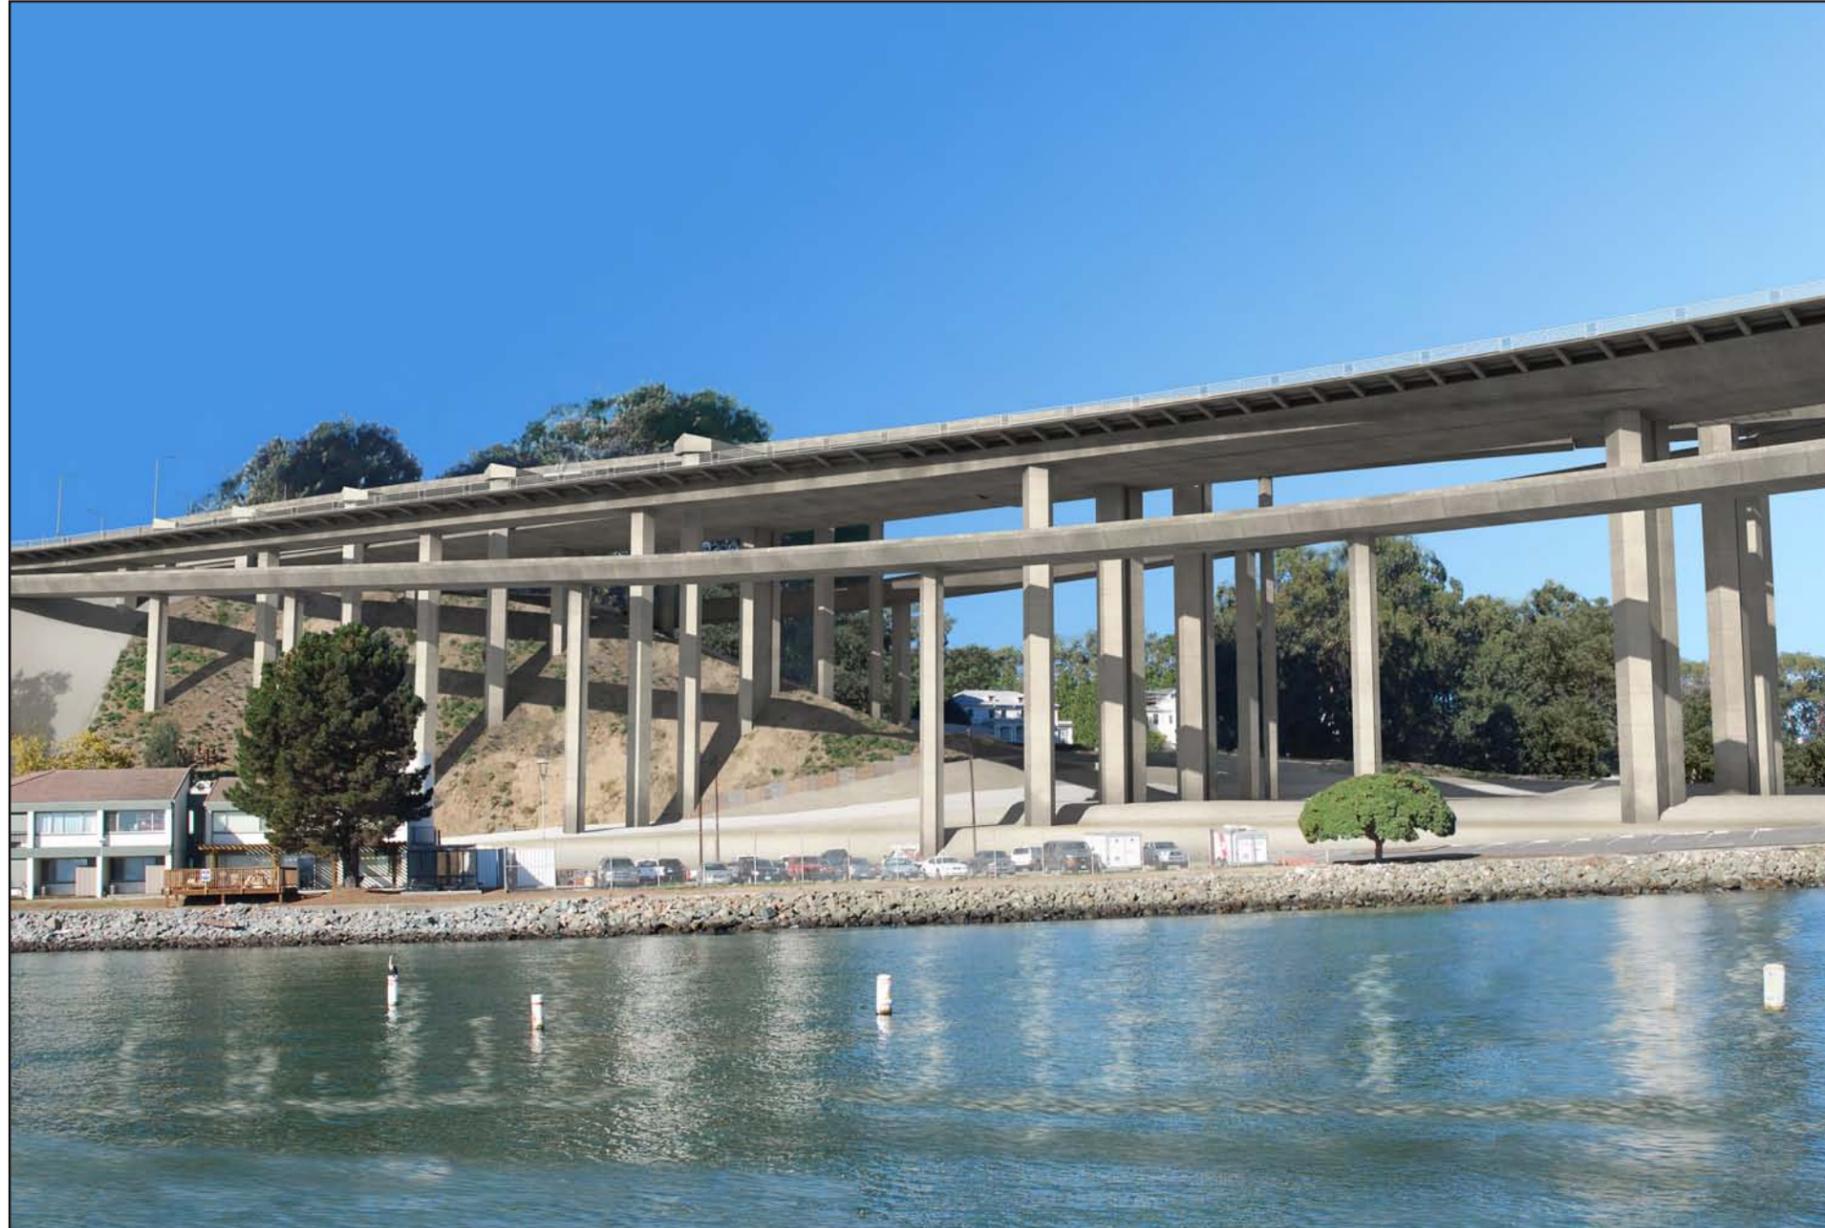
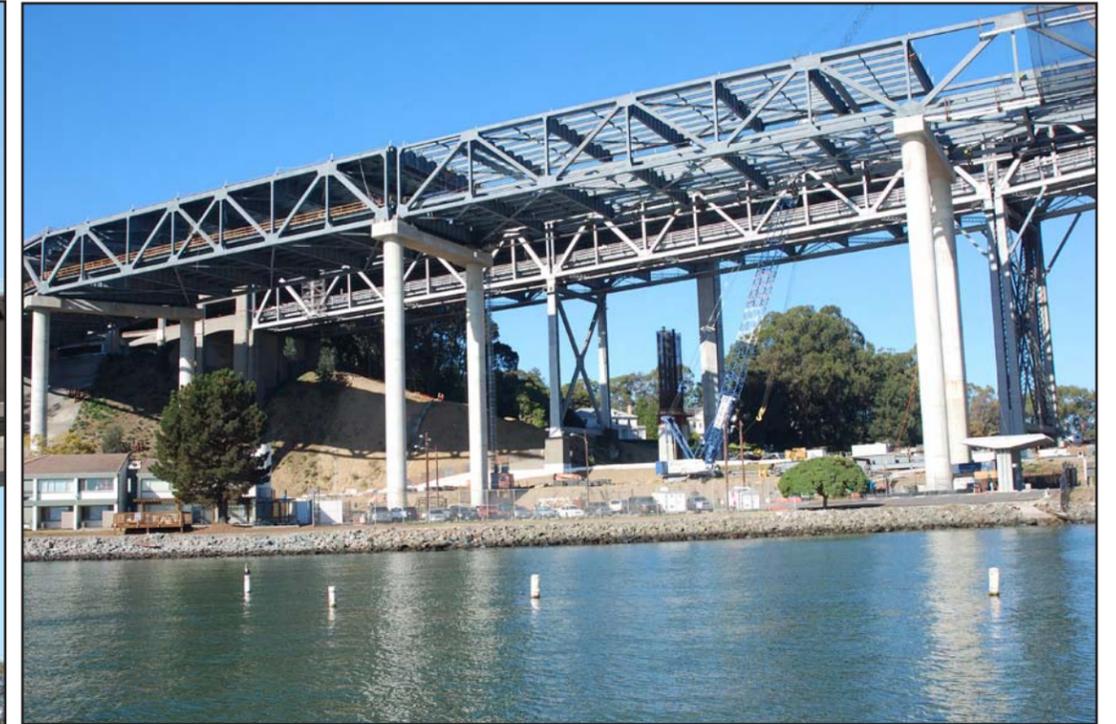
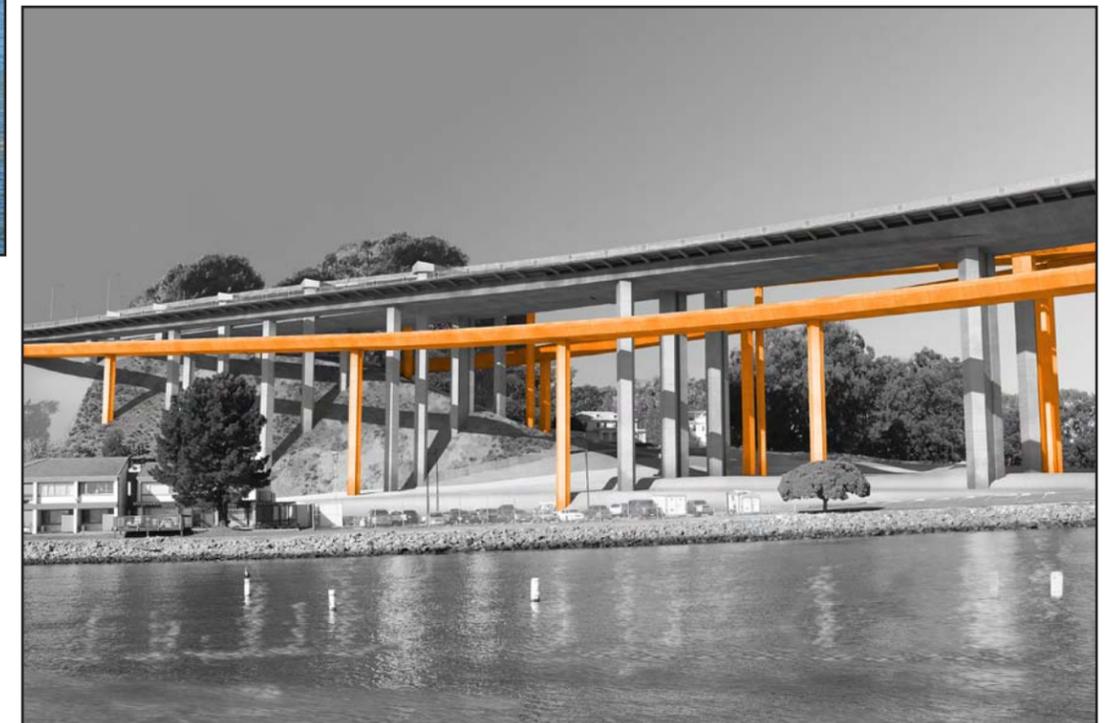
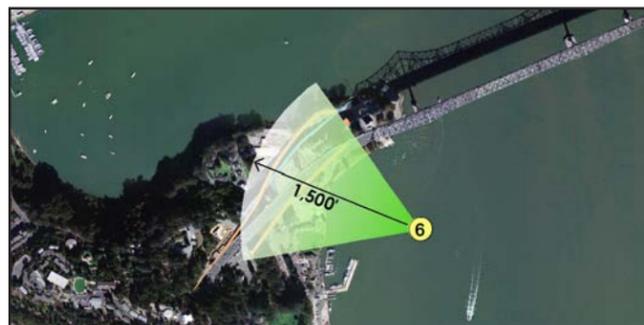
Figure 19: Alternative 4
Key Viewpoint 6: Eastern Yerba Buena Island Waterborne Approach

Simulated View

Existing View

Alternative 4 Ramp Components: Orange highlighting distinguishes Alternative 4 ramp components from SFOBB East Span project components

Geographic Context
Indicates distance from viewpoint to
Alternative 4 ramp components

This viewpoint illustrates a westward view of YBI as if on a waterborne approach to the island, from about 500 feet offshore. **Figure 19** depicts a photo-simulation of Alternative 4 from this viewpoint.

Overall Visual Quality: Alternative 4 would adversely affect the visual quality of the area. From a viewer's perspective, the on-ramp would cross their line of sight from left to right in front of the SFOBB Transition Structure while the off-ramp would pass behind the Transition Structure. The movement of the ramps has the effect of cluttering and "crowding out" the thin, simple lines of the Transition Structure. Compared to other viewpoints, relatively few people would observe this view. However, a number of these people would be involved in recreational boating activities that
