VISUAL IMPACT ASSESSMENT

**Yerba Buena Island
Ramps Improvement Project**

**District 04-SF-80
KP 12.3/13.2
EA 04-3A640**

**Caltrans District 4
Landscape Architecture**

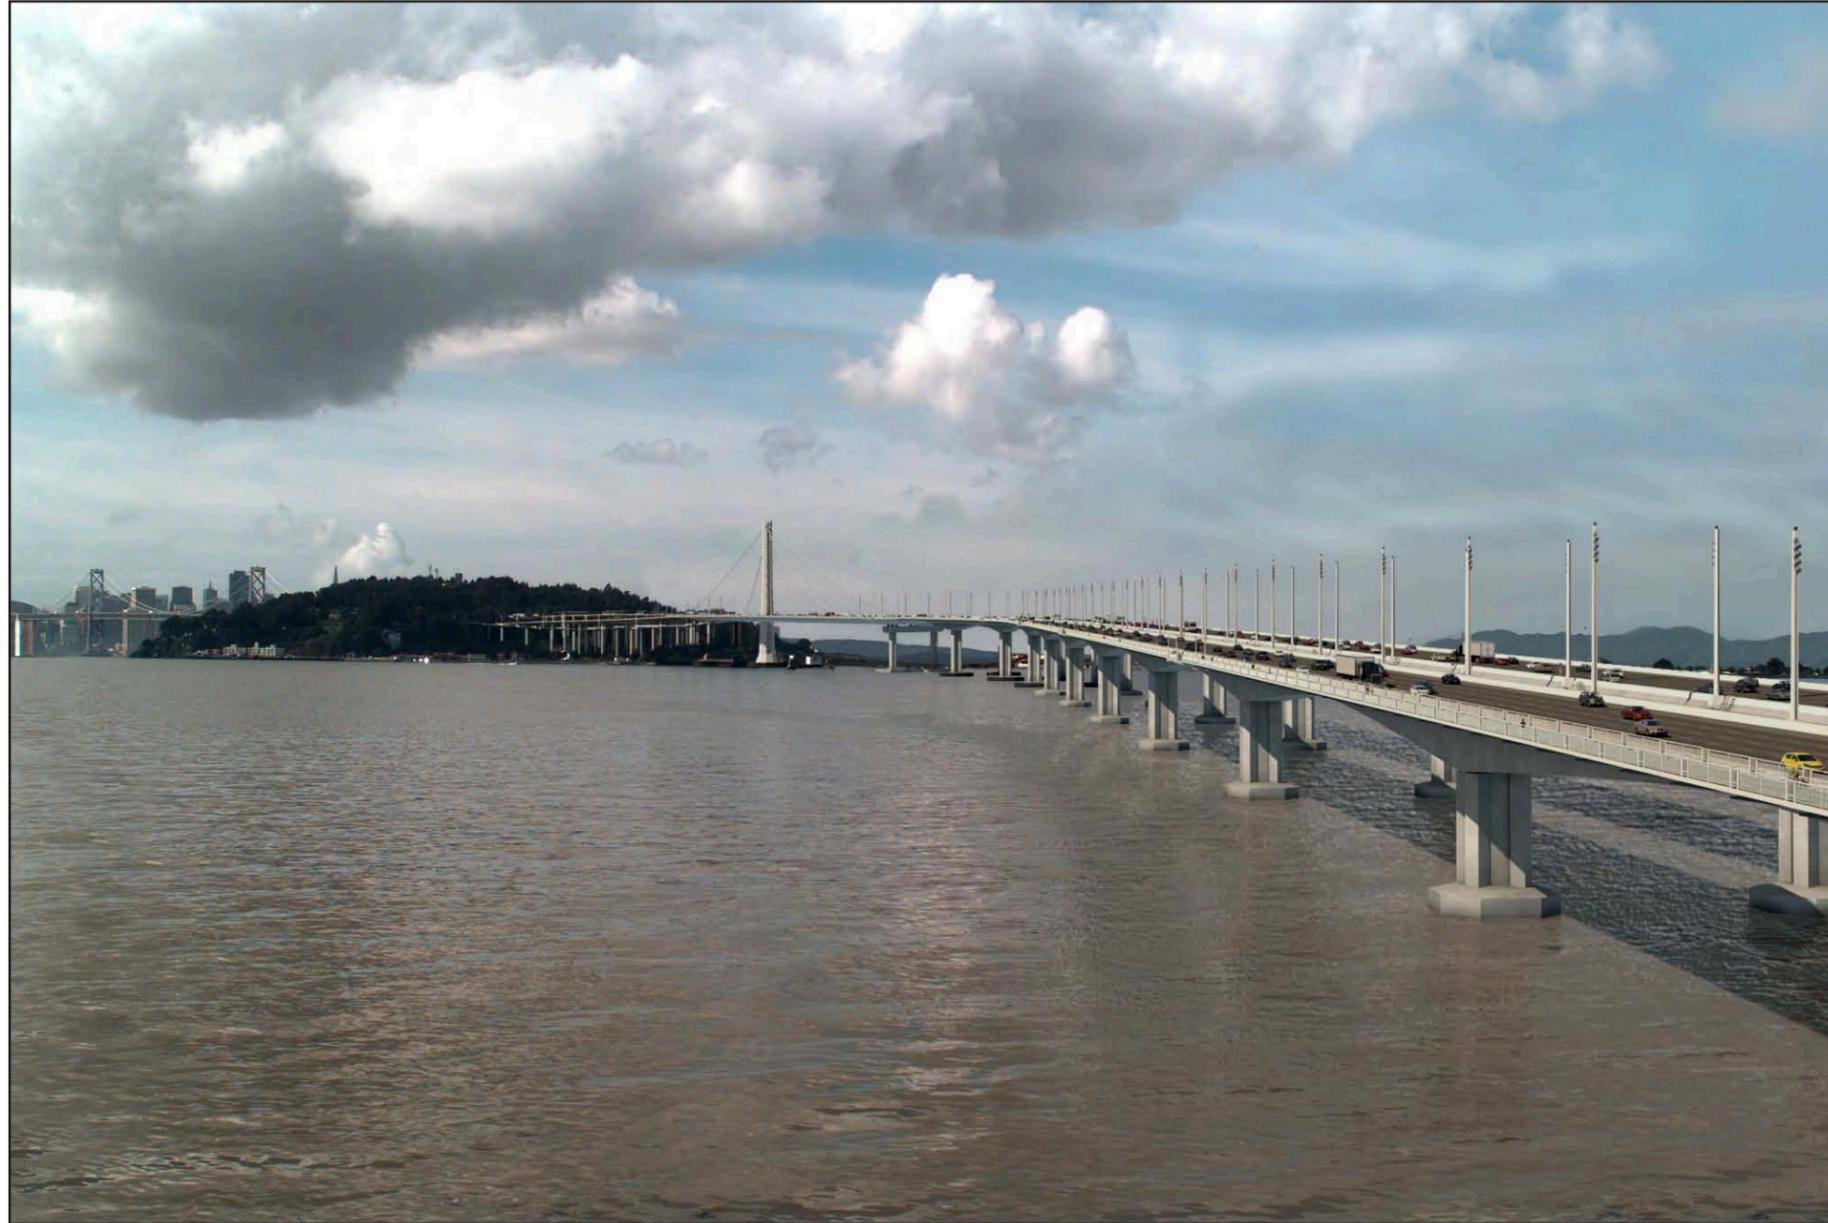
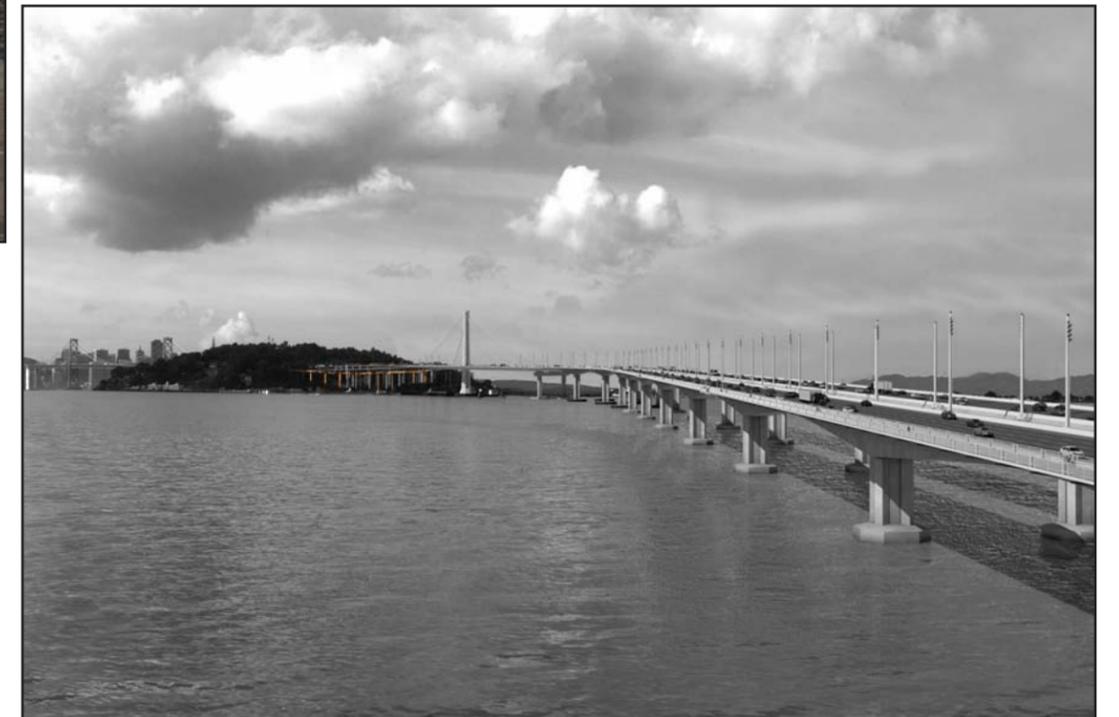
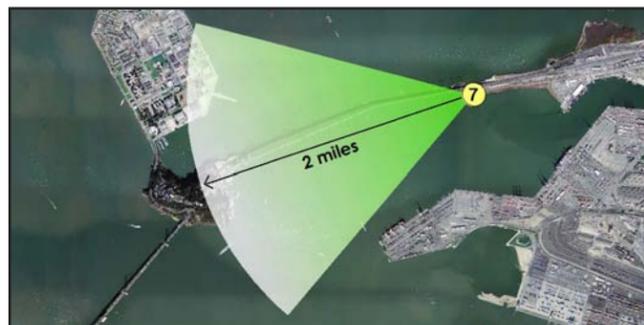
Figure 20: Alternative 4
Key Viewpoint 7: Oakland Touchdown

Simulated View

View prior to SFOBB east span and Alternative 4 construction

Alternative 4 Ramp Components: Orange highlighting distinguishes Alternative 4 ramp components from SFOBB East Span project components

Geographic Context
Indicates distance from viewpoint to
Alternative 4 ramp components

This key viewpoint looks west toward YBI from the SFOBB Oakland Touchdown area, which is located at a distance of about 1.25 miles from the island. **Figure 20** depicts a photo-simulation of Alternative 4 from this viewpoint.

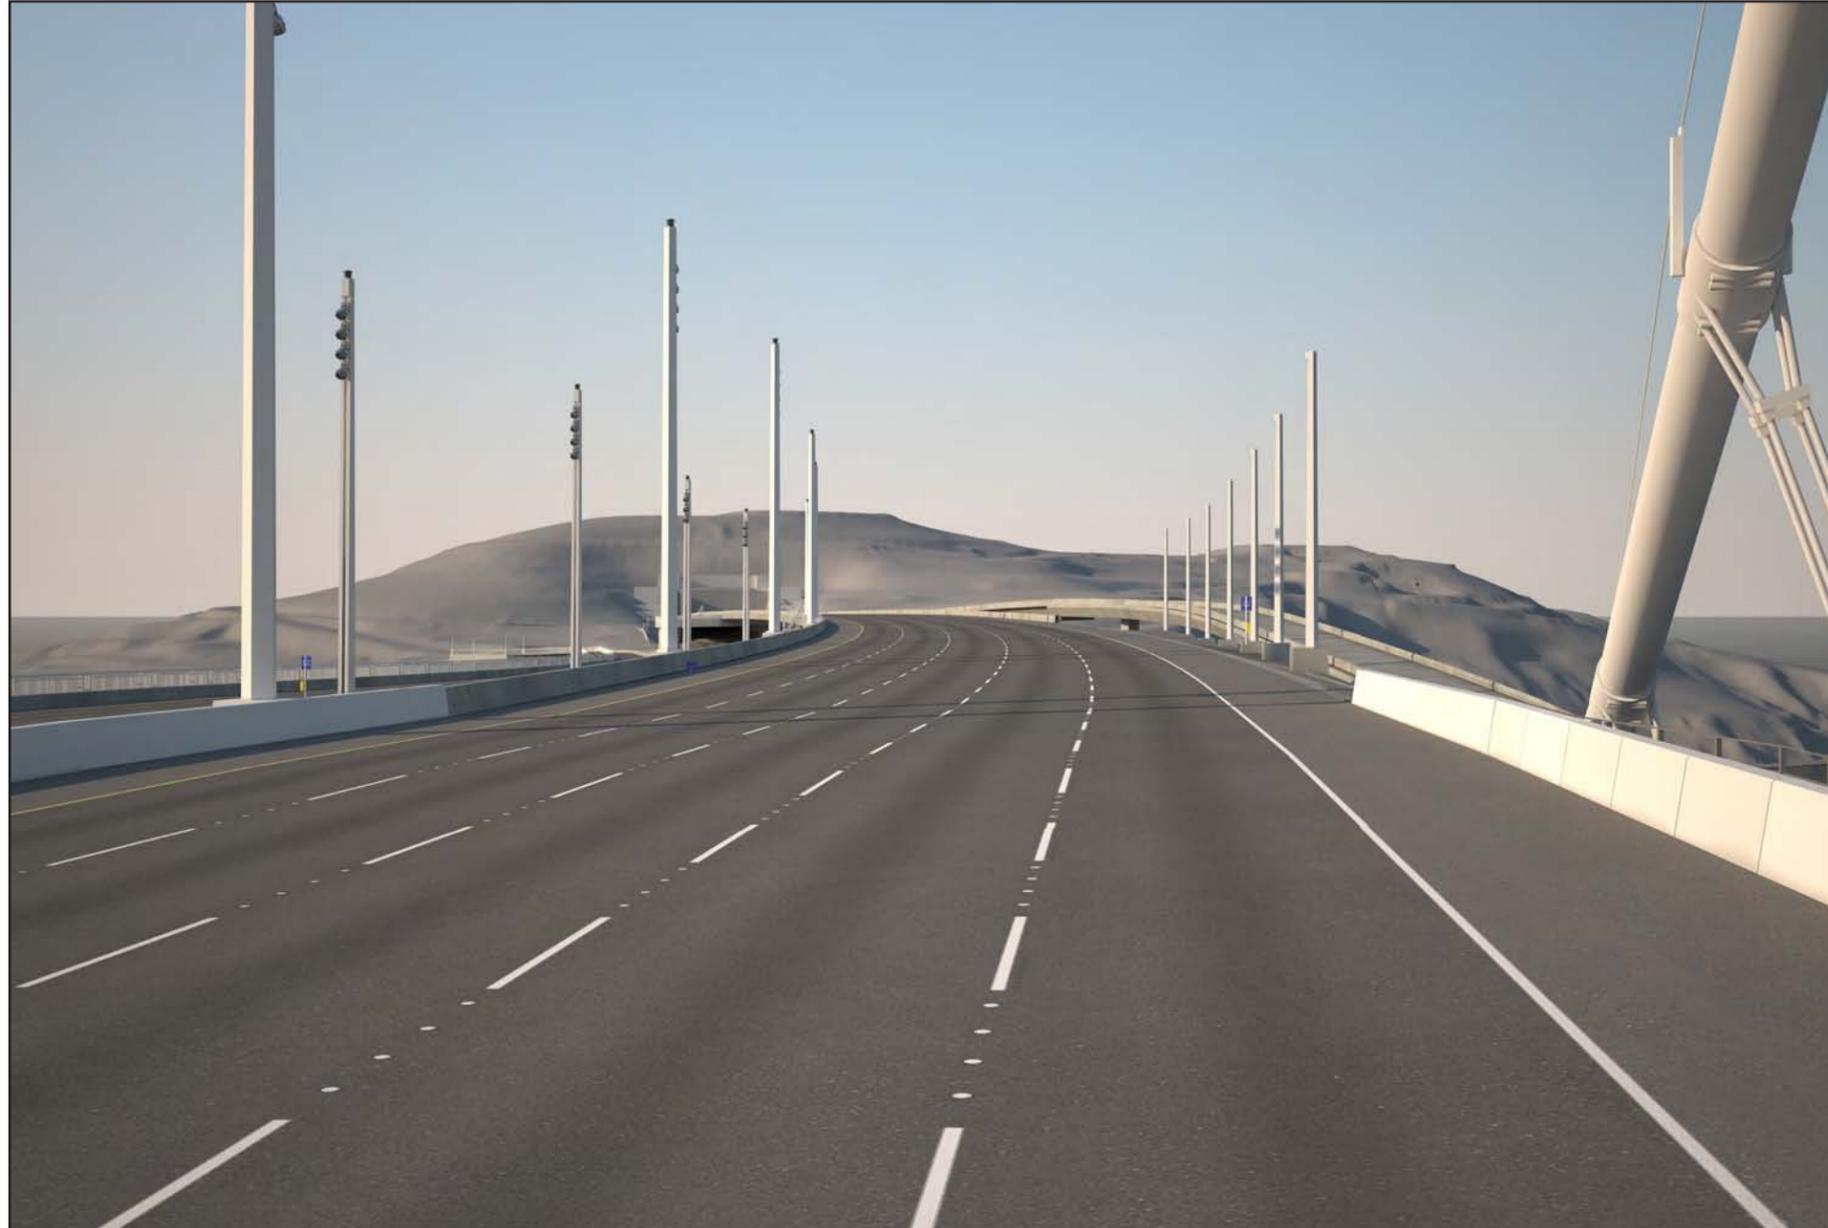
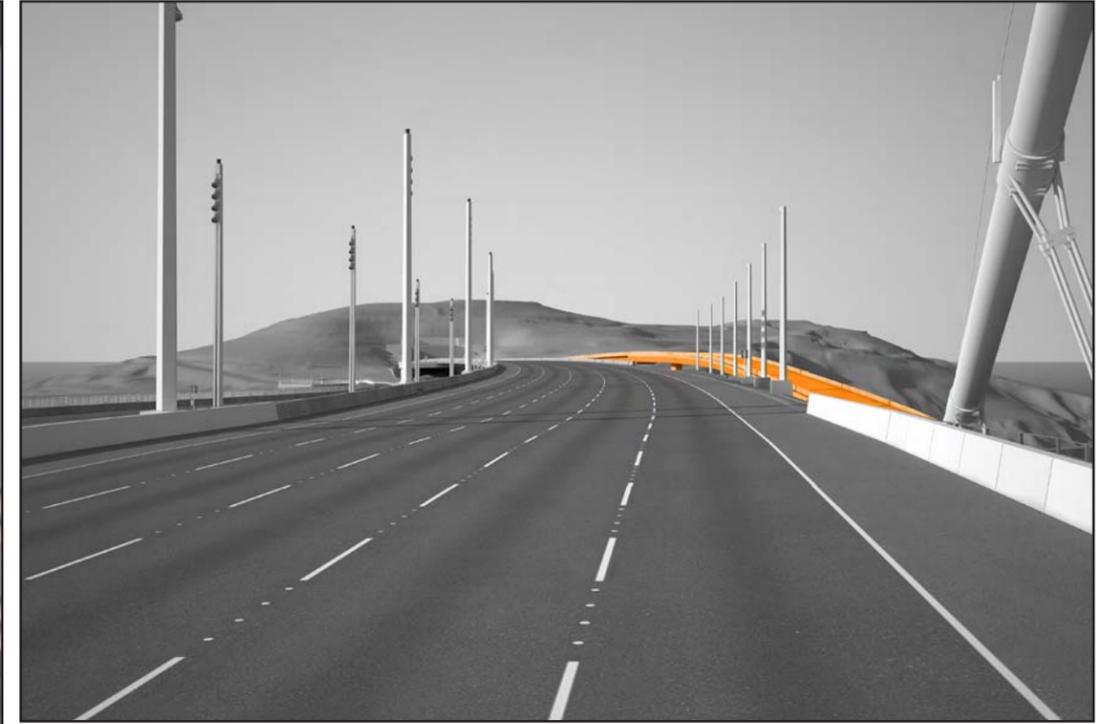
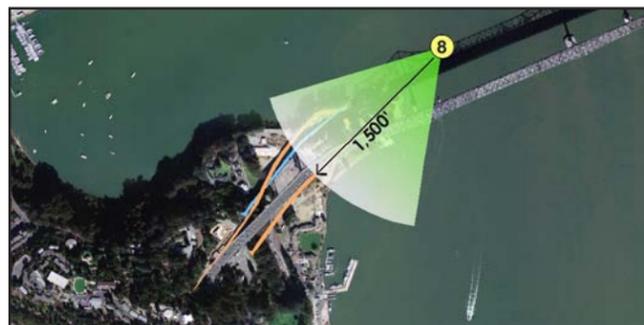
Figure 21: Alternative 4
Key Viewpoint 8: San Francisco-Oakland Bay Bridge Transition Structure

Rendered View

Alternative 4 Ramp Components: Orange highlighting distinguishes Alternative 4 ramp components from SFOBB East Span project components

Geographic Context
Indicates distance from viewpoint to
Alternative 4 ramp components

Because construction of the SFOBB East Span is not complete, and this viewpoint is from the roadway of the future East Span, it is not possible to describe the existing visual character of this viewpoint. Therefore, **Figure 21** shows only a rendering of the future view from this vantage point, rather than an image of an existing view followed by a photo-visual simulation as it would look after project implementation.

Visual Dominance: The on-ramp would be visible on the right side of the view as a motorist travels on the SFOBB East Span. From this location, the ramp would be visible but subordinate to other elements of the setting.

View Obstruction: The on-ramp would partially obstruct views toward YBI. However, the level of obstruction attributable to the ramp would be relatively minimal compared to the obstruction caused by the SFOBB East Span.
