Roadway Barrier Curb Investigation

State of California
Department of Public Works
Division of Highways
Materials and Research Department

Submitted herewith are the pertinent data and results of an investigation aimed at determining the relative efficiency of eleven different designs of barrier type highway curbs.

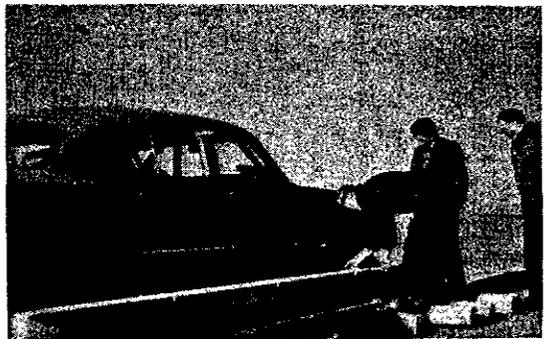
Automobile mechanic checked wheel alignment by use of illustrated frame at conclusion of each test run.

The mechanic immediately made a complete check of the car and appraised the damage caused by the particular test collision. The car was then taken to the alignment frame and an accurate check made of the alignment and camber measurements. The car was then immediately repaired either by replacing or repairing the damaged part.
