***Moisture Damage?  
The Mastic Matters!***

***National Moisture Damage  
Workshop***

***San Diego  
February - 2003***

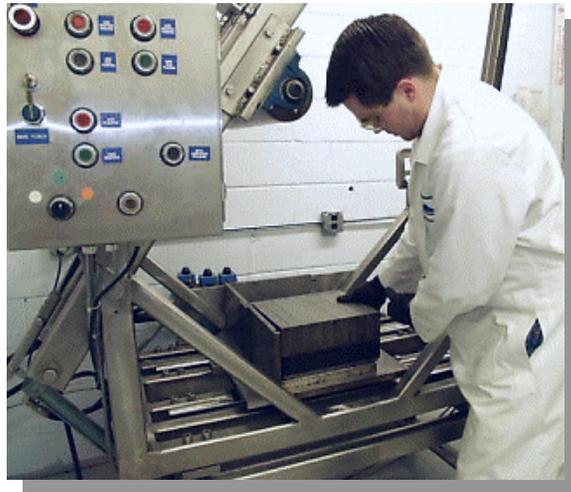
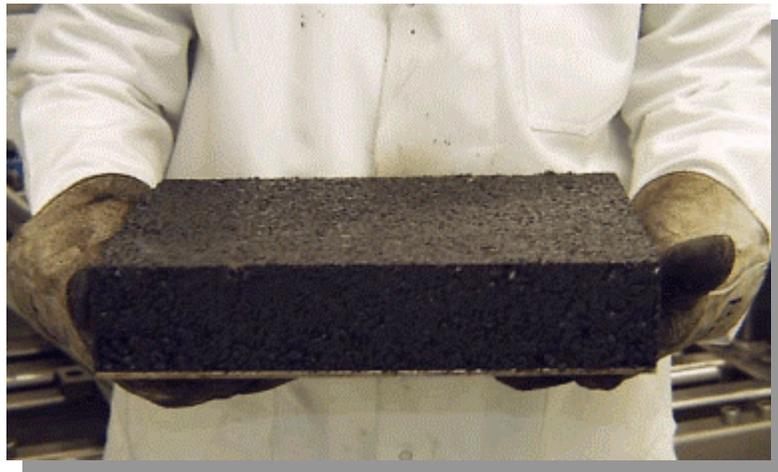
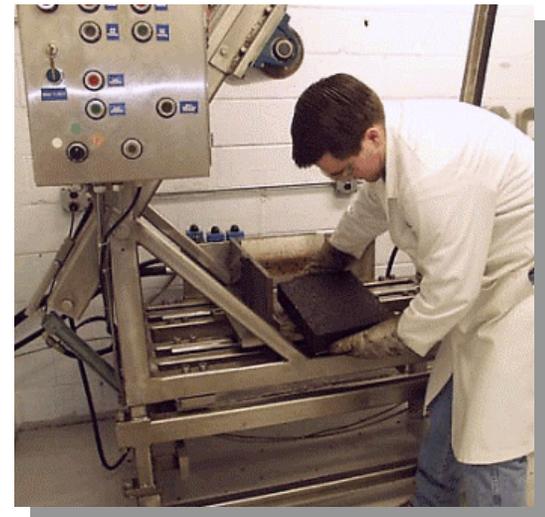
# *Linear Kneading Compactor*

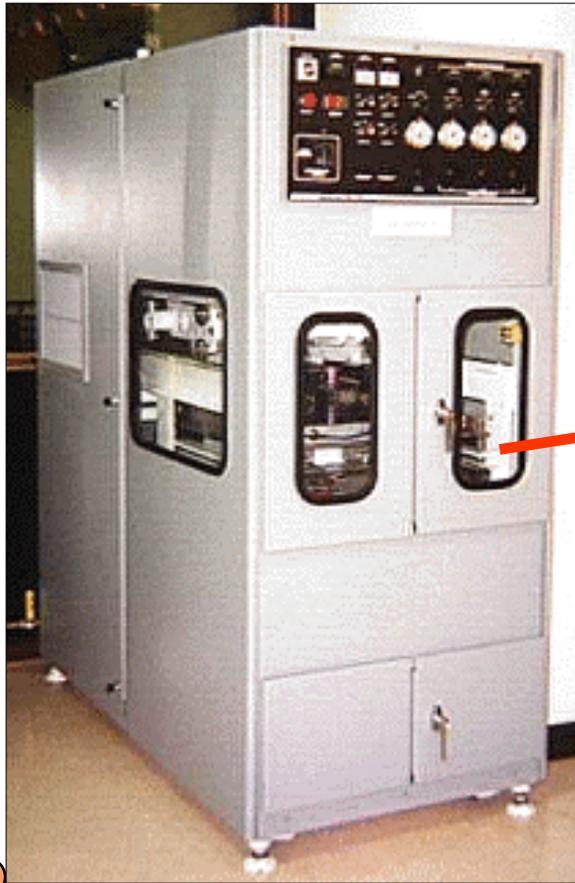
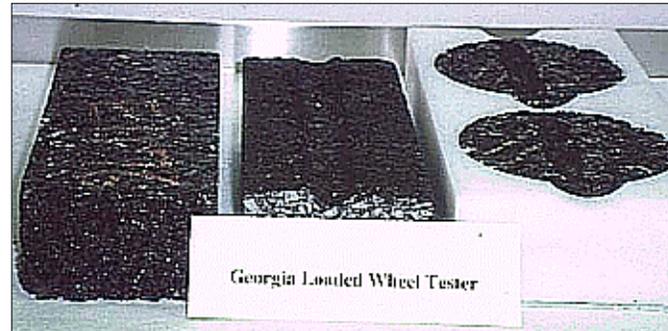
# *Asphalt Pavement Analyzer*
