A Report of A Survey of Earth-Borne Traffic Vibrations
Adjacent to a Private Home

May 1962

State of California
Department of Public Works
Division of Highways

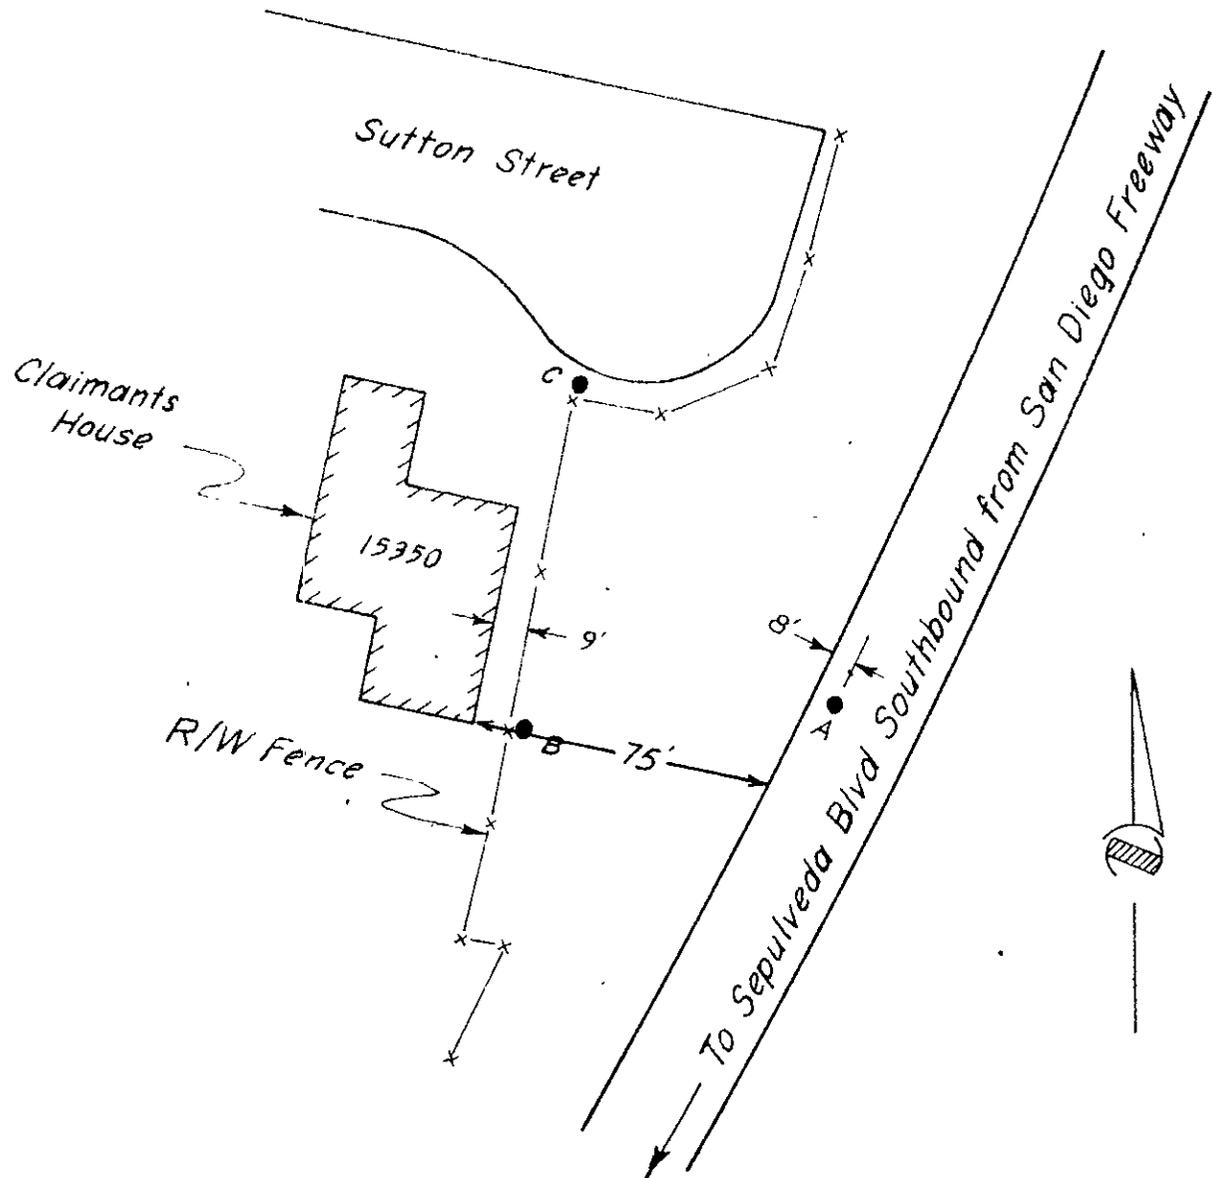
EXHIBIT 1

THREE SIMULTANEOUS VERTICAL
VIBRATION MEASUREMENT LOCATIONS
AT 15350 SUTTON STREET
ROAD VII-LA-158-LA(10)

- Vibration Tester Locations
Vibration Testers B & C are 6" from fence line

Vibration testers were located as shown on Exhibits 1 and 2. Simultaneous vertical vibrations were recorded for Locations A, B, and C, Exhibit 1, each time a heavy truck passed the claimant's house. Similarly, two vibration testers were later moved to Locations D and E, Exhibit 2, and simultaneous vertical vibrations were recorded each time a heavy truck passed the claimant's house.

Location of one vibration tester on the traveled roadway at "A" was to monitor the magnitude of the vibrations close to the source and vibration tester Locations B, C, D, and E measured the attenuated effects of the vibrations in the house vicinity.

Exhibit 3 tabulates the earth-borne vibration records of 18 vehicles passing the claimant's house with the transmitted vibration effect at the right-of-way fence. The exhibit shows that the largest vibration was due to a van line truck, Run #15, with a peak to peak displacement of 0.000060" at a frequency of 25 cps. This vibration was not transmitted to the fence line Location B. The largest vibration at the fence line, Location B, was 0.000030 inches at 28 cps. The earth-borne vibrations are extremely small at the fence line Location B and unmeasurable at Location C with our instruments.

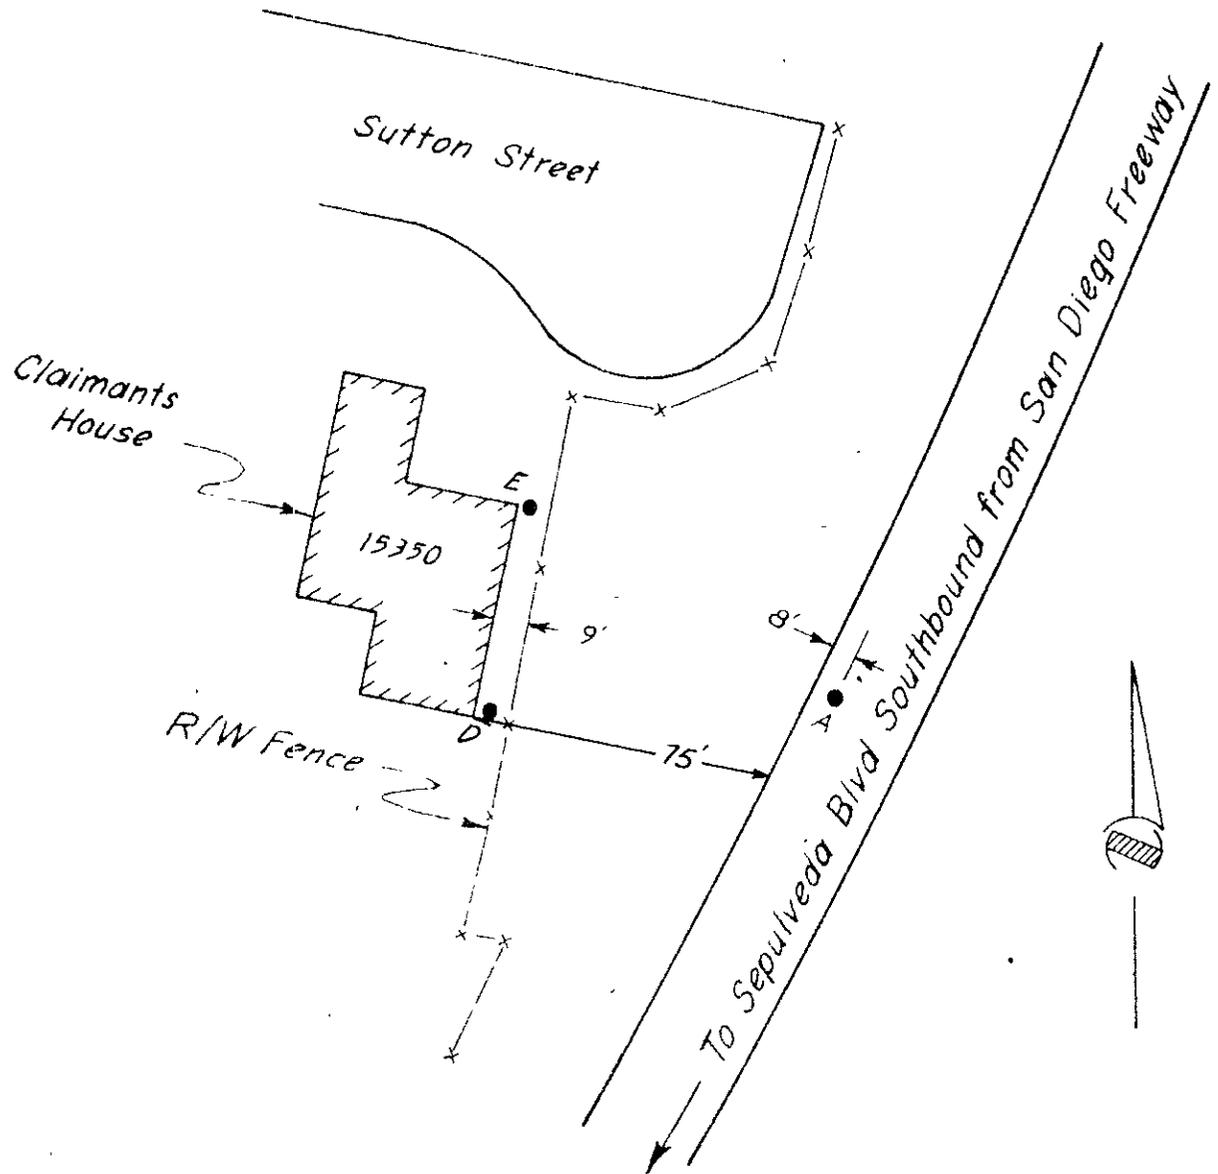
EXHIBIT 2

THREE SIMULTANEOUS VERTICAL
VIBRATION MEASUREMENT LOCATIONS
AT 15350 SUTTON STREET
ROAD VII-LA-158-LA(10)
Scale 1" = 50'

- Vibration Tester Locations
Vibration Testers D & E are 6" from edge of house

Exhibit 4 tabulates the vibration testers at Locations A, D, and E. Exhibit 4 shows that earth-borne vibrations from approach zero and were unmeasurable at the claimant's house corners.

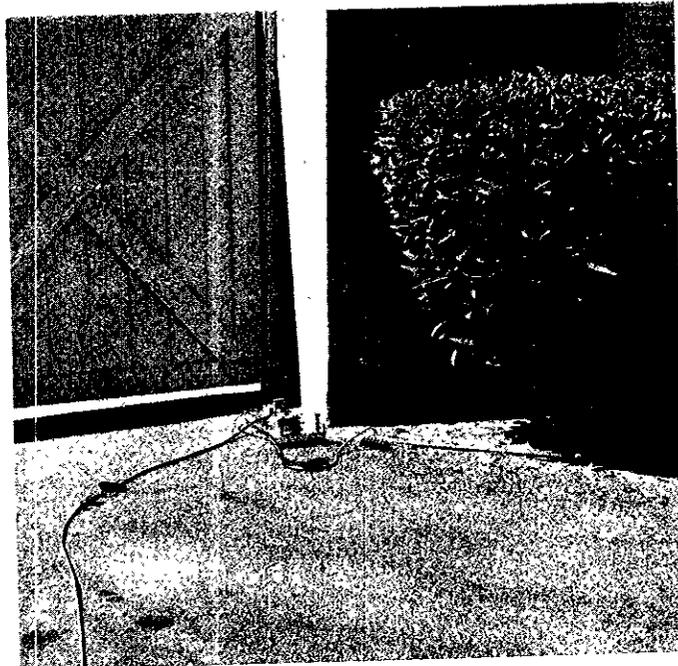
Simultaneous recordings of horizontal, transverse and vertical vibrations with respect to the roadway were made at Location E with three vibration testers. No tabulations are shown for these recordings as the vibrations were recorded as zero.

Exhibits 5 and 6 are photographs of the vibration tester locations. Exhibit 7 is an over-all view of the claimant's house from the roadway.

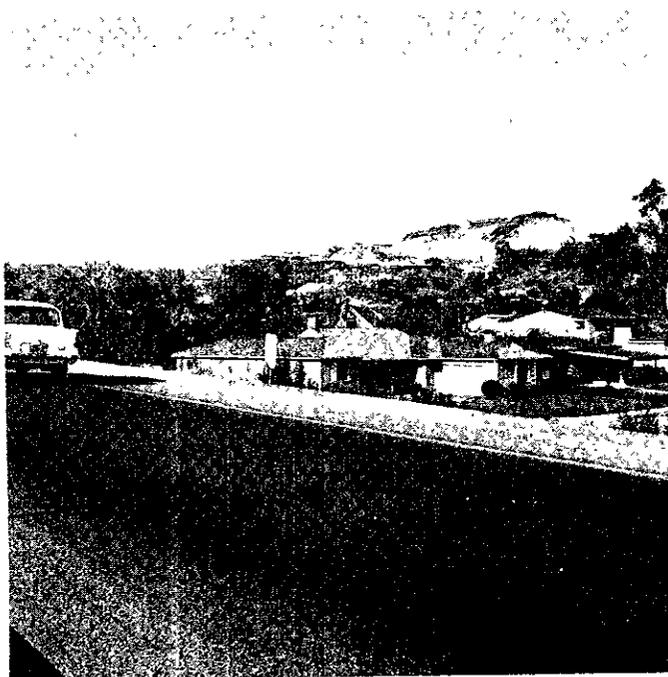
Over-all view of claimant's house from the roadway.
