Findings from the Use of Compensated Shrinkage Portland Cement in the Lodi Freeway Experimental Pavement

June 1965

State of California  
Highway Transportation Agency  
Department of Public Works  
Division of Highways  
Materials and Research Department

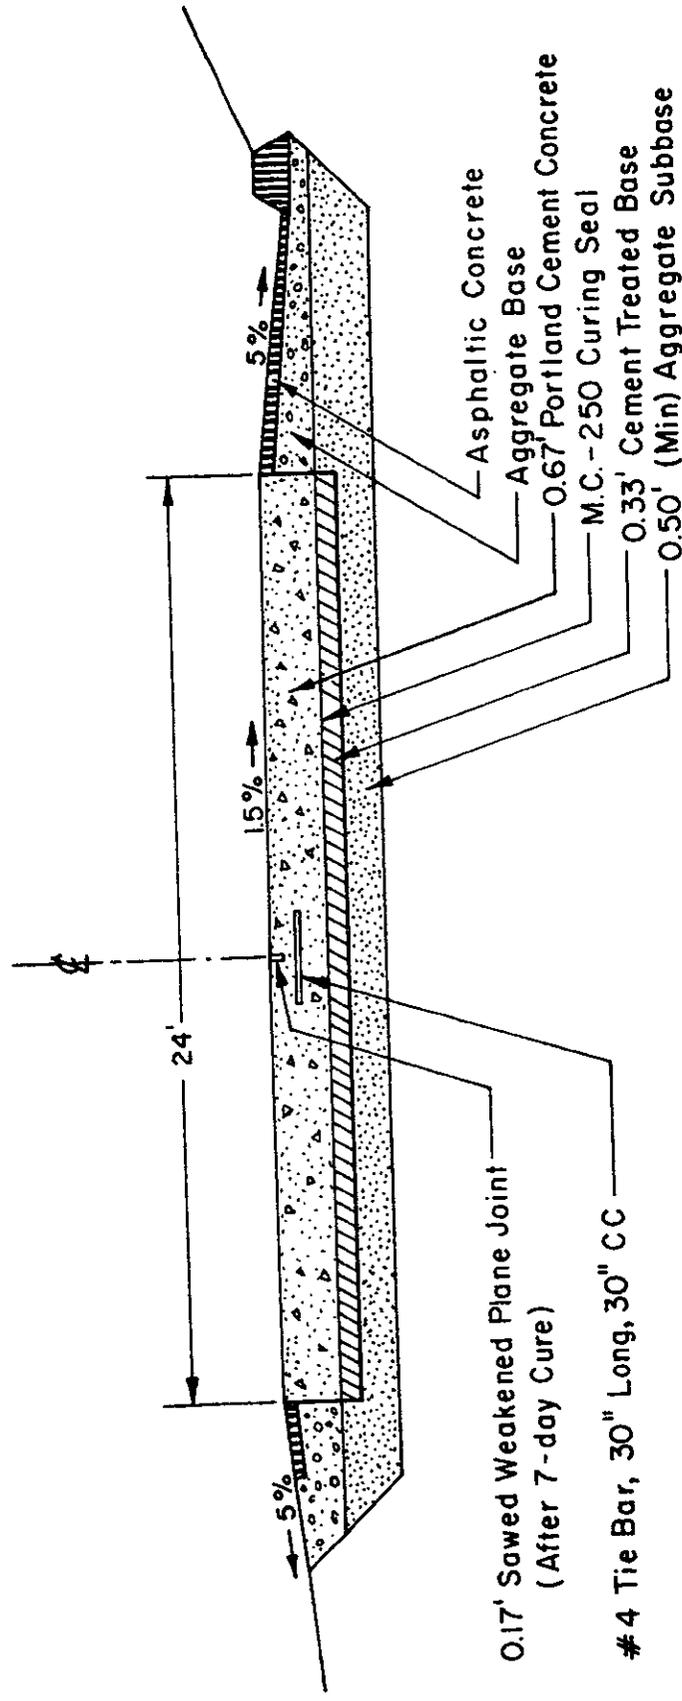
Figure 1-A

TYPICAL PAVEMENT CROSS SECTION

0.17' Sawed Weakened Plane Joint  
(After 7-day Cure)  
#4 Tie Bar, 30" Long, 30" CC

- A. The experimental section was to consist of six 1/4-mile units with different mix designs. (Refer to the "As Constructed" plan of the test section, Figure 1, and the "Typical Pavement Cross-Section", Figure 1-A.)

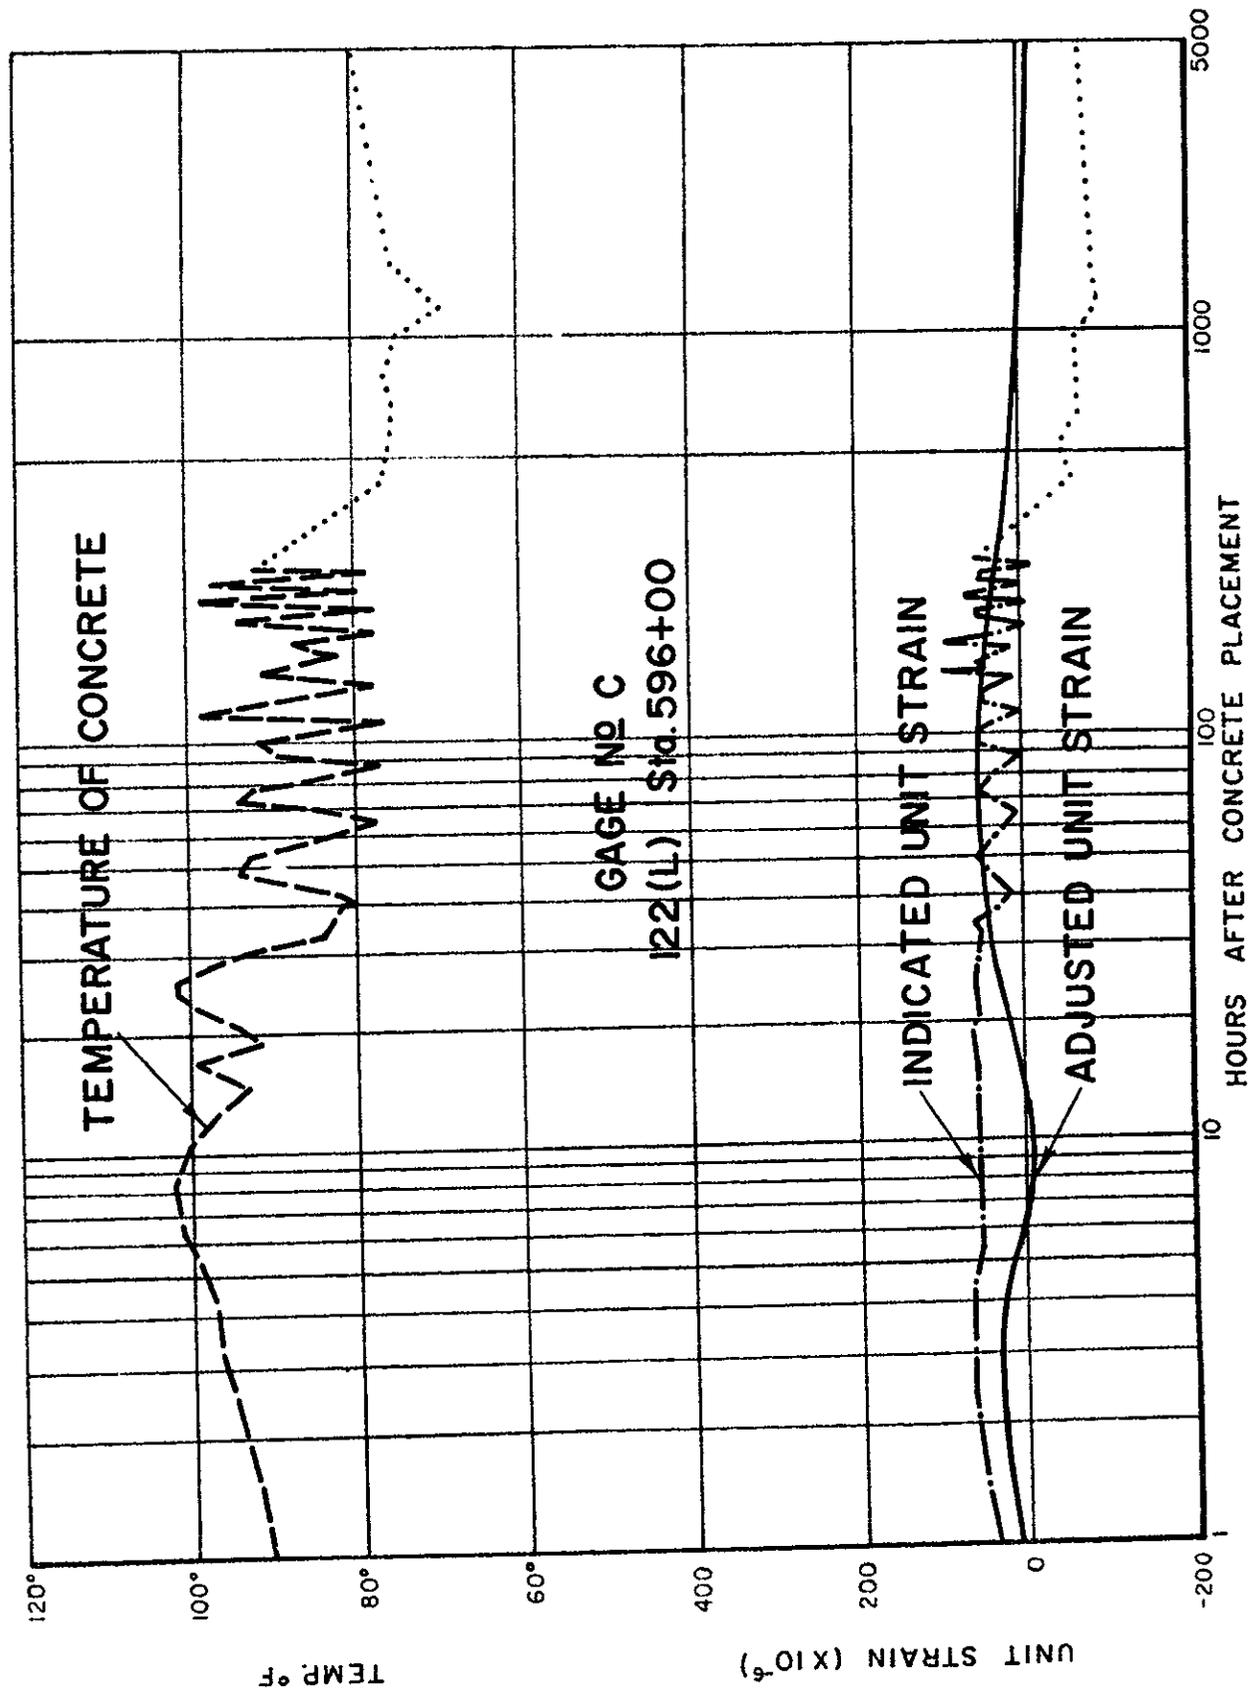
FIGURE 2

# CARLSON GAGE DATA - LODI FREEWAY

EXPERIMENTAL SECTION (UNIT A)

The Carlson strain gage data plotted versus time are shown in Figures 2 through 7. These curves show the temperature of the concrete and the unit strain. The "Indicated Unit Strain" curve was adjusted for thermal movements of the concrete, using an arbitrary coefficient of thermal expansion of  $5.5 \times 10^{-6}$  inches/inch/degree F. Thus, the "Adjusted Unit Strain" curves show the approximate net strain that can be attributed to the volume change caused essentially by the action of the expanding concrete. It will be noted that the major portion of the total expansion measured occurred within the first 24 hours after placement of the concrete.

The strain gage data obtained on this project correspond closely with those from the Antelope Valley Freeway project. In the compensated shrinkage cement units, the greatest amount of movement took place in the transverse and vertical directions. There was virtually no movement indicated in the longitudinal direction in any of the six units. No significant difference was noted in the expansion which took place in the air-entrained units as compared to the non-air-entrained units.

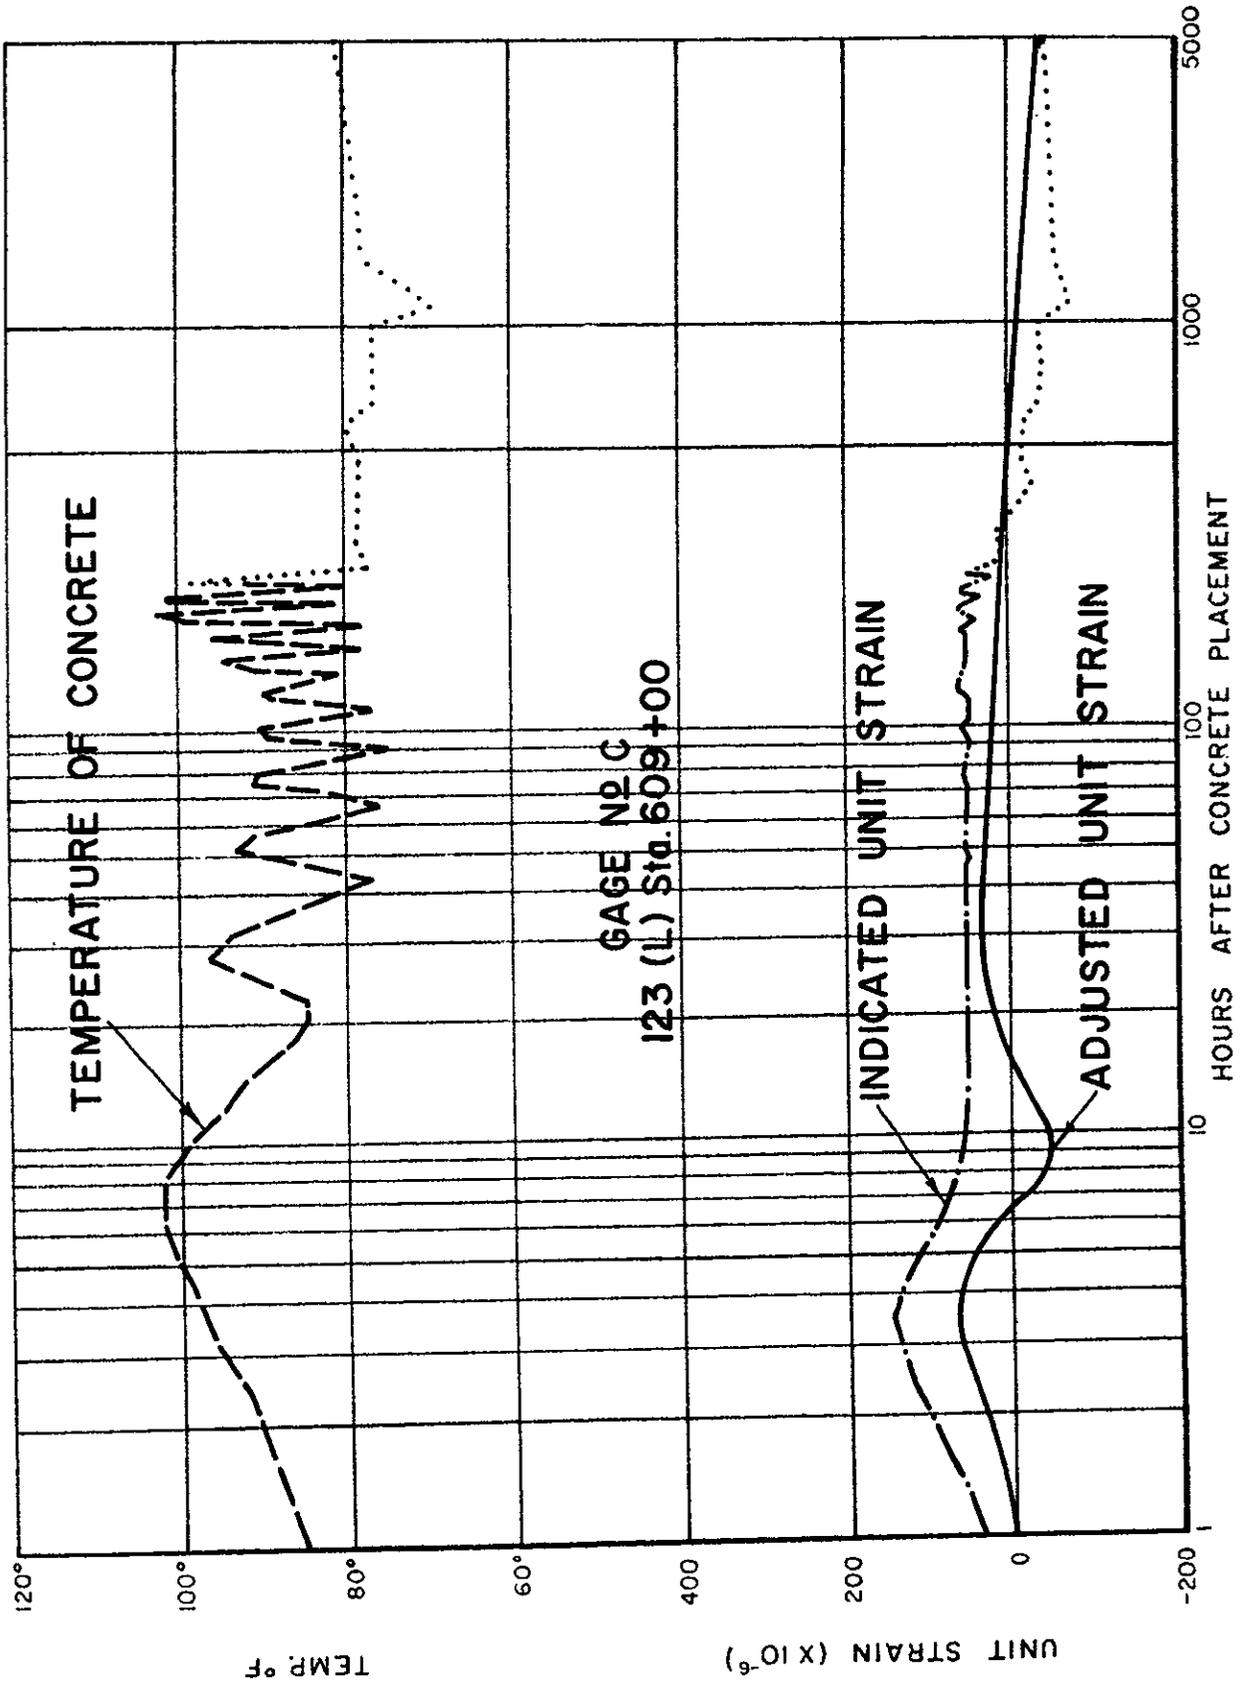
FIGURE 3

# CARLSON GAGE DATA -- LODI FREEWAY

EXPERIMENTAL SECTION (UNIT B)

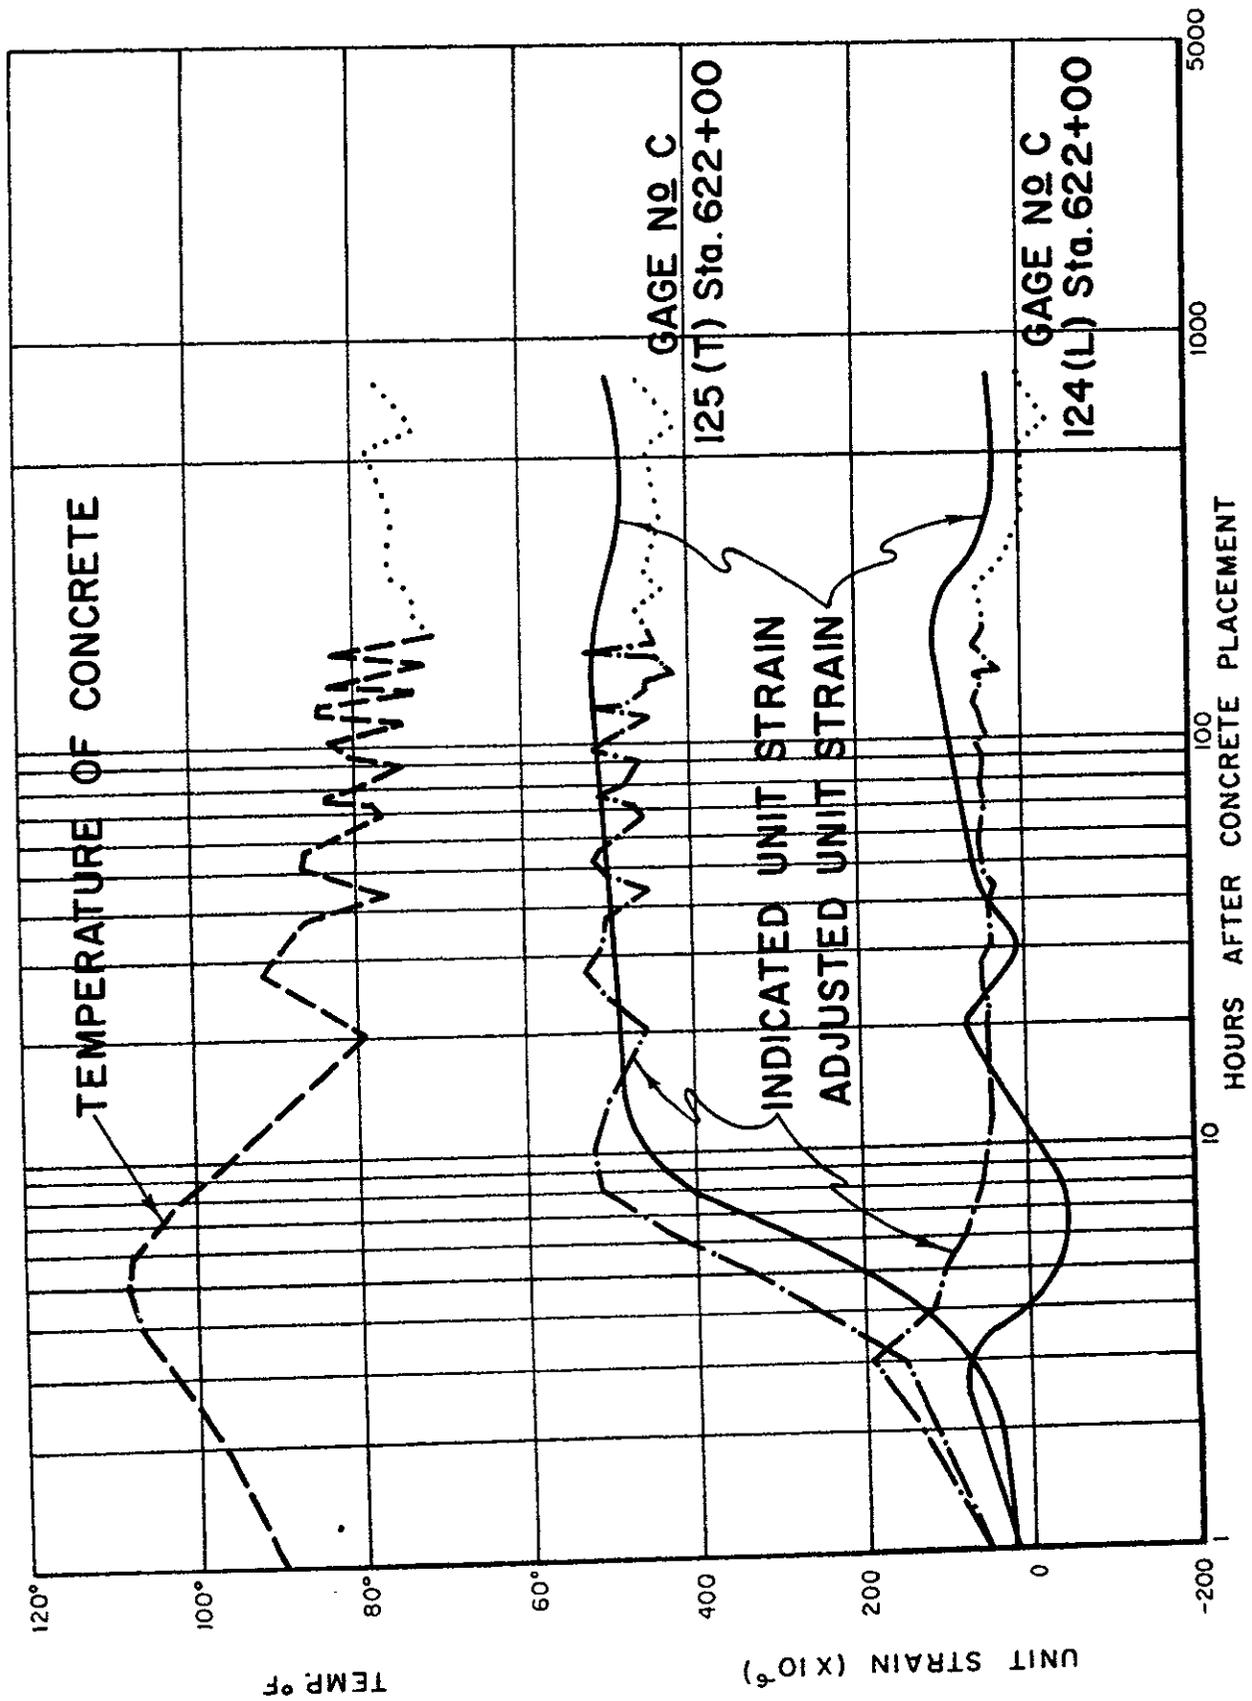
FIGURE 4

# CARLSON GAGE DATA - LODI FREEWAY

EXPERIMENTAL SECTION (UNIT C)

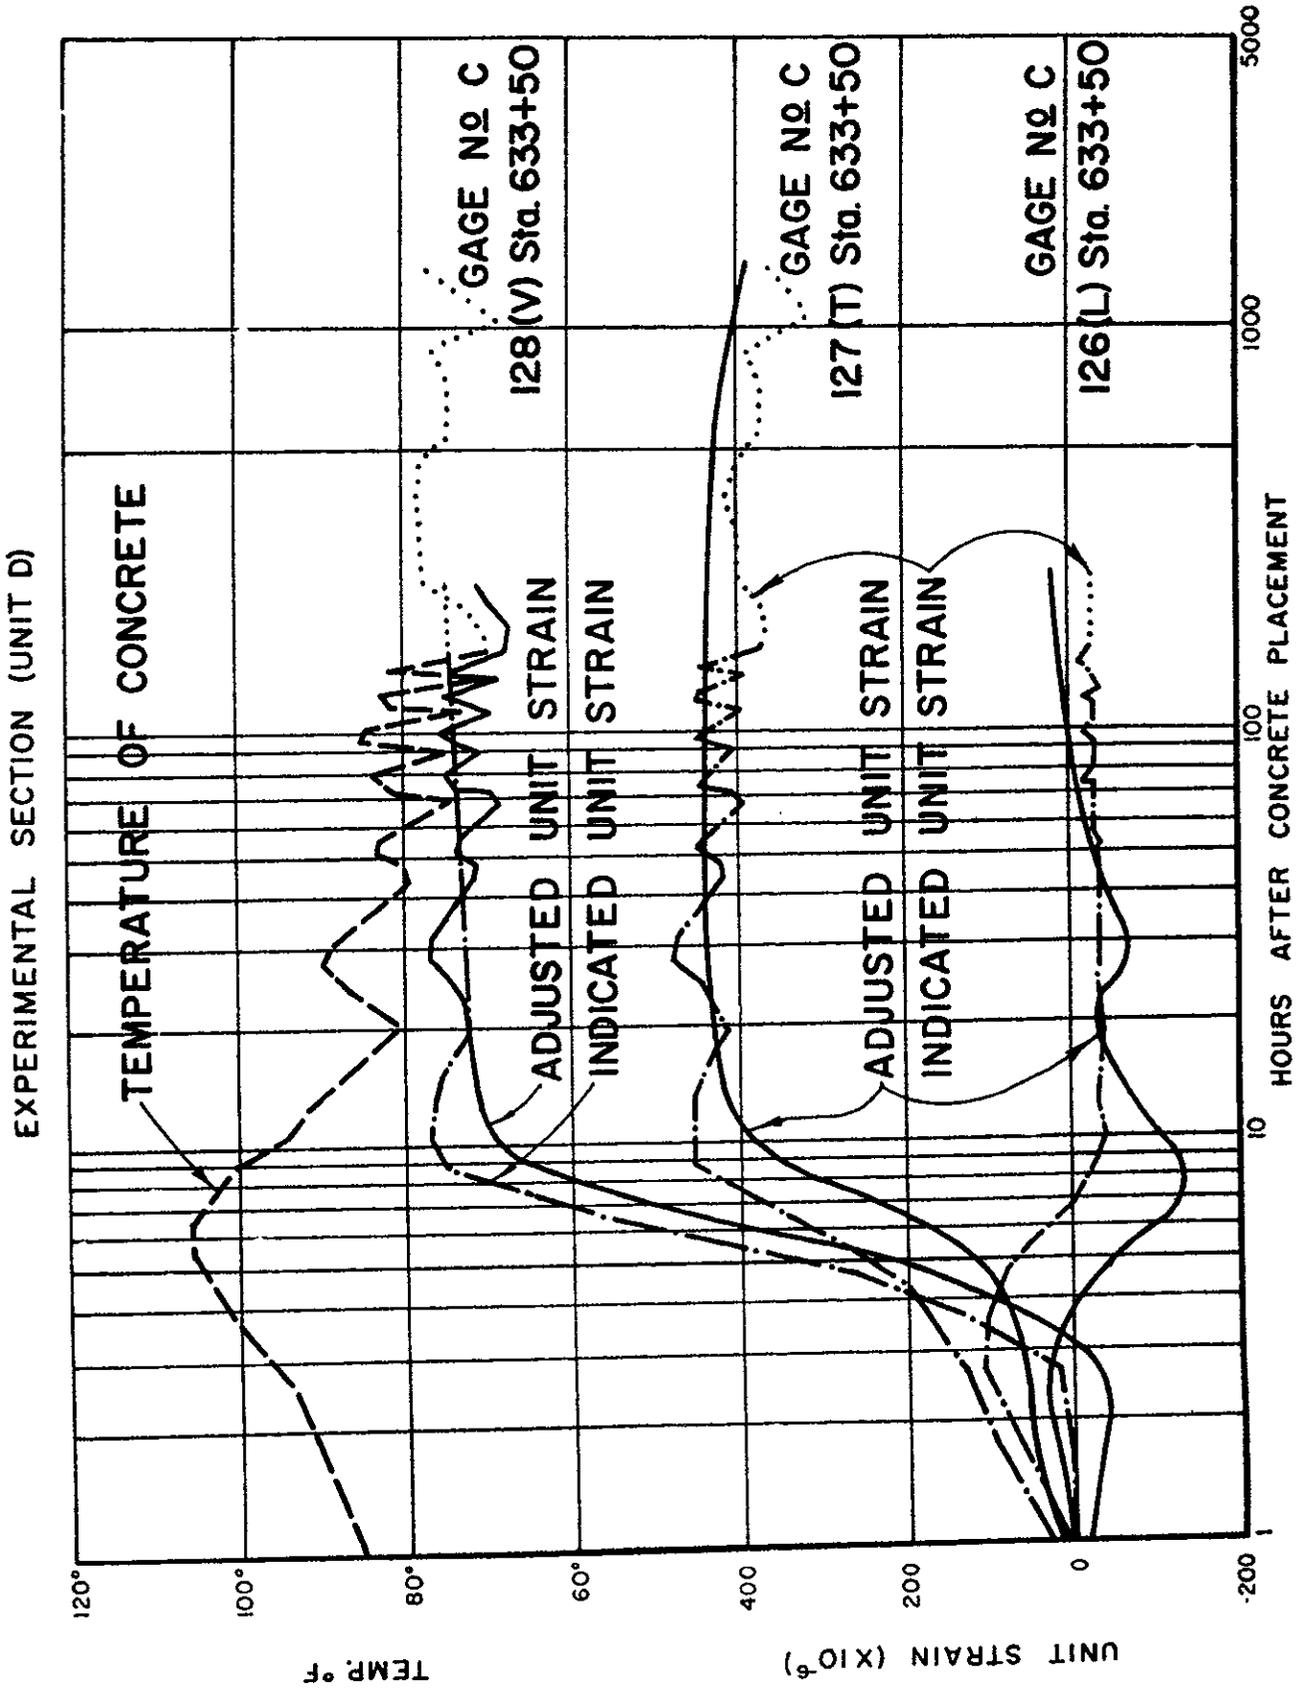
FIGURE 5

# CARLSON GAGE DATA - LODI FREEWAY

The vertical gage in Unit E was lost due to internal malfunction of the gage, but the other vertical gage (Unit D) indicated slightly less expansion than a similarly located gage on the Antelope Valley project. The transverse gages, on the other hand, indicate that a somewhat greater transverse expansion took place on the Lodi project.

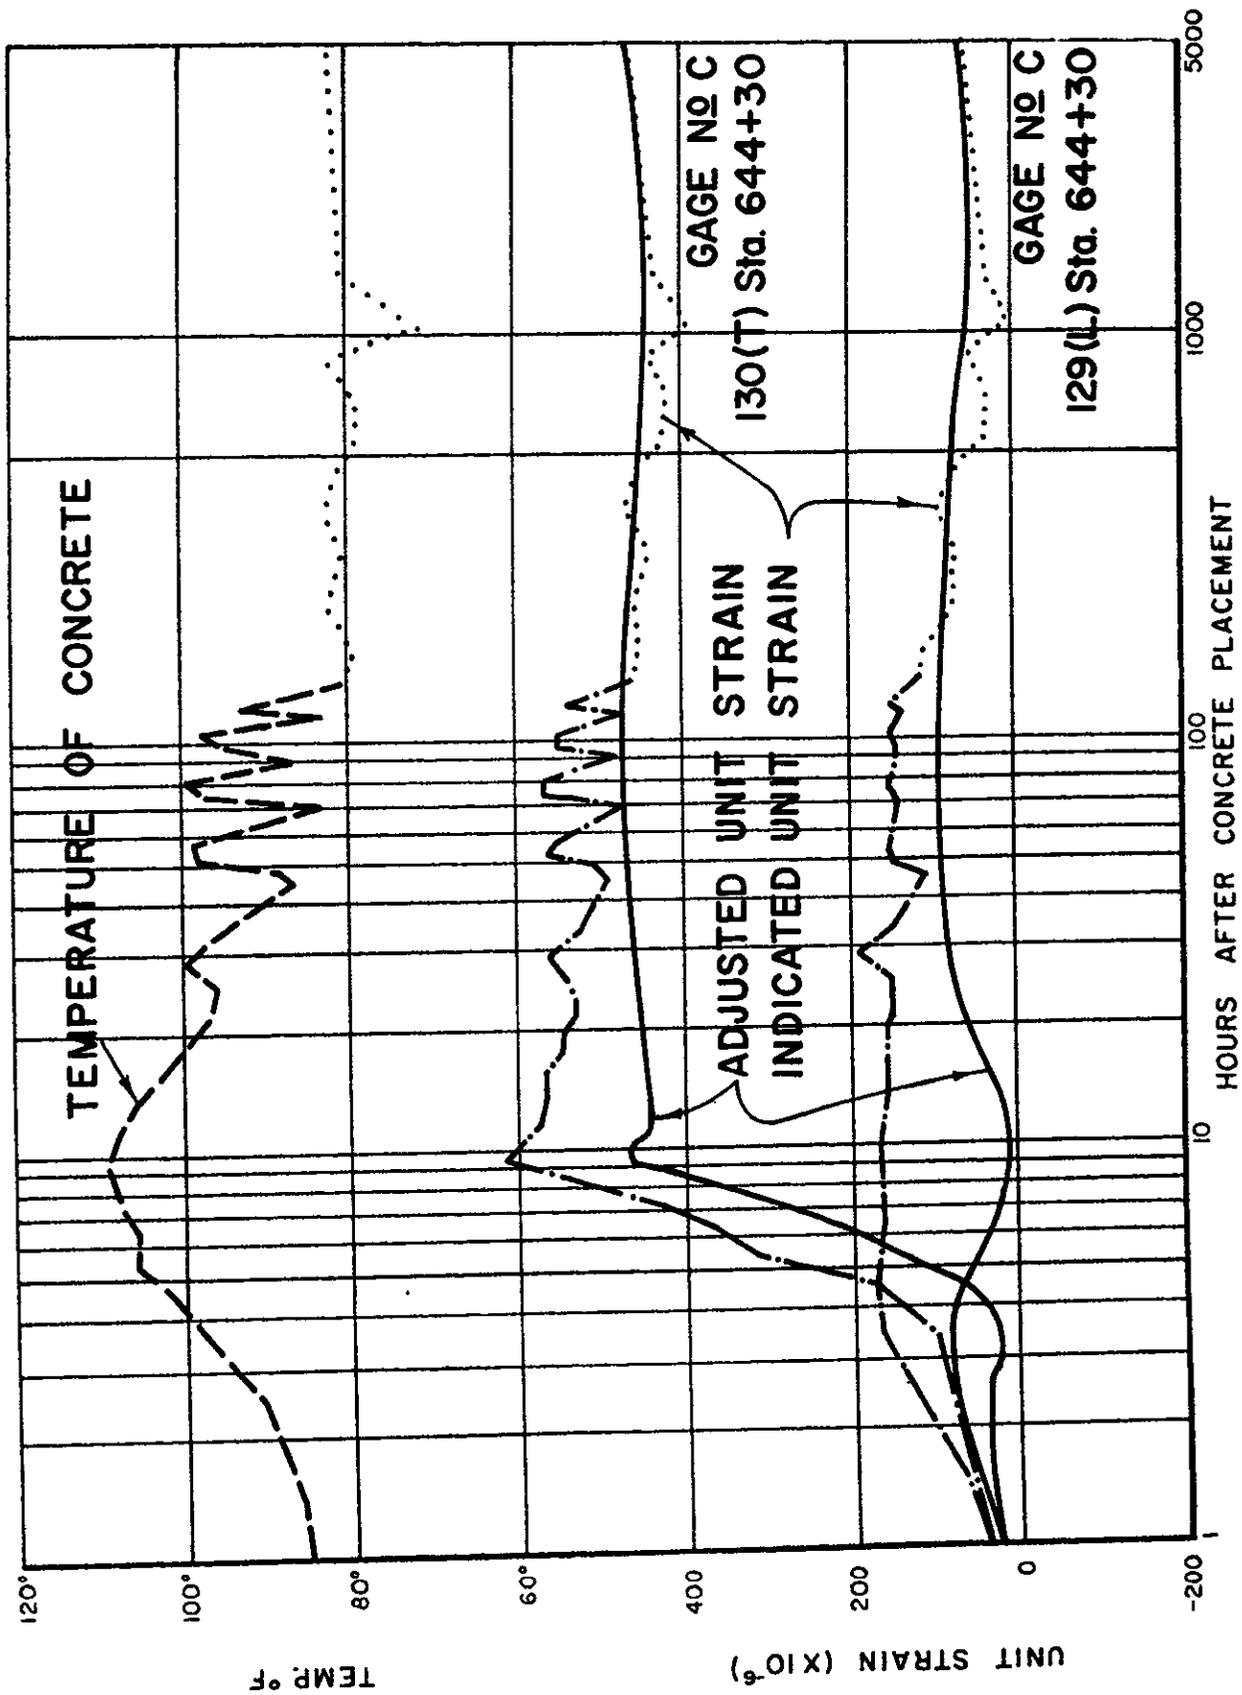
FIGURE 6

# CARLSON GAGE DATA - LODI FREEWAY

EXPERIMENTAL SECTION (UNIT E)

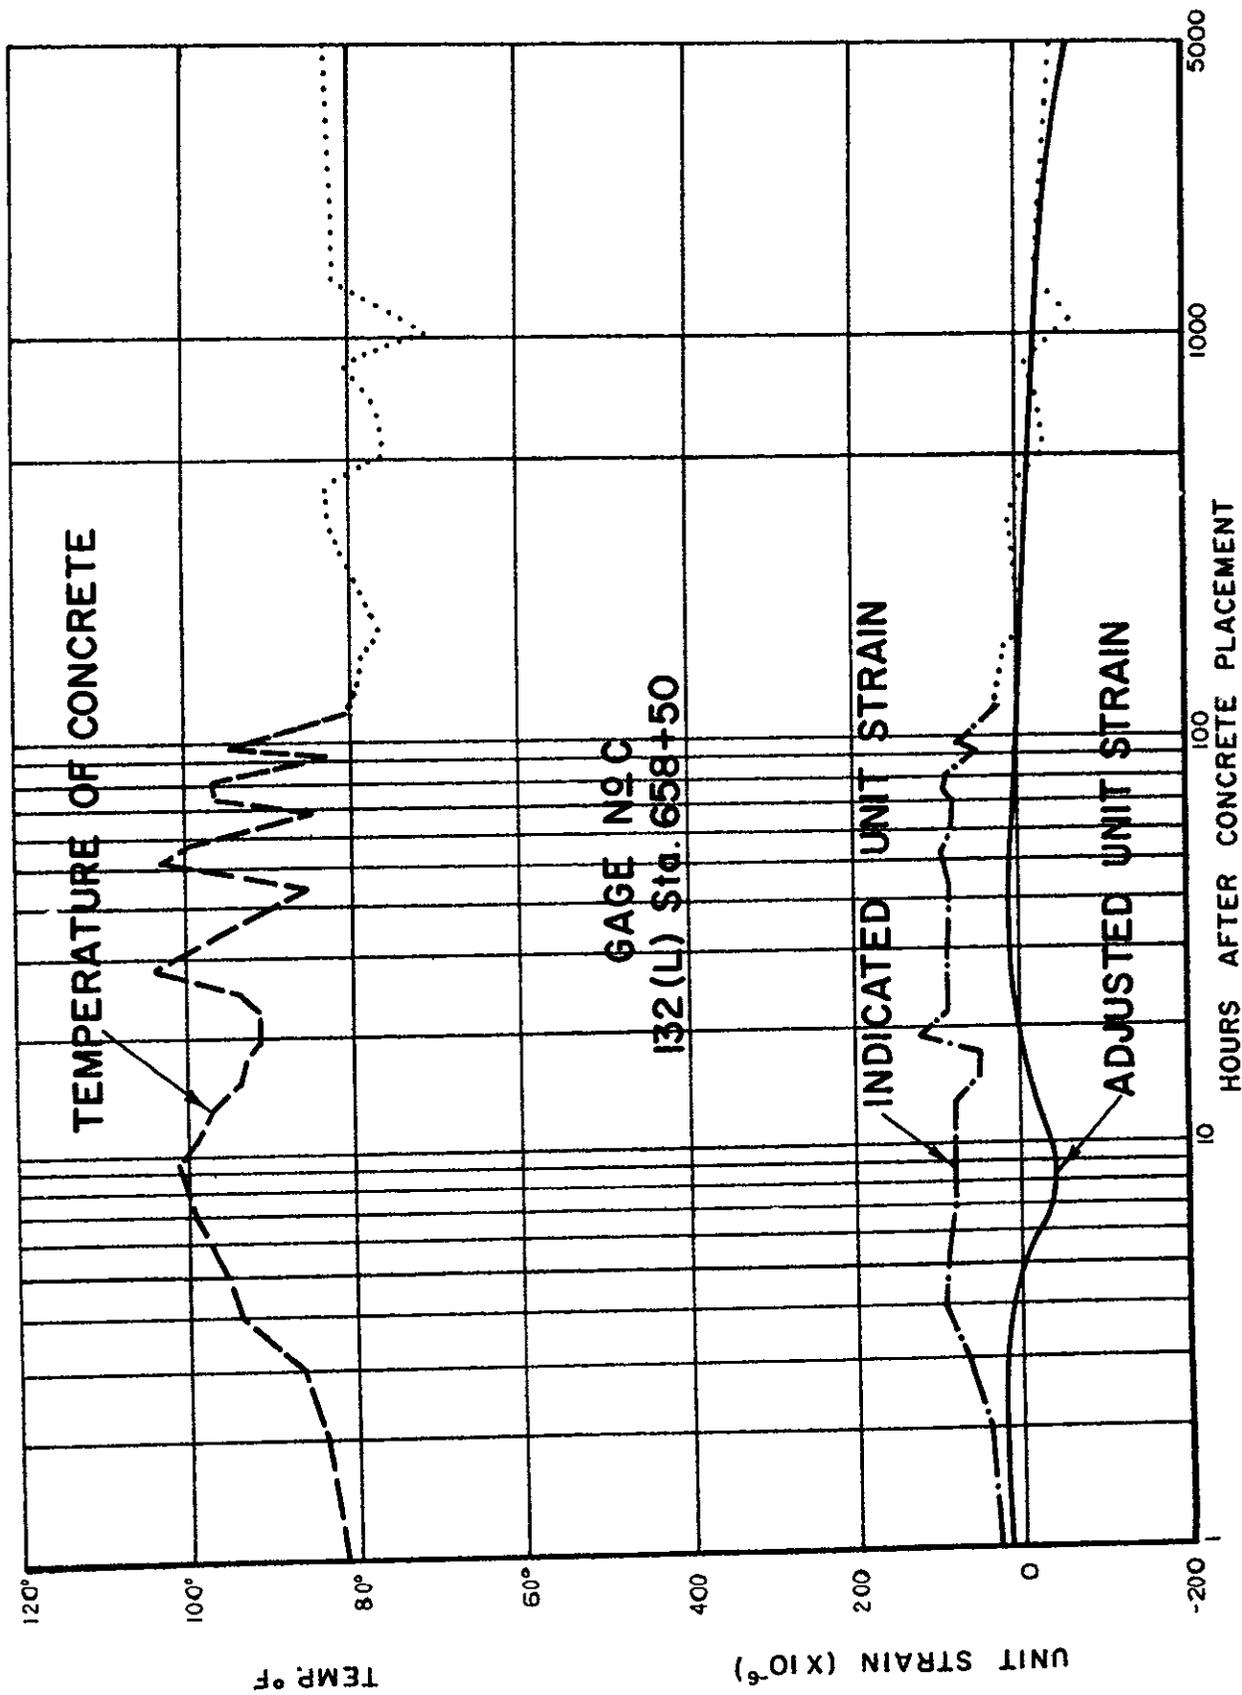
FIGURE 7

# CARLSON GAGE DATA - LODI FREEWAY

EXPERIMENTAL SECTION (UNIT F)

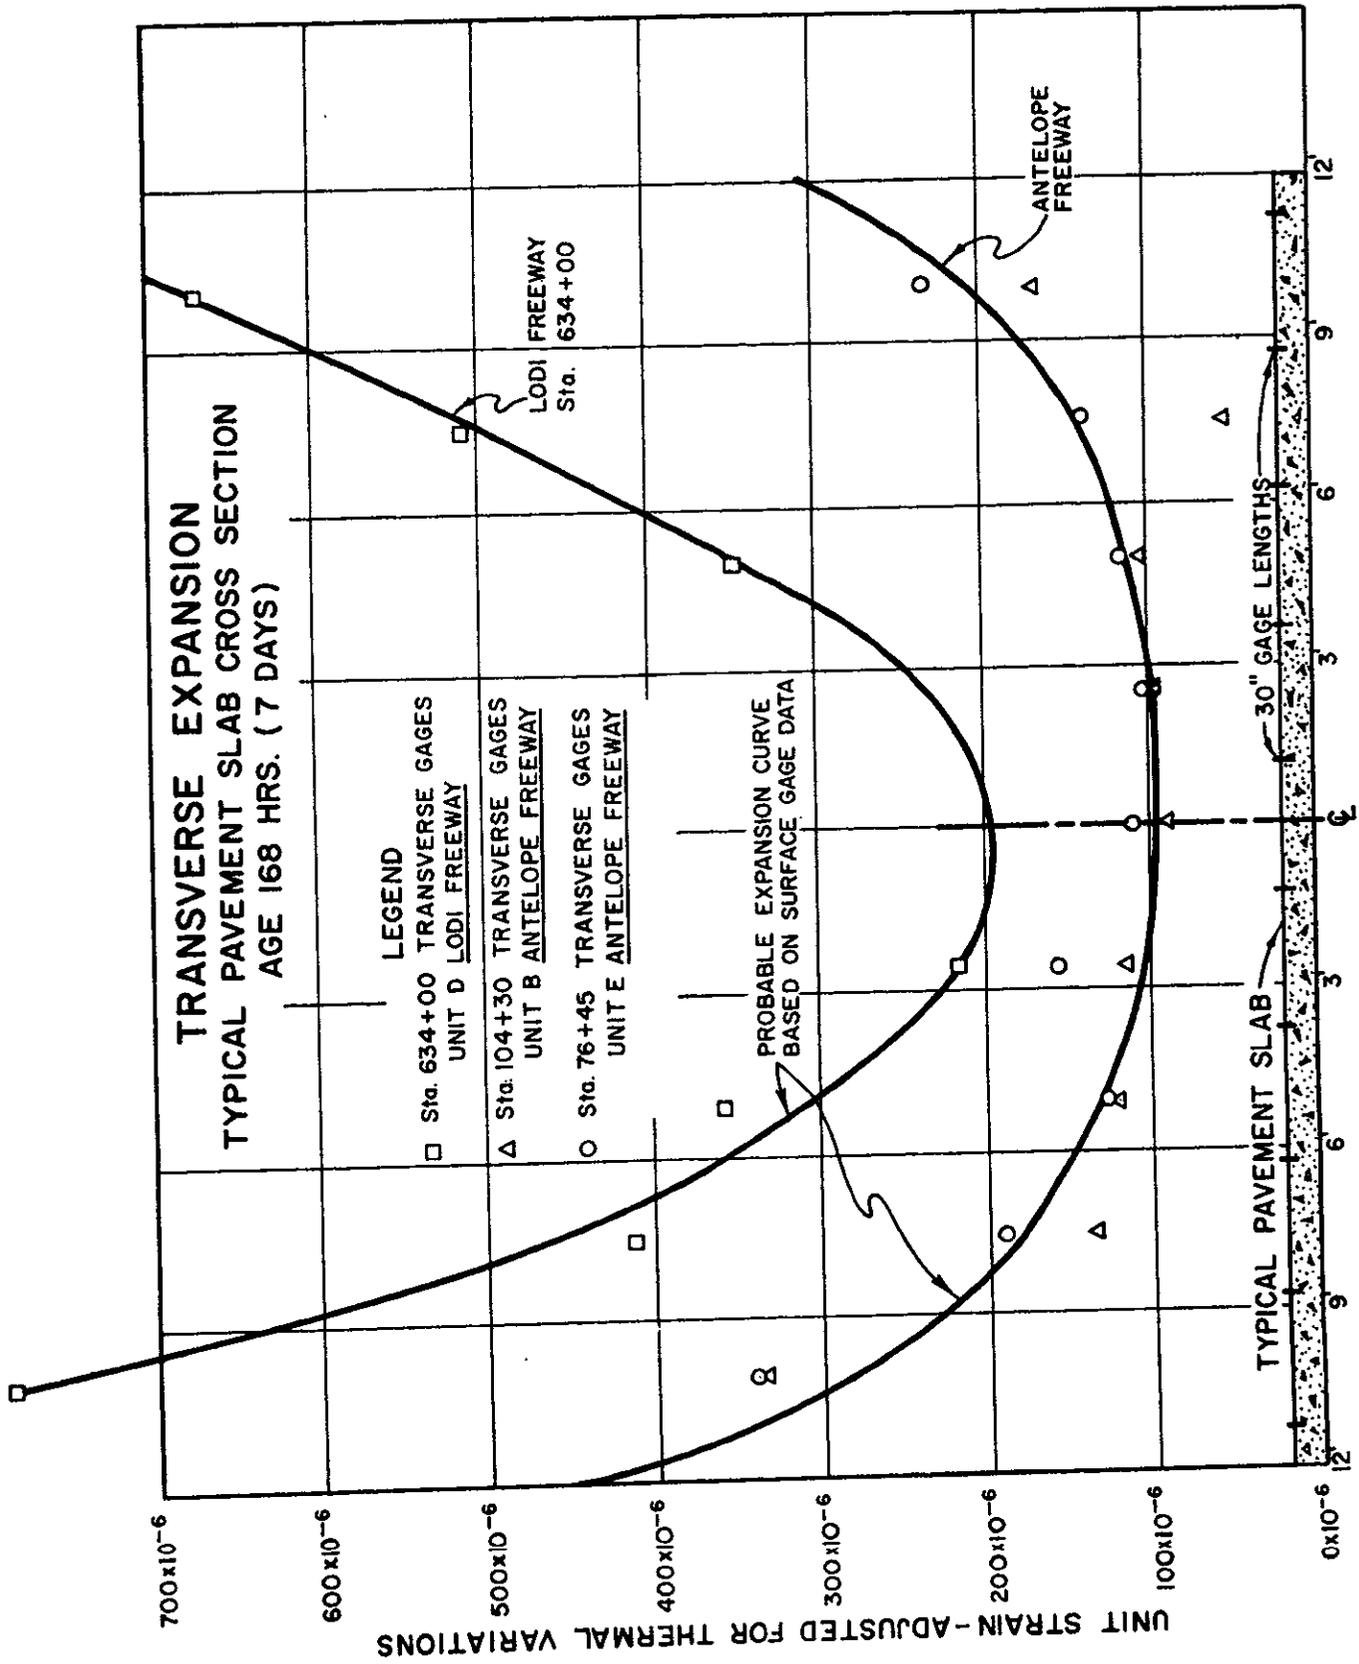
Figure 8

The longitudinally oriented surface gages indicated virtually no expansion which agrees with the Carlson gage data. The transverse surface gage expansion data obtained from Unit D was adjusted for thermal movements and is shown in Figure 8. Probable expansion curves are shown for both the Lodi and Antelope Valley projects. These curves indicate that considerably more transverse expansion took place at Lodi than at Antelope Valley. This condition was also noted, though to a lesser degree, in the data from transverse Carlson gages.

In the transverse direction, the unit expansion was greatest near the outer edges of the slab and least at the center of the slab. The tendency for expansion to take place is assumed to be

uniform throughout the width of the slab, with the resistance to expansion being developed by subgrade friction. The frictional force that must be overcome for any expansion to take place in a transverse direction is maximum at the center of the slab and minimum at the edges.

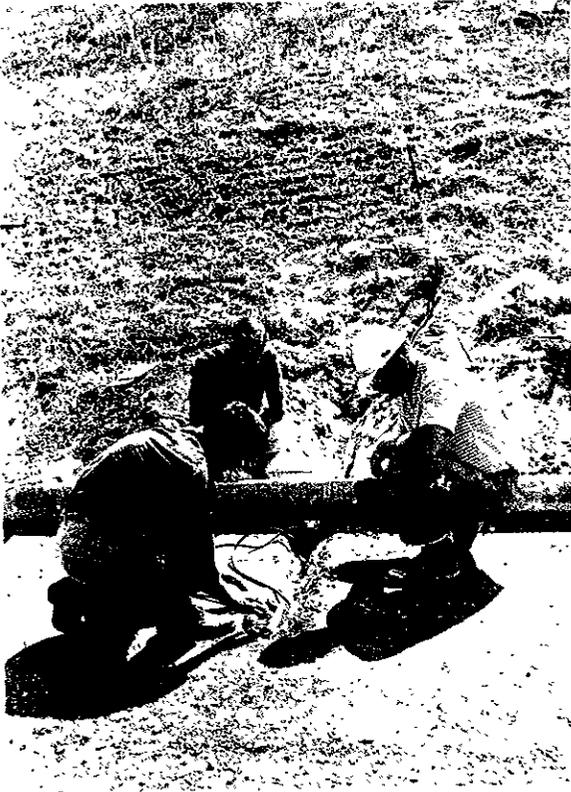
1. Placement of Carlson strain gages in subgrade trench for protection

The gages and lead wires were placed on the subgrade in advance of the paving. A canvas was placed over the gages and nailed to the subgrade to prevent their displacement while the concrete was being dumped from the paver. After the paving machine had passed, the gages were dug out of the fresh concrete and set in the desired position. The excavated concrete was then carefully replaced and compacted. (See photographs.) The lead wires were extended to a reading station approximately 5 feet outside the shoulder line and an initial reading was taken. A predetermined schedule of strain readings was followed.

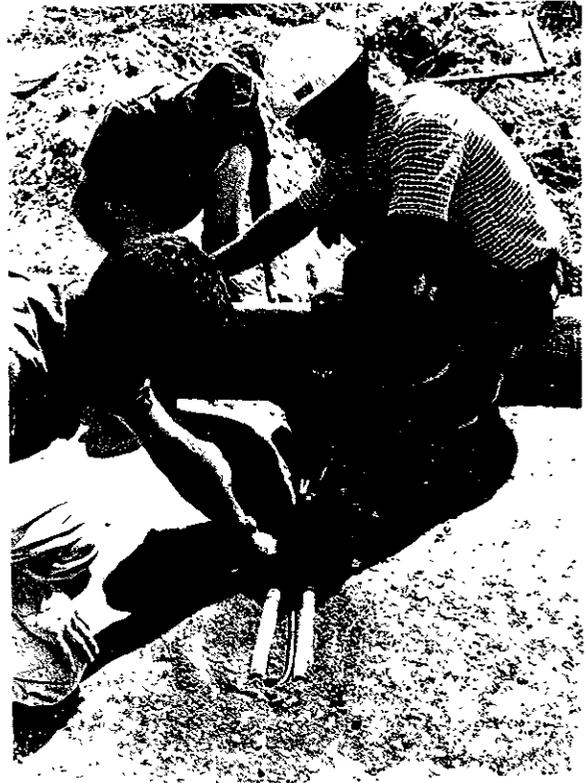
2. Close-up of Carlson gages

Actual unit strains and temperatures of the concrete in the test sections were determined by means of Carlson strain gages. These gages were placed near the longitudinal mid-point of the test units and at a distance of 3 feet from the outer edge of the pavement. (See Figure 1.) Where the Carlson gages were placed in a vertical position, it was necessary to excavate a shallow basin in the subgrade in advance of paving to accommodate their 10+-inch length, as the design thickness of the pavement was 8 inches. The gages oriented in a horizontal plane were located 4 inches below the surface of the concrete.

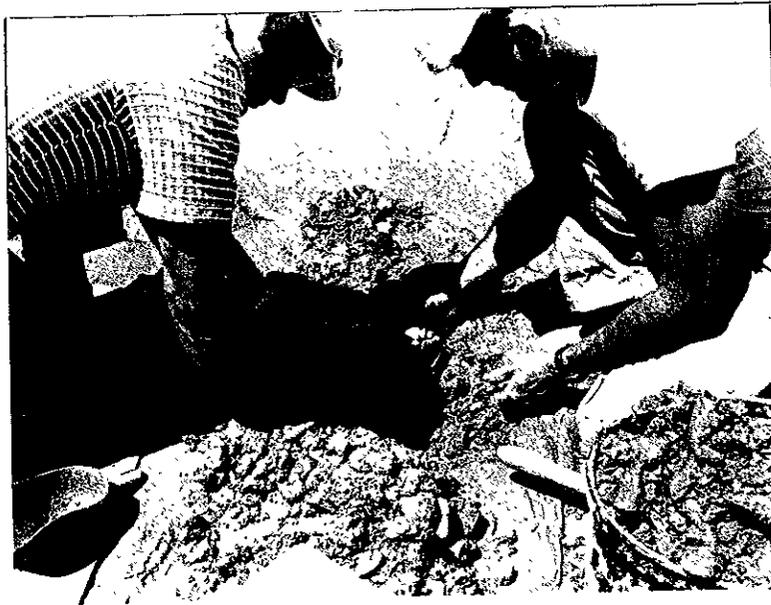
3. Orientation of longitudinal and transverse Carlson gages after concrete placement

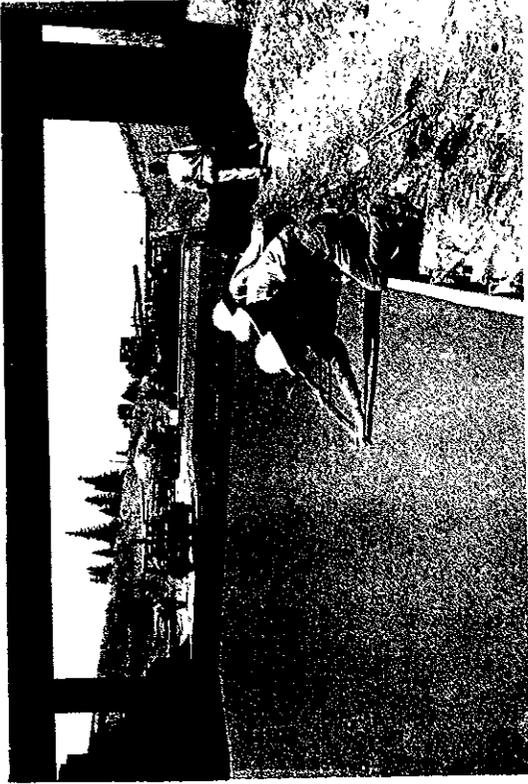
5. Positioning of longitudinal surface gage plugs for 30-inch extensometer measurements

The surface gage points consisted of brass plugs, 3/4-inch in diameter and 2 inches long, placed in the fresh concrete 30 inches apart. Each plug had a 1/16-inch diameter hole drilled in the top for receiving the point of a dial gage extensometer. Three sets of gage plugs were installed in each of the six units for measuring the longitudinal movement of the slab. These were installed in groups of three, spaced about 50 feet apart, giving a total of 6 gage lengths per unit. In addition, 10 gage plugs (9 gage lengths) were placed in Unit D for measuring transverse movement. (See Figure 1.)

The gage plugs were installed by the use of templates made of steel strap, when the concrete was about 2 hours old. Initial readings could not be taken until the concrete was about 6 hours old when it was determined that the plugs were secure enough to support the weight and manipulations of the extensometer without movement. Measurements were made to 0.0001-inch over a 30-inch

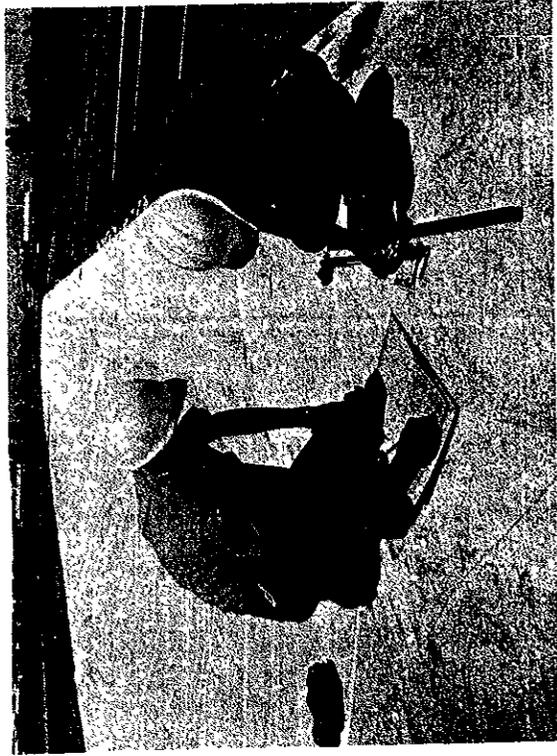
6. Engineers obtaining extensometer measurements at a longitudinal surface gage installation

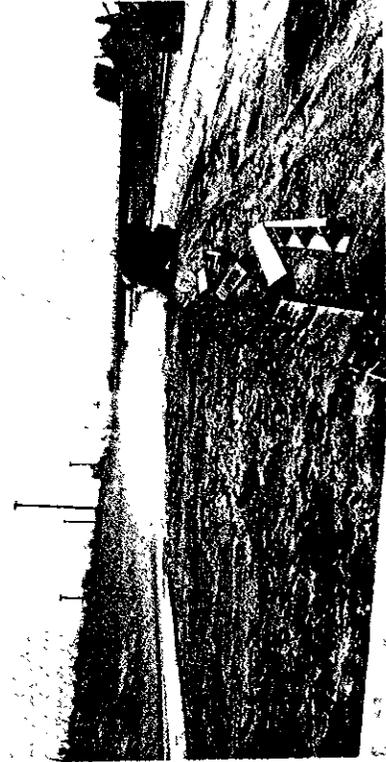
14. Watering of earth blanket

Units C and D were cured by covering the pavement with an earth blanket, starting when the concrete was about 6 hours old. The material used was fine-grained sandy silt, taken from the median area adjacent to the pavement. A backhoe and a power shovel were used to place the earth on the pavement, but hand labor was necessary to spread the material to form a 2 to 4 inch blanket. This procedure was inefficient, and had longer units been involved, more suitable methods of distributing the earth would have been necessary. Some of the concrete was about 24 hours old before all the earth blanket was applied. The use of a water truck "around the clock" was required to keep the pavement surface wet until all the earth blanket was placed. The earth cover was then kept wet by subsequent application of water during the 7-day curing period. (See photographs.) At the end of the 7-day curing period, the earth was removed by a power grader, a broom, and water spray.

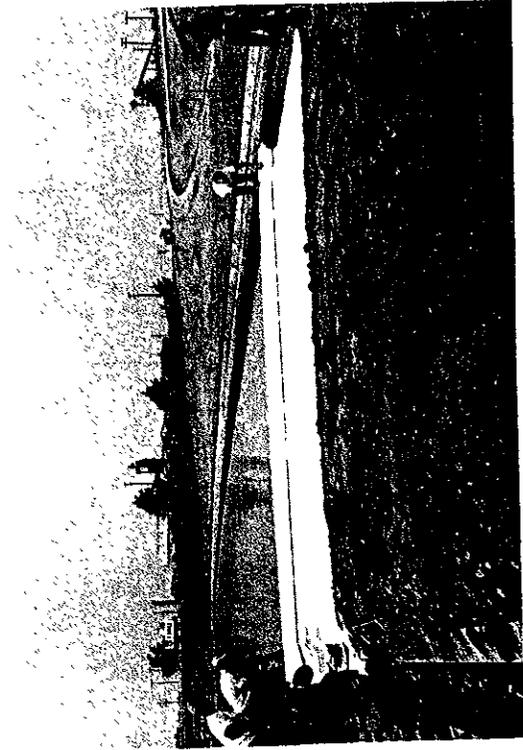
17. Beginning of polyethylene covering operation

The concrete in Units A, B, E, and F, was cured with white polyethylene sheets, 4 mils in thickness, applied 4-6 hours after the concrete was placed. The delay in application was to allow the concrete to "set" sufficiently to prevent deformation by the plastic sheeting and the creation of smooth, slick surfaces on the pavement. To prevent excess surface evaporation during the delay period, the concrete was kept wet by a fog spray from water trucks. The plastic sheeting, 28 feet wide, was unrolled by hand and the edges were banked with lumber and earth. (See photographs.) The sheeting was removed at the end of the 7-day curing period.

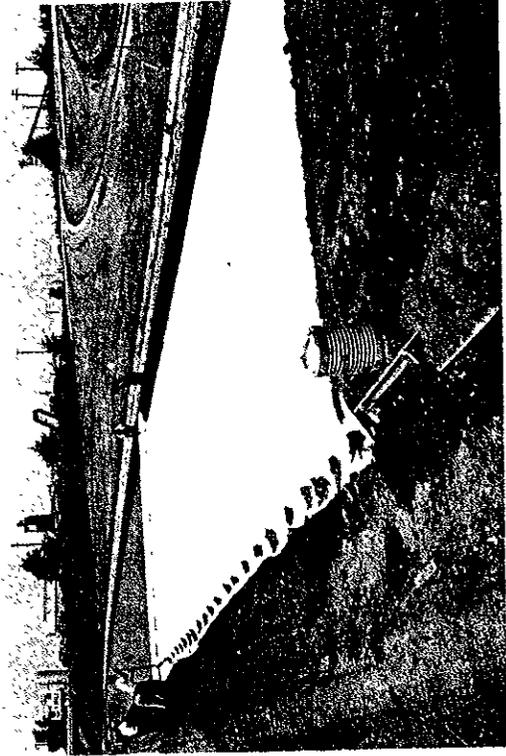
18. Continuation of covering operation with earth placement along edges
