Silt-Sand And Dust From Winter Maintenance Operations-  
Lake Tahoe Basin Study

LAKE TAHOE BASIN STUDY

Silt, Sand and Dust from Winter Maintenance Operations

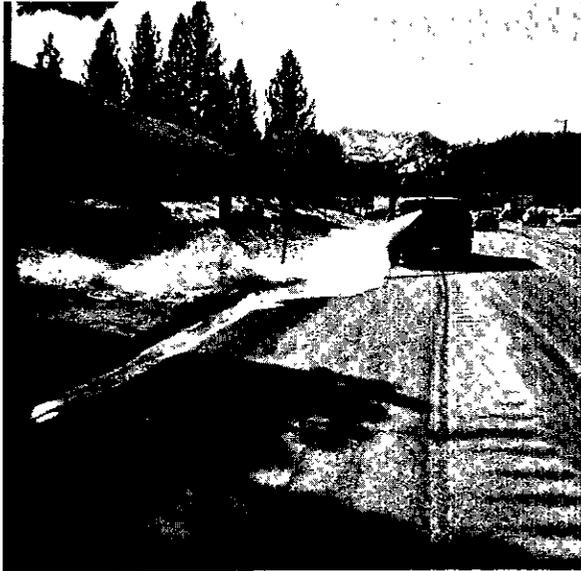
ED-50-SLT Use of high pressure nozzle on pumper proved unsatisfactory for urban areas. Note mud being splashed onto adjacent property.

A 3,500 gallon water truck with a high pressure pump and nozzle mounted on the front was used in an attempt to remove debris without causing dust in the South Lake Tahoe area.

The result was unsatisfactory for use in this area due to the excessive amount of silt-carrying water which resulted. It also threw the muddy water onto adjacent properties (see picture - Plate I).

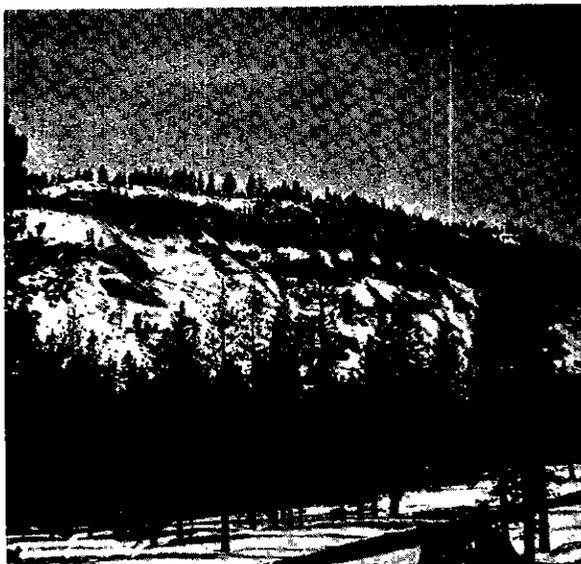
ED-50-Echo An example of the dirty snow in an area where cinders are used.

Complaints have also been received from residents in the Echo Summit area regarding the use of cinders. It is claimed that the cinders do not lend themselves as readily to being carried away by wind and water action and therefore tend to build up along the road, causing an unsightly appearance and inhibiting plant growth.
