Bridge Deck Rideability

# HIGHWAY RESEARCH REPORT

## BRIDGE DECK RIDEABILITY

**CA-DOT-TL-5287-1-74-21**

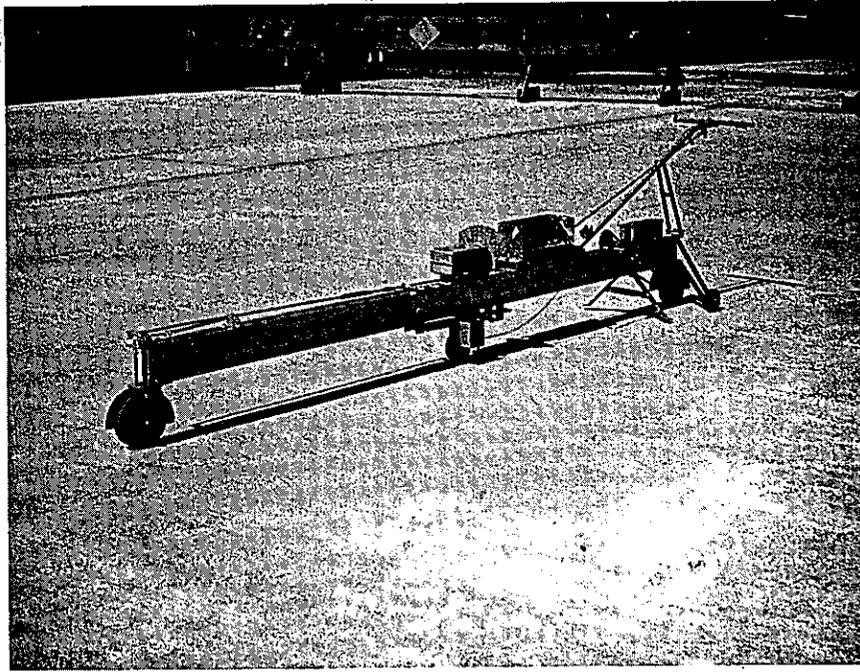
Figure 1. A modified Hi-Lo Detector (Bridge Profilograph) with recorder. It is 12 feet long and separates into two pieces for easy transport.

A Hi-Lo Detector was purchased from Soil Test Incorporated (see Figure 1) and was modified for use with a continuous strip chart recorder from a California 25-foot Profilograph.
