FHWA/CA-TL-86/03

Revegetation of Highway Slopes in the High Desert with Native Plant Seedlings

Interim 1982-1985

REVEGETATION OF HIGHWAY SLOPES
IN THE HIGH DESERT
WITH NATIVE PLANT SEEDLINGS:
INTERIM REPORT

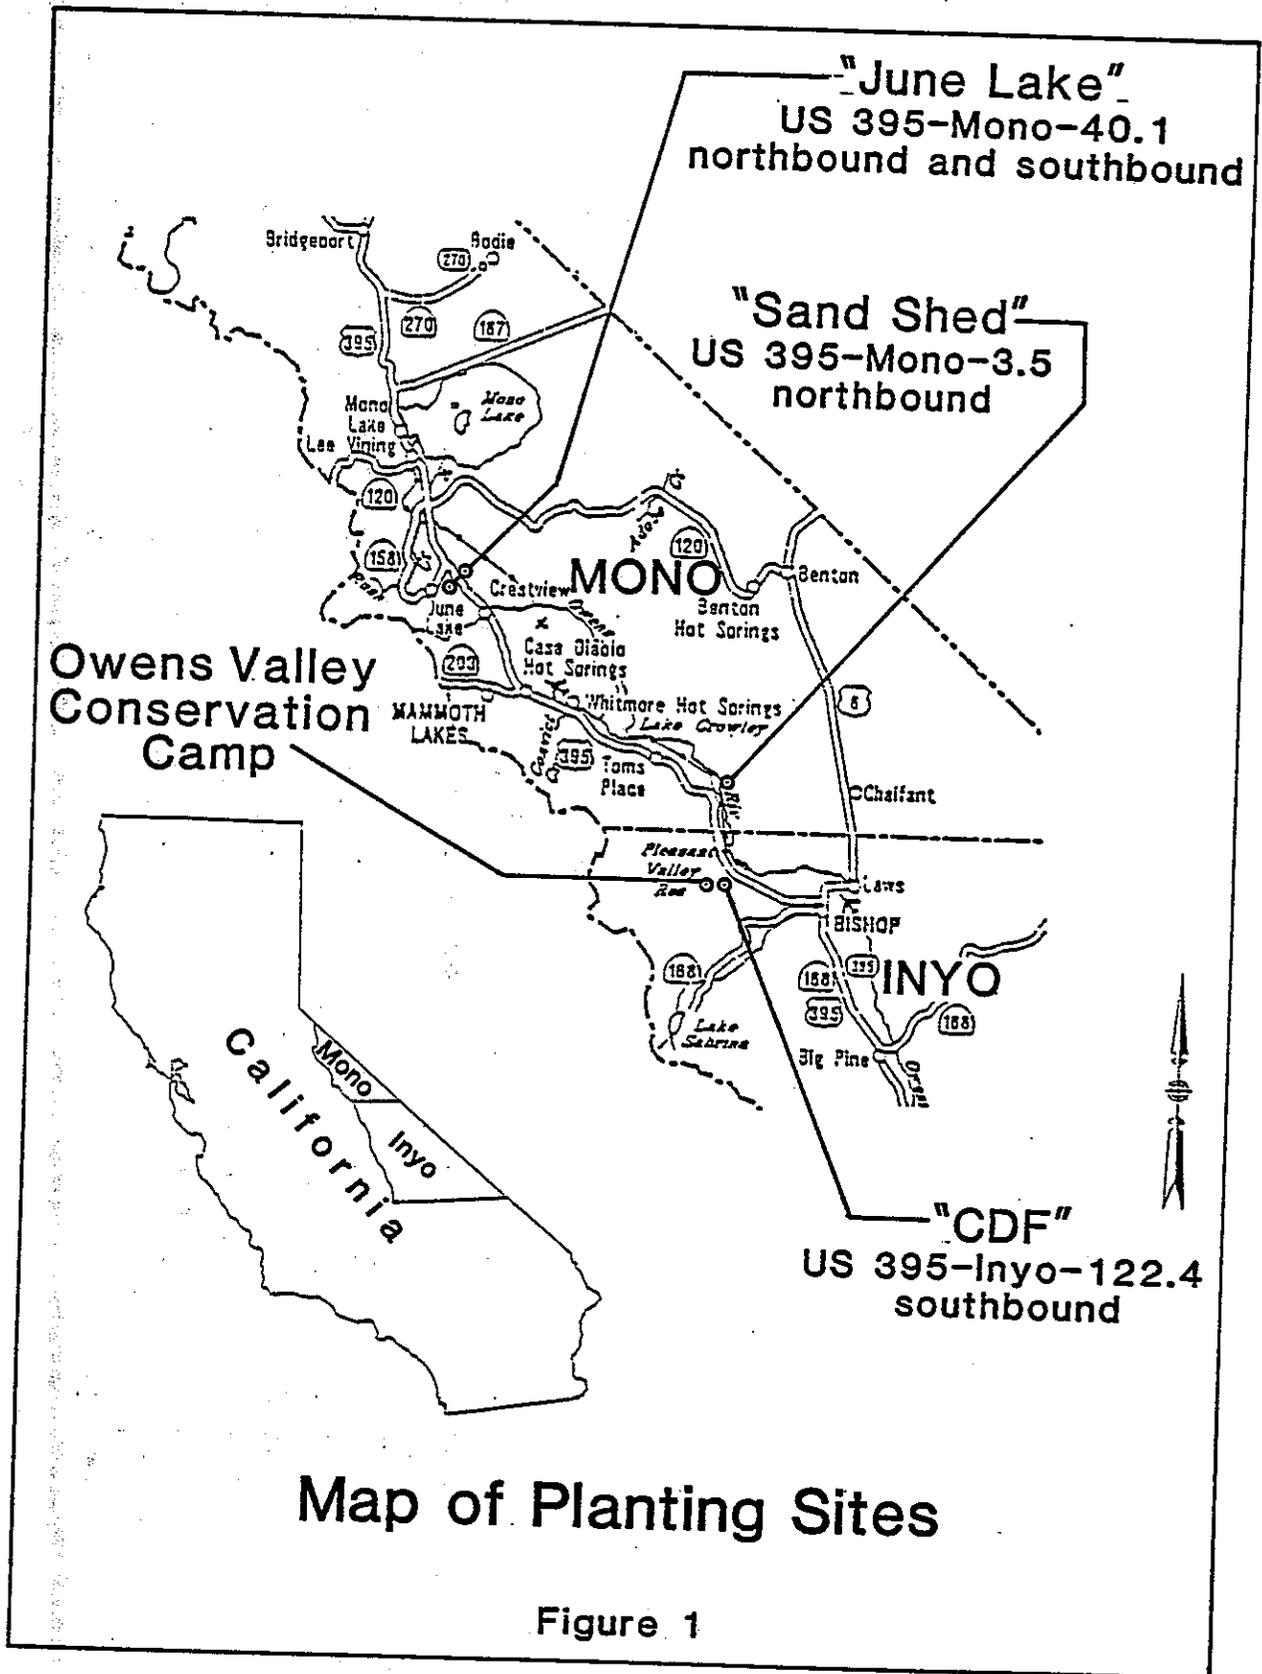
Figure 1 is a location map of the planting sites. Cut slopes, approximately twelve years old, were selected, where natural invasion of woody shrubs was progressing slowly.

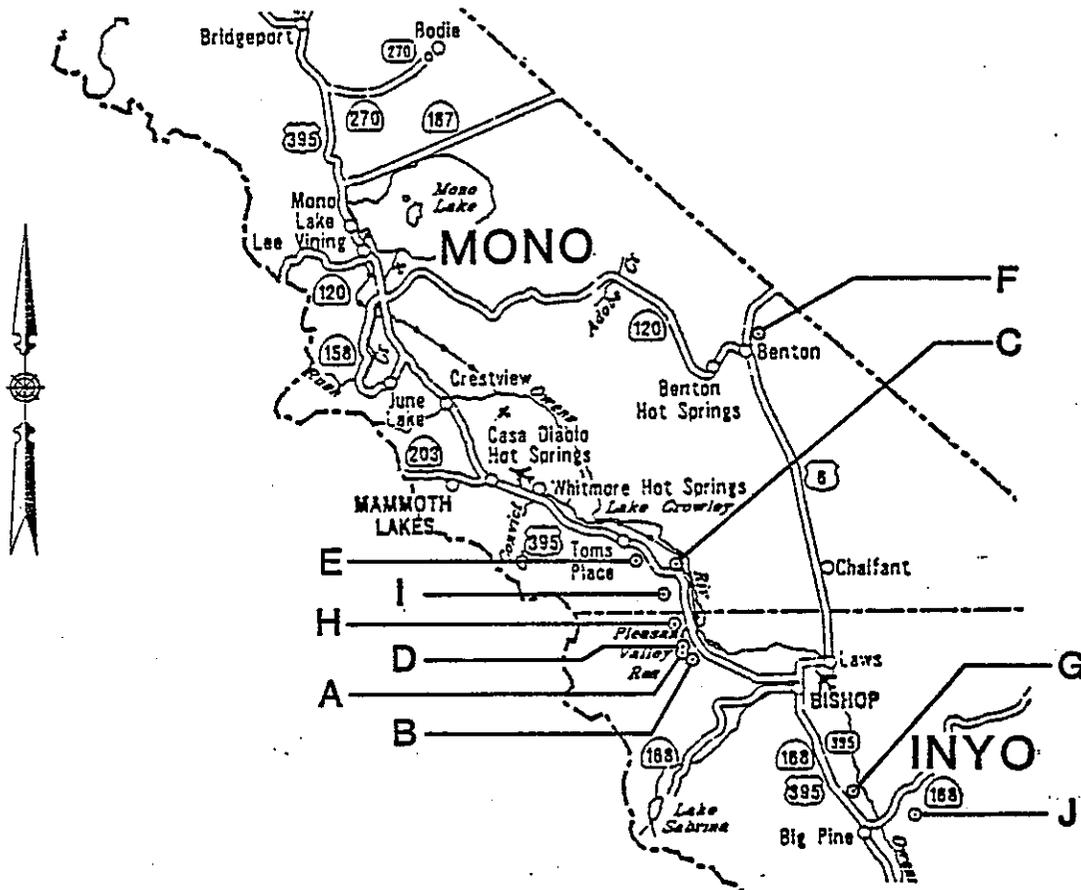
<u>Site</u>	<u>S p e c i e s</u>
A	<i>Chrysothamnus nauseosus, Artemisia tridentata</i>
B	<i>Chrysothamnus nauseosus, Artemisia tridentata</i>
C	<i>Chrysothamnus nauseosus</i>
D	<i>Artemisia tridentata, Ephedra nevadensis</i>
E	<i>Artemisia tridentata</i>
F	<i>Ephedra nevadensis</i>
G	<i>Atriplex canescens</i>
H	<i>Purshia tridentata</i>
I	<i>Purshia tridentata</i>
J	<i>Atriplex canescens</i>

Map of Sites for "Seed Collected Locally"

Tables A-1 through A-5 in the Appendix show detailed data of sources (county, state, landmark, elevation), dates of seed collection, and dates of seedling propagation. Figure 2 is a map of sites for seed collected locally. In Table A-5 the sites are cross-referenced to Figure 2.

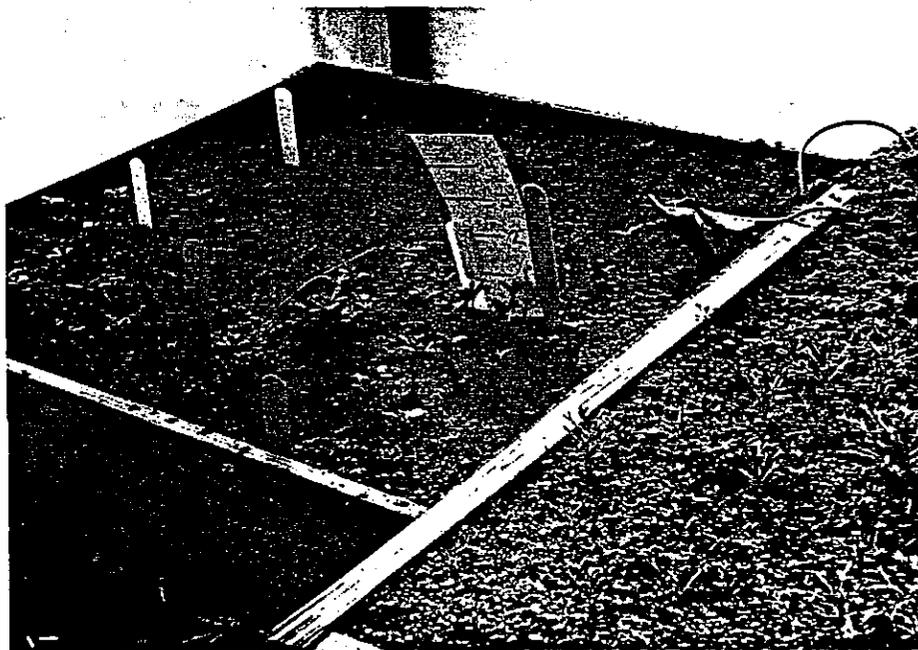
5B Flat With Seedlings

Antelope bitterbrush seeds were pretreated before planting in flats or roottrainers by COOL-MOIST STRATIFICATION, (Young and Evans, 9). Seeds were placed in plastic petri dishes (6-inch diameter with lids) in a refrigerator for 4 to 6 weeks. The petri dish was lined with moist charcoal and covered with an inert membrane (a disc of clean, panty hose) to keep the seeds out of the charcoal. One layer of seeds (approximately 100) was placed on the panty hose. Paper-towel discs were tried but did not work well, because mold grew on them. When white tips (root radicles) appeared, the seeds were planted either directly in bookbinder roottrainers or raised in flats and then transplanted to roottrainers. See Figure 5.

The soil used in the flats and roottrainers was a mixture of 7 parts peat moss and 10 parts sand. The sand was purchased from a local quarry and the peat moss was purchased from a local nursery. Slow release fertilizer (Osmicote, 18-17-10) was added to the planting mixture according to the instructions.

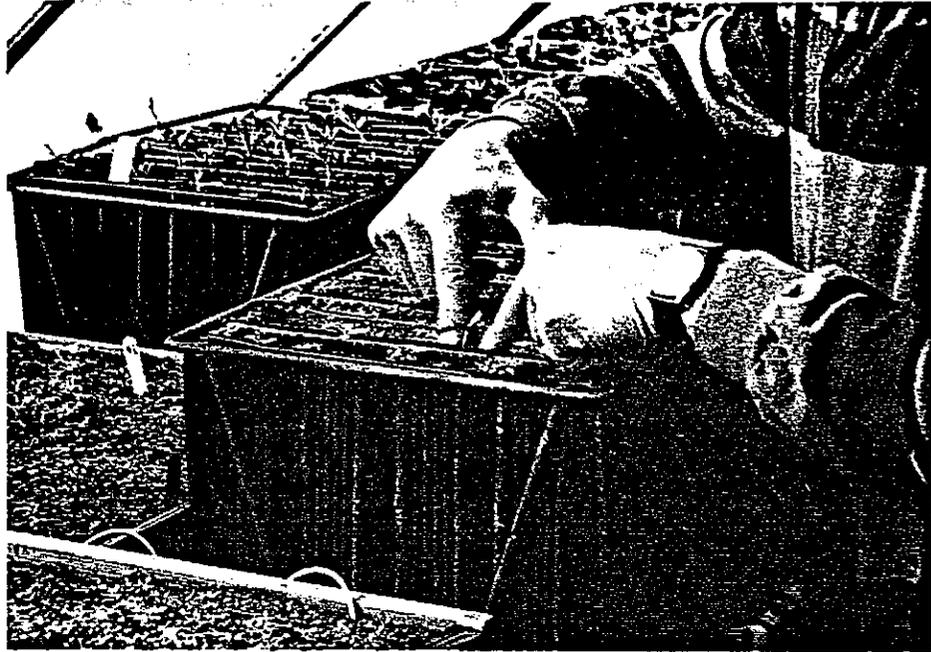
6A Transplanting Bitterbrush Seedlings

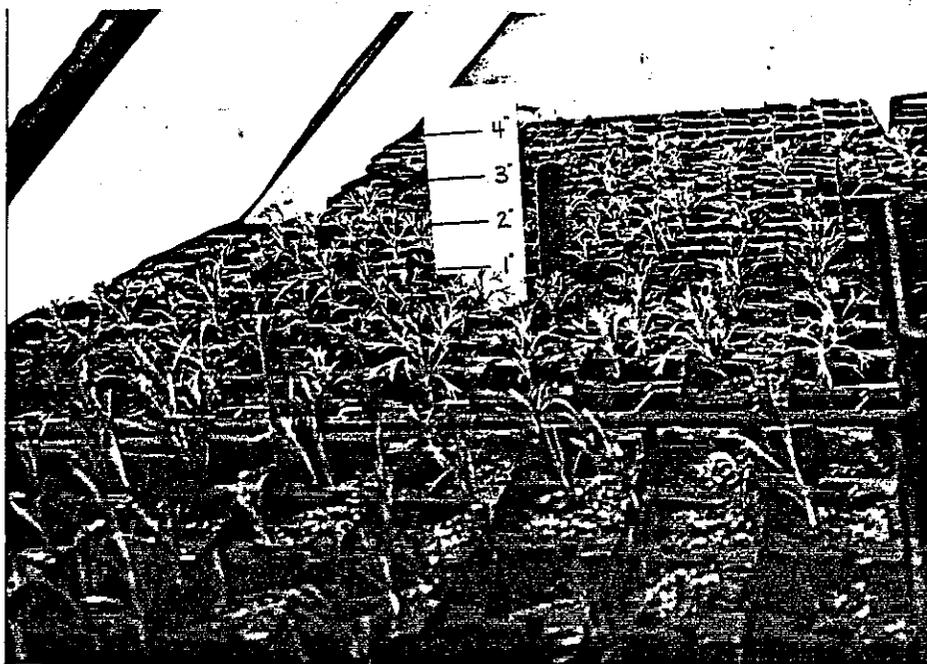
6B Bitterbrush Seedlings

Figure 6 shows photographs of bitterbrush being transplanted to a roottrainer and 1-inch tall seedlings in a rack. Figure 7 shows sagebrush and saltbush seedlings in completed racks. Figure 8 shows rabbitbrush and ephedra seedlings in completed racks.

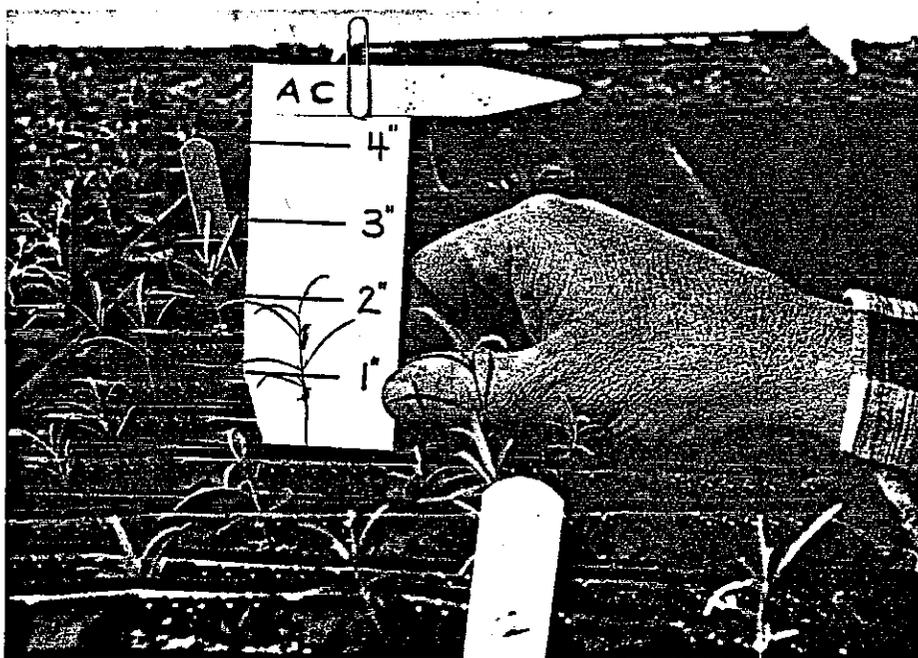
Figure 7

7A Big Sagebrush Seedlings (Artemisia tridentata)

7B Fourwing Saltbush Seedlings (Atriplex canescens)

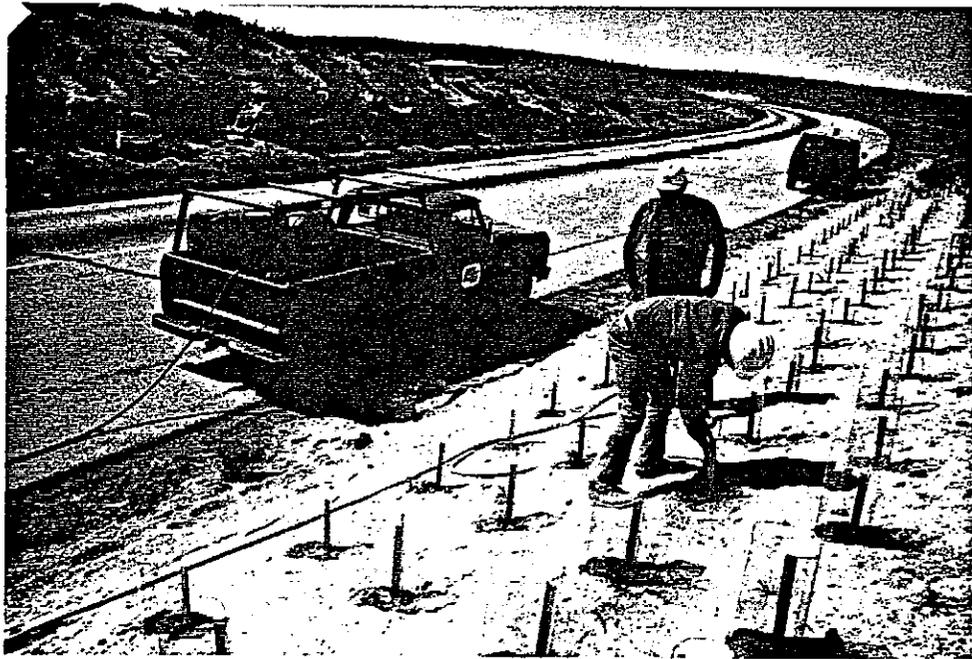
Figure 12

Watering Rig

A soil probe should be used for watering the root mass in soils with slow percolation rates, instead of surface watering in basins. A soil probe can be made from a 3/8-inch diameter by 8-inch long steel spike attached to a sawed-off shovel handle.

At six week intervals from the dates of planting until November, 1984, half the plants at each site were given one quart of water, using the soil probe. The watering rig was a skid-mounted, 100-foot hose and reel with a battery powered, 3-gallon per minute, diaphragm pump. Three, plastic 55-gallon drums held water. The watering rig was hauled in a 3/4-ton pick-up truck. See Figure 12.

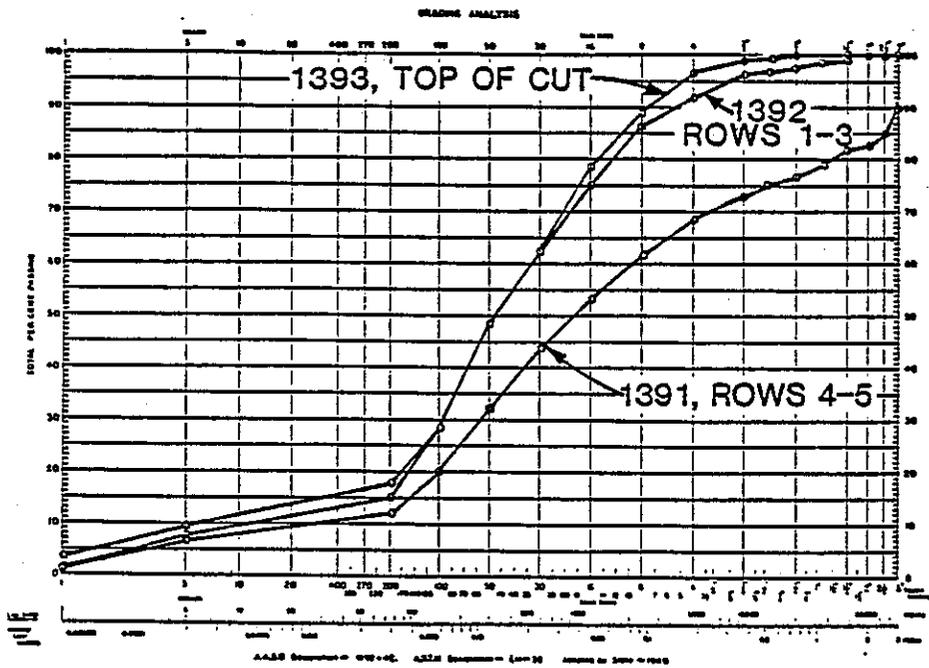
A-9B - June Lake Site, Southbound

GRADATION PLOTS, June Lake

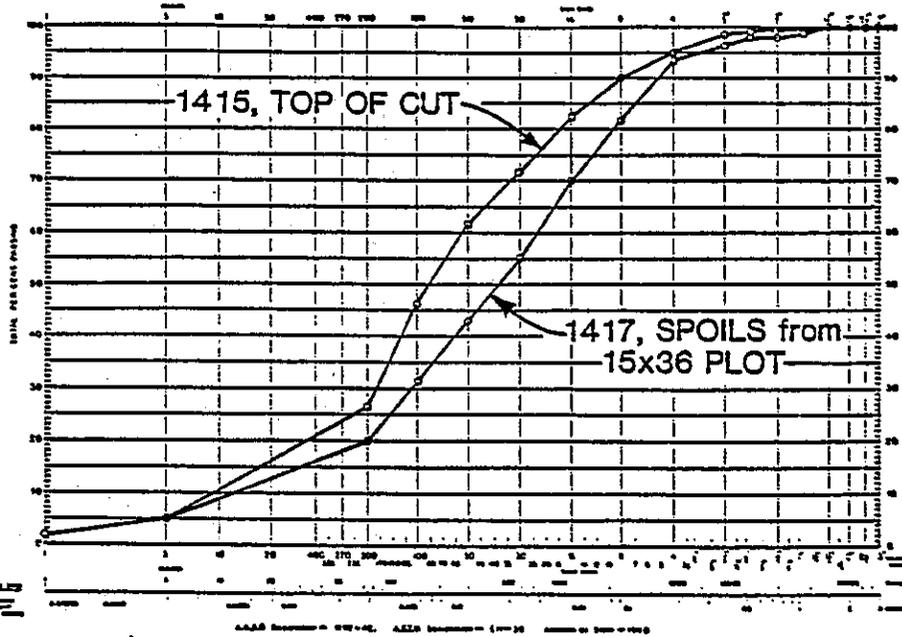
GRADATION ANALYSIS

GRADATION PLOTS, Sand Shed and CDF

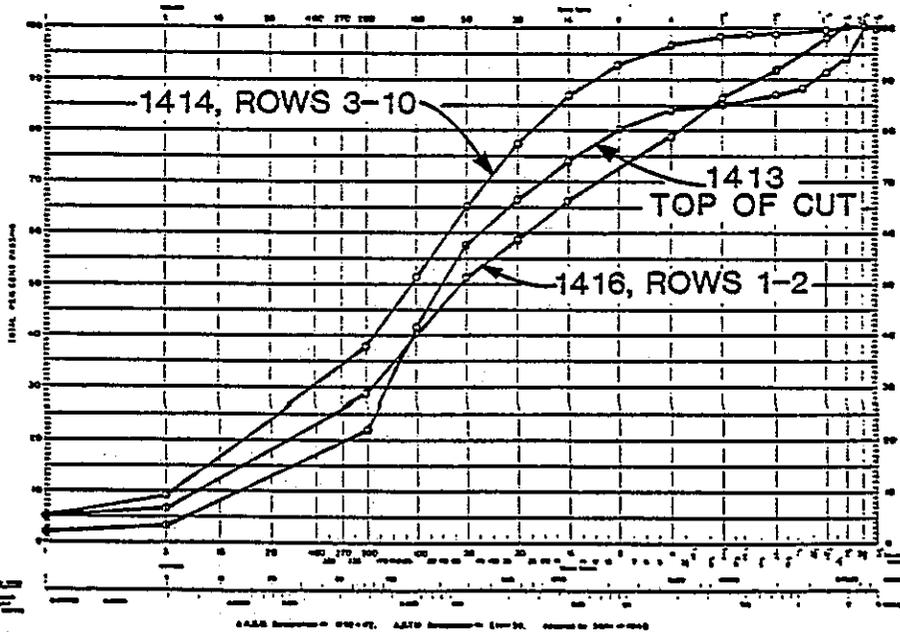
A-10B - CDF Site

GRADATION ANALYSIS
